# Great Lawn Tree Damage

# Barton Springs Pool Tree Court

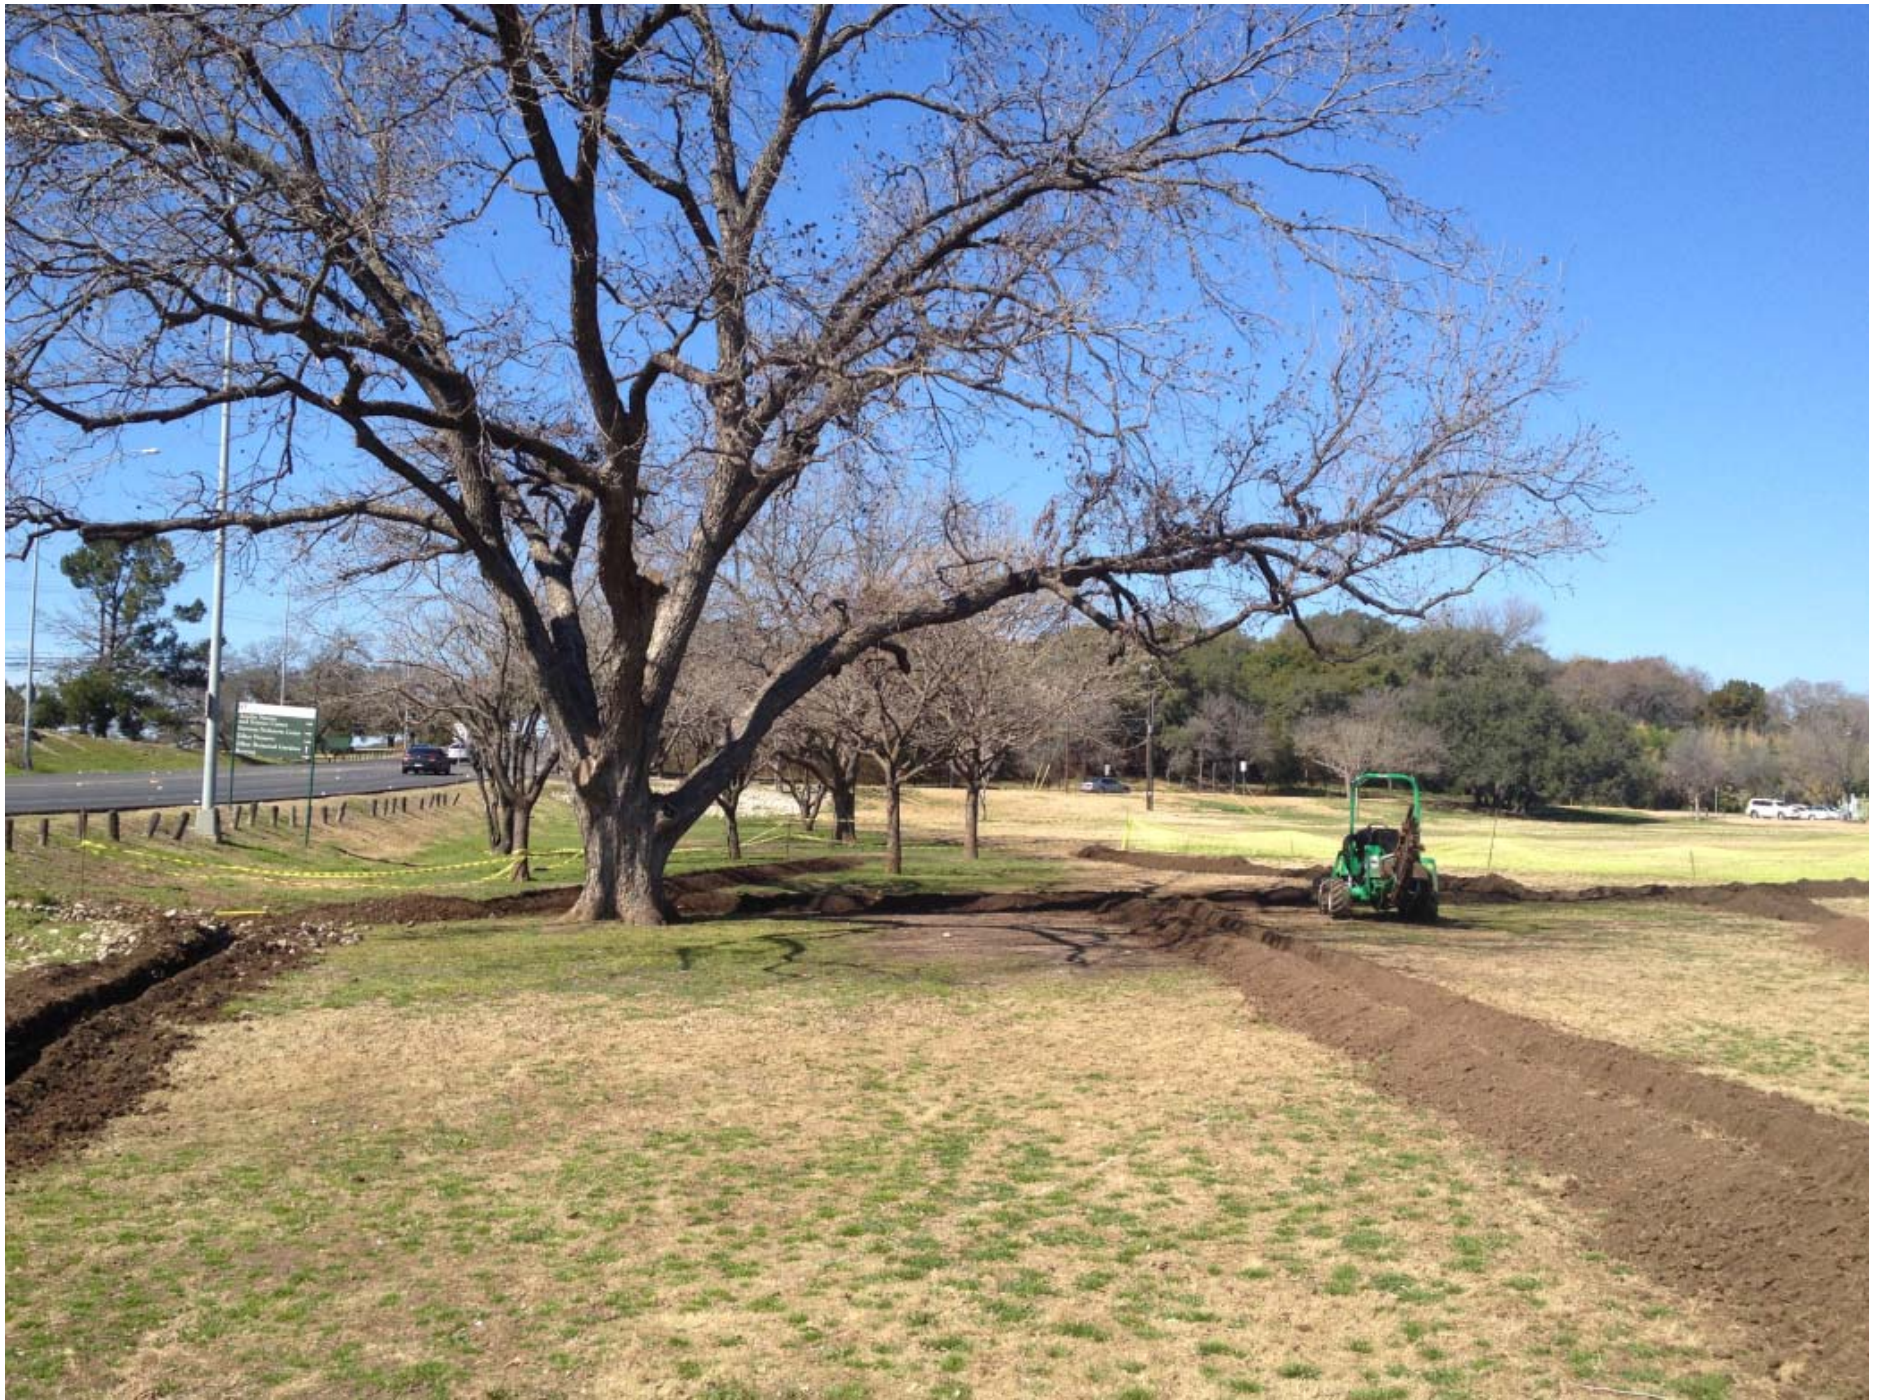
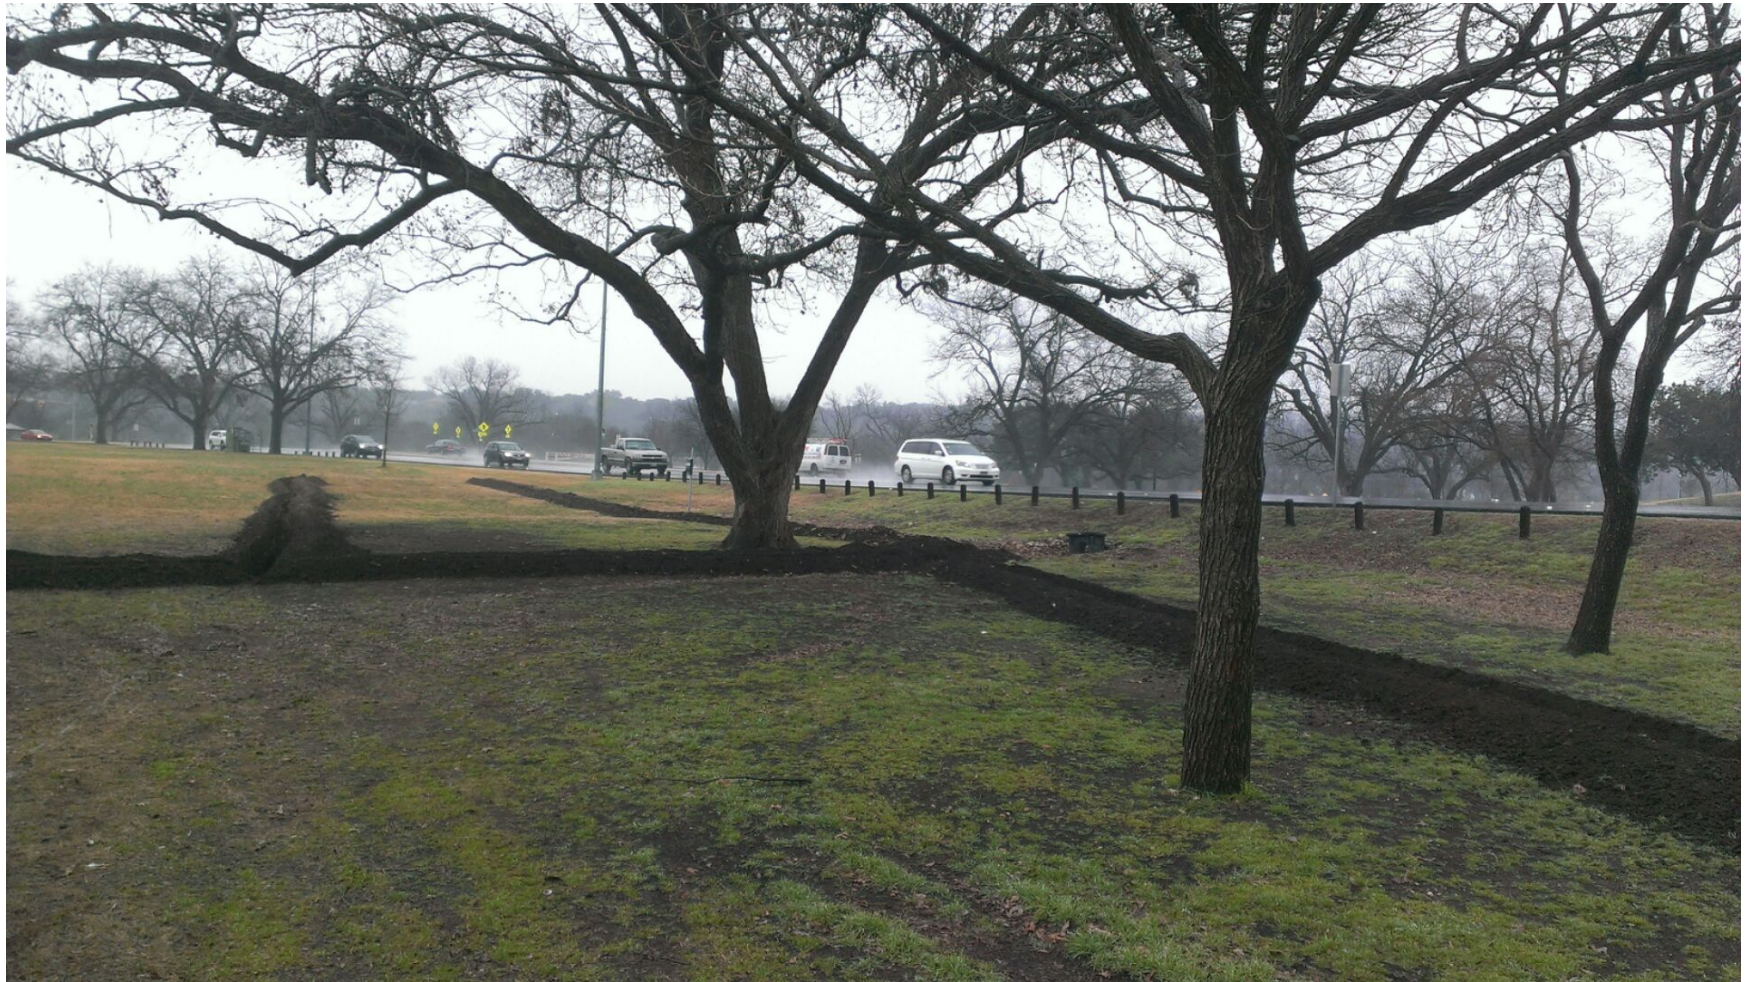
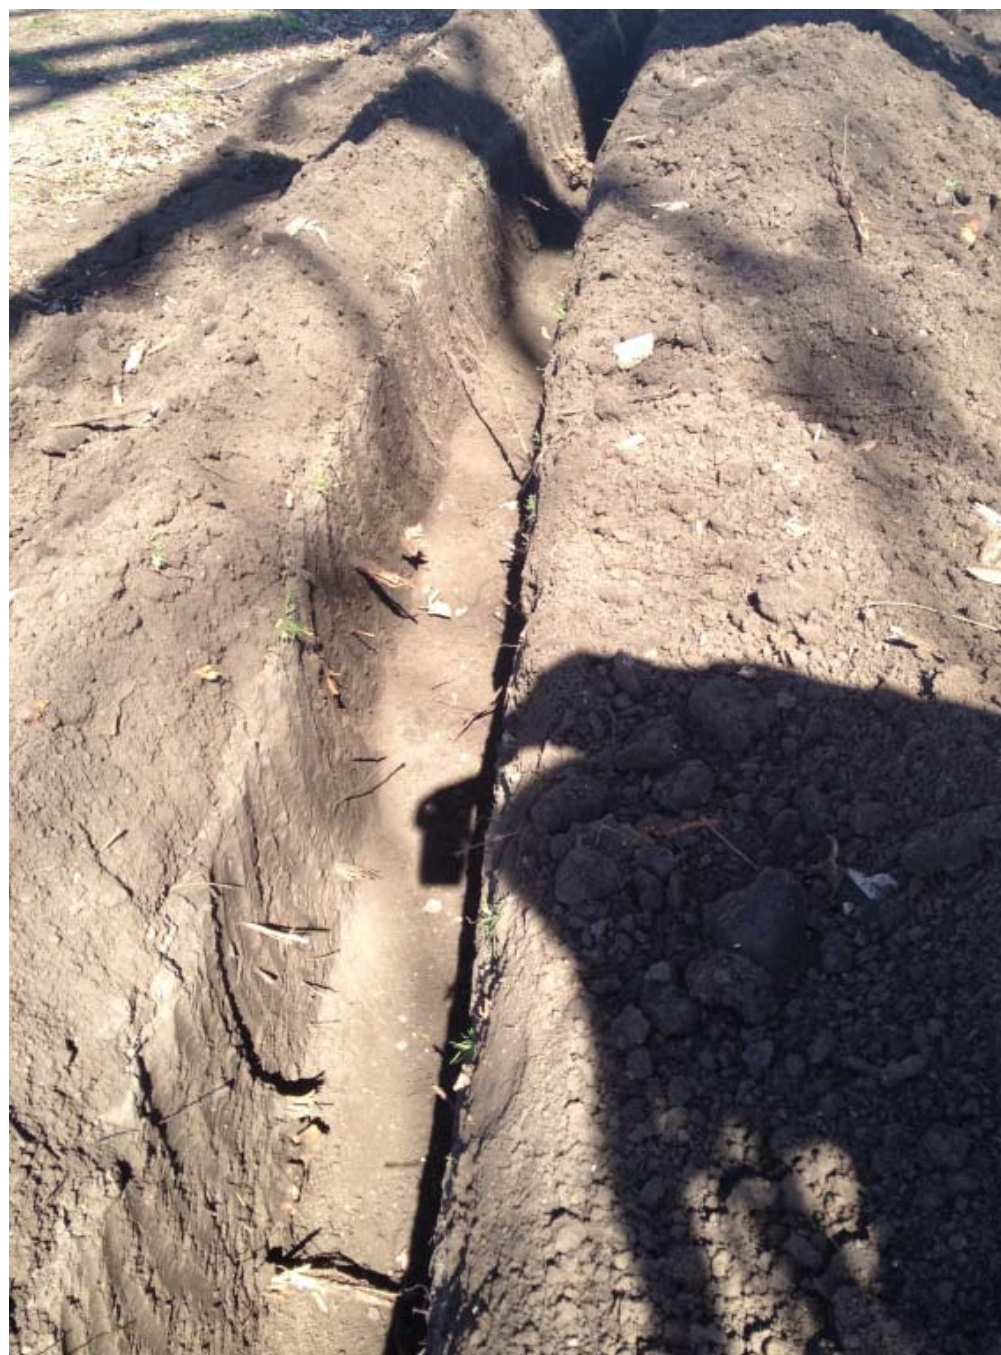
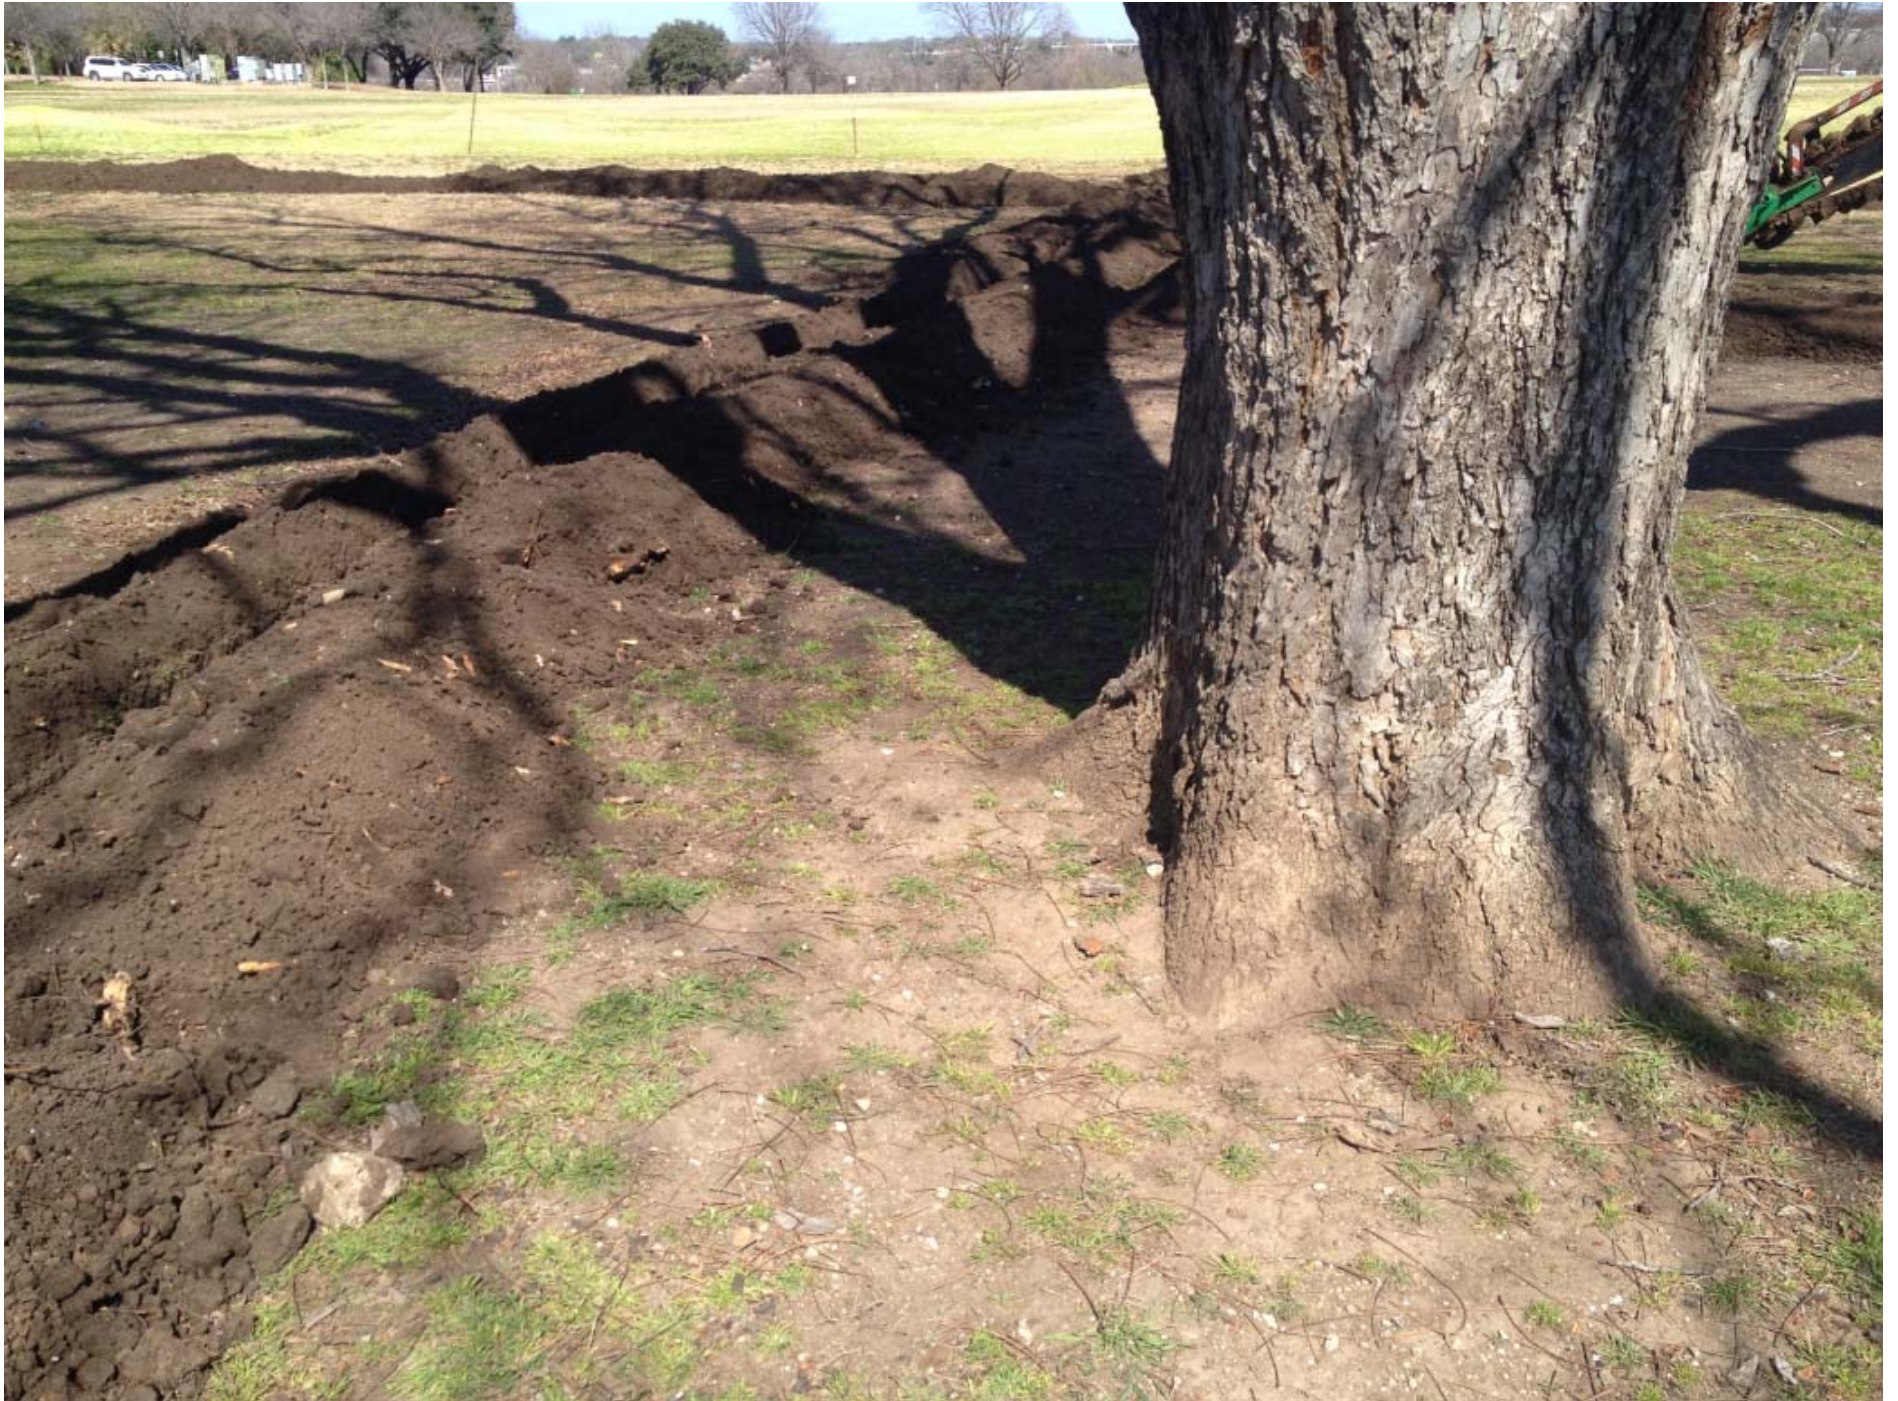
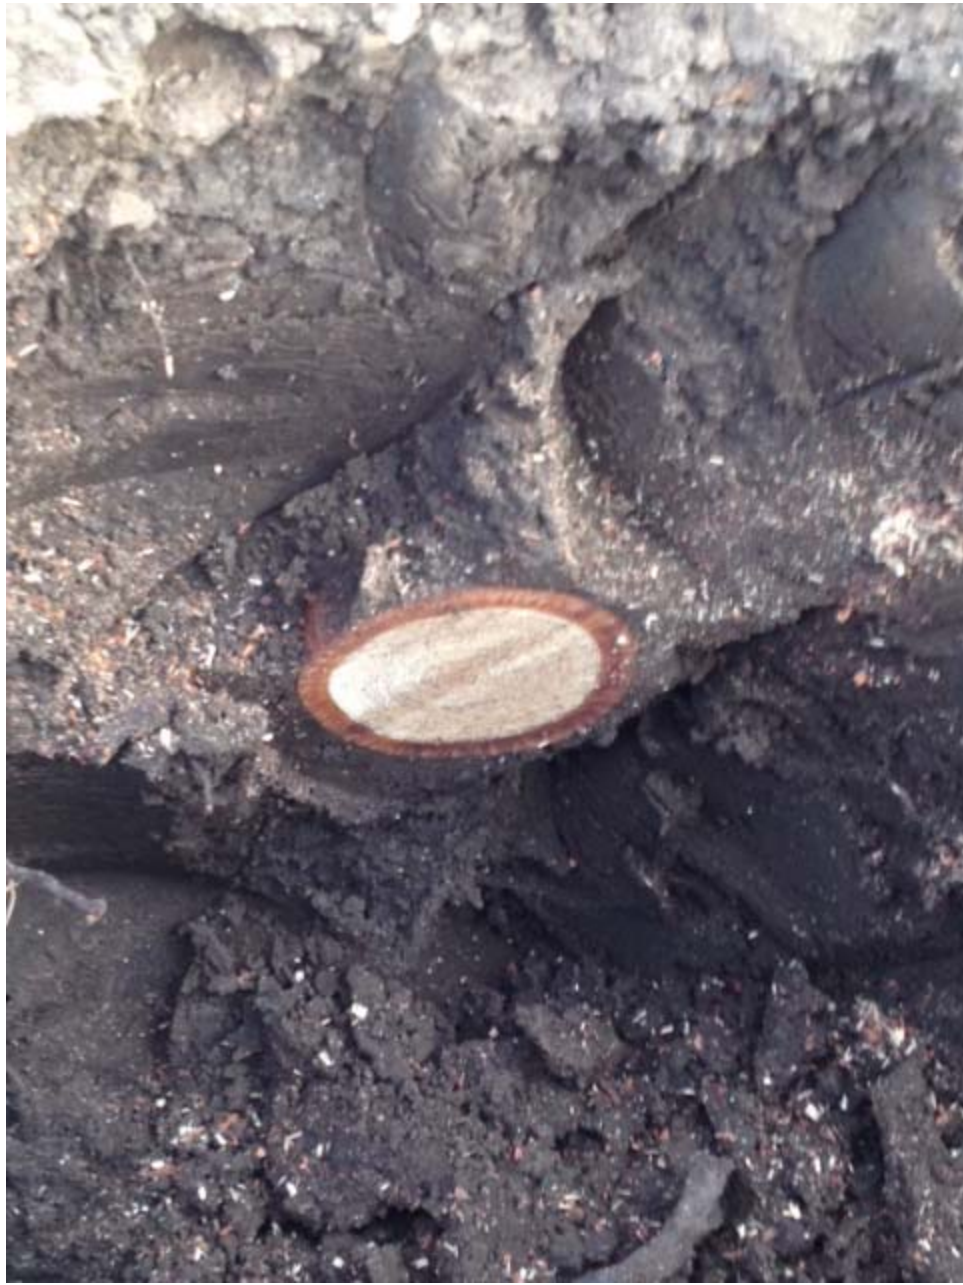
- 38" pecan along Barton Springs Road
- Trenched on 3 sides
  - 6' to west
  - 12' to south
  - 22' to north
- Seven 2-3" roots severed, many 1-2" roots
- Damage done by PARD central maintenance staff

- Damaged roots cleanly cut by an arborists and trenches backfilled (2-14-14), inspected by Forestry staff
- Central Parks Maintenance Staff submitted post-damage application for a Tree Ordinance Review by City Arborists Office
- Remediation and mitigation options under discussion
- Training program for parks maintenance staff about root physiology and root impacts

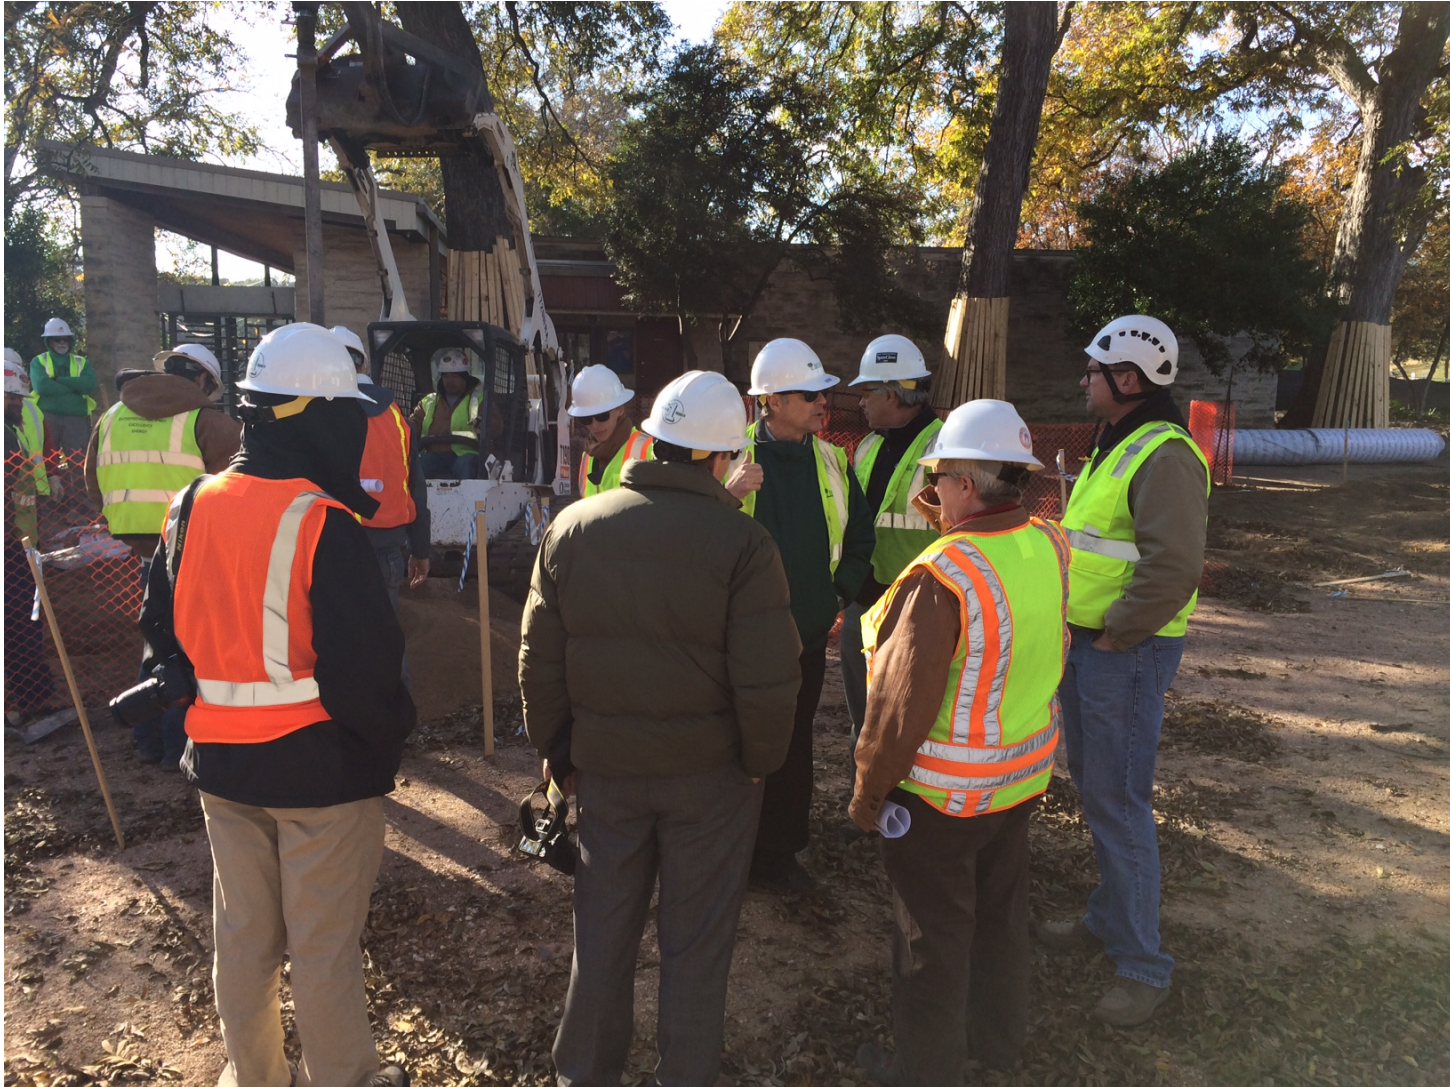
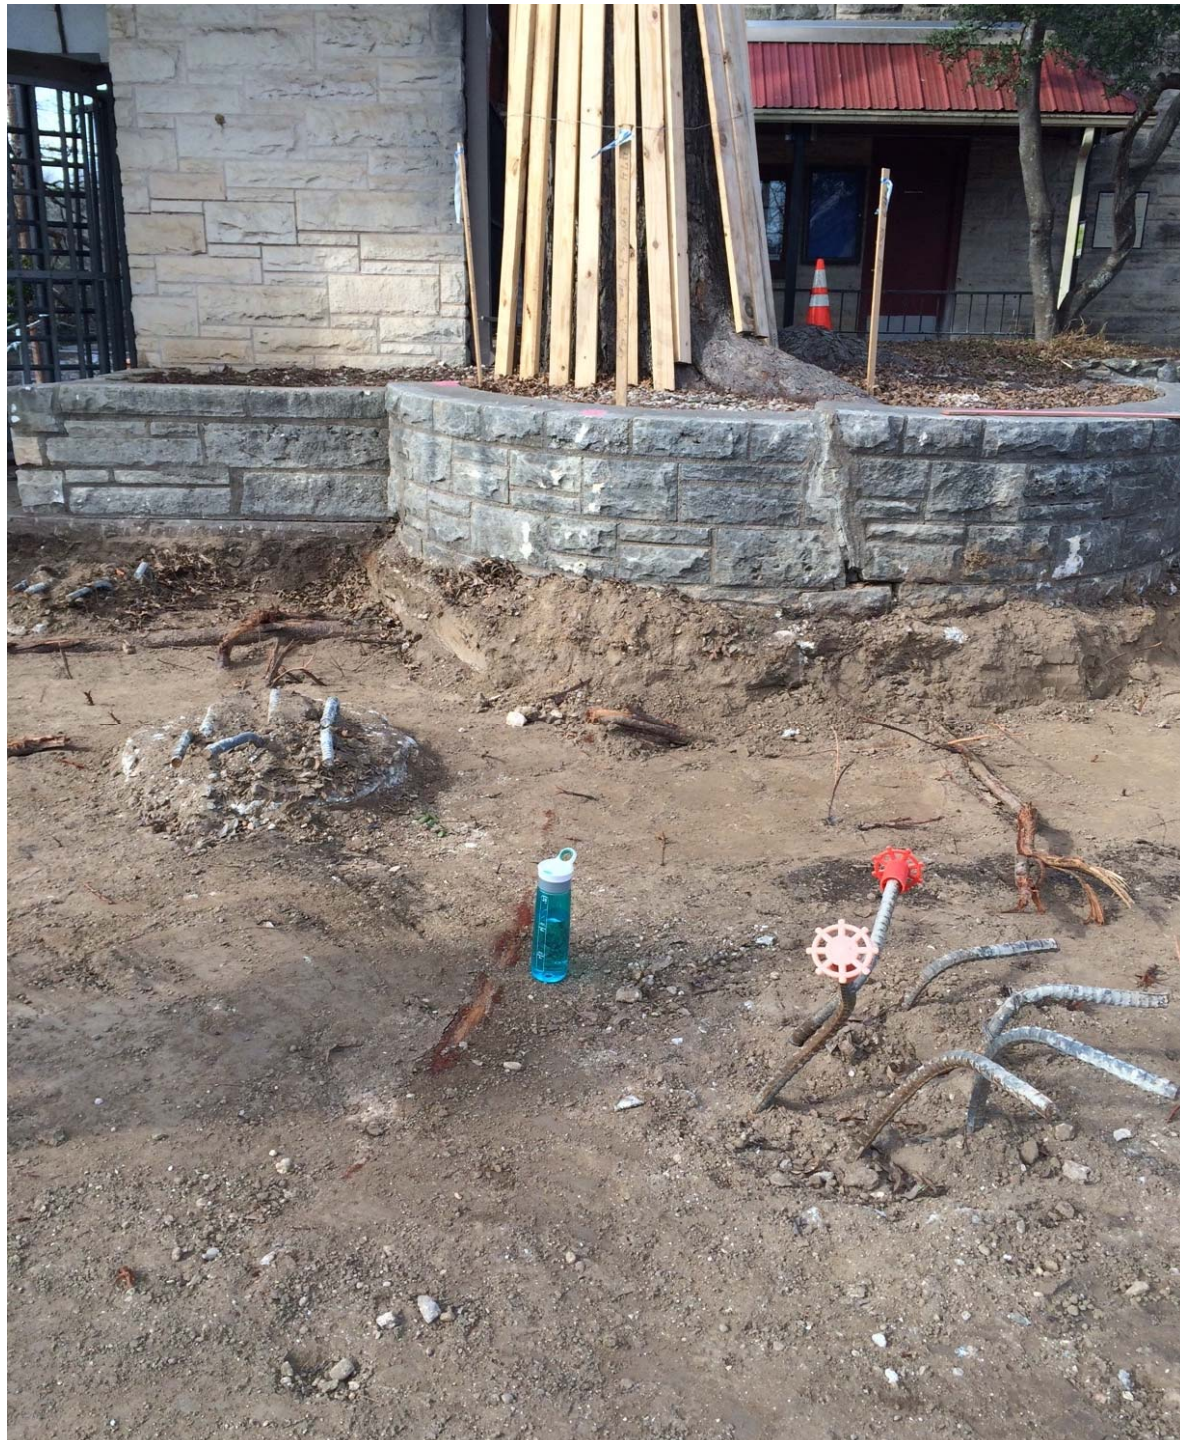
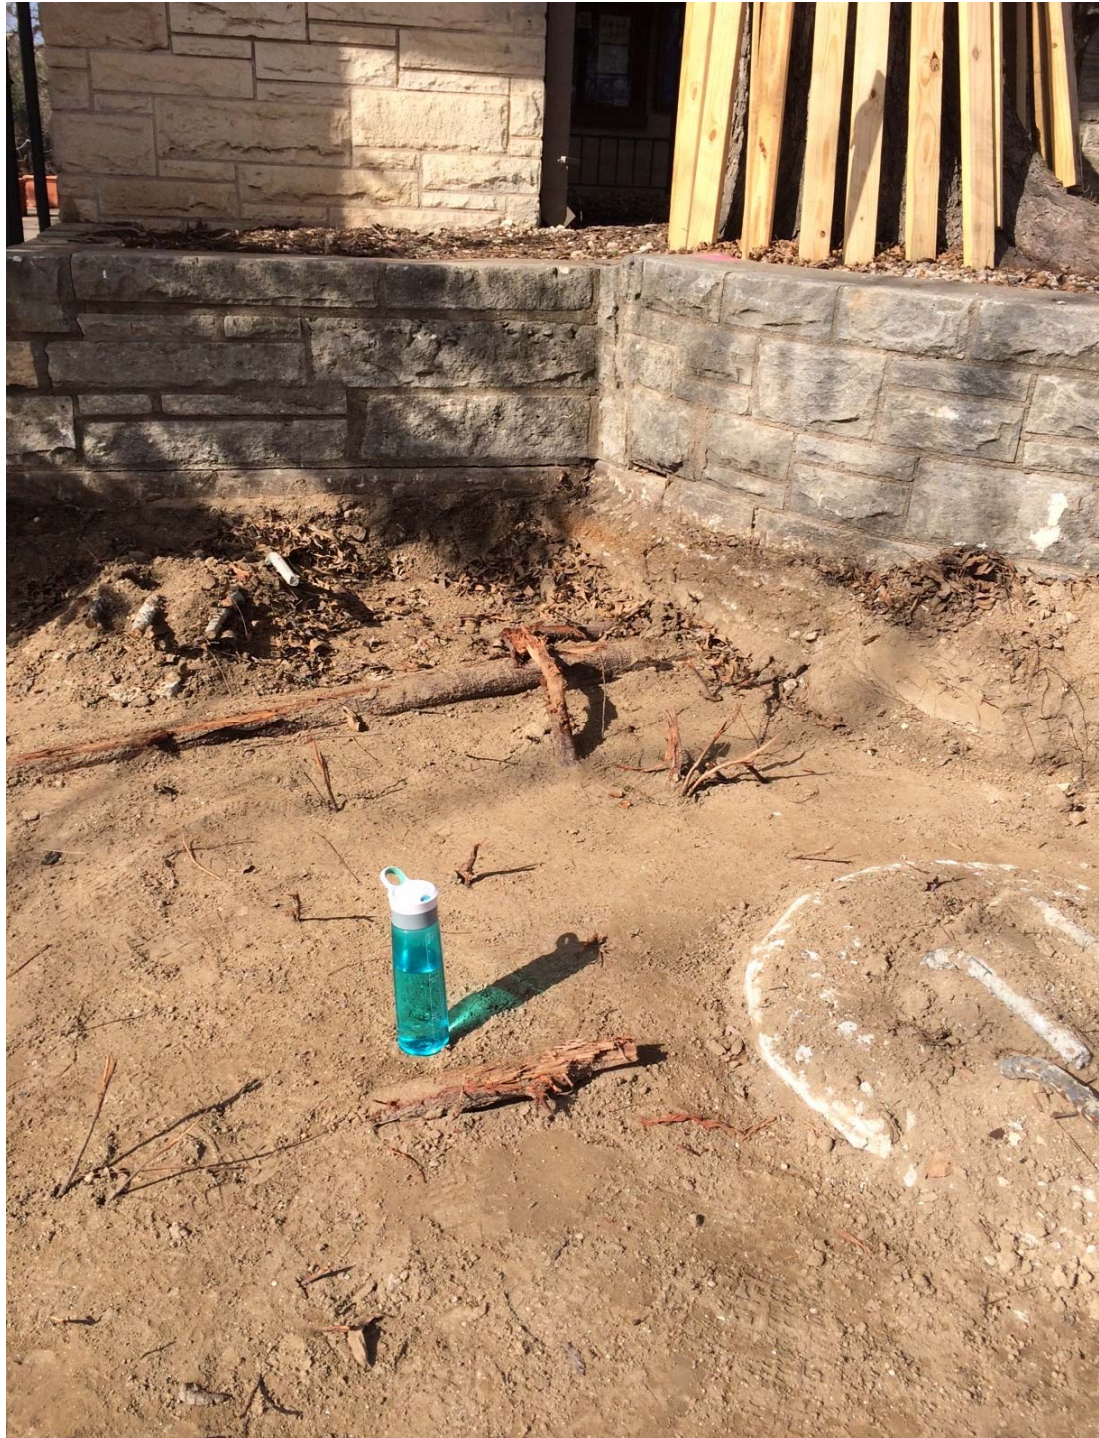
# Arborist Oversight and Consultation

- No other project has received the level of arborist inclusion and oversight as this project
- Full-time arborist hired to be on-site during all phases of project, weekly meetings, tree-focused project phasing
- While arborist not present, heavy equipment graded entire tree court area, causing compaction and torn roots during the week of 2-10-14

- All to be performed by ISA certified arborist
- Root repair
- Soil and root care plan
- While arborist not present, heavy equipment graded entire tree court area, causing compaction and torn roots
- Possible punitive damages
