Inspection Report

Property Address:
902 W. 30th
Austin TX 78705

PROPERTY INSPECTION REPORT

By: Jan Ode TREC 3770 / Critical Eye Home Inspections 2/13/2014
(Name and License Number of Inspector) (Date)

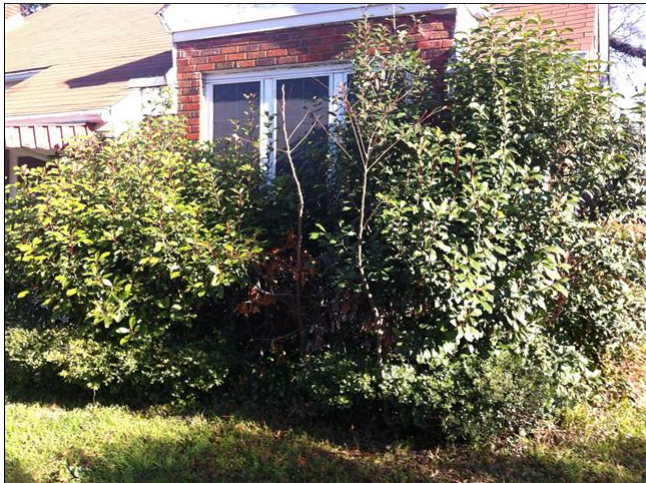
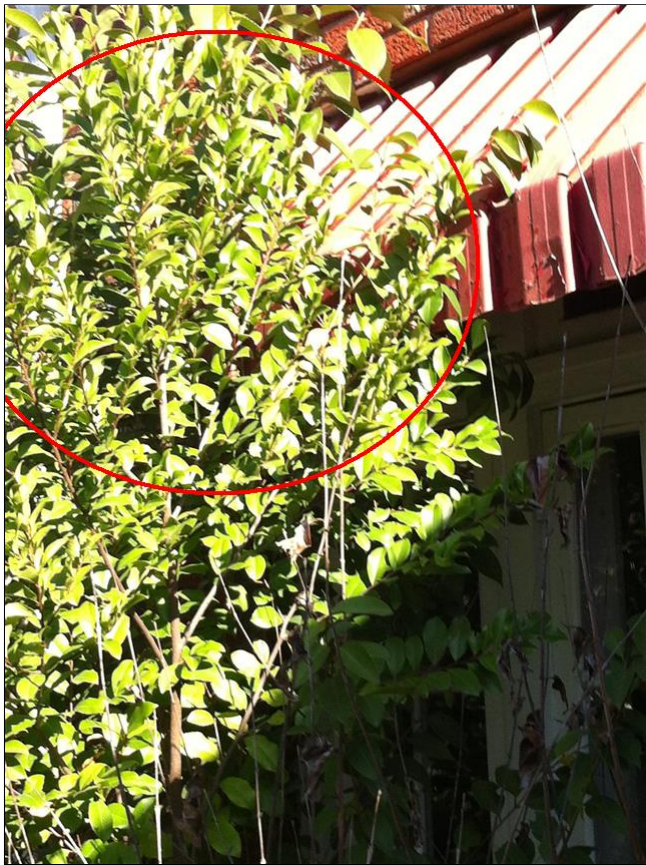
C. Item 1(Picture)

Item 1(Picture) Item 2(Picture) Recommend that the trees and bushes be cut back from house and roof as needed. Also there is ivy that needs to be trimmed back from house.

Item 1(Picture) Item 2(Picture) Recommend that the trees and bushes be cut back from house and roof as needed. Also there is ivy that needs to be trimmed back from house.

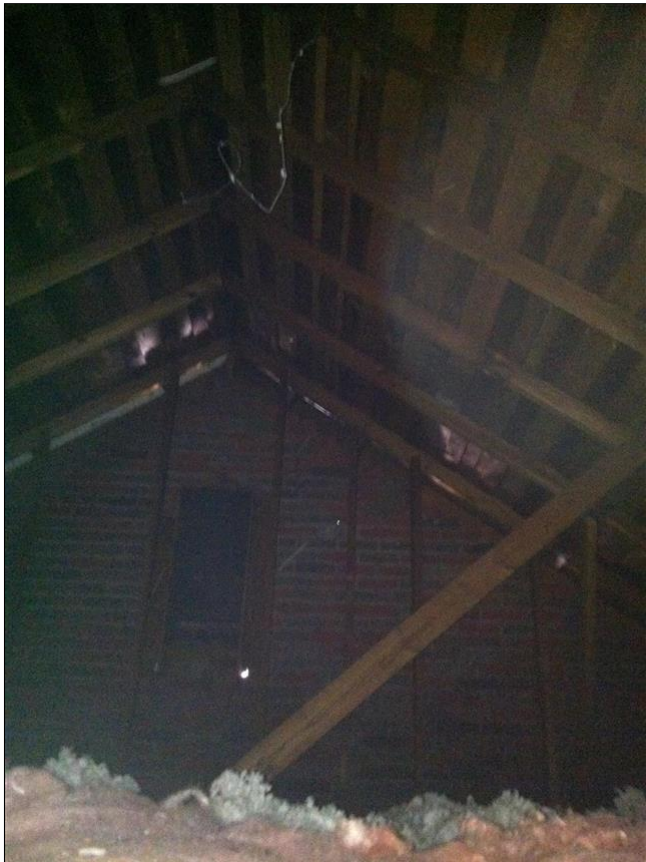
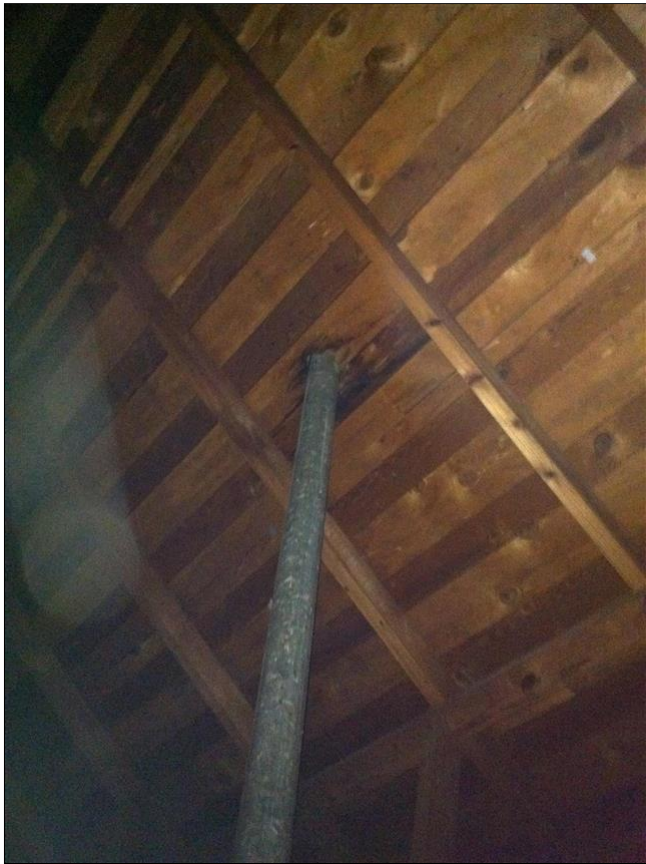
F. Item 1(Picture)

Item 1(Picture)Item 3(Picture) Roof and attic framing is 2x4 rafters and joists. No collar ties, perlins or stiff backs installed. Ridge material is 1x6. This framing does not meet the framing guidelines that are used today. The roof decking has been added which is an additional weight. Recommend that an engineer make repair recommendations.

Item 1(Picture)Item 3(Picture) Roof and attic framing is 2x4 rafters and joists. No collar ties, perlins or stiff backs installed. Ridge material is 1x6. This framing does not meet the framing guidelines that are used today. The roof decking has been added which is an additional weight. Recommend that an engineer make repair recommendations.

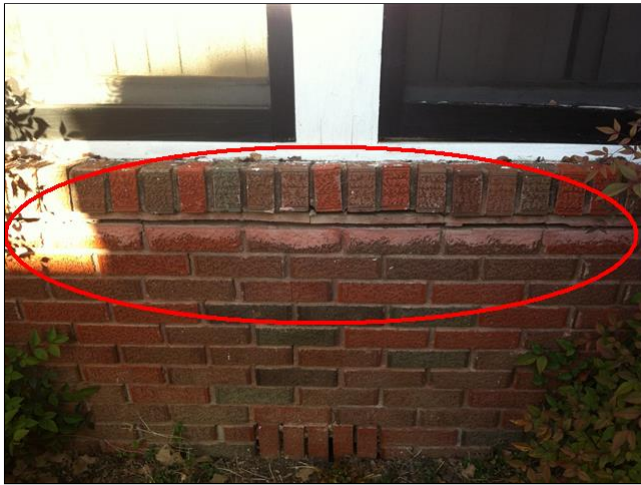
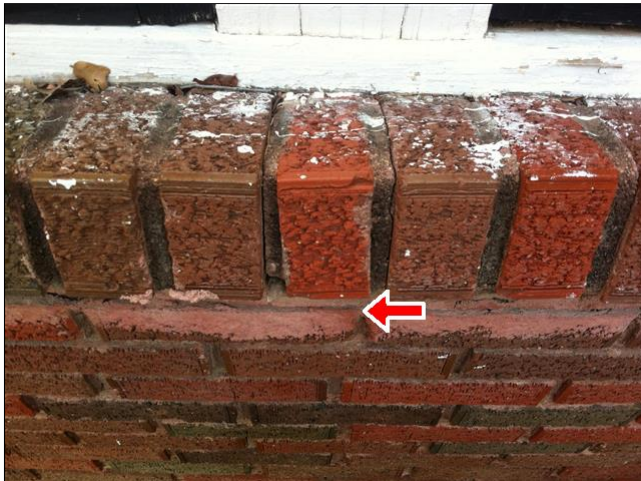
H. Item 1(Picture)

Item 1(Picture)Item 3(Picture) The wall on the right side of house is cracked in several areas and the brick under the windows has cracked and lifted. There is back slope so water drains back into the wall.

Item 1(Picture)Item 3(Picture) The wall on the right side of house is cracked in several areas and the brick under the windows has cracked and lifted. There is back slope so water drains back into the wall.

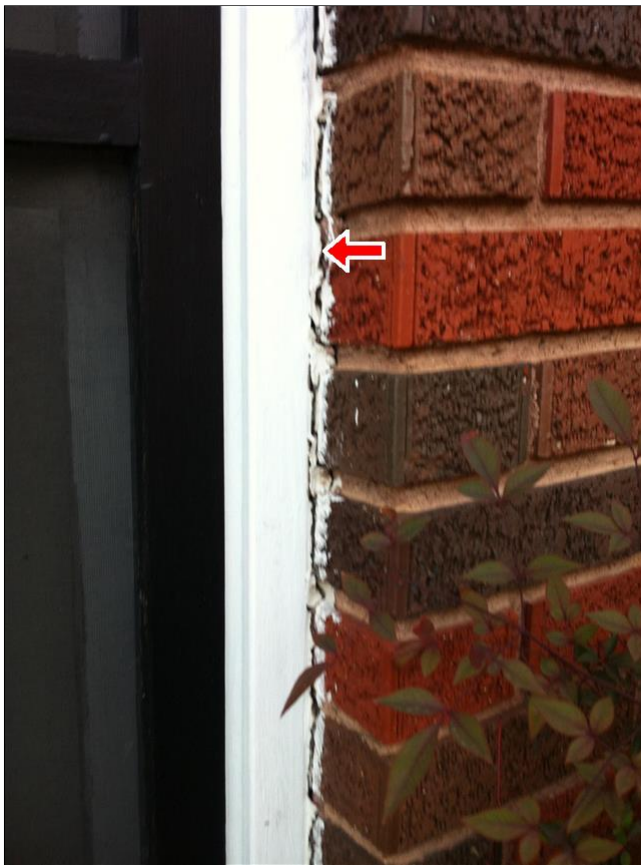
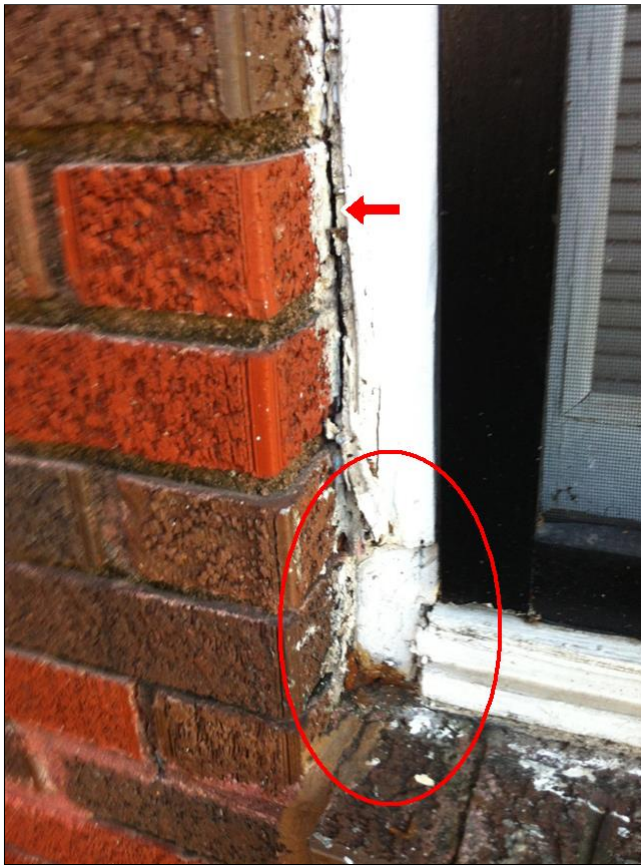
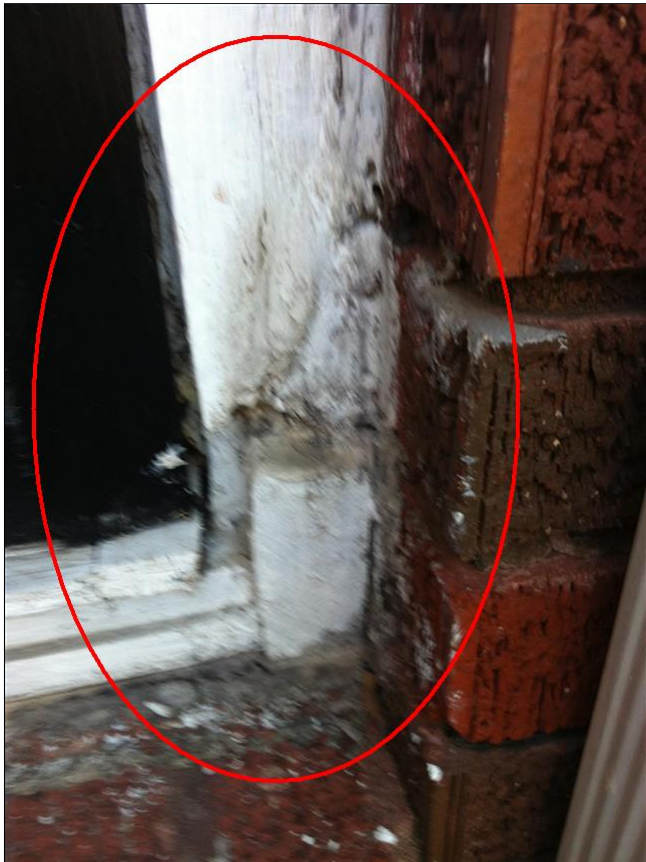
H. Item 2(Picture)

Item 2(Picture)Item 8(Picture)Item 10(Picture) There are gaps and damaged wood on nearly every window around the house.

Item 2(Picture)Item 8(Picture)Item 10(Picture) There are gaps and damaged wood on nearly every window around the house.

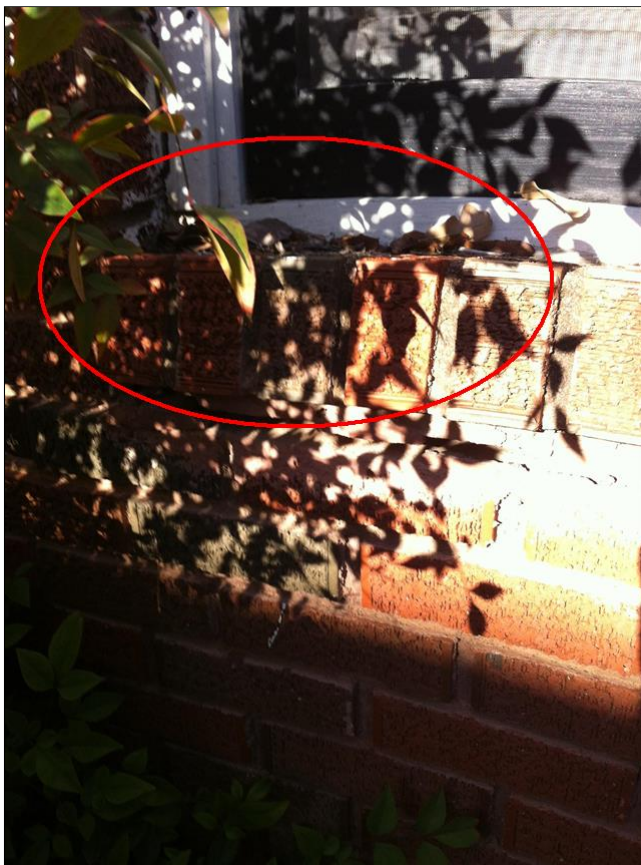
H. Item 4(Picture)

Item 4(Picture)Window sill and masonry is cracked.

Item 4(Picture)Window sill and masonry is cracked.

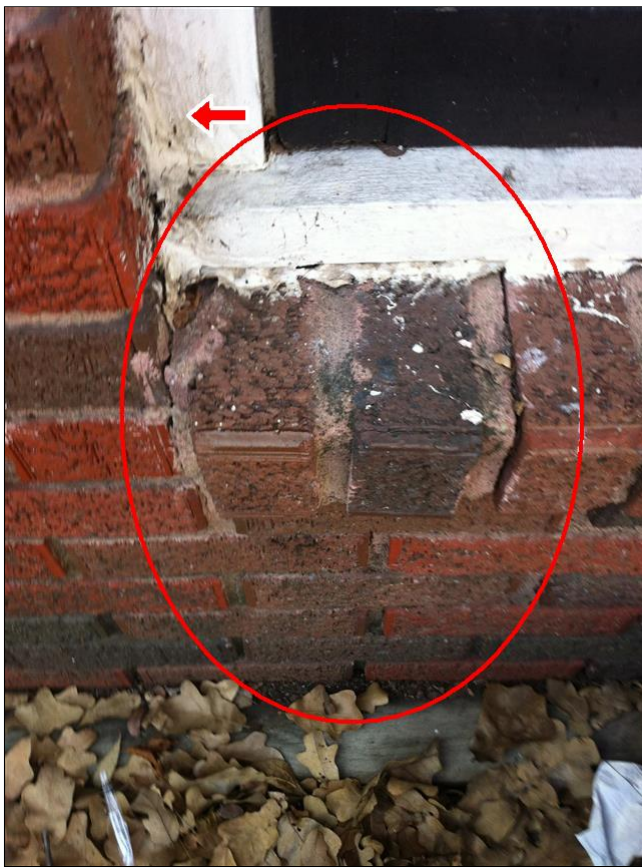
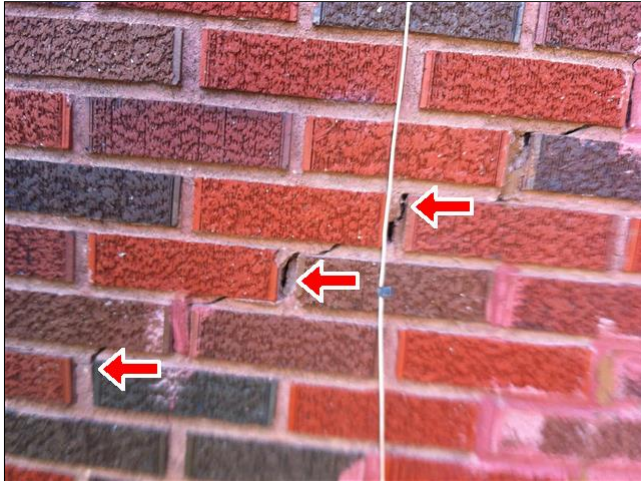
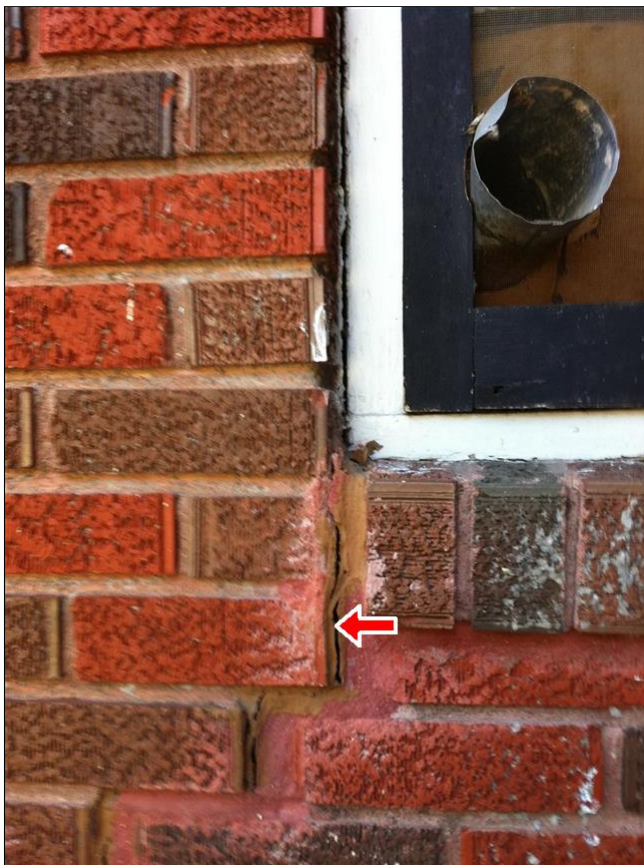
H. Item 6(Picture)

Item 6(Picture) Item 7(Picture)Item 9(Picture) Cracks in brick.

Item 6(Picture) Item 7(Picture)Item 9(Picture) Cracks in brick.

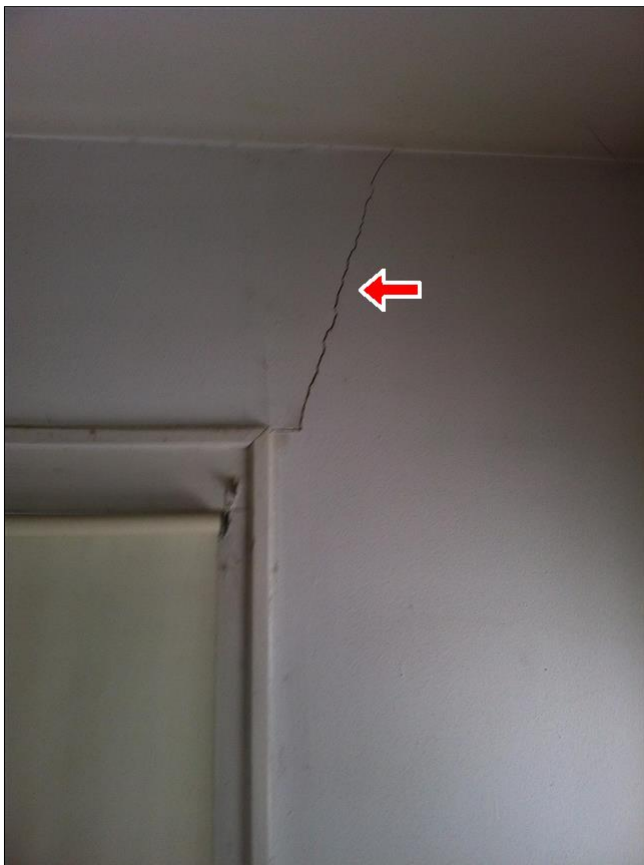
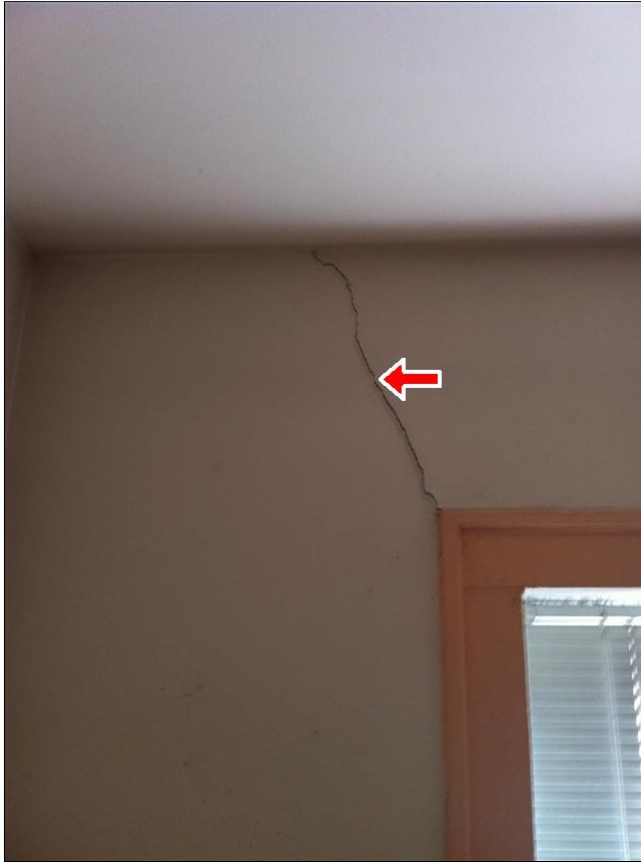
H. Item 11(Picture)

Item 11(Picture) Item 12(Picture) Cracks in walls in house.

Item 11(Picture) Item 12(Picture) Cracks in walls in house.

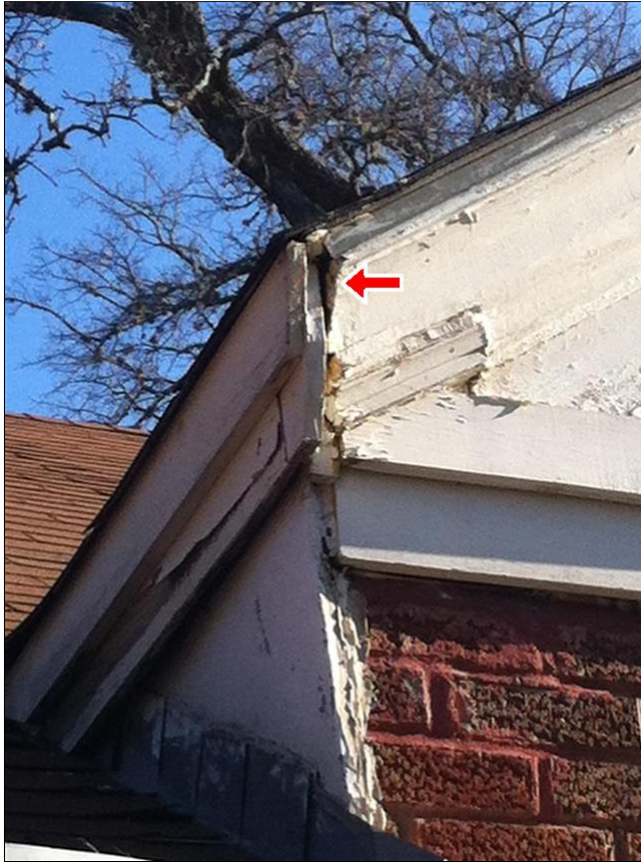
I. Item 3(Picture)

Item 3(Picture) Nearly all the trim around the house is loose, needs paint and caulking and or to be nailed back together.

Item 3(Picture) Nearly all the trim around the house is loose, needs paint and caulking and or to be nailed back together.

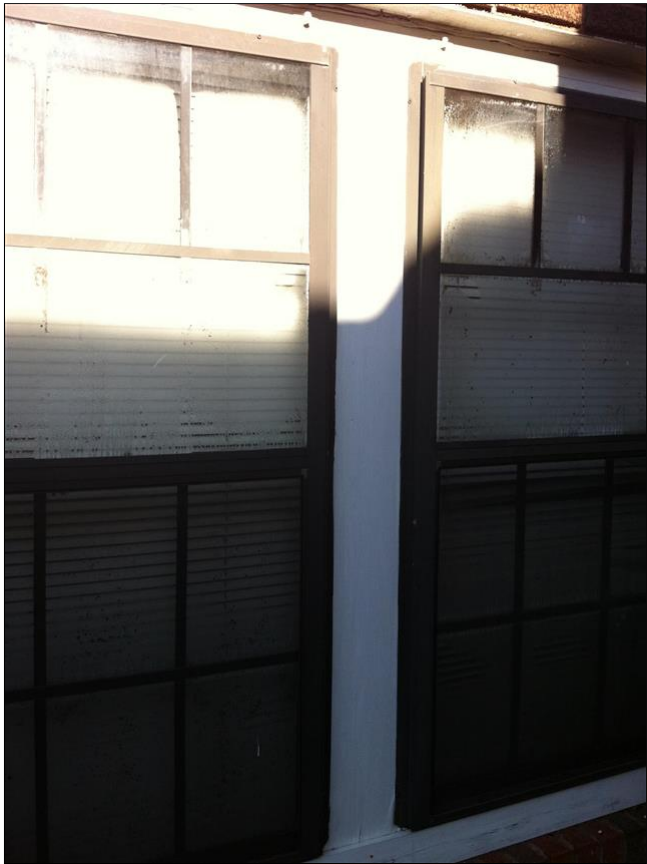
L. Item 1(Picture)

Item 1(Picture) There are 8 double paned windows that have broken seals.

Item 1(Picture) There are 8 double paned windows that have broken seals.

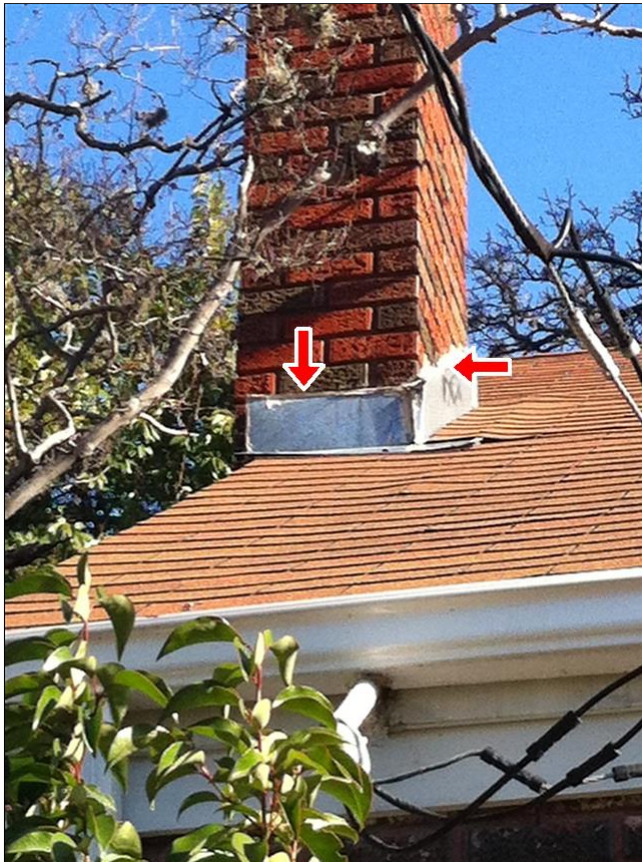
N. Item 1(Picture)

Item 1(Picture) Missing counter flashing on chimney.

Item 1(Picture) Missing counter flashing on chimney.

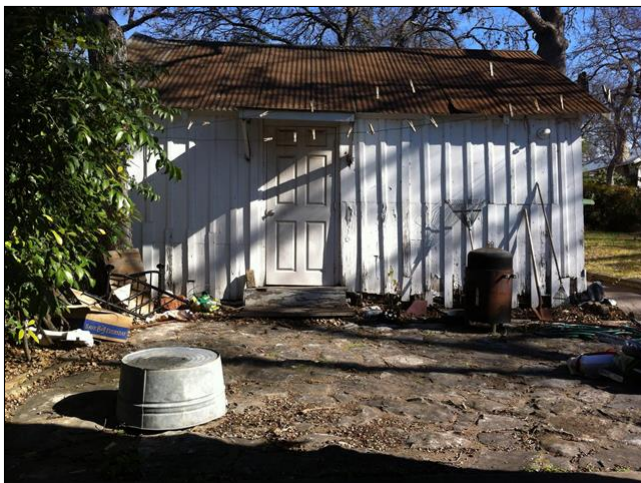
P. Item 1(Picture)

Item 1(Picture) I did not inspect the detached garage.

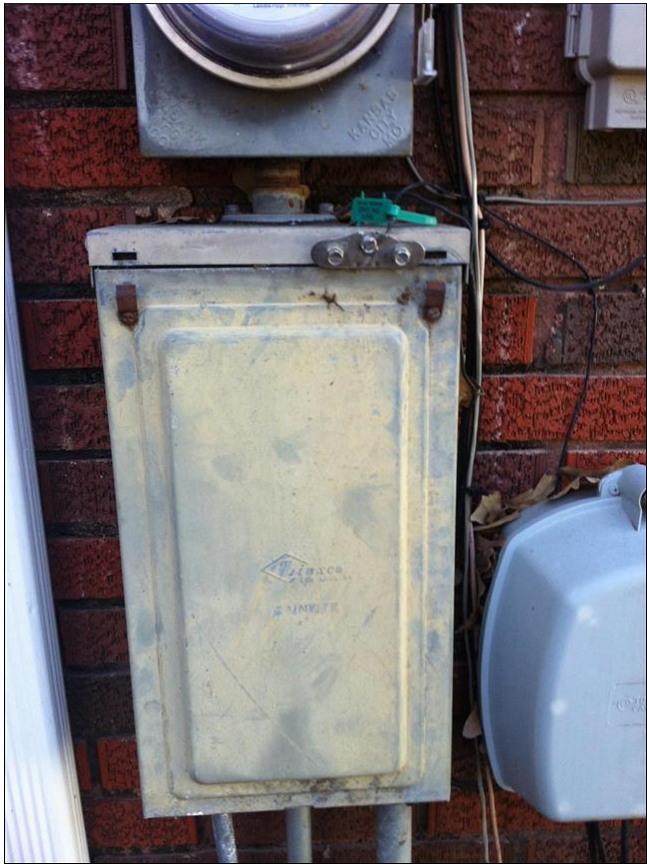
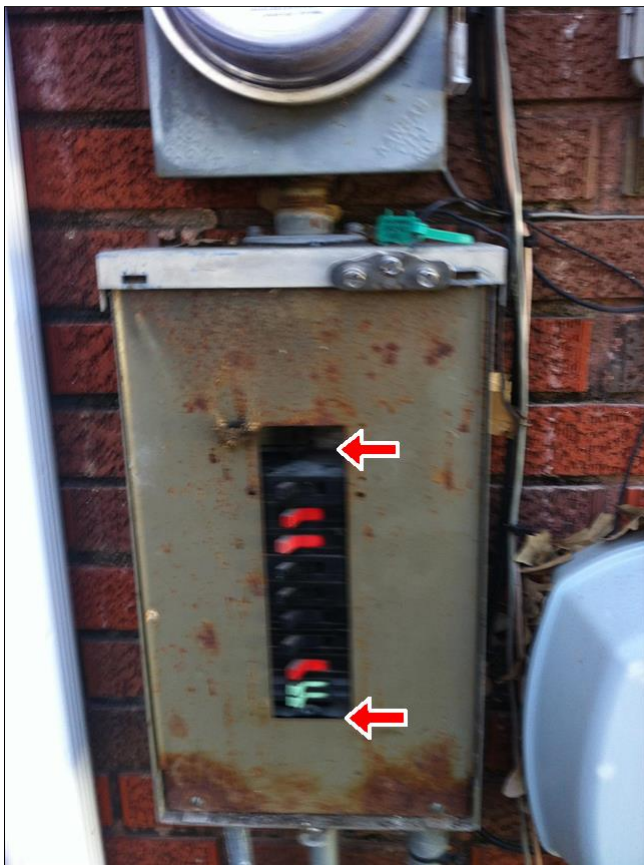
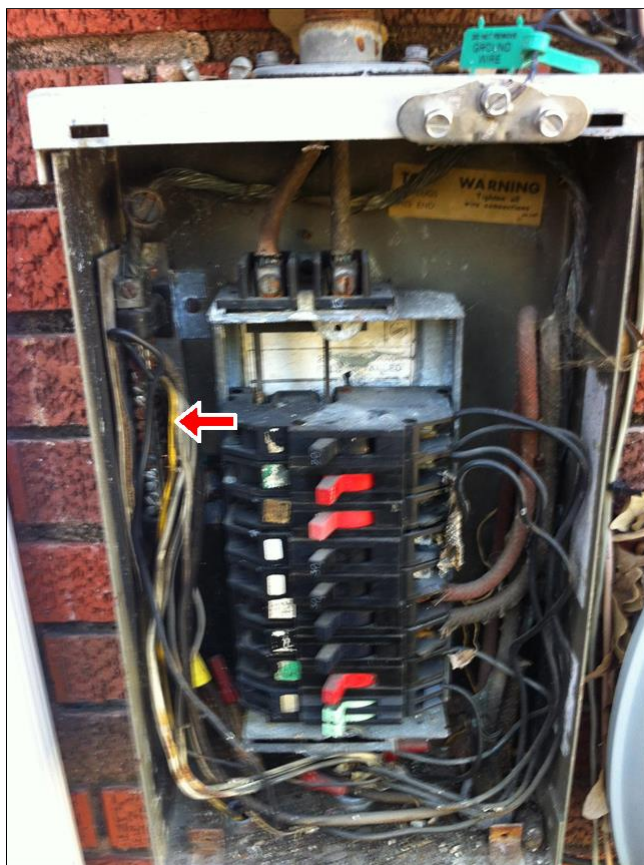
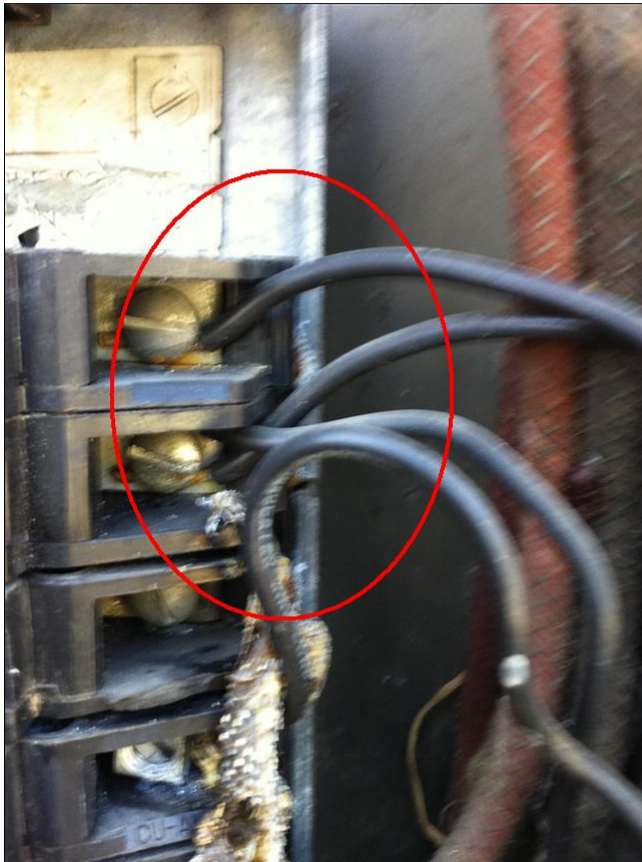
A. Item 4(Picture)

Item 4(Picture)Item 5(Picture)Item 6(Picture) Item 7(Picture) Zinsco Panel Recommend that it be replaced. Missing knockouts in panel. Front is loose. Two wire non grounded wiring through out house. Some aluminum wiring is present. Wires doubled up on breaker. Clean out debris and dead reptiles.

Item 4(Picture)Item 5(Picture)Item 6(Picture) Item 7(Picture) Zinsco Panel Recommend that it be replaced. Missing knockouts in panel. Front is loose. Two wire non grounded wiring through out house. Some aluminum wiring is present. Wires doubled up on breaker. Clean out debris and dead reptiles.

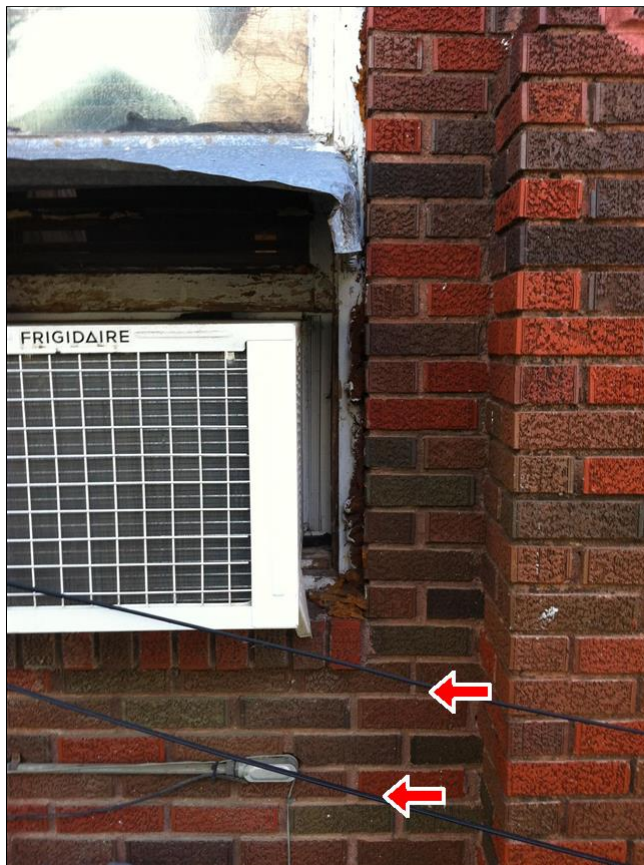
A. Item 8(Picture)

Item 8(Picture) Recommend that the cable and phone lines be raised.

Item 8(Picture) Recommend that the cable and phone lines be raised.

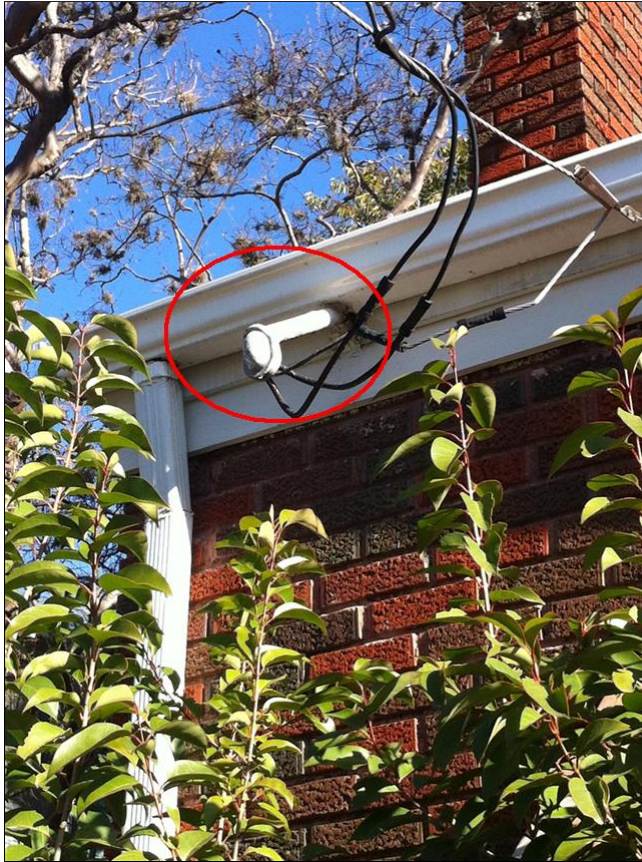
A. Item 9(Picture)

Item 9(Picture) Electrical riser needs to be straightened so it is vertical and not running down hill. Recommend that a licensed electrician make necessary repairs to all of the electrical items.

Item 9(Picture) Electrical riser needs to be straightened so it is vertical and not running down hill. Recommend that a licensed electrician make necessary repairs to all of the electrical items.

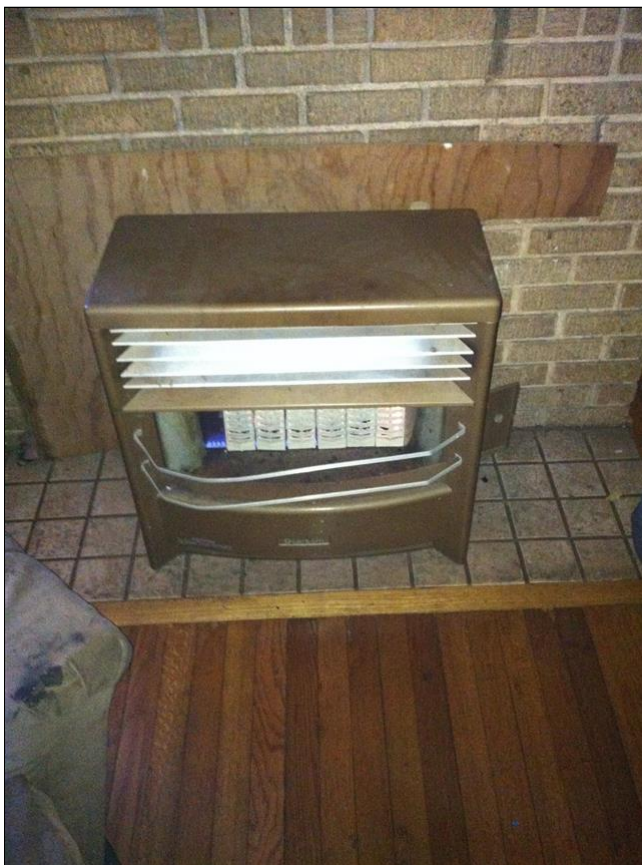
A. Item 1(Picture)

Item 1(Picture) Dearborn unvented gas heater. Recommend that it be removed from the house and a vented unit be installed.

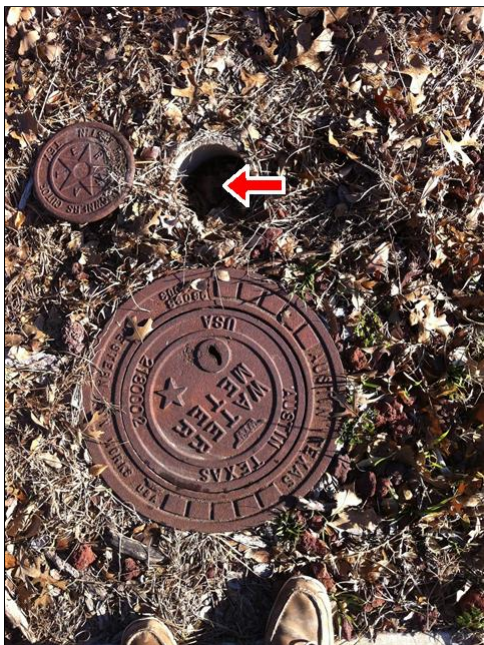
A. Item 1(Picture)

Item 1(Picture) Recommend that the valve boxes for the meter and the cut off be cleaned out and that the handles are operable. I did not see a PRV valve that regulates water pressure.

Item 1(Picture) Recommend that the valve boxes for the meter and the cut off be cleaned out and that the handles are operable. I did not see a PRV valve that regulates water pressure.

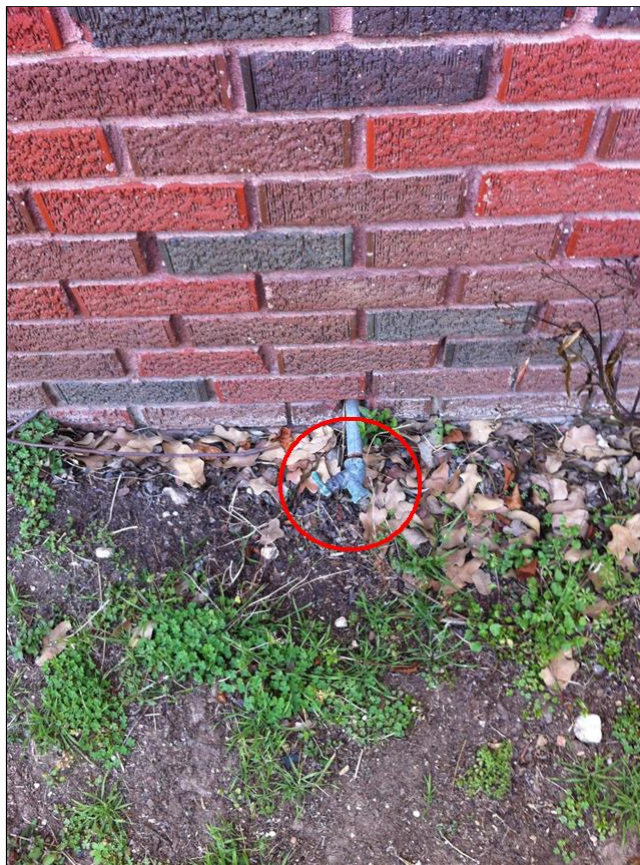
A. Item 2(Picture)

Item 2(Picture) Water line on right side of house. Low pressure in galvanized line. Broken handle and no backflow preventer installed. All outside hose bibs need backflow preventer and should be insulated.

Item 2(Picture) Water line on right side of house. Low pressure in galvanized line. Broken handle and no backflow preventer installed. All outside hose bibs need backflow preventer and should be insulated.

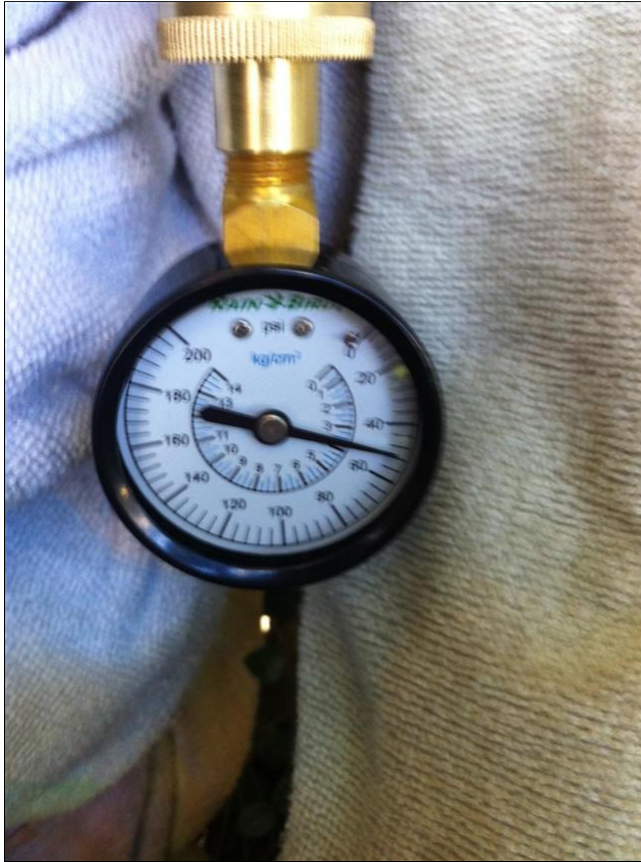
A. Item 3(Picture)

Item 3(Picture) 50 PSI water pressure at front hose bib. Missing backflow preventer.

Item 3(Picture) 50 PSI water pressure at front hose bib. Missing backflow preventer.

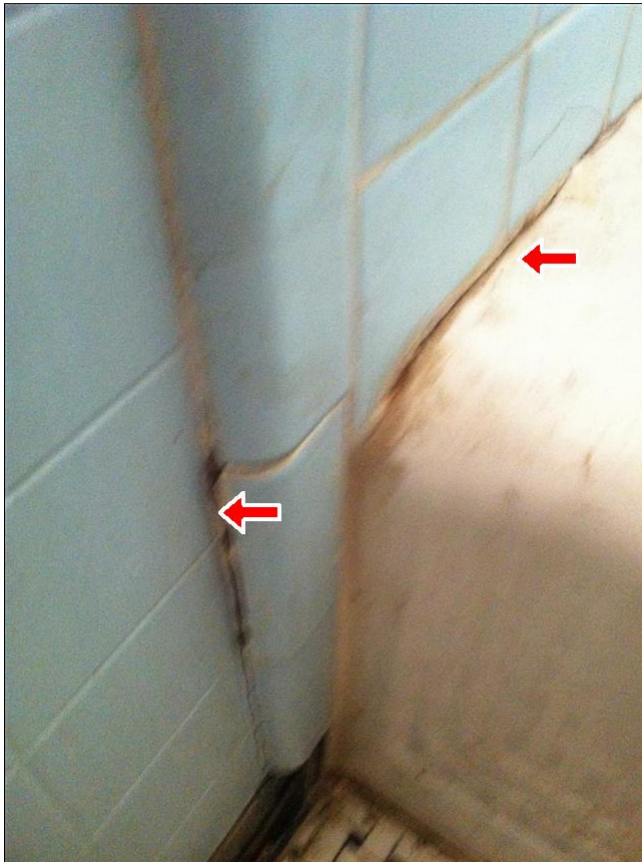
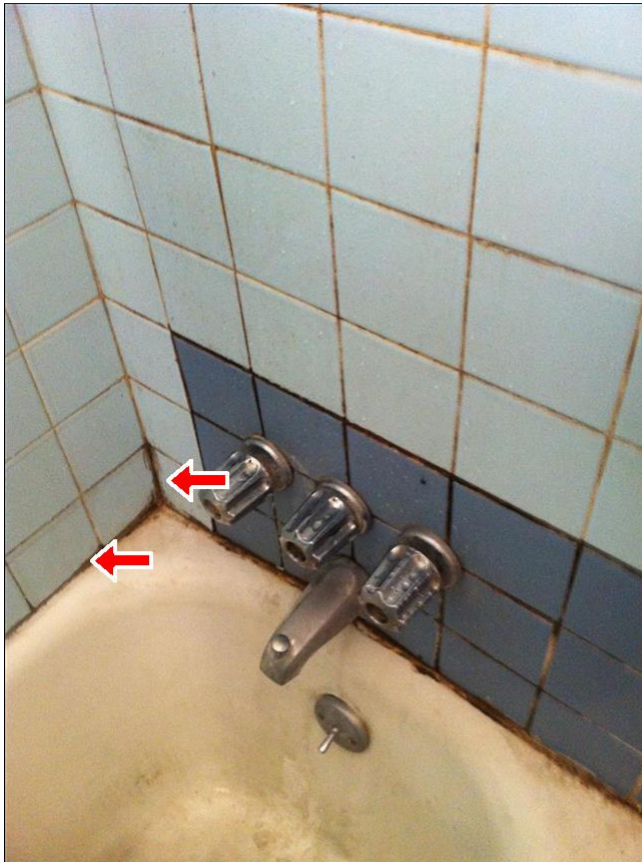
B. Item 3(Picture)

Item 3(Picture)Item 4(Picture) Repair damaged tile in tub

Item 3(Picture)Item 4(Picture) Repair damaged tile in tub

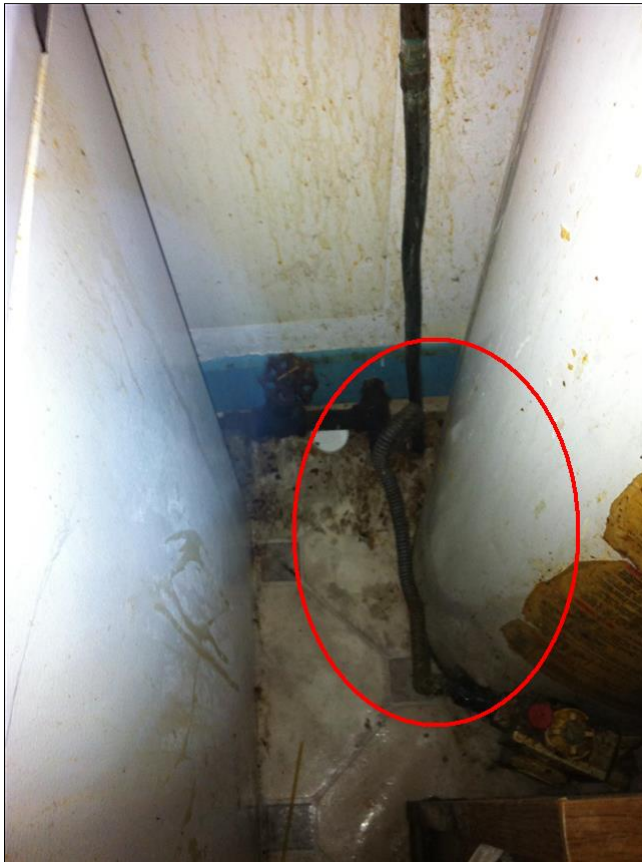
C. Item 3(Picture)

Item 3(Picture) Recommend that the water heater be cleaned to help prevent a fire.

Item 3(Picture) Recommend that the water heater be cleaned to help prevent a fire.

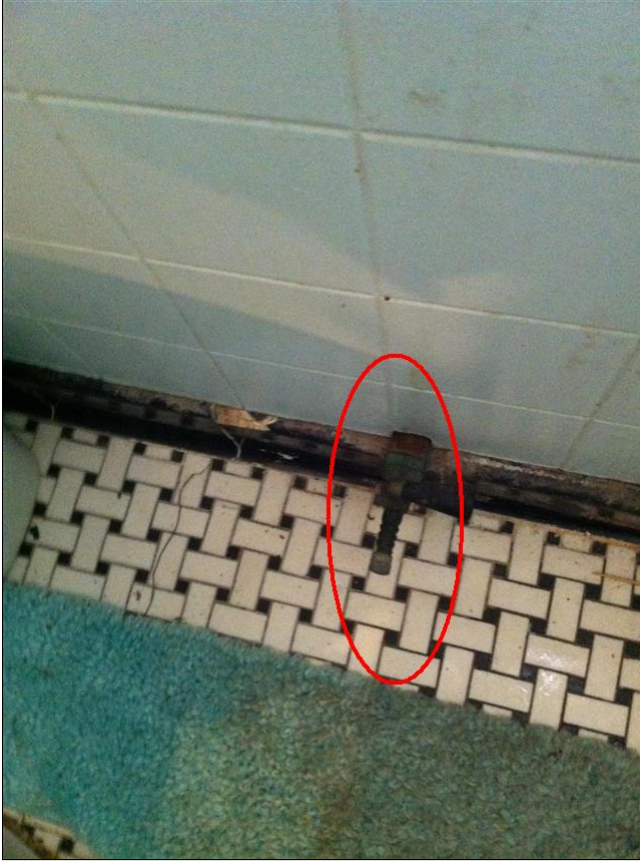
E. Item 1(Picture)

Item 1(Picture) Recommend that the gas valves be removed and sealed or new valves be installed.

Item 1(Picture) Recommend that the gas valves be removed and sealed or new valves be installed.

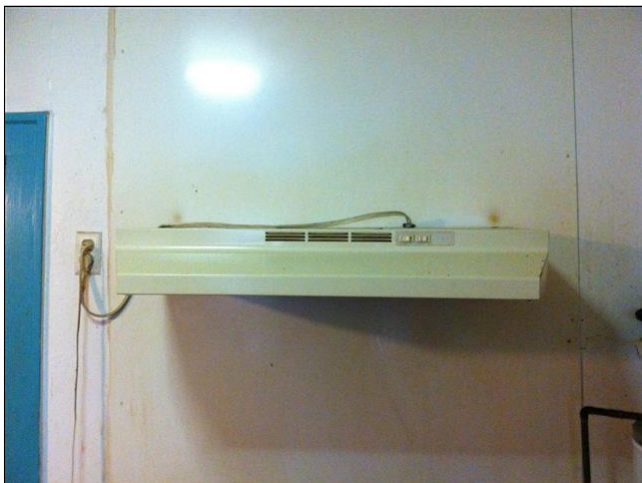
C. Item 1(Picture)

Item 1(Picture) Vent hood is a recirculating type. Light does not work. Recommend that the grease filter be cleaned and a charcoal filter installed.

Item 1(Picture) Vent hood is a recirculating type. Light does not work. Recommend that the grease filter be cleaned and a charcoal filter installed.

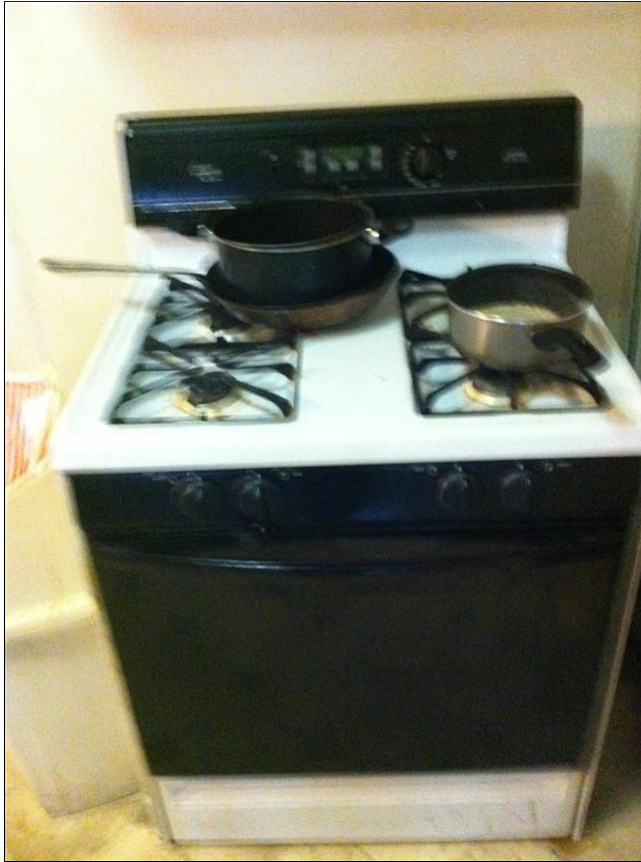
D. Item 1(Picture)

Item 1(Picture) No anti tip installed. Recommend that the range be cleaned. I did not turn on the range due to the grease build up.
