# APPENDIX B

## CULTURAL RESOURCES

## Cultural Resources Inventory

This inventory is generally arranged by location, moving from Kingsbury Commons at the south to the Bluffs at the north. Features that are found throughout the park (memorials, signage and culverts) are grouped at the end.

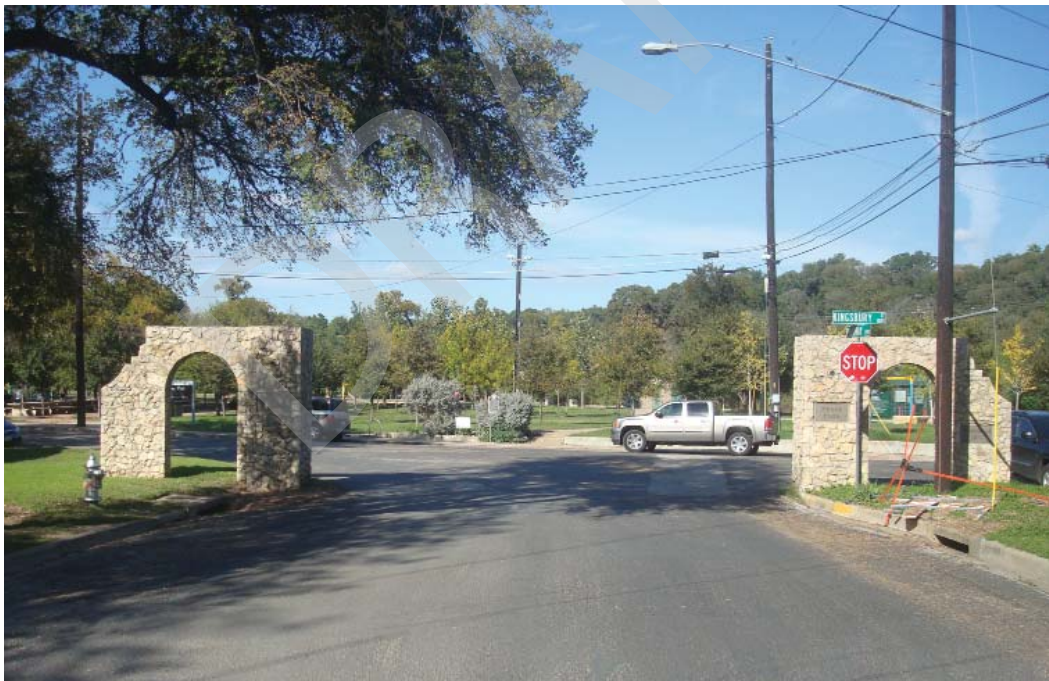
Pease Park Memorial Gates: a pair of uncoursed semi-dressed rubble limestone arches, flanking Parkway at the intersection with Kingsbury Street. Designed by Giesecke & Harris, the gates were built in 1926 as part of the Austin Kiwanis Club's beautification project. Construction drawings show wrought iron gates within the arches and lanterns atop the pilasters, neither of which are present in the existing structure. Historic documents also include a sketch depicting an arch with lantern between the two gates. New bronze plaques were installed by the Pease Park Conservancy in 2012.

Condition: The gates are in good condition and in no need of immediate work, but crowded by a stop sign and utility pole.

Looking north on Parkway, Kingsbury Commons visible beyond gates

Recommendation: No work necessary at this time. Future work may include addition of missing elements from drawings.

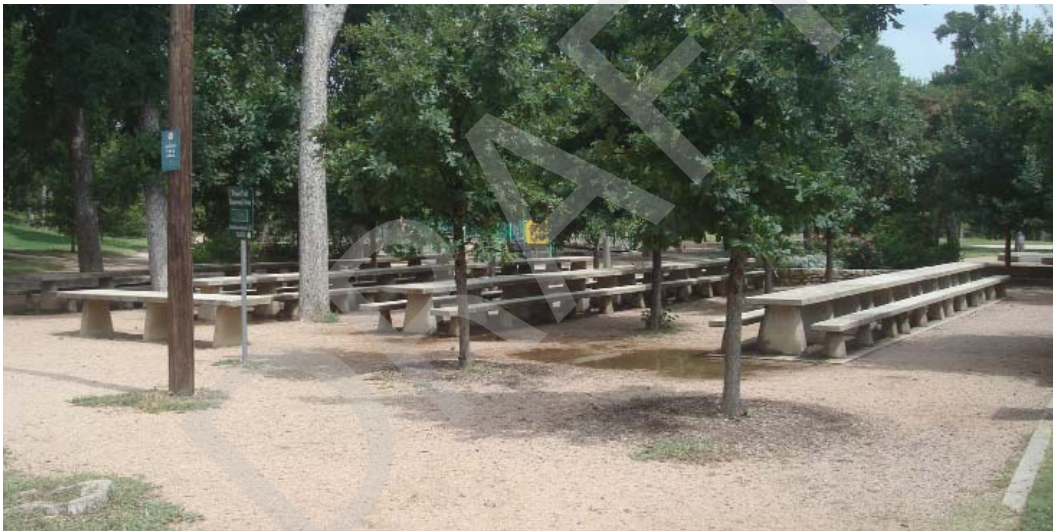
Condition: The tables and benches have benefited from recent restoration work and now appear in good condition.

Picnic Tables at Kingsbury Commons looking North

Recommendation: Clean and monitor for cracks.

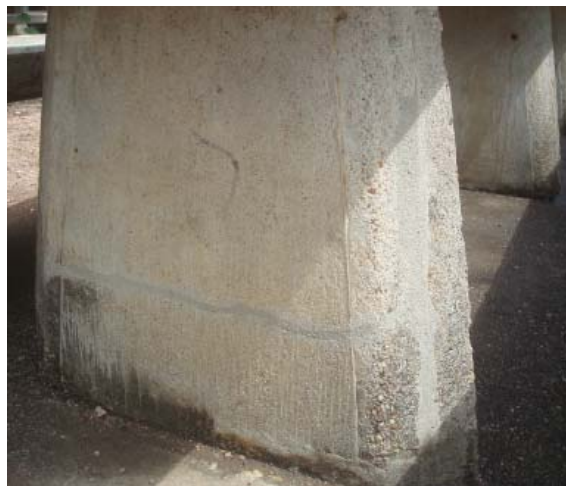
Detail at tapered, chamfered leg

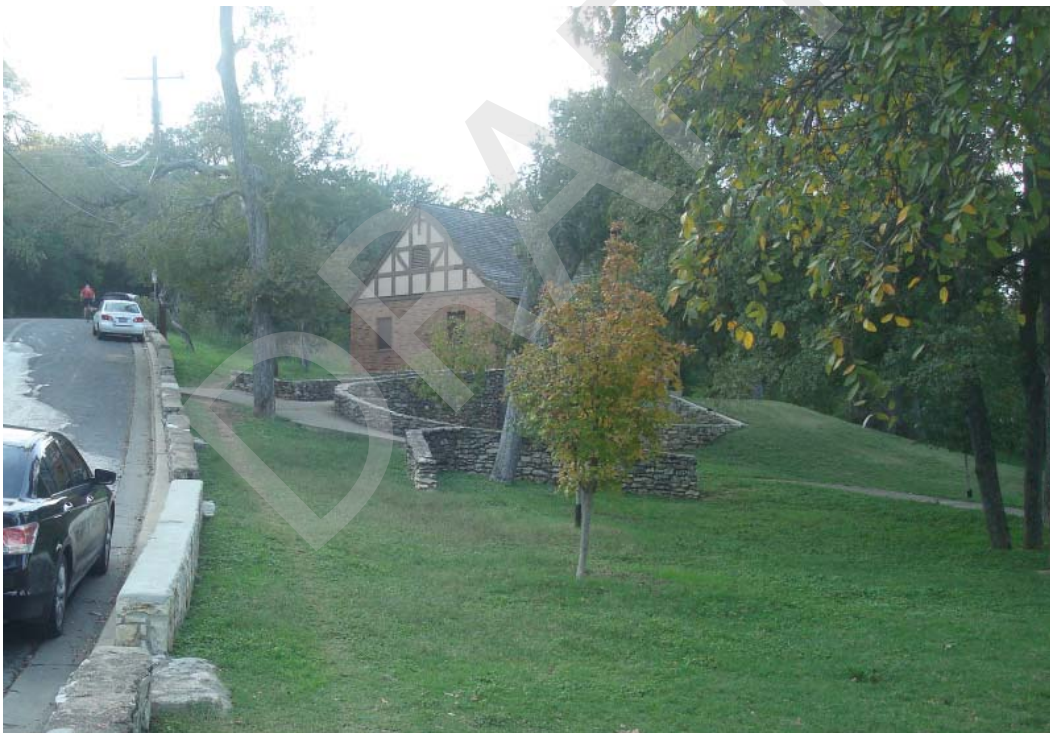
Condition: Portions of the wall have been recently repaired and are in good condition. The new cement wash appears to differ significantly from the existing, both in color and texture. The portions of the wall not part of the recent repairs are in fair condition. There are numerous small cracks in the mortar and cement wash. At a few limited locations the cracks pass through the entire wall and several stones are missing.

Looking west along Kingsbury. Lighter colored cement wash is recent work.

Recommendation: Small cracks should be re-pointed. Large cracks will require a limited amount of select stone removal and re-installation/ re-pointing. This repair work should be done in the near future to avoid further decay.

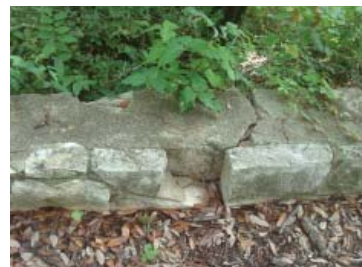
Typical cracks and missing stone

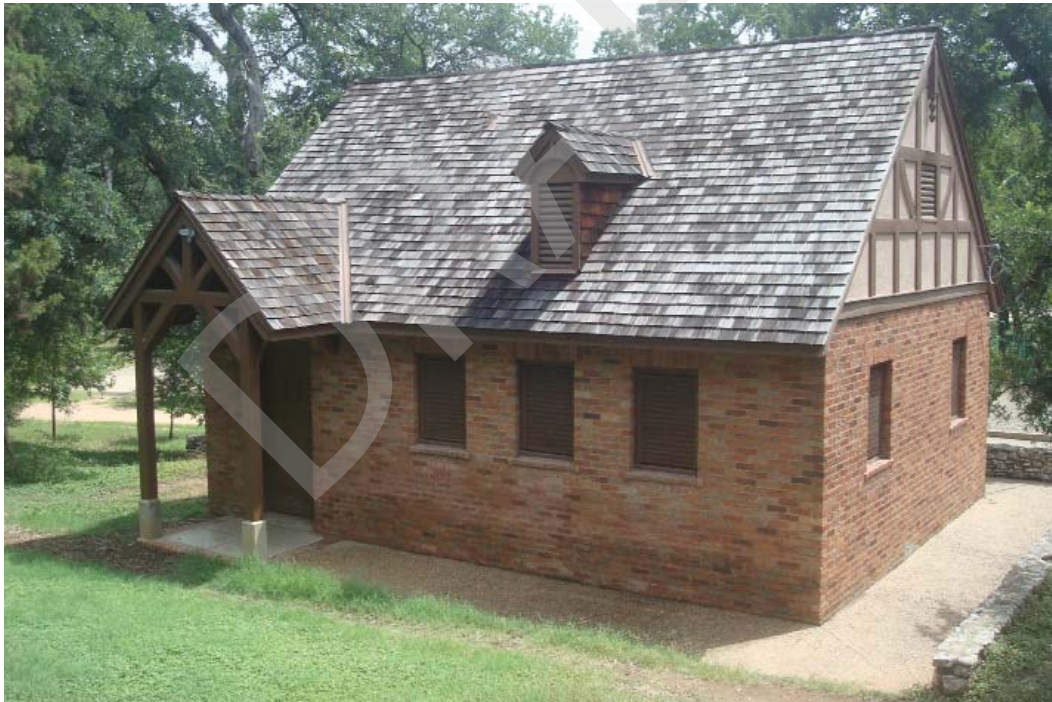
**Condition:** Exterior is in good condition, with recent brick repointing and a new roof. Interior is in poor condition.

Tudor Cottage as seen from Kingsbury, looking northeast

**Recommendation:** Continue on-going maintenance and renovate use as a Community Room, as described elsewhere in this document.

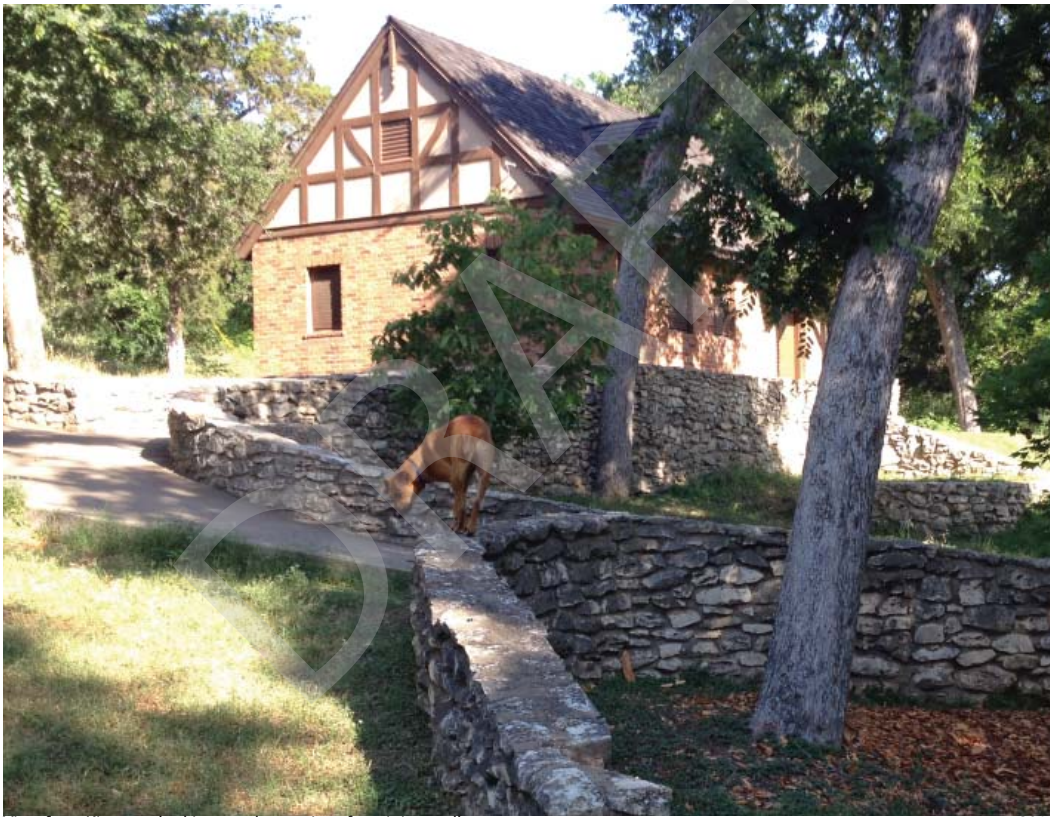
Condition: Generally good condition, with evidence of earlier repairs, and some isolated cracking.

View from Kingsbury looking north at series of retaining walls

Recommendation: Existing walls require spot repointing and graffiti removal. Remove some walls to accommodate adaptive re-use of Tudor Cottage.

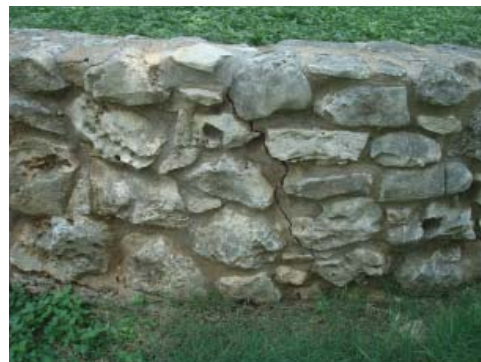
Typical cracking in wall

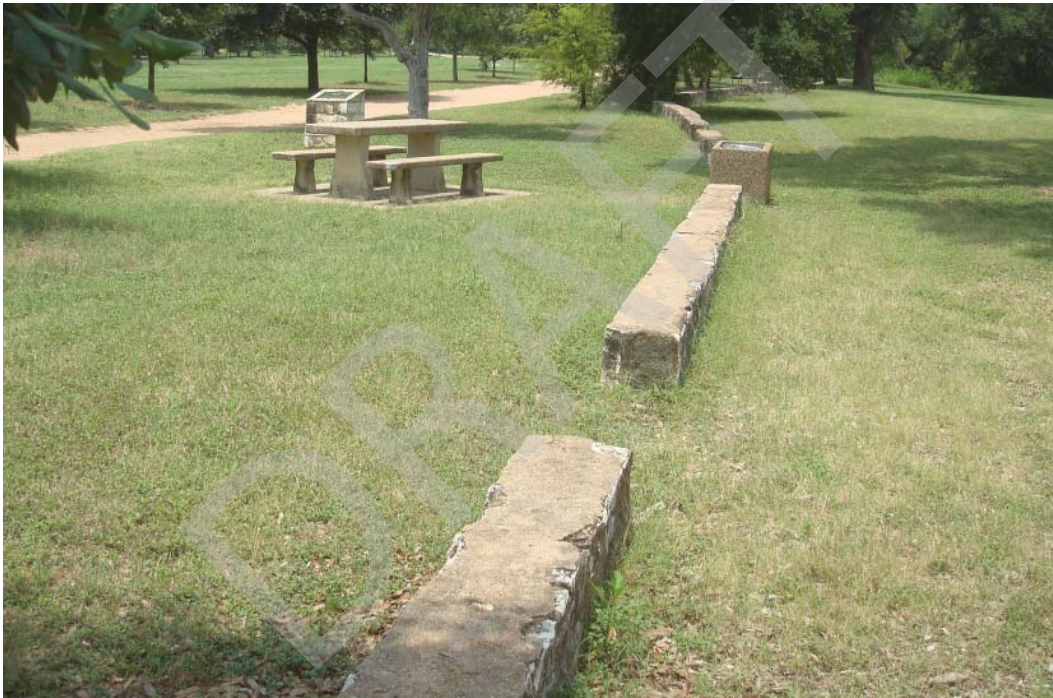
Condition: These walls are in fair condition. Small cracks are evident throughout, with several areas of larger through wall cracks and several missing stones.

Looking north from south end of wall system

Recommendation: Rebuild damaged portions of wall. Spot repointing and repair of cement

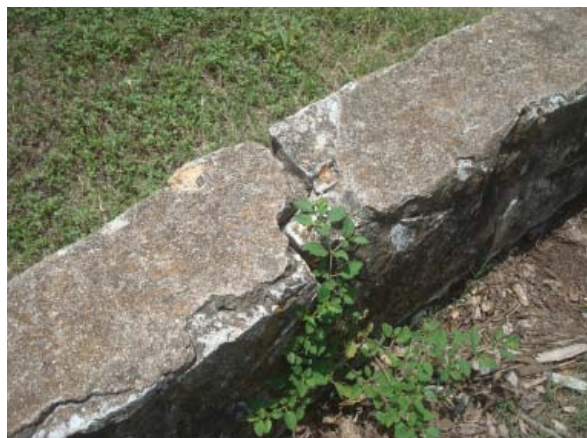
Typical through-wall crack

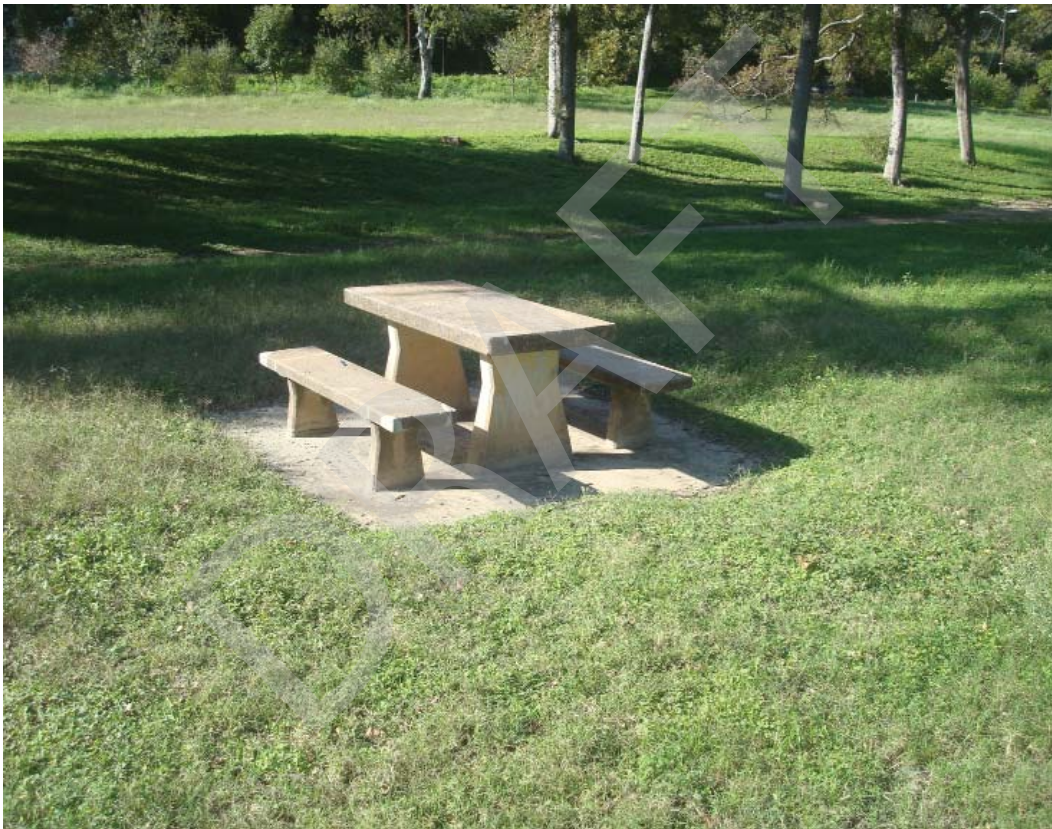
Condition: All of the tables and benches show evidence of recent repair work and are in good condition. There are isolated instances of graffiti.

Picnic table at Custer's Meadow

Recommendation: Clean graffiti. No other repair work required at this time.

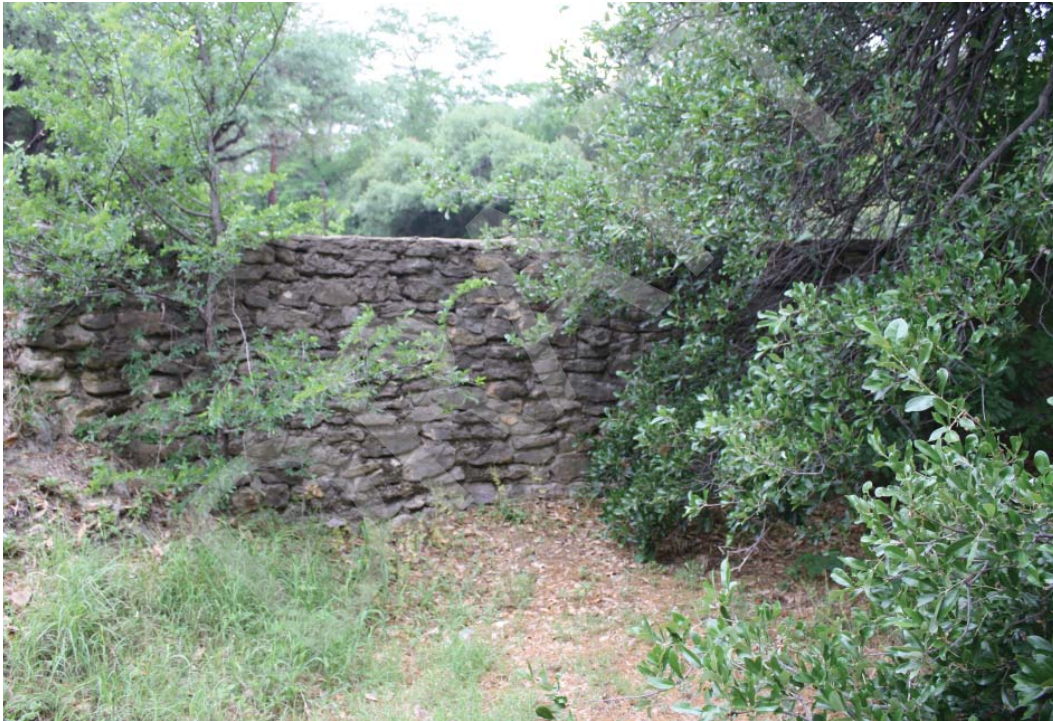
Condition: Good condition. No major deficiencies evident.

Looking west at wall. Parkway is immediately above wall.

Recommendation: No work at this time.

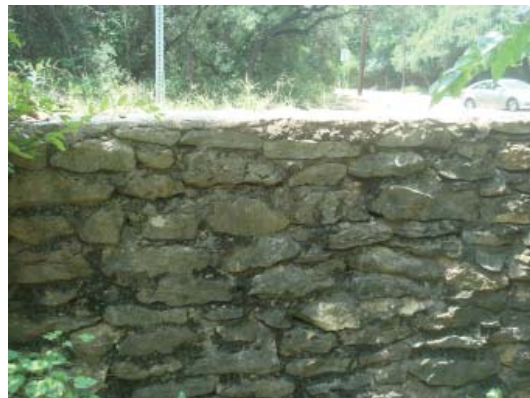
Detail of wall construction

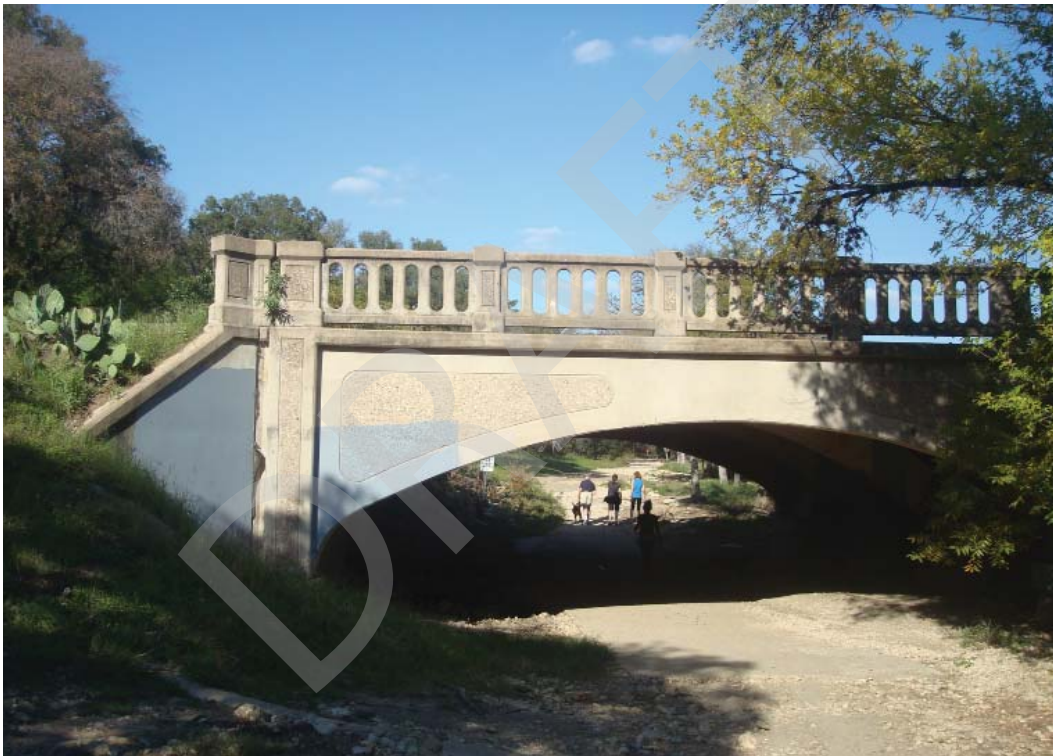
Condition: The structural condition of the bridge was not evaluated. The concrete generally appears to be in good condition, but has been painted in many places (to obscure graffiti).

View from trail looking north

Recommendation: Remove graffiti and paint. Provide new lighting under the arch at the path.

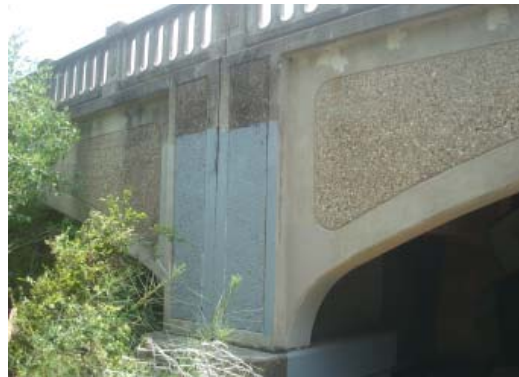
View from trail looking southeast

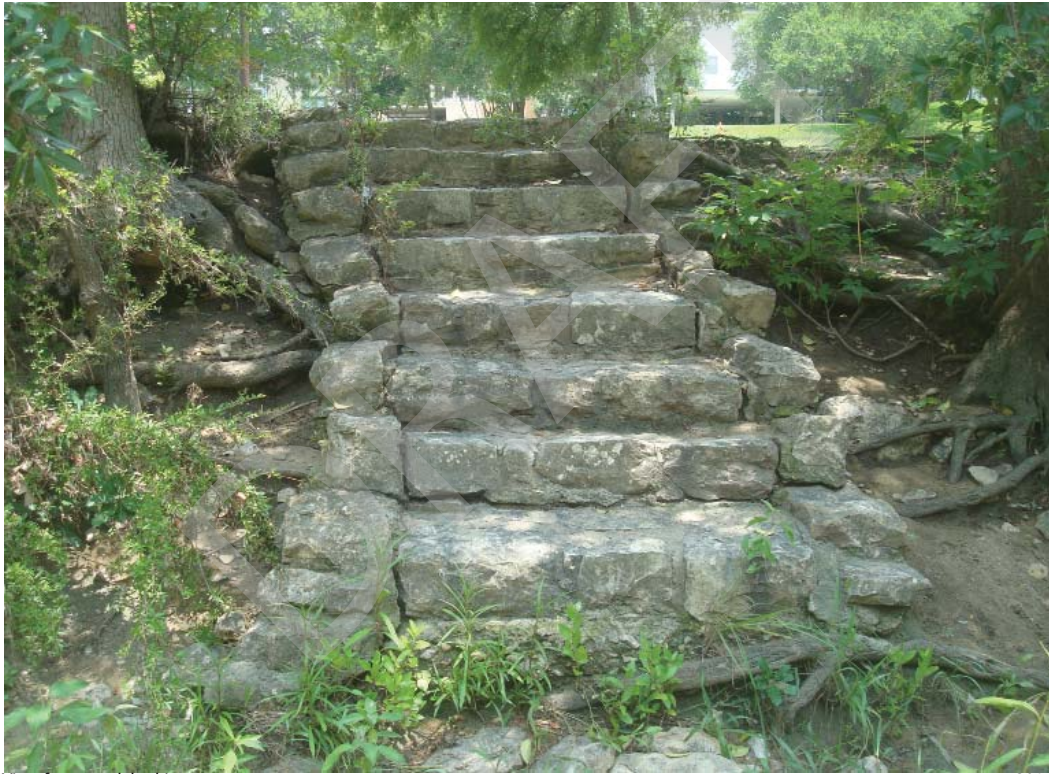
Condition: Poor. Sides are significantly undermined, and perimeter stones have separated from the body of the stair. The bottom step is approximately 2-ft above current grade.

View from creek looking east

Recommendation: Stabilize undermined sides and rebuild perimeter stones. Retain intact steps as is. Provide new boulder steps at base of stair.

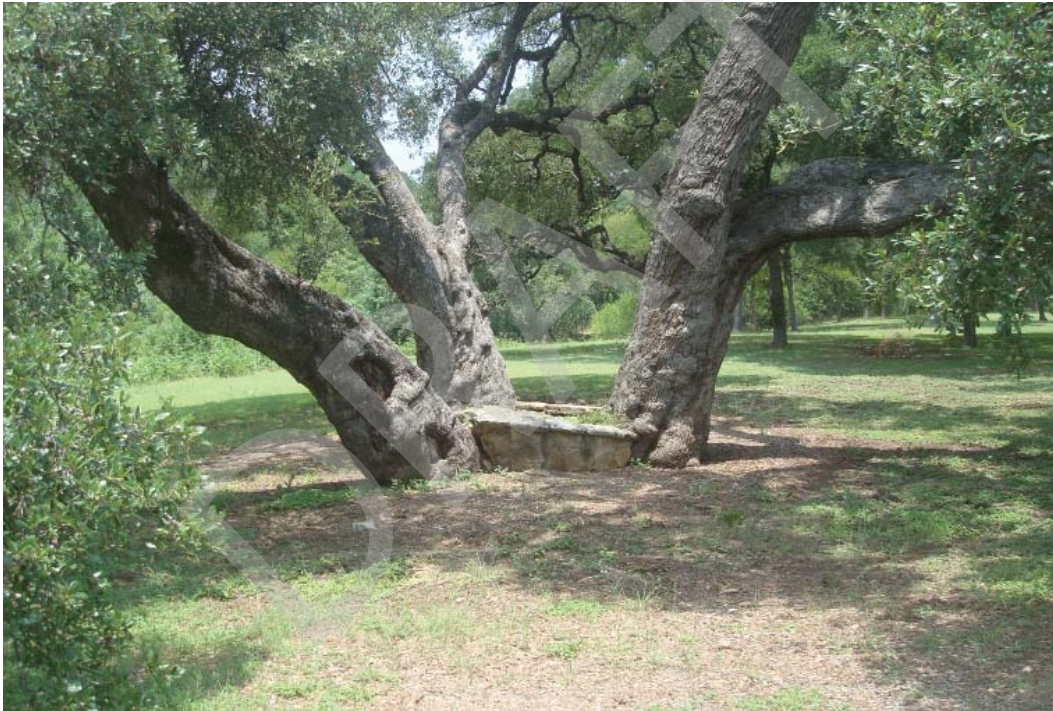
Condition: Poor. Two of the sides have massive upheaval, throwing the walls out of level and plumb. Several stones are displaced and some are missing.

View looking north

Recommendation: Major work at the trees is not recommended. Replace missing stones and secure displaced and loose stones. Do not correct for plumb and level. This is an artifact that is harmful to the heritage trees and is not recommended for restoration.

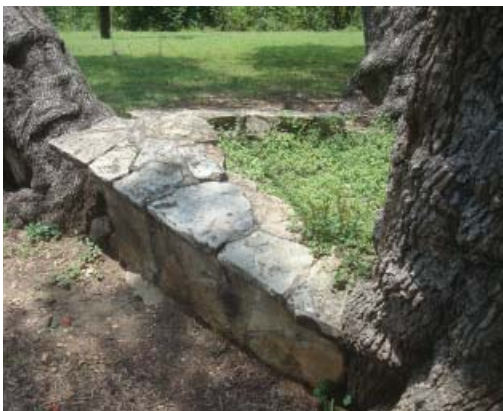
View looking north

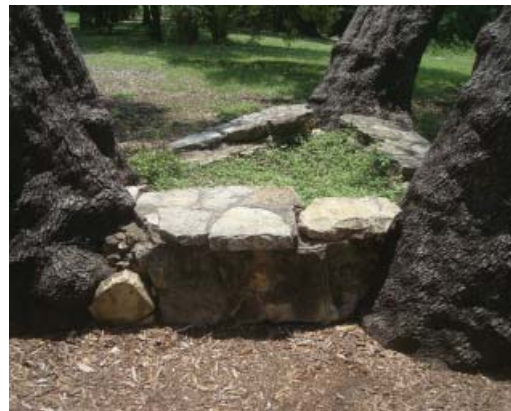
View looking south

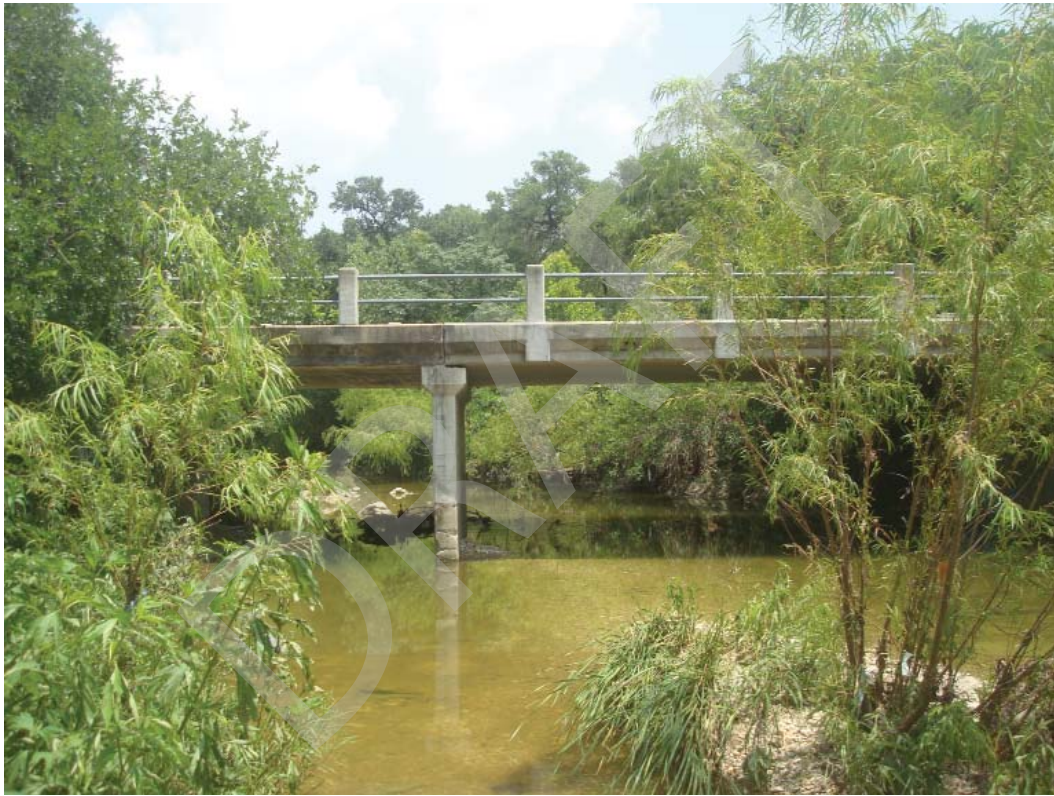
Condition: The structural condition of the bridge was not evaluated. The concrete generally appears to be in good condition, but has been painted in many places (to obscure graffiti).

Lower Shoal Creek Bridge viewed from creek looking east

Recommendation: Remove graffiti, clean and seal. Light bridge and area beneath bridge.

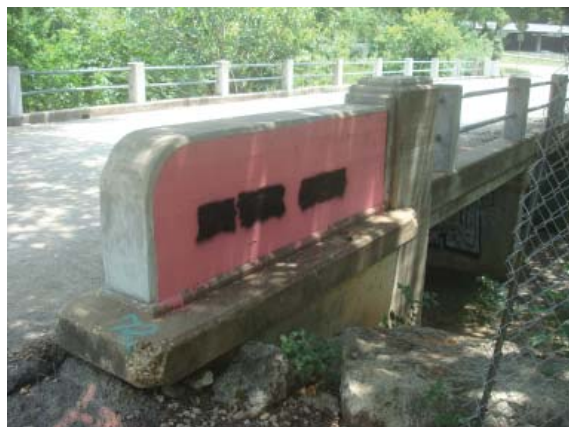
Northwest corner of bridge from trail

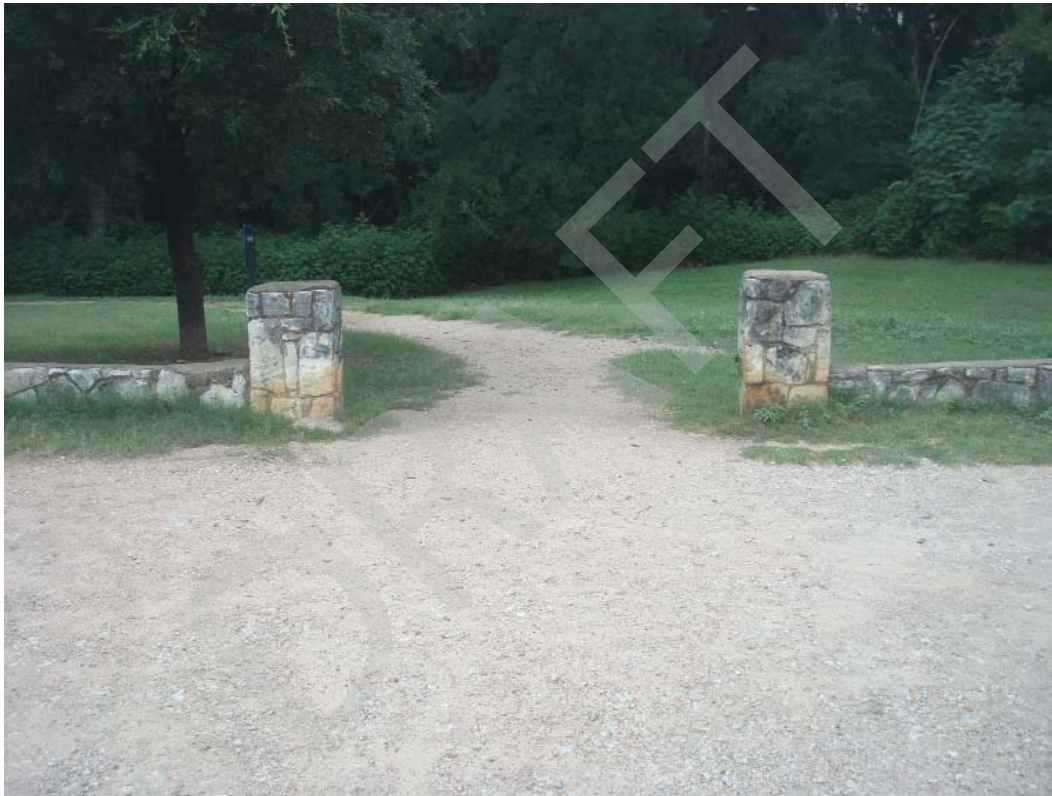
Condition: Poor. Much of the cement wash is missing and areas of the wall are crumbled.

Stone wall looking north at trailhead

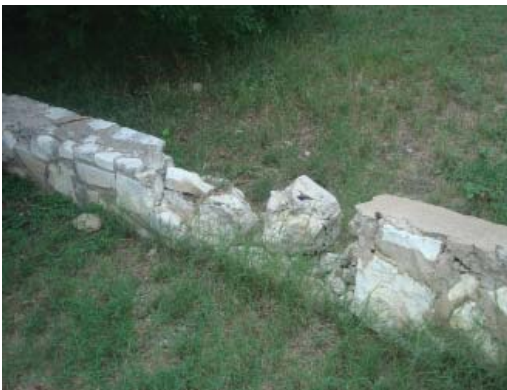
Area of crumbled wall

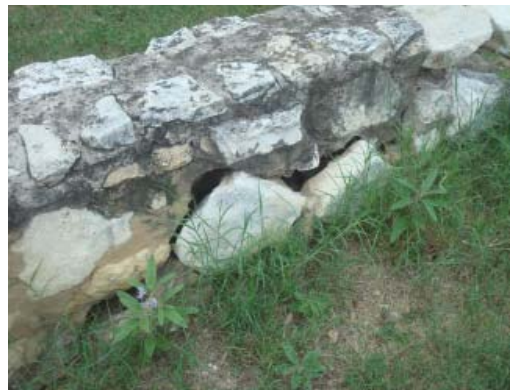
Typical cracking and stone displacement

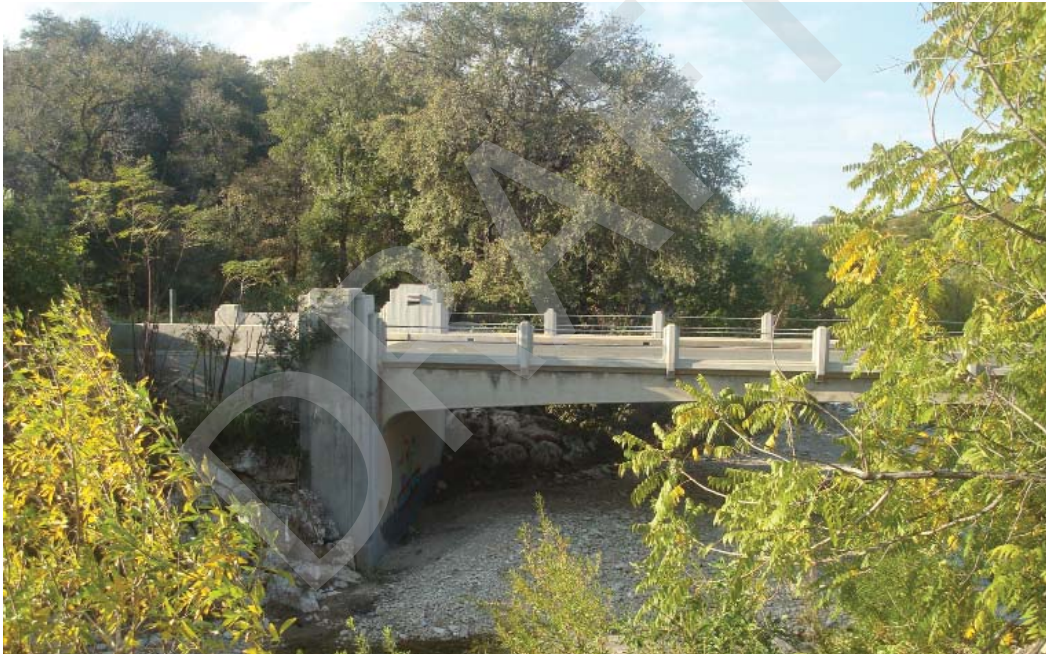
Condition: The structural condition of the bridge was not evaluated. The concrete generally appears to be in good condition, but has been painted in many places (to obscure graffiti).

Upper Shoal Creek Bridge looking north

Recommendation: Remove graffiti. Provide planters or covers at the open piers. Consider replacing pipe guard rails if further investigation indicates original rails were smaller. Light bridge and area beneath

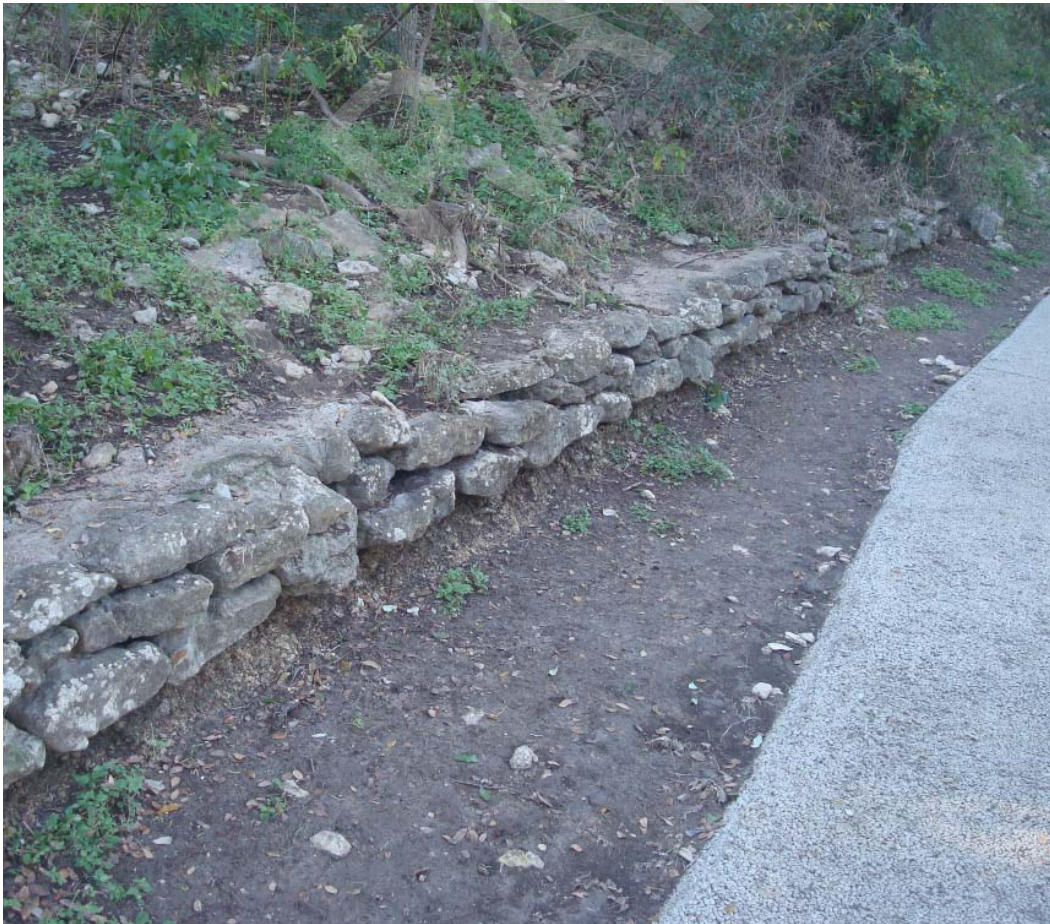
Condition: Good.

Stone wall on west side of trail

Recommendation: No work necessary at this time.

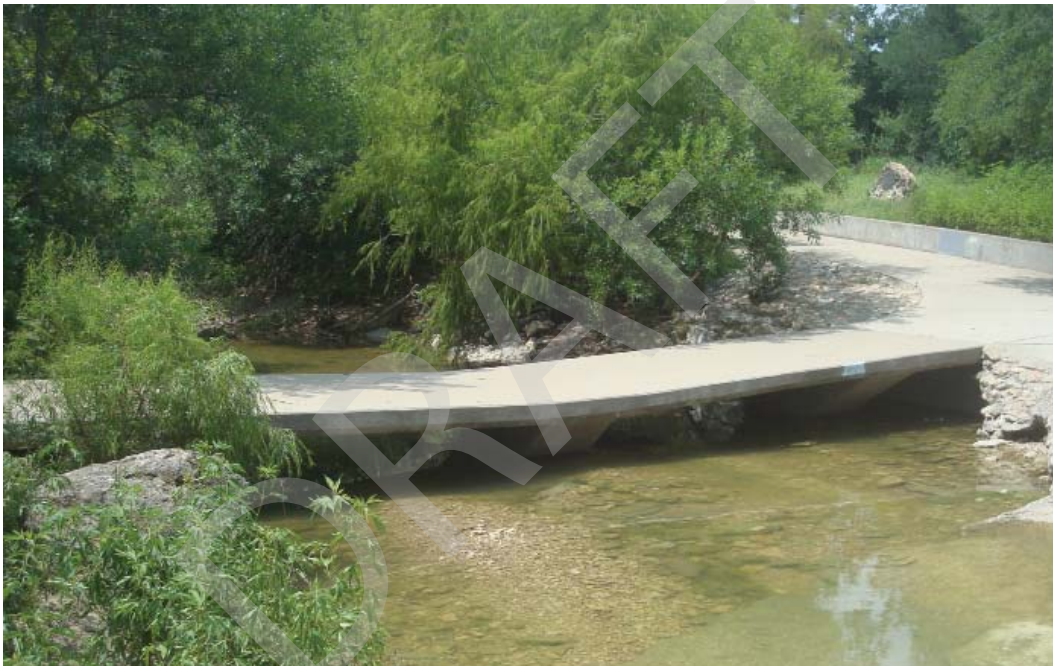
Condition: Good

Janet Fish Pedestrian Bridge viewed from edge of creek looking northwest. The memorial is visible beyond the bridge.

Recommendation: No work necessary at this time.

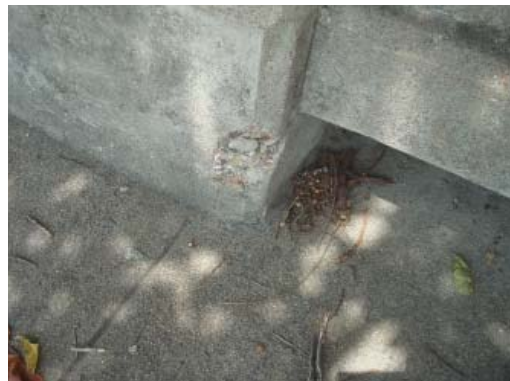
Condition: The structural condition of the bridge was not evaluated. The concrete generally appears to be in fair condition, with some limited spalling. Graffiti is present in accessible locations.

Detail of concrete spalling at guard rail

Recommendation: Remove graffiti. Spot patch concrete. Light bridge and area beneath bridge.

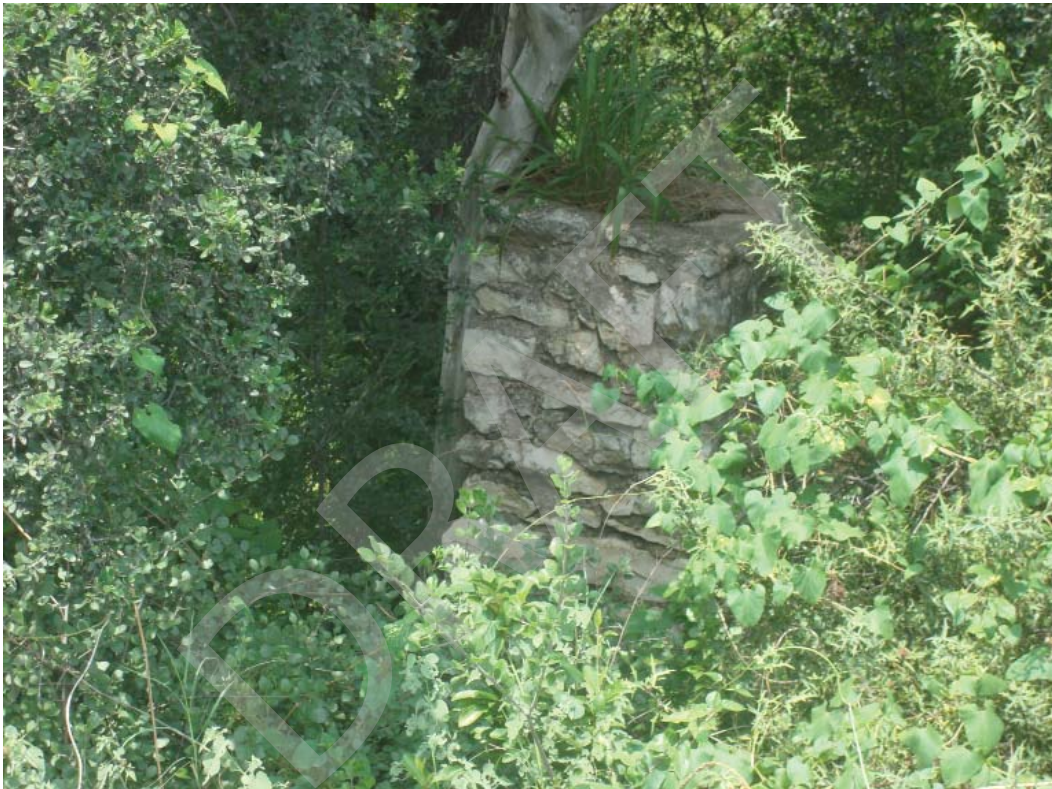
Condition: Poor. Some piers are cracked and out of plumb, others are almost completely crumbled.

Stone pylon viewed from Lamar sidewalk looking west

Recommendation: Rebuild piers and install new steel guard rail for potential new overlook.

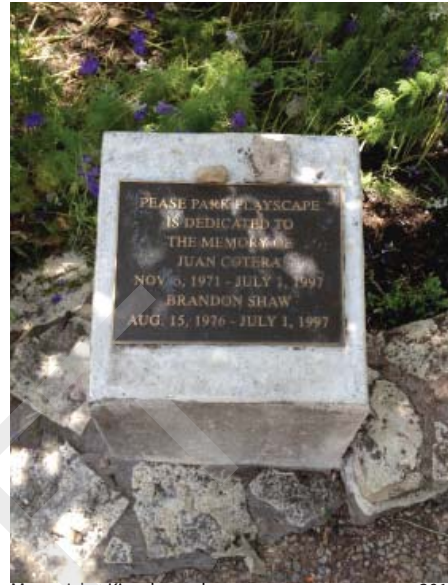
Condition: Plaque and base are both in good condition.

Memorial at Kingsbury playscape

Recommendation: Light cleaning required for both plaque and base. The memorial should be retained in any park reconfiguration. If the playscape is relocated the memorial should be relocated as well.

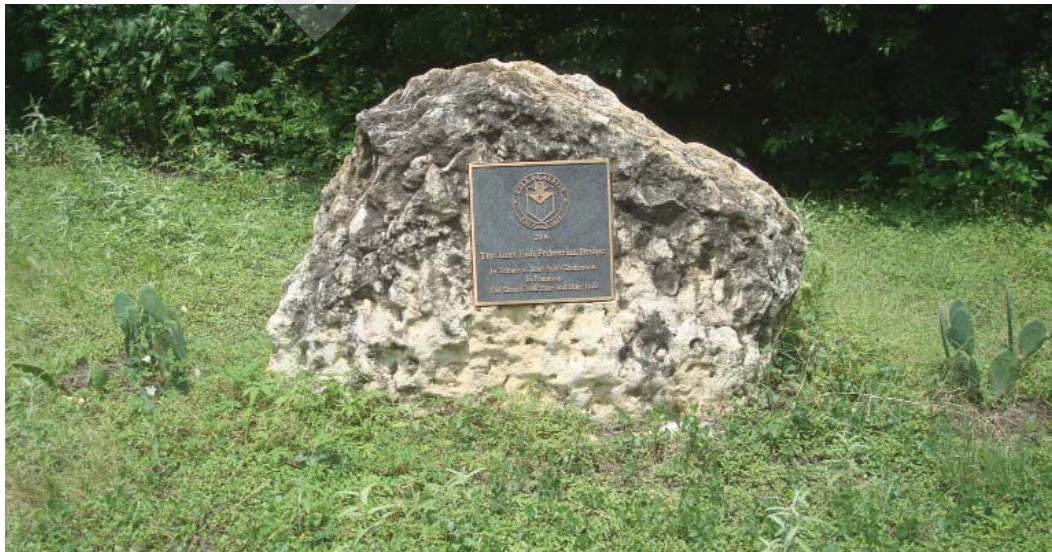
Condition: Plaque and base are both in good condition.

Memorial on east side of trail

Recommendation: No work needed at this time.

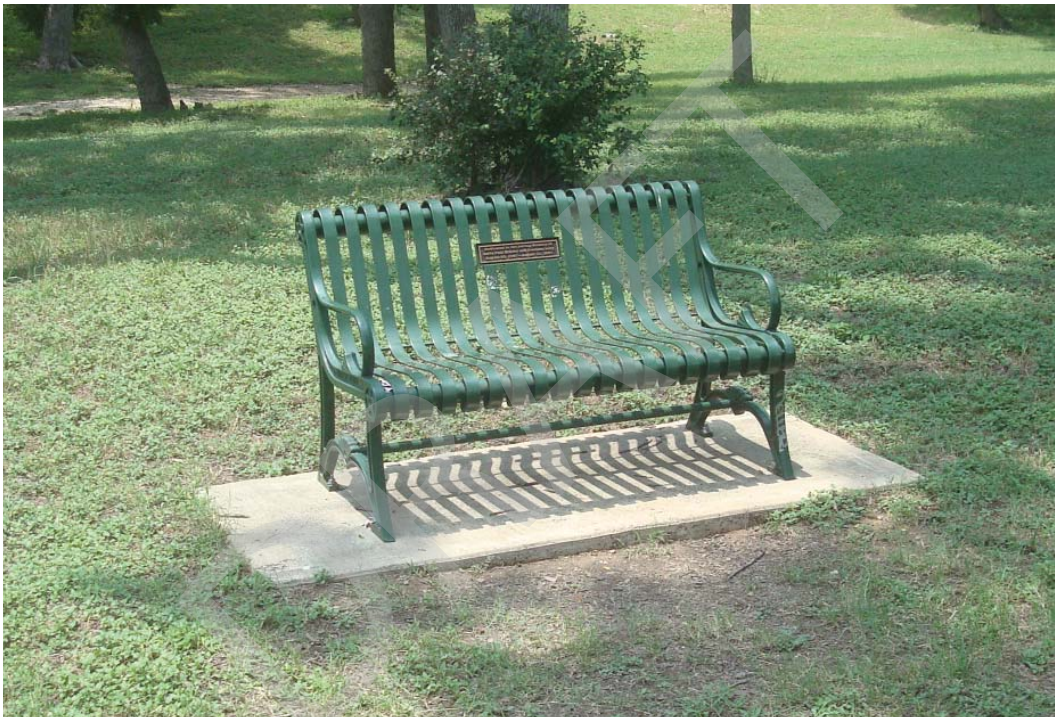
Condition: Good to excellent condition. There are a few minor blemishes in the paint.

Typical memorial bench at Custer's Meadow

Recommendation: Touch up paint.

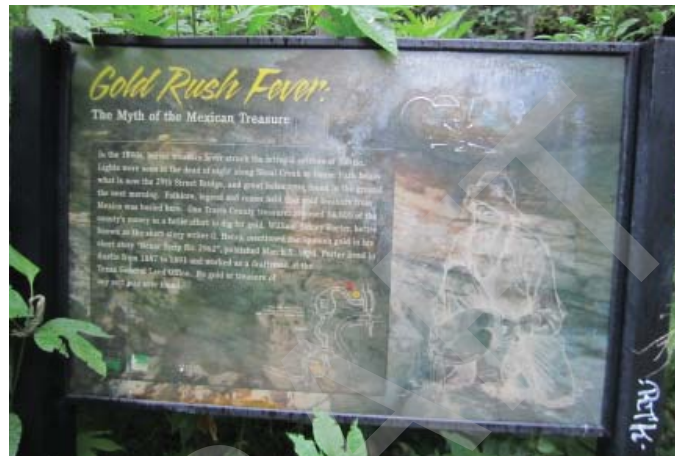
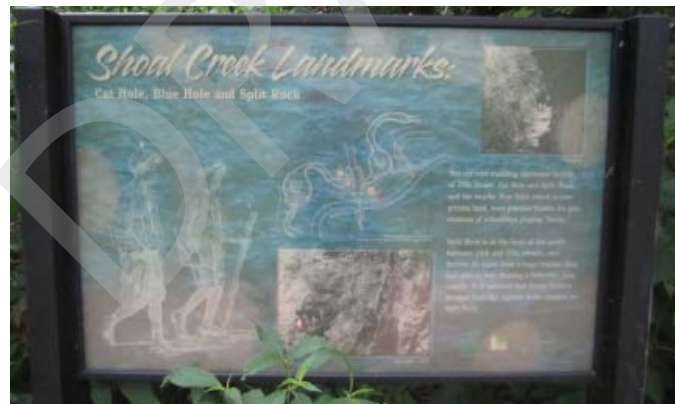
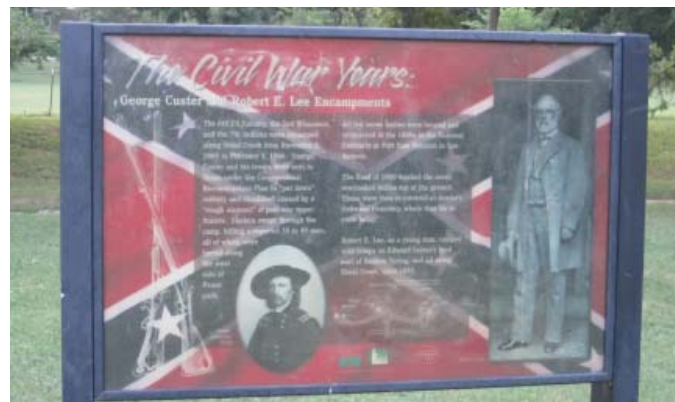
Condition: Signs are in good condition, suffering principally from graffiti. Images are somewhat faded and text is difficult to read.

Signs in Pease Park

Recommendation: No immediate work is needed. A new Interpretive Plan should be developed, including new signage throughout the park.

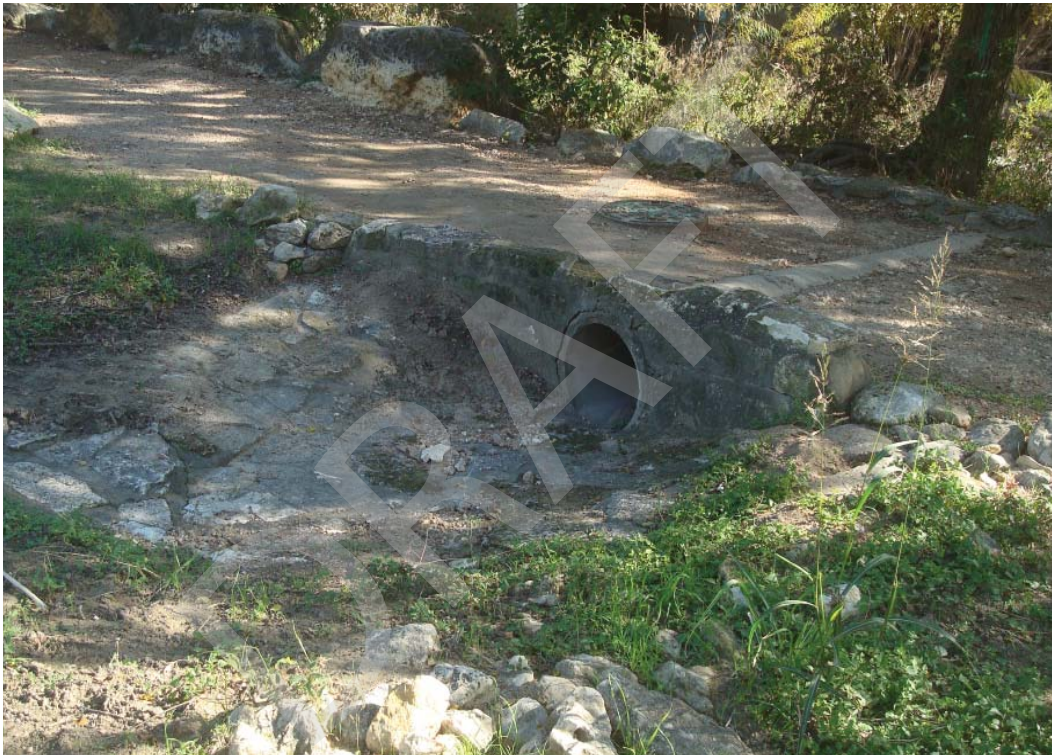
Condition: Culverts of all ages are in fair to good condition. Small cracks along mortar joints are typical.

Concrete pipe culvert in Wooten Woods

Recommendation: Spot repointing of stonework.

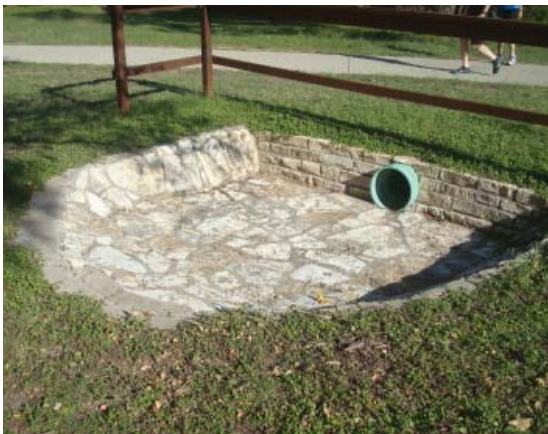
Concrete culvert near Custer's Meadow

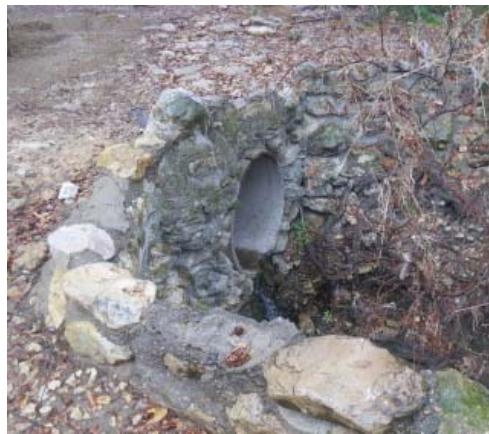
Plastic culvert near Custer's Meadow
