REQUEST FOR SHPO CONSULTATION:

Plaza Saltillo Rail Relocation Project

**HISTORIC RESOURCES
RECONNAISSANCE SURVEY REPORT
PLAZA SALTILLO RAIL RELOCATION PROJECT
AUSTIN, TRAVIS COUNTY, TEXAS**

Plaza Saltillo Rail Relocation Project
Historic Resources
Reconnaissance Survey Report
Austin, Travis County, Texas

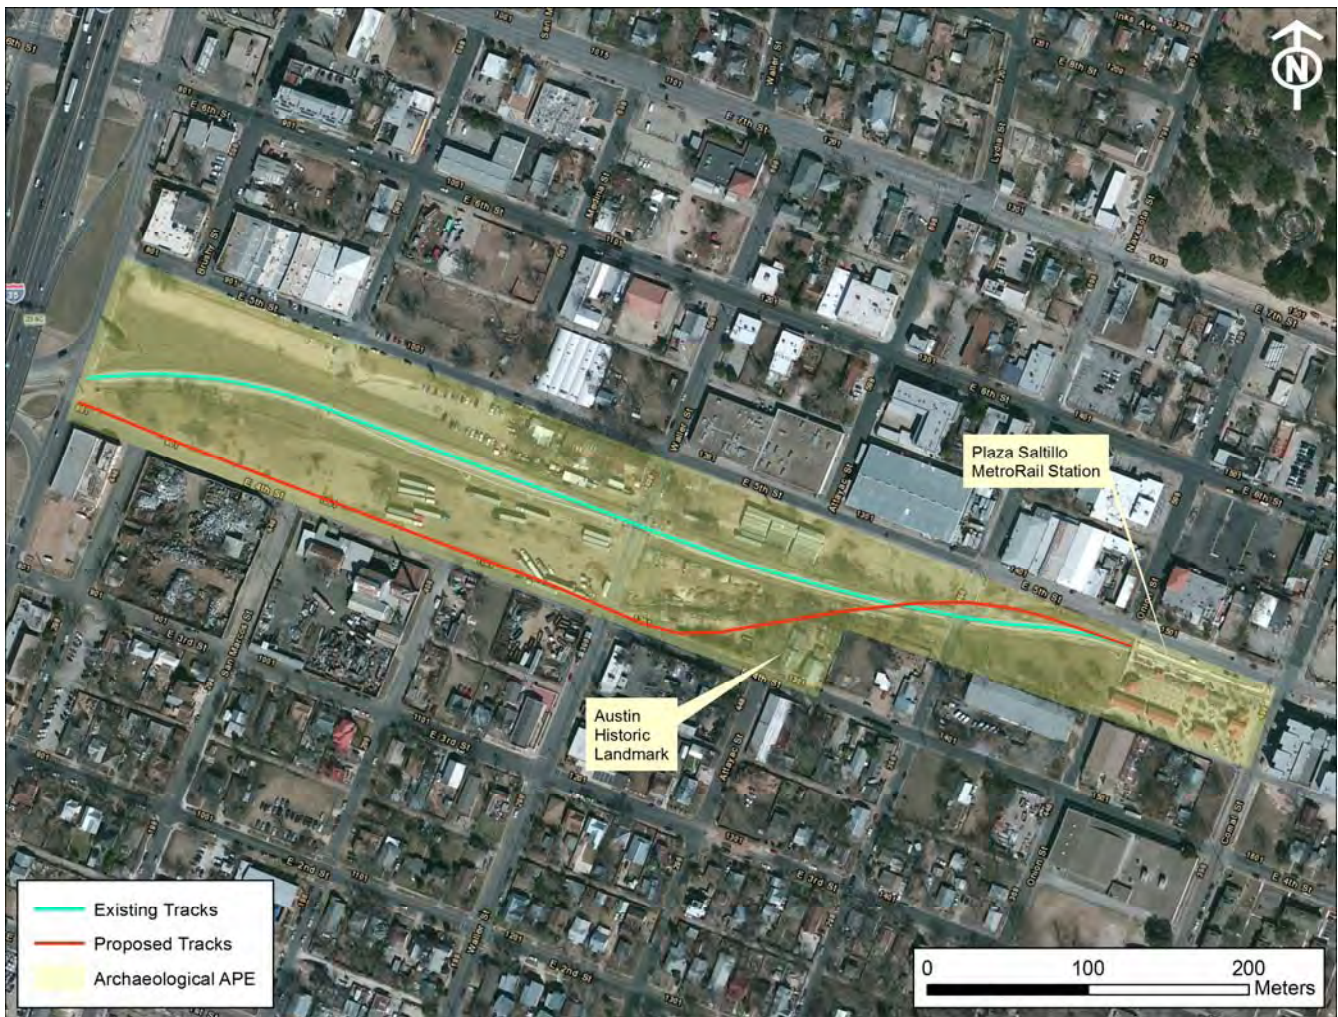
Figure 1. Contemporary aerial depicting the location of the archaeological APE, existing and proposed tracks, Austin Historic Landmark (former Texaco oil depot), and the Plaza Saltillo MetroRail Station (ESRI World Imagery).

Capital Metro proposes to relocate the existing railroad tracks between Onion Street and the IH-35 northbound frontage road in East Austin, Texas. The project is designed to facilitate the construction of pedestrian-friendly, mixed-use development surrounding commuter rail stations along the Metro Rail Red Line. Track relocation would open up land for development that is currently bisected by the rail line, limiting land use. The proposed double tracks would skirt East 4th Street with Interstate Highway 35 on the west and Waller Street on the east, before turning northeast to join with the current track alignment immediately west of the Plaza Saltillo MetroRail station located on the southwestern corner of East 5th Street and Onion Street (**Figure 1**). No new right-of-way or land will be required for this project.

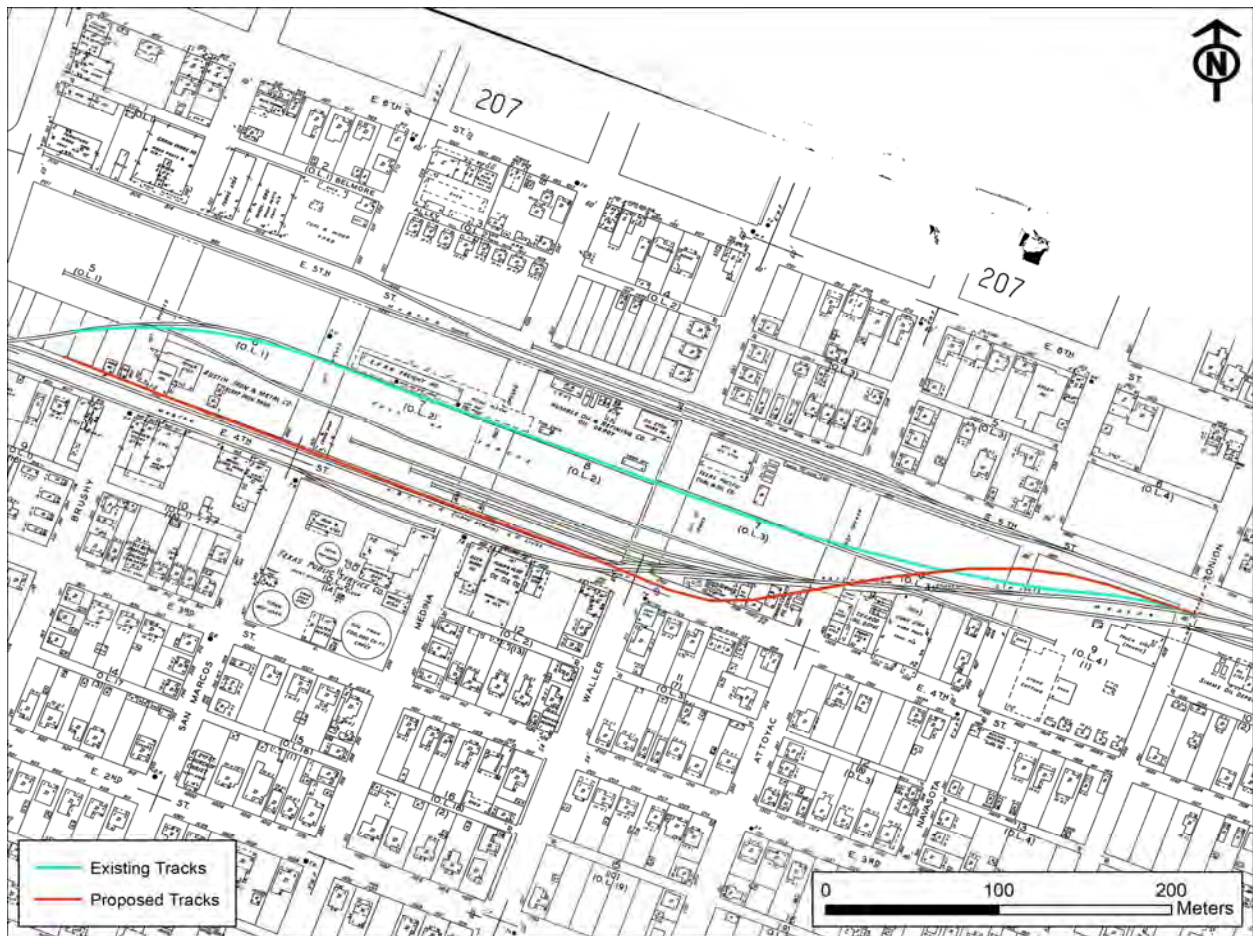
Figure 4. Sanborn Fire Insurance map of Austin, 1935 depicting the locations of the existing and proposed tracks.

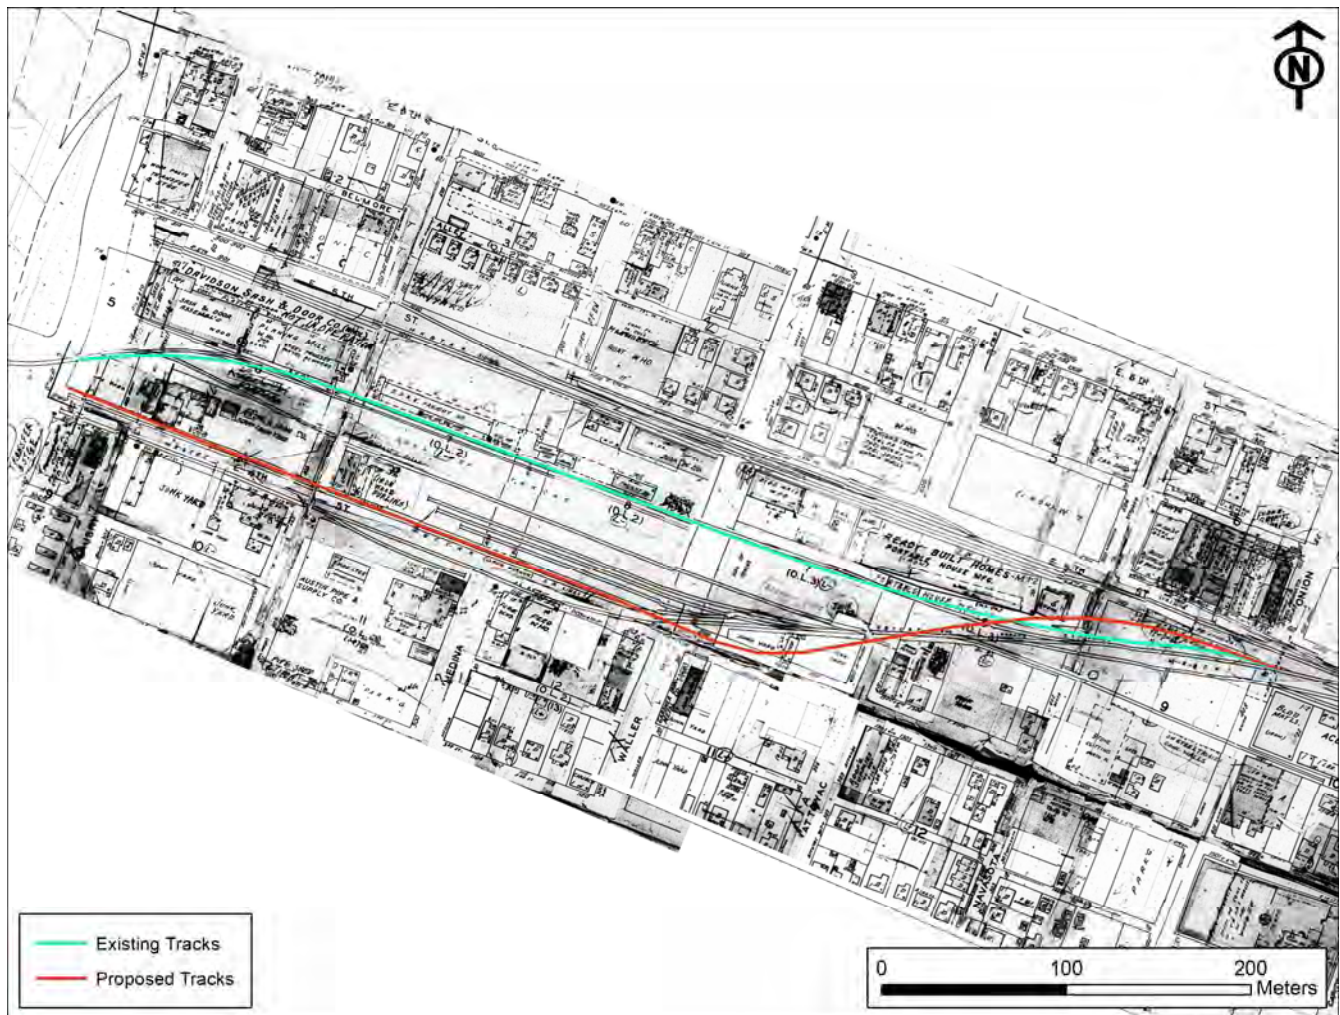
Figure 5. Sanborn Fire Insurance map of Austin, 1961 depicting the locations of the existing and proposed tracks.

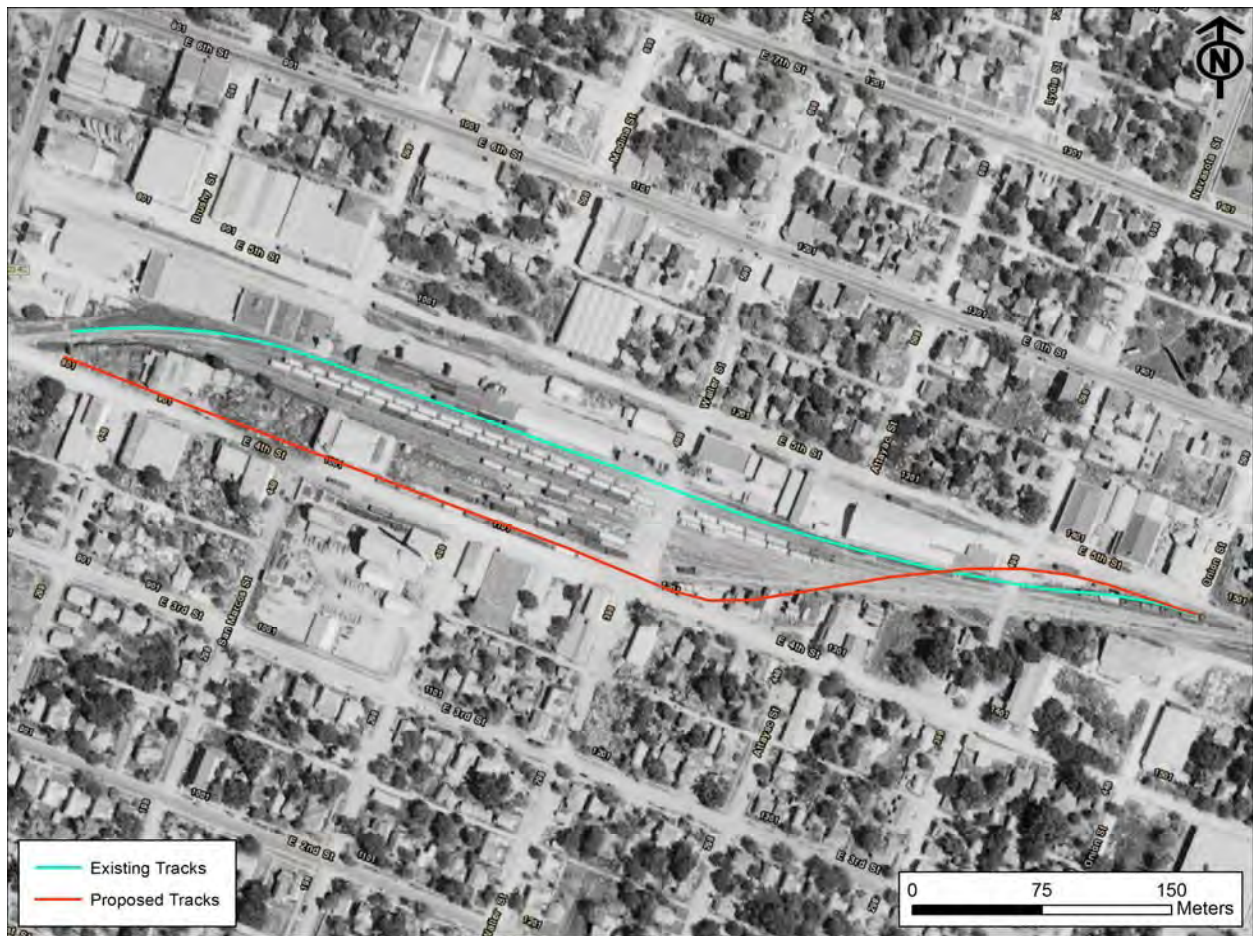
Figure 7. United States Geological Survey map, 1952. Note the presence of standing structures within and around the APE.

The area has been industrialized for the past 140 years and has seen the construction and demolition of numerous structures related to railroad activities and industrial use (**Figures 6 and 7**). As a result archaeological materials associated with 19th and 20th century industrial Austin are anticipated, but they likely are in poor condition and possibly lack geospatial integrity.

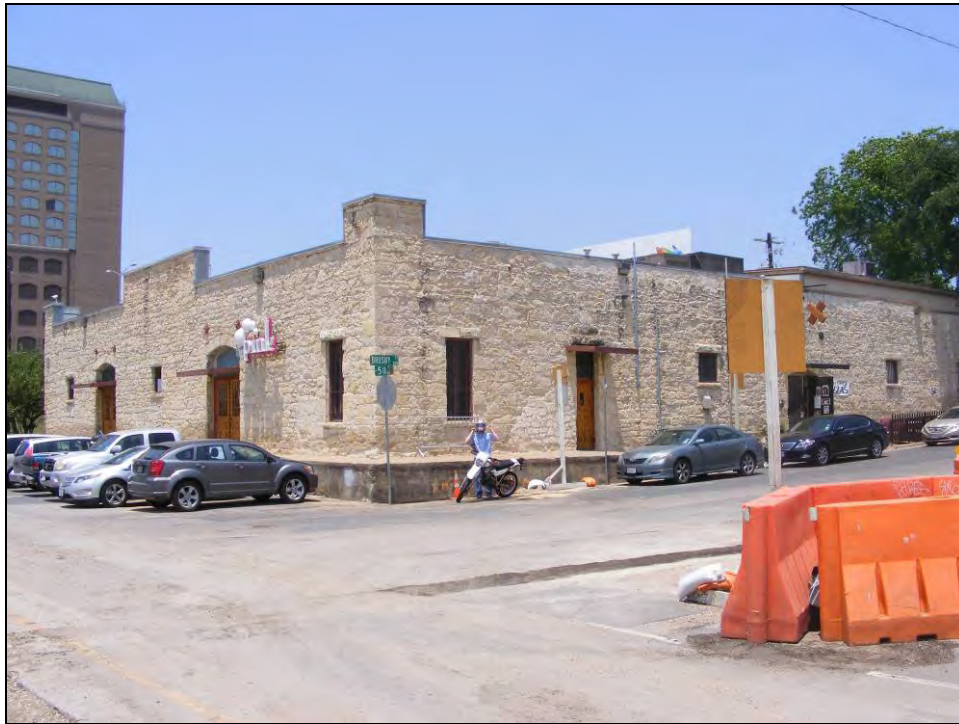
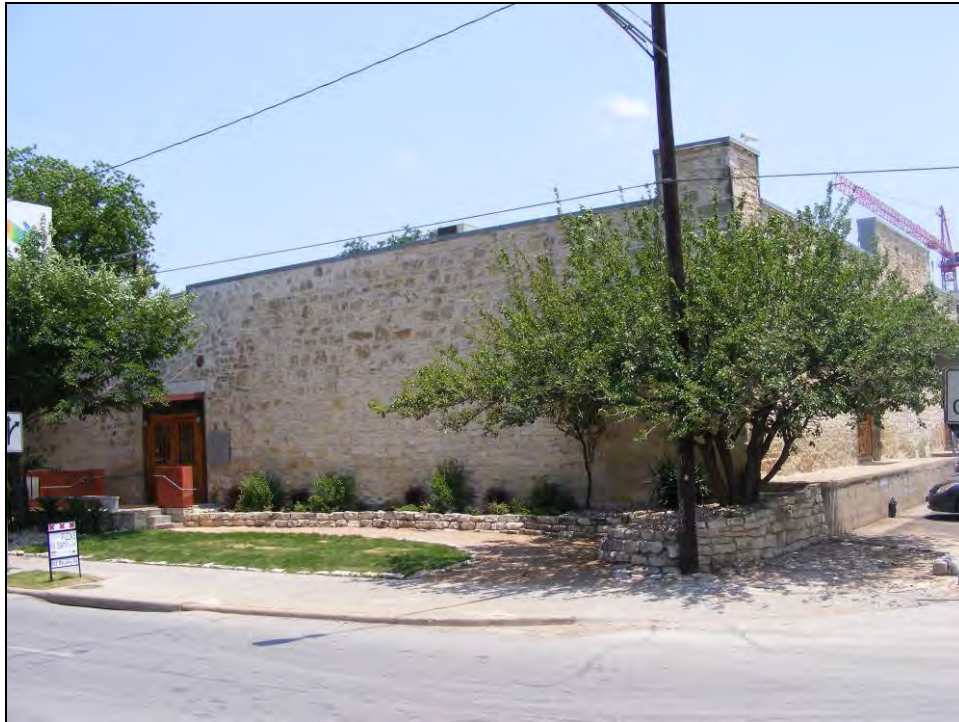
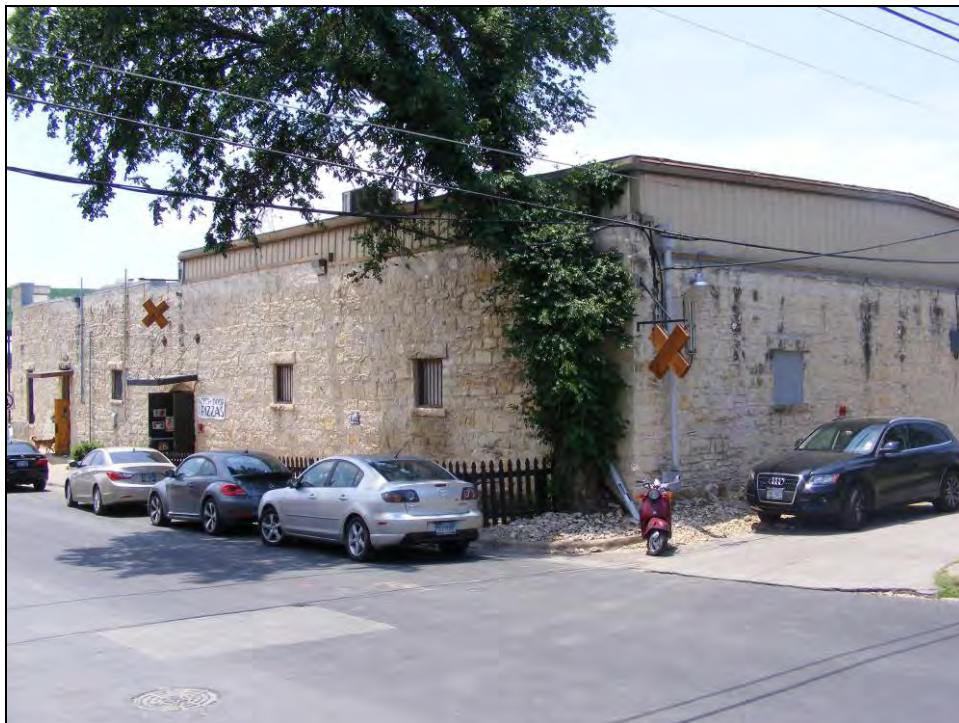
Map ID 1 is the 1872 Robinson Brothers Warehouse, an Austin Historic Landmark. The one-story commercial block building sits on a masonry foundation with stone walls topped with a stone parapet capped with modern metal flashing. The doors and windows, while fitting the aesthetics of the building, are modern. The northeast corner of the building has been modified with a shallow-pitched roof, with the rest of the roof being flat. The building houses a variety of commercial ventures, including a restaurant and offices. It has nominal significance for its commercial associations under Criterion A and is architecturally significant under Criterion C, but the building has undergone significant changes and alterations that impact its integrity of design, setting, materials, workmanship, and feeling. As such, it is recommended not eligible for listing in the NRHP.

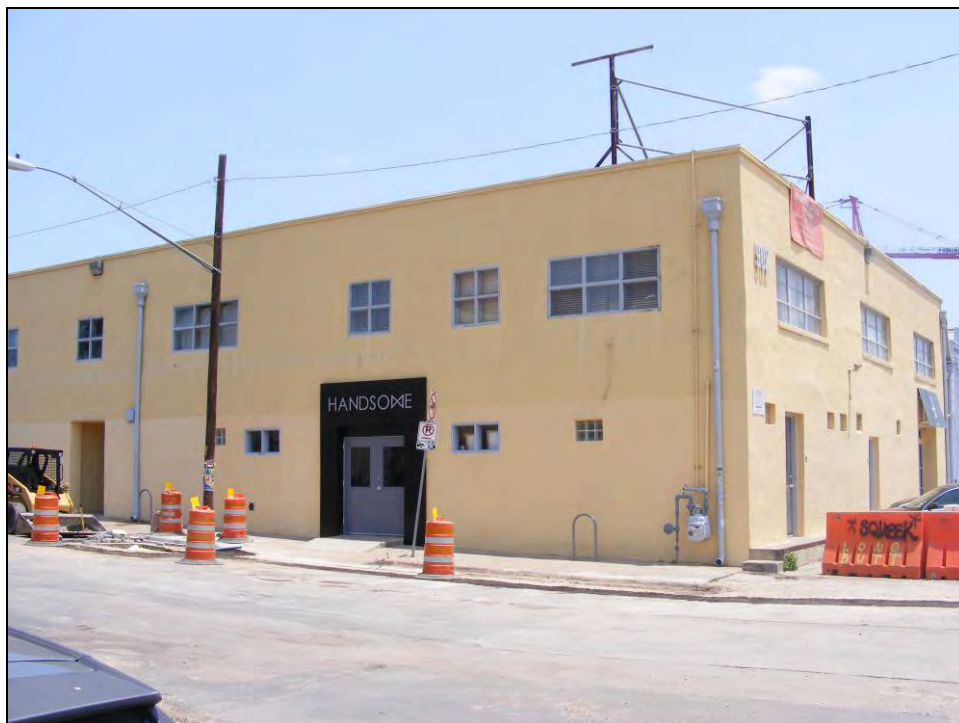
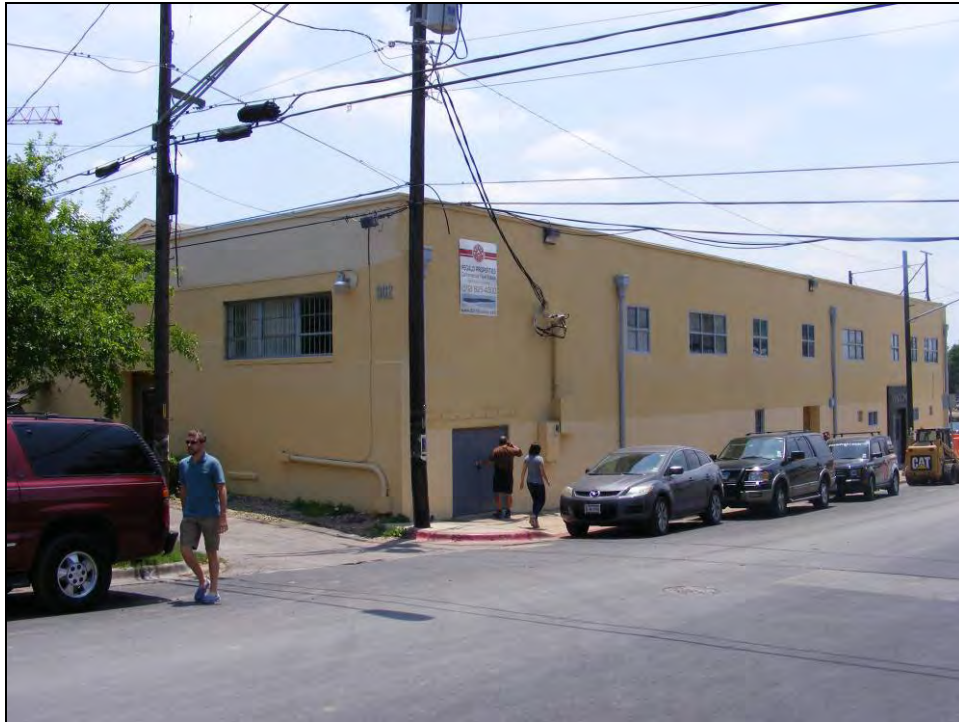
Map ID 2 is a circa 1960 commercial warehouse building. The two-story commercial block building sits on a concrete foundation and is partially embedded into a hill to the north. The masonry walls are coated with painted concrete stucco and have a mix of metal frame and casement windows. The minimal parapet has a simple concrete cap. Entries are a mix of single and double steel fire doors, some with decorative awnings. The roof is flat on the west side, with a shallow pitched metal roof

over the eastern two-thirds of the building. The building served as the J.R. Reed Music Company service center from 1960-1980, but has since been subdivided into multiple commercial spaces. It has minimal significance under Criterion A for its commercial associations but is not particularly noteworthy for its architecture under Criterion C. Alterations to the building impact its integrity of design, materials, workmanship, and feeling. As such, it is recommended not eligible for listing in the NRHP.

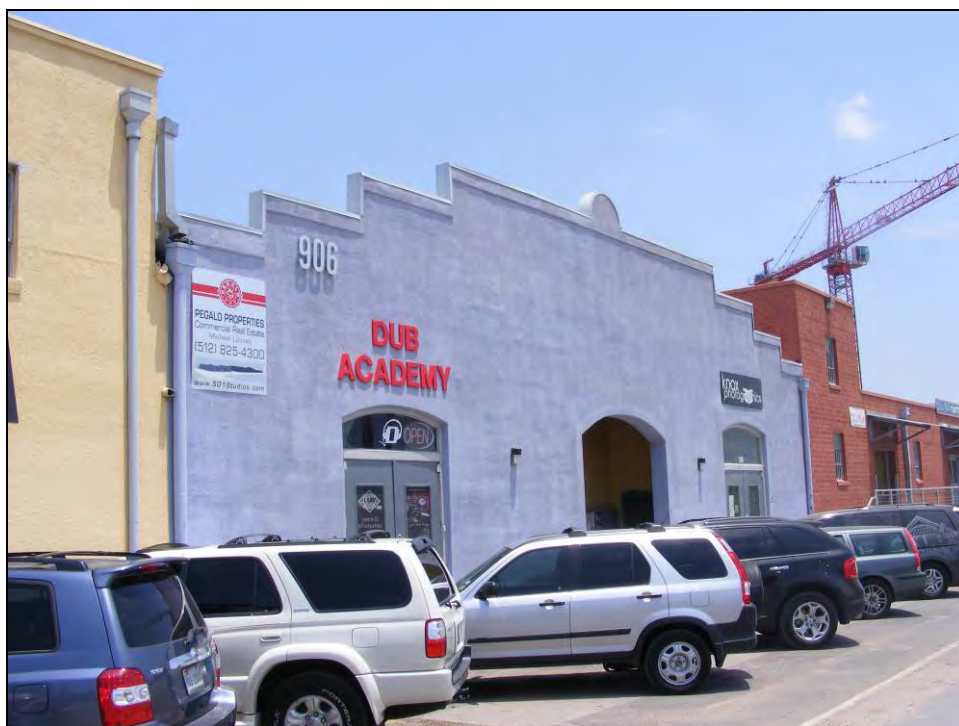
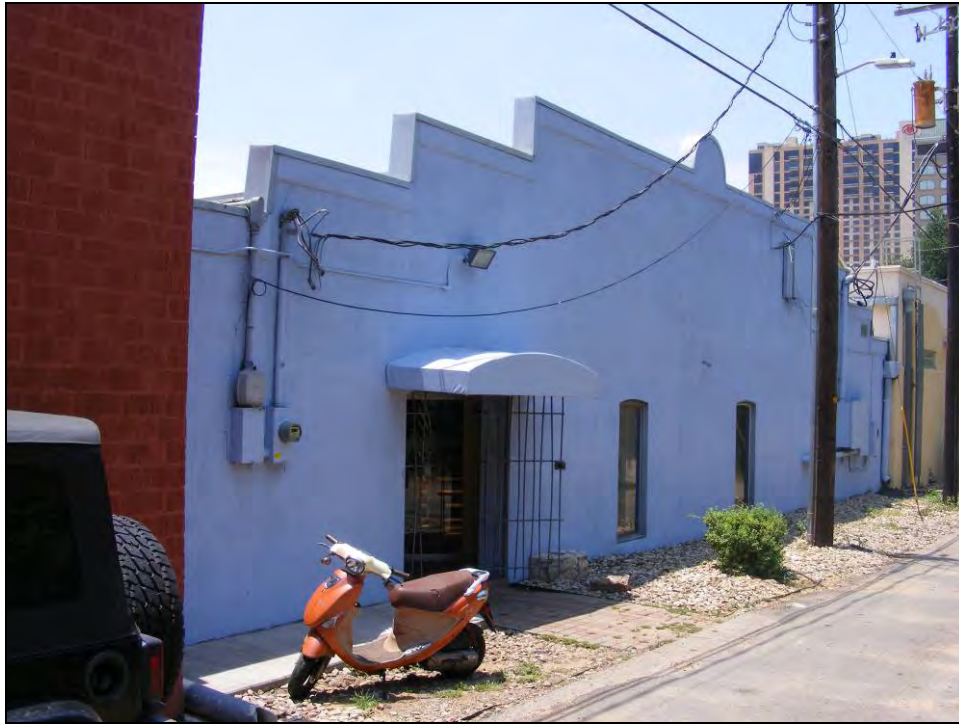
Map ID 3 is a circa 1920 commercial warehouse building. The two-story commercial block building sits on a concrete foundation and is partially embedded into a hill to the north. The masonry walls are coated with painted concrete stucco with three sets of double steel doors on the main façade and a single glass door with side lights on the rear alley. The center front door is recessed in a small alcove. All three front doors have arched windows of varying height above them. Two modern windows adorn the rear. The front and rear façades are a symbolic representation of the Alamo Mission in San Antonio, with a simple stepped parapet with a decorative half-circle in the middle. The roof is a shallow-pitched gambrel roof not visible from the street. The building has served a variety of commercial interests through its history, including wholesale grocers, a miscellaneous supply company, and the Davidson Sash and Door Company. It has since been subdivided into multiple commercial ventures. It has minimal significance under Criterion A for its commercial associations and is not particularly noteworthy for its architecture under Criterion C. Alterations to the building impact its integrity of design, materials, workmanship, and feeling. As such, it is recommended not eligible for listing in the NRHP.

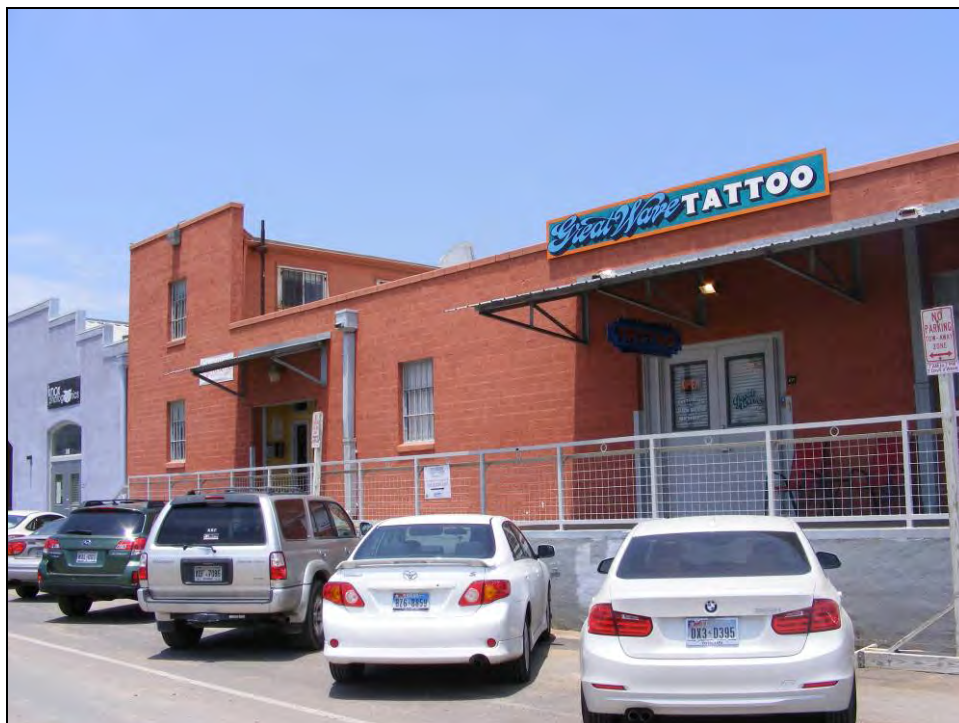
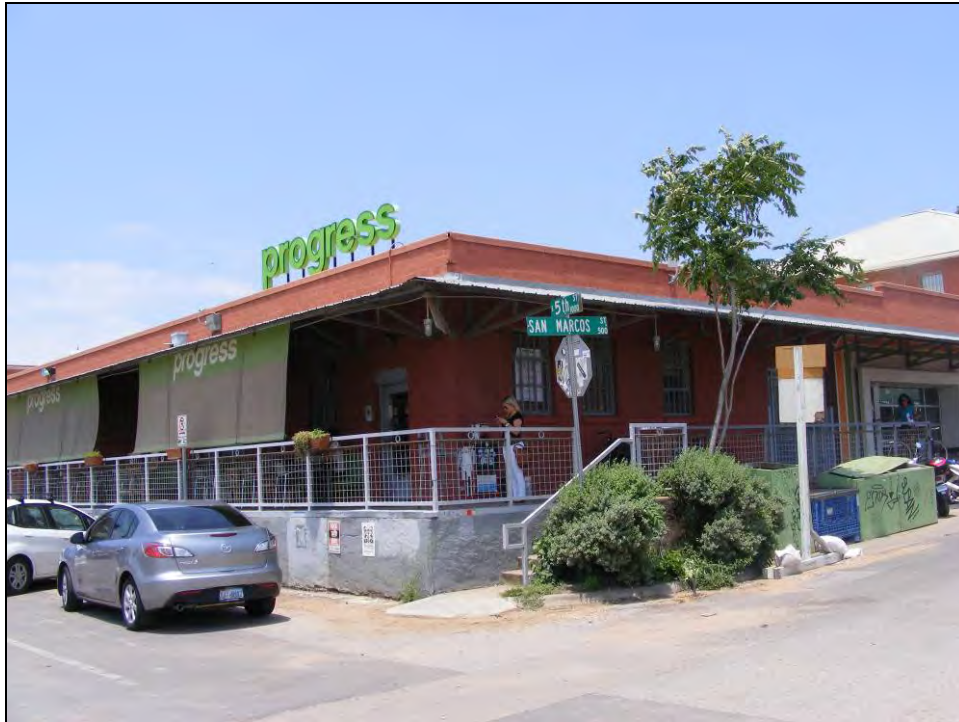
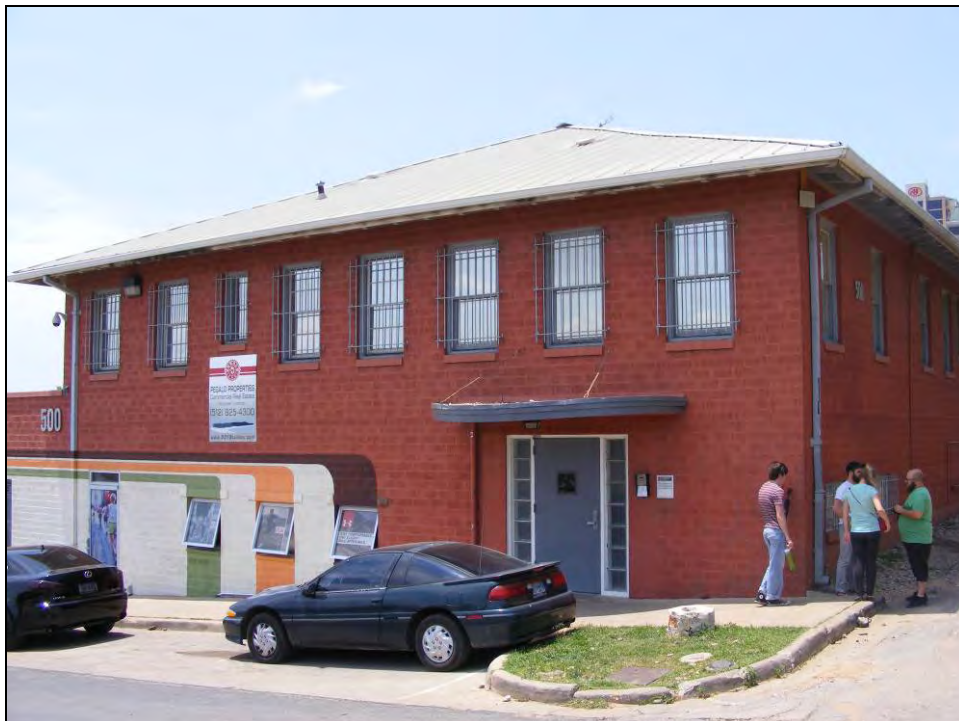
Map ID 4 is a circa 1945 commercial warehouse building. The one and two-story commercial block building is a combination of three buildings that have since been merged into one property. It sits on a raised concrete foundation with loading dock, with the rear of the building embedded into a hill to the north. The brick masonry walls have a simple brick parapet on the central single-story and west two-story sections. Windows are a mix of metal-frame casement and wood sash. The two-story section in the northeast corner is topped by a modern hipped metal roof with no eave. The building served as part of the Davidson Sash and Door Company up through the early 1970s, but has since been subdivided and now serves a variety of commercial ventures including a restaurant and tattoo parlor. It has minimal significance under Criterion A for its commercial associations and is not particularly noteworthy for its architecture under Criterion C. Alterations to the building impact its integrity of design, materials, workmanship, and feeling. As such, it is recommended not eligible for listing in the NRHP.

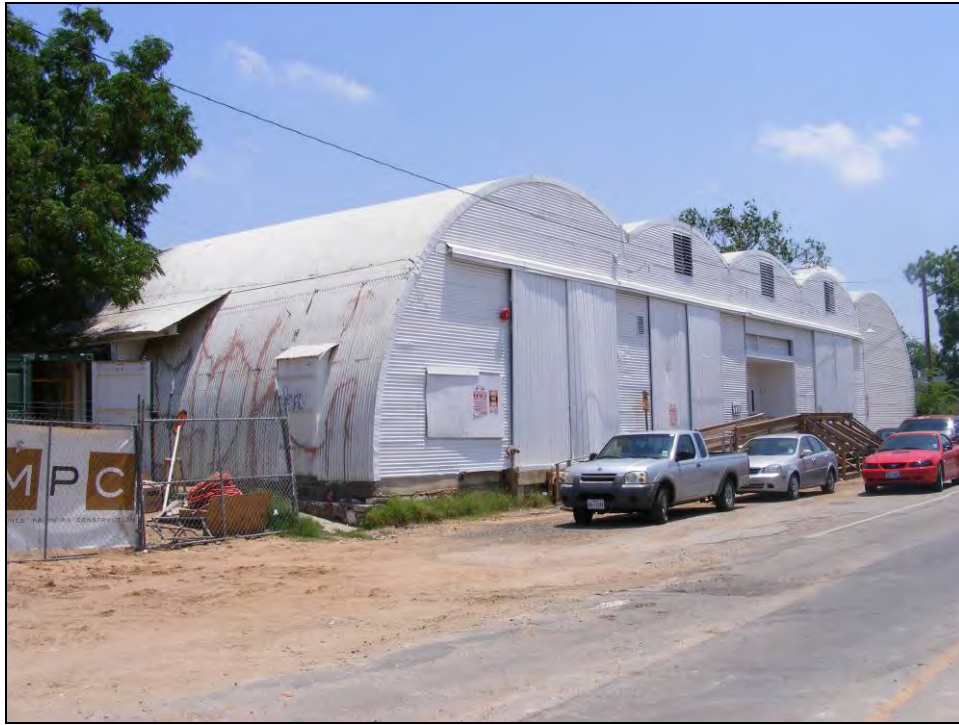
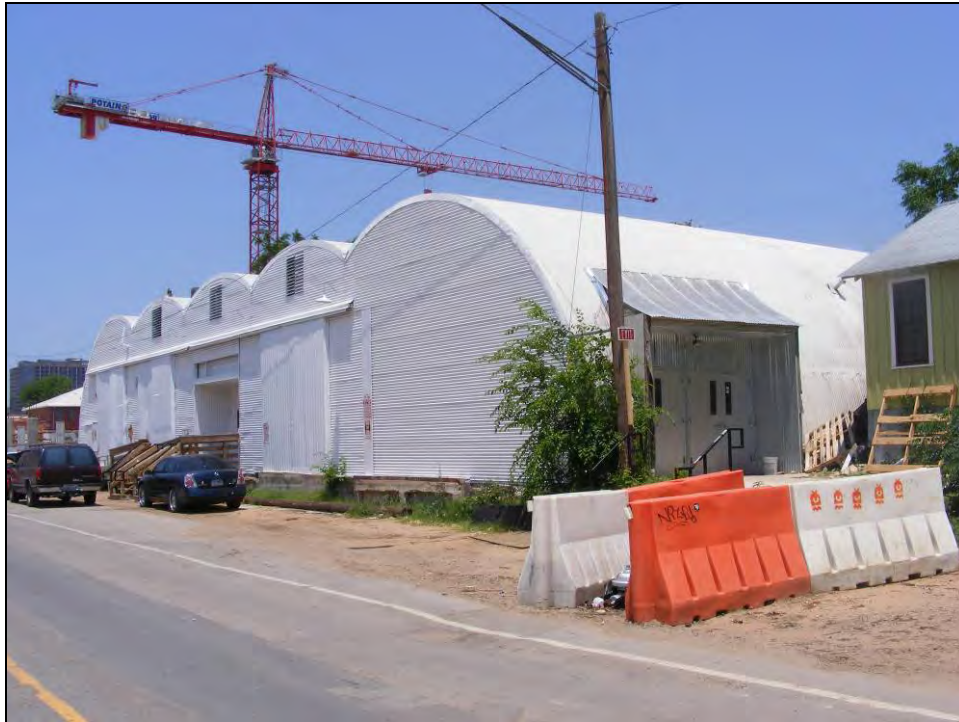
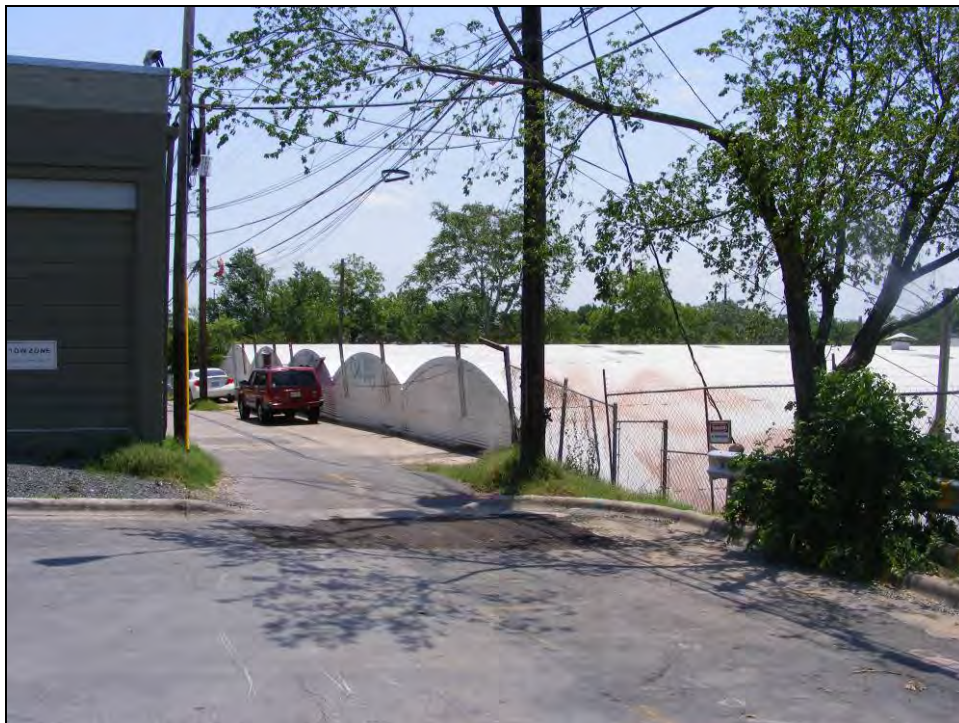
Map ID 5 is a circa 1950 commercial warehouse building. The single-story building is composed of five Quonset huts with joined barrel vault roofs and has steel frame walls with corrugated steel panels on a concrete foundation. The building has three large steel sliding doors and a pair of inset steel doors on the main facade, with a similar pair of inset steel doors on the east side. The building has no visible windows, but the three central vaults each have one metal slat vent near the top. A wood stairway is located on the front of the building. The building was occupied by the Steck Company in the 1950s, vacant in the 1960s, and used by the Glastron Mobile Homes Company in the 1970s. Its current use is unknown. It has minimal significance under Criterion A for its commercial associations. Its architecture is unusual for the area, but not particularly noteworthy or significant under Criterion C. It is recommended not eligible for listing in the NRHP.

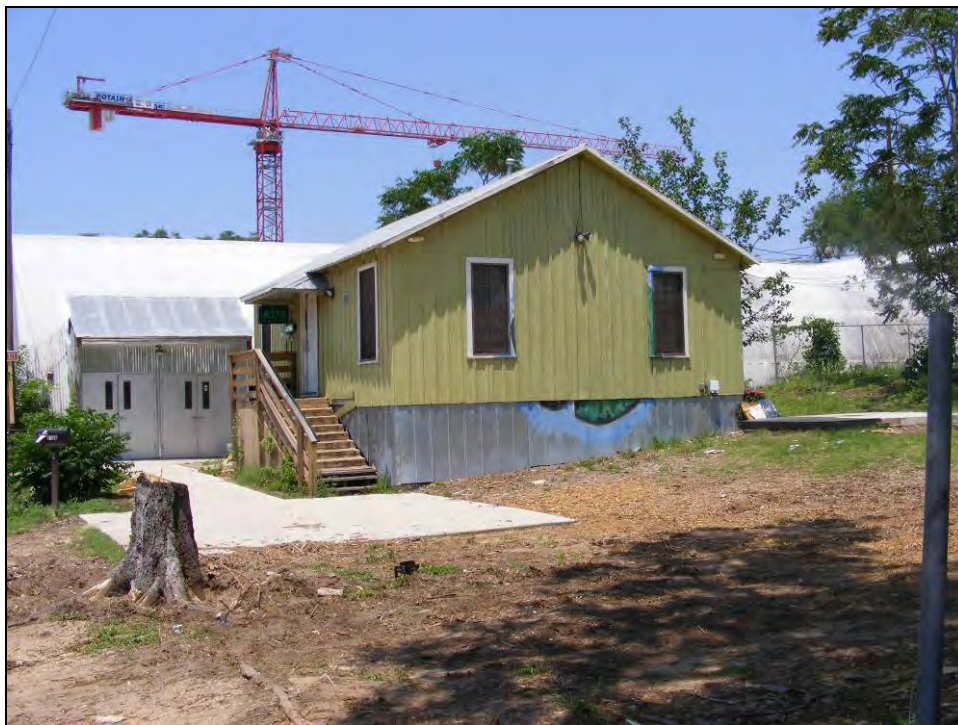
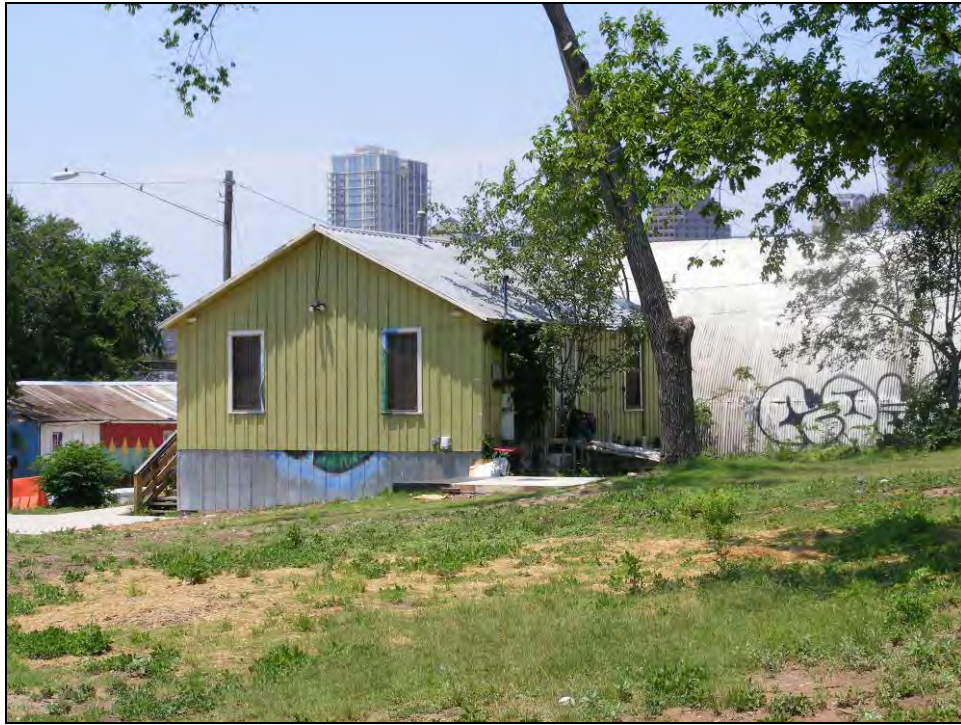
Map ID 6 is a circa 1935 single-story building that once served as a residence. The building sits on a raised foundation concealed by metal siding, with board and batten siding on the walls and a side-gabled roof with exposed rafter tails covered with standing seam metal roofing. Windows are multi-light wood sash. The front entry is accessed by a wood stairway leading to a raised concrete porch. The rear entry has a small wood ramp. The building has been converted into a business with an ATM (automated teller machine) sign hanging prominently above the main entrance but its present use is unknown. Sanborn maps indicate a second residence (since demolished) was located behind the existing one, facing the alley. The building has minimal significance under Criterion A for association with important events or trends and is not architecturally significant under Criterion C. As such, it is recommended not eligible for listing in the NRHP.

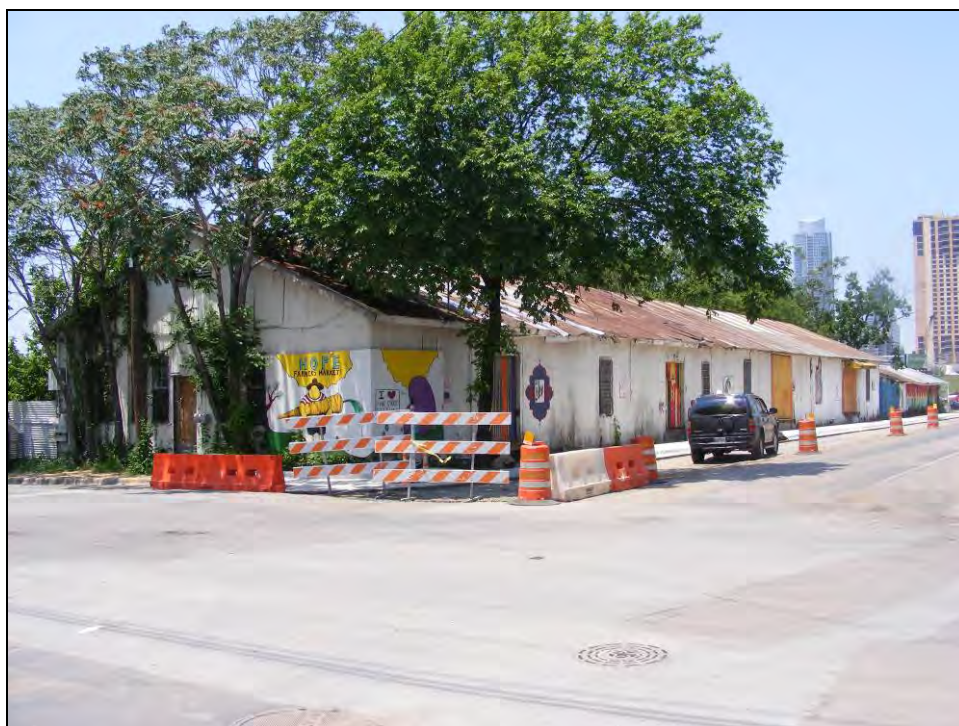
View facing southwest.

Map I.D. #:	7	Function/use, current:	COMMERCE/
Site Location:	414 Waller Street	Function/use, historic:	COMMERCE/
UTM Coordinates:	14/ 622035E/ 3348668N	Style/form:	No style/ rectangular plan
Date:	c. 1936 (city directory), 1935 (TCAD)	NR Eligibility:	Individual: no
Comments: Former Humble Oil and Refining Company (1935-1950), vacant (1950-1970), Davidson Sash and Door (1970). Original building expanded prior to 1961, and combined with the smaller building to the west post 1970.

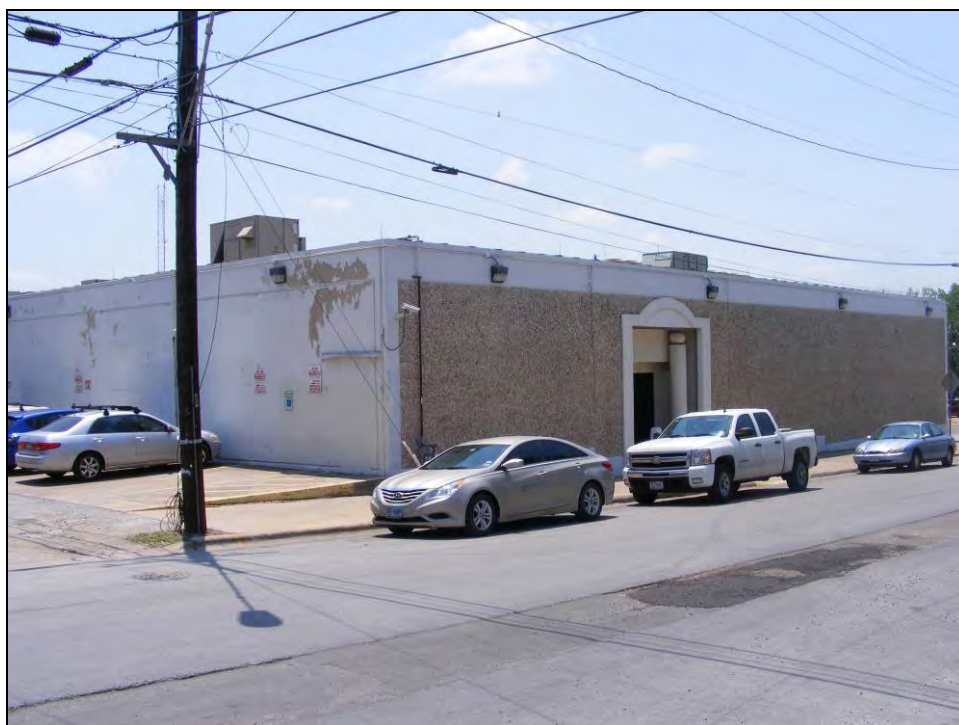
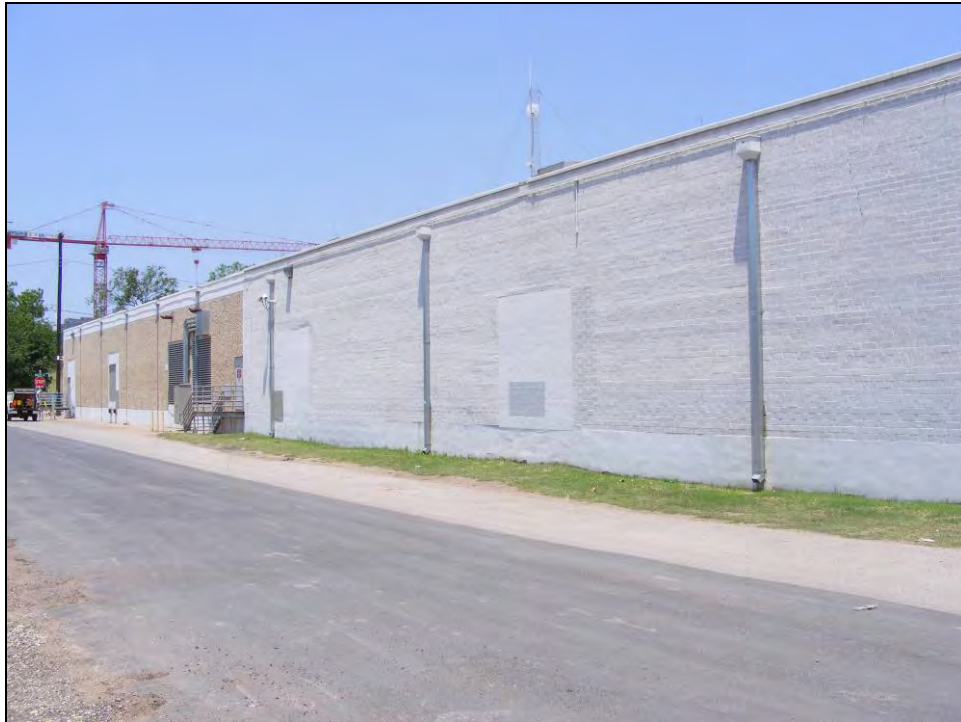
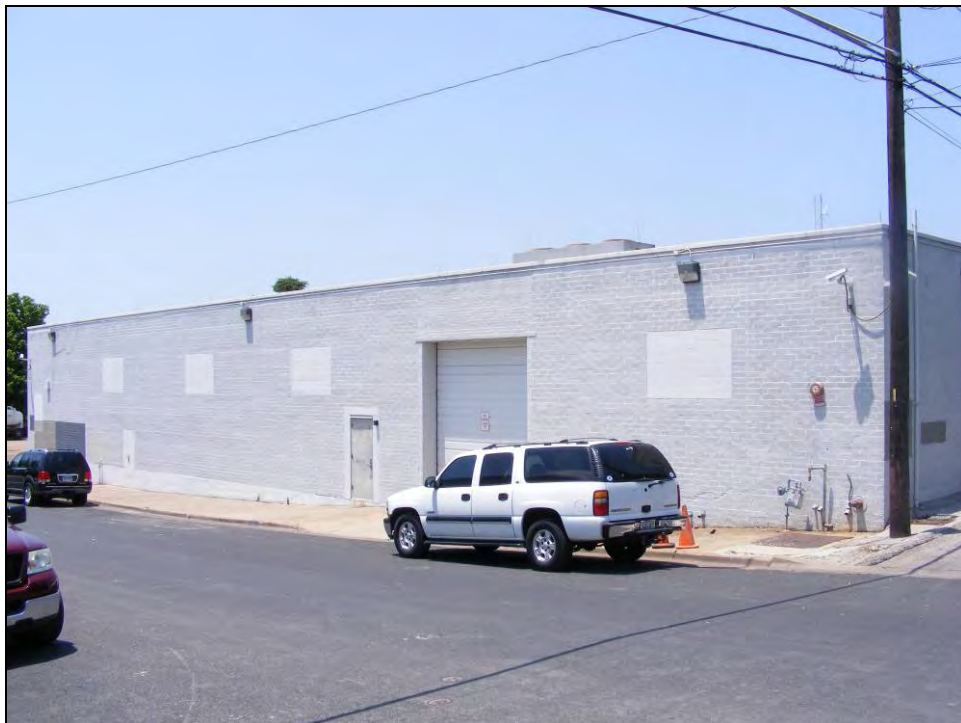
Map ID 8 is a circa 1955 commercial warehouse building. The large, single-story commercial block building has two distinct halves and sits on a concrete foundation. The original east half has brick masonry walls with a simple parapet topped by a brick course. A series of loading doors on the south side have since been bricked in, as have four windows on the east side. The west half of the building is a modern addition with modular concrete panel walls with decorative gravel. The warehouse originally served as Steck Warehouse #2, then later as part of the Davidson Sash and Door Company. It currently serves as the offices for Hostway Global Web Solutions. It has minimal significance under Criterion A for its commercial associations and is not particularly noteworthy for its architecture under Criterion C. Alterations to the building impact its integrity of design, materials, workmanship, and feeling. As such, it is recommended not eligible for listing in the NRHP.

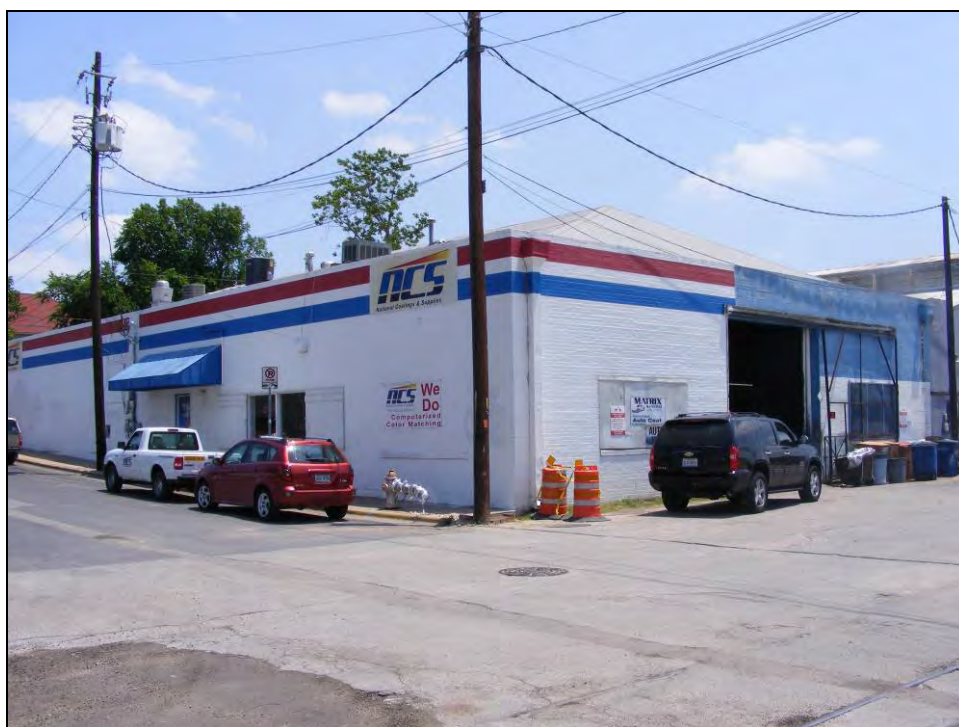
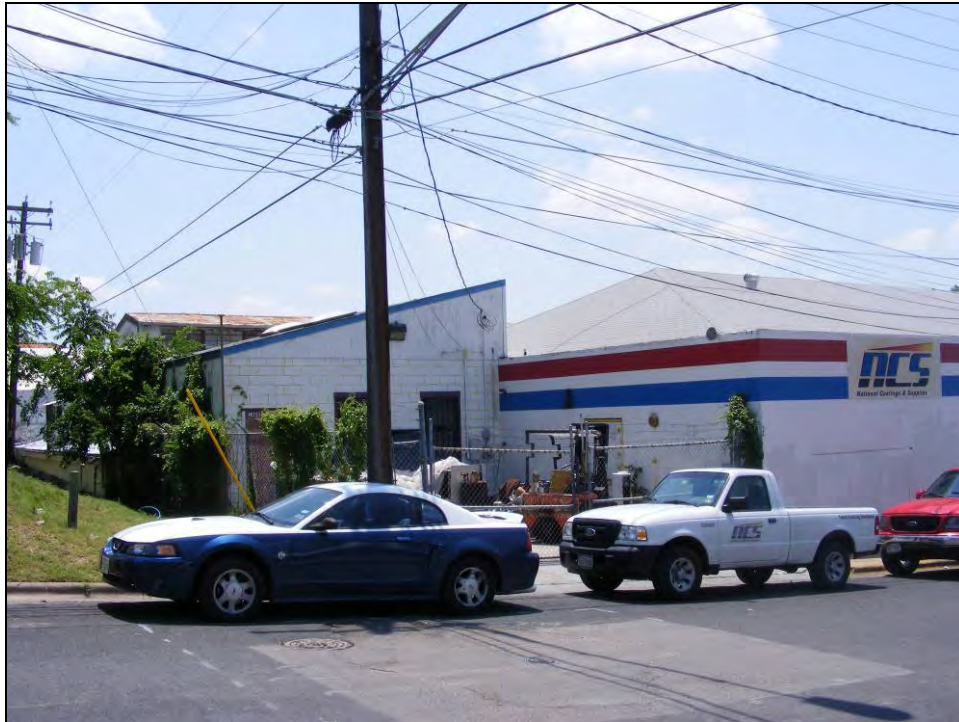
Map ID 9 is a circa 1950 industrial warehouse building. The single-story warehouse sits on a concrete foundation with brick masonry walls and a minimal, unadorned parapet. The roof is a shallow pitched hipped metal roof. The rear of the building has a small addition with concrete masonry unit walls and a shed roof with wood siding and metal roofing. Most of the windows have been boarded up, but visible windows are plate glass. Doors are either simple single-entry or large metal sliding bay doors. A small awning has been added over the west entrance. The building served a variety of industrial interests through its history, and currently hosts National Coatings and Supplies. It has minimal significance under Criterion A for its commercial associations and is not particularly noteworthy for its architecture under Criterion C. Alterations to the building impact its integrity of design, materials, workmanship, and feeling. As such, it is recommended not eligible for listing in the NRHP.
