REQUEST FOR SHPO CONSULTATION:

Plaza Saltillo Rail Relocation Project

**HISTORIC RESOURCES
RECONNAISSANCE SURVEY REPORT
PLAZA SALTILLO RAIL RELOCATION PROJECT
AUSTIN, TRAVIS COUNTY, TEXAS**

Plaza Saltillo Rail Relocation Project
Historic Resources
Reconnaissance Survey Report
Austin, Travis County, Texas

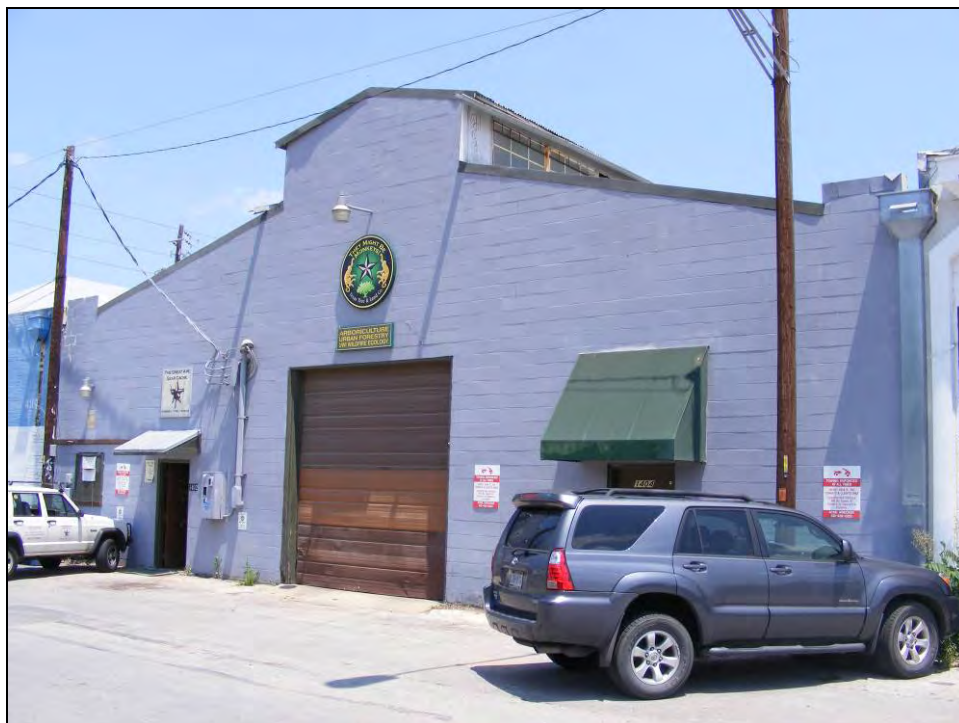
Map ID 10 is a circa 1950 industrial warehouse building. The single-story warehouse has a concrete foundation supporting concrete masonry unit walls, topped with a front-gabled roof with a full-length metal monitor with steel casement windows. The façade has a single large rolling bay door flanked by single entries, with a single window on the west side. The smaller doors both have awnings. The building originally served an industrial purpose and housed the D&H Foundry until 1963 and Hall Level and Manufacturing until the mid-1970s, but has since been converted to commercial use and now houses They Might Be Monkeys, an arboreal and forest service company. It has limited

significance under Criterion A for its industrial associations and is not particularly noteworthy for its architecture under Criterion C. As such, it is recommended not eligible for listing in the NRHP.

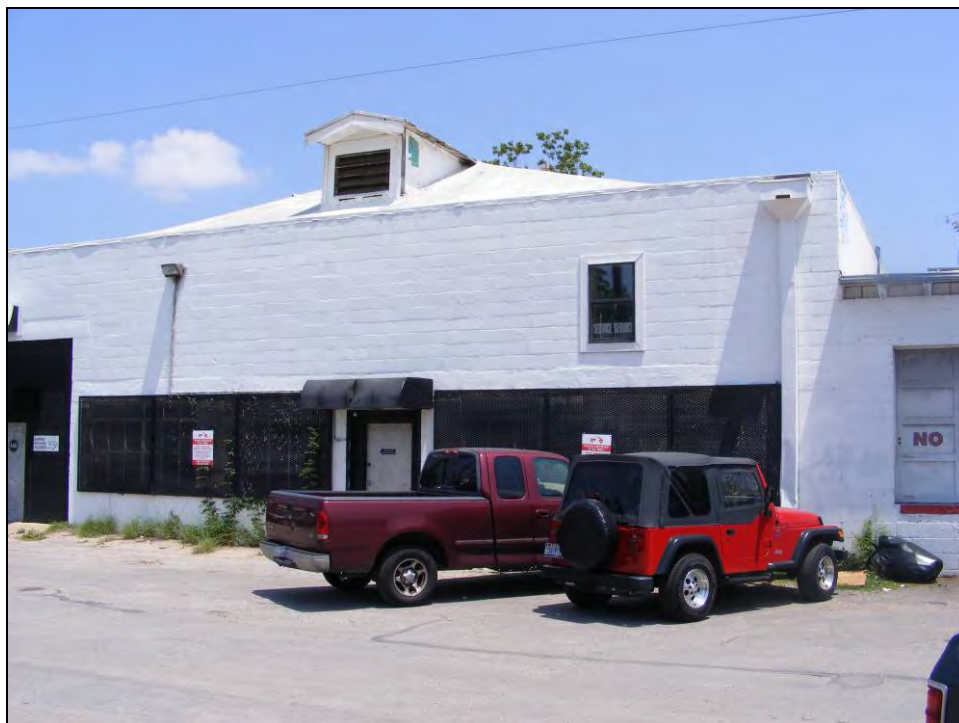
Map ID 11 is a circa 1950 industrial warehouse building. The single-story warehouse has a concrete foundation supporting concrete masonry unit walls, topped by a hipped gable roof with metal roofing and a small gabled ventilation dormer. Below a single modern sash window, a strip of metal casement windows covered with steel security mesh extend three-quarters the length of the facade. Two single steel doors on the main facade provide entry, the west door built in to a converted bay door (no longer functional). The building housed a variety of industrial ventures through its history, but has since been converted to commercial office use. It has limited significance under Criterion A for its industrial associations and is not particularly noteworthy for its architecture under Criterion C. As such, it is recommended not eligible for listing in the NRHP.

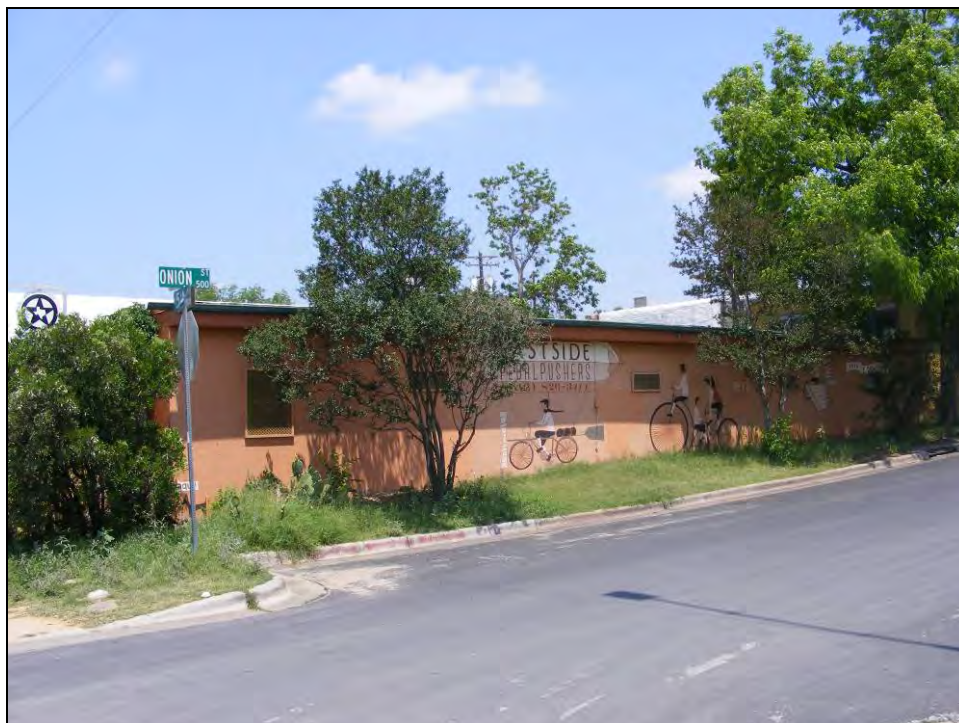
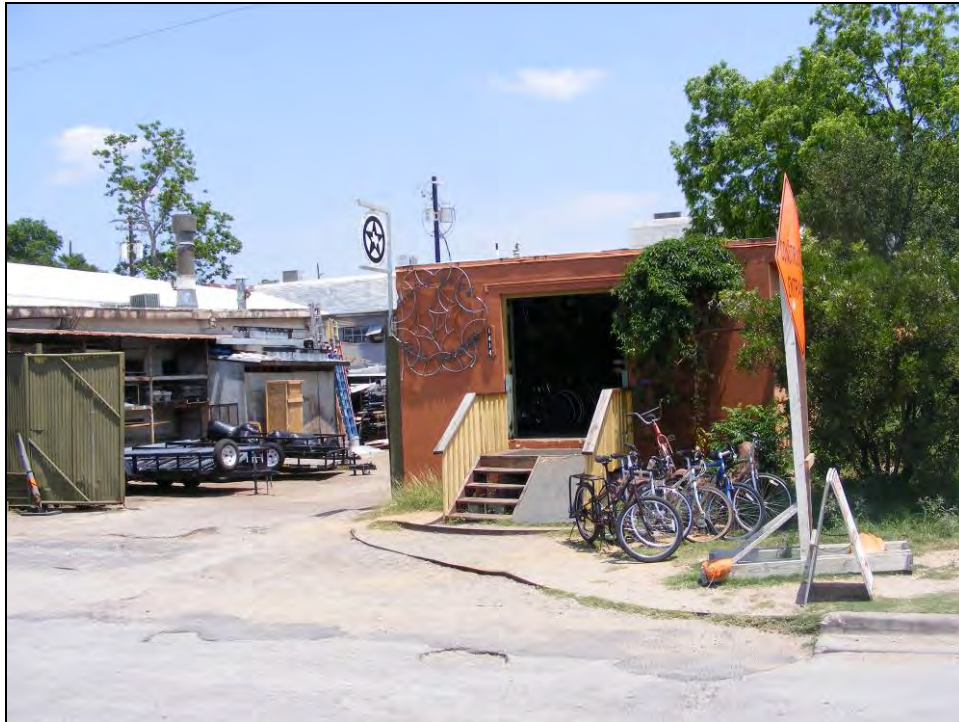
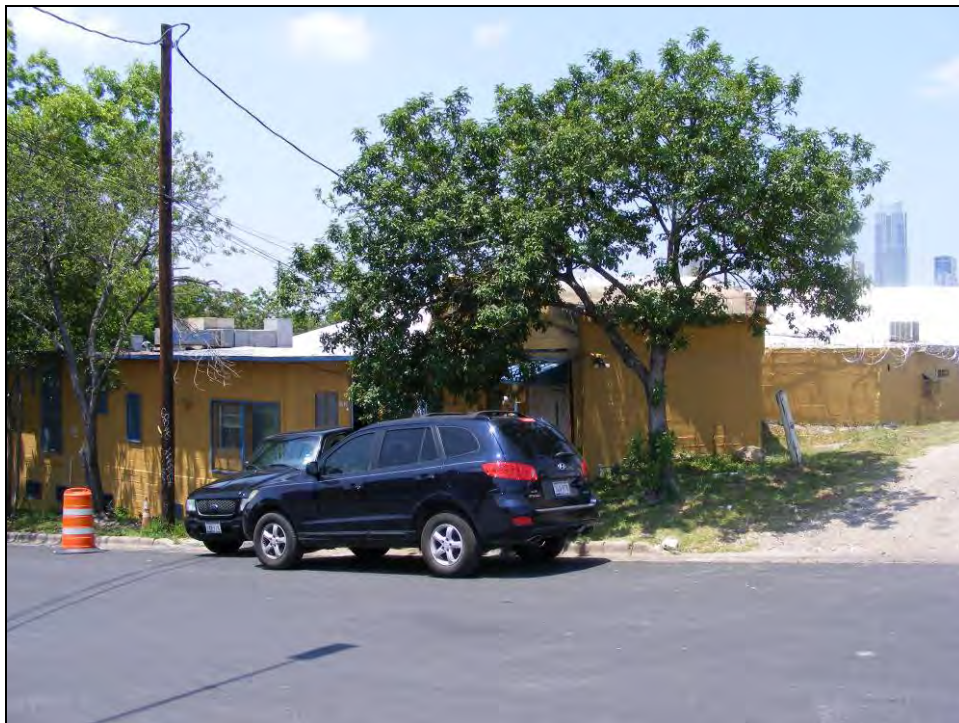
Map ID 12 is a circa 1950 industrial warehouse facility. The complex is composed of a string of buildings connected into a C-shape around an open service yard. The buildings are set on concrete foundations with concrete masonry unit walls and mixed roof forms, primarily flat and low-pitched gable with metal sheet roofing. Windows are a mix of steel casement, aluminum sash, and fixed pane. Doors are mostly modern replacement units. The complex housed Hall Industries in the early 1950s and the Holloway Company in the latter 1950s. Later use is unknown, but it now serves as commercial retail space (Eastside Pedal Pushers bike shop). It has limited significance under Criterion A for its industrial associations and is not particularly noteworthy for its architecture under Criterion C. As such, it is recommended not eligible for listing in the NRHP.

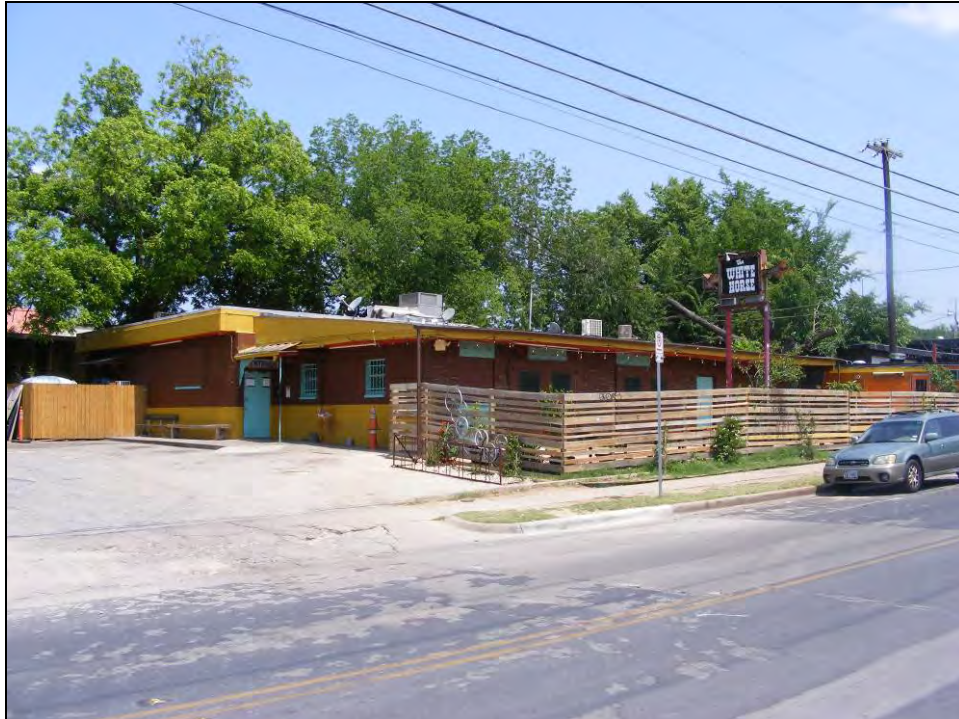
View facing northwest.

Map I.D. #:	13	Function/use, current: COMMERCE/ bar
Site Location:	500-506 Comal Street	Function/use, historic: COMMERCE/ bar
UTM Coordinates:	14/ 622458E/ 3348568N	Style/form: Modern/ irregular plan
Date:	1965 (city directory), 1966 (TCAD)	NR Eligibility: Individual: no
Comments: Occupied by The Back Door 1965-1975.

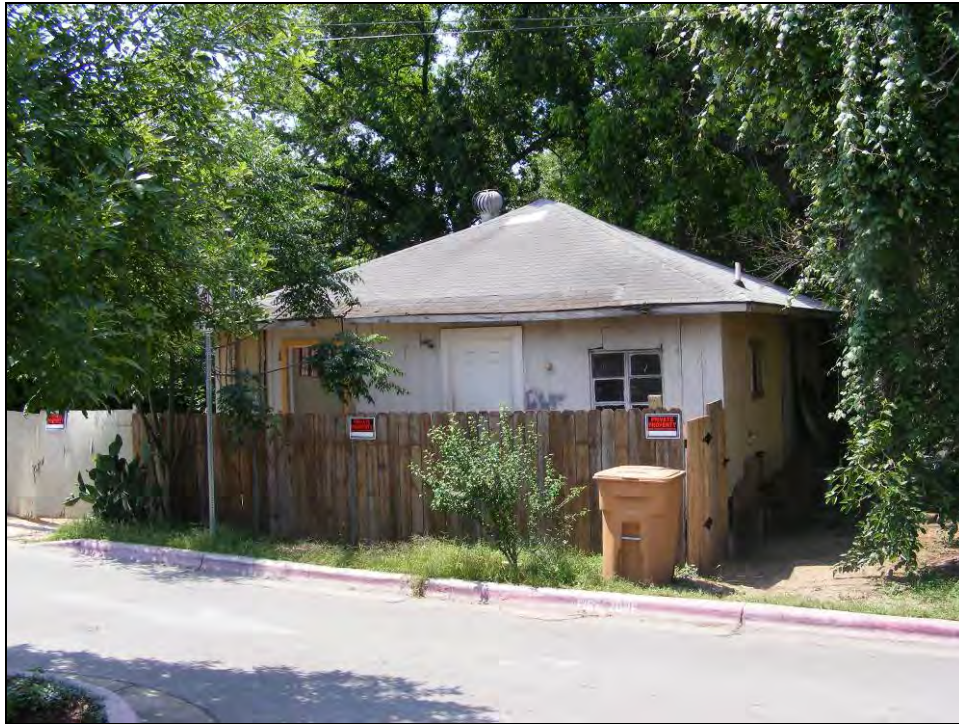
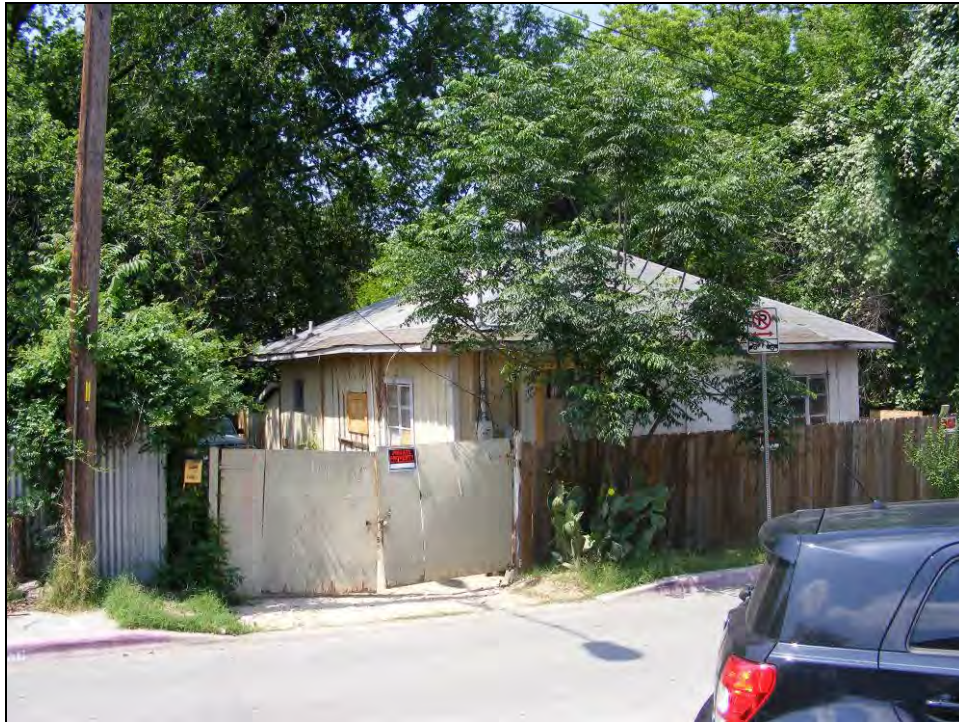
Map ID 14 is a circa 1935 residence. The single-story building has no discernible style, but features board and batten siding mixed with plywood, under a hipped low-pitch roof with moderate eaves. Windows are six-light metal casement or replacement aluminum sash. The rear has a small shed addition. An adjoining residence, located to the north, was removed sometime after 1980. The house

has limited significance under Criterion A for association with events or trends, but has minimal significance under Criterion C. However, the alterations and changes to the house impacting integrity of setting, materials, workmanship, and feeling overshadow any architecture significance. It is recommended not eligible for listing in the NRHP.

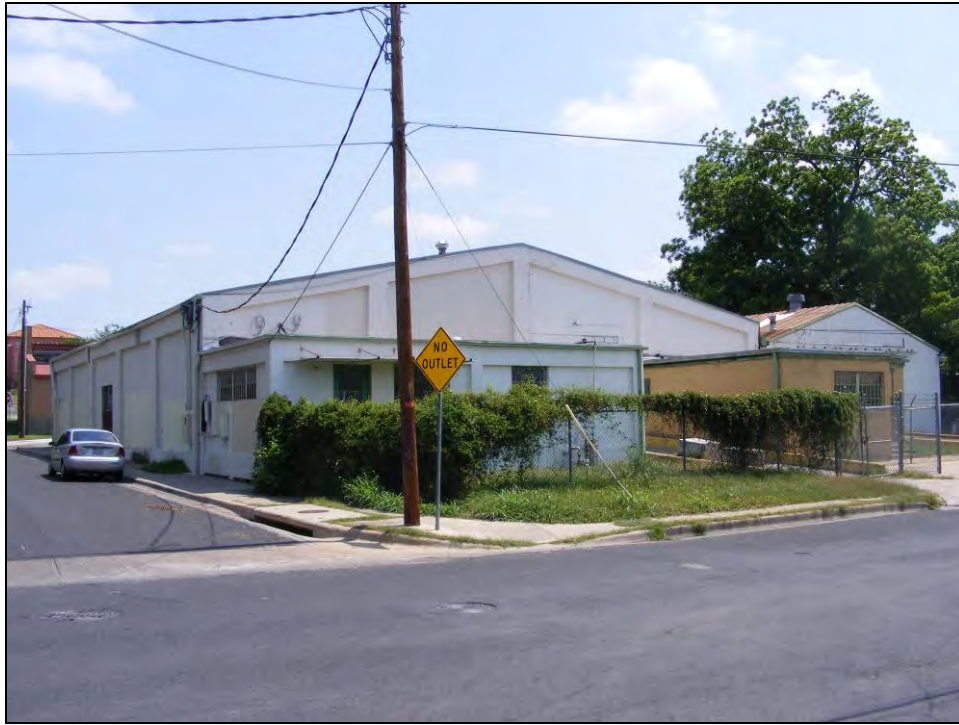
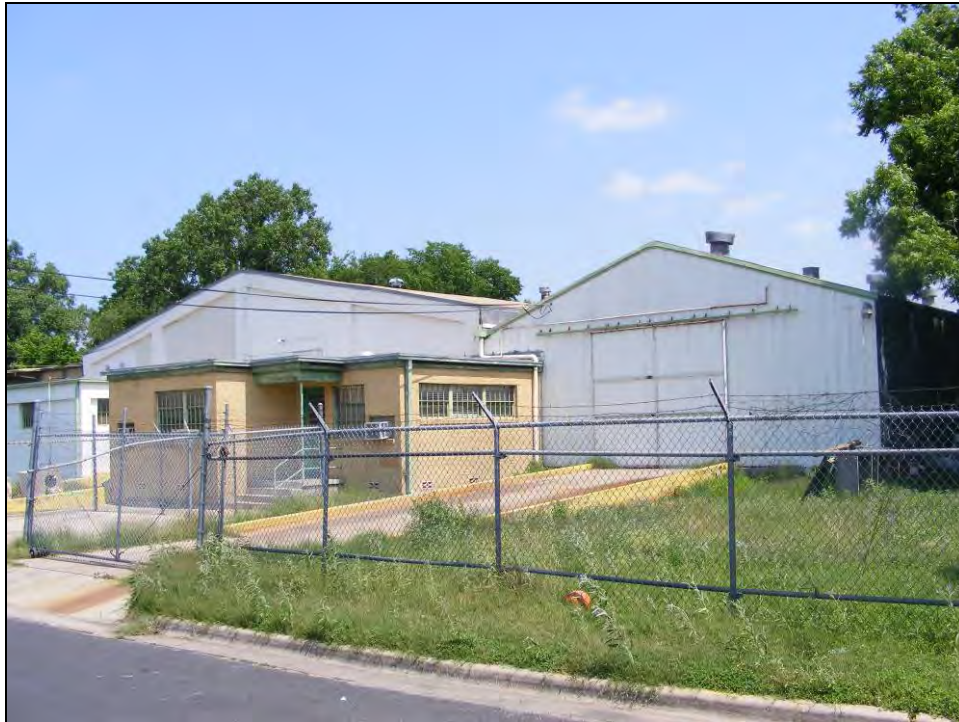
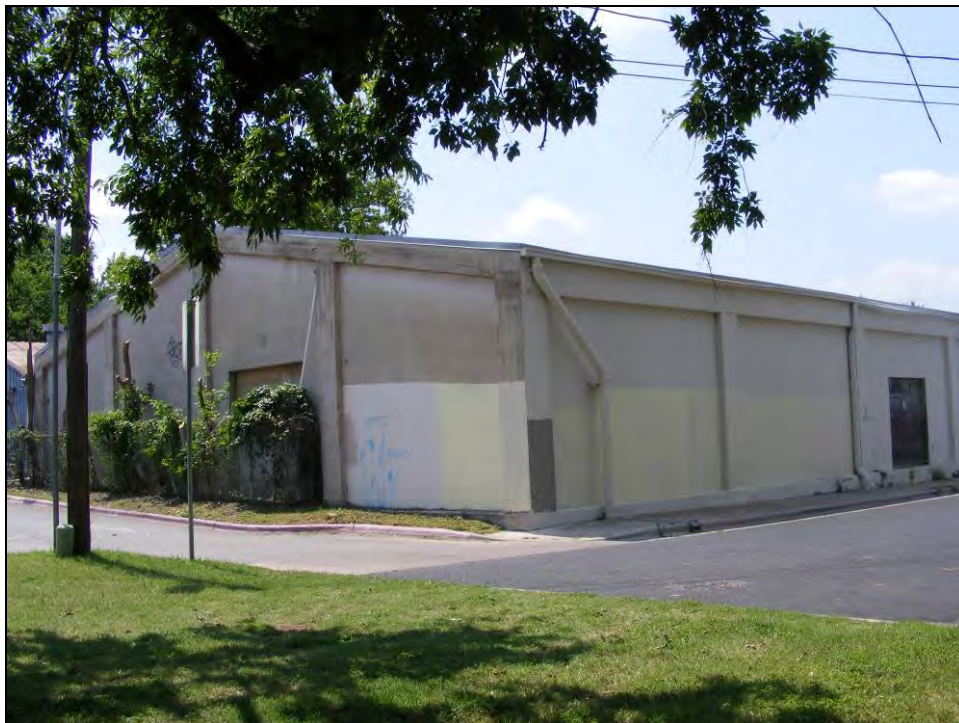
Map ID 15 is a circa 1950 commercial warehouse building. The single-story building rests on a concrete foundation, with concrete frame and panel construction for the walls and a shallow-pitched front-gabled roof. Windows are mostly covered on the main building. A small entry building with fixed and wood sash windows and a flat roof is attached to the left side of the main façade, with a later small brick addition attached to the right side. A metal Butler building sits adjacent to the main building on the east side. The building served the Austin Beverage Company from 1952-1960, and Jax Beer Distributing Company from 1963-1970. Its current occupant, if any, is unknown. It has minimal significance under Criterion A for its commercial associations but is not particularly noteworthy for its architecture under Criterion C. Alterations to the building impact its integrity of design, materials, workmanship, and feeling. As such, it is recommended not eligible for listing in the NRHP.

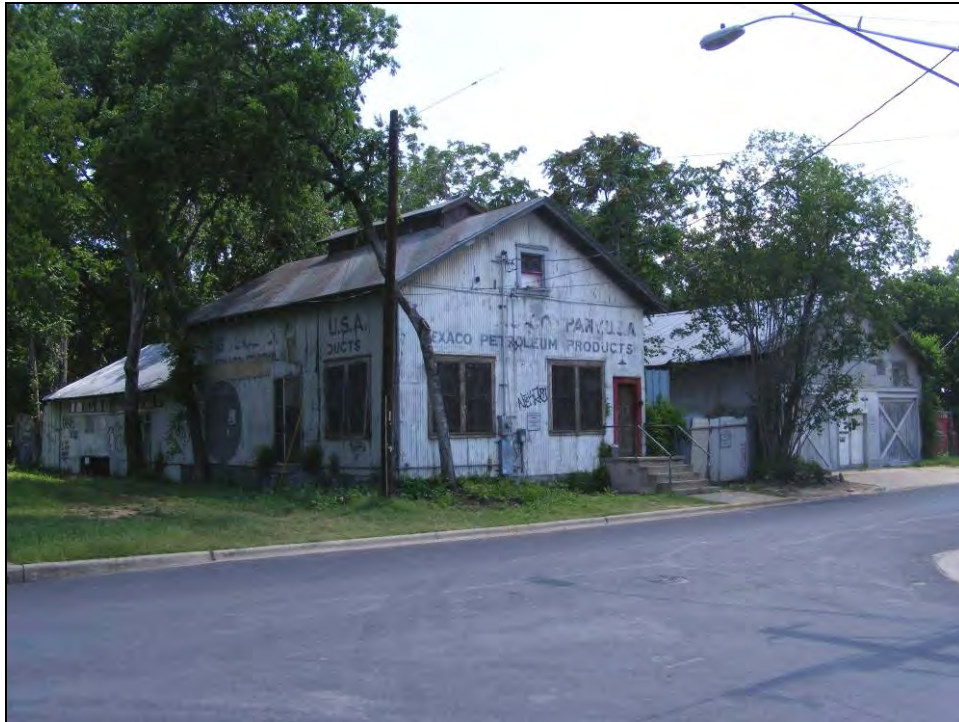
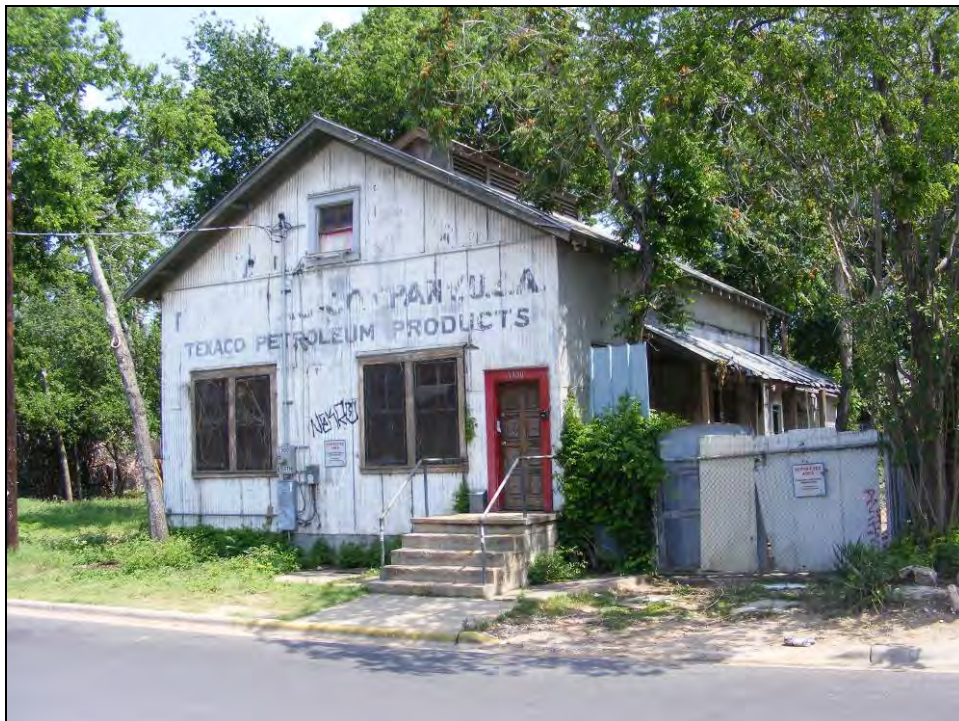
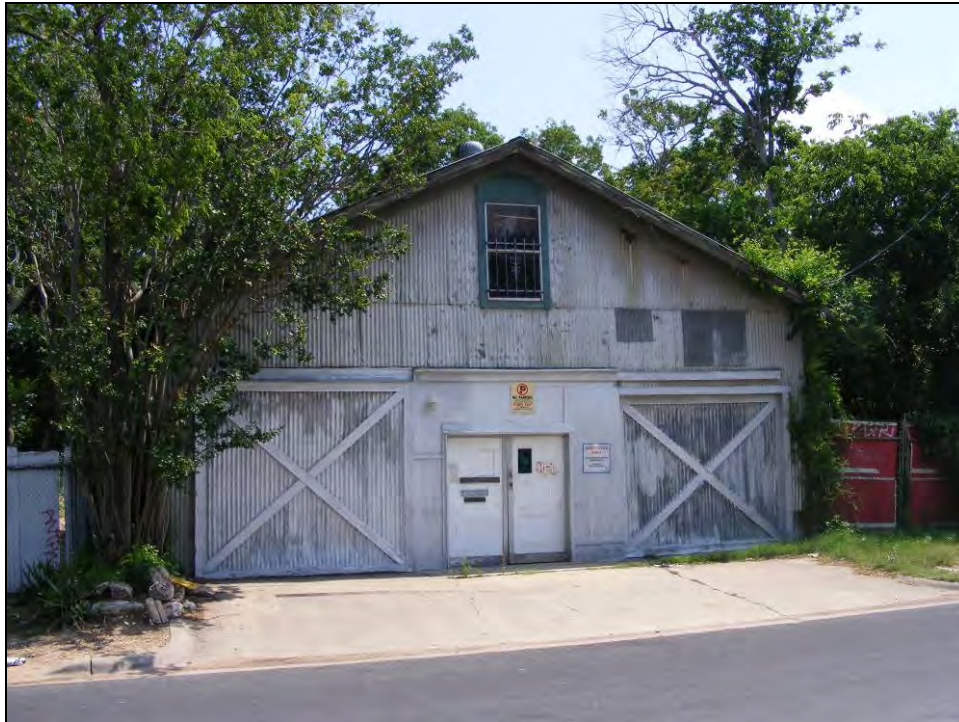
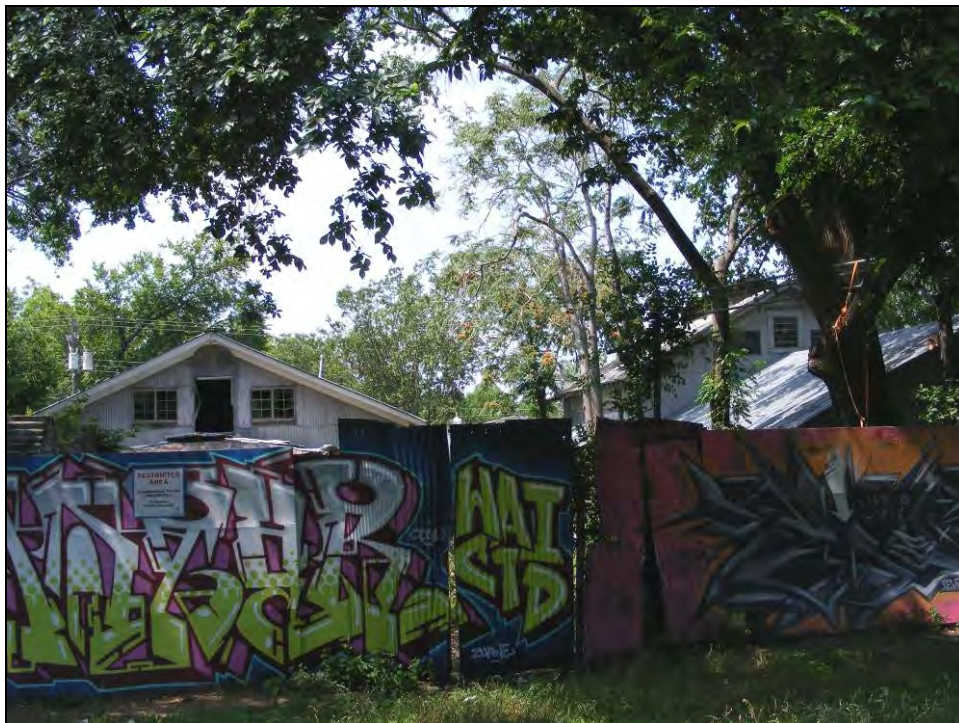
Map ID 17 is the circa 1915 former Texaco Oil Depot, an Austin Historic Landmark. The complex consists of three buildings (two of them connected) on a small lot between E. 4th Street and the railroad tracks to the north. The primary building in the southwest corner is a one-and-one-half-story wood-frame building on a pier and beam foundation. The building has corrugated metal siding, wood

sash windows, and a replacement wood paneled door under a front-gabled roof with exposed rafter tails, composite shingles, and a ventilation monitor. Attached to this building is a smaller, one-story building with corrugated metal siding, replacement sliding sash windows, and standing-seam metal roofing. To the east is a one-and-one-half-story wood-frame building with corrugated metal siding, two replacement wood sliding barn doors, two replacement wood single doors, and a replacement aluminum sash window under a front-gabled roof with exposed rafter tails and standing seam metal roofing. The primary building once served as the office for the Texaco Oil Depot, while the rear building served as oil storage and the separate barn building functioned as a pump and machinery building. Gas storage tanks at the rear of the property have since been removed. The property has moderate significance under Criterion A for its association with local commercial and industrial ventures, and limited significance under Criterion C as an example of early twentieth century local industrial architecture. Although it has undergone some modifications and alterations, it retains sufficient integrity of location, design, setting, materials, workmanship, feeling, and association to convey its significance. As such, it is recommended **eligible** for listing in the NRHP at the local level under Criteria A and C in the areas of Commerce and Architecture, respectively, with a period of significance of 1915-1935.

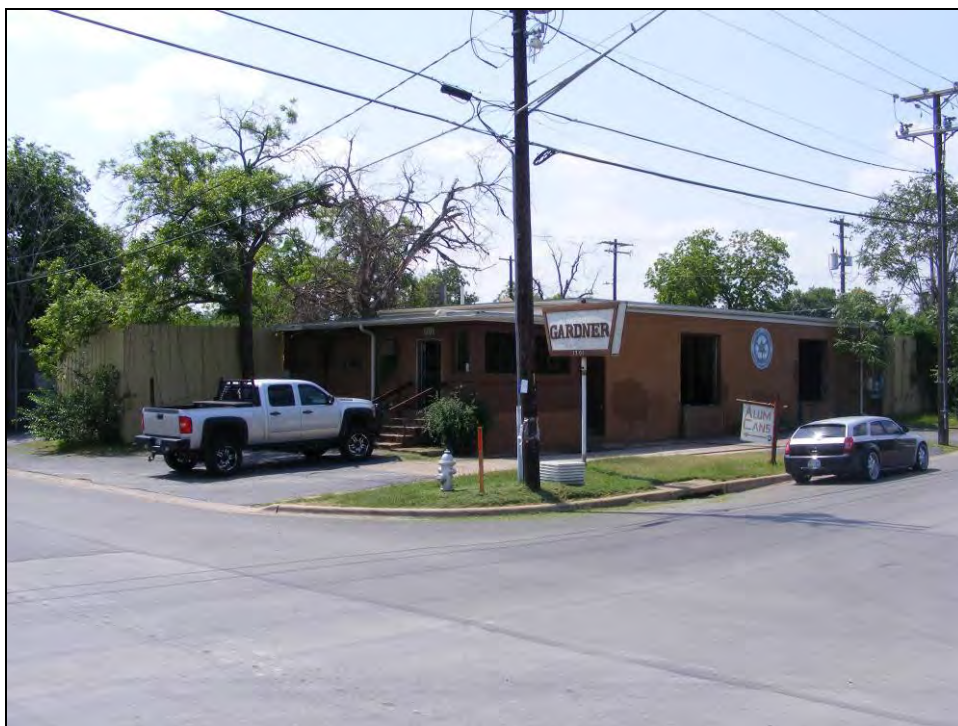
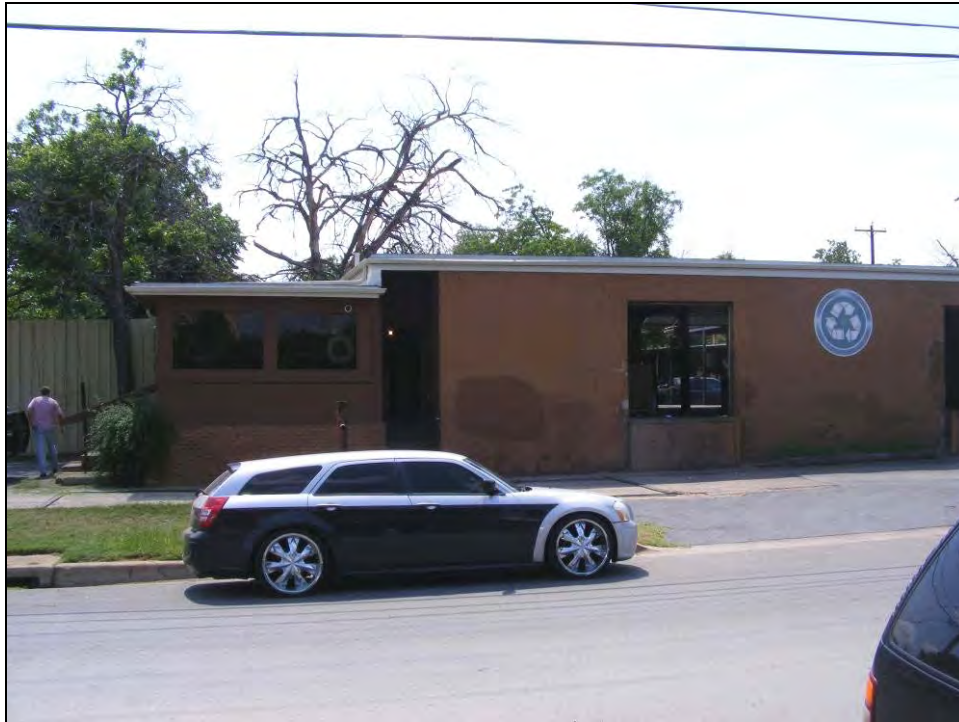
Map ID 18 is a circa 1955 commercial building. The one-story building with International Style influence has a concrete foundation, with two distinct parts of the building. The front office area has walls of brick and concrete with plate glass windows set into concrete window frames. The roof is flat, with wide projecting eaves. A single, short flight of steps lead to the entry on the north facade. The rear warehouse area has concrete masonry unit walls, concrete loading bays on the west side, wide bay doors on the east side, and a flat roof. Immediately to the east of the building is a large work area used for metal recycling and enclosed by a tall (15-foot) steel fence, with a gated entrance immediately east of the building. The building has served as the home of Gardner Iron and Metal Company since construction. The building has limited significance under Criterion A, and while it does display characteristics of the International Style it is not a particularly noteworthy example of the style. As such, it is recommended not eligible for listing in the NRHP.

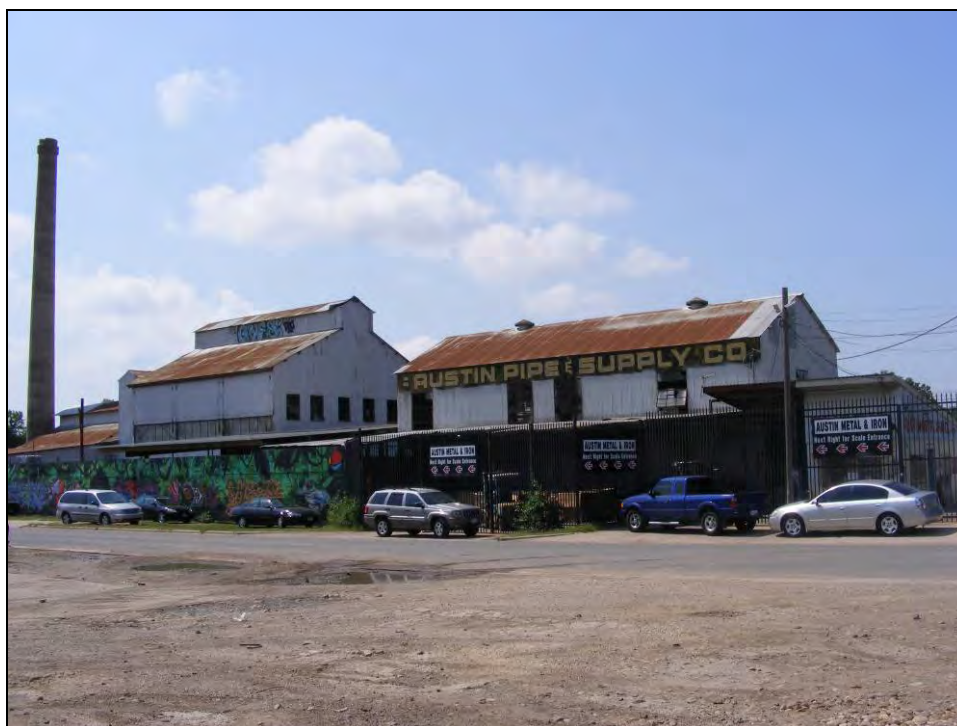
View facing southeast.

Map I.D. #:	19	Function/use, current:	COMMERCE/business
Site Location:	300 Medina Street	Function/use, historic:	INDUSTRY/energy
UTM Coordinates:	14/ 621894E/ 3348584N	Style/form:	No style/ rectangular and irregular plan
Date:	1935 (city directory), 1910 (TCAD)	NR Eligibility:	Individual: no
Comments: Industrial property converted to a commercial metal business. Occupied by Texas Public Service Company 1935-1949; Southern Union Gas Co. 1955-1960; Austin Pipe & Supply/ Austin Iron and Metal 1965-present. Concrete smokestack post-dates 1935, property used to have two additional buildings and four large gas tanks (up to 500K cubic foot capacity).

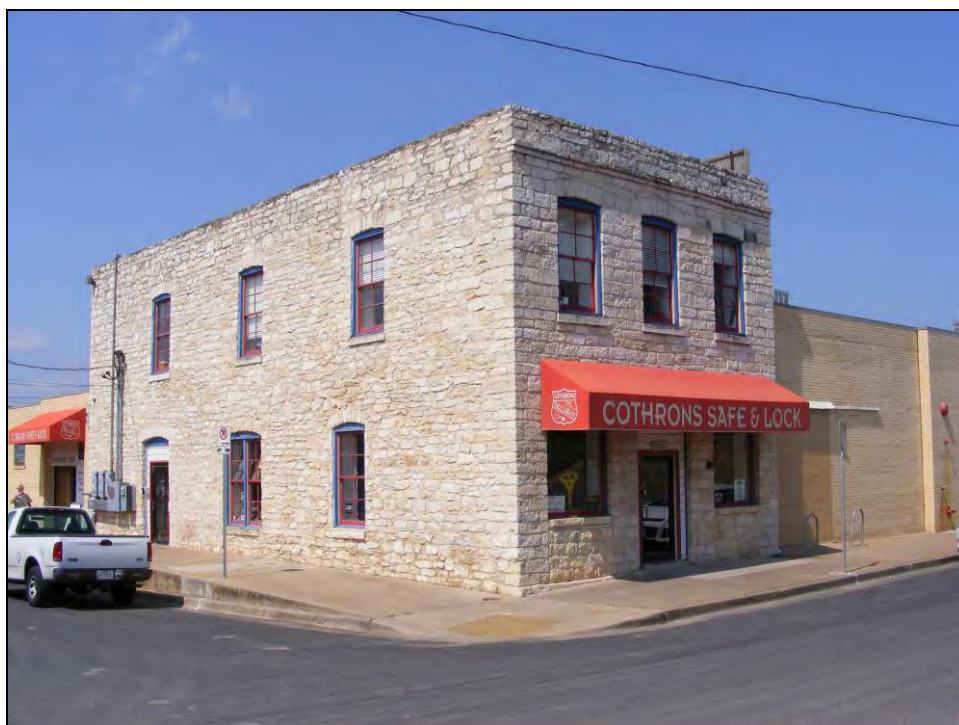
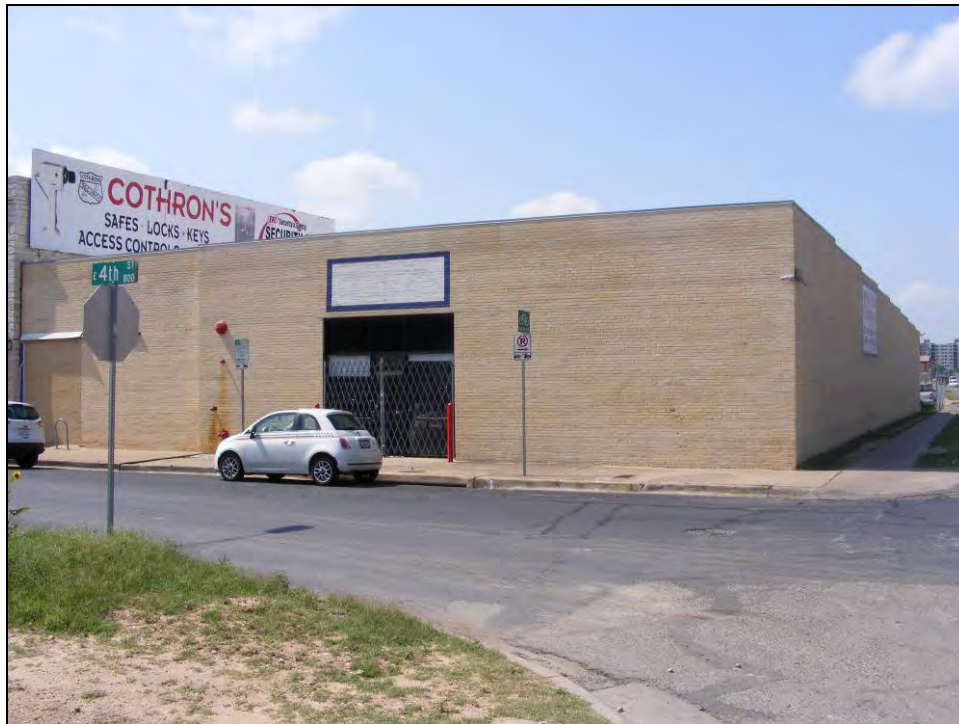
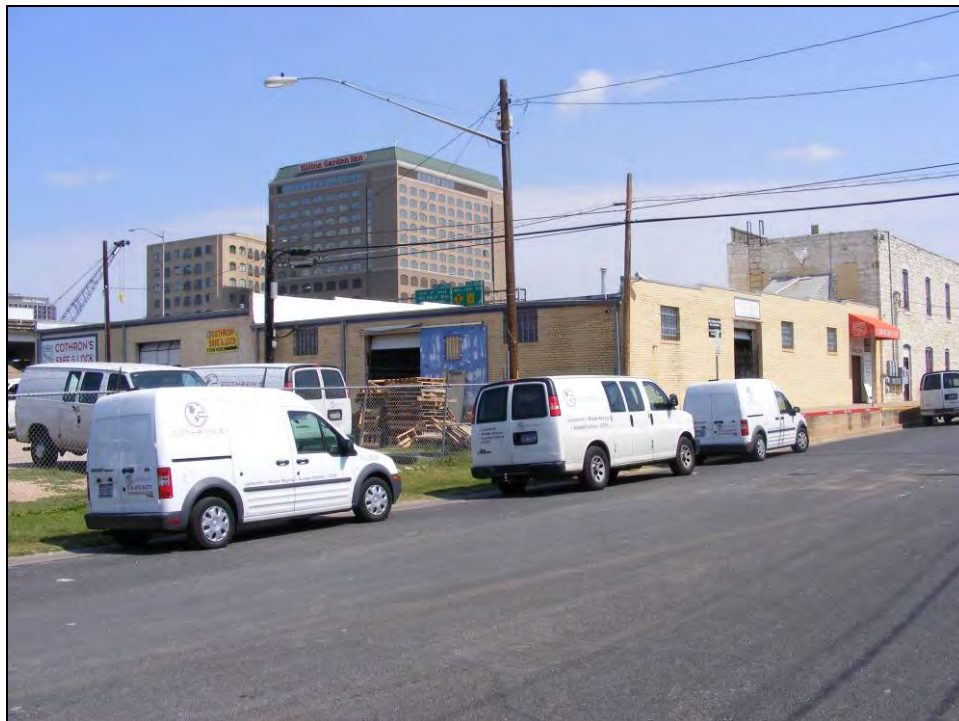
Map ID 20 is a commercial property of mixed age. The oldest building is a circa 1890 two-story, stone masonry building with a stone parapet and a facade-length stone belt course. Windows are two-over-four-light wood sash with stone lintels and arches. Entry is through doors on the north and east sides of the building, both modern replacements set into the original stone arches. Two windows on the first floor of the facade appear to have been converted door openings as well, but the date of the conversion is unknown. South of the building is a circa 1950 one-story brick masonry warehouse with high set steel windows and simple entry doors. West of these two buildings is a large, circa 1960 one-story brick masonry warehouse with no windows and large roll-up bay doors. The west wall is stepped to follow the contours of the ground, as is the east wall of the 1950 building. The building currently serves as the home of Cothron's Safe and Lock Company. Although the building has minimal significance under Criterion A for its commercial heritage, the original building is a good example of late nineteenth century commercial block architecture. However, the large additions to the south and west impact integrity of setting, design, workmanship, and feeling, and the building can not convey its significance under Criterion C. Better examples of this style of architecture may be found in the nearby Sixth Street NRHP historic district. Consequently, it is recommended not eligible for listing in the NRHP.
