ZONING CHANGE REVIEW SHEET

CASE NUMBER: C14H-2015-0001

HISTORIC NAME: Dedrick-Hamilton House

ADDRESS OF PROPOSED ZONING CHANGE: 908 E. 11th Street

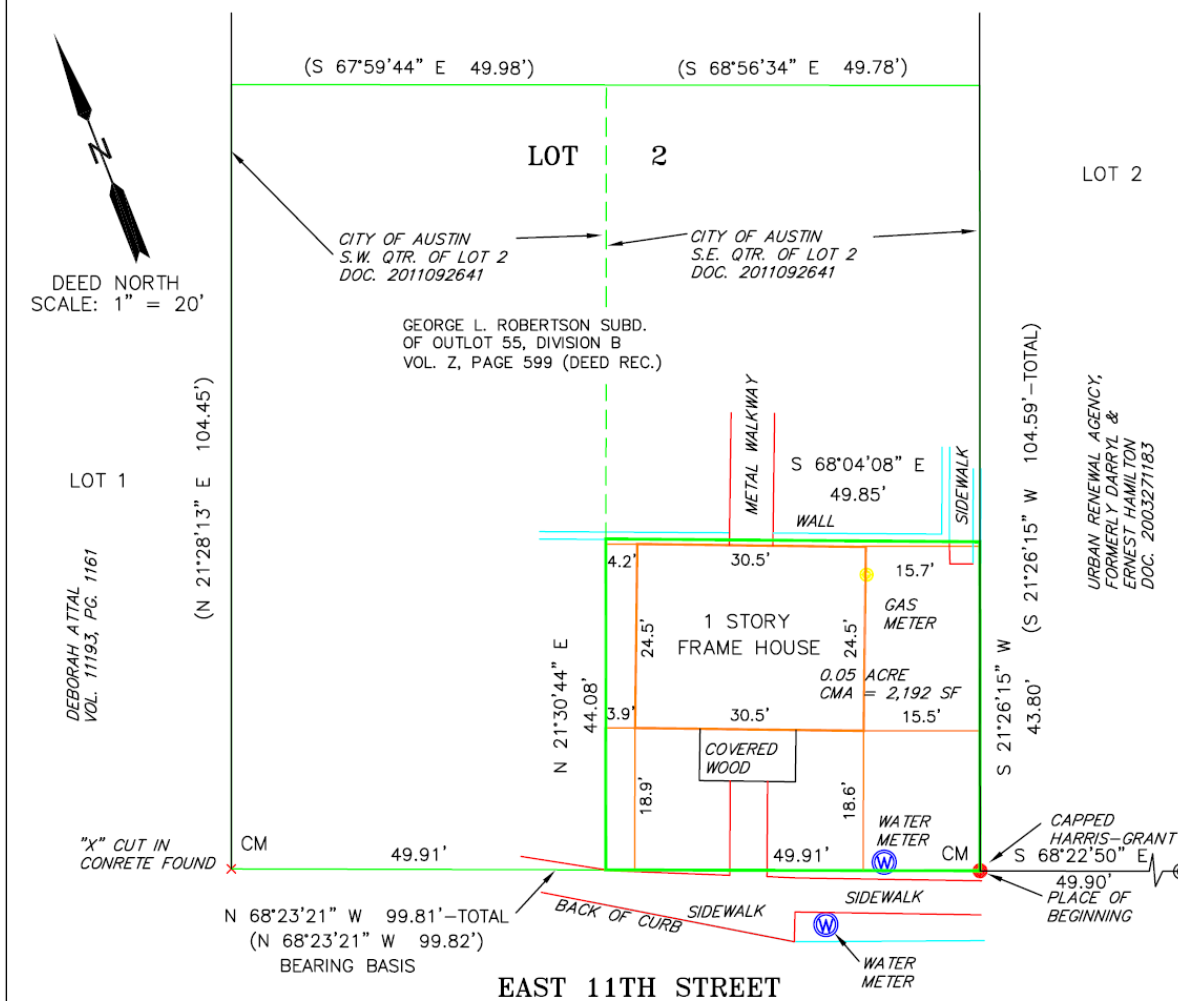
SKETCH TO ACCOMPANY LEGAL DESCRIPTION FOR ZONING CHANGE

BEING 0.05 ACRES, MORE OR LESS, OUT OF LOT 2, "GEORGE L. ROBERTSON SUBDIVISION OF OUTLOT 55, DIVISION B", A SUBDIVISION IN TRAVIS COUNTY, TEXAS AS RECORDED IN VOLUME Z, PAGE 599 OF THE DEED RECORDS OF TRAVIS COUNTY, TEXAS, AND BEING PART OF THAT CERTAIN TRACT OF LAND CONVEYED TO THE CITY OF AUSTIN BY DEED RECORDED IN DOCUMENT NO. 2011092641 OF THE TRAVIS COUNTY OFFICIAL PUBLIC RECORDS (TCOPR), SAID TRACT OF LAND BEING MORE PARTICULARLY DESCRIBED BY METES AND BOUNDS AS FOLLOWS:

BEGINNING at a ½" rebar found, capped "Harris-Grant", on the north right-of-way line of East 11th Street, at the southeast corner of said City of Austin property cited above, described as the southeast quarter of Lot 2, said point being also the southwest corner of the Urban Renewal Agency property that was formerly described in a deed to Darryl and Ernest Hamilton recorded in Document No. 2003271183 of the TCOPR, for the southeast corner and **PLACE OF BEGINNING** hereof, from which point an "x" found cut in concrete on the north right-of-way line of East 11th Street, at the southwest corner of said City of Austin property described as the southwest quarter of Lot 2, also the southeast corner of the Deborah Attal property described in Volume 11193, Page 1161 of the Travis County Real Property Records, bears N 68°23'21" W 99.81 feet, and also from which point a ½" iron pipe found on the north right-of-way line of East 11th Street bears S 68°22'50" E 49.90 feet;

THENCE with the north right-of-way line of East 11th Street, N 68°23'21" W 49.91 feet to a calculated point for the southwest corner hereof;

THENCE with the common line between the southeast quarter and the southwest quarter of said Lot 2, N 21°30'44" E 44.08 feet to a calculated point for the northwest corner hereof;

THENCE crossing through the southeast quarter of Lot 2, and with the south edge of an existing wall, S 68°04'08" E 49.85 feet to a calculated point on the common line between the southeast quarter of Lot 2 and the above described Hamilton property, for the northeast corner hereof;

THENCE with the common line between the southeast quarter of Lot 2 and the Hamilton property, S 21°26'15" W 43.80 feet to the **PLACE OF BEGINNING** and containing 0.05 acre of land or a calculated map area of 2,192 square feet of land, more or less.

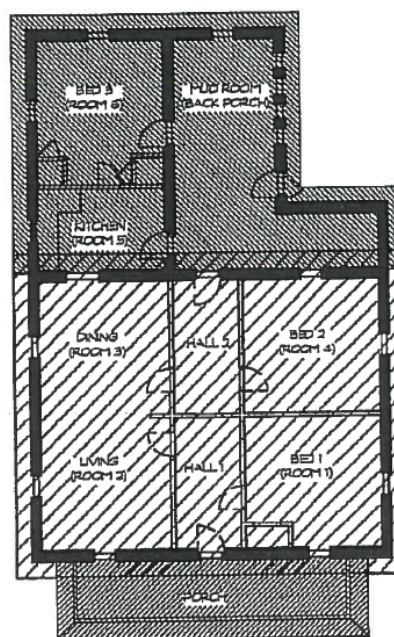
DIAGRAMMATIC PLAN

The Dedrick-Hamilton House was constructed of vertical planks nailed to head and sill plates with battens used to seal the joints between boards. Based upon visual observations and no selective demolition, the original structure is believed to be rooms 1, 2, and 3, with a central open-air breezeway. Painted vertical boards with ghost lines of removed battens are visible at the perimeter of rooms 1, 2, and 3, and within the central corridor between rooms 1 and 2. Vertical boards are also visible inside room 4, but are not visible from the exterior to determine whether or not they are an original exterior finish. The theory that Room 4 is not original to the house is based upon differences in exterior trim details and slight differences in window framing details. The accessible window sashes in Rooms 1-4 are 6/6 lite double hung, single glazed wood window sash, and appear to match one another. We expect that more details regarding the evolution of the building can be ascertained once the building is cleared and stabilized for safe access.

The original battens were later removed, and lateral support was provided with the installation of horizontal siding nailed over the original board walls at the front portion of the oldest portions of the house, encompassing rooms 1, 2, 3, 4, and the central corridor. Additions to the north and east (Rooms 5, 6, and the mud room) were constructed for use as a kitchen, third bedroom, and an enclosed porch. The original front porch was replaced with a concrete slab with wrought iron railings and posts, typical of a post WWII-era modification. The porch roof framing predates the wrought iron railings, and is in extremely poor condition. The building in general is in very poor condition, particularly to the north. The northern end of the central corridor and the post 1900 additions, specifically Rooms 5, 6, and the enclosed porch, are severely deteriorated, with several open holes in the roof, exterior walls, and floor. These rooms have been reconstructed and rebuilt at least once with salvaged materials and 1/4" plywood sheathing. Walls of the additions are reportedly framed with 2x4 studs at 48" to 60" on center.⁵ Open holes in the roof allow constant water infiltration, which has caused the floor to rot through in the center hall and in the enclosed Mud Room (back porch) area. Open holes in the north wall of the Mud Room (back porch) and in the west wall of the kitchen allow additional water infiltration and provide entrances for animals into the building.

make it infeasible to reconstruct these additions with any measure of accuracy. For these reasons, we recommend that the southernmost/front portion of the house be preserved, and the additions removed.

The preservation philosophy is to stabilize the Dedrick-Hamilton House according to the concepts outlined in this document and stabilization plans provided by Frank Lam. Ensuing work will include restoration of the southernmost four rooms and central corridors, reconstruction of the historic front porch, and interior rehabilitation of the house to serve as an integral part of the African American Cultural and Heritage Facility. All work will follow the Secretary of Interior's Standards for Rehabilitation. Final restoration and rehabilitation plans will be provided to the Texas Historical Commission (THC) for a final determination of effect in accordance with Section 106 requirements before construction begins. The project is scheduled to be complete by Fall, 2012.

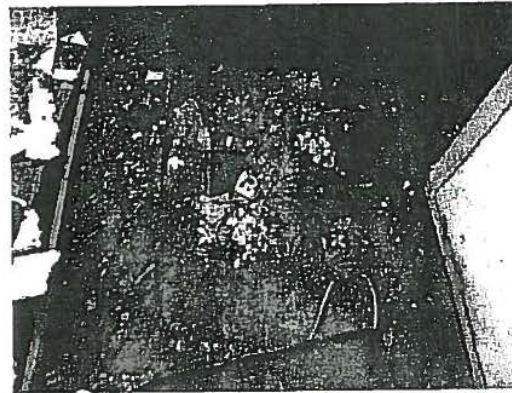
Figure 13 - An example of recently discovered turn-of-the-century patterned linoleum found in Room 3.

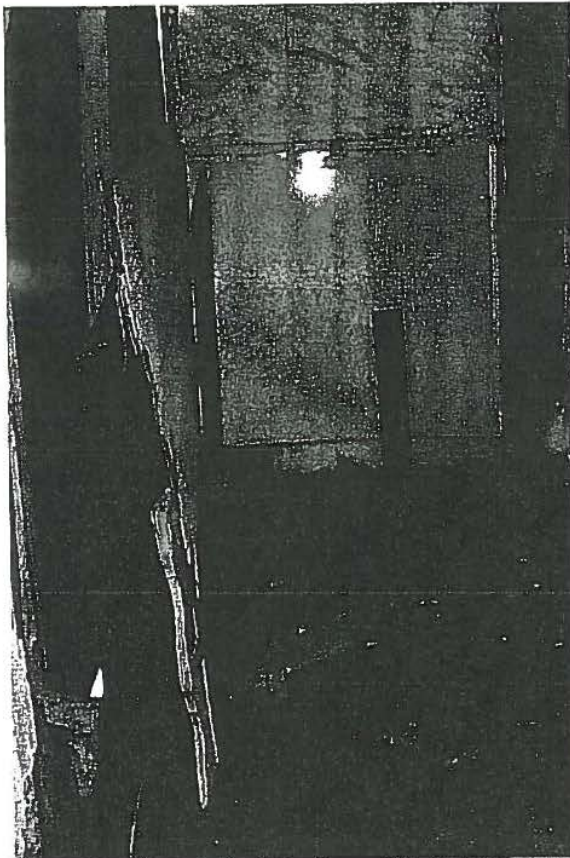
Figure 15 - An example of conditions within the later addition. Access to these rooms will be improved for documentation, then removed.

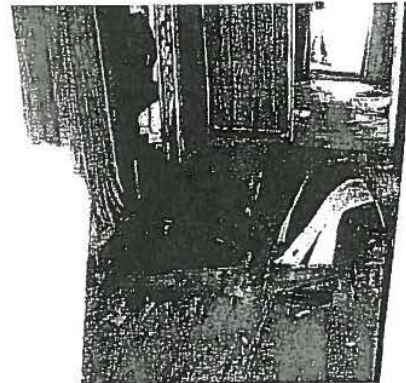
Figure 14 - An example of severe rot found in the center corridor. This area will require complete replacement in the stabilization phase.

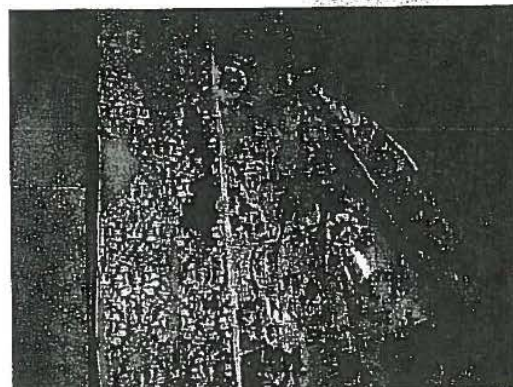
Figure 16 - An example of wallpapers found in Room 2 that will be collected and archived.
