# Thornton Traffic Study

*Austin, Texas*  
November 25, 2015

*Prepared for*  
Oden|Hughes, LLC.

*Prepared by*  
HDR Engineering, Inc.  
Texas P.E. Firm Registration No. F-754  
504 Lavaca Street, Suite 1175  
Austin, Texas 78701 USA  
Telephone 512 904-3700  
Facsimile 512 904-3773  
Website: [hdrinc.com](http://hdrinc.com)

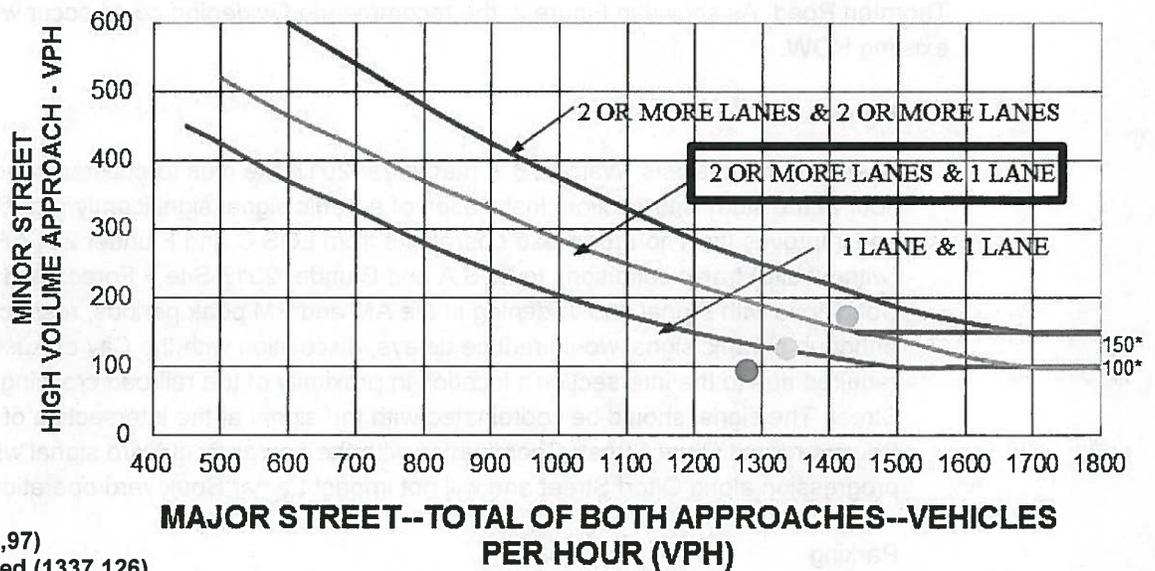
Figure 2: Peak Hour Volume Warrant. (Warrant 3)

To determine the need for a traffic signal at the intersection of Thornton Road and Oltorf Street, a peak hour signal warrant analysis (Warrant 3) was completed based on 2015 existing, 2017 forecasted (without site), and 2017 site plus forecasted conditions. Based on the analysis, Warrant 3 is met under 2017 site plus forecasted condition at the study intersection. A summary of the warrant analysis results are shown in Figure 2.

**\*Note: 150 vph applies as the lower threshold volume for a minor-street approach with two or more lanes and 100 vph applies as the lower threshold volume for a minor-street approach with one lane.**

Based on the analysis, Warrant 3 is met under 2017 site plus forecasted condition peak hour at the study intersection. Installation of a traffic signal significantly reduces delays and improves the Thornton Road operations from LOS C and F under 2017 Forecasted (without site) traffic conditions to LOS A and B under 2017 Site + Forecasted Traffic Conditions with Signal and Widening in the AM and PM peak periods, respectively. Although a traffic signal would reduce delays, discussion with the City of Austin would be required due to the intersection's location in proximity of the railroad crossing on Oltorf Street. The signal should be coordinated with the signal at the intersection of Lamar Boulevard and Oltorf Street. Coordination with the Lamar Boulevard signal will allow for progression along Oltorf Street and will not impact Lamar Boulevard operations.

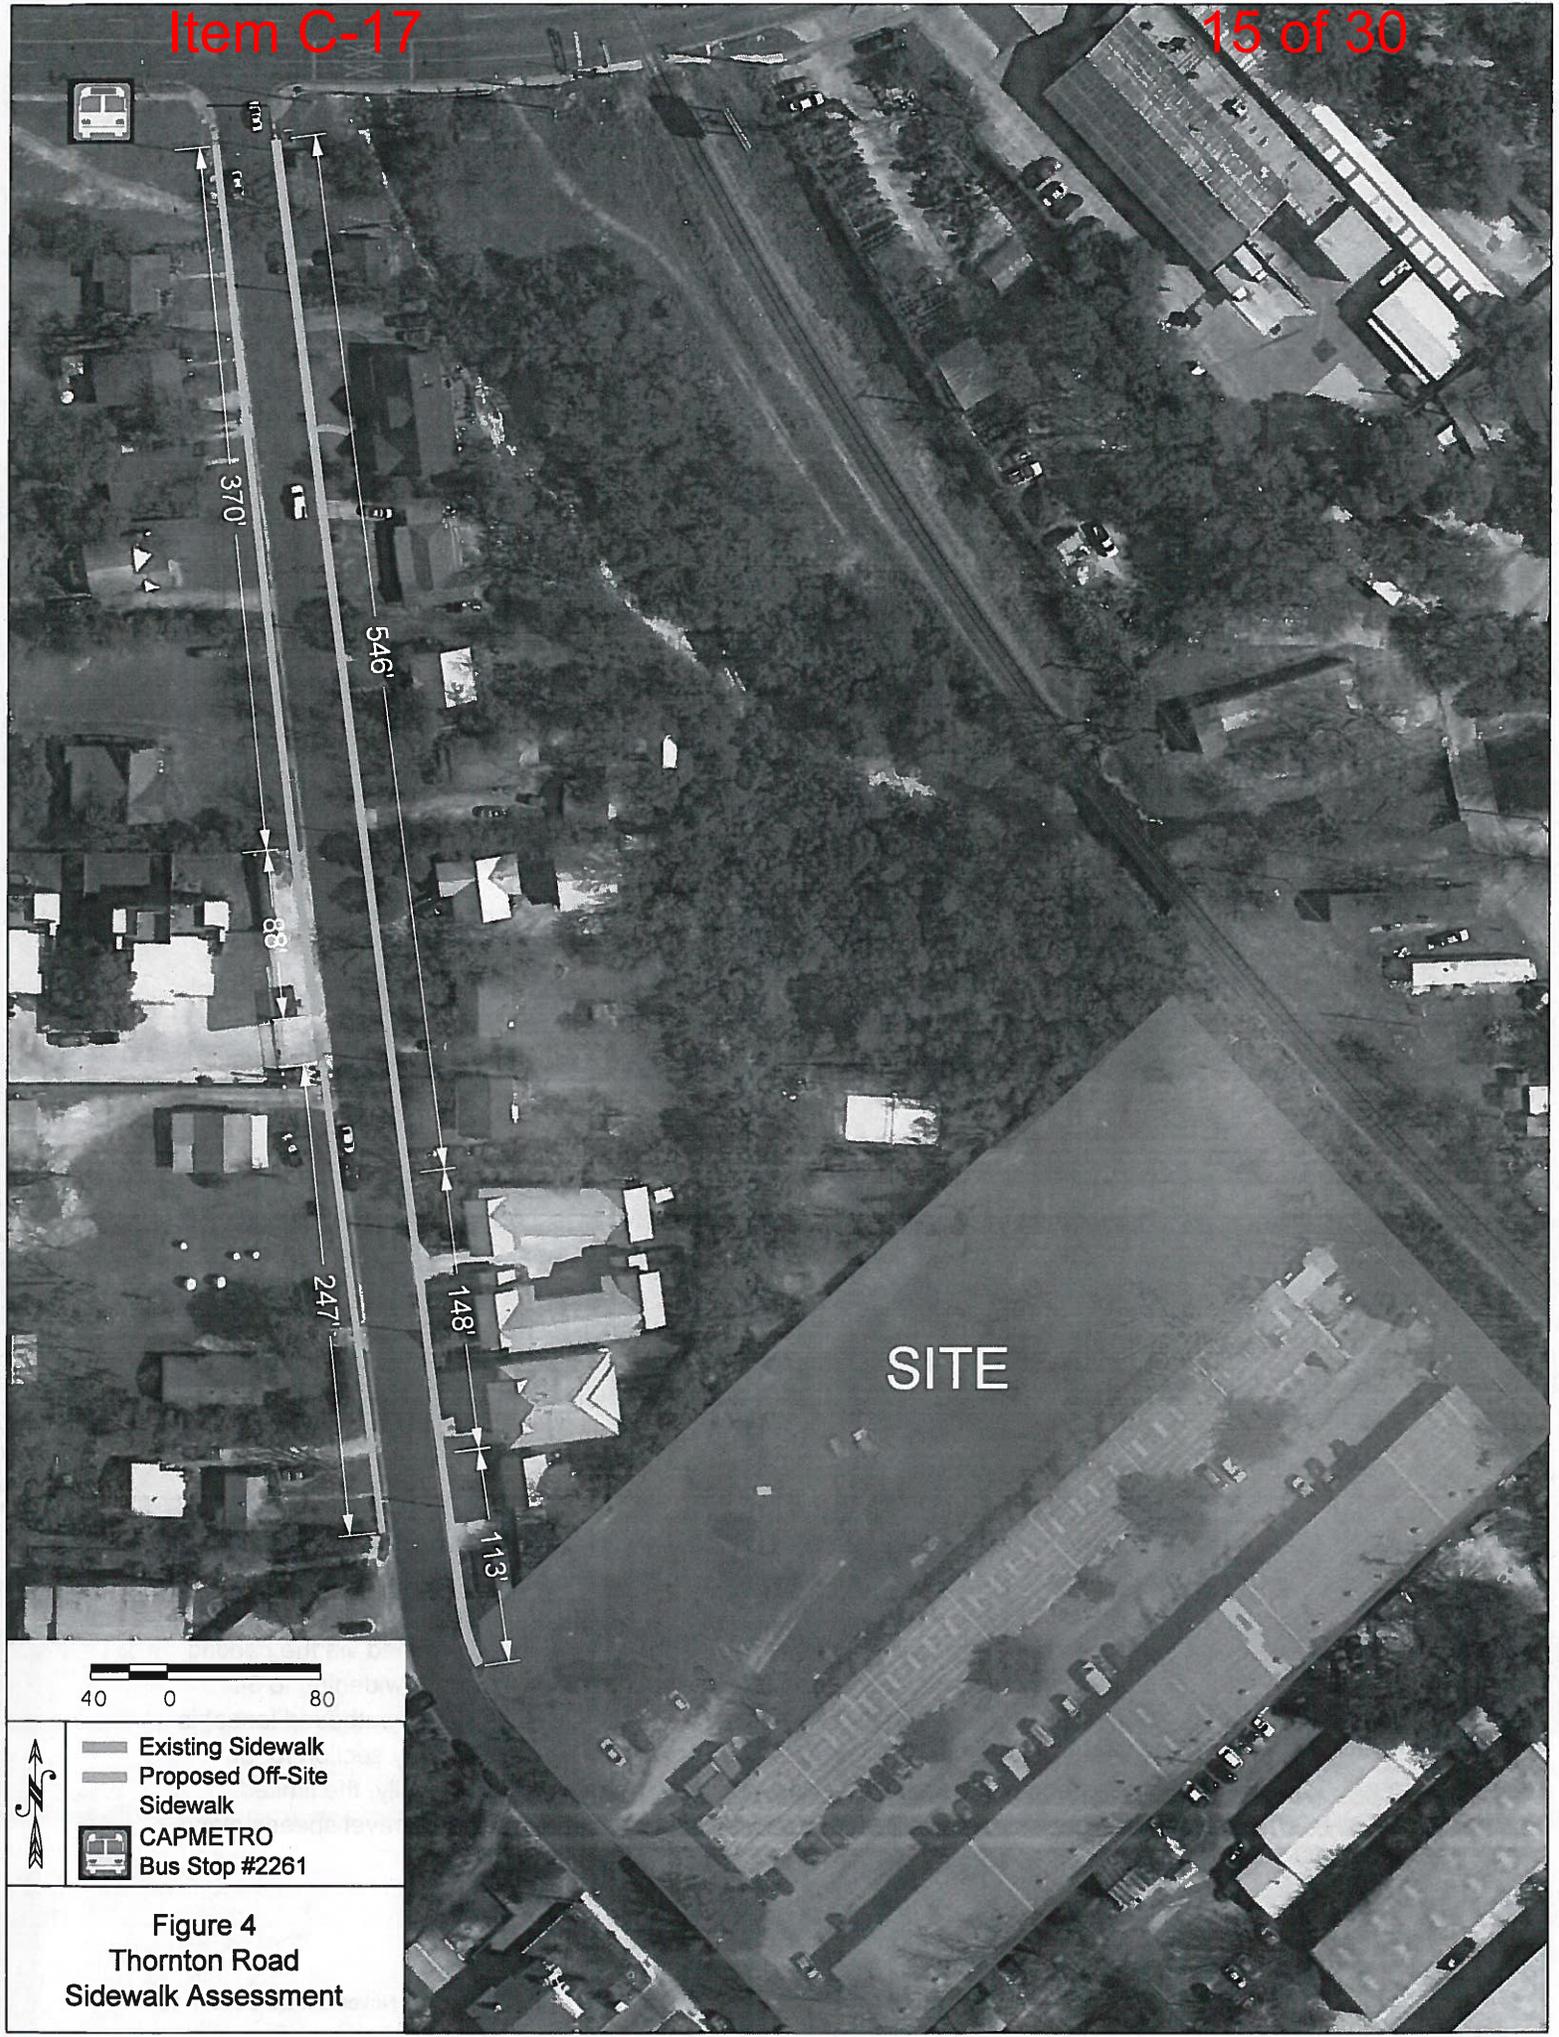
Figure 4  
Thornton Road  
Sidewalk Assessment

- Existing Sidewalk
- Proposed Off-Site Sidewalk
- CAPMETRO Bus Stop #2261

Residents are currently discussing residential parking permits along a portion of Thornton Road. This will reduce parking turnover and deter commercial parking for businesses on adjacent streets. Due to parking being a contributing source of the congestion along Thornton Road, it is recommended that parking be further restricted to one side of Thornton Road to allow sufficient width for vehicles to travel in both directions when the parking is occupied. Neighborhood support would be required for these parking modifications. Eliminating parking within 200' of Oltorf Street will allow for a two-lane approach to the intersection. It should be noted that an on-site parking garage and inset street-parking are proposed by the project which will accommodate residents and guests of the apartments. Figure 3 depicts the existing and proposed sidewalk infrastructure along Thornton Road.

Sidewalk facilities are very limited on Thornton Road causing pedestrians to walk in the roadway. It is recommended that sidewalks be installed on Thornton Road, connecting the proposed development with existing pedestrian facilities along Oltorf Street, including the Capital Metro Bus Stop. This would improve pedestrian safety and increase connectivity which has the potential to decrease access to the site by automobile. It should be noted that the Thornton Apartments development to the south has plans to install sidewalks along the east side of Thornton Road. Sidewalks along the west side of Thornton Road should be installed with roadway widening.

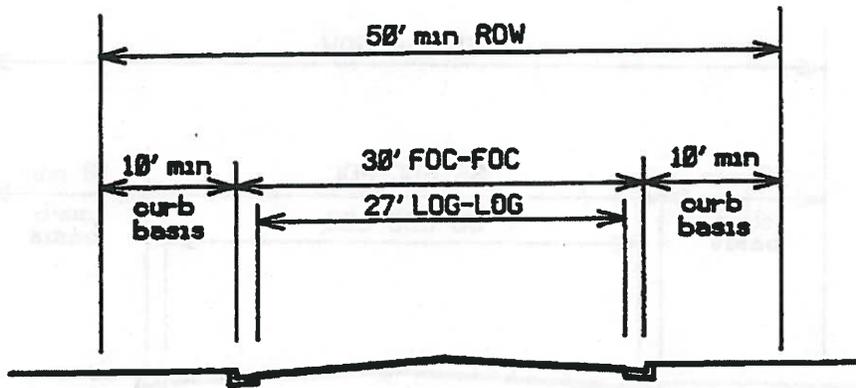
Figure 1-22 Design Criteria For Local Streets (SF-1 or SF-2)

Typical ADT Range, less than 1000  
 Design Speed, 25, 30 mph  
 General Length, less than 1500'  
 Minimum Centerline Radius, See Page 1-8  
 Minimum Tangent Length Between Horizontal Curves, 50'  
 Minimum Curb Basis, 10'  
 Zoning, SF-1 or SF-2 (Or comparable land use) \*

### TYPICAL CROSS-SECTION

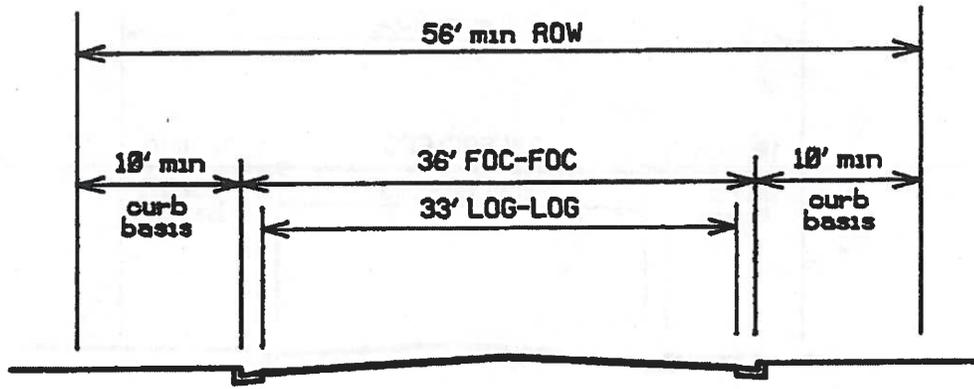
Figure 1-23 Design Criteria for Local Streets (SF-3 thru SF-6)

Typical ADT Range, less than 1000

Design Speed, 25, 30 mph

General Length, less than 1500'

Minimum Centerline Radius, See Page 1-8

Minimum Tangent Length Between Horizontal Curves, 50'

Minimum Curb Basis, 10'

Zoning, SF-3 thru SF-6 (Or comparable land use)

### TYPICAL CROSS-SECTION

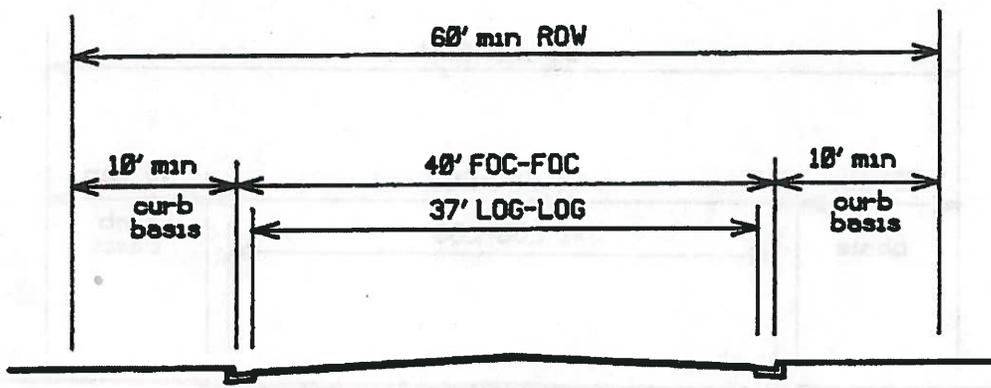
Figure 1-27 Design Criteria for Residential Collector Streets

- Typical ADT Range, 500 to 3000
- Design Speed, 30, 35 mph
- General Length, less than 1 mile
- Typical Spacing Between Residential Collectors, 1/4 mile
- Typical Spacing Between Intersections, 300'
- Minimum Centerline Radius, See Page 1-8
- Minimum Tangent Length Between Horizontal Curves, 100'
- Minimum Curb Basis, 10'
- Zoning, SF-1 thru SF-6, MF-1 (Or comparable land use)

### TYPICAL CROSS-SECTION

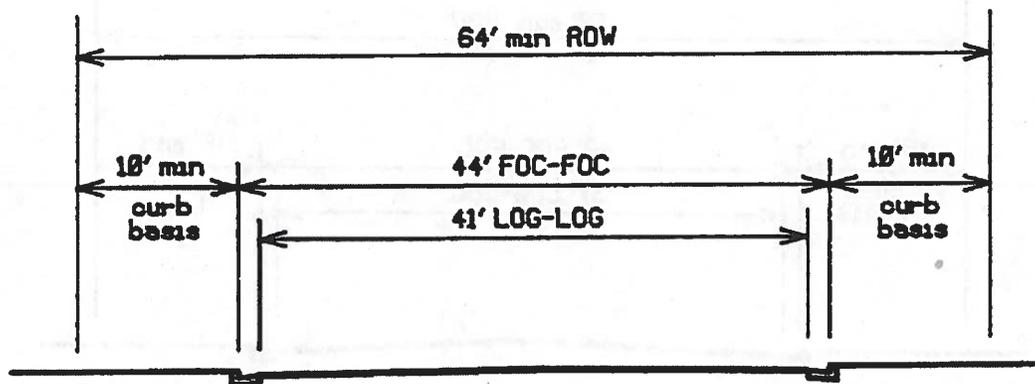
Figure 1-28 Design Criteria for Neighborhood Collector Streets

- Typical ADT Range, from 2000 to 6000
- Design Speed, 35 mph
- General Length, 1-2 miles
- Typical Spacing Between Intersections, 500'
- Typical Spacing Between Neighborhood Collectors, 1/2 mile
- Minimum Centerline Radius, See Page 1-8
- Minimum Tangent Length Between Horizontal Curves, 100'
- Minimum Curb Basis, 10'

### TYPICAL CROSS-SECTION

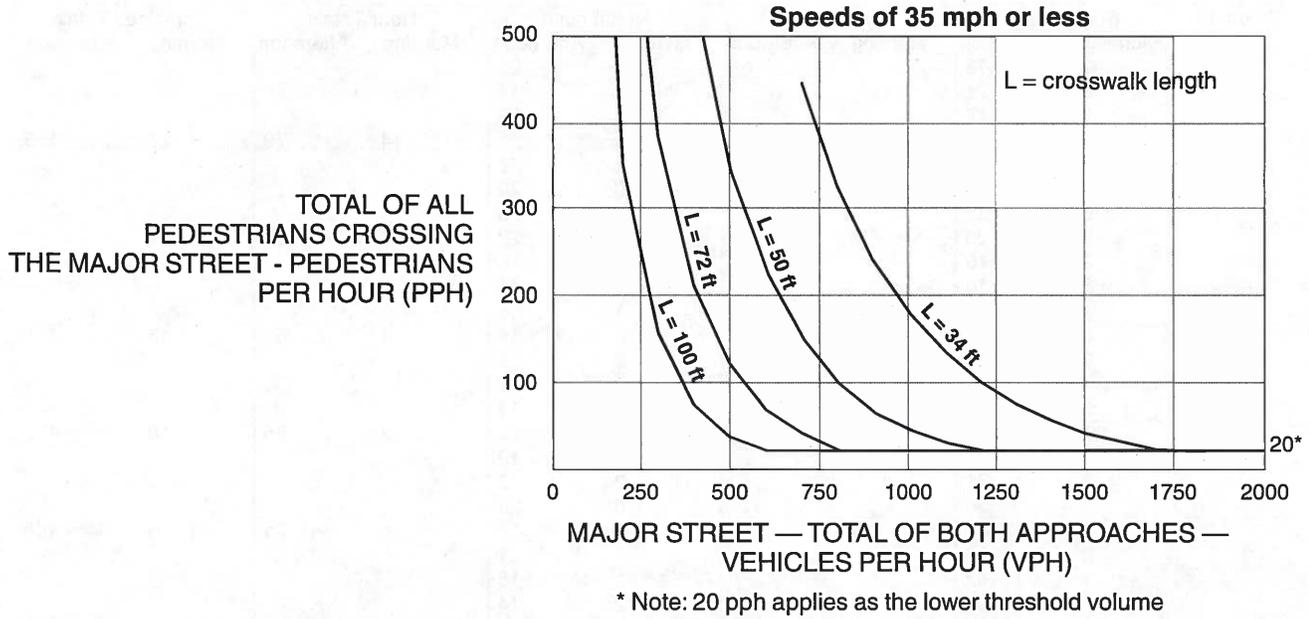
**Figure 4F-1. Guidelines for the Installation of Pedestrian Hybrid Beacons on Low-Speed Roadways**

As pedestrian volumes increase in the vicinity of the project area due to the proposed and surrounding developments, a Pedestrian Hybrid Beacon should be considered, across the east leg of Oltorf Street at Thornton Road to facilitate pedestrian crossings. The beacon should be installed when pedestrian and vehicular volumes in the field warrant installation. Guidelines for the Installation of Pedestrian Hybrid Beacons are provided in the Appendix. If a traffic signal is warranted and installed in the field, the pedestrian hybrid beacon would not be required.

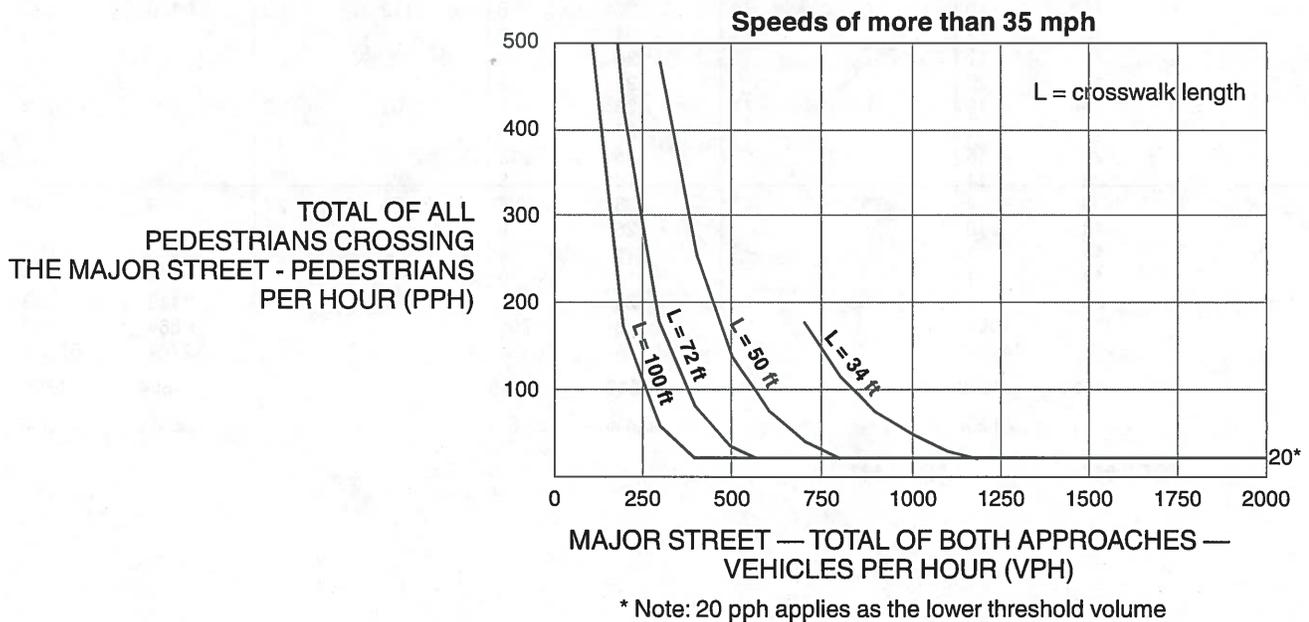
**Figure 4F-2. Guidelines for the Installation of Pedestrian Hybrid Beacons on High-Speed Roadways**
