AGREEMENT BETWEEN THE CITY OF AUSTIN AND
THE AUSTIN INDEPENDENT SCHOOL DISTRICT
ESTABLISHING SITE DEVELOPMENT STANDARDS
FOR THE BOWIE HIGH SCHOOL PRACTICE FIELDS

Environmental Resource Inventory

1. SITE/PROJECT NAME: _____ AISD Bowie High School Practice Fields
2. COUNTY APPRAISAL DISTRICT PROPERTY ID (#'s): _____ 844947
3. ADDRESS/LOCATION OF PROJECT: _____ 3700 W. Slaughter Lane, Austin, TX 78749

ATTACHMENT A

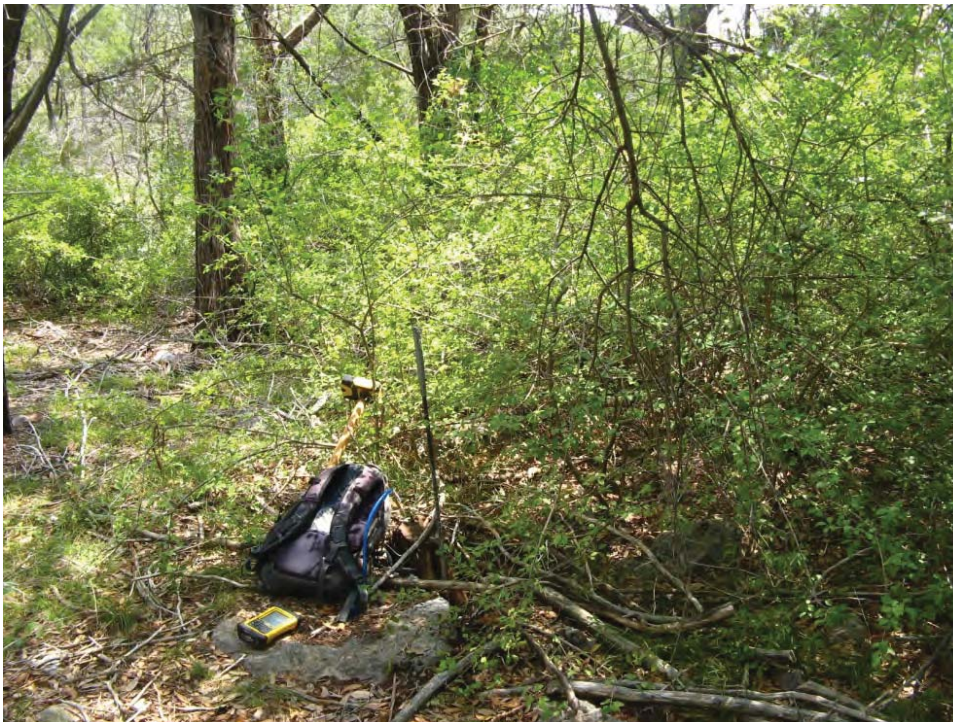
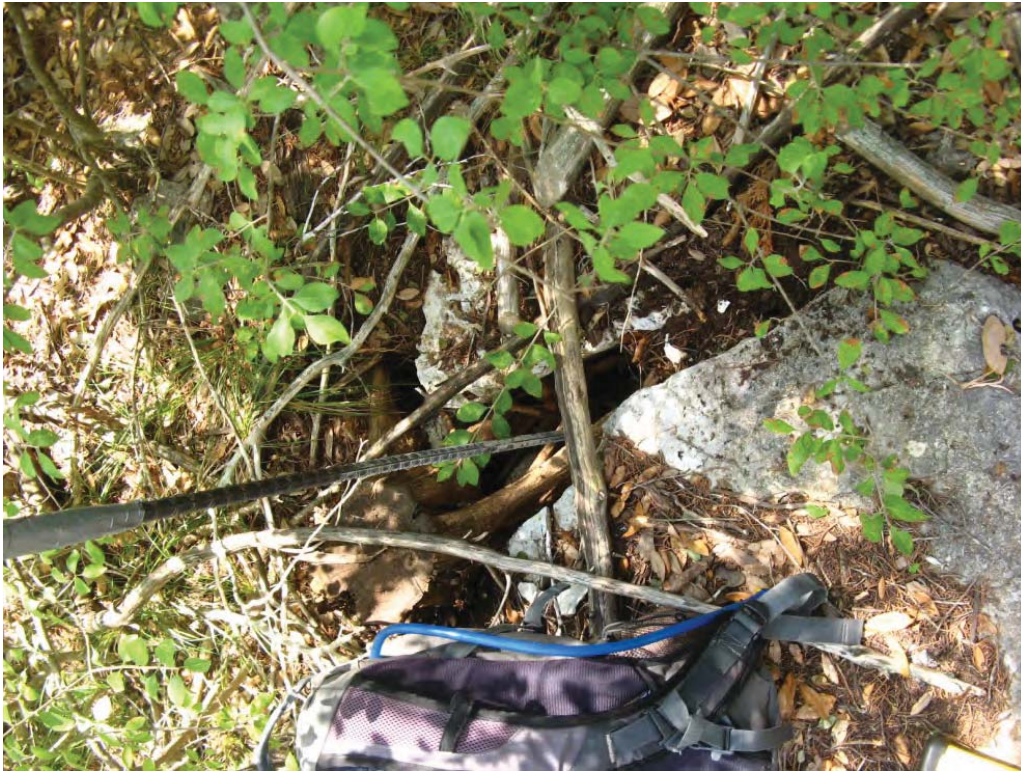
G01 – Point Recharge Feature (solution-enlarged fracture)

Dimensions: 1.5 ft L x 0.8 ft W x 1 ft D.
Infill: Leaves, duff.
Substrate: Compacted, dry, silty clay soil.
Recharge Indications: Limited sapping of soil.
Infiltration Rate: Low to moderately low.
Topo Setting: Flat terrain with slopes between 1% and 2%.
Comments: Clustered with G02 and G03. All are potentially associated with a geologic fault.

View of G01 from south.

Close up view of G01 from above.

Proposed Setback: Standard setback per City of Austin Environmental Criteria Manual [Sec 1.3.0(A)1.e]. Setback to encompass clustered features G01, G02 and G03. 50-ft setback downslope and cross-slope from the edge of the cluster. 50-ft setback tapering to a point 300 ft upslope from the edge of the cluster (see Attachment E).

Because of compatible land use, ground slope, and vegetation conditions upslope of the feature, COA may allow reduction of the upslope extent of the setback to a minimum of 150 ft. In either case, most of the setback upslope of the feature is outside of the subject property and not under control of the project site owner.

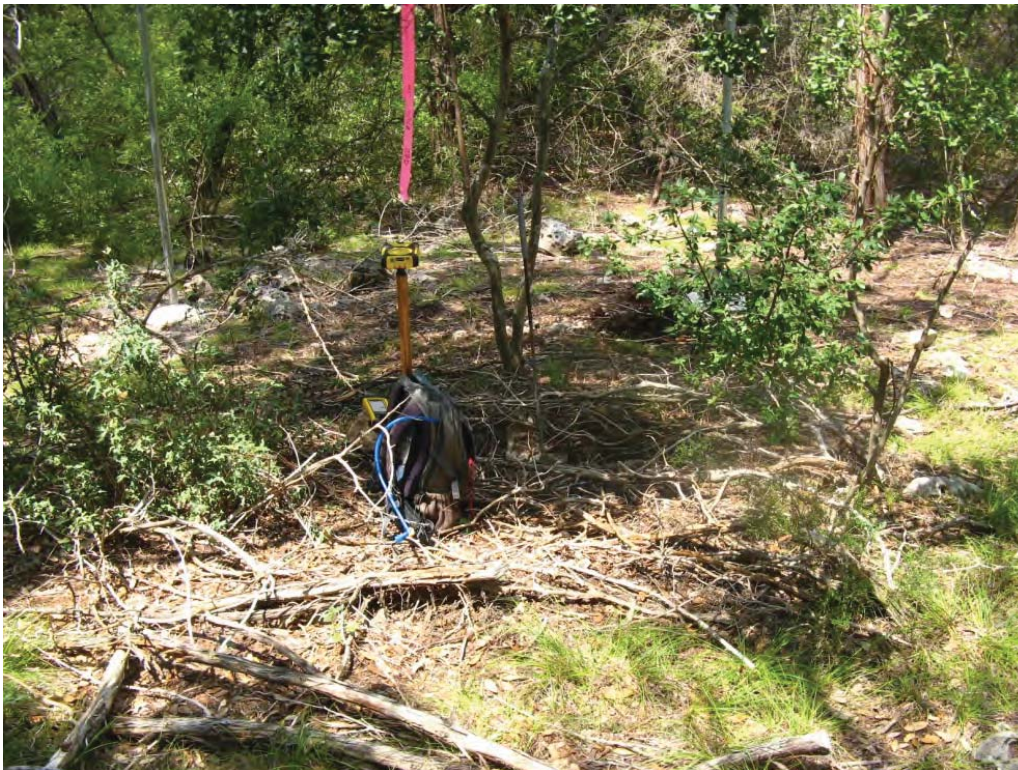
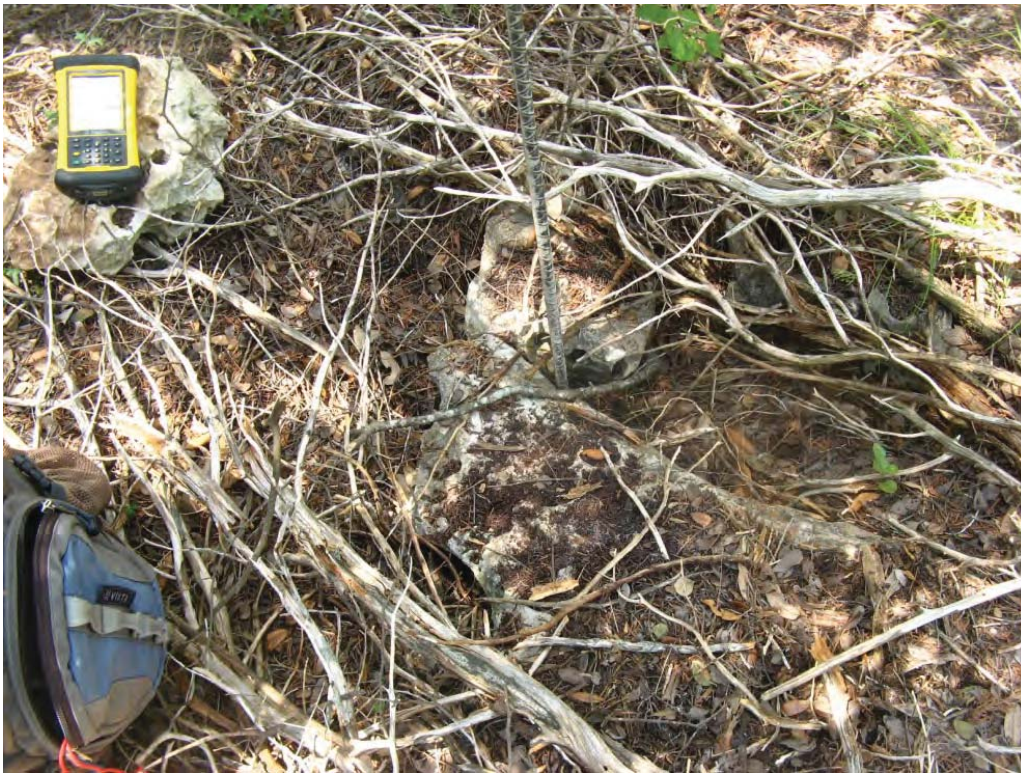
G02 – Point Recharge Feature (closed depression)

Dimensions: 2 ft L x 2 ft W x 1 ft D.
Infill: Duff, sticks, and a few loose, small boulders.
Substrate: Compacted, dry, silty clay soil.
Recharge Indications: Some soil sapping.
Infiltration Rate: Low to moderately low.
Topo Setting: Flat terrain with slopes between 1% and 2%.
Comments: Clustered with G01 and G03. All are potentially associated with a geologic fault.

View of G02 from the south.

Close up view of G02 from above.

Proposed Setback: Standard setback per City of Austin Environmental Criteria Manual [Sec 1.3.0(A)1.e]. Setback to encompass clustered features G01, G02 and G03. 50-ft setback downslope and cross-slope from the edge of the cluster. 50-ft setback tapering to a point 300 ft upslope from the edge of the cluster (see Attachment E).

Because of compatible land use, ground slope, and vegetation conditions upslope of the feature, COA may allow reduction of the upslope extent of the setback to a minimum of 150 ft. In either case, however, most of the setback upslope of the feature is outside of the subject property and not under control of the project site owner.

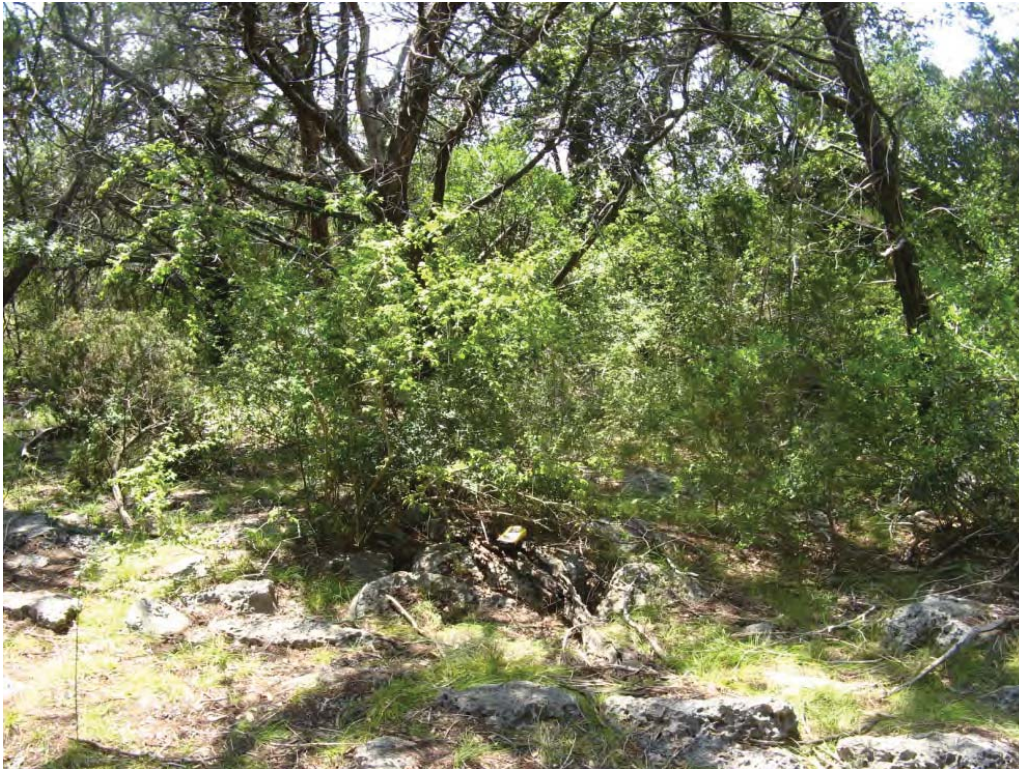
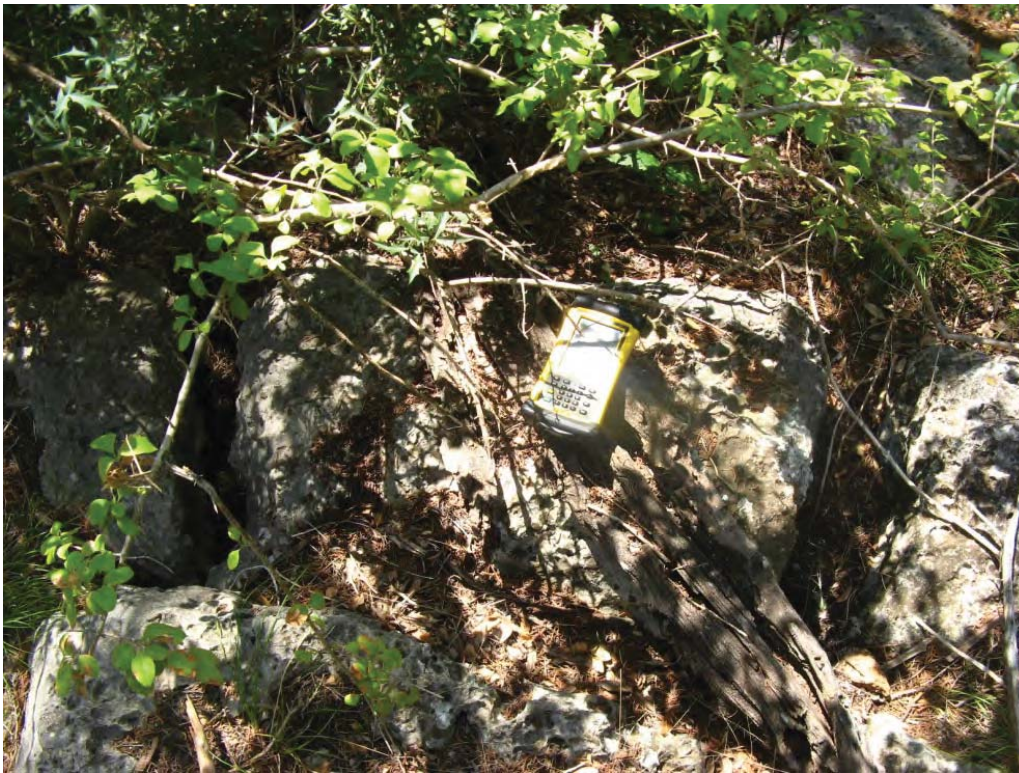
G03 – Point Recharge Feature (closed depression beneath large boulder)

Dimensions: 2 ft L x 1.5 ft W x 1 ft D.
Infill: Duff and leaves.
Substrate: Compacted, dry, silty clay soil and limestone bedrock.
Recharge Indications: Some soil sapping.
Infiltration Rate: Low to moderately low.
Topo Setting: Flat terrain with slopes between 1% and 2%.
Comments: Depression is beneath a flat-lying boulder that is separated from two flanking boulders by surface fractures. A cave cricket was observed beneath the void beneath the central surface boulder. G03 is clustered with G01 and G02; all are potentially associated with a geologic fault.

View of G03 from the southeast.

Close up view of G03 from above.

Proposed Setback: Standard setback per City of Austin Environmental Criteria Manual [Sec 1.3.0(A)1.e]. Setback to encompass clustered features G01, G02 and G03. 50-ft setback downslope and cross-slope from the edge of the cluster. 50-ft setback tapering to a point 300 ft upslope from the edge of the cluster (see Attachment E).

Because of compatible land use, ground slope, and vegetation conditions upslope of the feature, COA may allow reduction of the upslope extent of the setback to a minimum of 150 ft. In either case, however, most of the setback upslope of the feature is outside of the subject property and not under control of the project site owner.

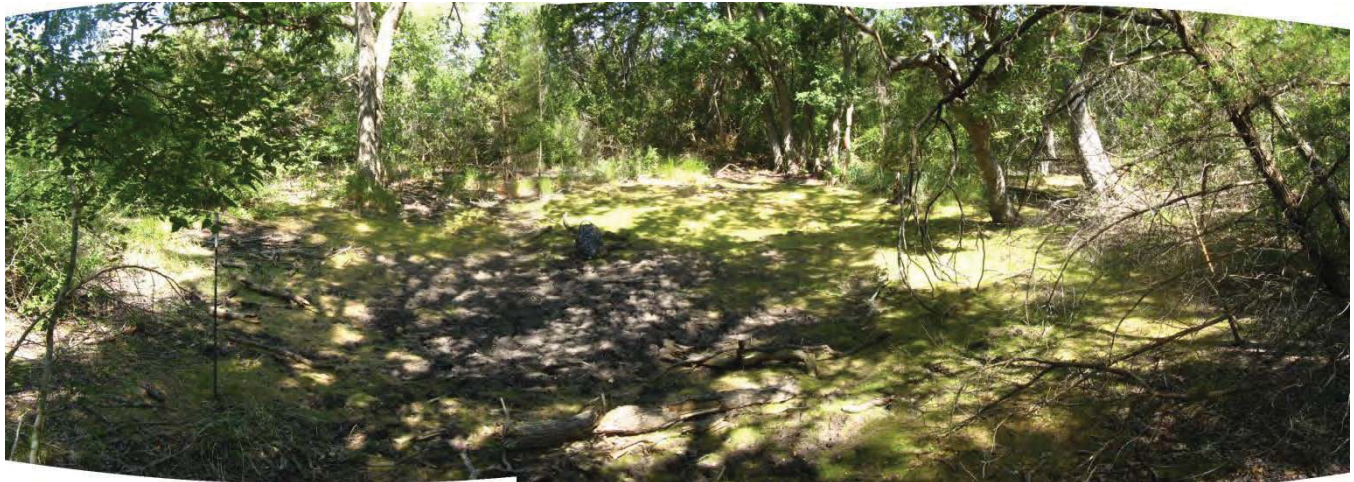
G05 – Wetland (within a closed depression)

Dimensions: 55 ft L x 50 ft W x 3 ft D.
Infill: High plasticity and low permeability clay soil with extensive desiccation cracks.
Substrate: Clay(?).
Recharge Indications: None.
Infiltration Rate: Very low to nil.
Topo Setting: Flat terrain with slopes slightly more than 2%.
Comments: Depression contains hydric soil and hydrophytic vegetation. Feature may have resulted from ground subsidence or collapse, but the feature is primarily a wetland; not a recharge feature.

View of G05 from southeast side.

Proposed Setback: Standard setback per City of Austin Environmental Criteria Manual [Sec 1.3.0(A)1.f]. 150-ft minimum radius from the edge of the depression. The northernmost edge of the setback would be outside of the subject property and not under control of the project site owner. The setback will overlap the setback for G06 (see Attachment E).

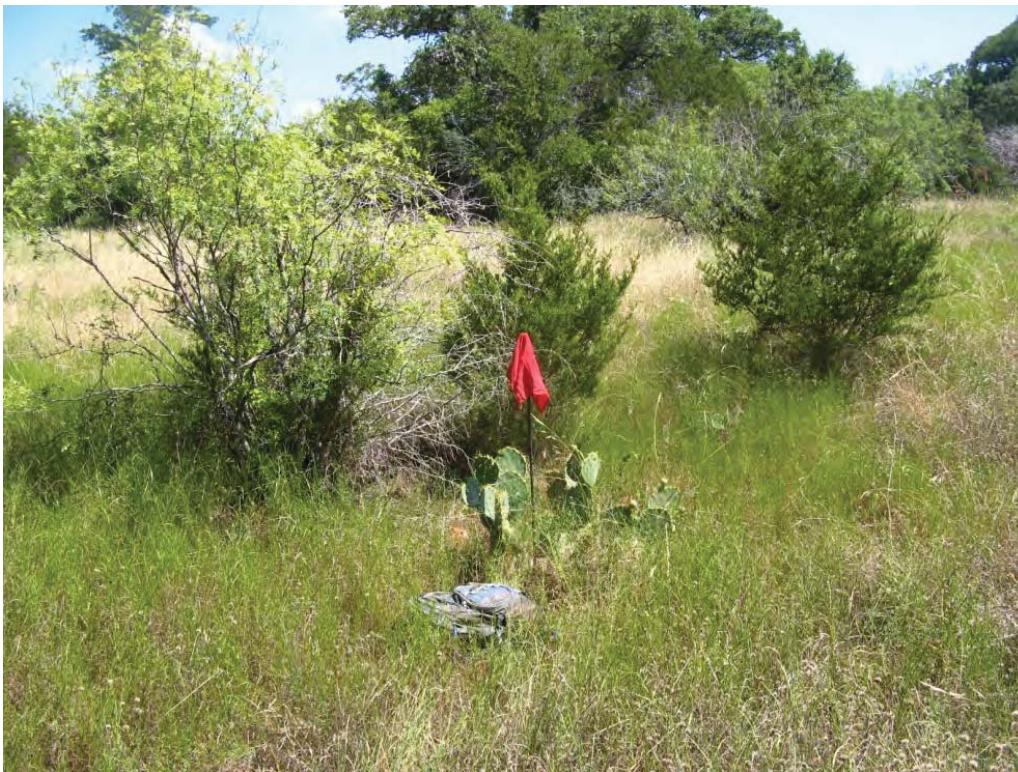
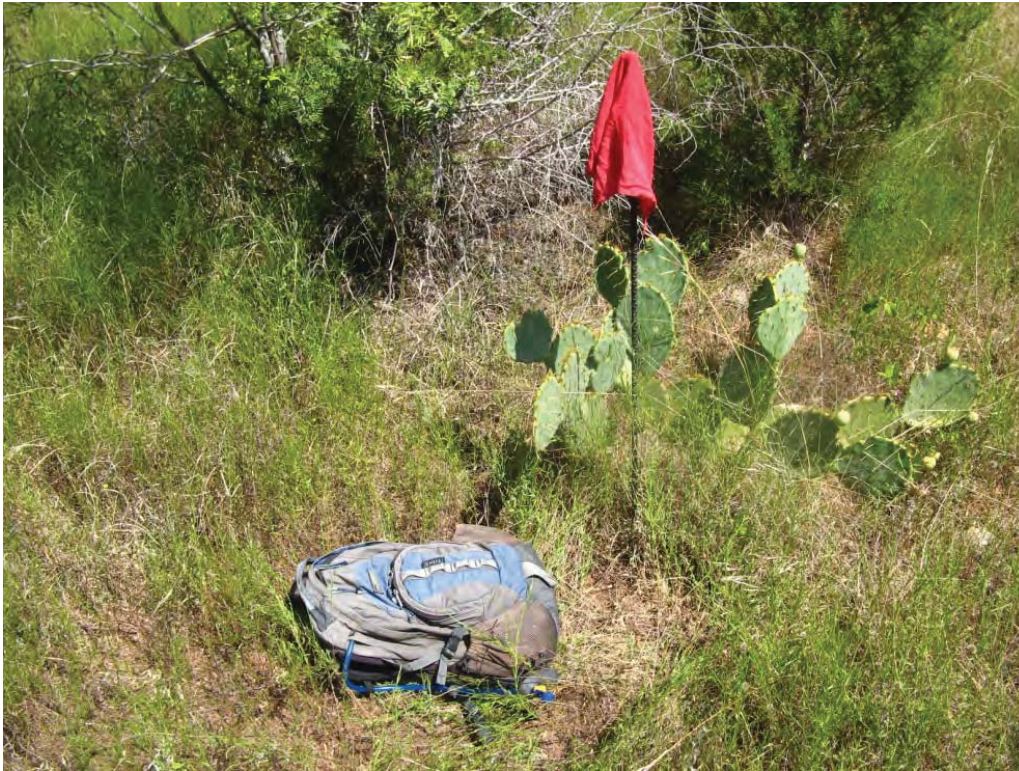
G06 – Point Recharge Feature (closed depression)

Dimensions: 8 ft L x 8 ft W x 1.5 ft D.
Infill: Few gravel- and cobble-sized limestone fragments.
Substrate: Firm, sandy, silty clay.
Recharge Indications: None.
Infiltration Rate: Low to moderately low.
Topo Setting: Flat terrain with slopes greater than 2%.
Comments: Depression is densely vegetated with native grasses.

View of G06 from the south.

Close up view of G06 from southeast.

Proposed Setback: Standard setback per City of Austin Environmental Criteria Manual [Sec 1.3.0(A)1.e]. 50-ft setback downslope and cross-slope from the edge of the cluster. 50-ft setback tapering to a point 300 ft upslope from the edge of the feature (see Attachment E). The setback will overlap the setback for G05.

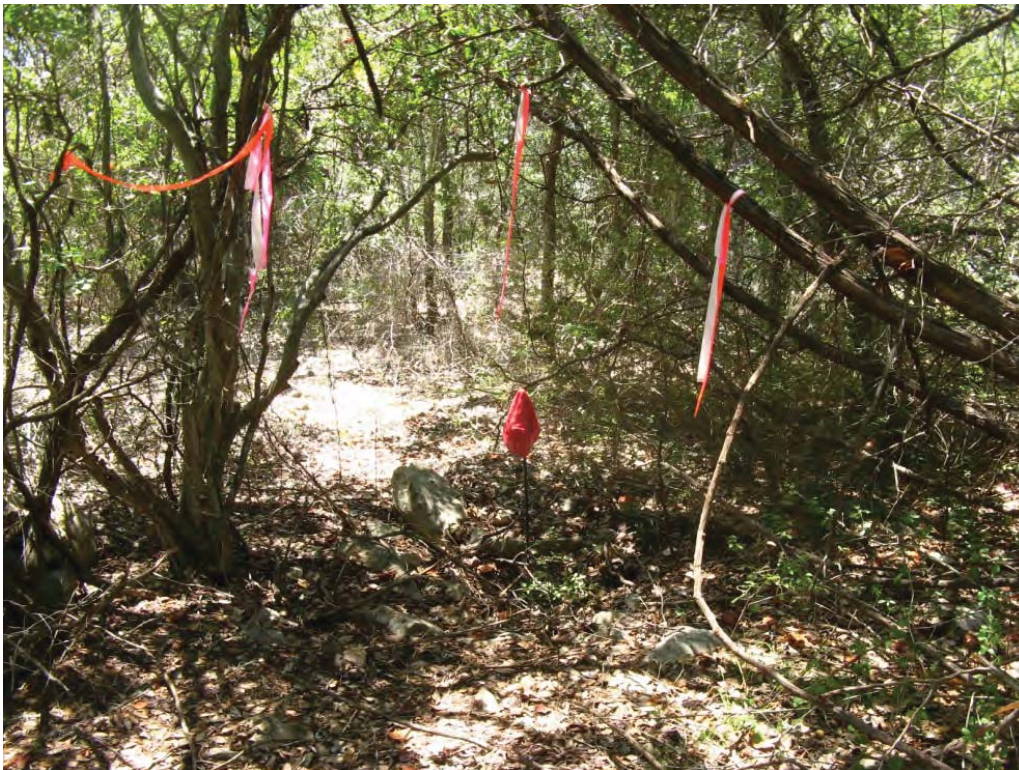
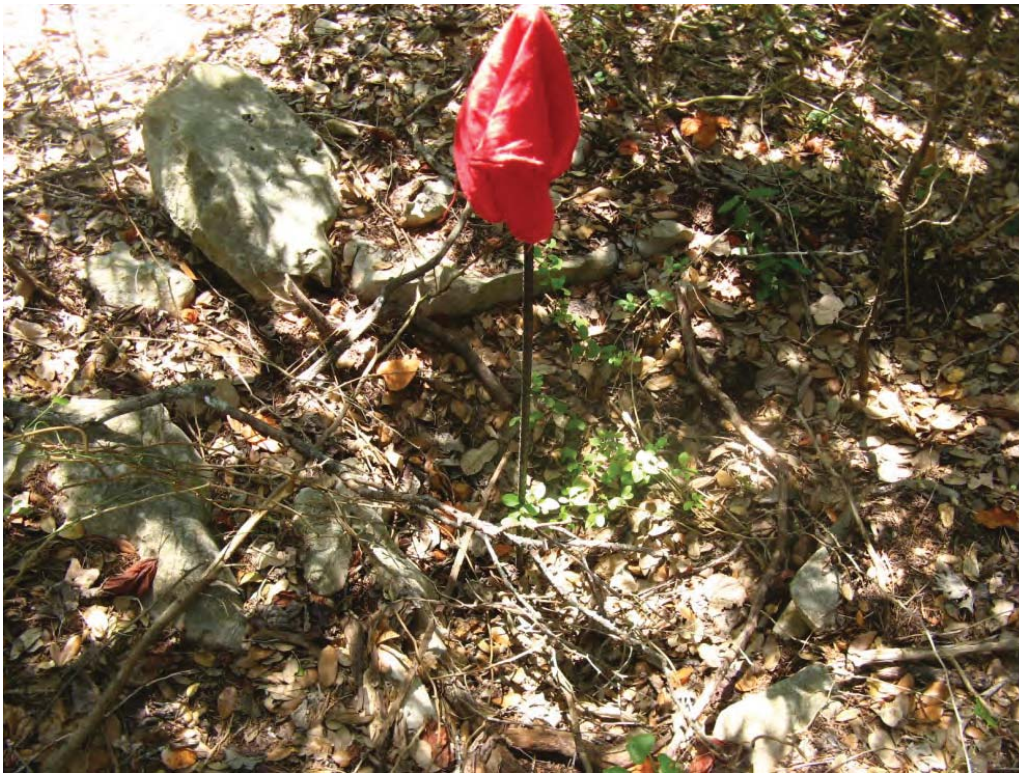
G07 – Point Recharge Feature (sinkhole)

Dimensions: 7 ft L x 7 ft W x 1.5 ft D.
Infill: Loose, flat, small, limestone boulders; duff, leaves.
Substrate: Limestone.
Recharge Indications: Little or no soil infill.
Infiltration Rate: Moderate to rapid.
Topo Setting: Flat terrain with slopes greater than 2%.
Comments: Perimeter of sinkhole consists of broken limestone rock slumped toward the center of the depression.

View of G07 from the northeast.

Close up view of G07 from above.

Proposed Setback: Standard setback per City of Austin Environmental Criteria Manual [Sec 1.3.0(A)1.e]. 50-ft setback downslope and cross-slope from the edge of the cluster. 50-ft setback tapering to a point 300 ft upslope from the edge of the feature (see Attachment E).

Mapped topography of the project site (Attachment E) suggests the catchment area for G07 extends at least 300 ft upslope from the edge of the feature. Detailed mapping may show the catchment area to be smaller, which may allow the upslope setback distance to be reduced.

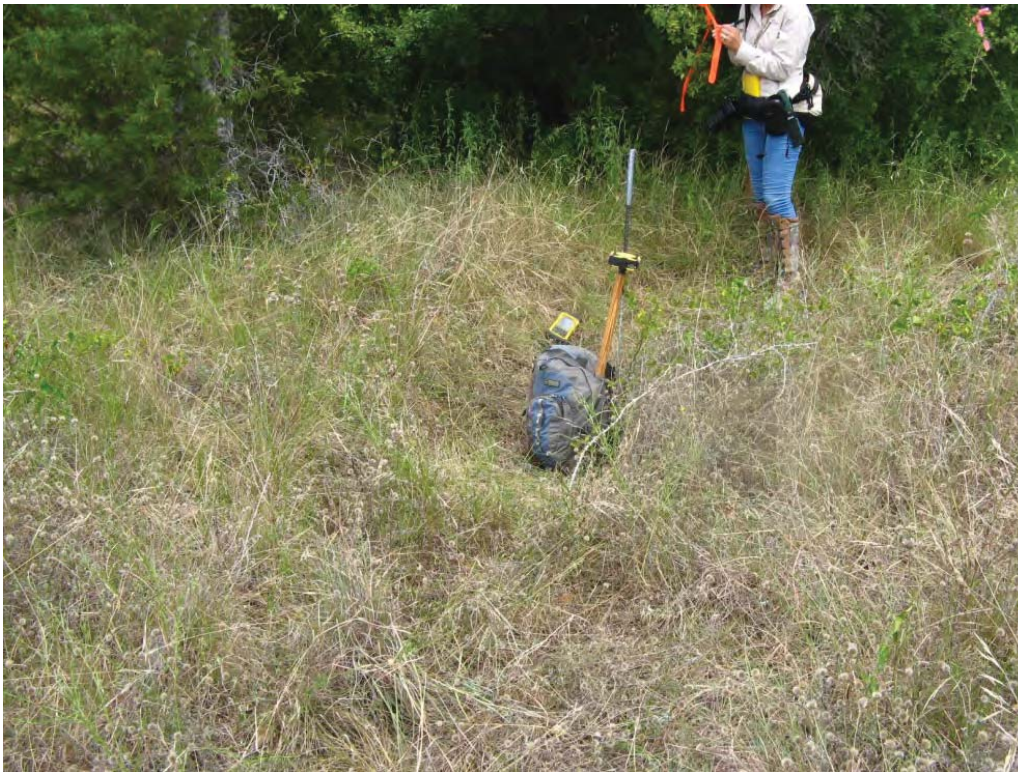
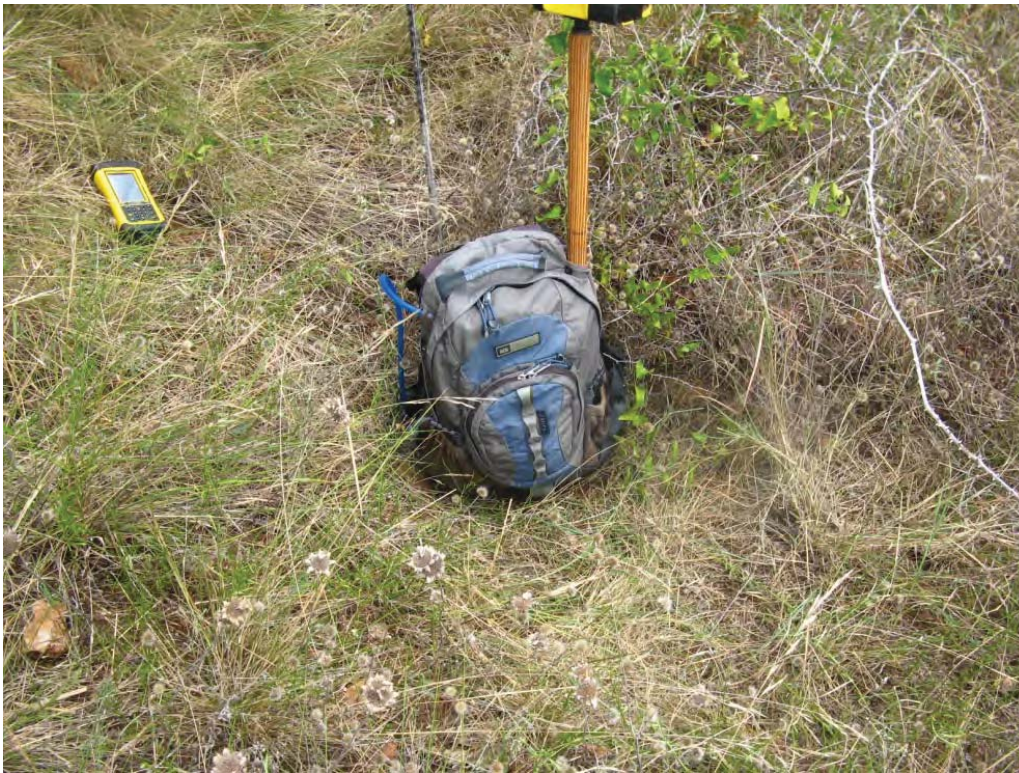
G08 – Point Recharge Feature (closed depression)

Dimensions: 12 ft L x 8 ft W x 2 ft D (with long axis oriented 165°)

Infill: None.

Substrate: Firm, silty clay.

Recharge Indications: None.

Infiltration Rate: Low to moderately low.

Topo Setting: Flat terrain with slopes greater than 2%.

Comments: Depression is densely vegetated with native grasses.

View of G08 from the south.

Close up view of G08.

Proposed Setback: Standard setback per City of Austin Environmental Criteria Manual [Sec 1.3.0(A)1.e]. 50-ft setback downslope and cross-slope from the edge of the cluster. 50-ft setback tapering to a point 300 ft upslope from the edge of the feature (see Attachment E). Most of the setback upslope of the feature is outside of the subject property and not under control of the project site owner.

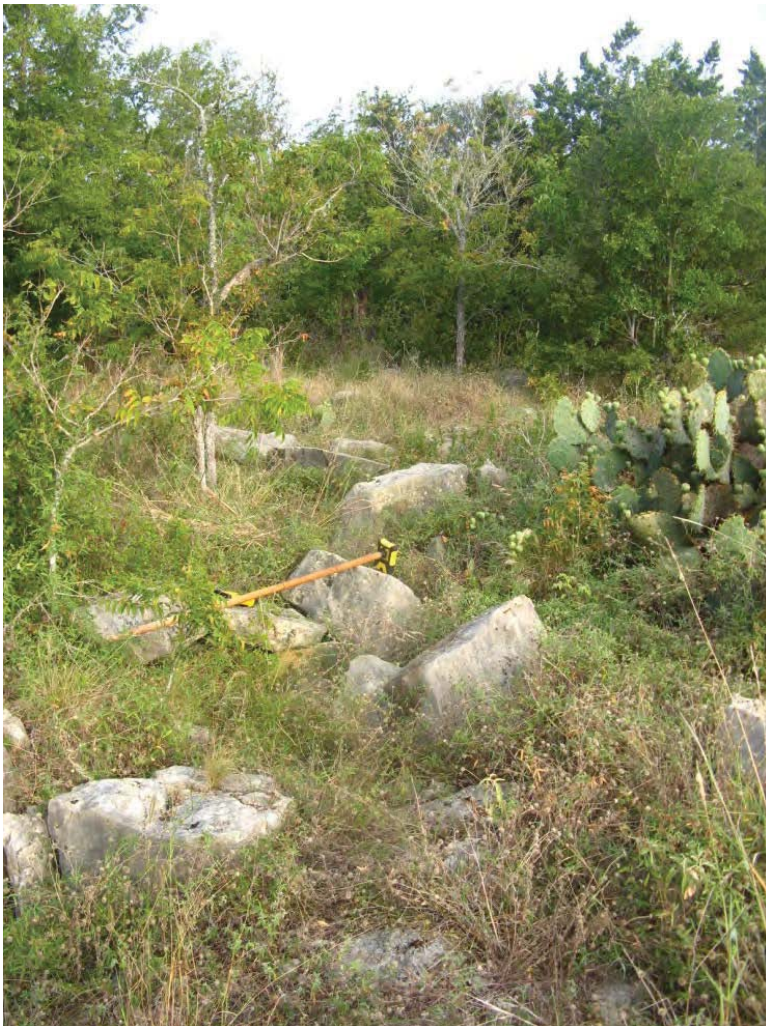
G11 – Point Recharge Feature (clustered closed depressions)

Dimensions: 30 ft L x 15ft W x 1.5 ft D (overall dimensions)
Infill: None.
Substrate: Firm, silty clay.
Recharge Indications: Soil sapping.
Infiltration Rate: Low to moderately low.
Topo Setting: Flat terrain with slopes between 1% and 2%.
Comments: Multiple, oval to circular, closed depressions in a field of notably large limestone boulders.

View of G11 from the southeast.

Proposed Setback: Standard setback per City of Austin Environmental Criteria Manual [Sec 1.3.0(A)1.e]. 50-ft setback downslope and cross-slope from the edge of the cluster. 50-ft setback tapering to the upslope limit of the catchment area 160 ft upslope from the edge of the feature (see Attachment E). The entire setback is outside of the subject property and not under control of project site owner.

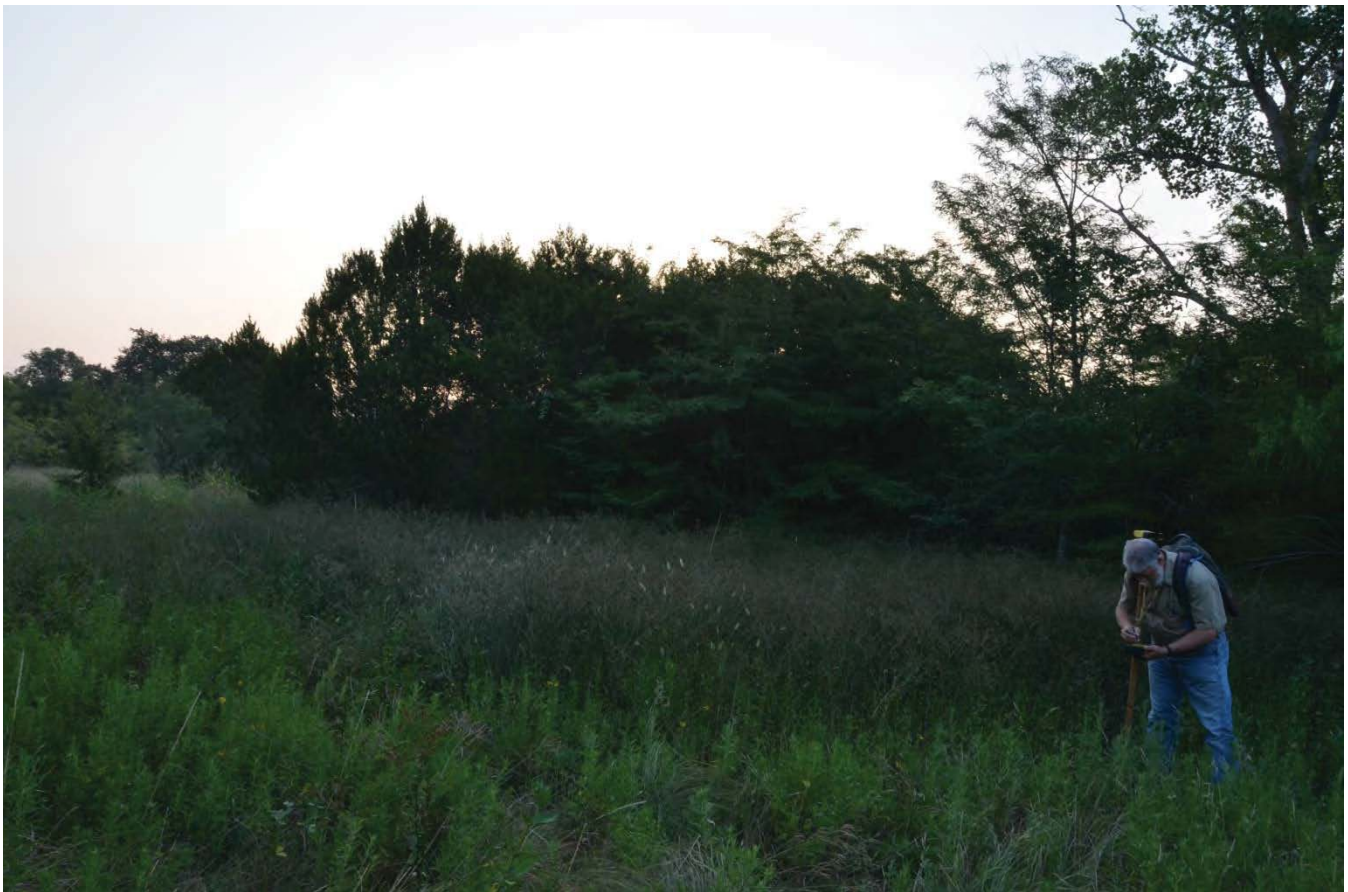
G12 – Wetland (within a drainage course)

Dimensions: 62 ft L x 40 ft W x 0.5 ft D (overall dimensions)
Substrate: Silty clay soil over limestone bedrock.
Recharge Indications: None.
Infiltration Rate: Very low to nil.
Topo Setting: Generally flat terrain along a gently sloping drainage channel.
Comments: Small depression dominated by vegetative species characteristic of hydric conditions.

Overview of G12. Wetland within drainage channel.

Proposed Setback: Modified from the standard setback per City of Austin Environmental Criteria Manual [Sec 1.3.0(A)1.f] to achieve the same buffer area required, while altering the buffer shape to keep it within the onsite Water Quality Transition Zone and Critical Water Quality Zone (see Attachment E).

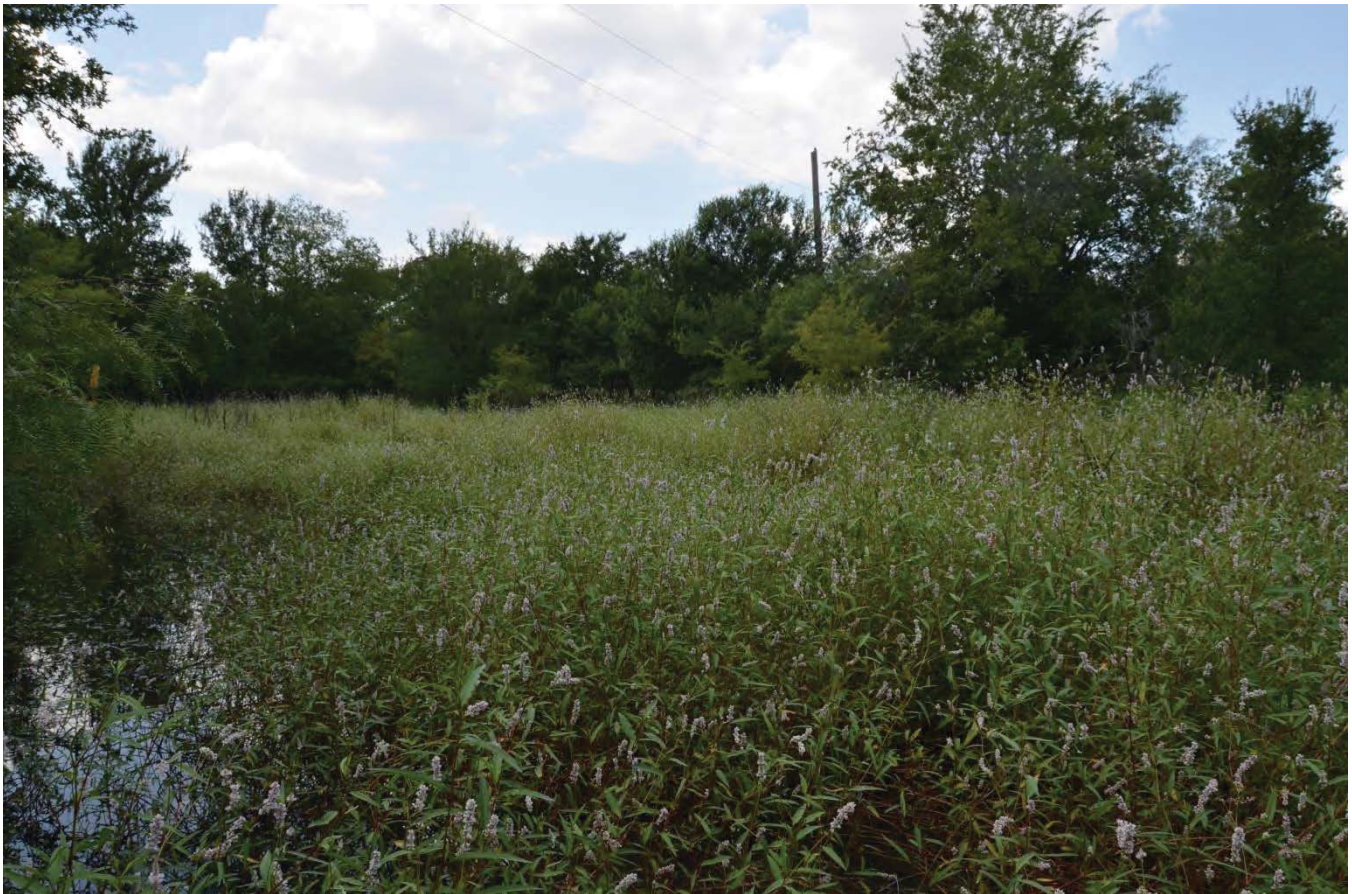
Structural Sink – Wetland (former stock tank)

Dimensions: 160 ft L x 54 ft W x 0.5 ft D (overall dimensions)
Substrate: Low plasticity and low permeability clay.
Recharge Indications: None.
Infiltration Rate: Very low to nil.
Topo Setting: Generally flat terrain along a gently sloping drainage channel.
Comments: Depression dominated by vegetative species characteristic of hydric conditions and ponding present.

Overview of Structural Sink. Contained water at time of site visit and dominated by *Polygonum* sp.

Proposed Setback: Standard setback per City of Austin Environmental Criteria Manual [Sec 1.3.0(A)1.f]. 150-ft minimum radius from the edge of the depression. Only the southwestern part of the setback would be within the subject property and under control of the project site owner. (see Attachment E).

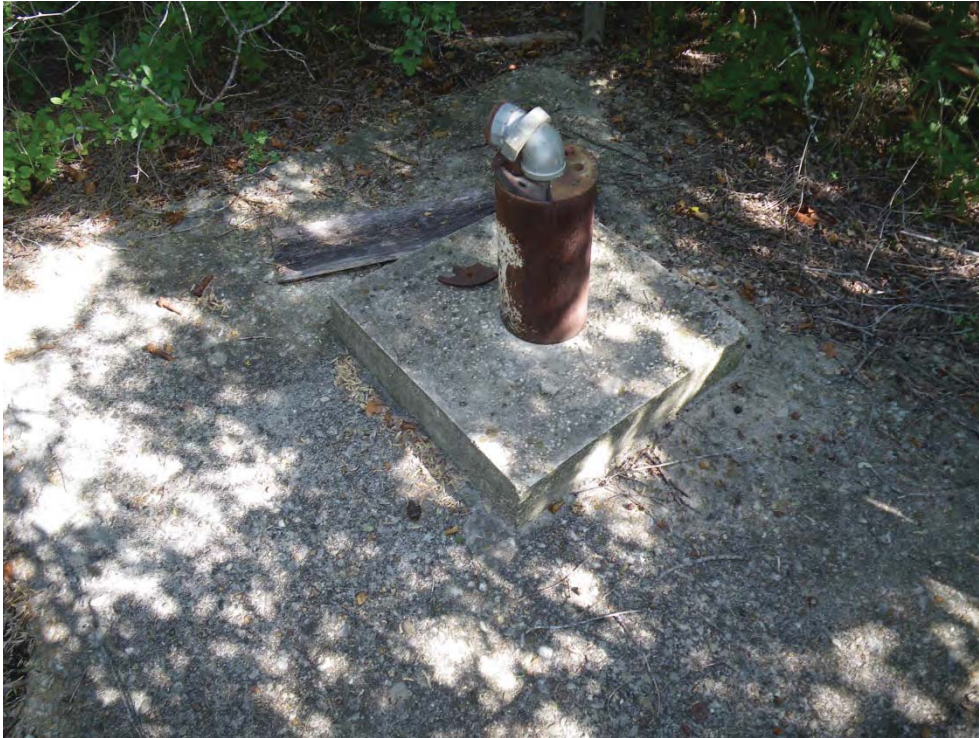
Water Well 58-50-411

Water Well – TWDB Well No. 58-50-411**Description:**

This is an unused water well located approximately 100 ft outside of the project site boundary. The well was reportedly drilled in 1940, presumably for livestock watering and/or domestic water supply. The well consists of 6-inch ID steel casing extending from a height of 1.5 ft above ground level to an unknown depth. The well is reported to be 469ft deep. The well casing is not sealed to prevent entry of contaminants. Water level measurements taken between 1978 and 2005 show water levels to be 217 to 231ft below ground surface.
