The Contemporary Austin Laguna Gloria

AUSTIN HISTORIC COMMISSION PRESENTATION
JULY 25 2016

BETTY AND EDWARD MARCUS SCULPTURE
PARK AT LAGUNA GLORIA

REED HILDERBRAND

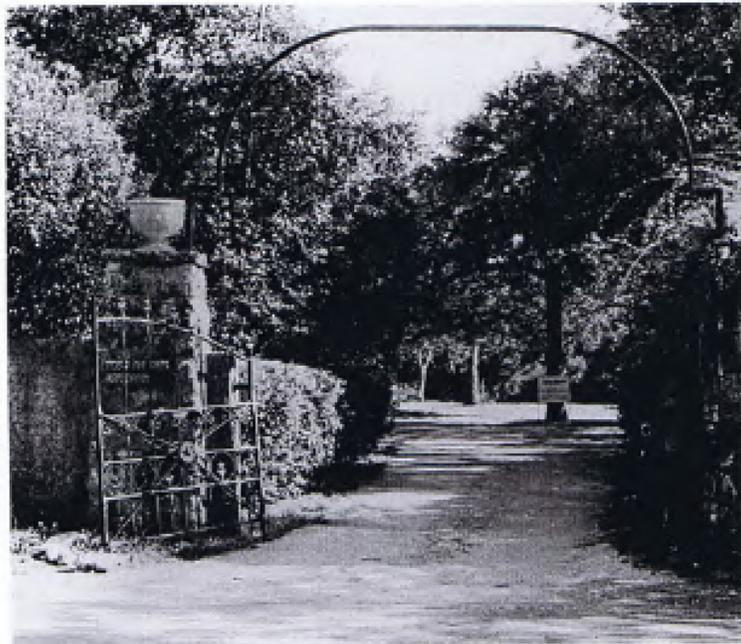
Photo 3.27 Original Front Gates, 1968 (earliest photo available)

- Clara Driscoll purchased (2) sets of gates from the Texas State Capitol grounds for relocation to Laguna Gloria as early as 1925
- The original 35th St. entry gates were removed, whereabouts unknown
- Existing gates at 35th St. entry were originally located at the Temple of Love
- The exterior wall was reconfigured in the 1970s to incorporate a cul-de-sac and sidewalk
- The gates were modified from their original shape and width to incorporate (2) pedestrian gates on each side in the 1980s

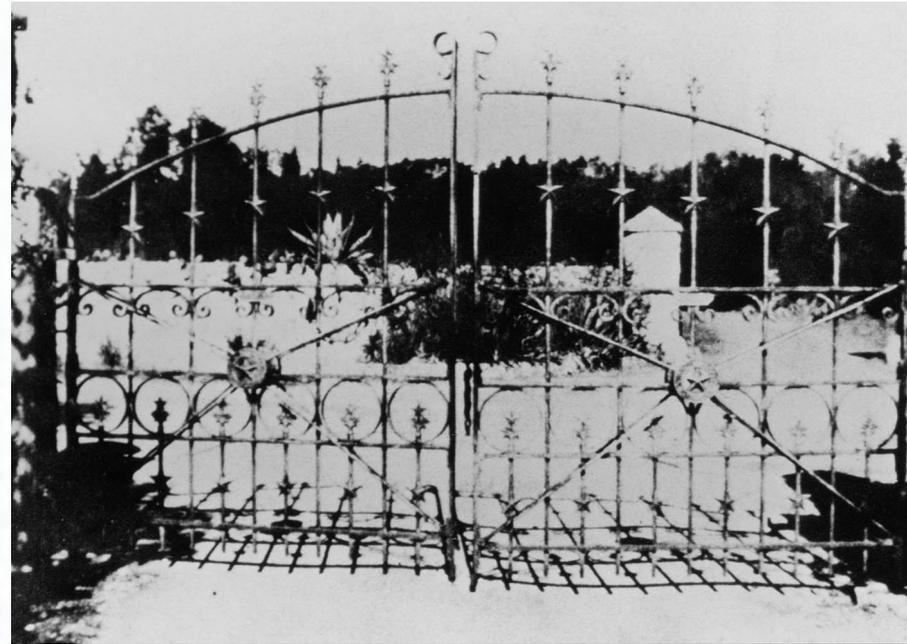
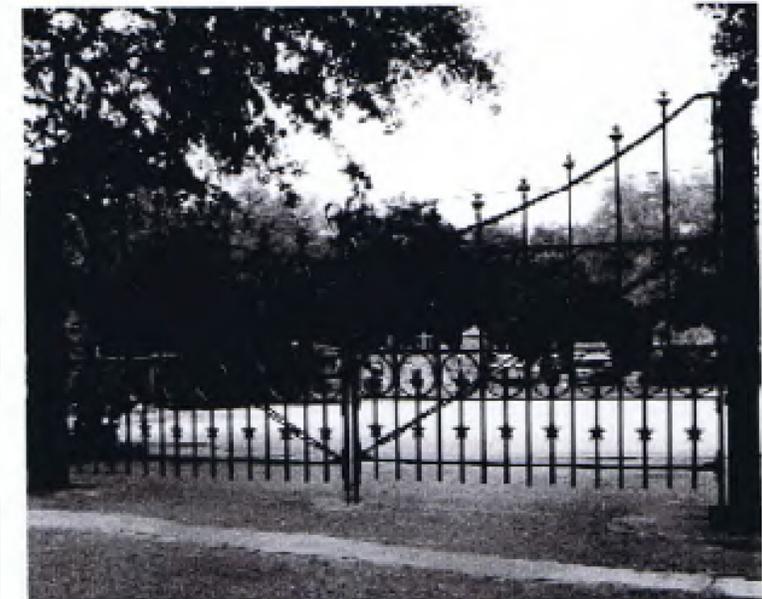
Photo 3.26 Existing Front Gates formerly at end of Path to the Point, 1998

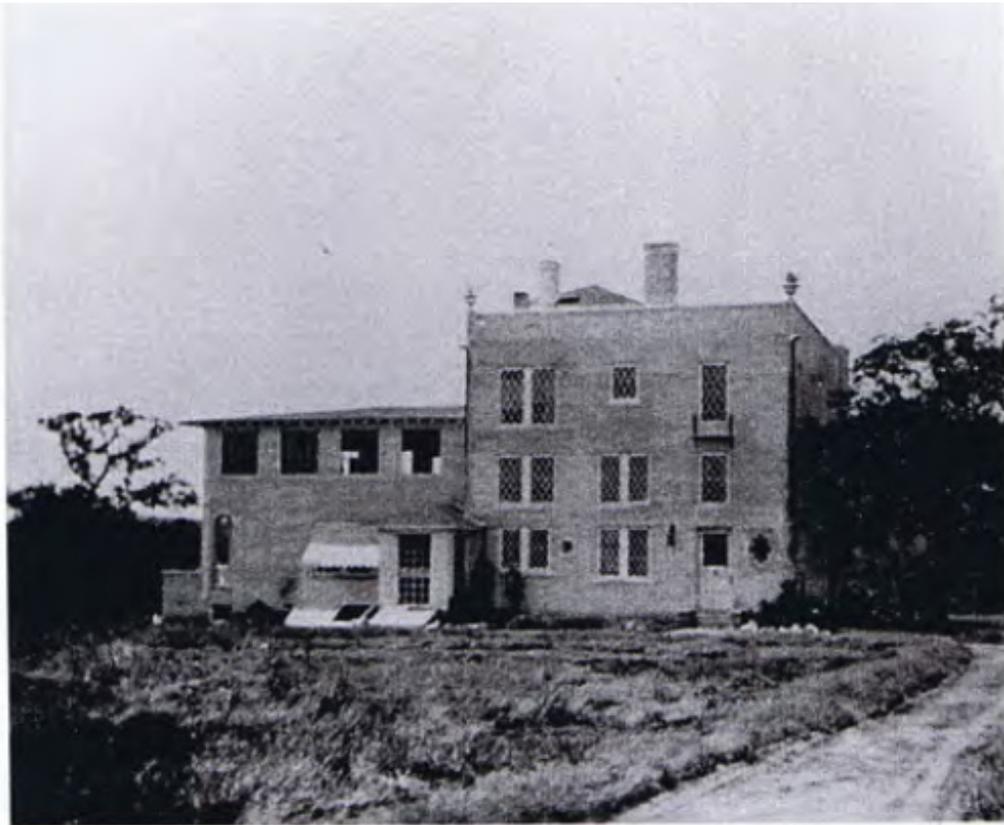
Photo 3.14 View of Oval Drive, c. 1919

- Drive was crushed stone or gravel during Driscoll Period of Significance (1915-1938)
- The original width was that of a carriage drive (approx. 11 ft wide)
- The oval has been modified several times and has been paved in asphalt to accommodate parking

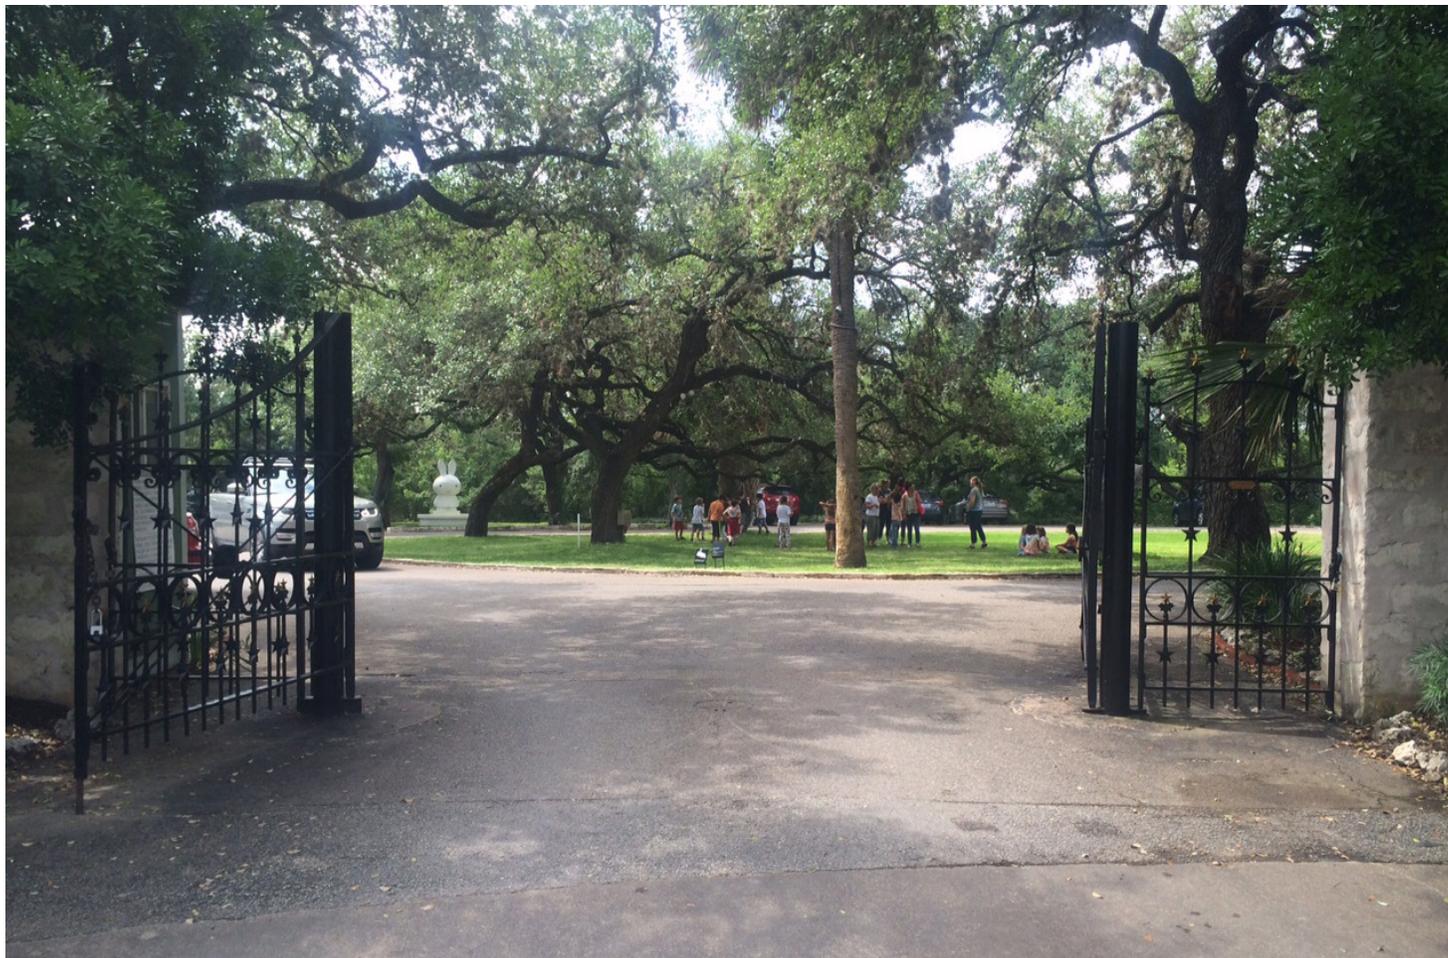
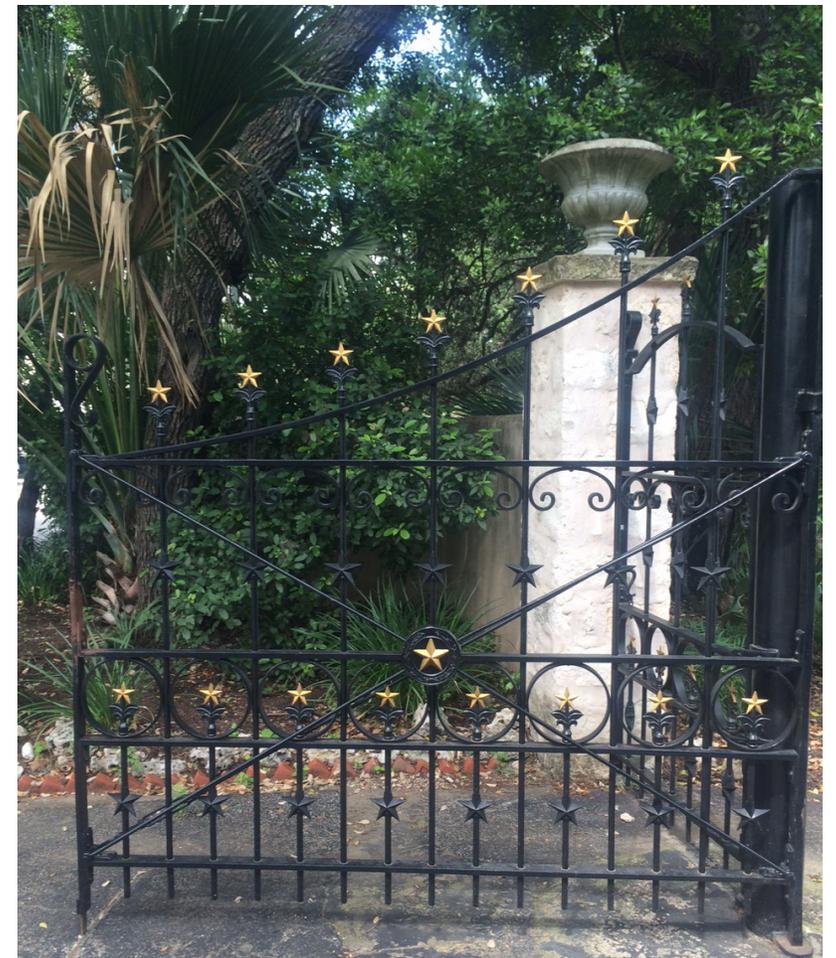
EXISTING CONDITION - GATES

- “The overall layout of the main entrance at 35th St. has changed significantly since the historic period. The walls have been reconfigured to accommodate a cul-de-sac turn-around with sidewalks.”
- “It is recommended that the gates that are currently located at the front entrance be returned to their historic location at the end of the Path to the Point.”

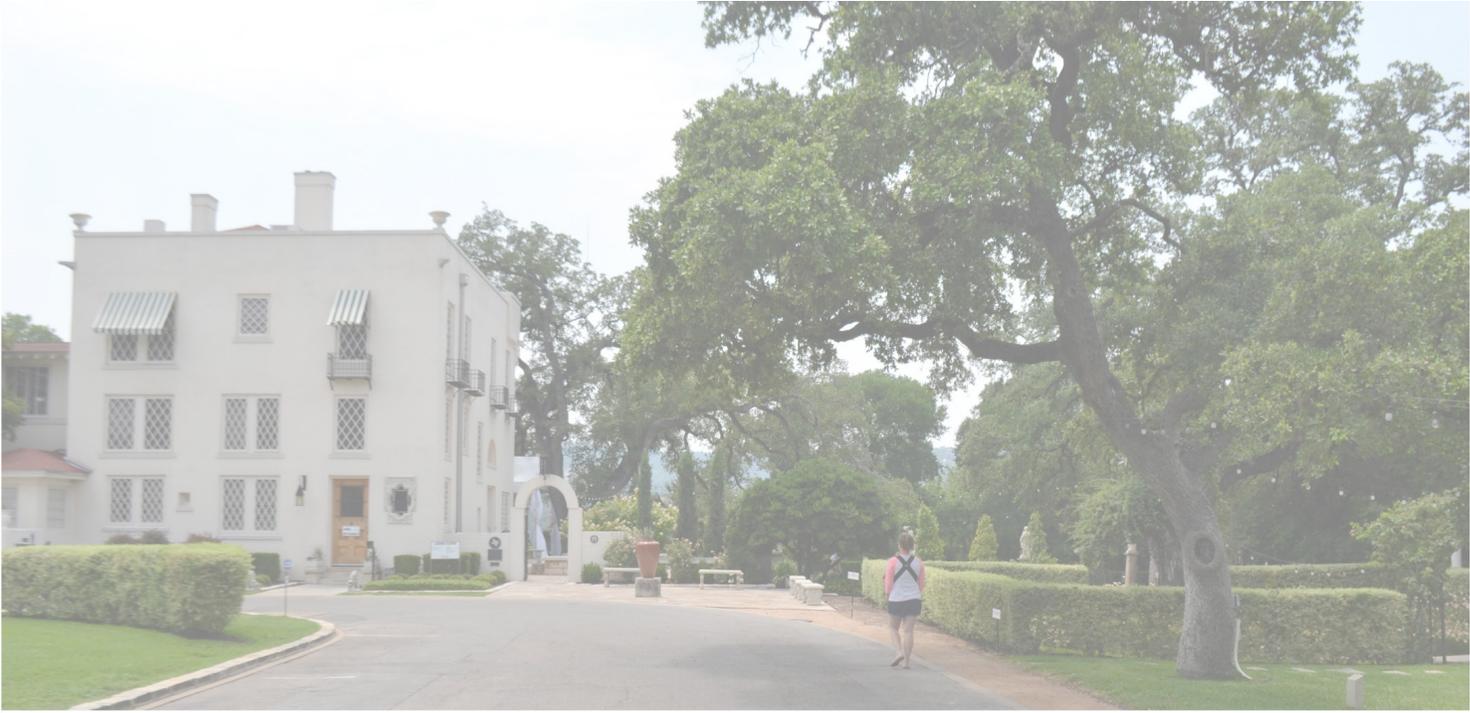
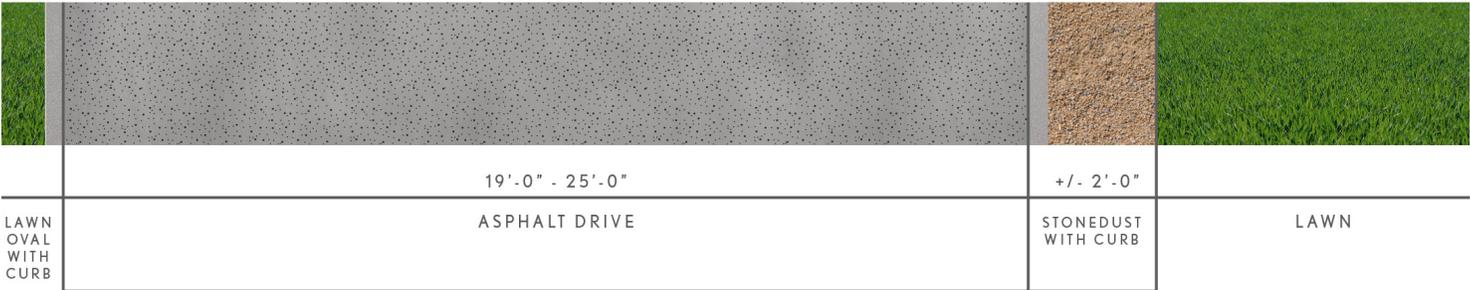
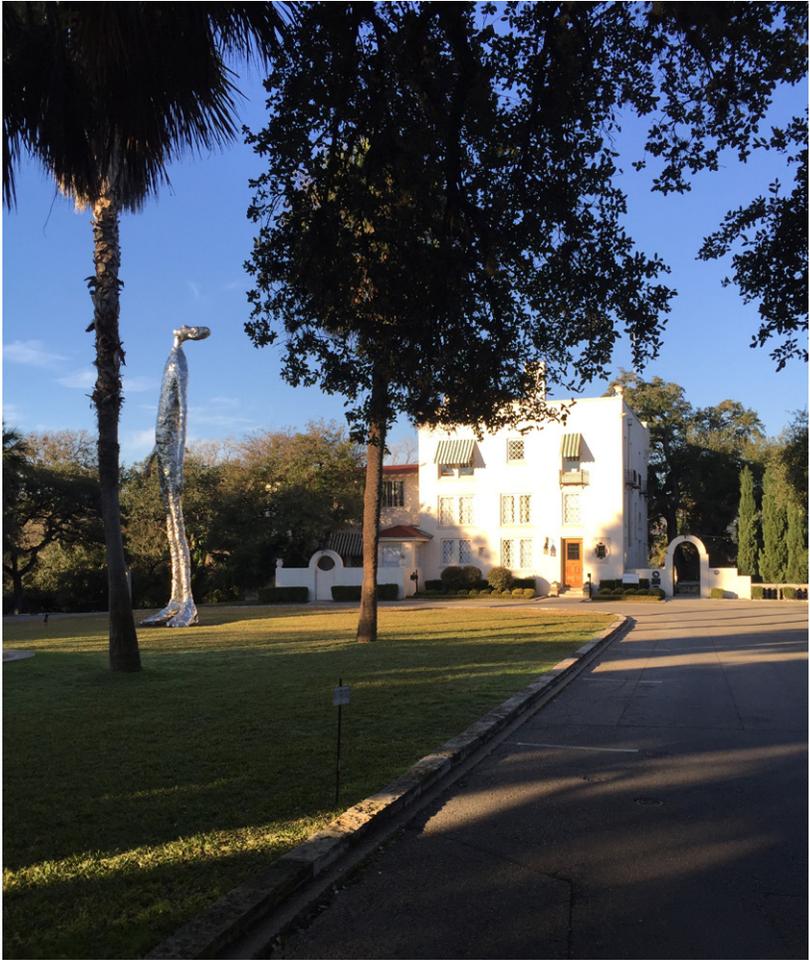
EXISTING CONDITION - OVAL

- “...considerations include reduce the scale of the driveway to its historic width, removing the asphalt, and replacing it with crushed stone to match the historic condition.”

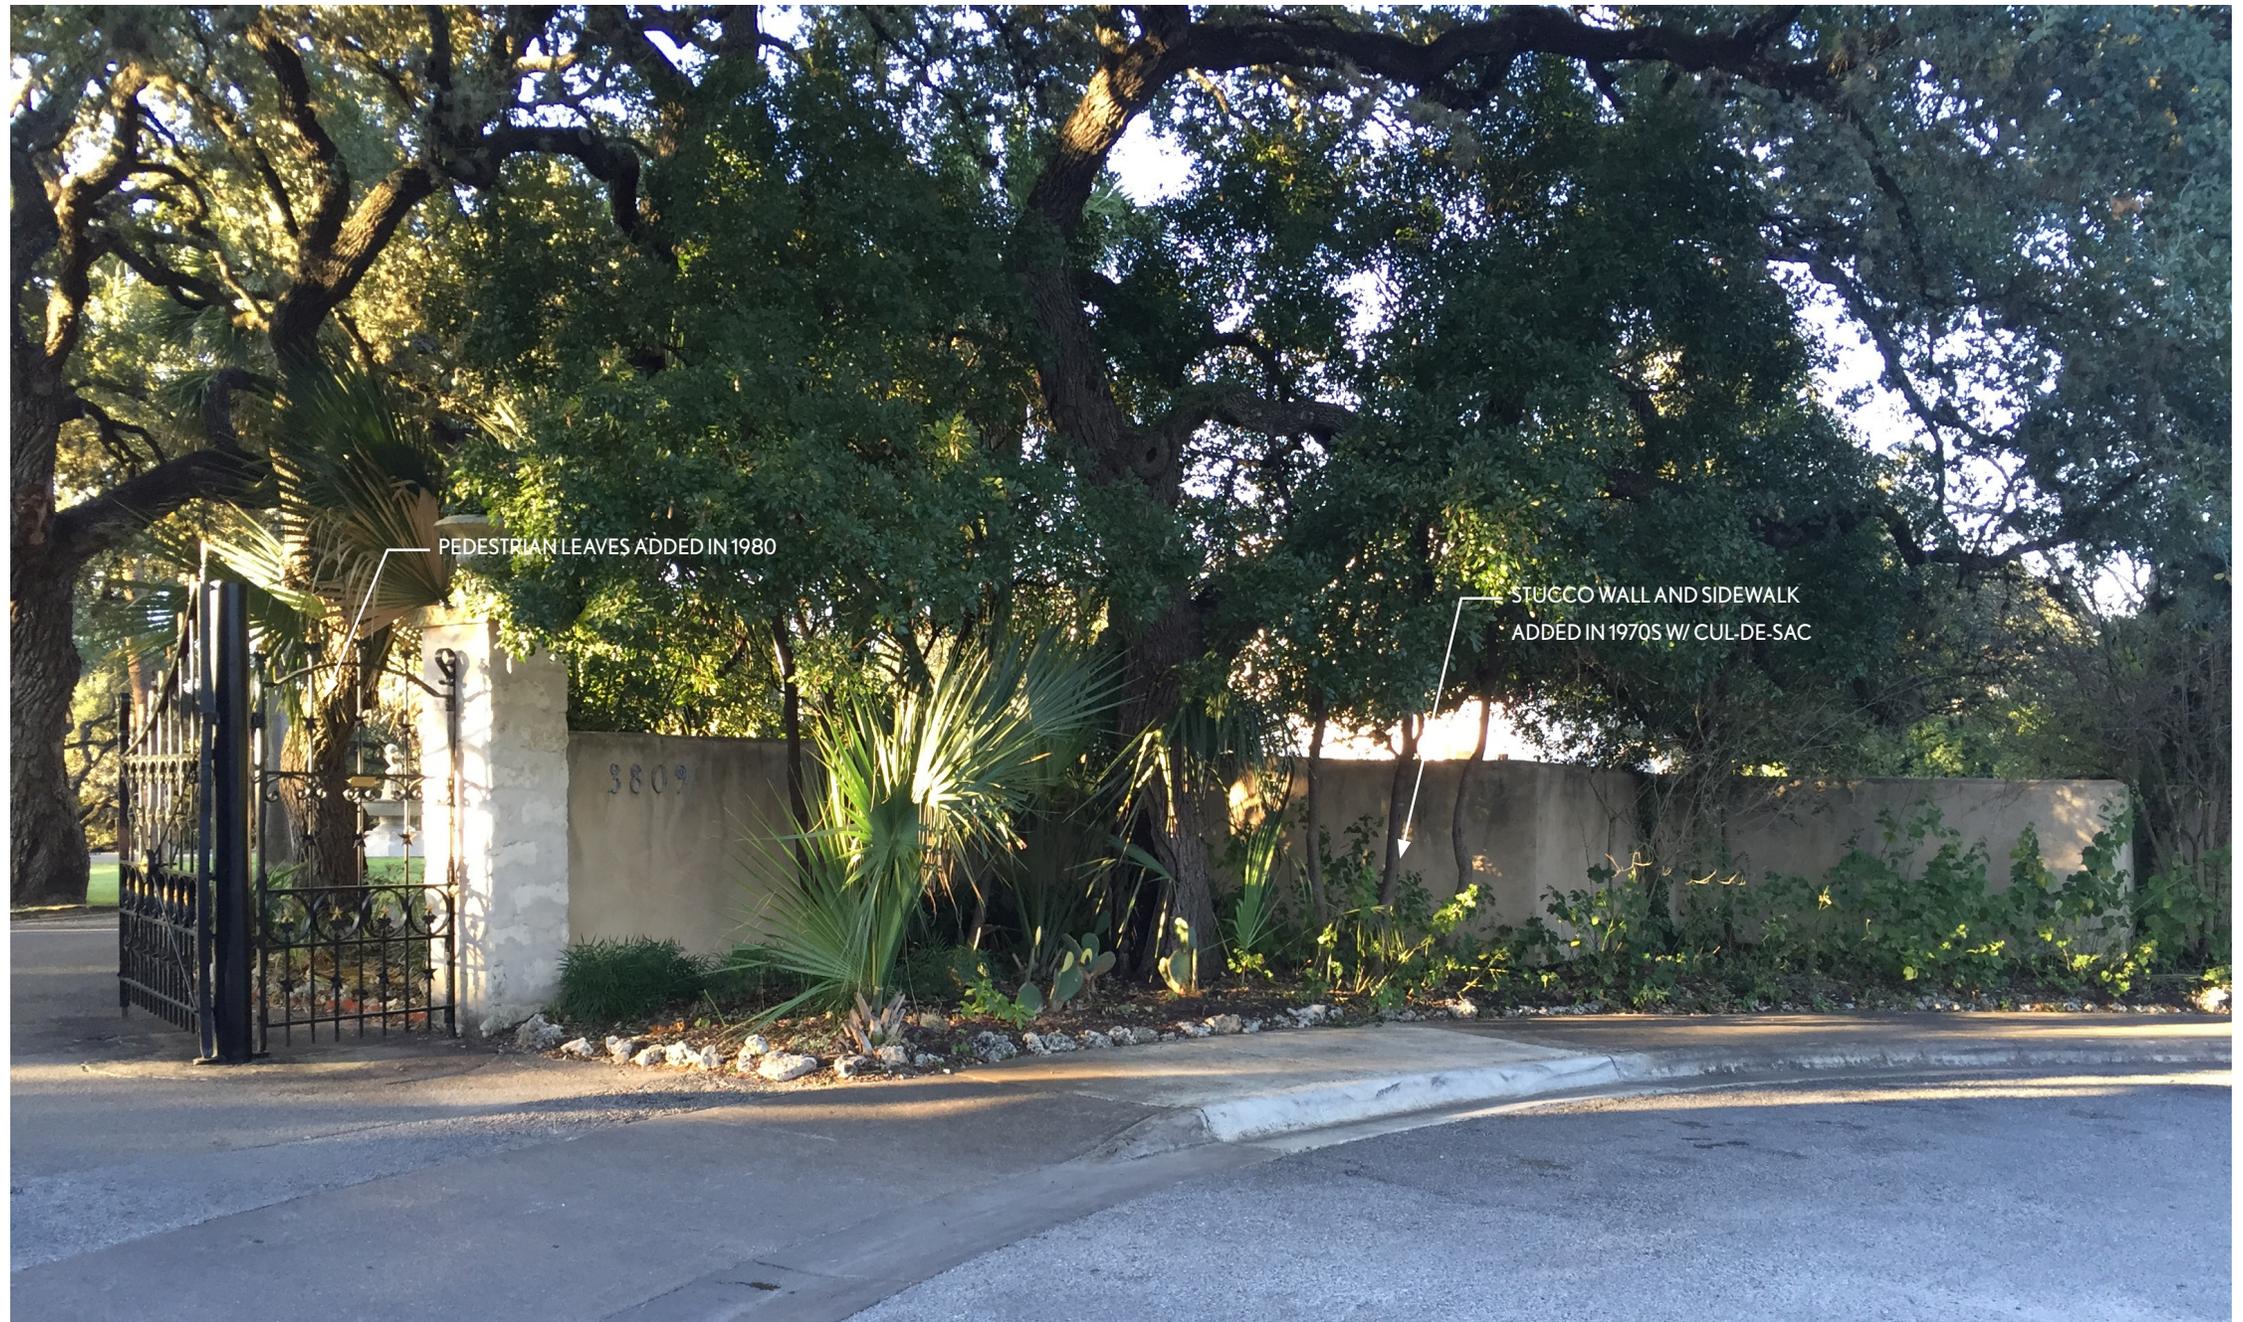
View at Entry Gate

Existing Condition - Before

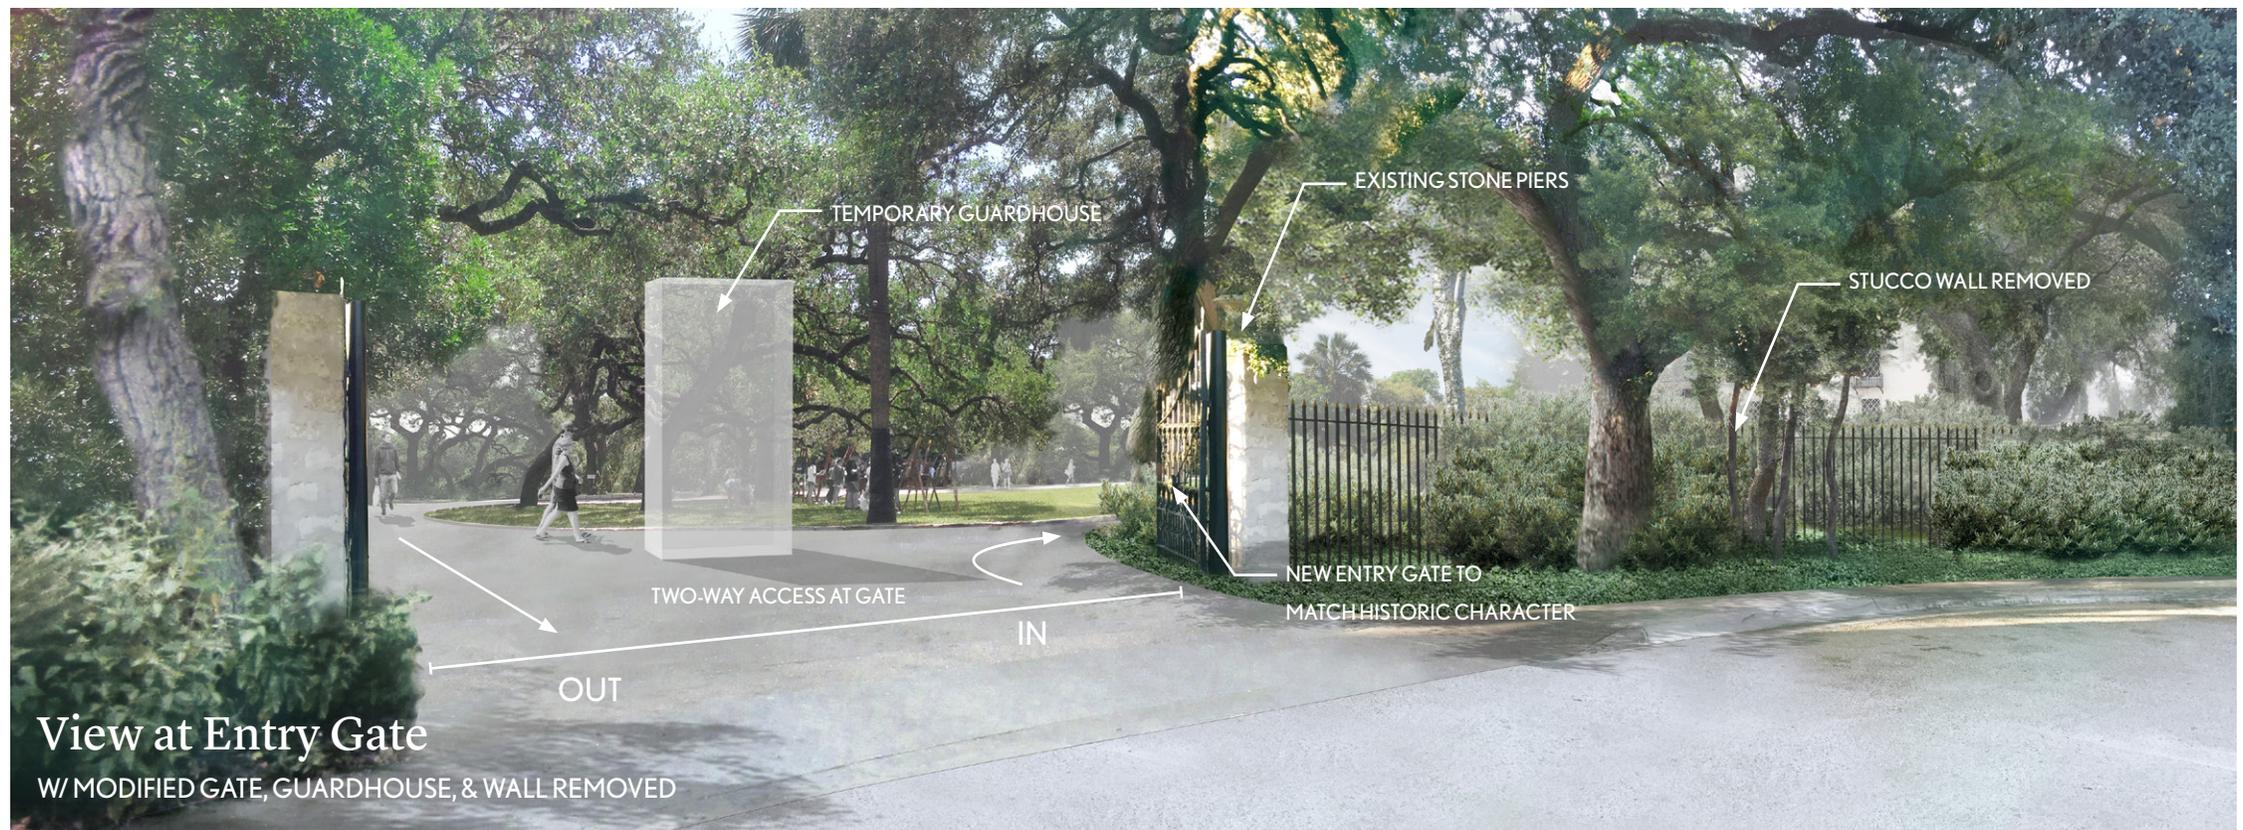
Entry Gate and Exterior Wall - Initial Phase of Rehabilitation

- Existing 35th St. gates to be “rehabilitated” to existing condition and relocated to the Temple of Love
- Existing stone gate piers to remain intact - any structural repair to be completed as part of “rehabilitation” according to historic character and appearance
- New front entry gates to be fabricated to replicate character and materiality consistent with original historic entry gates; “rehabilitated” to accommodate contemporary use - the gates will allow two-cars to pass through with the incorporation of a temporary guard house building to facilitate one-way traffic and increase safety in the historic zone
- Stucco wall to be removed

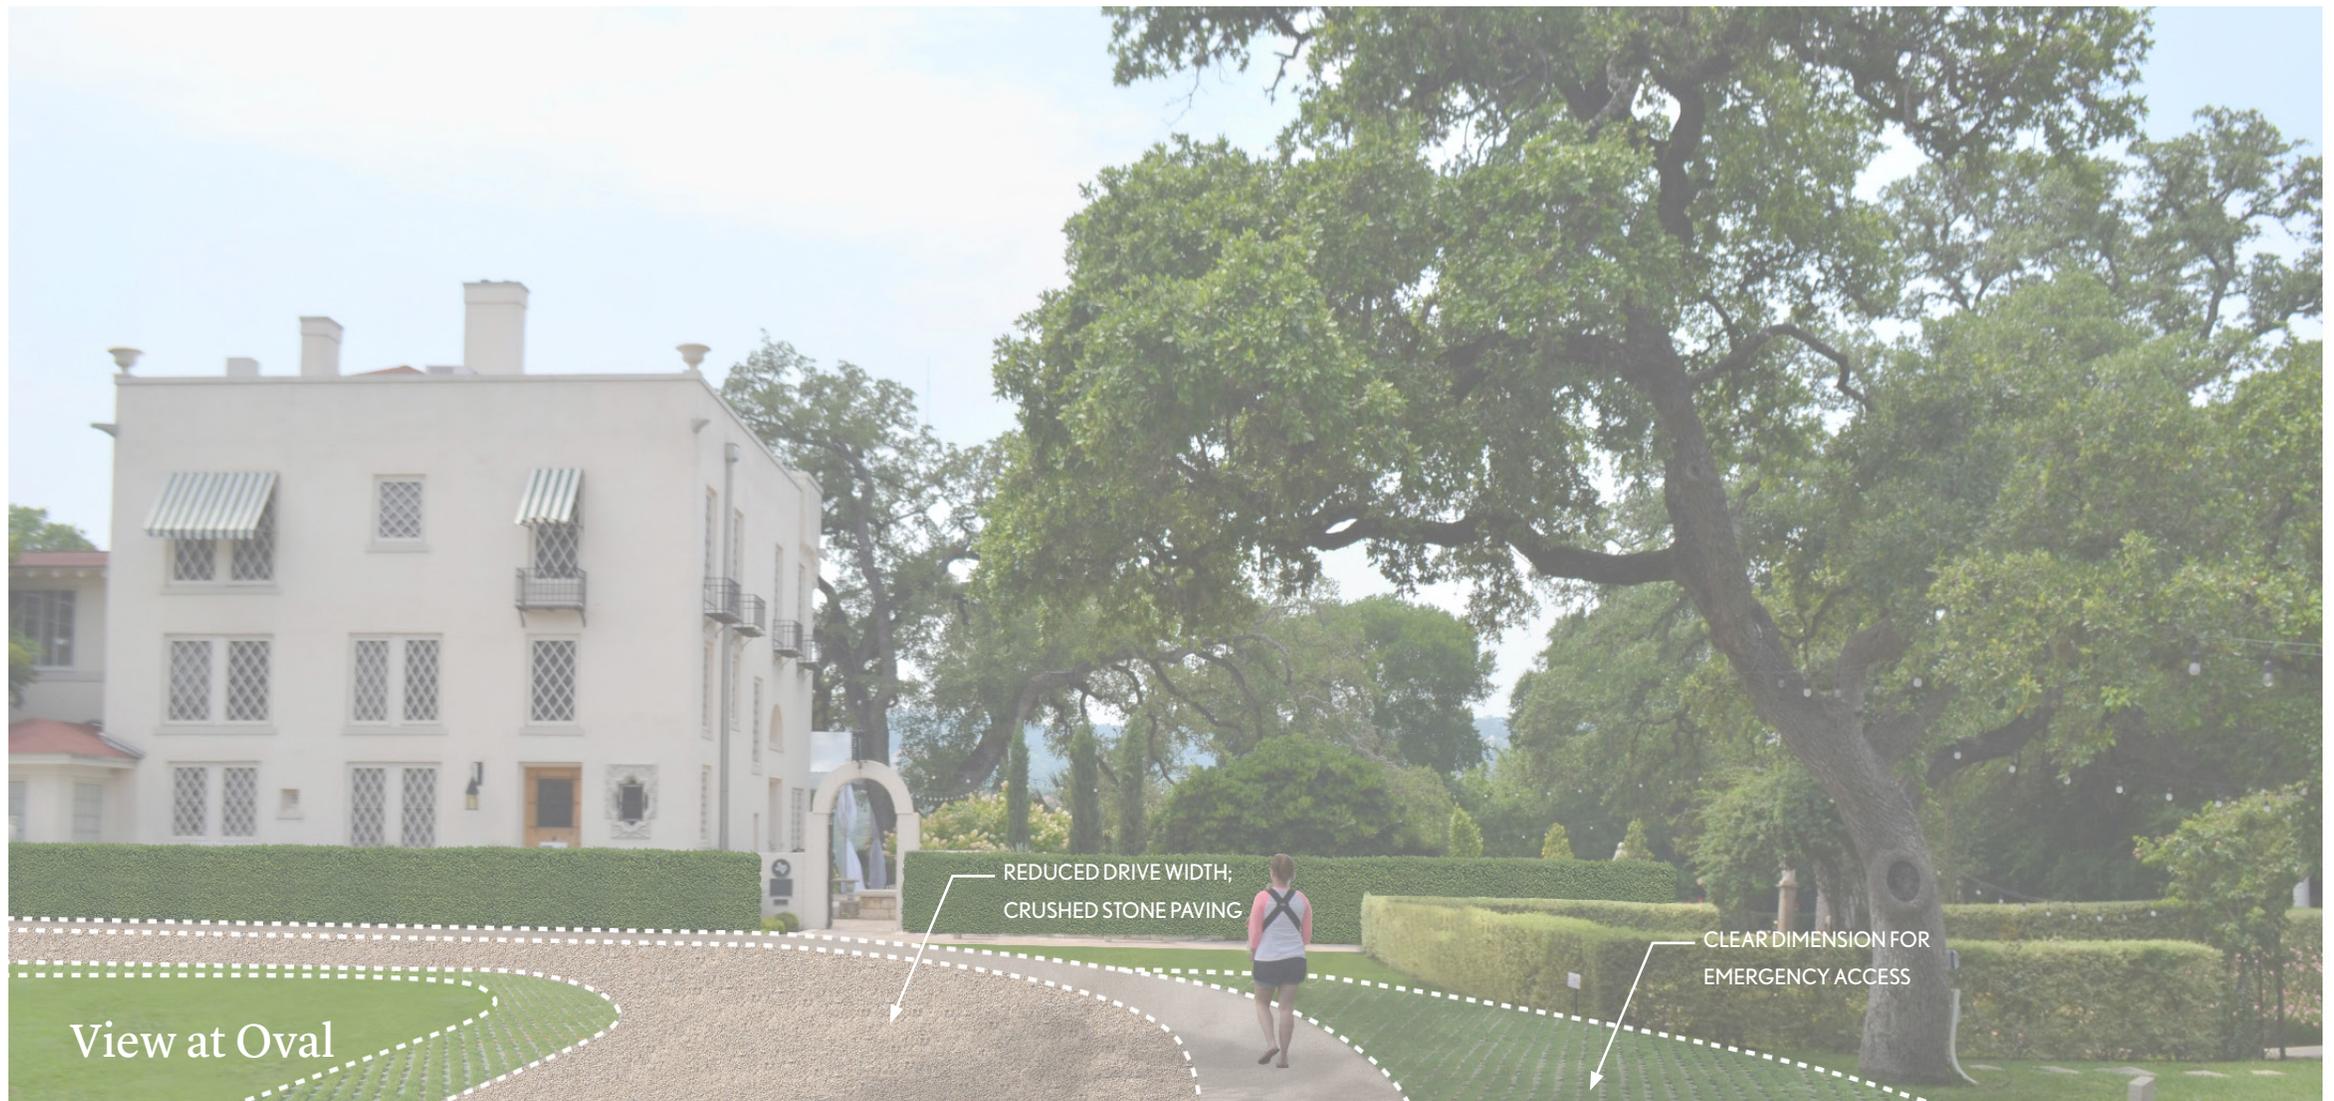
Oval Drive - Initial Phase of Rehabilitation

- Oval width to be reduced to match historic character for partial length
- Asphalt to be removed and replaced with crushed stone to match historic character for partial length
- Traffic circulation to be controlled by temporary guardhouse and reduced to one-way loop
