Natural Area Management Guidelines

Management Units

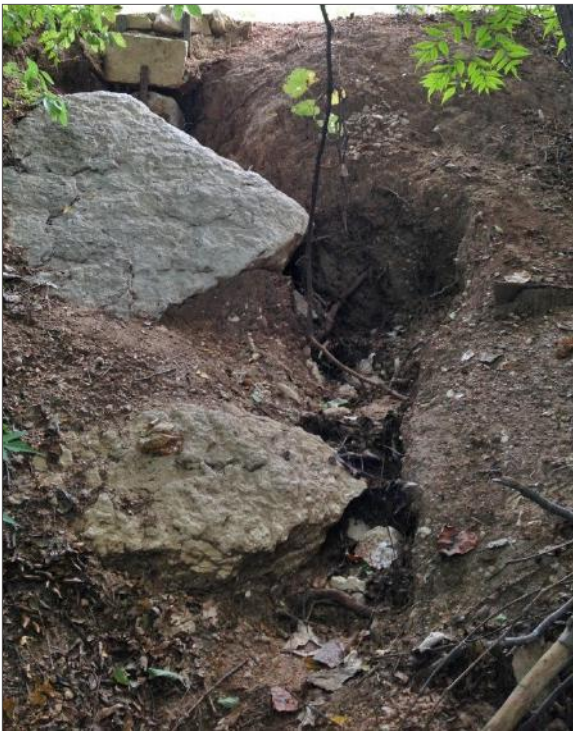
Figure 2.54: Gully erosion is a more advanced stage of rill erosion.

Gully erosion is a more advanced stage of rill erosion in which the incisions are 1 ft deep or more (Figure 2.54). It occurs most often in areas with long, steep slopes. Gullies that have not been armored or stabilized pose a threat to the Trail as they may eventually intercept and damage it.

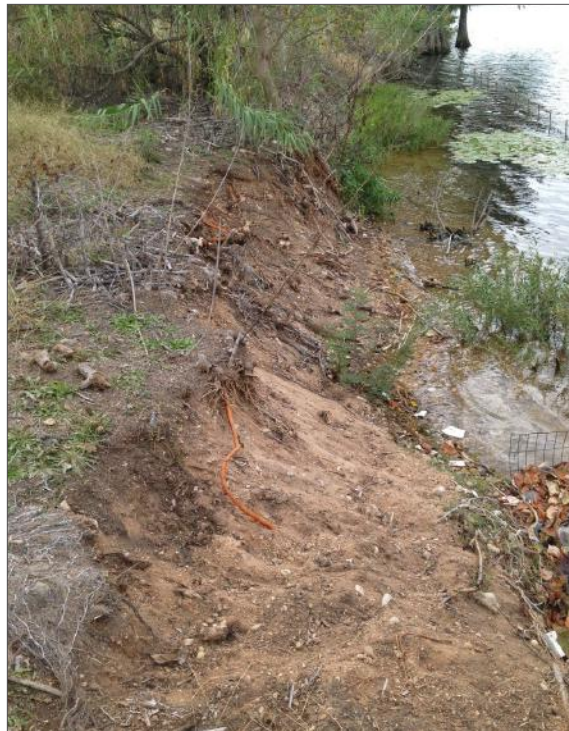
Figure 2.55: Bank erosion often occurs where giant reed has been removed, such as this area near Longhorn Dam.

as downpours. Waller Creek exhibits the greatest amount of streambank erosion. Plans are currently underway to address Waller's erosion issues. Recent restoration work at Shoal Creek has mitigated some of the bank erosion. Minor lakeshore erosion is taking place in many places along Lady Bird Lake, particularly in areas where giant reed has been treated, as shown in Figure 2.55.

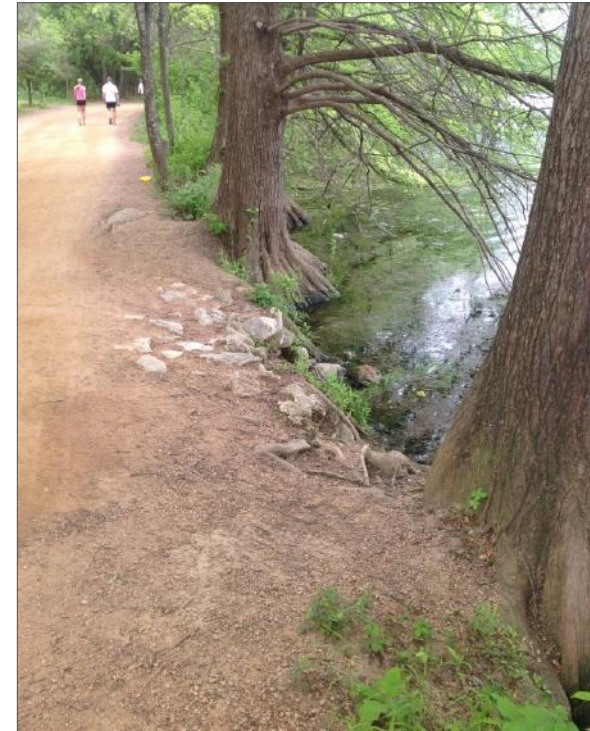
Figure 2.56: Decomposed granite is sloughing off the Trail directly into the Lake.

A tremendous volume of decomposed granite is leaving the Trail and entering the natural areas or the Lake itself (Figure 2.56). This material can bury

the native herbaceous plants and soil, making the soil more susceptible to future erosion and lowering the quality of the natural area. Examples of deposition occur throughout the study area, but are most evident where the Trail is close to the Lake on the north shore near Austin High, at Festival Beach, just east of Congress Avenue on the south shore, and at the water access points between Barton Creek and the Lamar Bridge. Some of the steep slopes on the northern edge of Zilker Park are also being impacted by this process.

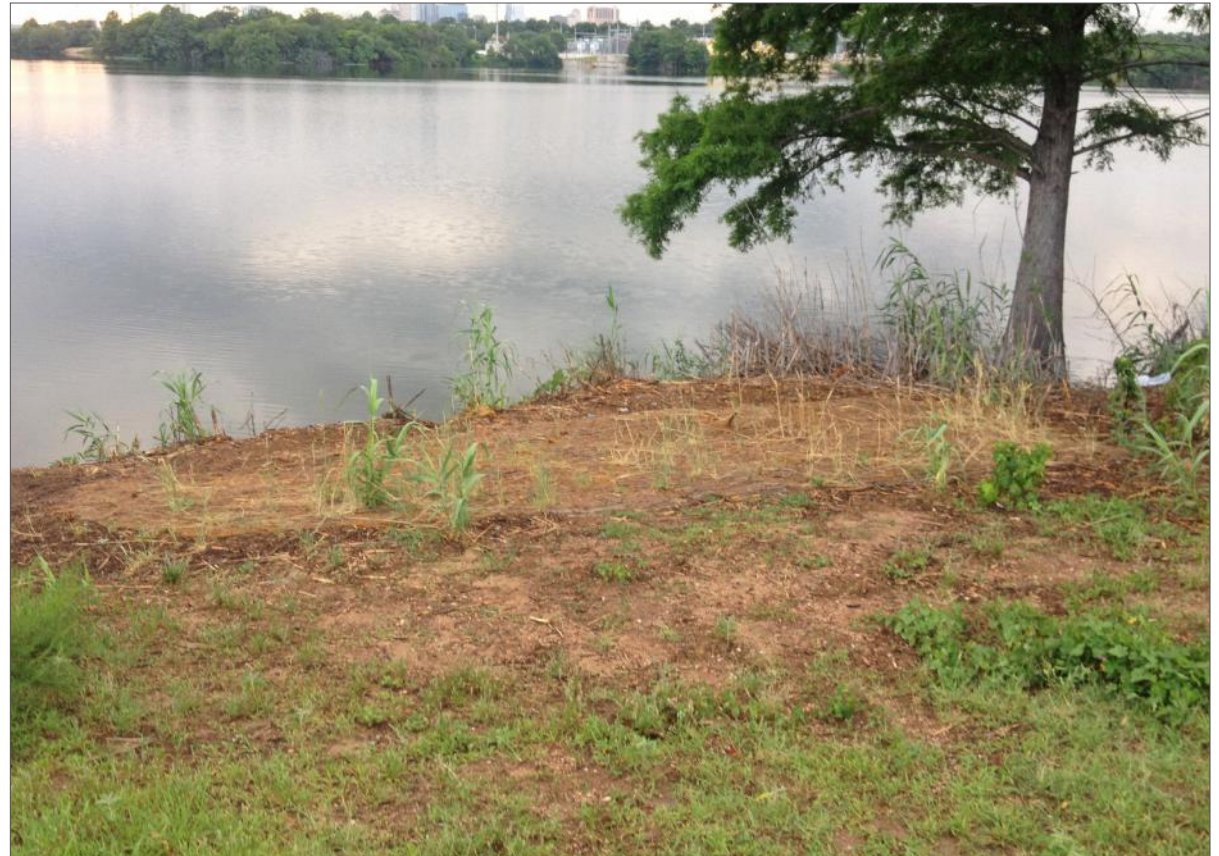
Figure 3.3: Giant reed resprouting after treatment.

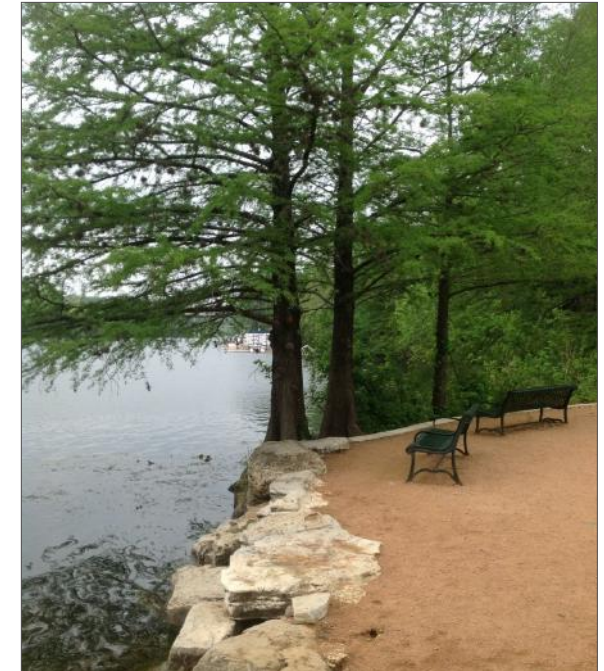
Figure 3.4: Formal water access areas, like the "Northshore Overlook" installed by The Trail Foundation in 2006, allow visitors to engage with the water without causing damage to the sensitive lakeshore.

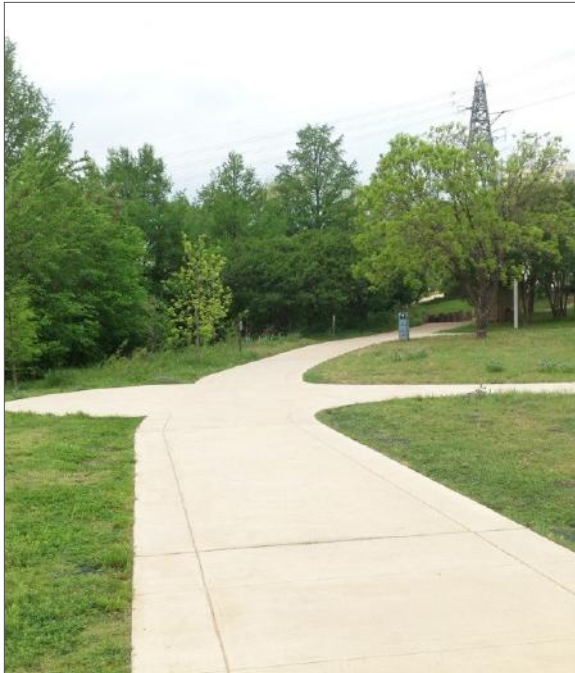
Figure 3.5: In areas where the Trail cannot be moved away from the shore, such as the Shoal Creek peninsula, the surface should be stabilized by paving or other means.

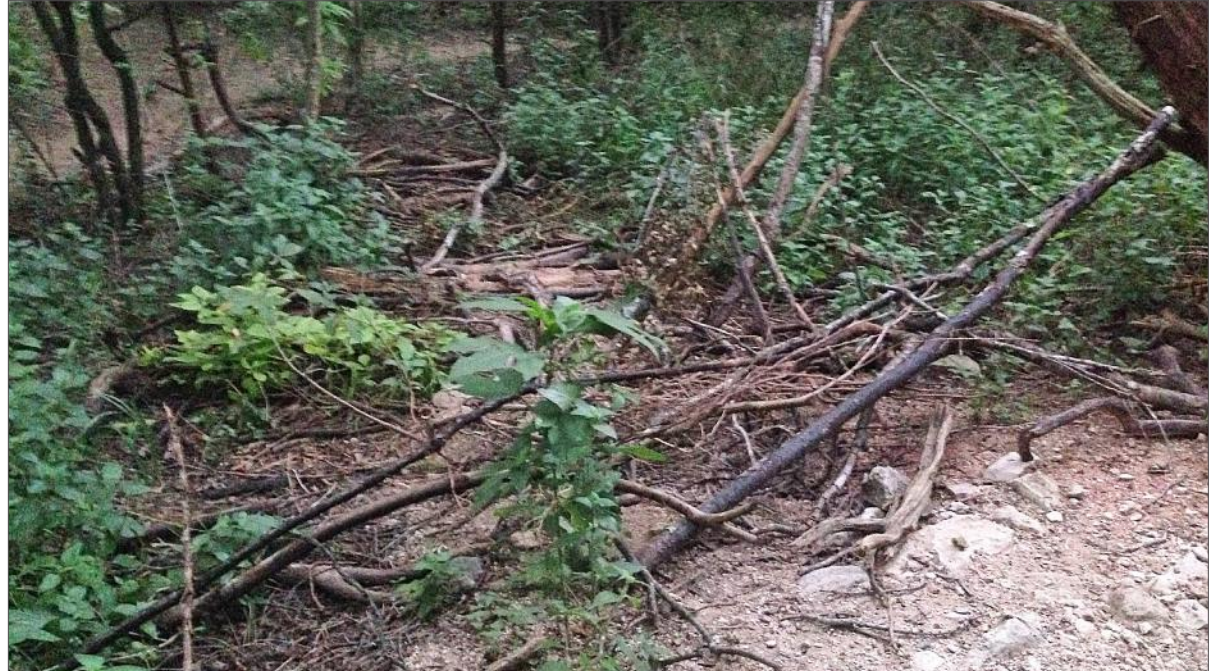
Figure 3.6: Brushing, as seen here on the Barton Creek Greenbelt, is an effective way to deter informal trail use.

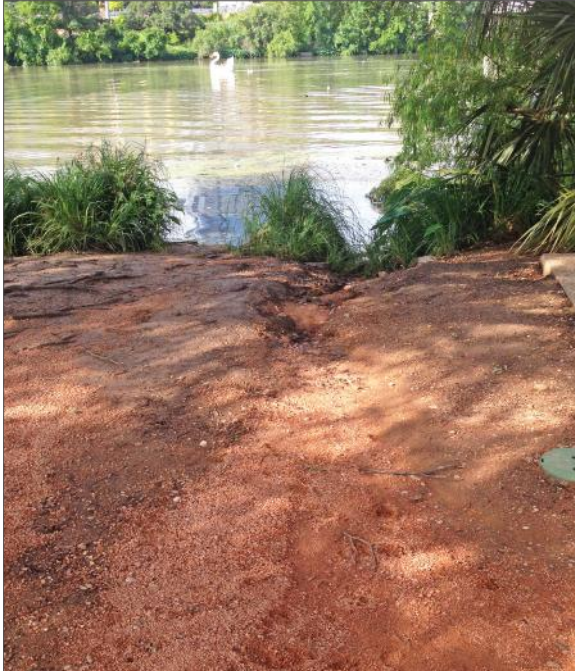
Figure 3.7: Runoff from infrastructure is causing rill erosion and erosion of trail material at Auditorium Shores.

are caused by culvert discharges onto steep slopes. In these areas, water-dispersing armoring should be installed where feasible. A variety of materials may be used to disperse the water, including rip-rap, concrete, loose stones, and limestone block gabions. Native rock is the preferred material.

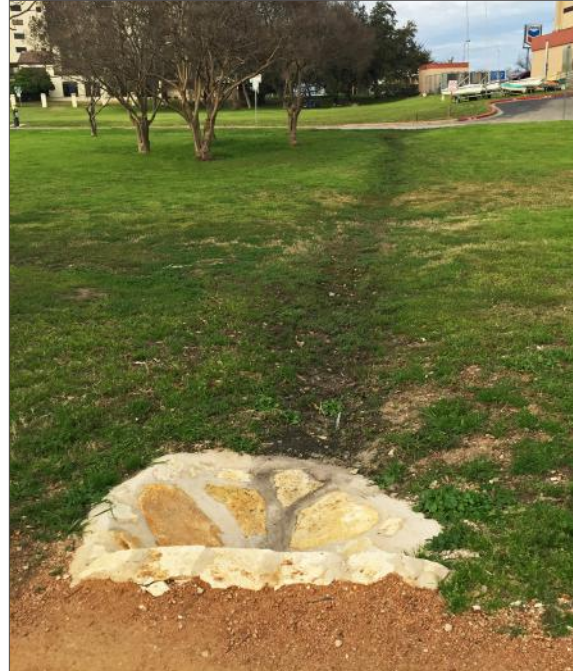
Figure 3.8: One of the locations where creation of streamlets is recommended in the Rainey management unit.

Stormwater moving across the study area at regular intervals, when accommodated, is a useful resource. The recommendations above address areas where it is not currently being accommodated. In a few instances, it is possible to utilize the existing erosion channel to create a streamlet within the study area. A streamlet is simply a small drainage channel. Where they occur naturally in central Texas, they are filled with plants that do not require consistently wet soils but thrive in seasonally wetter soils, such as Lindheimer's muhly and seep muhly. Formalizing the existing channels by reinforcing the erosion bed with rock and gravel, planting appropriate plants, and reducing mowing frequencies to once a year or less will prevent erosion issues, accommodate the water flow, and create a more dynamic environment in the natural areas. There are two sites near Rainey Street (one is shown in Figure 3.8) and two sites in Festival Beach where this technique is recommended, as discussed in the Management Units chapter.

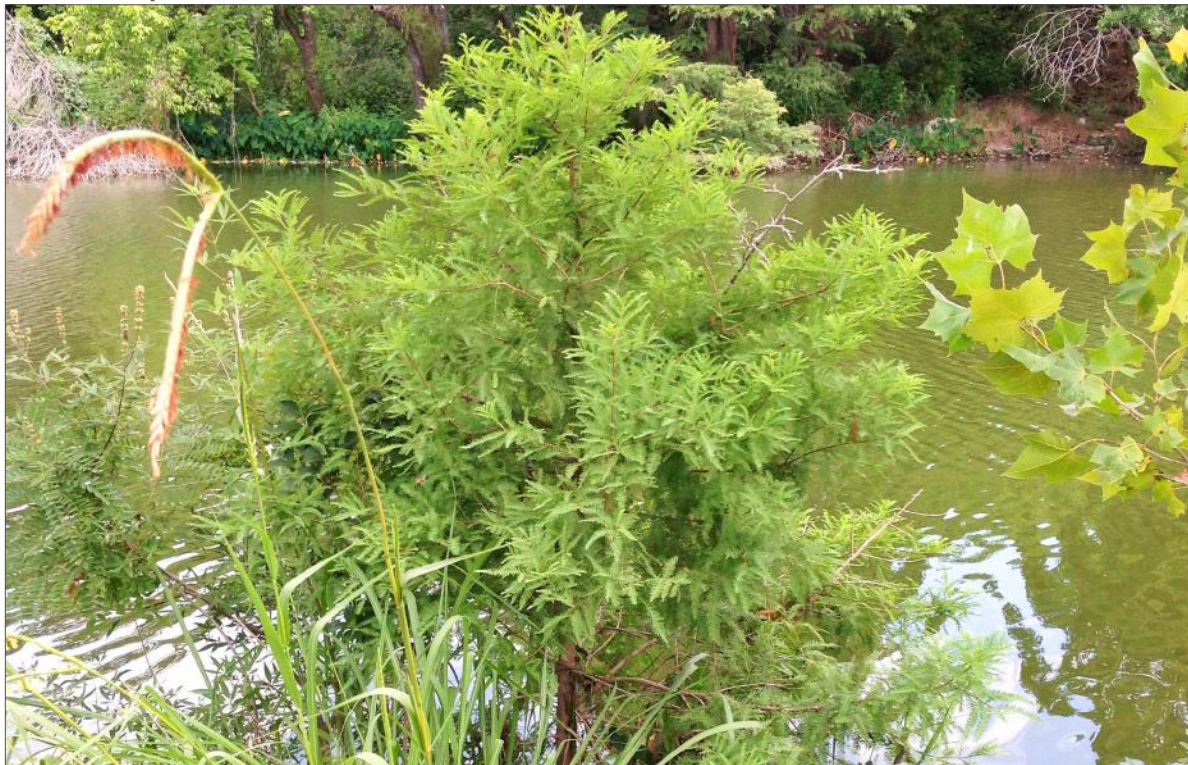
Figure 3.10: Planting shoreline species like bald cypress and eastern gamagrass close to the water will greatly increase the likelihood of restoration success.

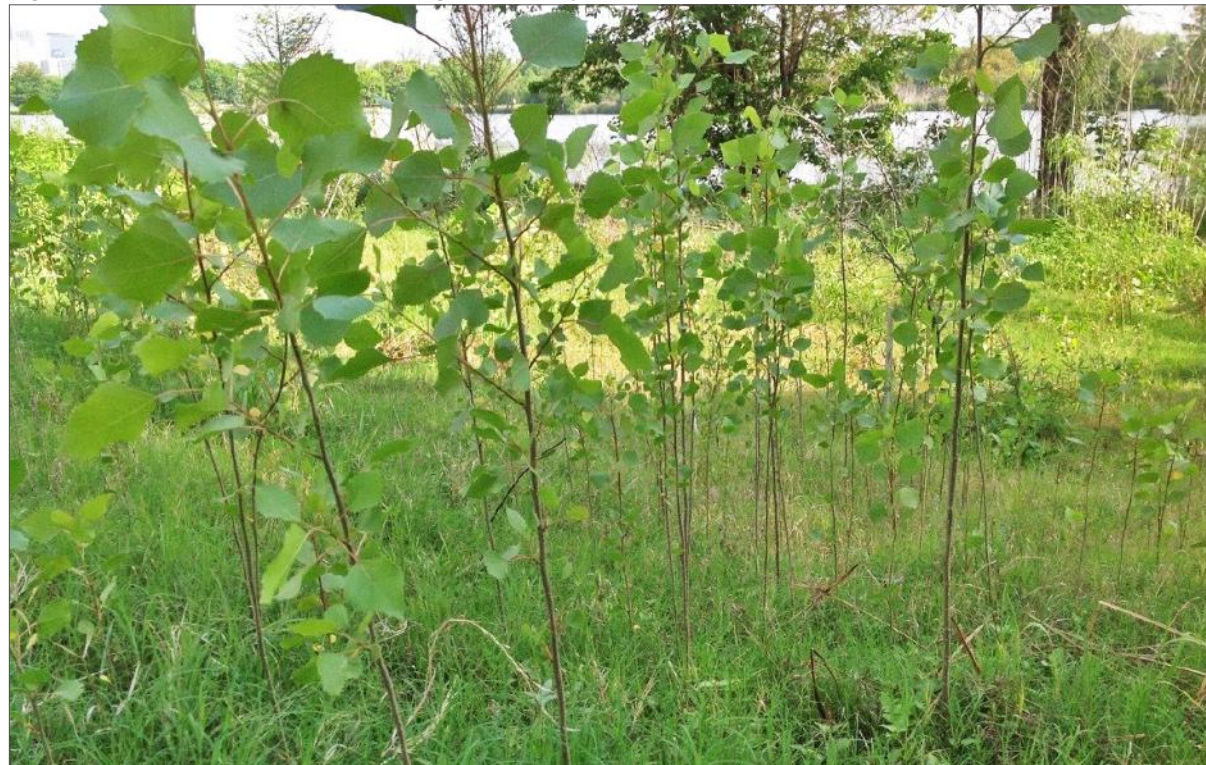
Figure 3.11: Abundant cottonwood seedlings in a recently converted Grow Zone in the Southeast Shore.

This expansion will begin to naturally happen through regeneration (as seen in Figure 3.11) in areas designated as Grow Zone—which we suggest should include all areas recommended for woodland enhancement, woodland expansion, or savanna restoration in Figure 3.9. The simple act of changing visitor use patterns and mowing regimes will create new woodlands, though some maintenance will be needed to ensure that the regenerating species are desirable.

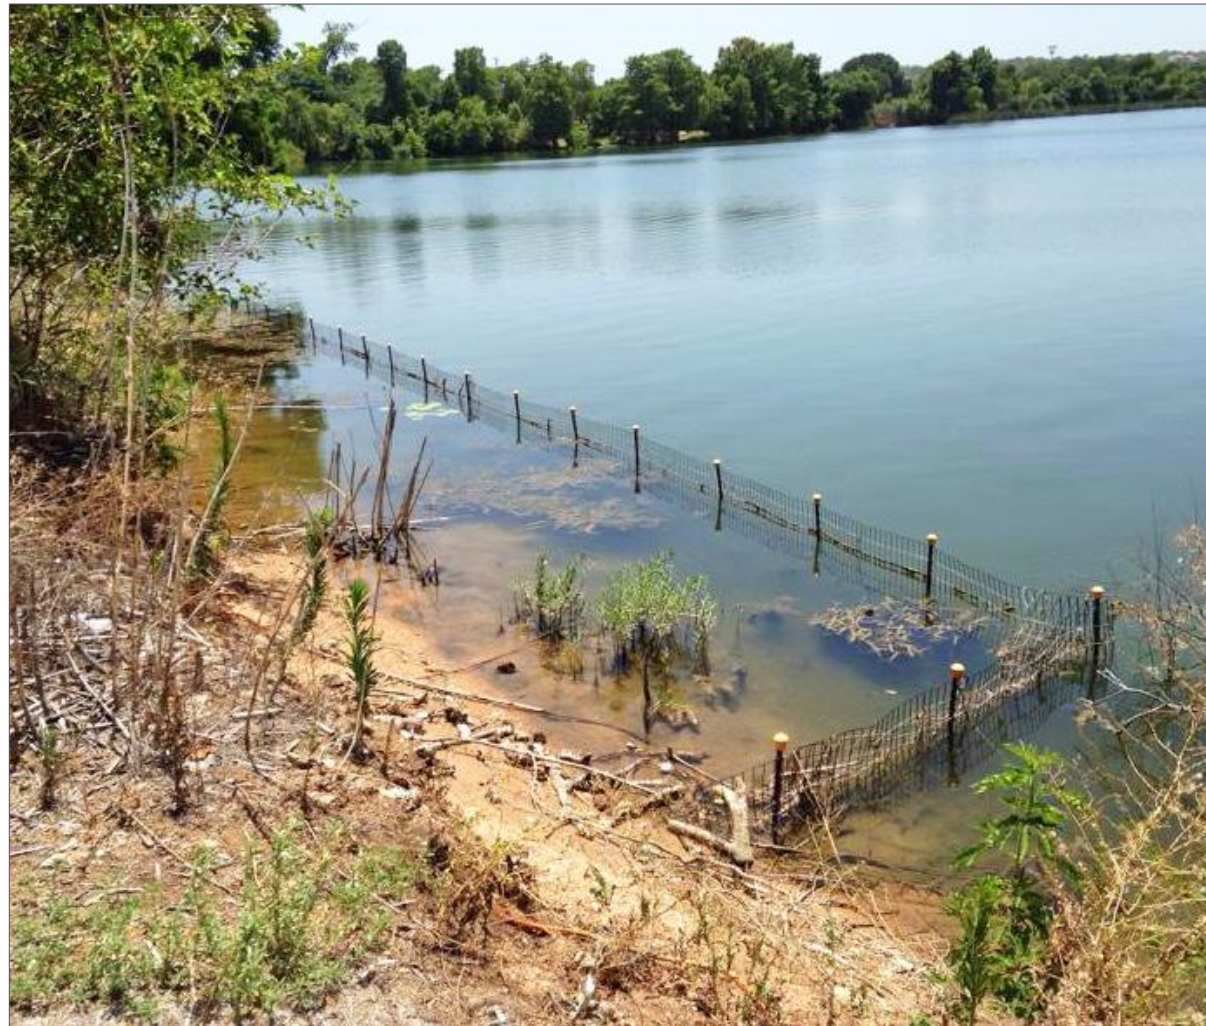
Figure 3.12: Exclosures are recommended for some aquatic plantings to protect against herbivory.

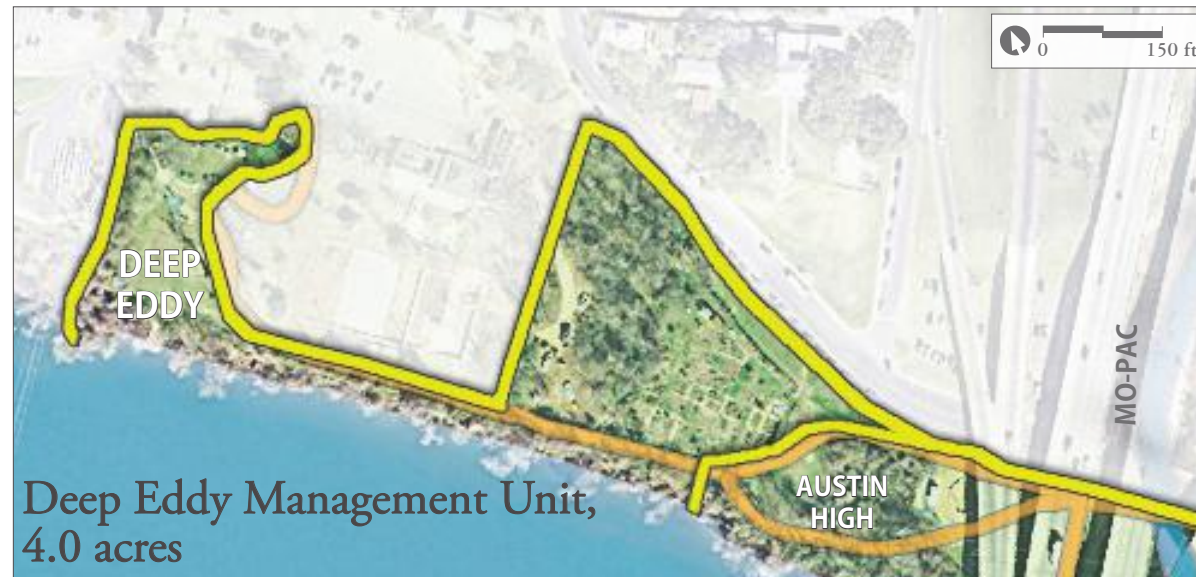
Figure 4.3: Deep Eddy Management Unit boundaries. Sources: COA, NAIP

The Deep Eddy Unit consists of the western portion of Eilers Park (the eastern portion of which contains Deep Eddy pool) and woodland areas on the western edge of the park and south of Butler Creek Trail (Figure 4.3). The unit also includes a woodland area east of Eilers Park that is fenced off and a community garden, neither of which were included in the description and recommendations below. Recommendations are made for 1.3 acres of the 4-acre unit (Figure 4.5).

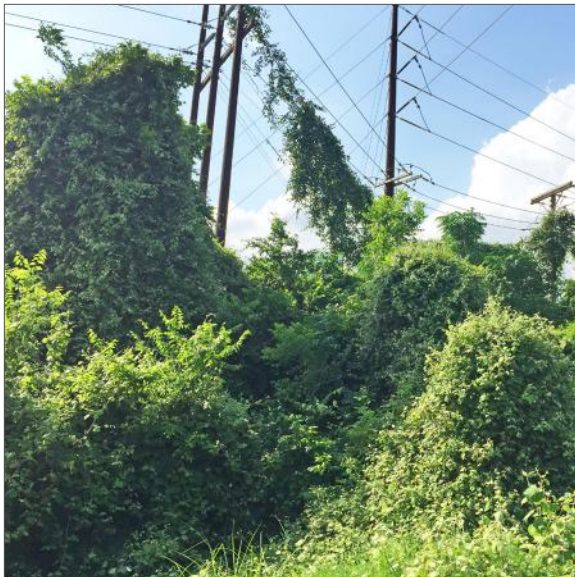
Figure 4.4 (Left): Abundant vines cover much of the Deep Eddy Unit. Figure 4.5 (Below): Invasive species, erosion issues, and recommended restoration work in the Deep Eddy Unit. Sources: COA, NAIP.

land include sugar hackberry, pecan, American elm, and Chinaberry. Chinese tallow, black willow, and bald cypress are common along the shore. It is not a very dense shoreline woodland, with fewer than 5 trees per 100 ft of shoreline. The woodland is dominated by small trees, with only 6 protected trees in the woodland. The understory consists primarily of cherry laurel, along with white mulberry and Texas redbud along the Trail. There are also substantial patches of American elm regeneration. The slope from the Trail to the Lake is relatively steep. The most distinguishing feature of this management unit is the proliferation of vines that cover much of the natural area. English ivy is an abundant groundcover and many trees and shrubs are shrouded in peppervine, poison ivy, mustang grape, Virginia creeper, and sweet autumn clematis (Figure 4.4). Large metal scraps and the remains of a short

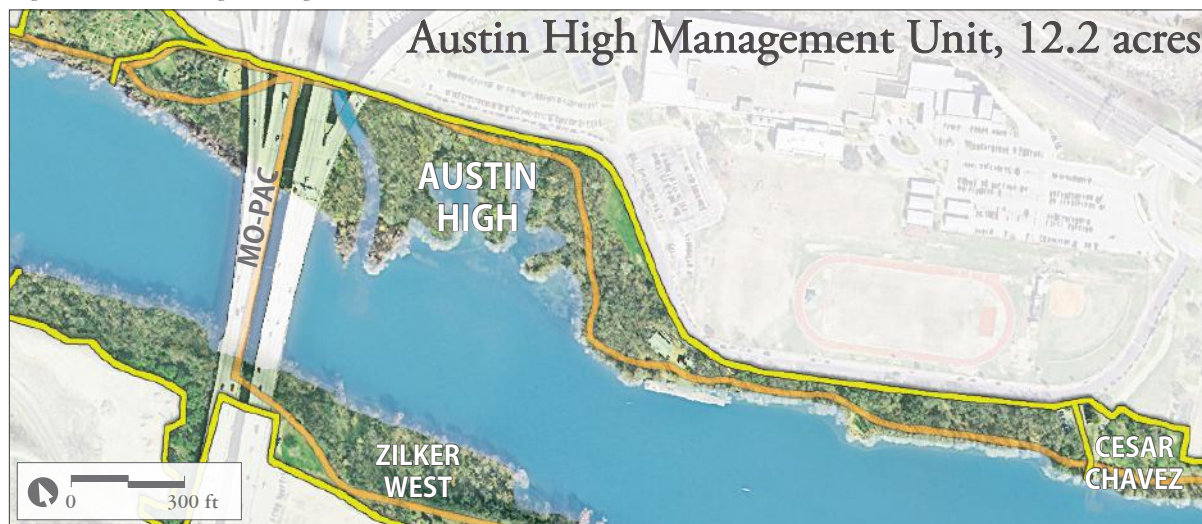
Figure 4.6: Austin High Management Unit boundaries. Sources: COA, NAIP.

The Austin High Unit lies between Veteran's Trail to the north, the community gardens to the west, the Lake to the south, and the boat ramp to the east (Figure 4.6). The far western extent of the unit is part of Eilers Park, but the remainder is part of Lamar Beach at Lady Bird Lake Metro Park. MoPac and Johnson Creek cross the unit, Austin High is just to the north, and there is a rowing facility within the unit. The unit includes 12.2 acres with recommendations here for 10.2 acres and aquatic restoration recommended in an additional 2.8 acres (Figure 4.9).

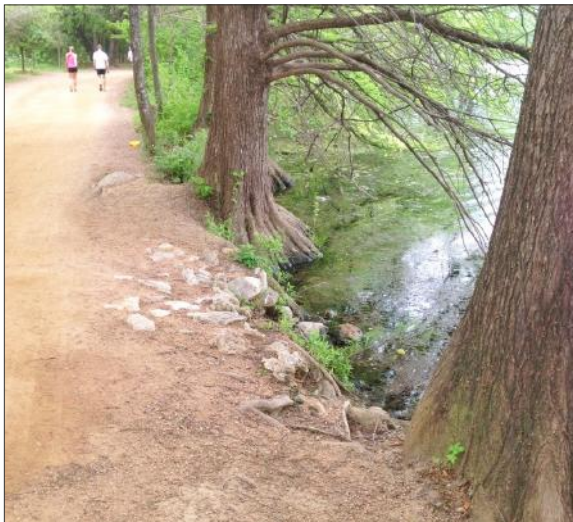
Figure 4.8: Decomposed granite covering riparian vegetation and falling directly into the Lake.

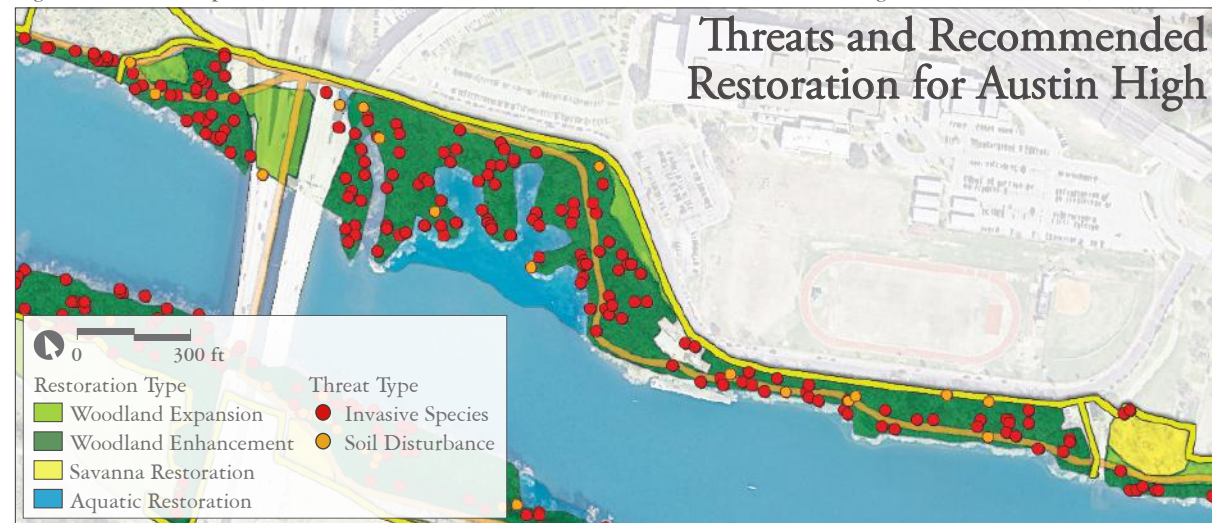
Figure 4.9: Invasive species, erosion issues, and recommended restoration areas in the Austin High Unit. Sources: COA, NAIP.

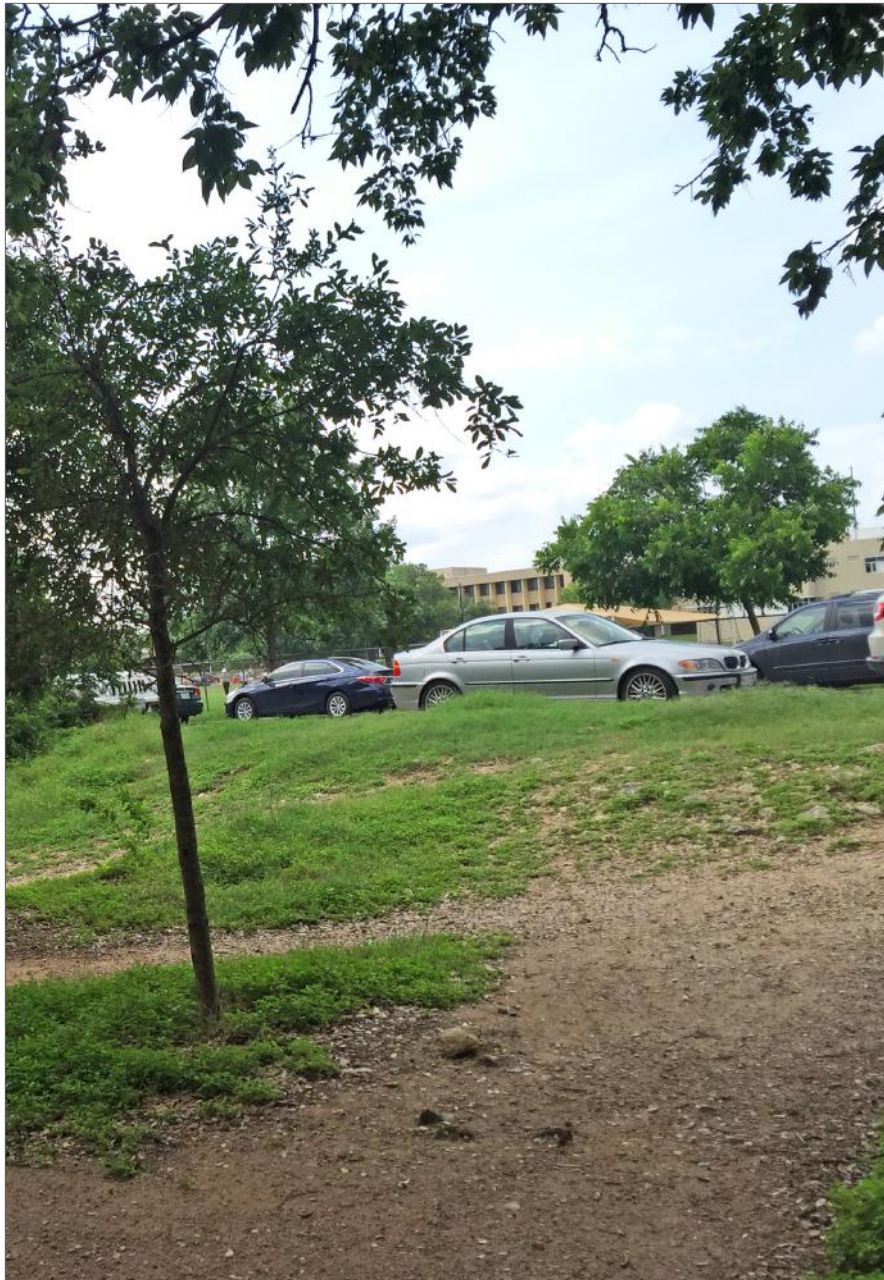
Figure 4.10: One of several of the heavily used informal trails between Veteran's Drive and the Trail.

Several heavily used informal trails connect Veterans Drive to the Trail (Figure 4.10). These trails are quite wide in some areas and have compacted soils. Additional informal trails are found on the peninsulas. One heavily used trail goes to a wooden landing at the water's edge, suggesting that it was at one time a formal trail. Several other more lightly used trails lead farther onto the peninsulas, some leading to trash and debris from former encampments. High water events have also deposited large amounts of trash on the peninsulas and led to bank erosion along Johnson Creek.

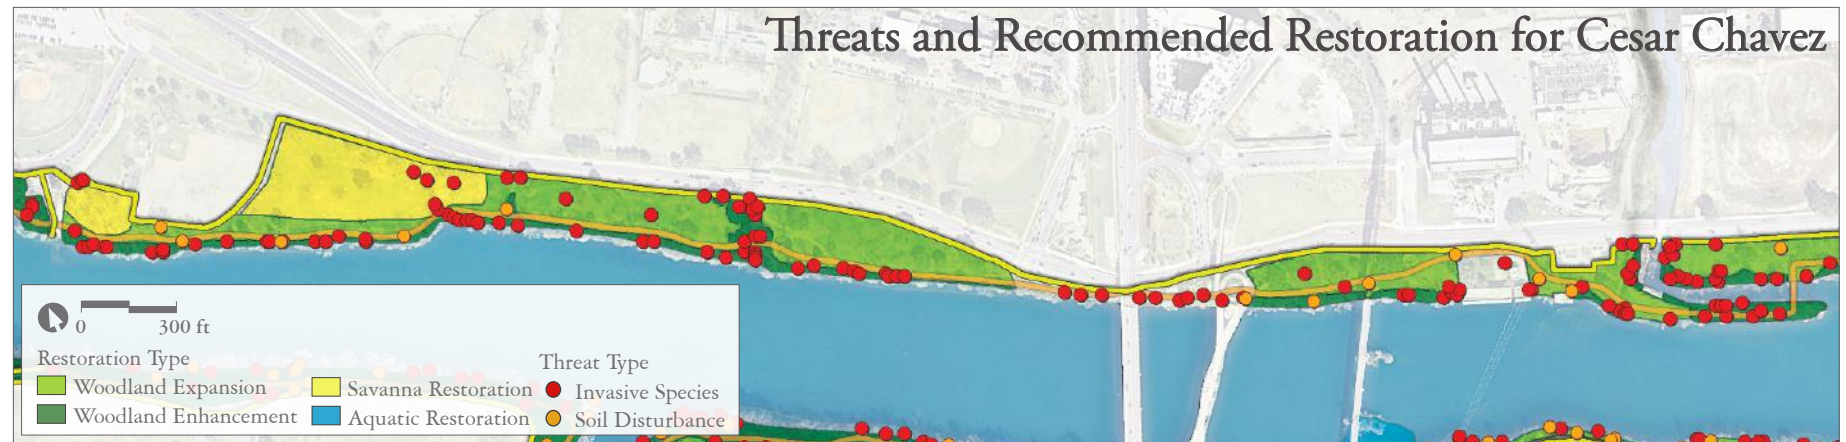
Figure 4.13: Invasive species, erosion issues, and recommended restoration areas in the Cesar Chavez Unit. Sources: COA, NAIP.

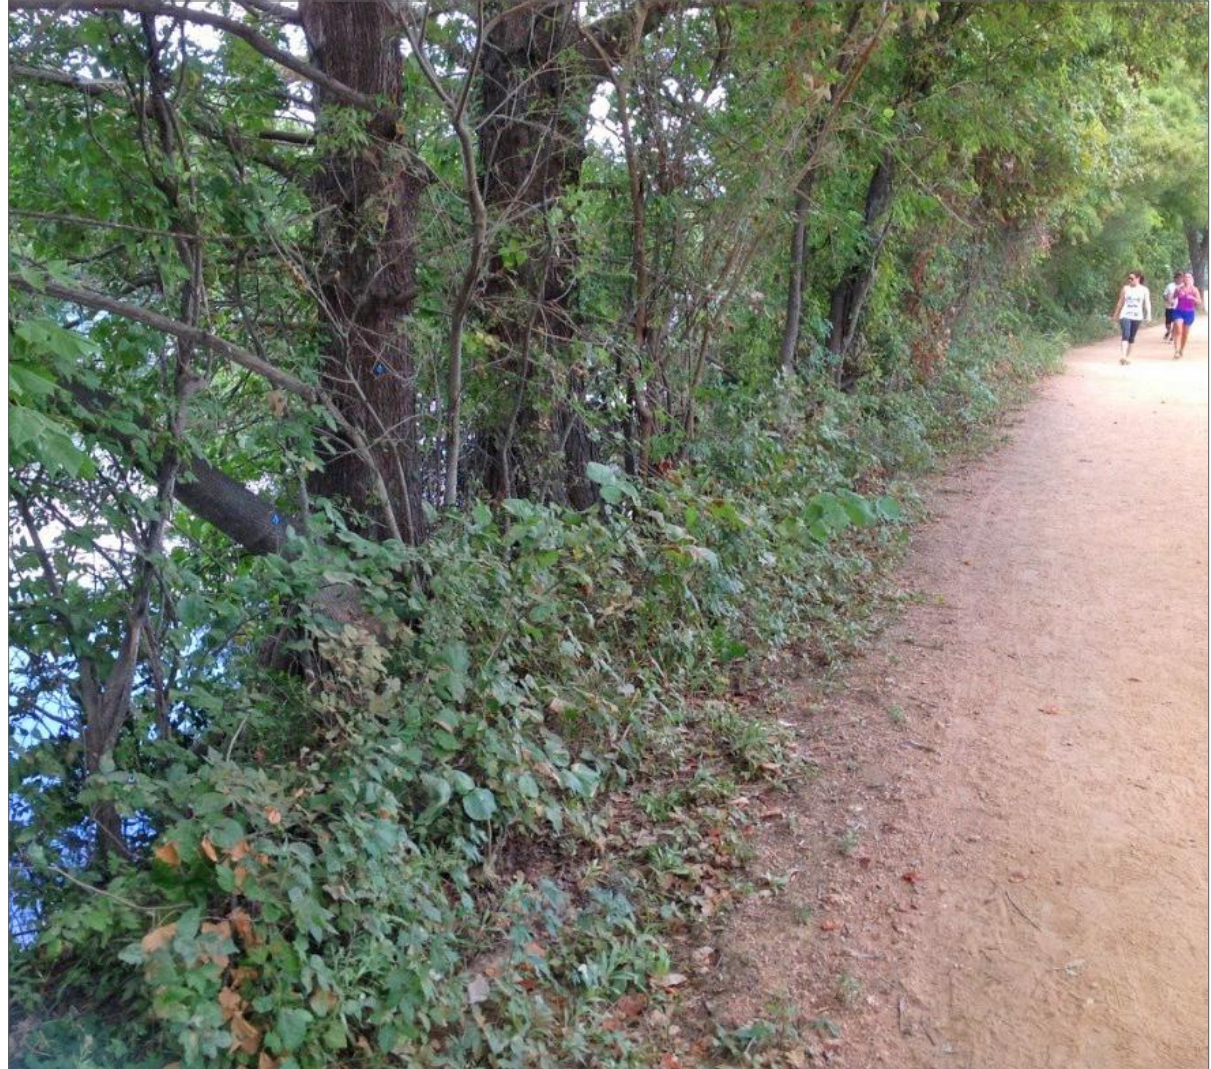
Figure 4.14: The Trail is extremely close to the Lake in parts of the Cesar Chavez unit. Trail realignment would allow for a wider riparian edge.

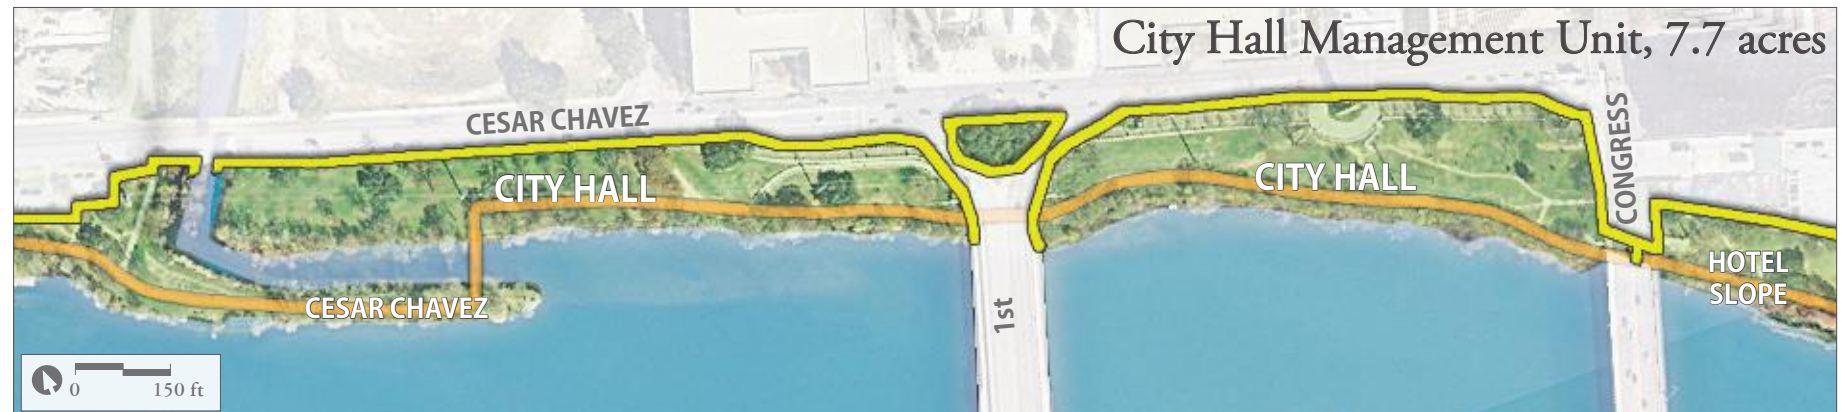
Figure 4.15: City Hall Management Unit boundaries. Sources: COA, NAIP.

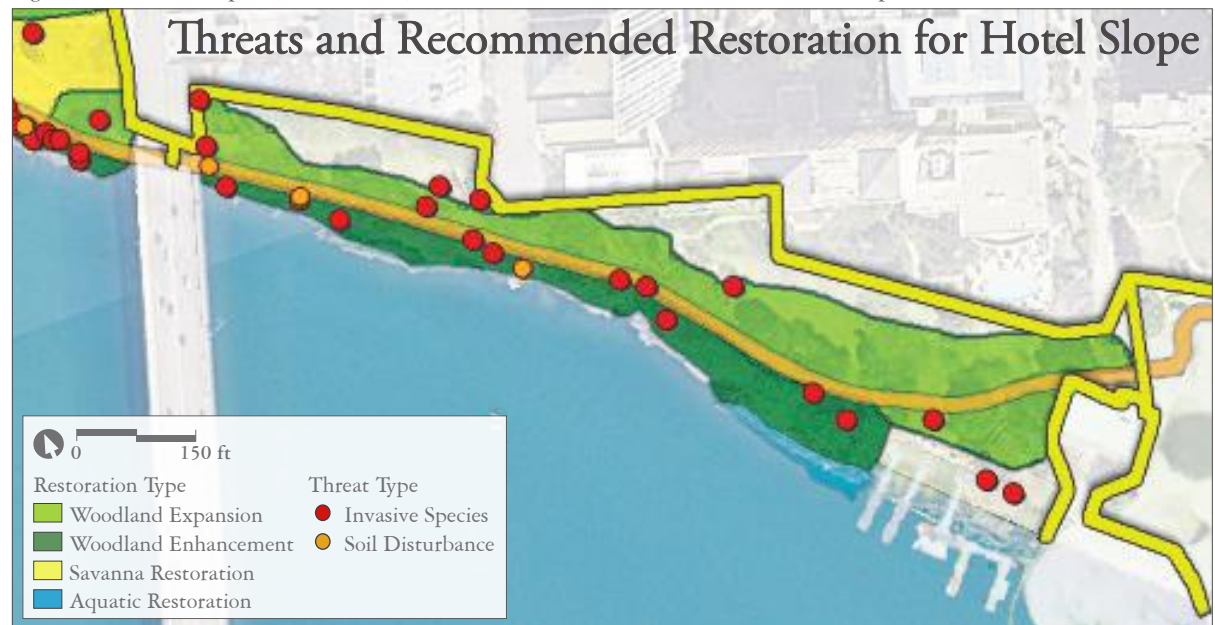
Figure 4.22: Invasive species, erosion issues, and recommended restoration areas in the Hotel Slope Unit. Sources: COA, NAIP.

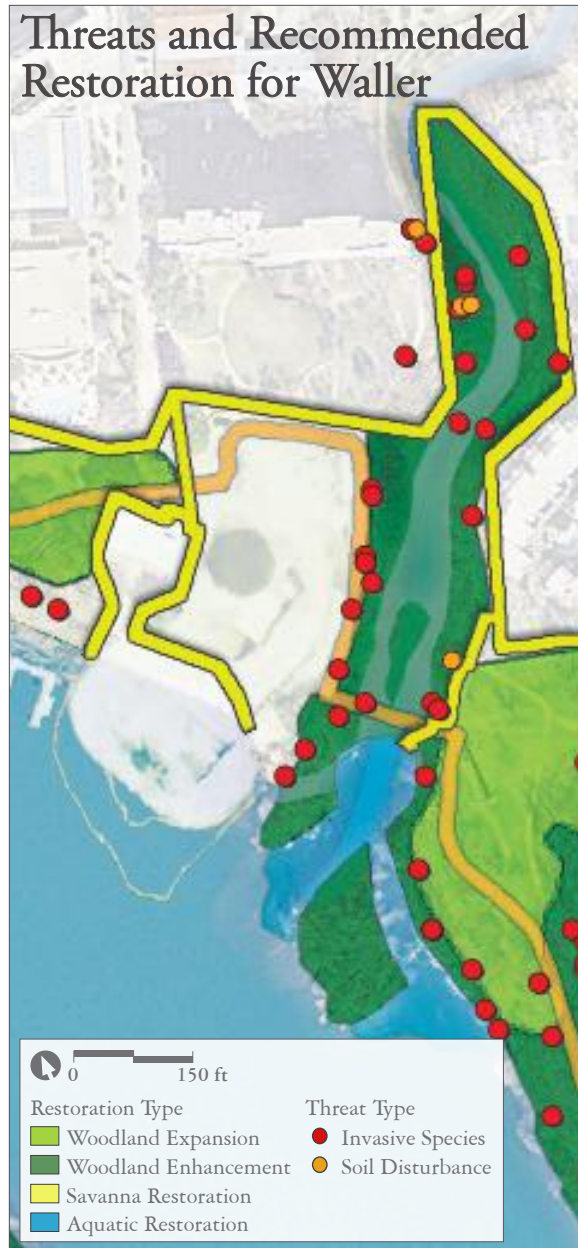
Figure 4.26: Invasive species, erosion issues, and recommended restoration areas in the Waller Creek Unit. Sources: COA, NAIP.

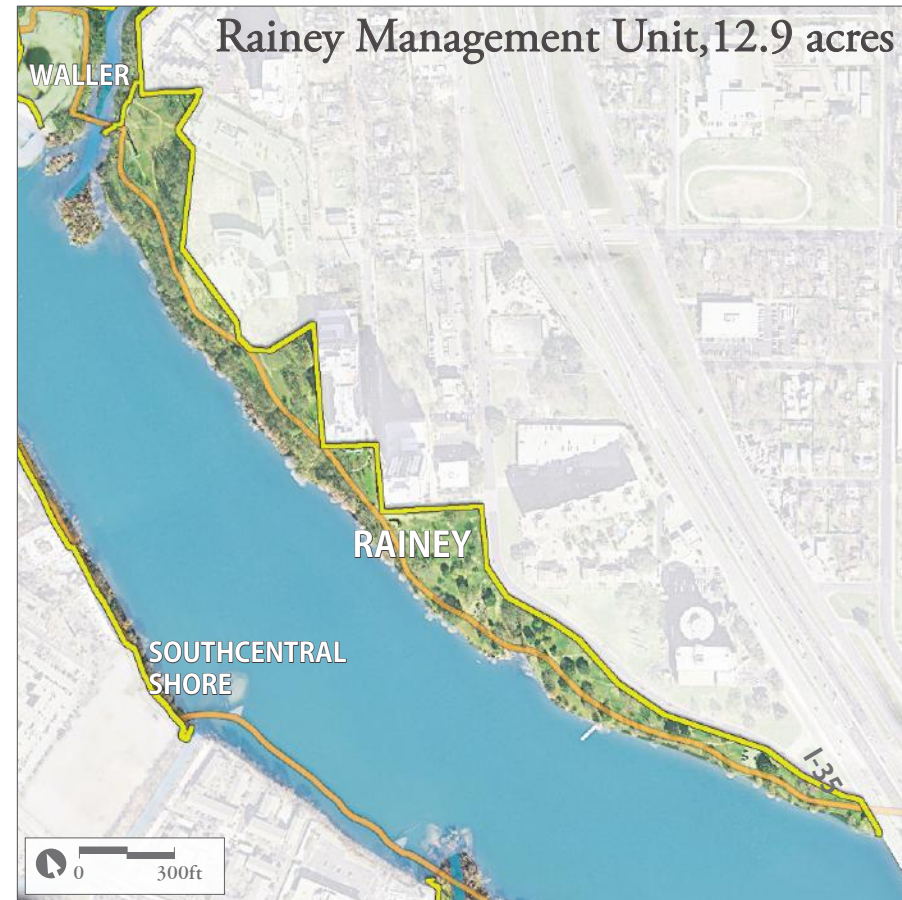
Figure 4.27: Rainey Management Unit boundaries. Sources: COA, NAIP.

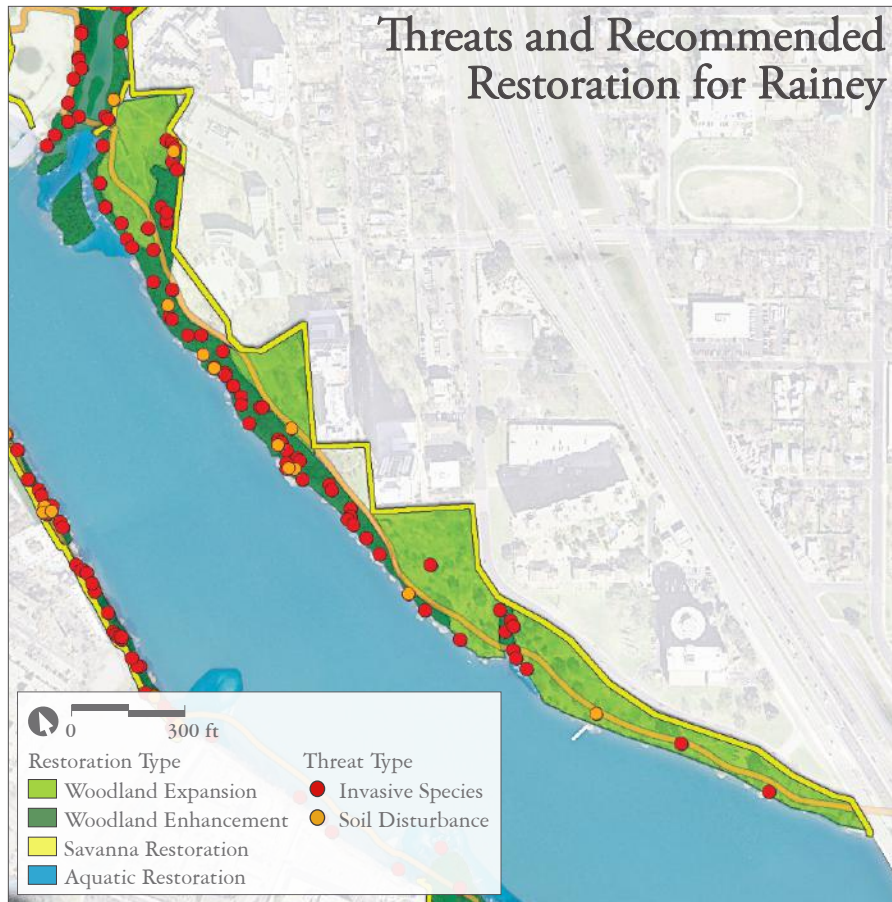
Figure 4.30: Invasive species, erosion issues, and recommended restoration work in the Rainey Unit. Sources: COA, NAIP.

Converting areas of underutilized lawn to woodland and enhancing the diversity of the existing woodlands are priorities for this unit. This aligns with the work of the Urban Forestry Program, which has deemed the census tract containing the Rainey Unit a high priority for tree planting (Halter 2014). There are multiple erosion issues that need to be addressed before restoration plantings occur. Grading and green infrastructure should be used in western and eastern portions to slow down stormwater entering the areas and address gully erosion. Rill erosion caused by culverts under the Trail can be miti-

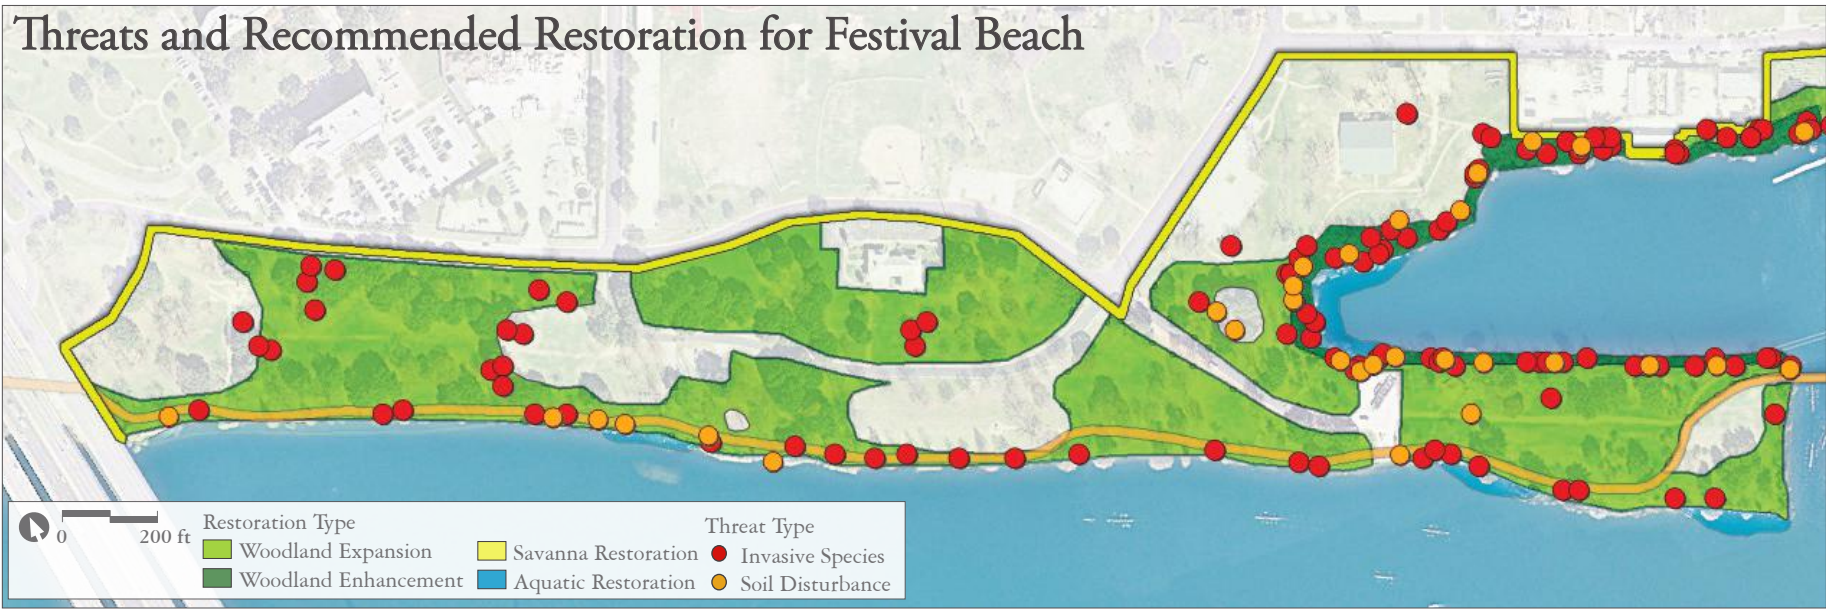
Figure 4.32: Invasive species, erosion issues, and recommended restoration work in the Festival Beach Unit. Sources: COA, NAIP.

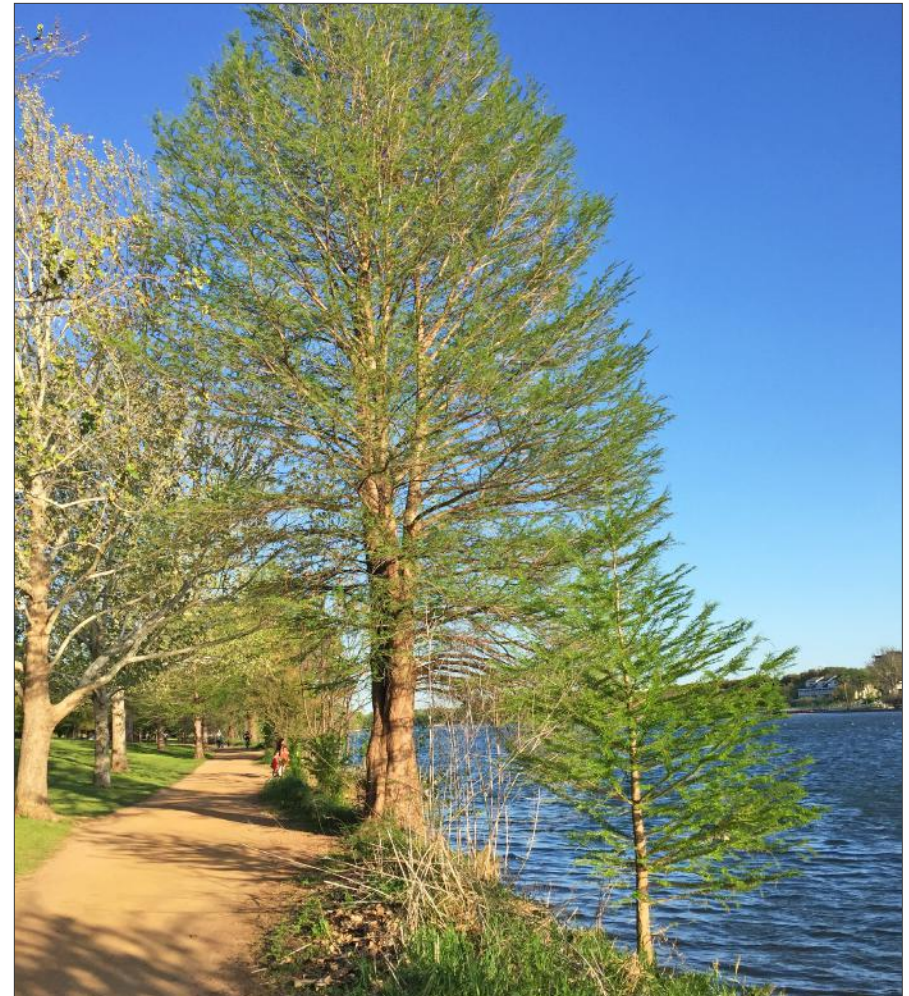
Figure 4.33: The majority of the Festival Beach unit has only a thin strip of vegetation between the Trail and the shoreline and has scattered trees rather than a continuous canopy.

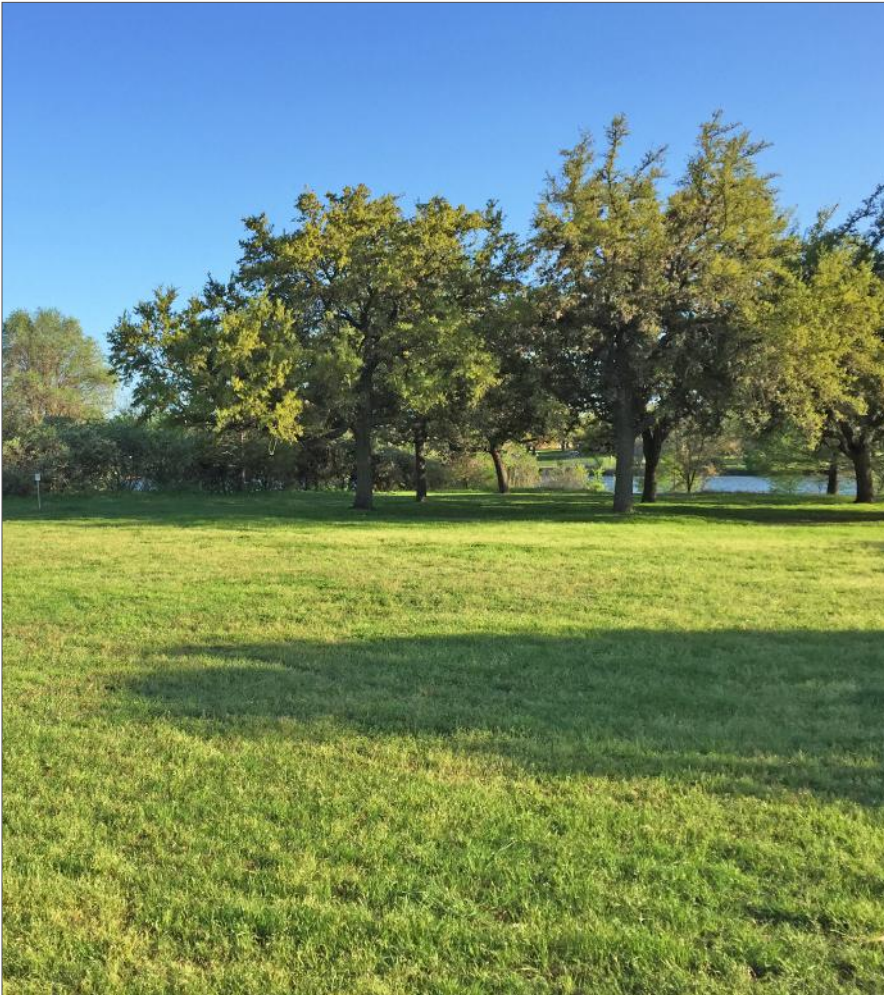
Figure 4.34: Festival Beach consists primarily of large underutilized lawns.
