Natural Area Management Guidelines

Management Units

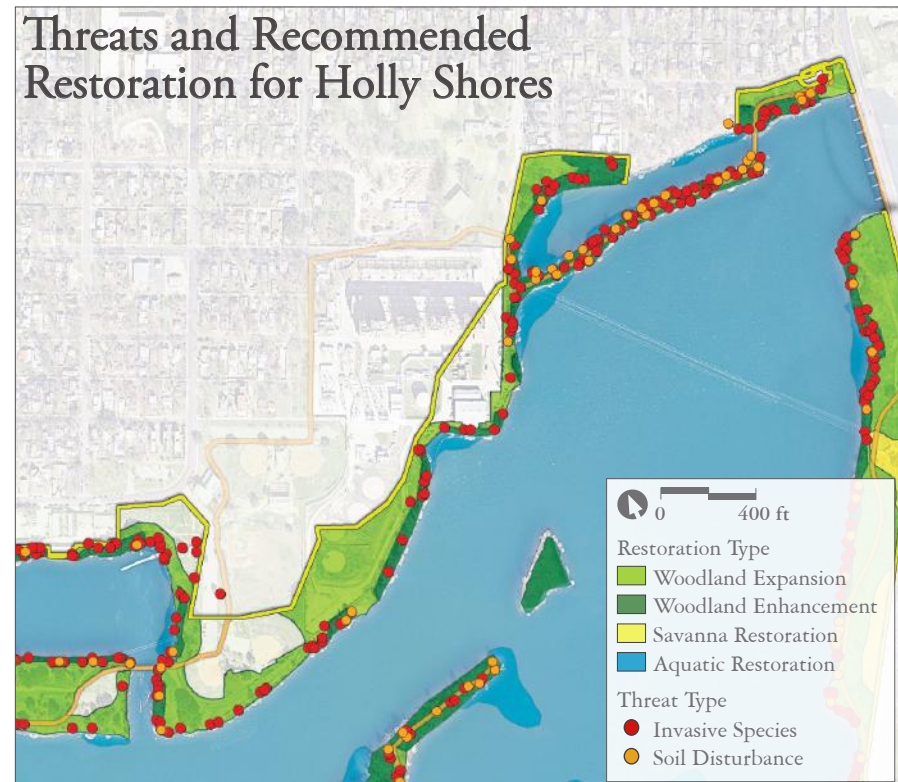
Figure 4.36 (Above): The woodland along the western edge of the Holly Shores unit contains several large bald cypress. Figure 4.37 (Below): Invasive species, erosion issues, and recommended restoration work in the Holly Shores Unit. Sources: COA, NAIP.

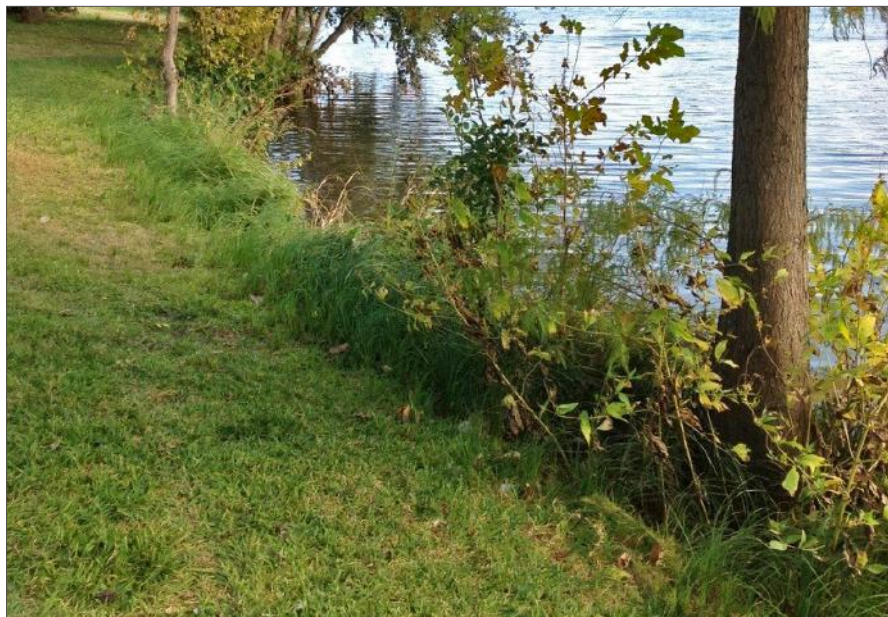
Figure 4.38 (Above): The strip of vegetation between lawn and Lake is extremely narrow south of the baseball fields. Figure 4.39 (Below): Trail material extends well beyond the width of the Trail on portions of the peninsula.

In the eastern part of this management unit, the Trail crosses a long, narrow peninsula. On the peninsula, 10 to 15 ft on each side of the Trail is mowed, and decomposed granite from the Trail has migrated into the surrounding vegetation in many places (Figure 4.39). The woodland of the peninsula differs slightly from the woodland of the mainland, containing more sycamore trees and invasive common chaste tree. Some of the natural area along the peninsula is in comparatively good condition, with eastern gamagrass, sawgrass, and natural regeneration of bald cypress.

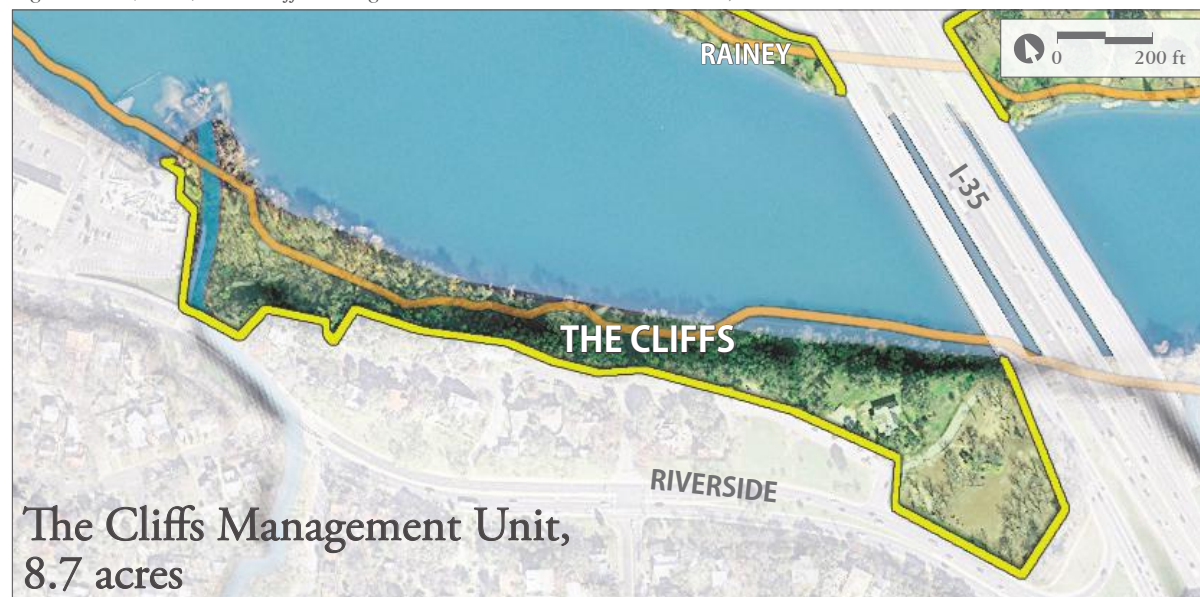
Figure 4.44 (Above): The Cliffs Management Unit Boundaries. Sources: CAO, NAIP.

The Cliffs Unit is bound by I-35 on the east, the Lake on the north, Blunn Creek on the west, and Riverside Drive, residential lots, and Edgecliff Terrace on the south (Figure 4.44). The unit is within the Norwood Tract at Town Lake Metro Park. The Boardwalk cuts through the unit near Blunn Creek and runs parallel to it over the water to I-35. The area is 8.7 acres, with land management recommendations for 5.6 acres and 0.9 acres of aquatic restoration (Figure 4.47). Recommendations were not made for the dog park or Norwood House lot as their specific uses are incompatible with natural area management and therefore beyond the scope of this project.
