**EVALUATION OF ARCHITECTURAL ELEMENTS  
OF  
1618 PALMA PLAZA, AUSTIN, TEXAS**

**Prepared for FourT Realty  
1601 Rio Grande Street, Suite 333  
Austin, Texas 78701**

**By  
John V., Nyfeler, FAIA  
P. O. Box 4479  
Austin, Texas 78765-4479**

**October 21, 2016**

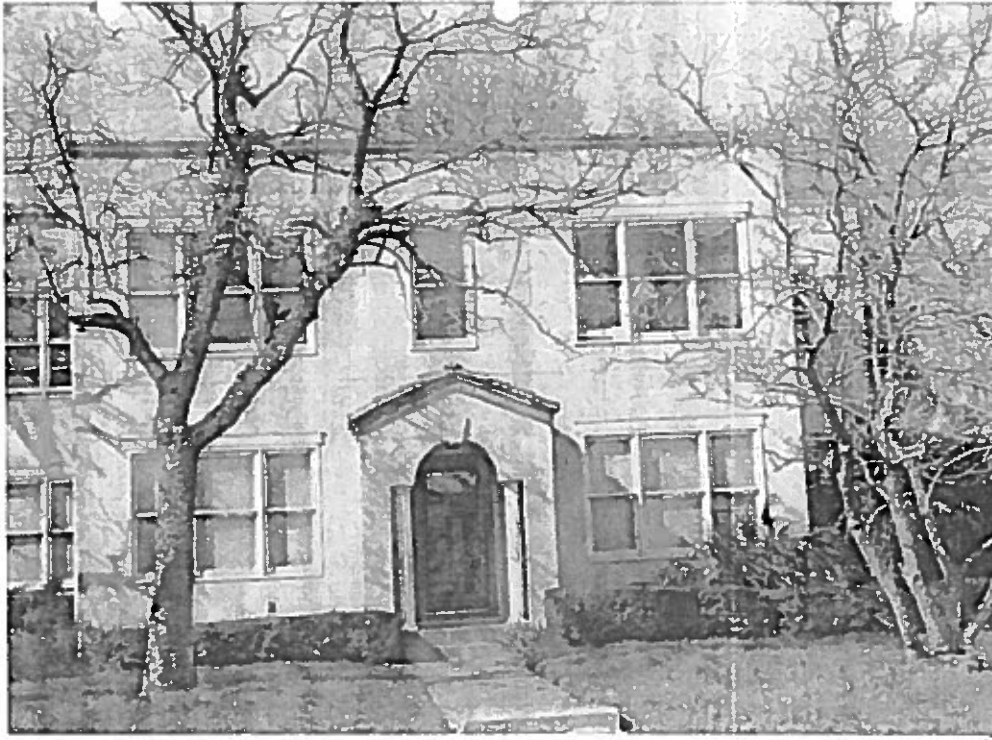
Southeast Elevation (facing Palma Plaza), Winter view without tree vegetation, showing 1980's porch addition with clay tile detail and "Doric" columns, exterior EIFS skin and replaced windows.

3. The building exterior has been completely concealed by an Exterior Insulation and Finish System (EIFS) faux stucco layer completely obscuring the original exterior surface. (See Exhibits 16 a, b and c)

5. By examination of the aerial photographs of different dates, an original front porch has been replaced by a different and larger porch with clay tile roof shingles, false, sheet metal "Doric" straight-sided columns. (See Exhibits 17 and 18)

8. The existing property includes a front porch added in the 1980's after demolition of the original porch. The new front porch added a few clay tile roof shingles on the roof over an arched portal entrance. The addition incorporated a pair of sheet metal "Doric" straight-sided columns. This applied front porch element replacing the original does not constitute the distinguishing characteristics of a Spanish Colonial Revival architectural style.
