SEGMENT IV: 7TH TO 10TH STREETS

SEGMENT V: 10TH TO 12TH STREETS

SEGMENT VI: 12TH TO 15TH STREETS

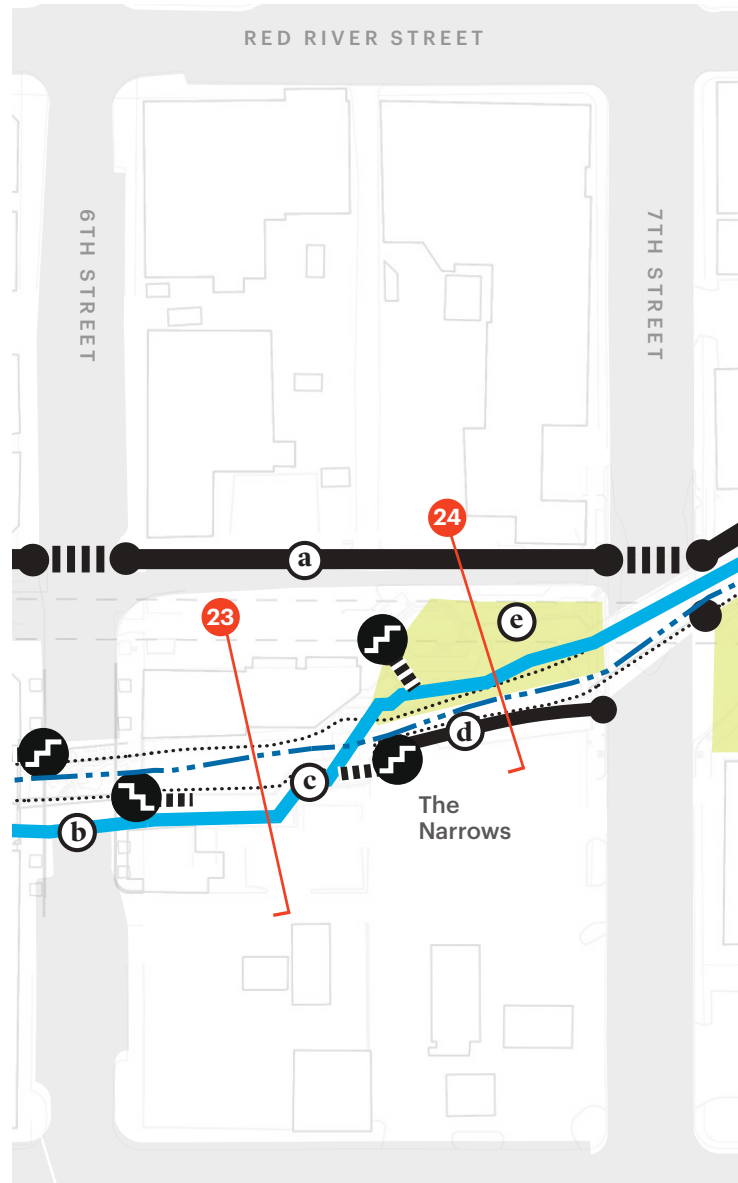
- a. The Sabine Street Promenade between 6th and 7th Streets will be the primary north-south bicycle connection in The Narrows. At 7th Street, cyclists may travel one block to the bikeway at Red River Street.
- b. Existing tunnel under 6th Street Bridge is re-opened and modified for safe public passage
- c. The existing creekside trail is to remain, preserving the general character of the relationship of the creek to the city on this block. Some modifications may be made to the low-water-crossing “dominos” to improve safety and accessibility.
- d. A proposed street-level connection may require modification of an existing vertical retaining wall.
- e. Existing parkland reconfigured to support an ADA/TAS accessible trail from creekside to Sabine Street Promenade

- In this block the channel is constrained on all sides by concrete and bedrock.
- The existing trail crossing at the middle of this block creates a flow restriction and will continue to require regular maintenance cleanings.
- The flow restriction caused by the existing trail crossing will also continue to cause localized flooding during storm events if excessive debris is allowed to accumulate.
- The proposed metal grating along the foot bridge will need to be removable for regular maintenance cleanings.

- This block is characterized by a highly constrained channel formed by the sides of existing buildings. Creative alternatives to standard riparian restoration techniques should be encouraged.
- The west bank is formed by an existing building downstream of the alley and will not be modified. Upstream of the alley, existing PARD land will be reconstructed to allow for an ADA/TAS accessible path and some laying back of slopes.
- The east bank is channelized by existing structures and will not be modified at creek level. Reconstruction of the top of bank may be required to allow for a new ADA/TAS accessible path.

- There is existing bedrock close to the 6th Street Bridge that is to remain and be protected.
- An aquatic organism passage is proposed just downstream of the existing weir at 7th Street.

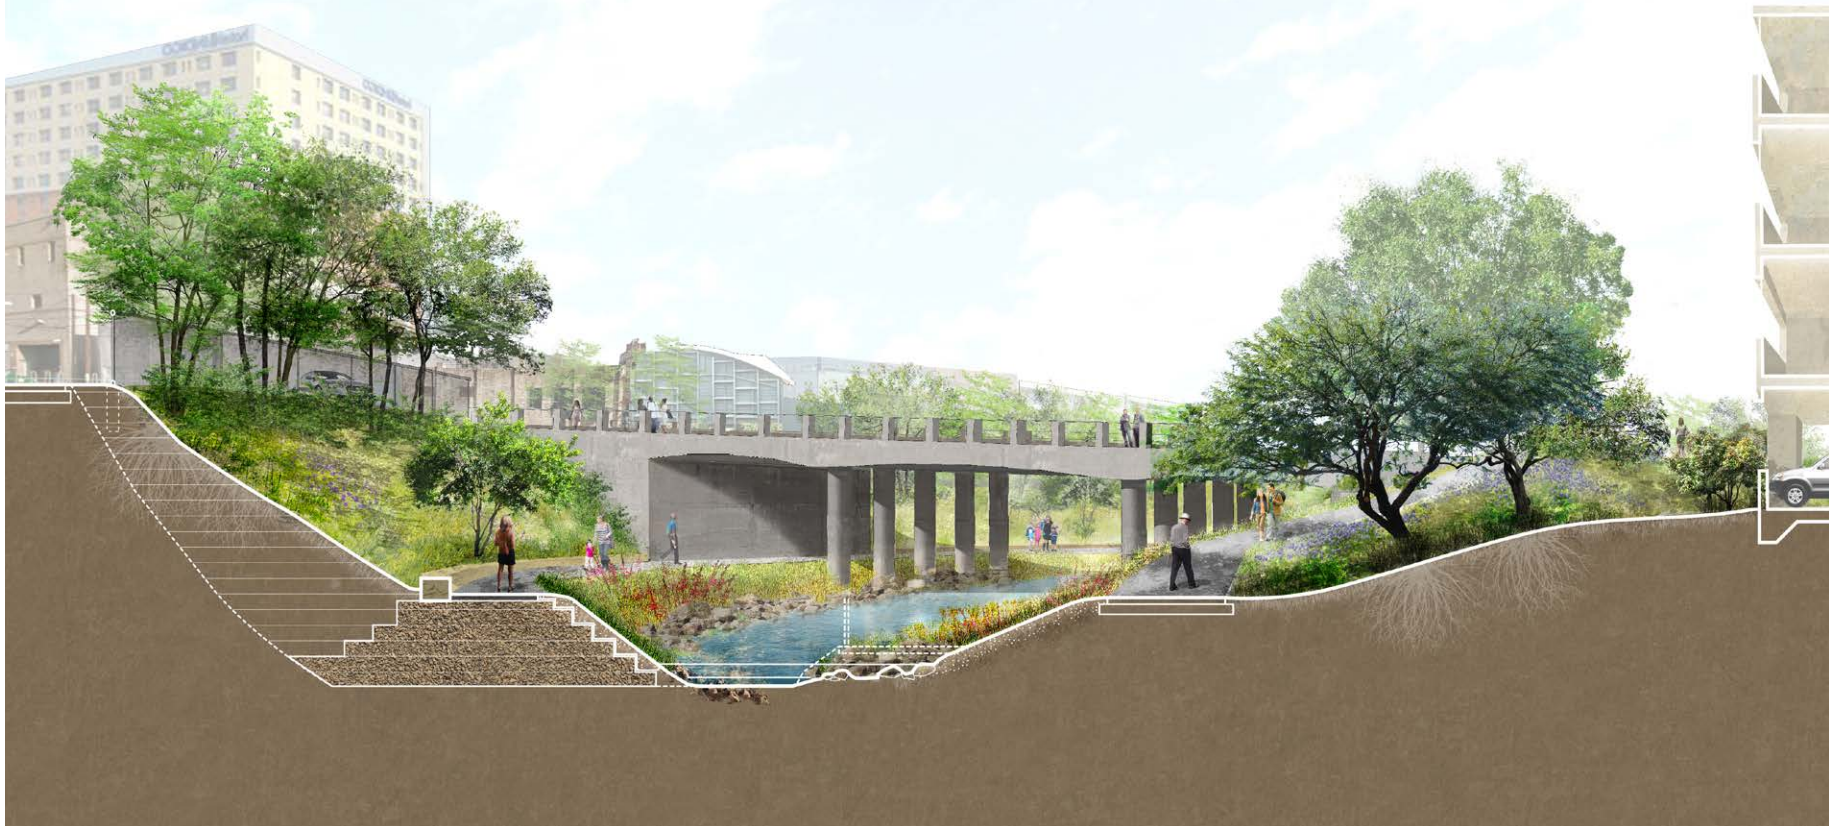
Some of the most eroded slopes caused by overbank flow in the creek district exist within this segment. In this case, the construction of the trail at the toe of the failed slope acts as a slump block for geotechnical stability and would be built as a stone key that would anchor the reconstruction of the slope and the restoration of the riparian landscape. In this segment, there will also need to be an extensive use of boundary fences at the top of slope for separation of land uses. This construction at the boundary of creek bank should also be paired with measures to mitigate overbank stormwater flow.

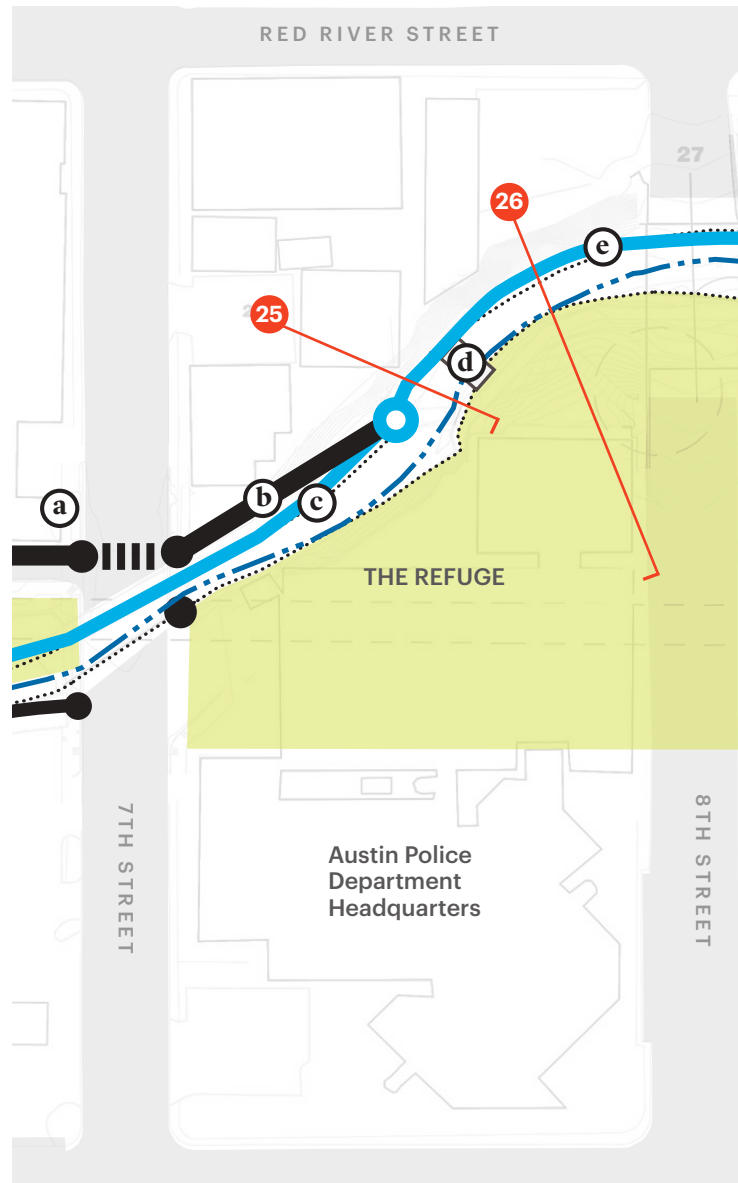
7TH TO 8TH STREETS

- a. Terminus of Sabine Street Promenade. Mid-block crossing creates connection to Red River bikeway (via 7th Street)
- b. Proposed trail connects Sabine Street Promenade at street level to creek level trail system. Requires coordination with private property owner and 7th Street Bridge abutments.
- c. Existing creekside trail to remain.
- d. Low-water crossing to be relocated upstream to allow for grading at the convergence of (b) and (c).
- e. Severe erosion downstream of 8th Street. Proposed creekside trail to be integrated with bank improvements. Bank condition limits width of trail.

- Reconstruction of the west bank will constrict flood flows and may increase water surface elevations. Upon future redevelopment of the APD headquarters site into “The Refuge” island, this increase may be partially offset.
- In the future condition with “The Refuge” island, the west branch of the split channel (the existing creek channel) will provide the primary flow conveyance. The east branch of the split channel will be designed to provide demonstrational and educational benefits.
- A new weir is proposed downstream of the confluence of the split channels and will be associated with the island.

- The west bank is severely eroded and requires reconstruction. The failure of this bank, particularly at mid-block, threatens the stability of top-of-bank structures. Runoff from unpaved mid-block alley may be contributing sediment loads to creek.
- Near 8th Street, overbank runoff from an existing parking lot may be contributing to bank failure. Slope reconstruction should integrate stormwater management facilities.
- The east bank is currently supported by limestone retaining walls and in stable condition. Until the APD headquarters are redeveloped, this slope should be preserved, with potential reseeding/replanting to augment the existing mown lawn.

- One existing Heritage Tree on east bank, at Austin Police Department Headquarters
- One existing Heritage Tree on west bank in poor condition. Construction of new trail may require removal at (b).

- Two outfalls discharge into the creek (#60664 and 60663). Both enter from the east bank and appear to serve the Austin Police Department Headquarters site.
- In their current configuration, outfalls #60662 and #60663 present no trail conflicts and do not carry volumes of water sufficient to warrant retrofit treatment; no action is recommended.

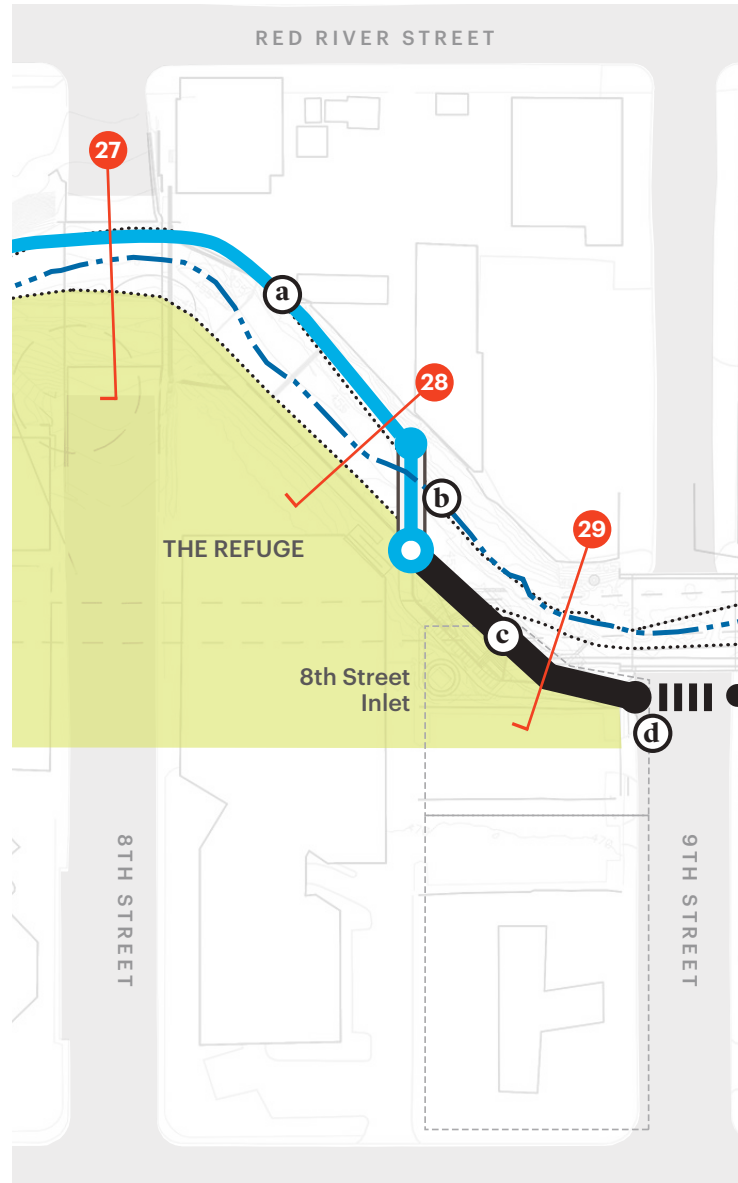
- a. Creekside trail, elevations and alignment to be coordinated with adjacent program.
- b. A proposed creek crossing just downstream of the 8th Street Inlet weir allows continuous north-south connectivity before redevelopment of Austin Police Headquarters site.
- c. Proposed trail on 8th Street Inlet site. Inlet requires regular truck access for maintenance; timing and available area for public thoroughfare must be coordinated.
- d. No vertical clearance for trail under 9th Street Bridge; mid-block crossing connects to street-level trail.

- The west bank is severely eroded. Upper slopes require restoration and coordination with adjacent private property owners, as overbank runoff may be contributing to slope failure.
- The east bank will be completely reconstructed by the 8th Street Inlet structure.

- An existing American elm on the west bank is in fair to good condition. It is nearing a size that makes it eligible for classification as a Heritage Tree.
- Highly disturbed slopes due to erosion have encouraged invasive species, such as giant cane.
- Bank restoration may require significant removal of existing invasive or compromised vegetation, followed by replanting.

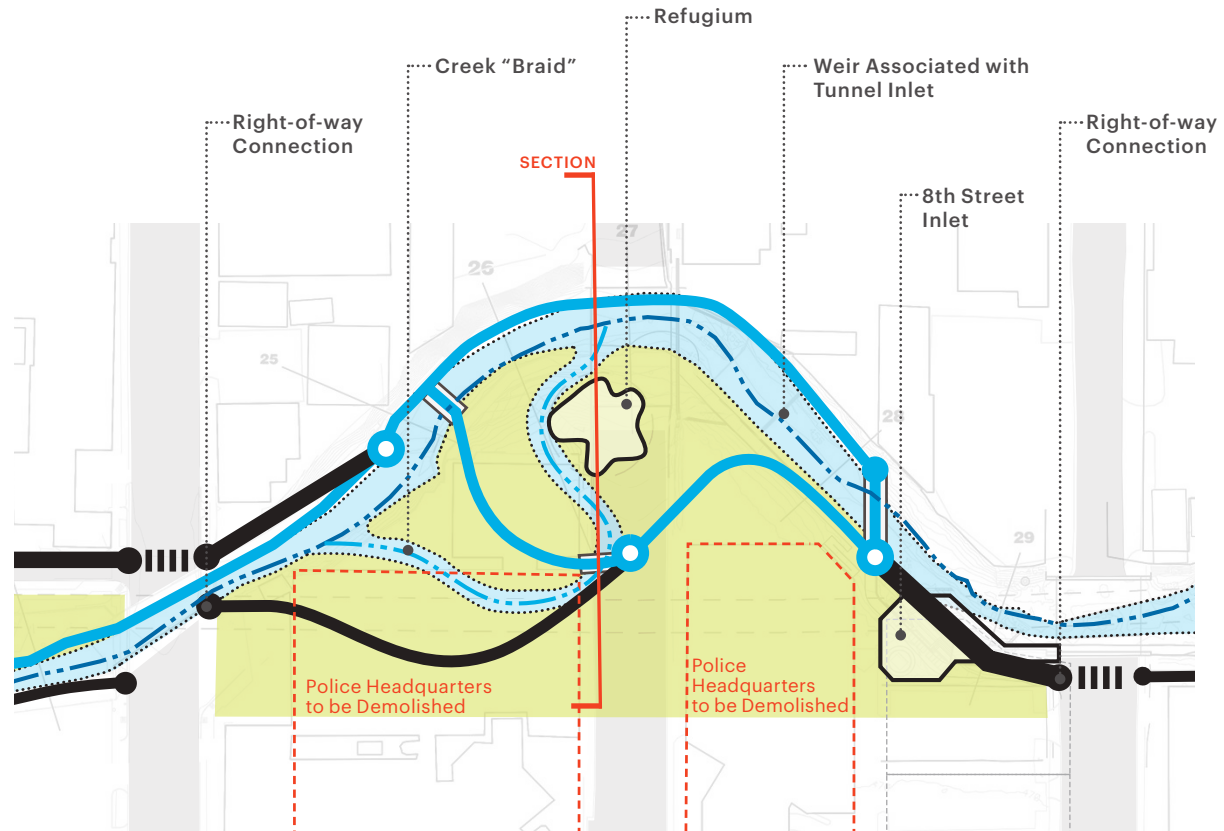
PHASE 2: THE ISLAND PARK

With the inevitable relocation of the City of Austin police headquarters, the demolition of the existing buildings opens up the opportunity to reconstruct the east bank into a new park site. The expanded trail network associated with this re-shaping of the channel allows for universally accessible connections between 7th Street, 9th Street, and the Island Park at creek level. The island itself would be approximately 20,000 sf, with an additional of 30,000 sf of reconstructed creek bank.

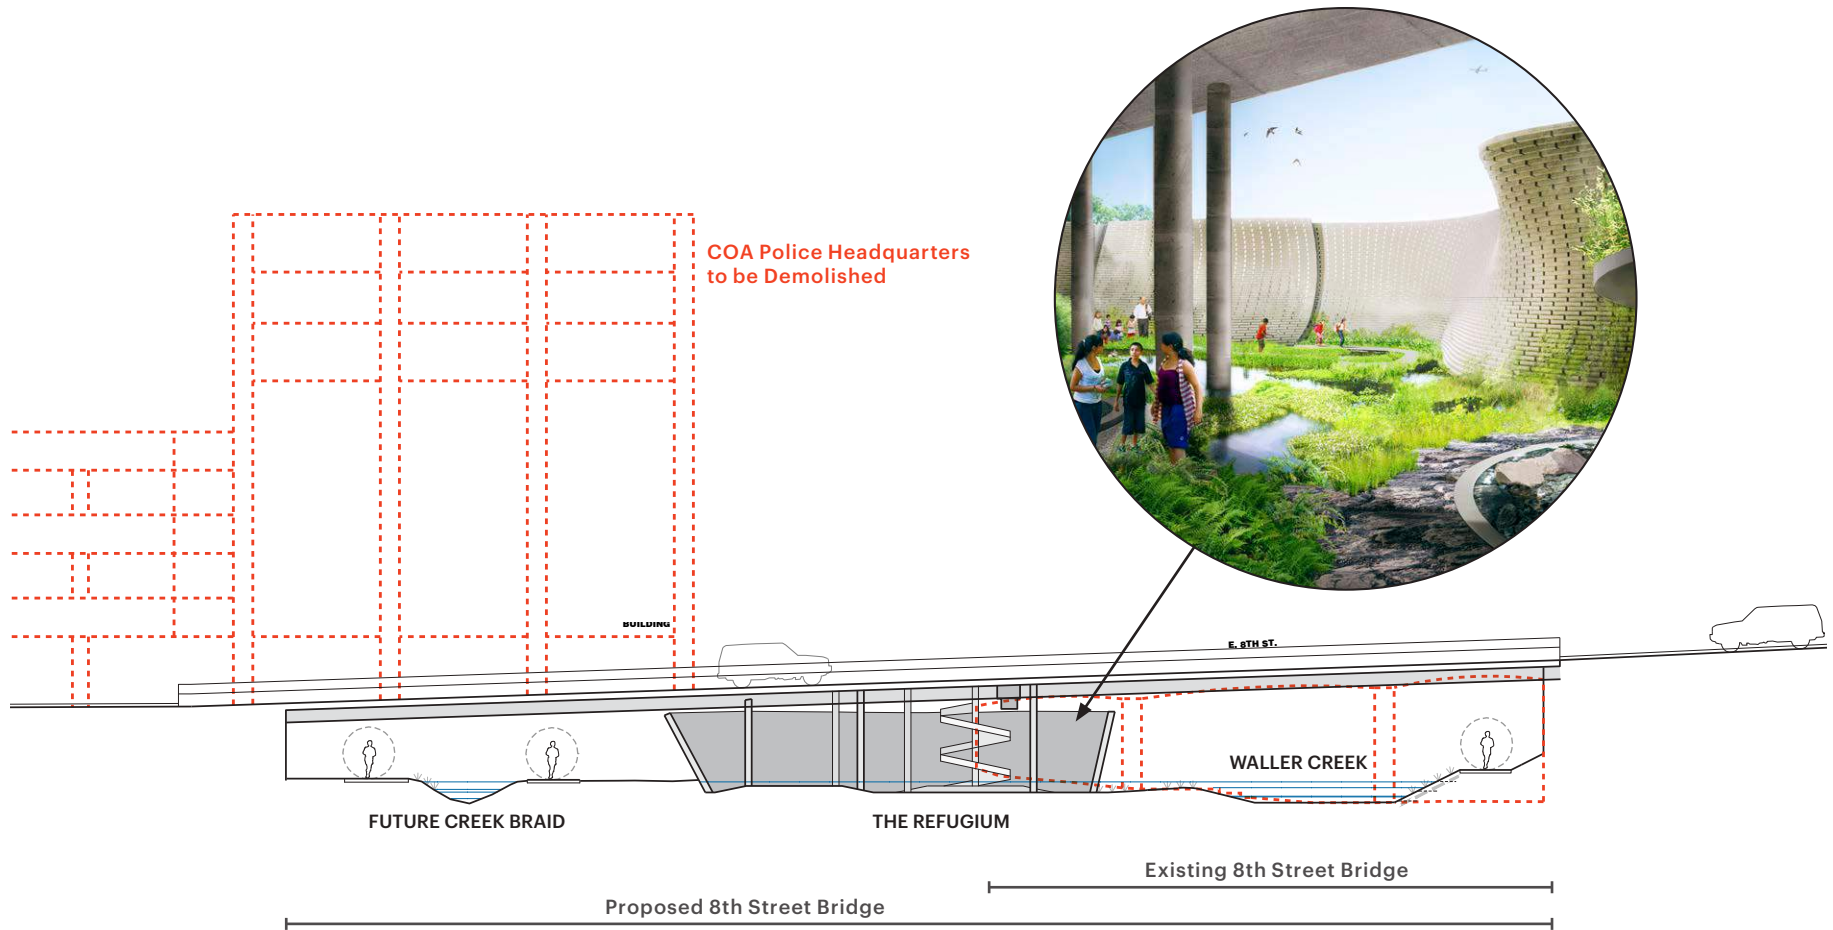
PHASE 2: 8TH STREET BRIDGE

The extended 8th Street Bridge is a model for how new urban infrastructure can sustain rather than weaken the natural environment it sits in. Local school groups will be encouraged to become “Waller Creek Stewards,” collecting seeds and even fish eggs to hatch and rear in the classroom.

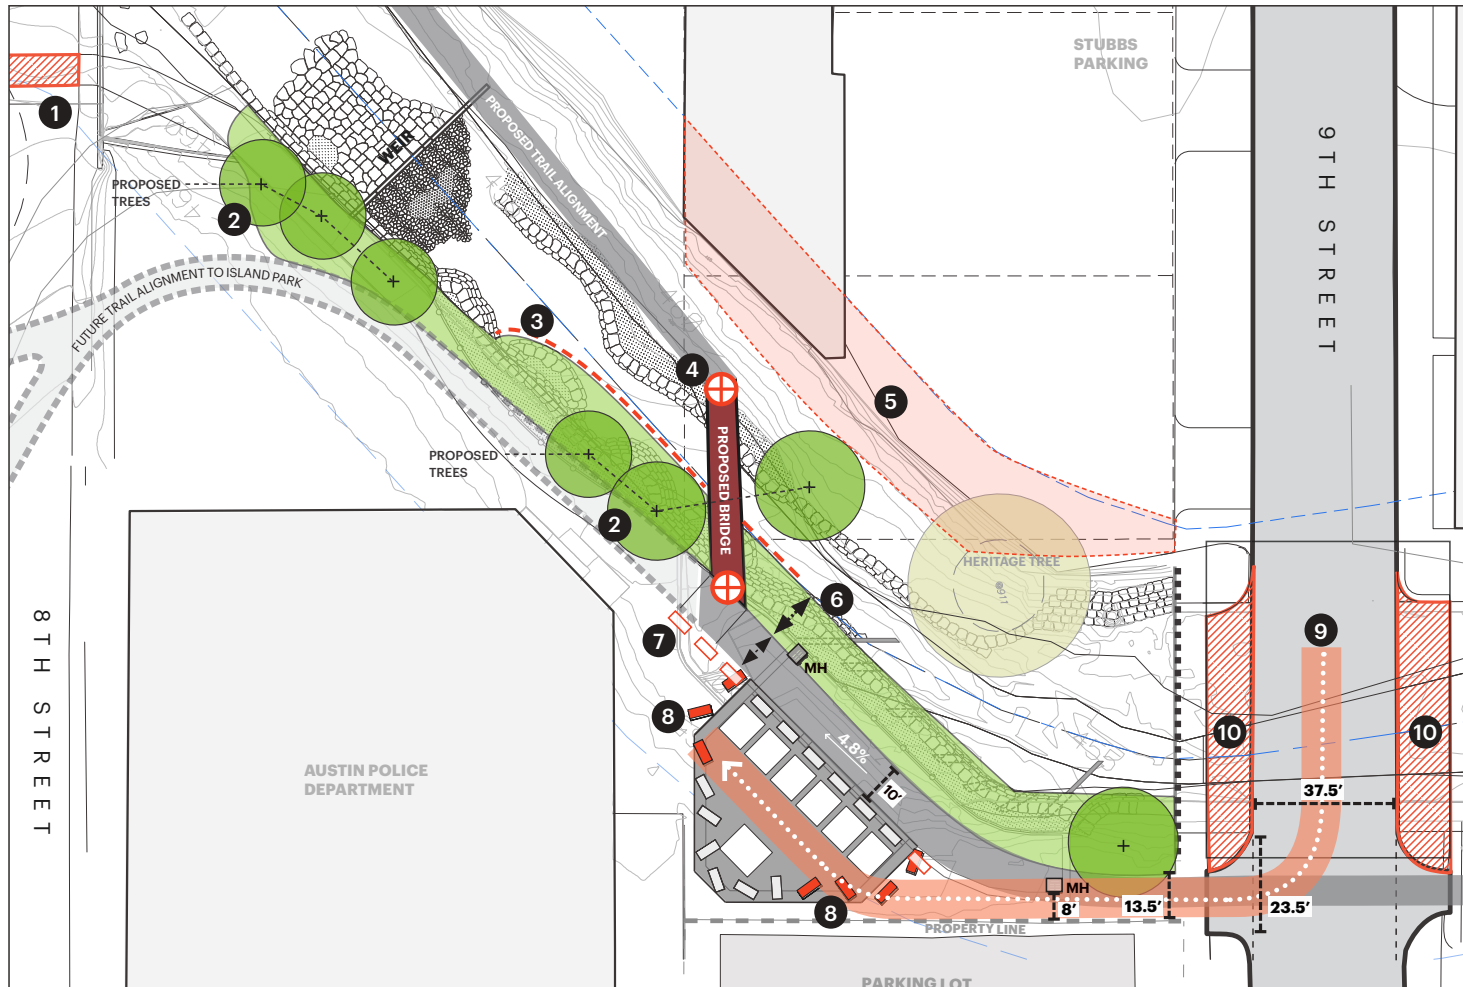
PROPOSED IMPROVEMENTS

1. Existing trail to be removed
2. Modify east bank for tree planting
3. Reconfigure stone block wall for planting and bridge abutment
4. Drilled pile footings for bridge to be coordinated with tunnel construction
5. Future overbank stormwater treatment modifications
6. Expand landscape area and reduce width of pavement
7. Reconfigure limestone blocks (add or adjust)
8. Remove limestone blocks
9. Public works/watershed to confirm feasibility to change access for inlet debris removal operations
10. Remove parking & widen sidewalks on 9th Street Bridge

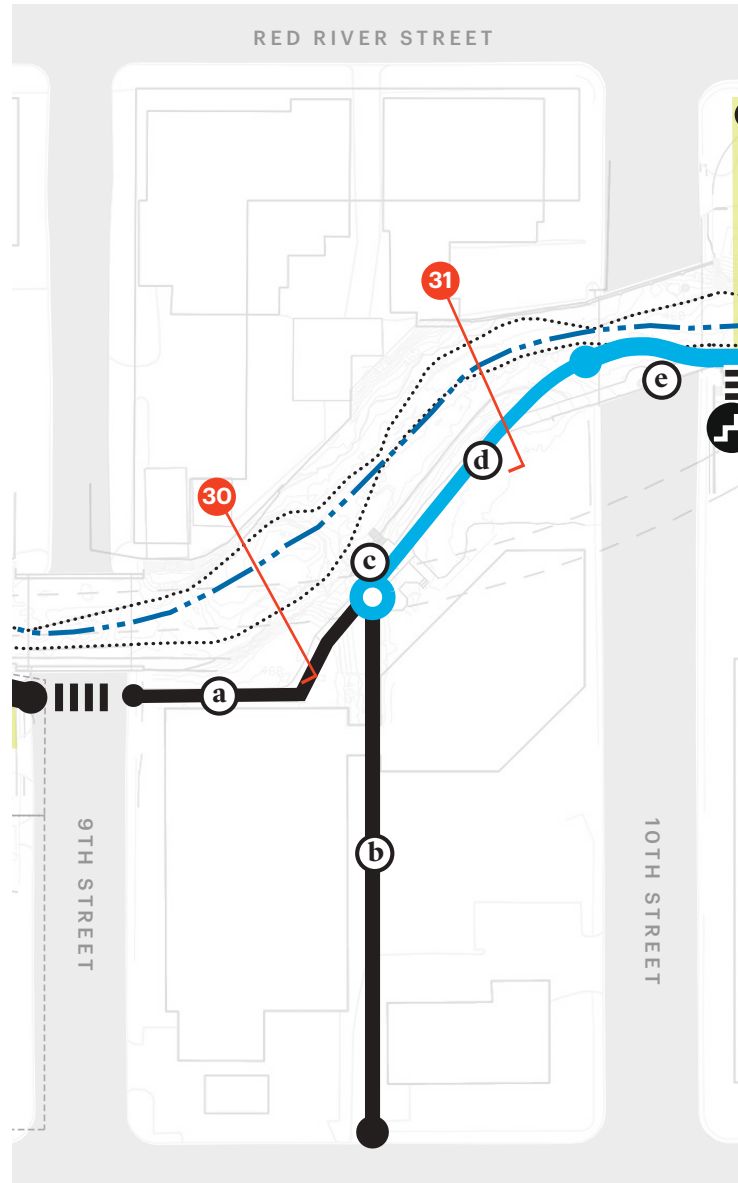
- a. No vertical clearance under 9th Street Bridge for trail; existing street-level trail to remain.
- b. Existing open stormwater channel to be regraded to build a new trail connection. Future I-35 modifications may open up additional connections to East Austin (see p. 124).
- c. Reconfigured bridge over open stormwater channel connects to new trails (see p. 124).
- d. New trail at <5% slope and rebuilt in ADA/TAS compliant materials.
- e. Low vertical clearance under 10th Street Bridge; path realignment eliminates conflict with existing raised utility manhole (see p. 125).

- The west bank consists of exposed bedrock near water level and relatively stable slopes and existing retaining structures.
- Near 10th Street on the west bank, there is evidence of overbank runoff from adjacent development that should be mitigated.
- Near 9th Street on the west bank, new and old retaining walls are affecting the existing slopes. This portion of the bank should be restored, with care taken to protect a large existing cypress tree.
- The east bank is in good condition; most of it should be preserved.
- A portion of the east bank near 10th Street requires reconstruction to allow a trail at <5%, as well as repair of failing gabions.

- Four existing Heritage Trees on this block. Two are in good condition, two are in fair condition.
- Generally, the existing vegetation on this block is in good condition, requiring only selective removal of problem species in preservation/restoration areas.

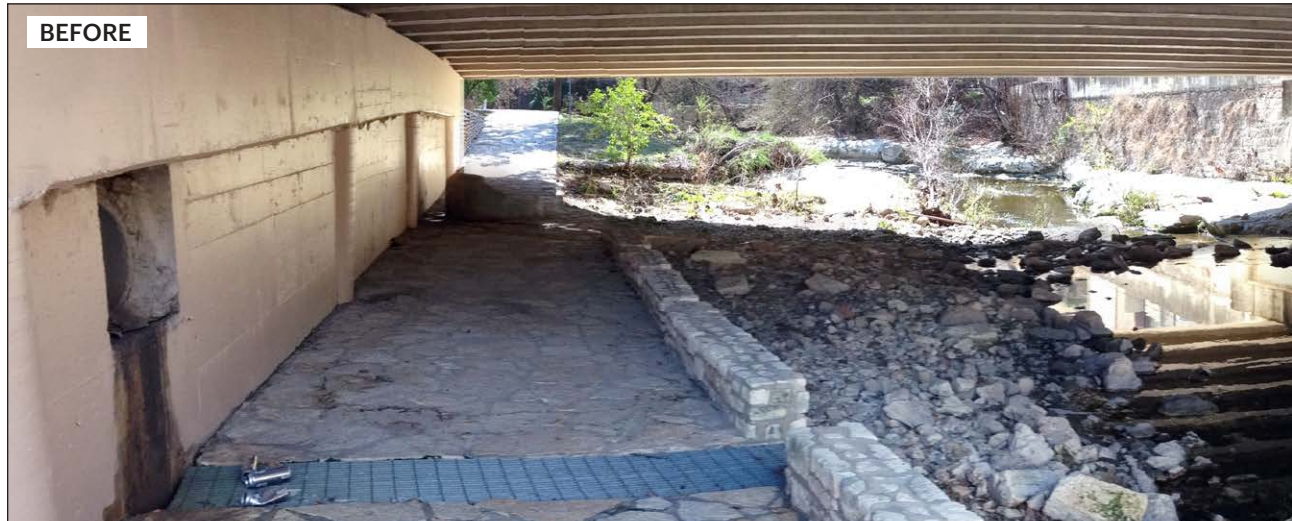
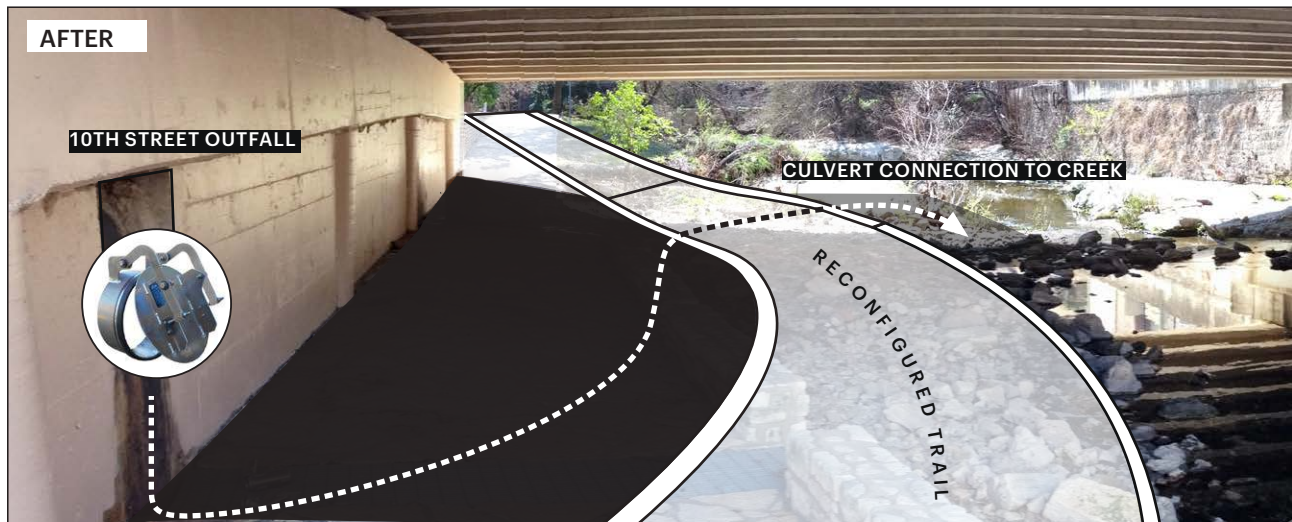
9TH TO 10TH STREETS

This segment of the creek contains several of the most beautiful moments on the creek. However, they are often paired with the worst conflicts with end of pipe flows and places where pedestrians walk. Strategic adjustments mitigate this conflict but are also shaped to provide numerous other benefits in additional stormwater quality improvements, improved sightlines around bridge structures, new connections to street level, improved head clearance, and habitat creation.

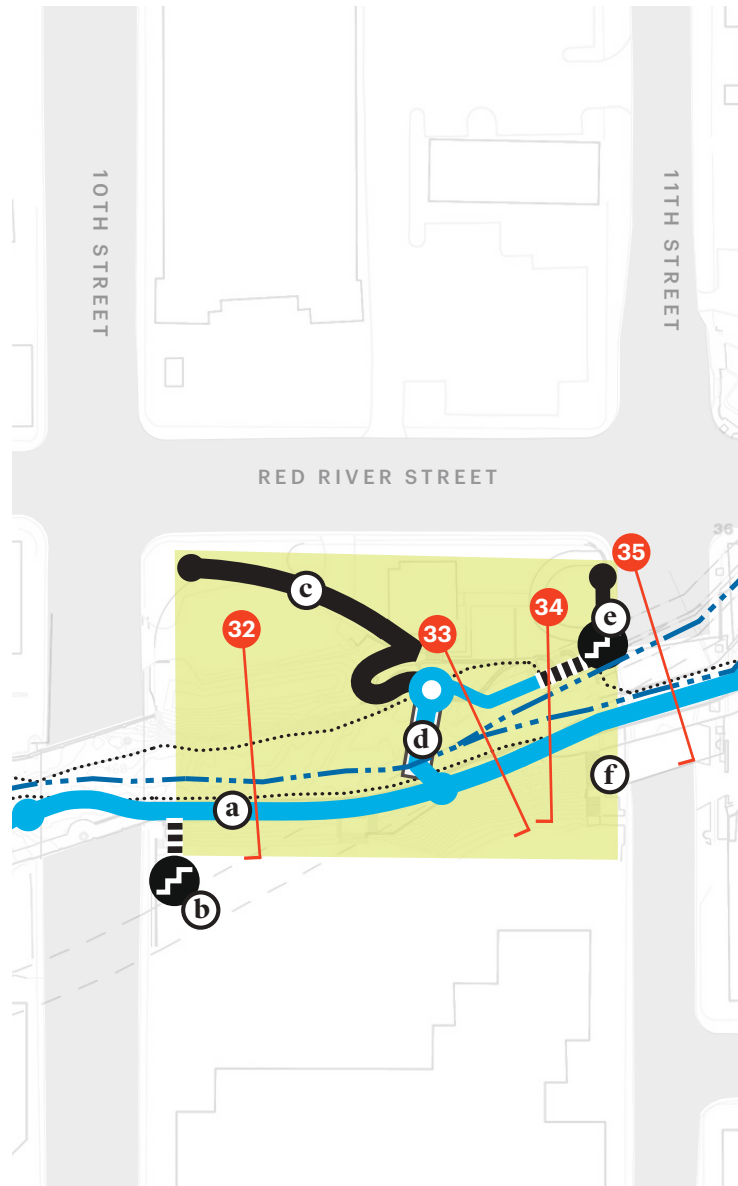
10TH TO 11TH STREETS

- a. Existing creekside trail to remain. Existing stone paving is not ADA/TAS compliant; any work on this trail would potentially trigger surface replacement to bring up to current accessibility standards.
- b. Re-opened stair connection to 10th Street (currently locked off from public access). Regrading of adjacent slope needed to improve sightlines.
- c. Proposed accessible trail connection to 10th Street via reconfiguration of existing COA parking lot
- d. Existing low-water crossing to remain.
- e. Proposed connection from existing street-level plaza at 11th Street to creek level.
- f. Removal of existing stair with poor sightlines. See (b) and (e) for proposed street-level connections.

- Downstream of the low-water crossing, the west bank is to be restored. Overbank run-off from the existing parking lot may be contributing to bank erosion; replanting is recommended.
- Upstream of the low-water crossing, the lower slope of the west bank is supported by a limestone wall in good condition. This wall also serves to maintain grades around a large Heritage Tree.
- Proposed stair connection to 11th Street (e) requires slope reconstruction/construction just downstream

- On the east bank, downstream of the low-water crossing, a stone retaining wall supports a lawn on COA-owned land. Future design work will explore opportunities to lay-back this slope, remove/reduce the retaining wall, and open sight lines to the proposed stair connection to 10th Street.
- On the east bank, upstream of the low-water crossing, the slope is stable and only requires some removal of problem species and replacement planting.

- There are seven Heritage Trees on this block. Five are at or near street-level, and offer opportunities for shaded “trailheads.”
- Six heritage-class trees in good condition surround the existing COA parking lot.

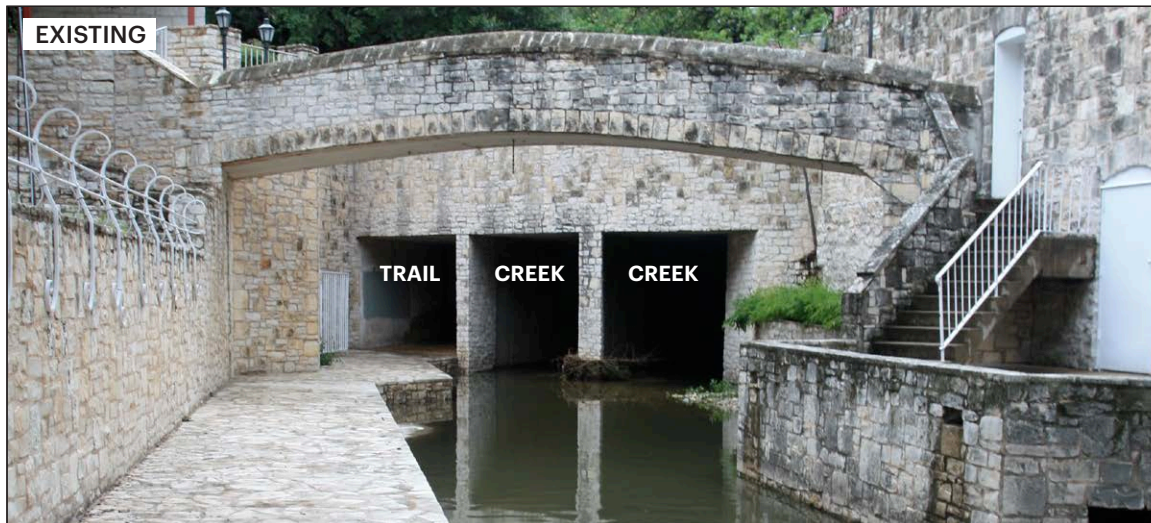
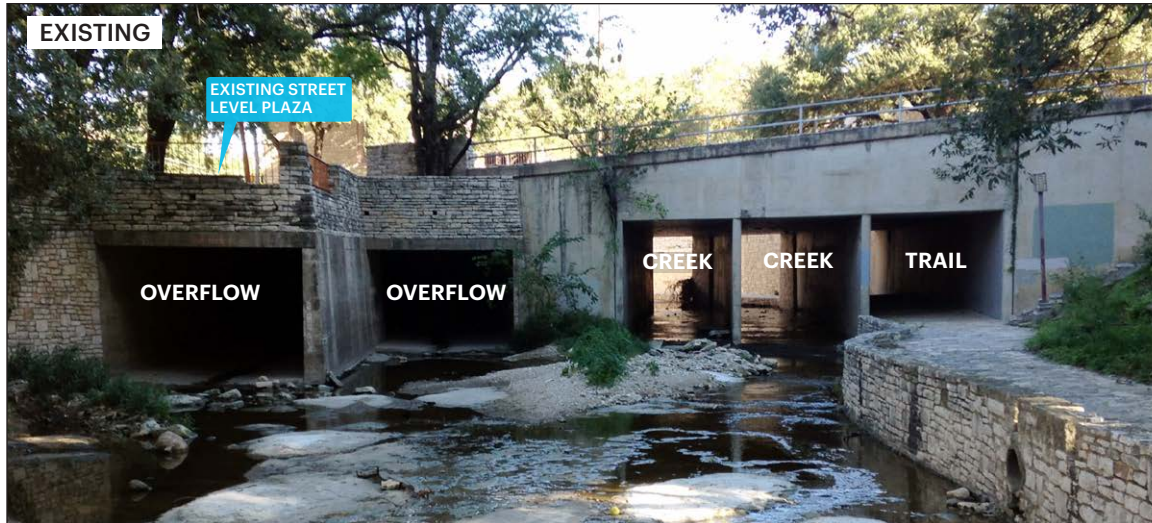
10TH TO 11TH STREETS

The existing trails at Symphony Square are of insufficient width to accommodate the future volume of pedestrians, particularly following the redevelopment of Waterloo Park to the north. A more generous paved area also facilitates a welcoming threshold to the park with better sightlines at the connections beneath 11th Street and Red River. This change also opens the door for Symphony Square to have more engagement with the creek in the future.

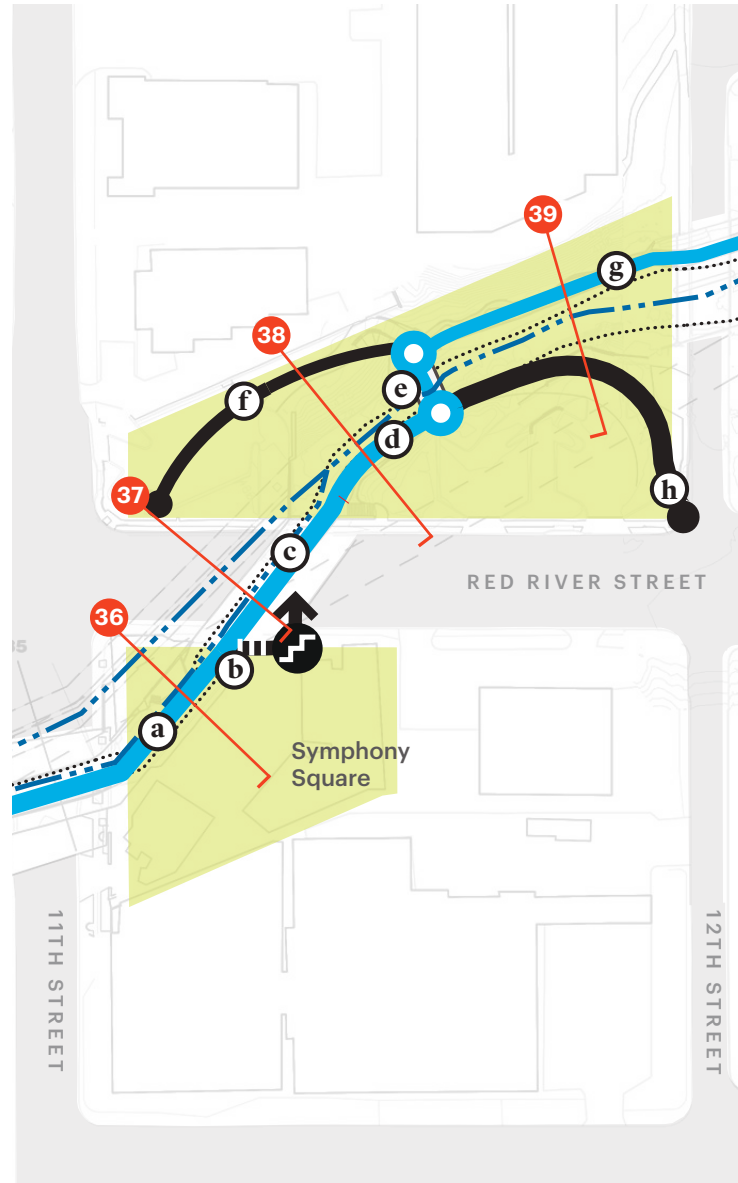
11TH TO 12TH STREETS

- a. Proposed expansion of paved gathering area at Symphony Square
- b. Stair connection to Red River Street
- c. Existing trail to remain under Red River Bridge
- d. Existing trail exceeds 5% slope; trail improvements to be coordinated with slope modifications, including connection to street level at 12th Street
- e. Existing low-water crossing to remain
- f. Proposed trailhead and access to 11th Street may require reconfiguration of existing parking lots and mid-bank stormwater flume
- g. Existing trail to remain
- h. Proposed trailhead and access to 12th Street and Red River may require reconfiguration of existing parking lots

- Smaller storm flows will be conveyed through the box culverts passing under the intersection of 11th Street and Red River.
- Symphony Square is located at a low elevation relative to Waller Creek. Large storm events may create backwater downstream of 11th Street that will cause temporary local flooding in Symphony Square. Very large storm events (>100-year event) may also need to flow through Symphony Square from upstream of Red River.

- Between 11th Street and Red River, the channel is composed of the sides of existing buildings.
- The west bank *between* Red River and 12th Street is to be restored. Failing gabions at the toe of slope near Red River should be replaced. Overbank run-off from the existing parking lot may be contributing to bank erosion; replanting is recommended.
- Upstream of Red River, on the east bank, a low retaining wall and steep lawn slopes will be

- There are three Heritage Trees within the creek corridor; several large Heritage Trees above top of bank in adjacent properties contribute shade.
- Several Heritage-class trees in good condition are in the upper terrace levels of Symphony Square, on the east bank.

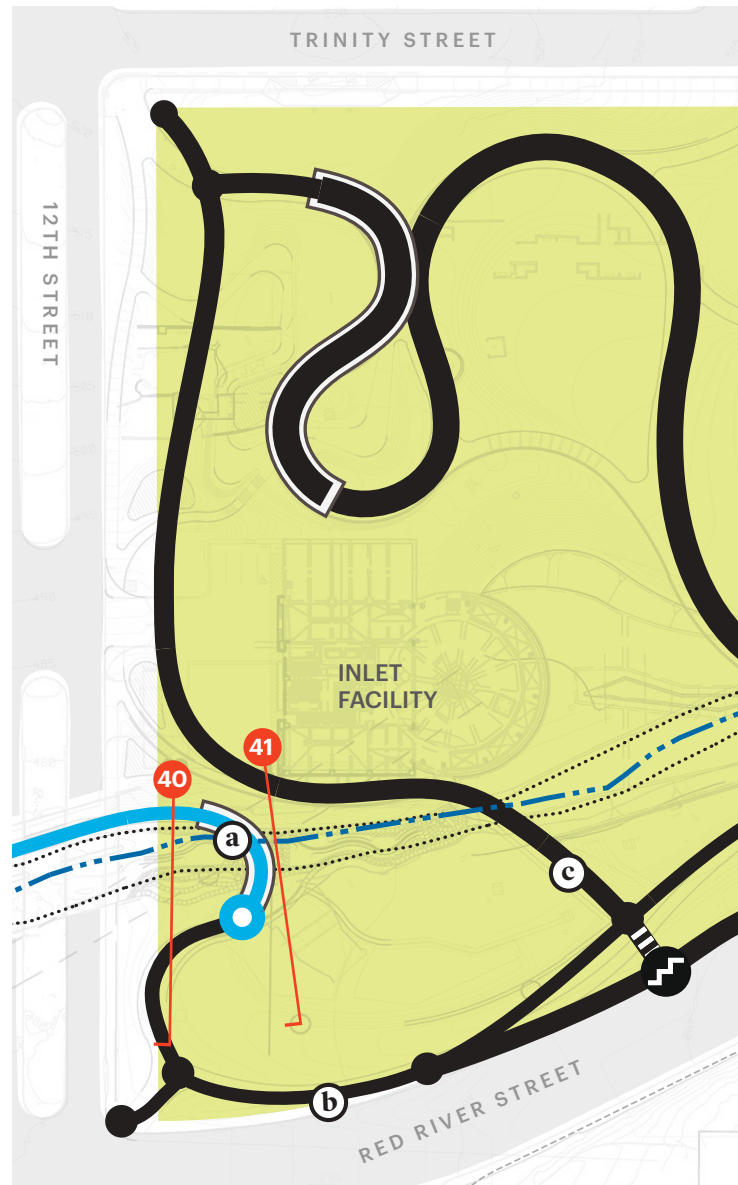
12TH STREET AND INLET FACILITY

- Zone 3 Assessment performed along Waller Creek from Red River to 3rd Street on April 2, 2015.
- Overall assessed condition is FAIR. (Riparian Zone = FAIR, Geomorphology = FAIR, Aquatic Habitat = POOR)
- Improvements should increase the overall assessed condition to GOOD or EXCELLENT.
- Consider increasing the riparian zone width, structural diversity of canopy and understory trees, reducing soil compaction, using log structures, providing shade along the channel, using natural materials such as native vegetation and rock to provide a stable channel form, and providing floodplain connectivity to improve stream function.

- Two Heritage Trees on this block are on the east bank and in fair condition.

- This block contains the primary trail connection to Waterloo Park. Heavy use is anticipated, particularly when events are being held at the Waterloo Park event venue.
- There is no direct access to the Eco-Weir, but it should be monitored for litter dropped from the pedestrian bridge above.
- Infrastructure related to the flood control functions of the Waller Creek Tunnel (e.g. the dam, recirculators, etc.) will be maintained separately from parkland and trails.

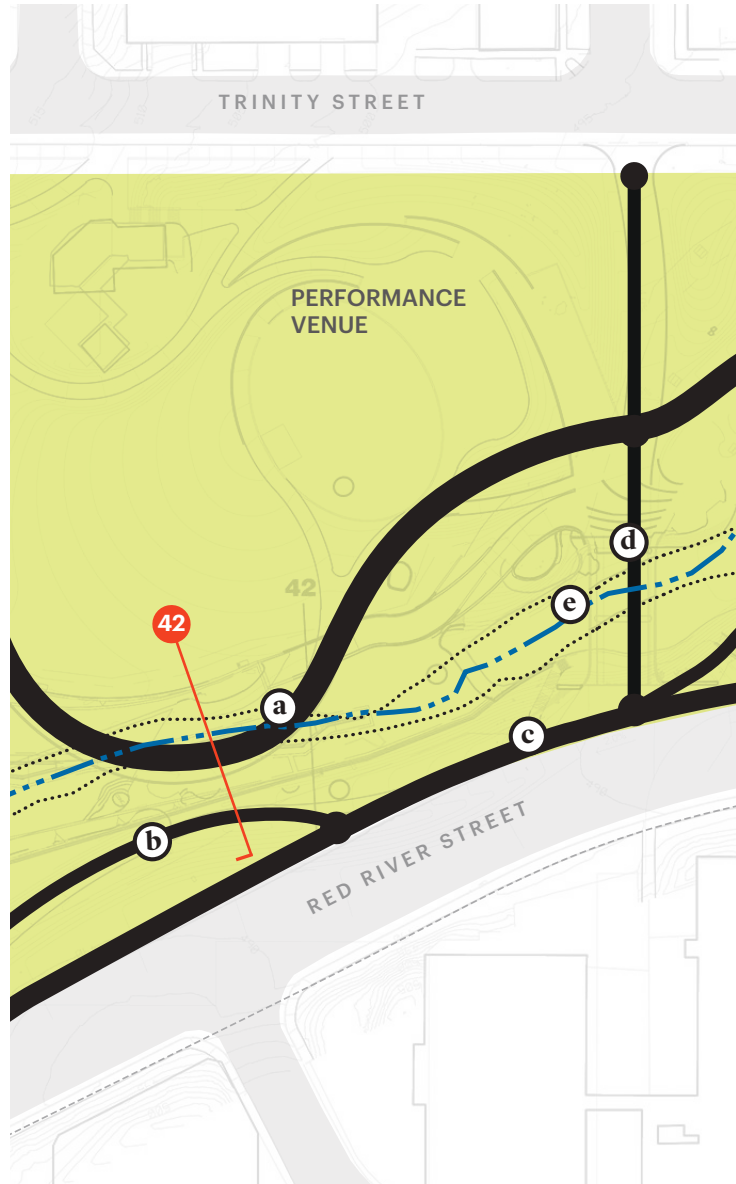
- The hydraulics in this area are controlled by the 14th Street bridge and the approach structure for the tunnel inlet.
- During the 5-year to 50-year events, the shallow, fast moving water entering Waterloo pond creates conditions conducive for a hydraulic jump or standing wave. The existence of a standing wave is not significantly altered by the presence or removal of the low-water crossing.
- The 14th Street Bridge will be overtopped during floods greater than the 25-year event.

- The creation of aquatic habitat on this block is limited by the conditions of the Waller Creek Tunnel inlet pond.
- The pond itself is constructed entirely out of

- There are three Heritage Trees on this block, all on the west bank, near the 14th Street Bridge. Two are known to be in poor condition.

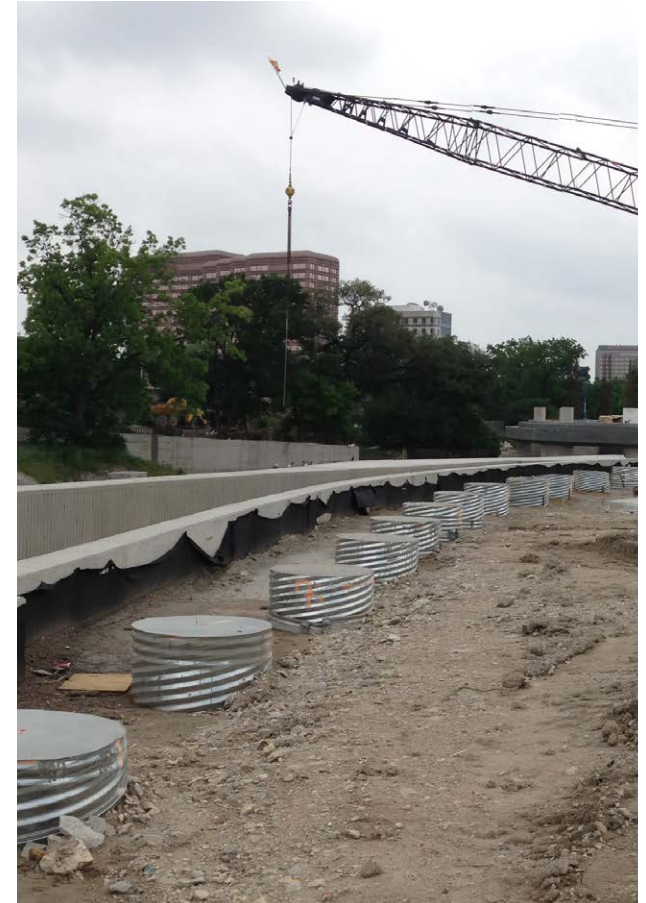
THE LAWN STRUCTURE

A critical move for the redevelopment of Waterloo Park is coordinating the current construction of the tunnel inlet facility to accommodate future sleeves for piles (pictured on right) that will support 16,000 sf expansion of park area over the inlet pond and hydrological pond vane. This structure helps mitigate the presence of these concrete structures in a park context and makes it feasible once more for Waterloo Park to host performance events and festivals

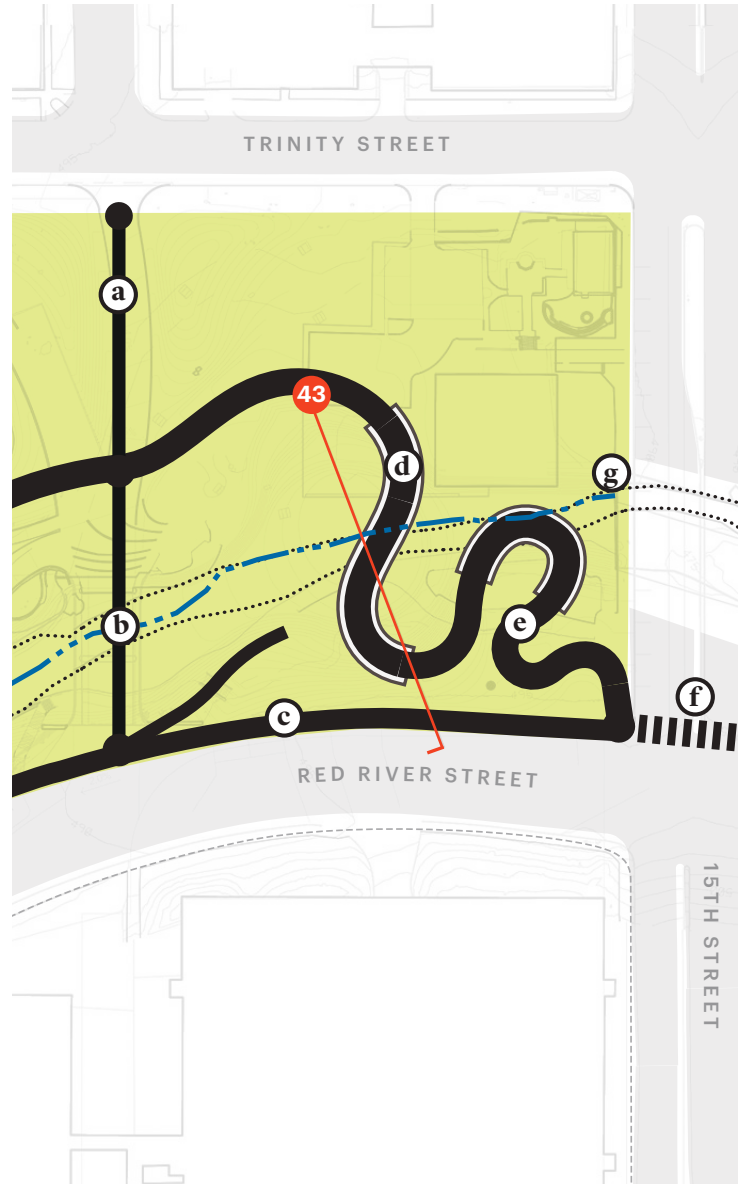
- e. A pedestrian connection (<5%) to 15th Street works around existing Heritage Trees.
- f. Primary trail pedestrian connection to new medical district occurs on the east bank of Waller Creek. A signalized pedestrian crossing is recommended with the re-alignment of Red River Street.

- The 15th Street bridge will be overtopped during floods greater than the 25-year event.
- The orientation of the 15th Street bridge relative to the downstream channel creates conditions conducive to high levels of turbulence and bank erosion.

- There are seven Heritage Trees on this block; all but one are in good or fair condition.
