GRANT APPLICATION

HISTORIC PROPERTY AND ADDRESS: 1887 West 6th Street Bridge Over Shoal Creek, located
on 6th Street between West Avenue and Wood Street.

PROJECT NAME: 1887 West 6th Street Bridge Over Shoal Creek Restoration Project

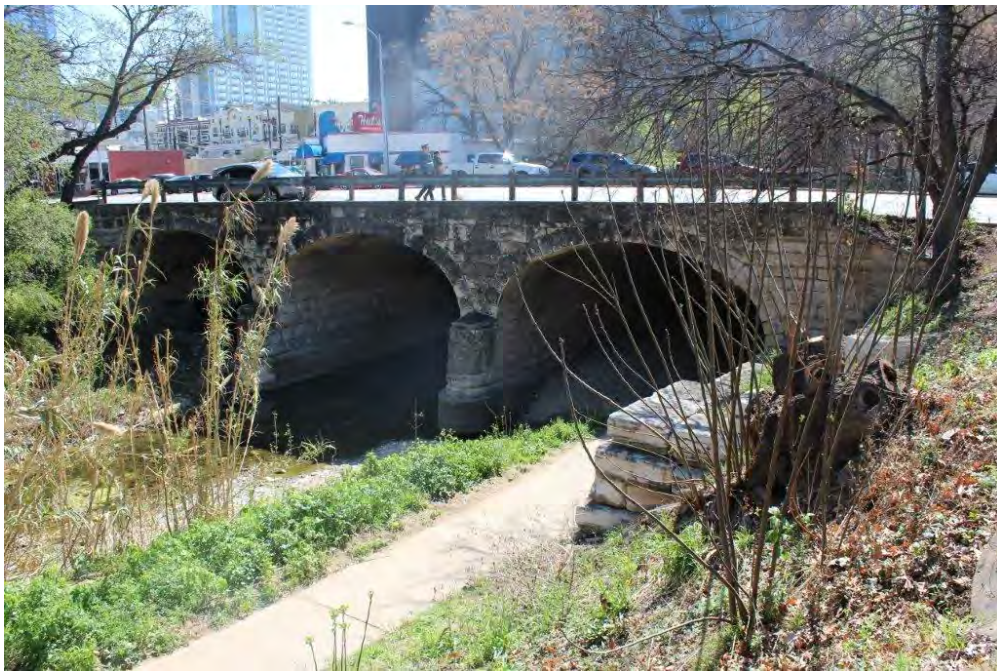
West 6th Street Bridge, north face. The metal guardrail installed in place of the destroyed parapet is visible here. The northwest retaining wall made of large stone blocks is visible on the right side of the photo.

Destroyed after many years of buffeting by flood waters, the bridge's north parapet has been replaced by a metal guardrail. The lack of lighting presents a serious safety issue and when remedied, will help draw community to the bridge. The Conservancy, Sparks

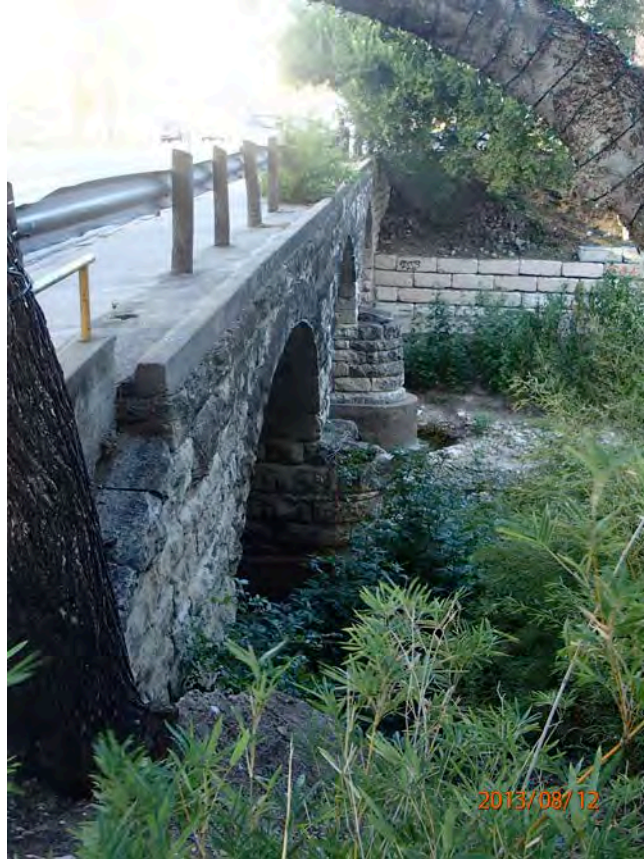
Another view of the bridge's north side and metal guardrail. The northwest retaining wall is visible here on the right side of the photo.

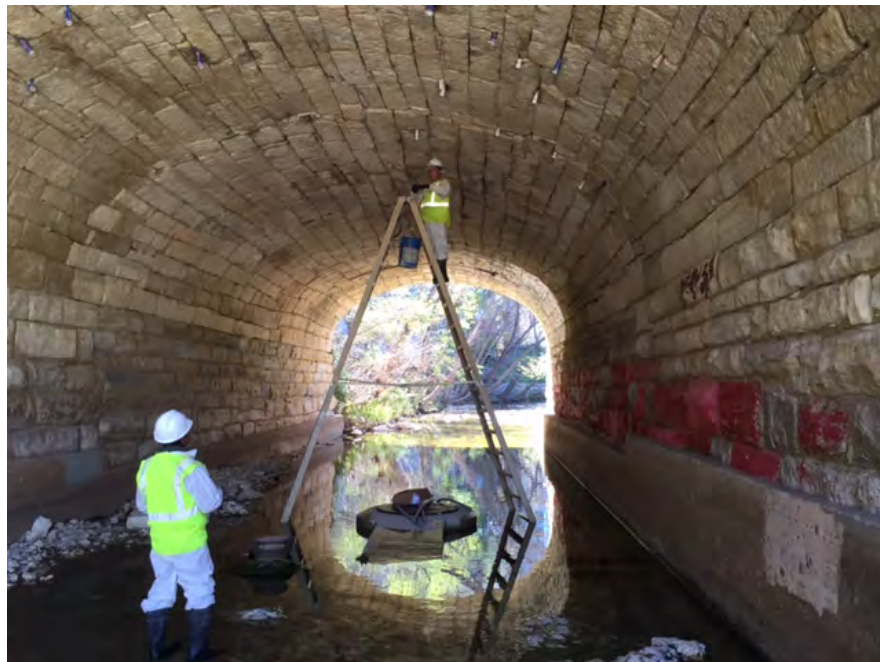
Regrouting of the bridge in 2016. The little tubes inserted in between the stones are escape chutes for the bridge's resident bats.

The *1887 West Sixth Street Bridge at Shoal Creek Restoration Study*, conducted in 2015, revealed a serious public safety concern. Severe loss of mortar had significantly reduced the carrying capacity of the bridge to only 20% of its original capacity. Shoal Creek Conservancy shared these findings with the City of Austin, which resulted in emergency re-grouting of the bridge by the City of Austin Public Works Department. The Conservancy facilitated conversations between the City, Sparks Engineering, and Bat Conservation International to ensure that the repairs both preserved the historic integrity of the bridge and ensured the safe and humane evacuation of the bridge's resident bats.

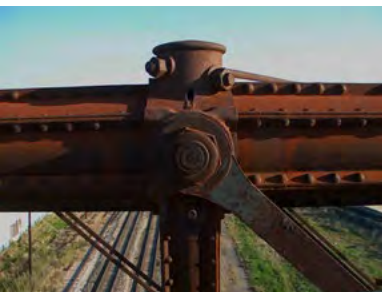
Above: Upper chord pin and eyebar connection, during assessment.

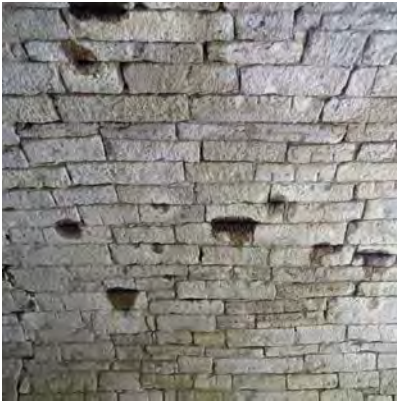
Bat colonies at dark spots

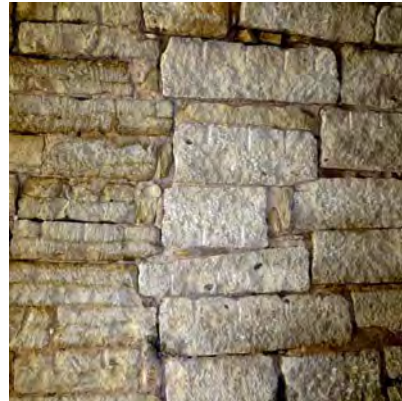
Construction joint
- change in stone -

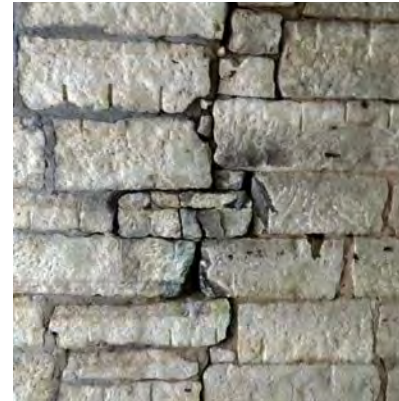
Broken stone / Missing mortar

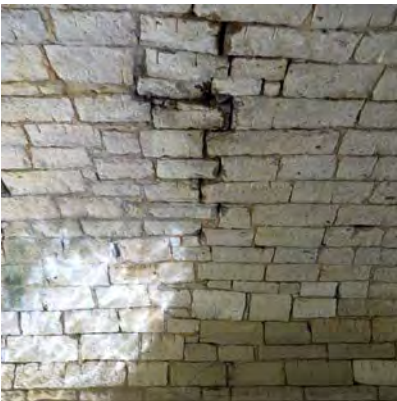
Stone slippage at joint

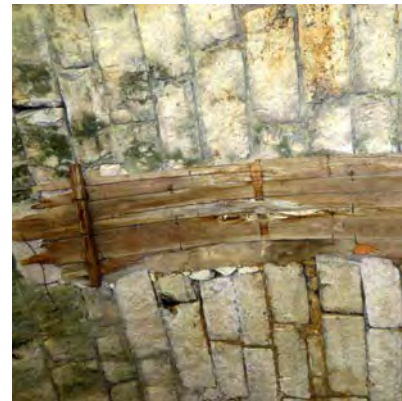
Utilities cut into arch stones

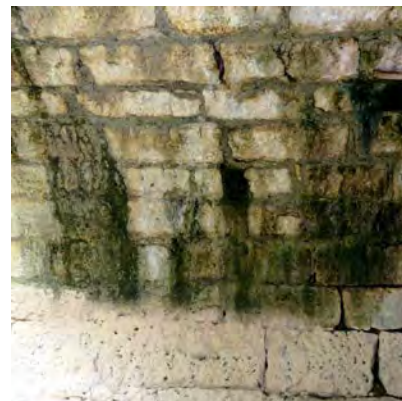
Water infiltration

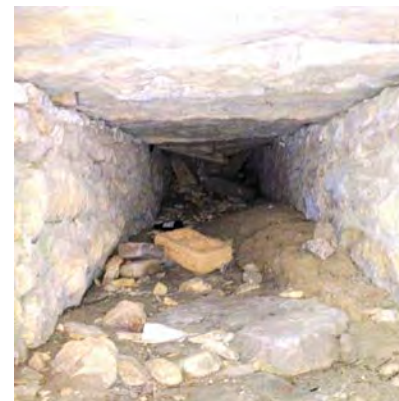
Tunnel collapse, vault A

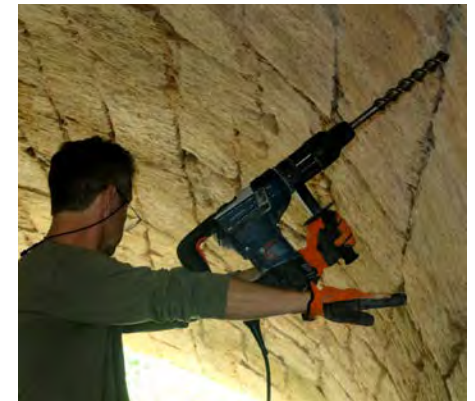
SEI drilling through an arch stone mortar joint to determine the amount of backing present within the bridge.
