# Zilker Park Bathhouse Zone Feasibility Study

City of Austin
Parks + Recreation Department

This study was prepared, and issued 10 June 2016, under the authority of W. Owen Harrod PhD, AIA, LEED AP. The text, illustrations, and appendices of this study are issued as a single unified document. This unified document is not for regulatory approval, permitting, or construction.

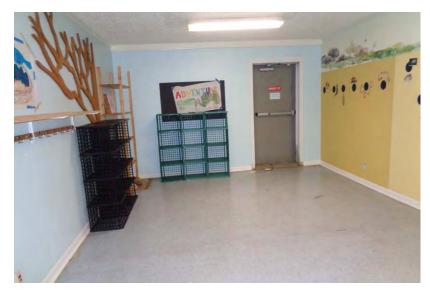
**Sheffield Center Classrooms:** The existing classrooms are too small. The emergency exit discharging into the pool enclosure is inconsistent with both the current Building Code and the Texas Administrative Code.

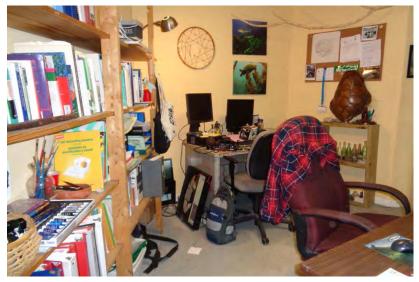
**Sheffield Center Offices:** The limited support space available to Sheffield Center staff constrains the efficient operation of facility programs.

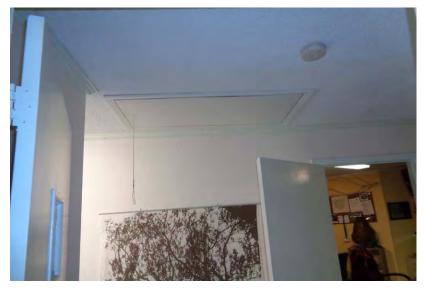
**Sheffield Center Storage Space:** Operation of the Sheffield Center is facilitated by the utilization of a mezzanine above the classrooms, accessible through this pull-down ladder.
