**SITE PLAN REVIEW SHEET  
ENVIRONMENTAL VARIANCE REQUEST ONLY**

**CASE:** SP-2017-0279D

**PROJECT NAME:** Island Cove Boat Dock

**CITY OF AUSTIN  
ENVIRONMENTAL RESOURCE INVENTORY  
FOR THE  
0.55-ACRE 4409 ISLAND COVE TRACT**

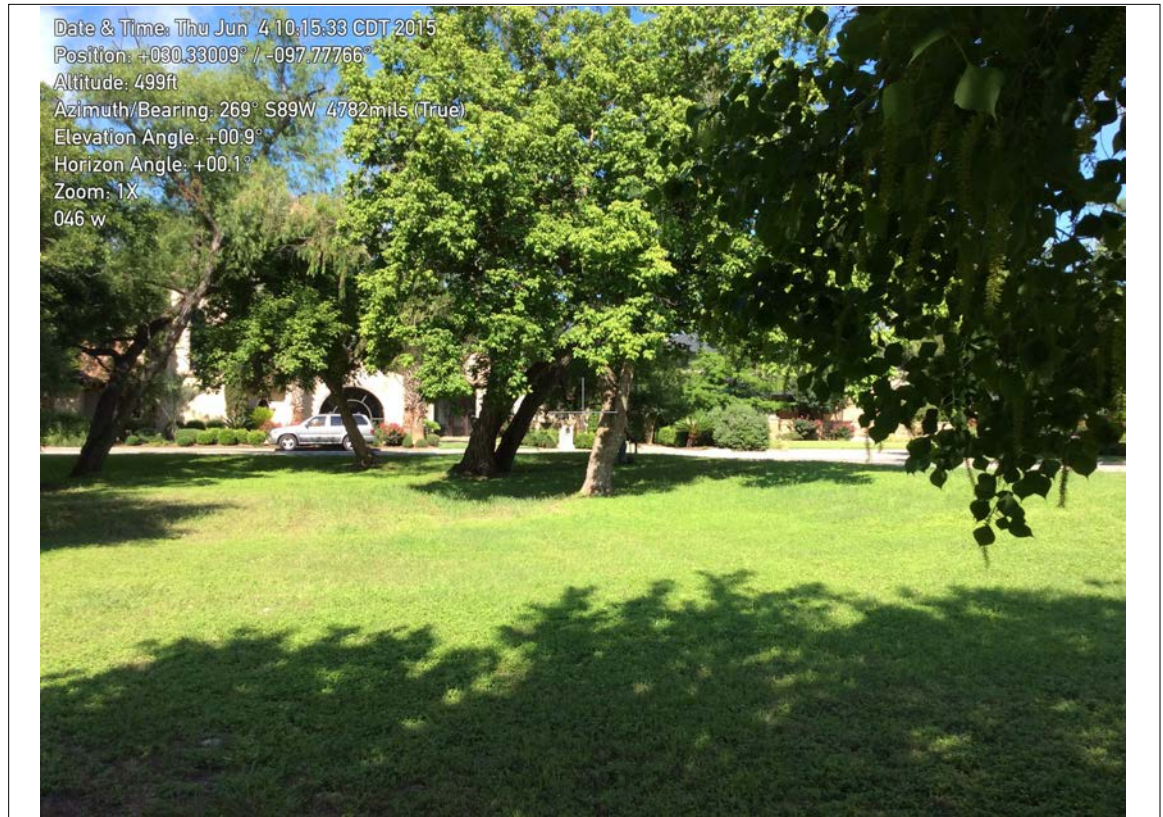
**Waypoint 046**

Photo # 002 was taken from the eastern extent of the property looking west. This photo shows the typical characteristics of the subject area. While some tree species are found on site the majority of the ground cover vegetation includes bermudagrass, cedar sedge, and straggler daisy.

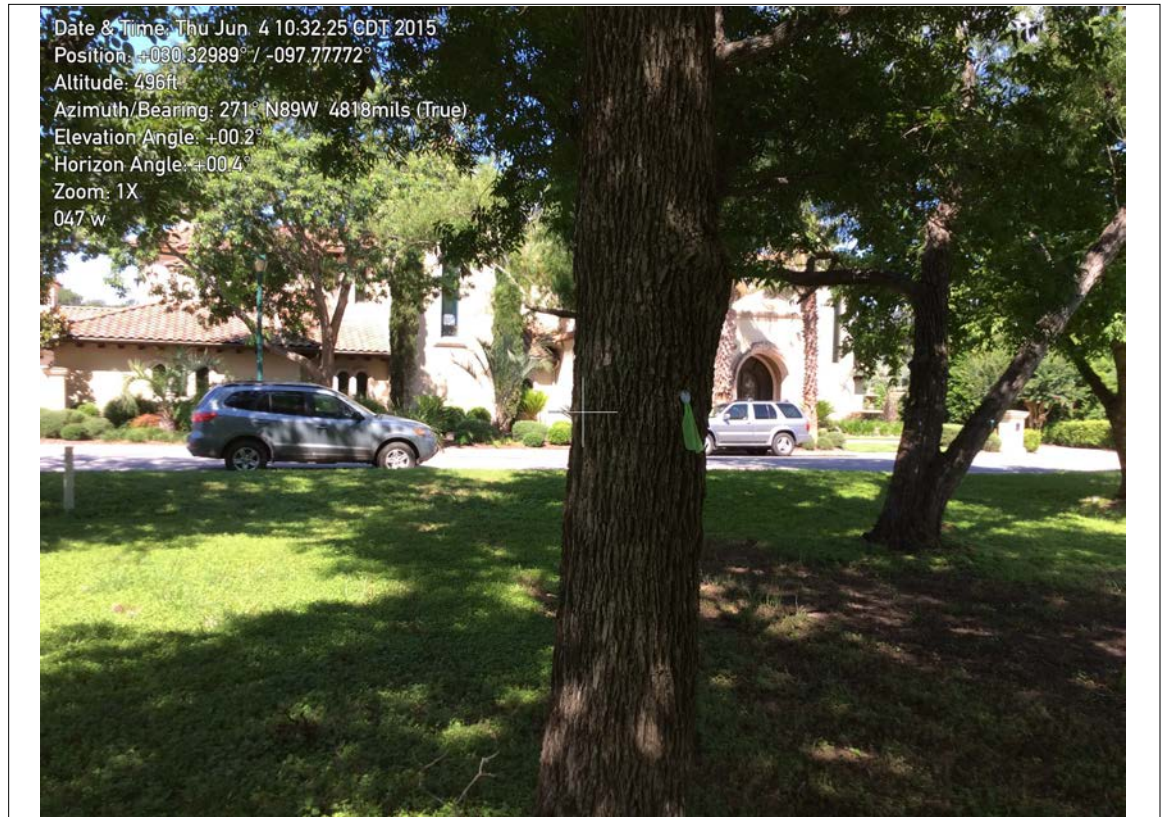
### Waypoint 047

Photo # 003 was taken from the eastern extent of the property looking west. This photo shows the typical characteristics of the subject area at this point. The majority of the ground cover vegetation includes cedar sedge and straggler daisy. Tree species near this point include pecan, green ash, white mulberry and a black willow.
