Duckworth Residence

2414 Harris Blvd.  
Austin, TX 78703

EXTERIOR ELEVATIONS

**PROJECT**  
2414 Harris Blvd.  
Historic Knippa-Huffman House

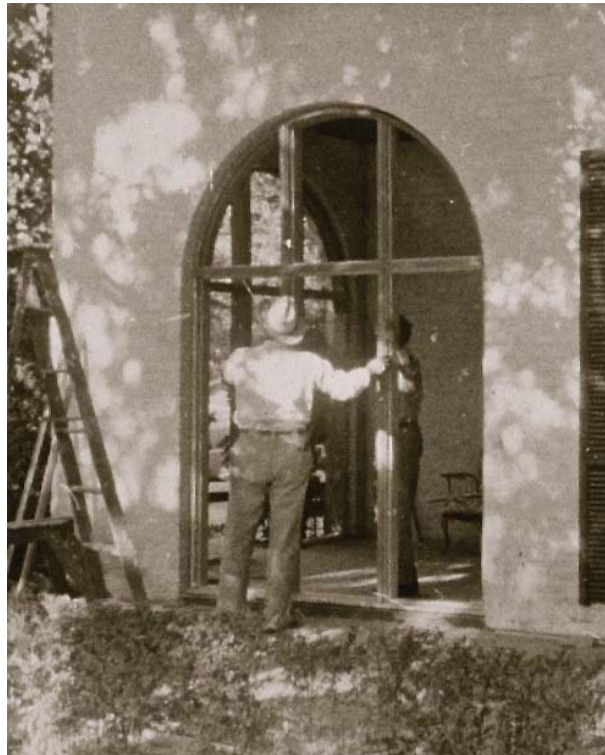
PREVIOUS OWNERS INFILLED  
SIDE PORCH TO CREATE NEW  
ENTRY; REMOVED AND STORED  
MANSBENDEL FRONT DOOR IN  
THE GARAGE.

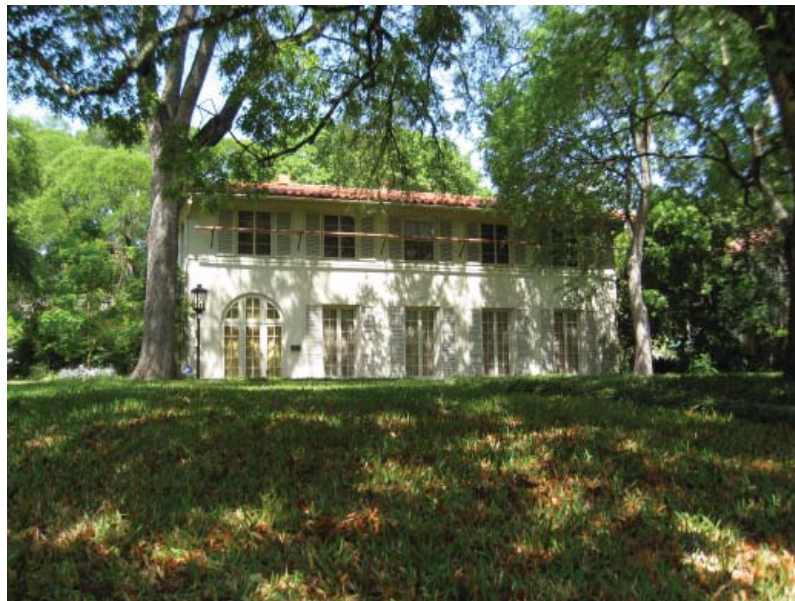
PHOTOGRAPH OF RESIDENCE WHEN CURRENT HOMEOWNERS  
PURCHASED THE HISTORIC HOME AND CHOSE TO PURSUE HISTORIC  
LANDMARK STATUS. THE SIDE PORCH WAS RETURNED TO ITS  
ORIGINAL CONDITION AS AN OPEN AIR PORCH. THE MANSBENDEL  
FRONT DOOR WAS REMOVED FROM STORAGE, RESTORED, AND  
RE-INSTALLED IN ITS ORIGINAL LOCATION.

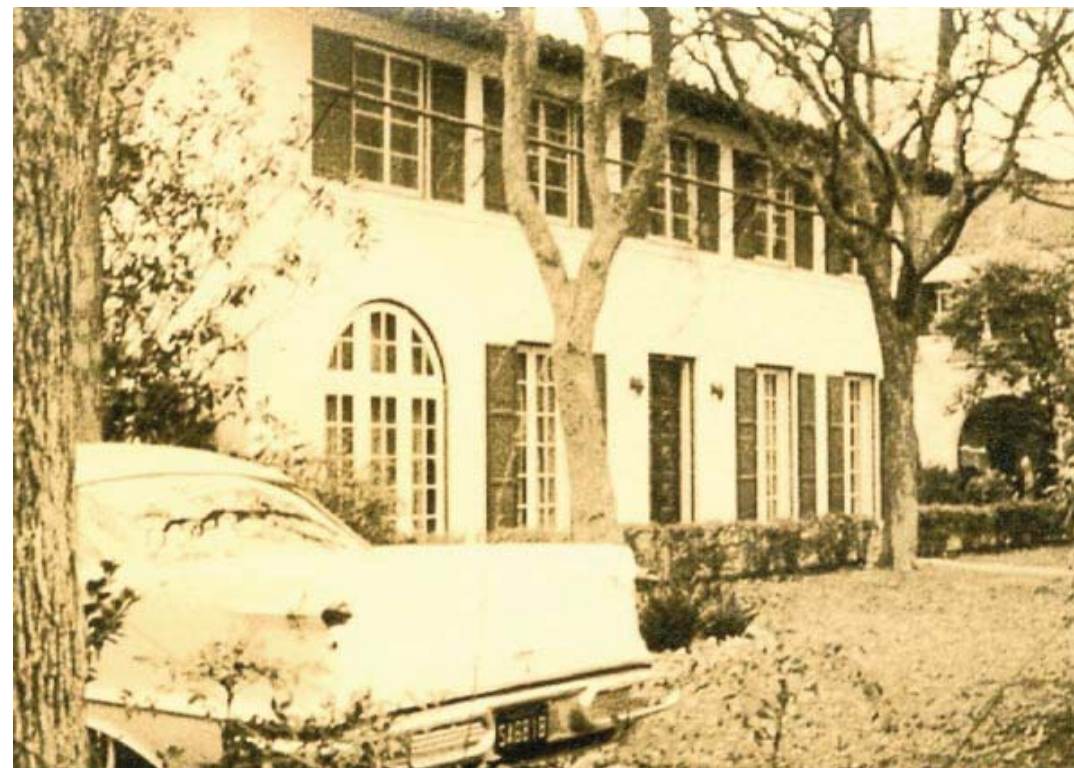
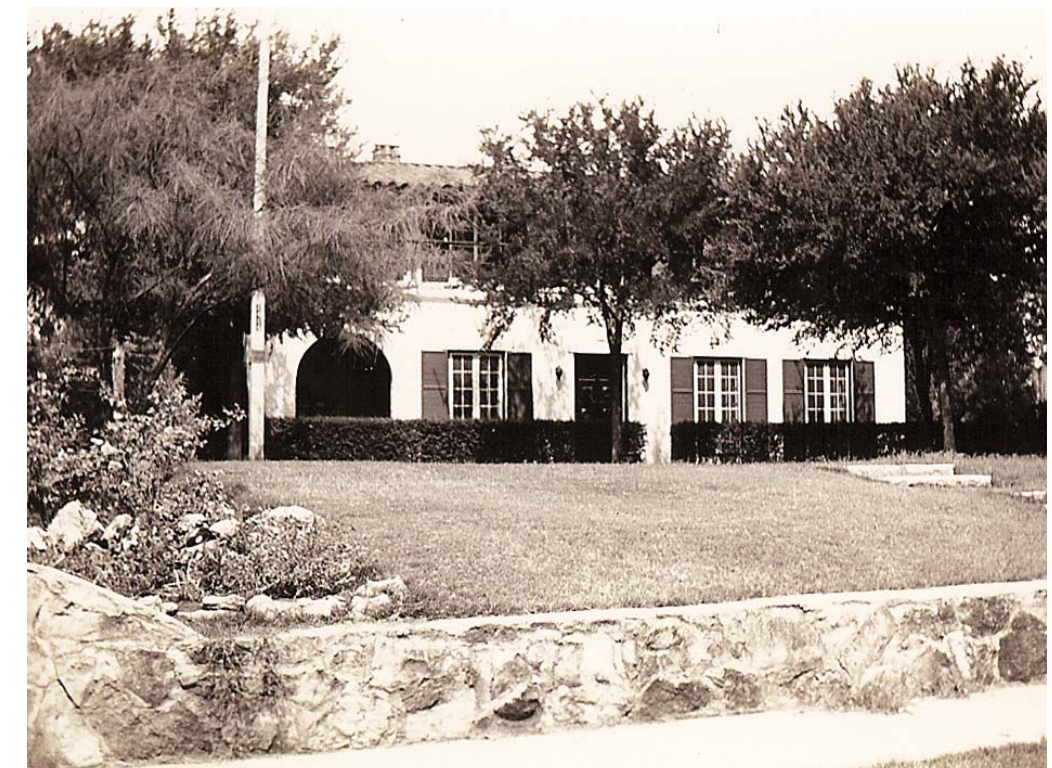
DOCUMENTATION OF EXISTING CONDITION OF ORIGINAL BUILDING FELT WITHIN WALL CAVITY.

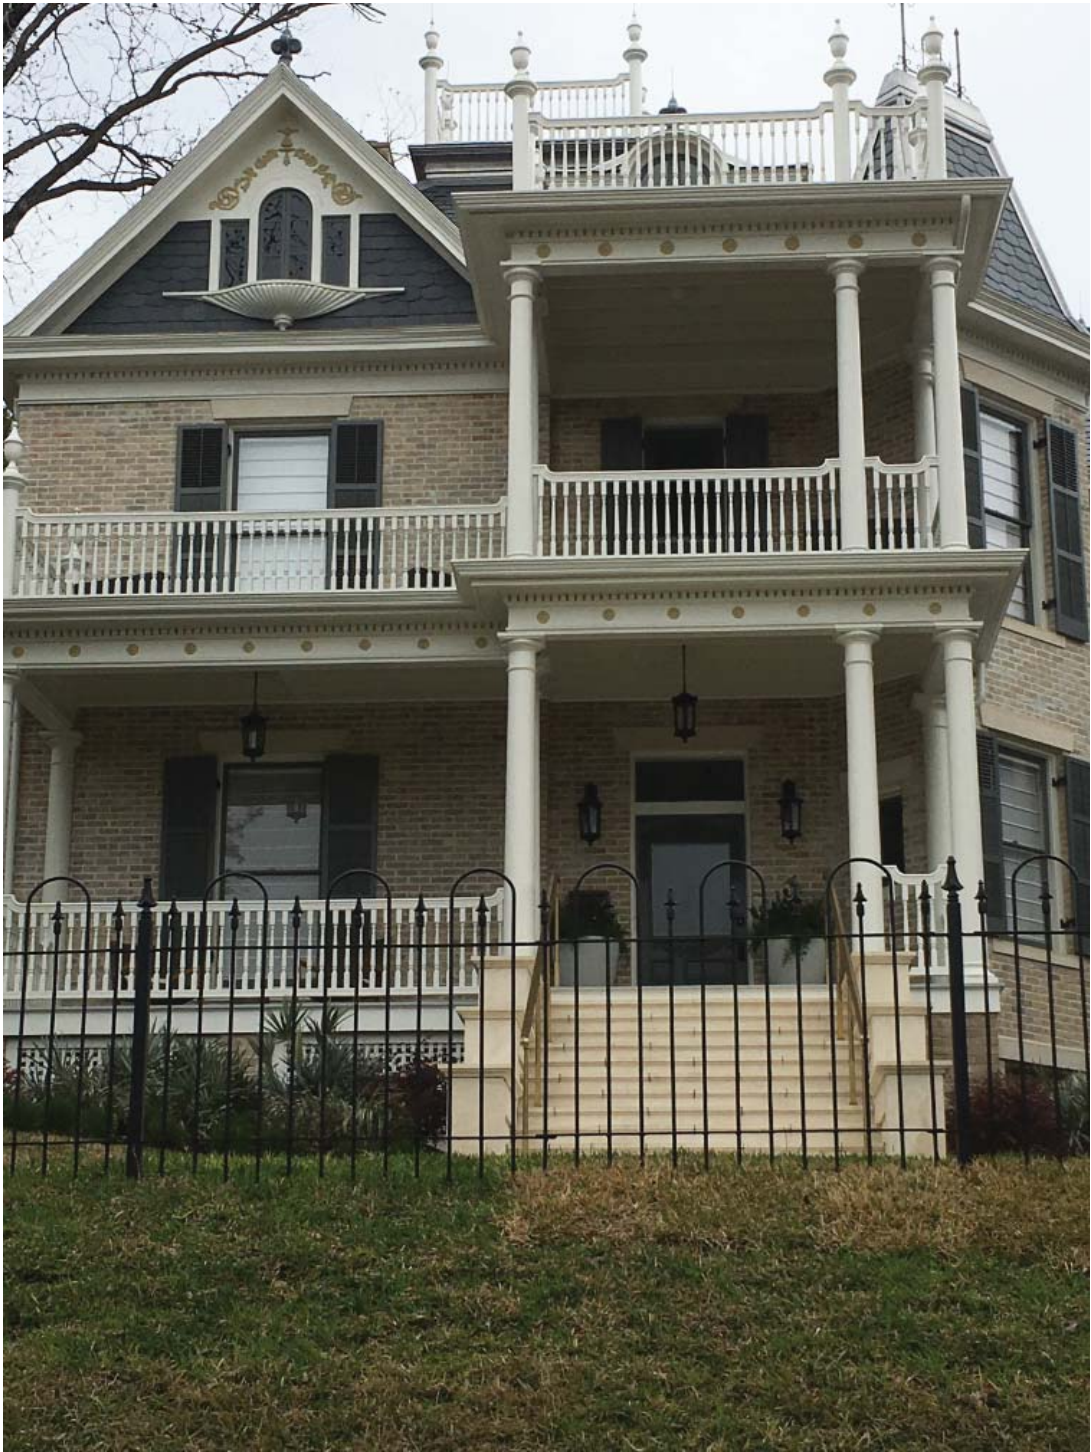
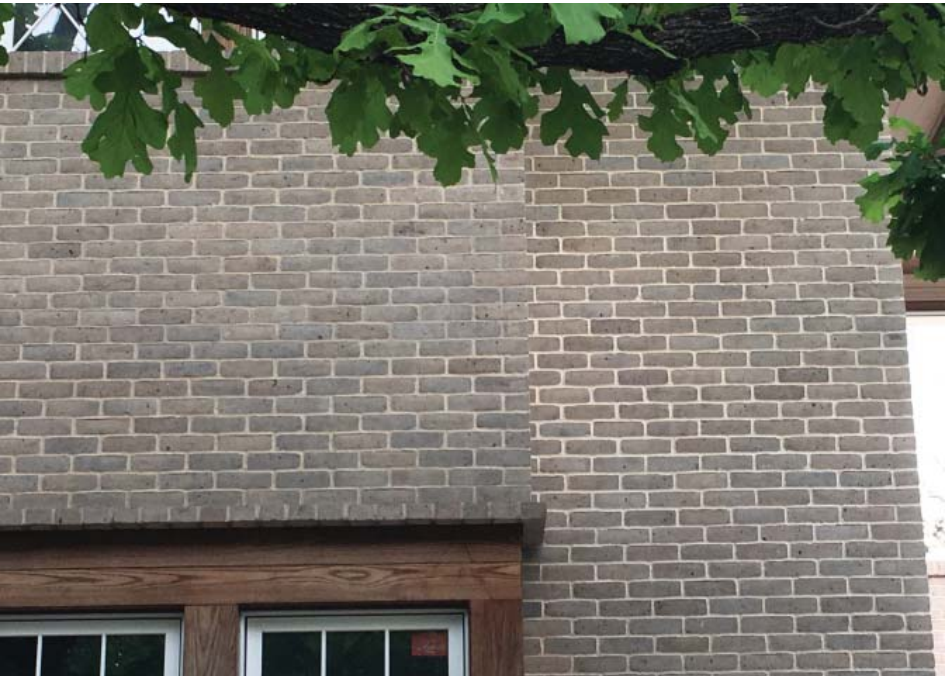
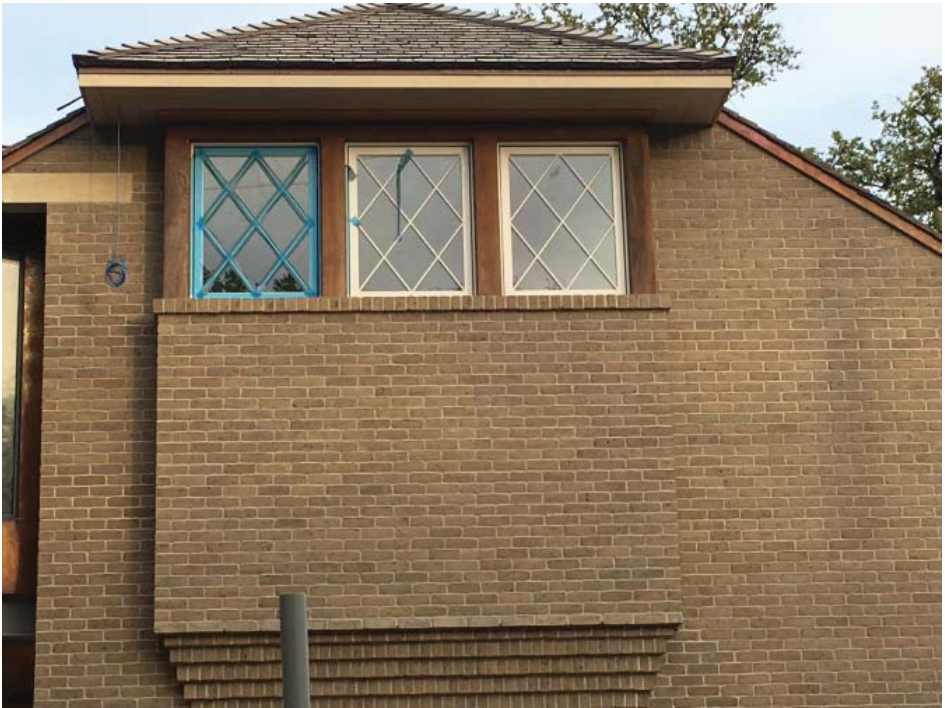
IMAGES OF COMPLETED WORK BY MASON, MICHAEL WILLIAMS. MR. WILLIAMS HAS WORKED ON SEVERAL HISTORIC, THE CONTRACTOR HAS RETAINED MR. WILLIAMS SERVICES BASED ON HIS SPECIFIC SKILL SET WORKING WITH HISTORIC MASONRY.
