Robertson/Stuart & Mair Historic District

APPENDIX D

ROBERTSON/STUART & MAIR HISTORIC DISTRICT

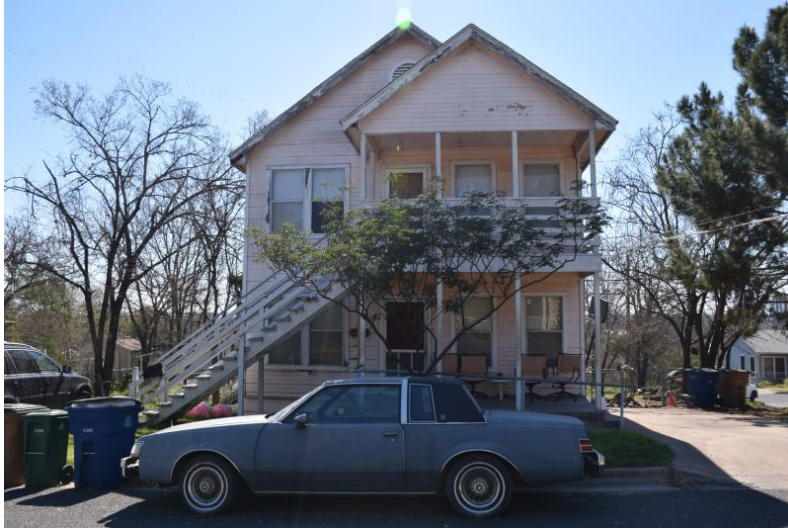
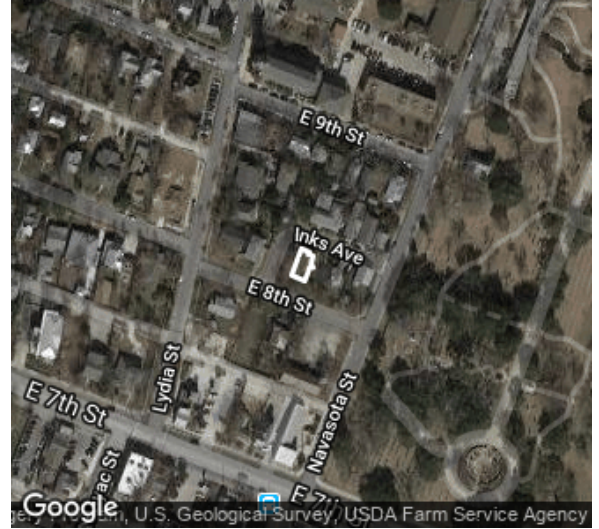
1211 INKS AVE

Alterations	None visible
Additions	None visible
Relocations	None known
Integrity notes	None

Current use	Residential
Original use	Residential
Year built	1983
Source for year built	TCAD
Type	Apartment Building
Form	Irregular plan
Stylistic influences	No style

Recommended local designations	Noncontributing
Justification for local recommendation	Not historic age
Local recommendation notes	None

Exterior wall materials	Fiber cement siding
-------------------------	---------------------

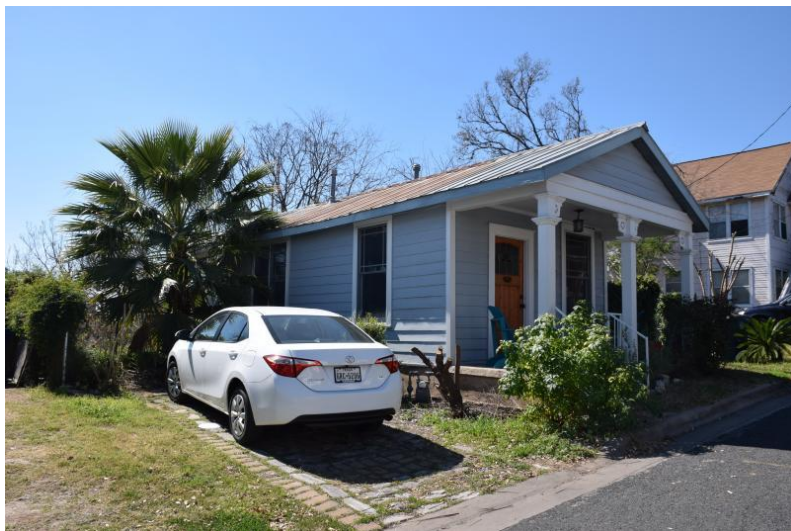
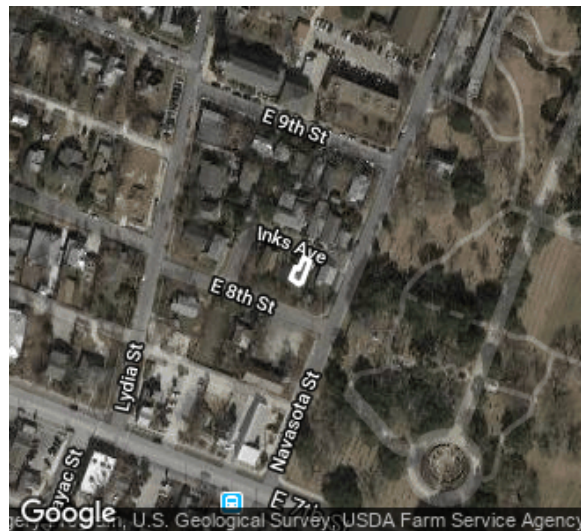
1215 INKS AVE

Current use	Residential
Original use	Residential
Year built	1936
Source for year built	TCAD
Type	Single-Family House
Form	Shotgun
Stylistic influences	Folk Victorian

Alterations	Exterior wall materials replaced with horizontal siding resembling original, Doors replaced, Windows replaced, Porch altered, Repaired and remodeled in 1980 per permit, Repaired and remodeled in 1983 per permit
Additions	Merged with neighboring building to create duplex at some point between 1962 and 1983; Restored to single-family in 1983; Addition to create bedroom in 1984 per permit, Bedroom/sunroom/laundry room in 2005 per permit
Relocations	None known
Integrity notes	None

Recommended local designations	Contributing
Justification for local recommendation	Retains integrity
Local recommendation notes	None

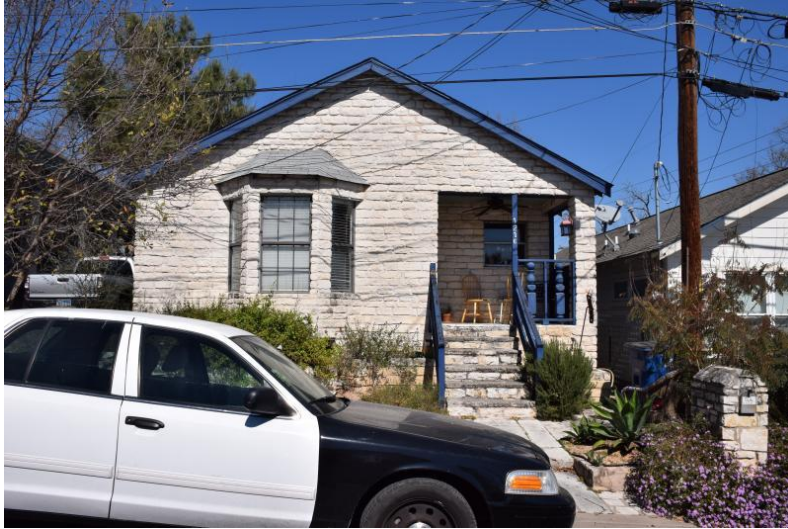
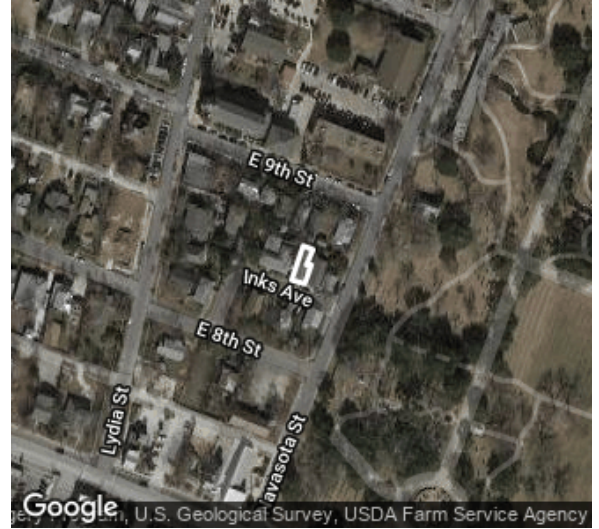
1216 INKS AVE

Alterations	Exterior wall materials replaced, Windows replaced, Doors replaced, Fenestration altered, Angled bay added, Porch altered.
Additions	Rear addition, likely in 1966 per TCAD
Relocations	None known
Integrity notes	None

Recommended local designations	Noncontributing
Justification for local recommendation	Lacks integrity
Local recommendation notes	None

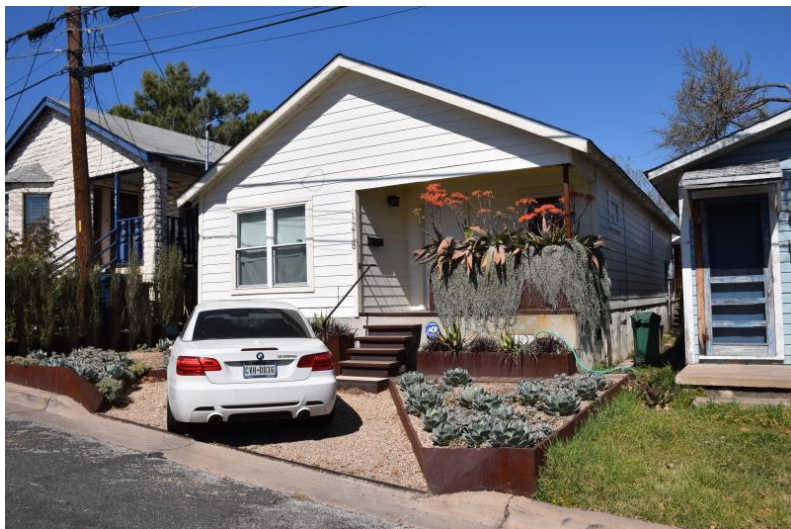
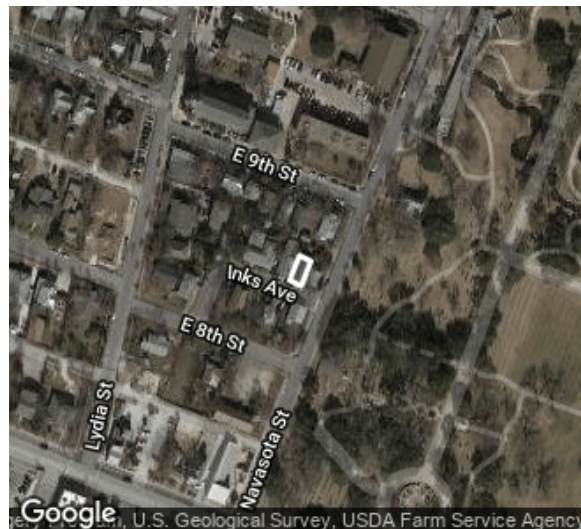
1218 INKS AVE

Alterations	Exterior wall materials replaced with horizontal siding resembling original, Doors replaced, Windows replaced, Repaired and remodeled in 1983 per permit, Interior demolition and remodel in 2008 per permit, Replaced doors/windows/panels and interior remodel in 2009 per permit
Additions	None visible
Relocations	None known
Integrity notes	None

Recommended local designations	Contributing
Justification for local recommendation	Retains integrity
Local recommendation notes	None

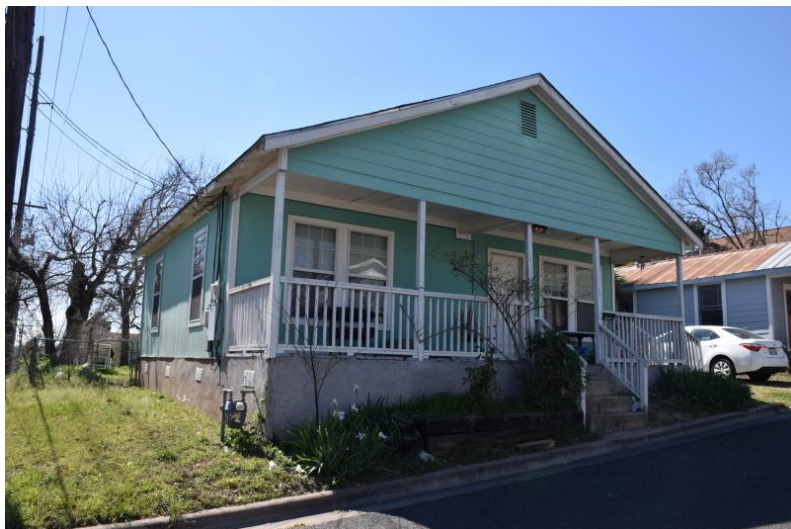
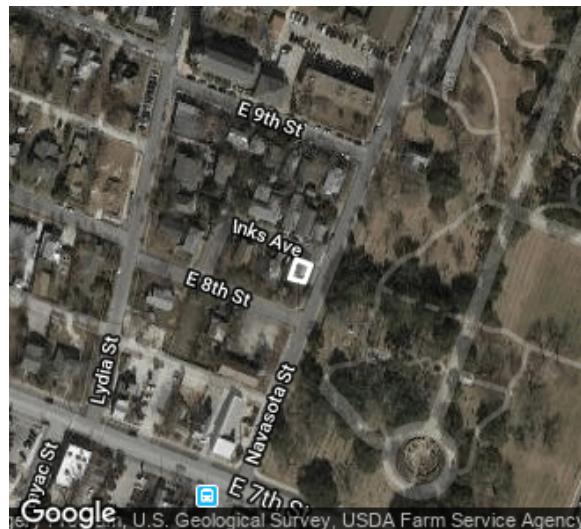
1219 INKS AVE

Alterations	1962 permit for "remodel" actually new building, Doors replaced, Windows replaced, Porch altered, Re-roofed and replaced siding in 2007 per permit (siding partially matches original horizontal siding)
Additions	Rear addition in 1976 per permit
Relocations	None known
Integrity notes	None

Recommended local designations	Contributing
Justification for local recommendation	Moved onto lot within period of significance
Local recommendation notes	None

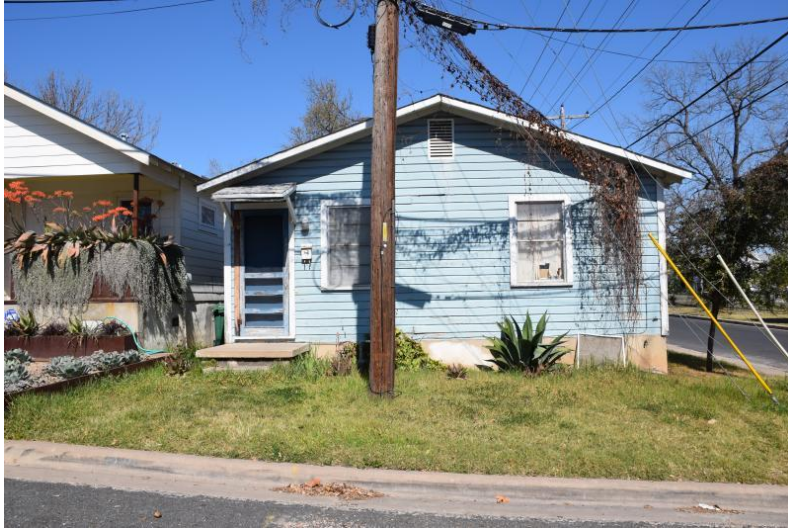
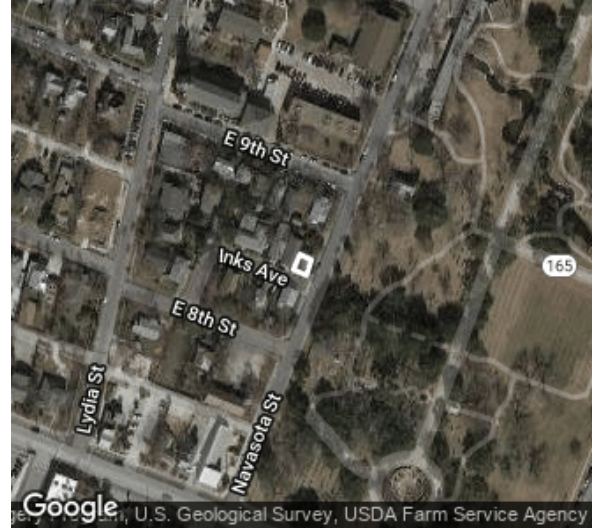
1220 INKS AVE

Recommended local designations	Contributing
Justification for local recommendation	Retains integrity
Local recommendation notes	None

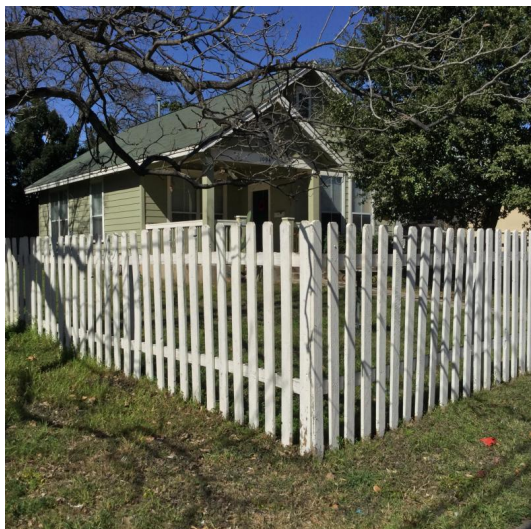
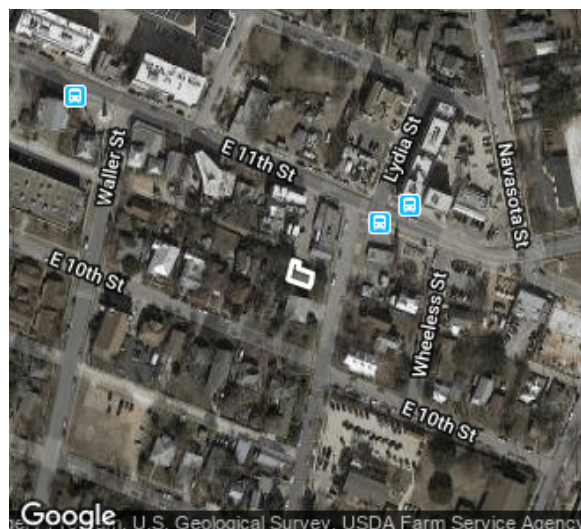
1004 LYDIA ST

Alterations	Doors replaced, Windows replaced, Exterior wall materials replaced
Additions	None visible
Relocations	None known
Integrity notes	None

Recommended local designations	Noncontributing
Justification for local recommendation	Not historic age
Local recommendation notes	None

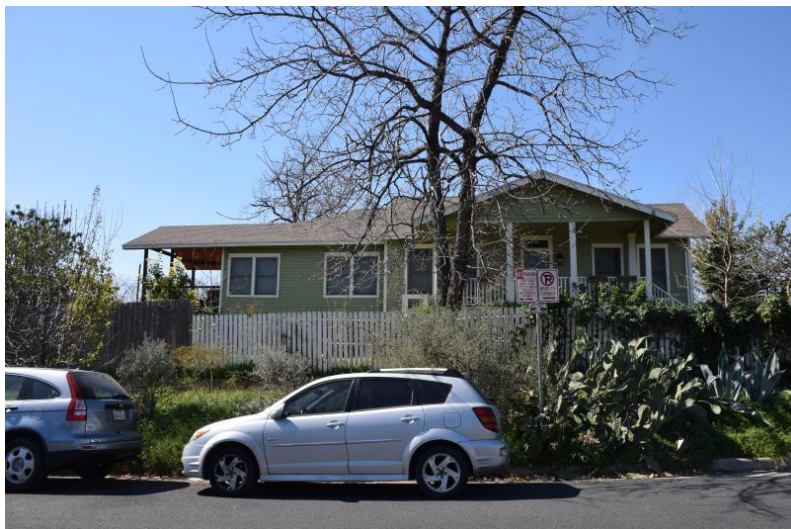
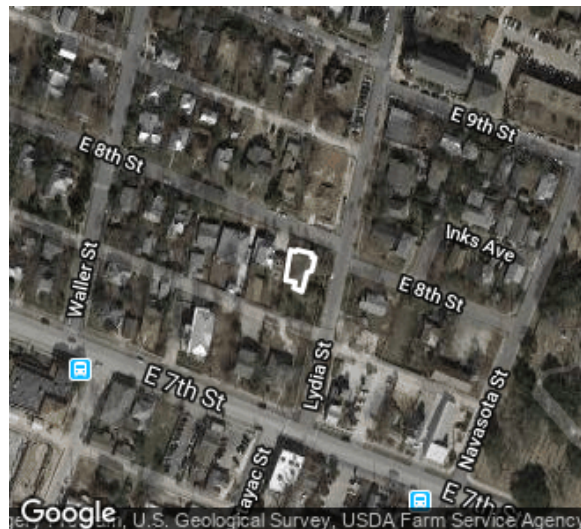
710 LYDIA ST

Recommended local designations	Contributing
Justification for local recommendation	Retains integrity
Local recommendation notes	None

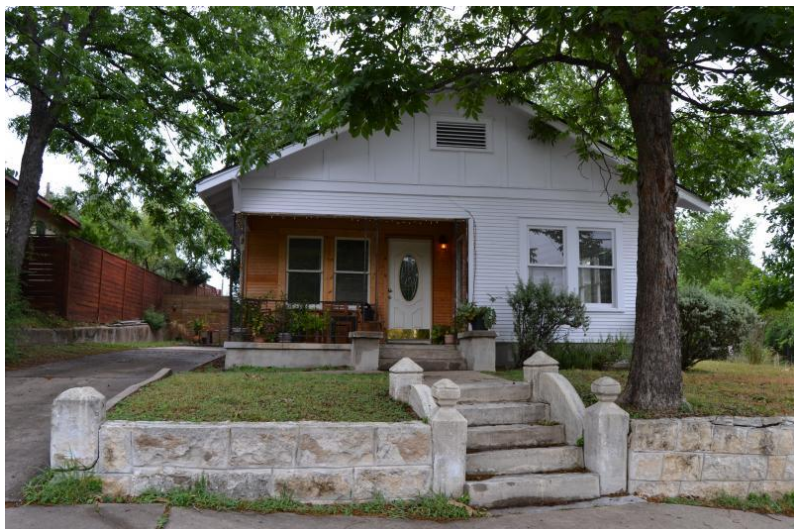
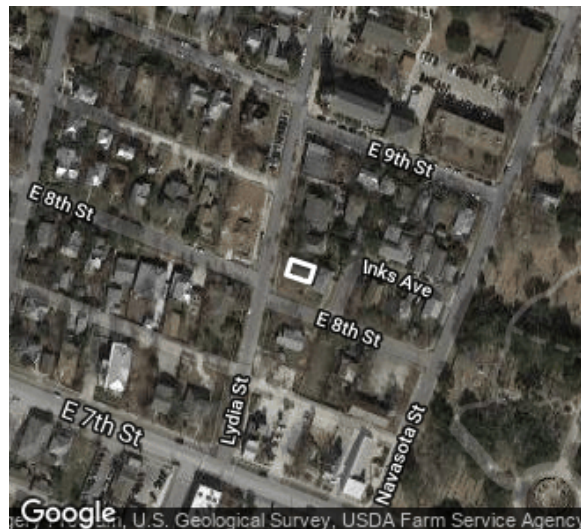
801 LYDIA ST

Alterations	Doors replaced, Porch altered, Side dormer added
Additions	None visible
Relocations	None known
Integrity notes	None

Recommended local designations	Contributing
Justification for local recommendation	Retains integrity
Local recommendation notes	None

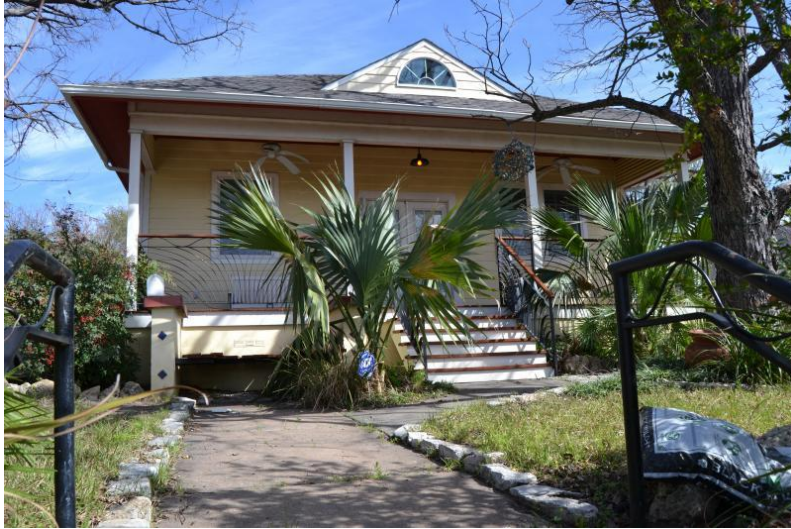
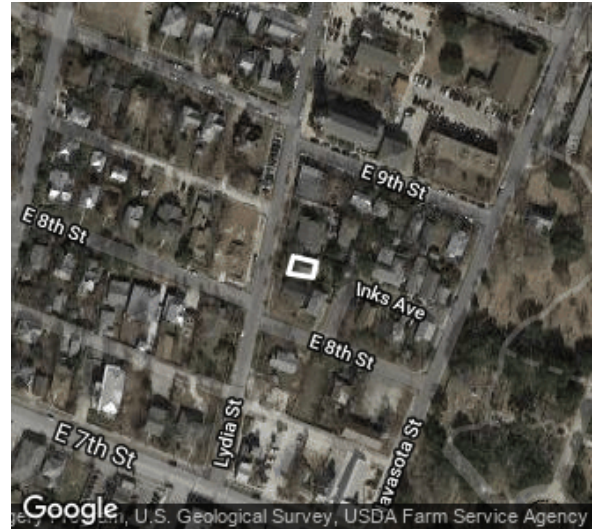
803 LYDIA ST

Alterations	Doors replaced, Windows replaced, Re-roofed in 1947 per permit, Enclosed porch in 2003 per permit, Dormer added, Fenestration altered.
Additions	None visible
Relocations	None known
Integrity notes	None

Recommended local designations	Noncontributing
Justification for local recommendation	Lacks integrity
Local recommendation notes	None

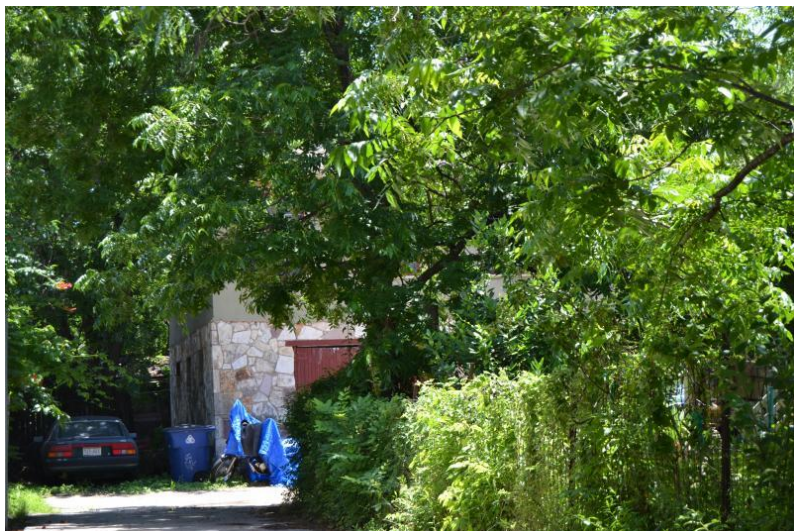
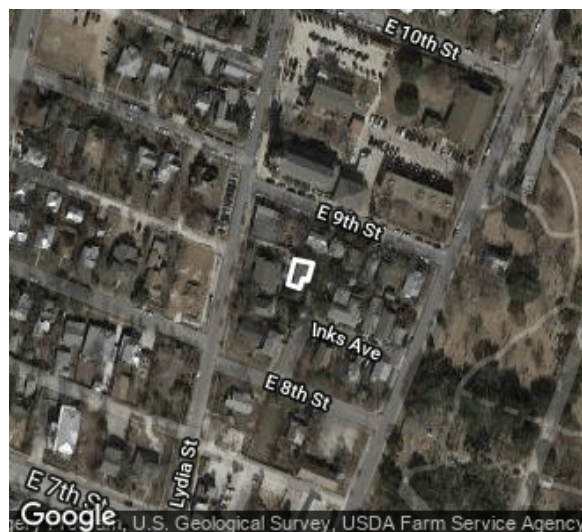
805 LYDIA ST

Alterations	Doors replaced, Windows replaced, Exterior wall materials replaced
Additions	None visible
Relocations	None known
Integrity notes	Alterations compatible

Recommended local designations	Contributing
Justification for local recommendation	Retains integrity
Local recommendation notes	None

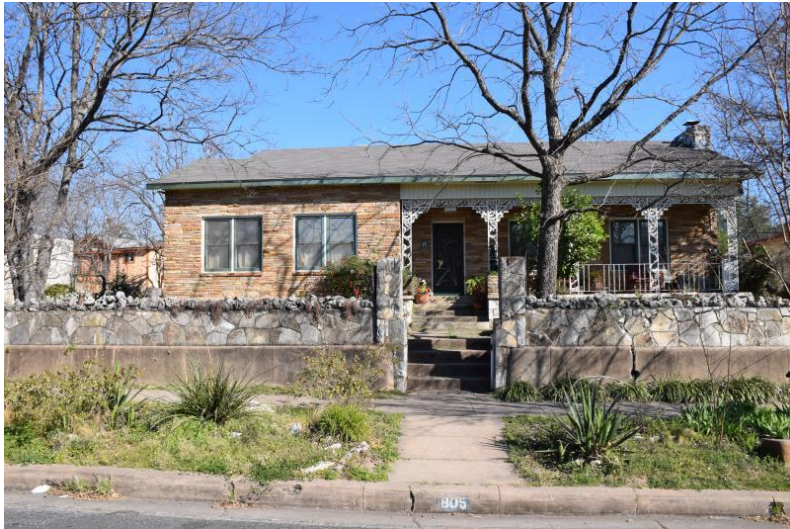
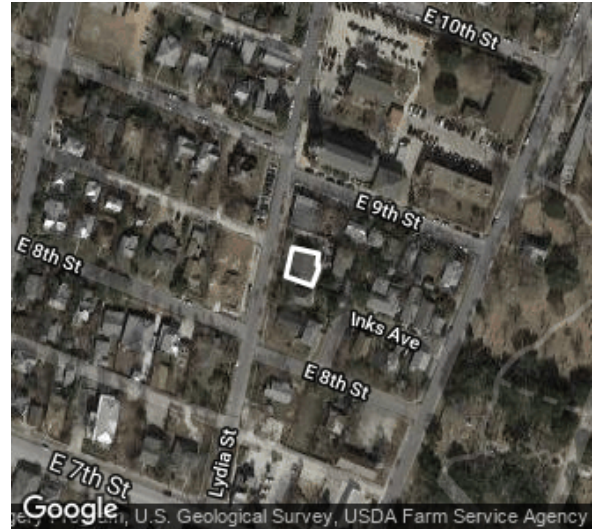
805 LYDIA ST

Recommended local designations	Contributing
Justification for local recommendation	Retains integrity
Local recommendation notes	None

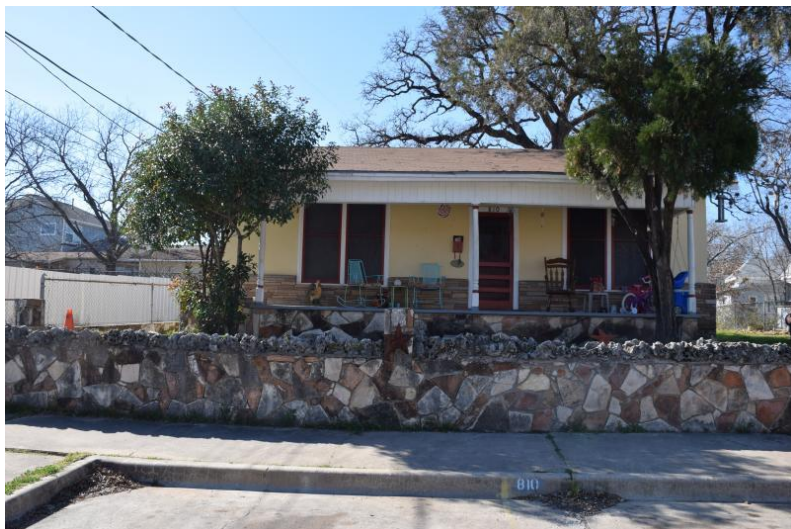
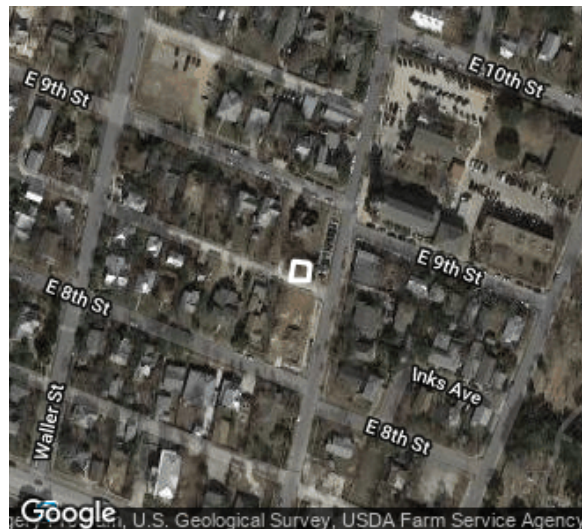
810 LYDIA ST

Alterations	Exterior wall materials replaced
Additions	None visible
Relocations	None known
Integrity notes	None

Recommended local designations	Contributing
Justification for local recommendation	Retains integrity
Local recommendation notes	None

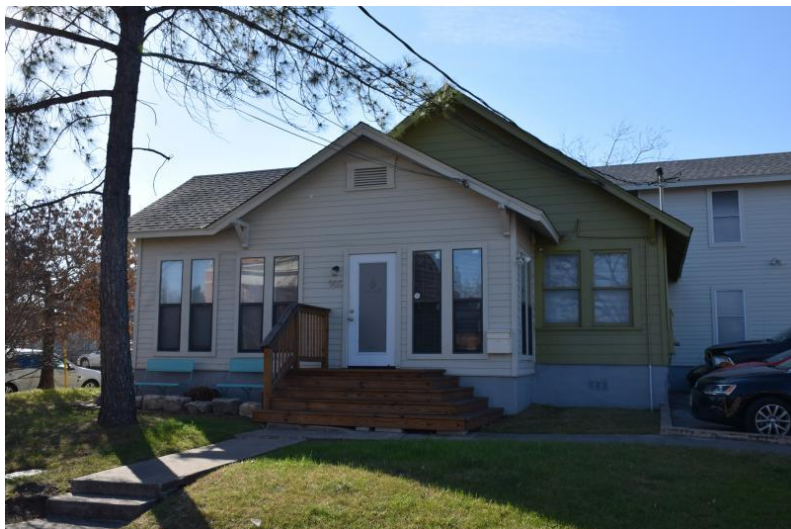
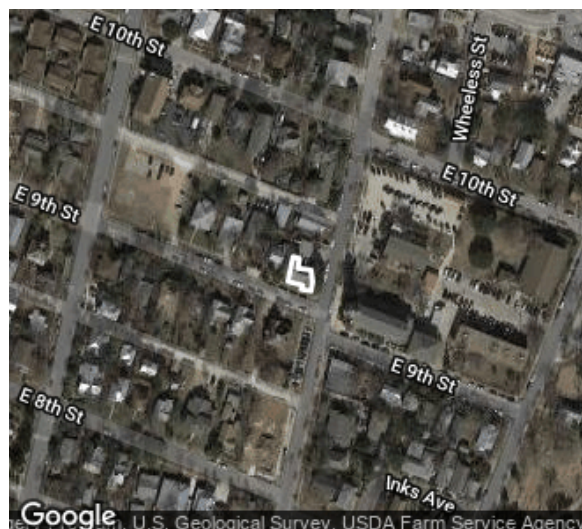
900 LYDIA ST

Alterations	Porch enclosed, Exterior wall materials replaced, Remodeled in 1980 per permit, Converted from residence to doctor's office in 1988 per permit, replaced wood deck in 2014 per permit
Additions	Office addition in 2014 per permit
Relocations	None known
Integrity notes	None

Recommended local designations	Noncontributing
Justification for local recommendation	Lacks integrity
Local recommendation notes	None

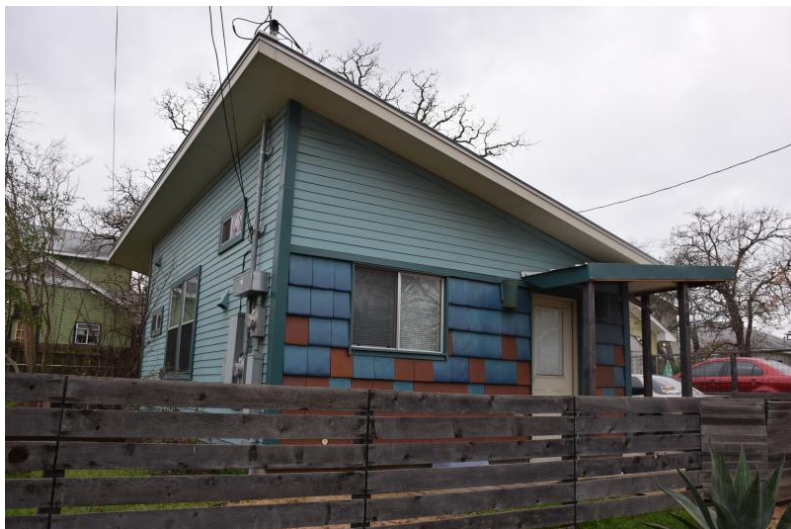
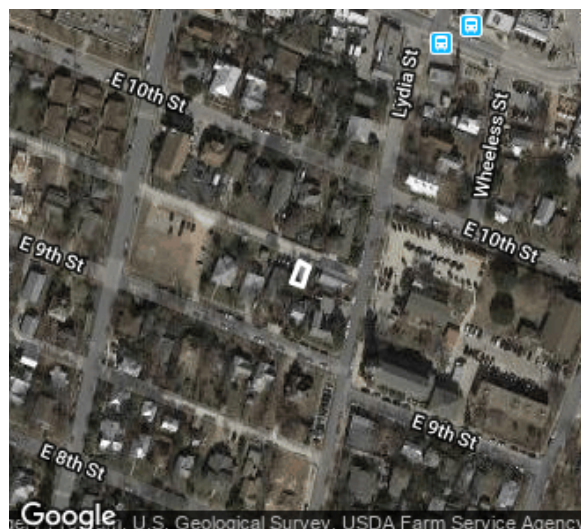
904 LYDIA ST

Recommended local designations	Noncontributing
Justification for local recommendation	Not historic age
Local recommendation notes	None

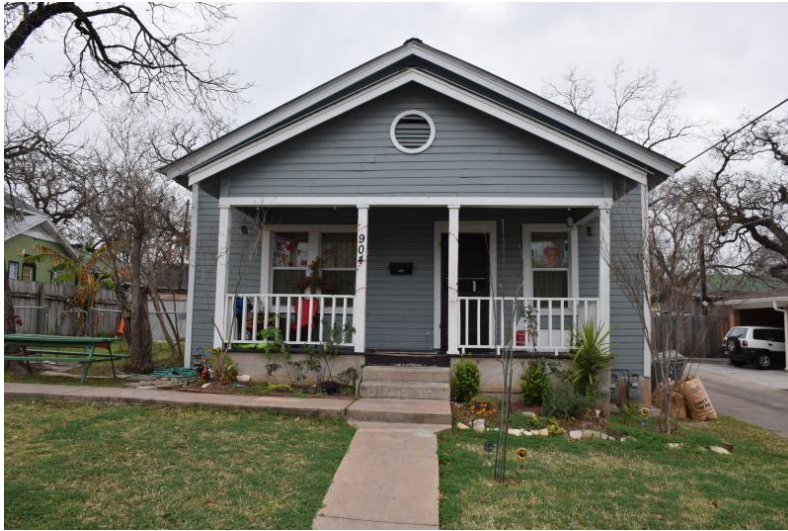
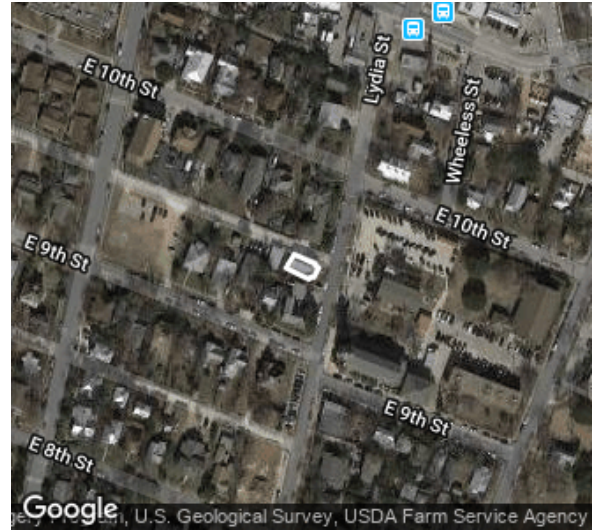
904 LYDIA ST

Alterations	Some windows replaced, Door replaced, Fenestration altered
Additions	None visible
Relocations	None known
Integrity notes	None

Recommended local designations	Contributing
Justification for local recommendation	Retains integrity
Local recommendation notes	None

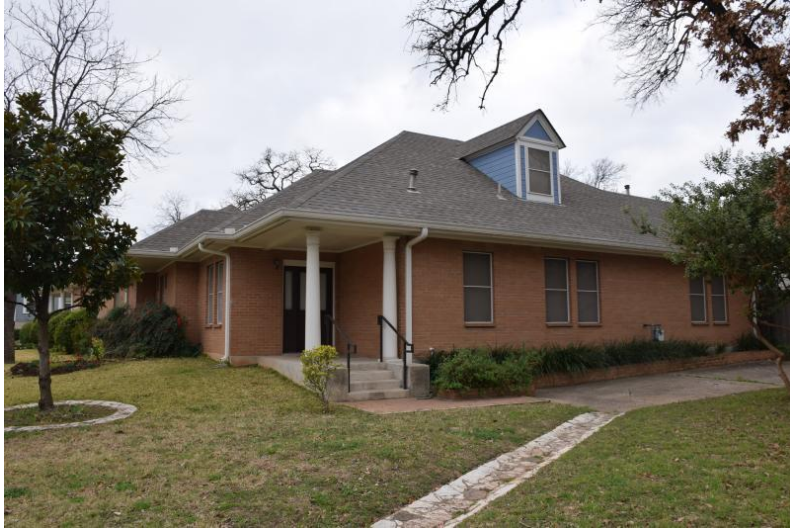
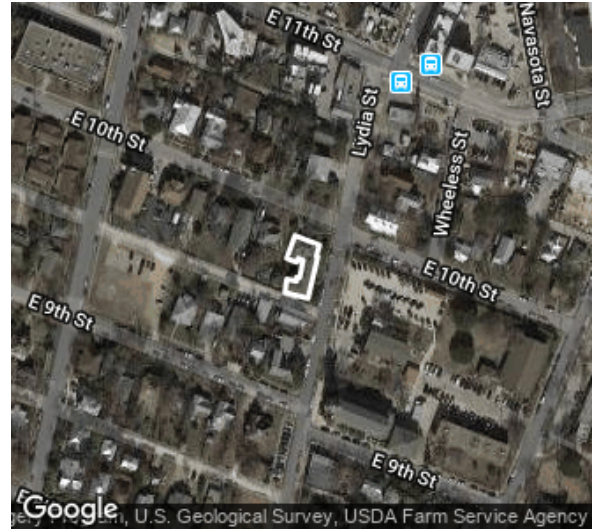
912 LYDIA ST

Recommended local designations	Noncontributing
Justification for local recommendation	Not historic age
Local recommendation notes	None

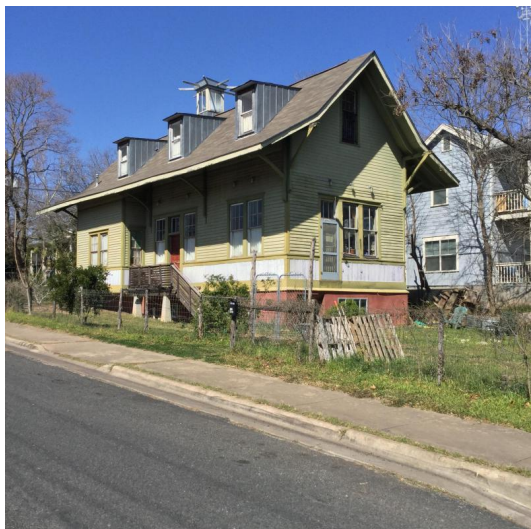
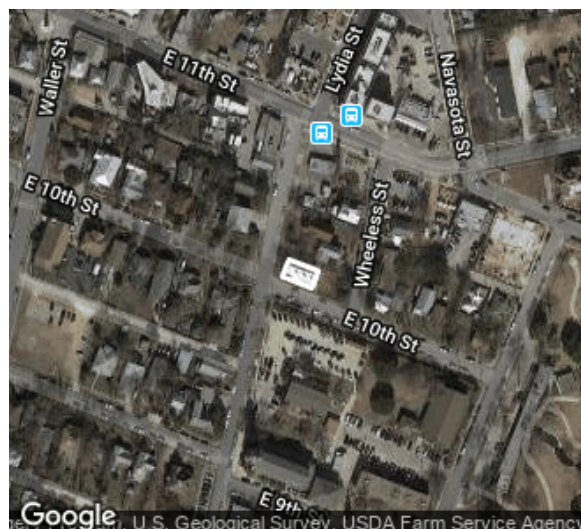
1001 LYDIA ST

Alterations	Dormers altered, Porch altered, Some exterior wall materials replaced
Additions	None
Relocations	None
Integrity notes	Moved to current location from Granger ca. 2010

Recommended local designations	Non-contributing
Justification for local recommendation	Relocated ca. 2010; new context not adjacent to railroad tracks
Local recommendation notes	Robertson Hill

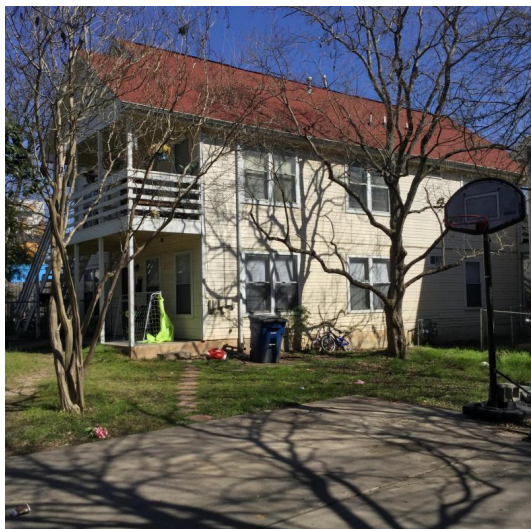
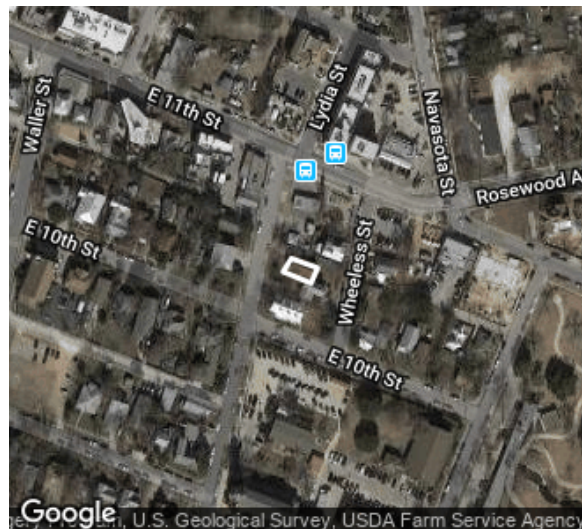
1005 LYDIA ST

Recommended local designations	Non-contributing
Justification for local recommendation	Not historic age
Local recommendation notes	Robertson Hill

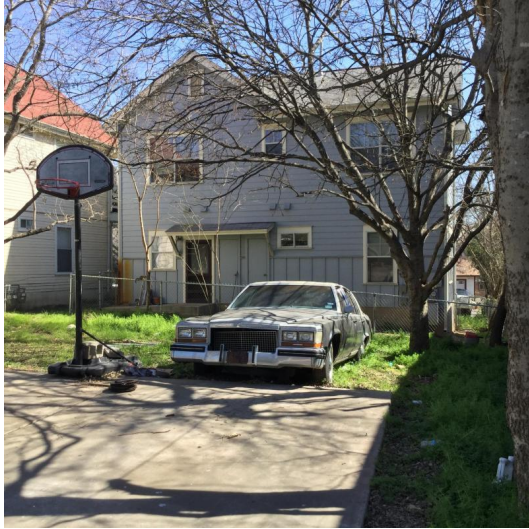
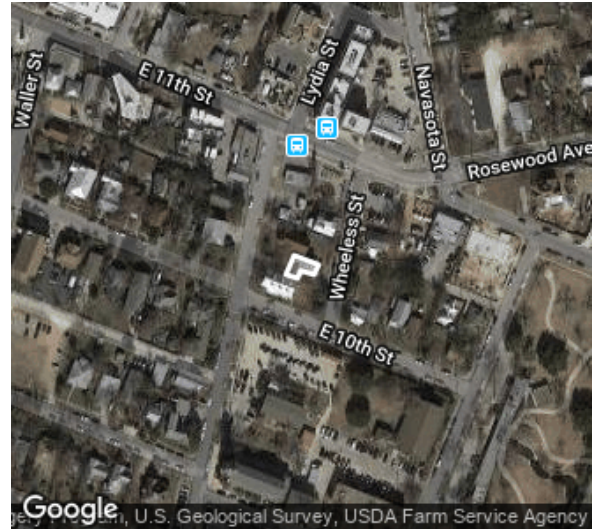
1005 LYDIA ST

Recommended local designations	Non-contributing
Justification for local recommendation	Not historic age
Local recommendation notes	Robertson Hill

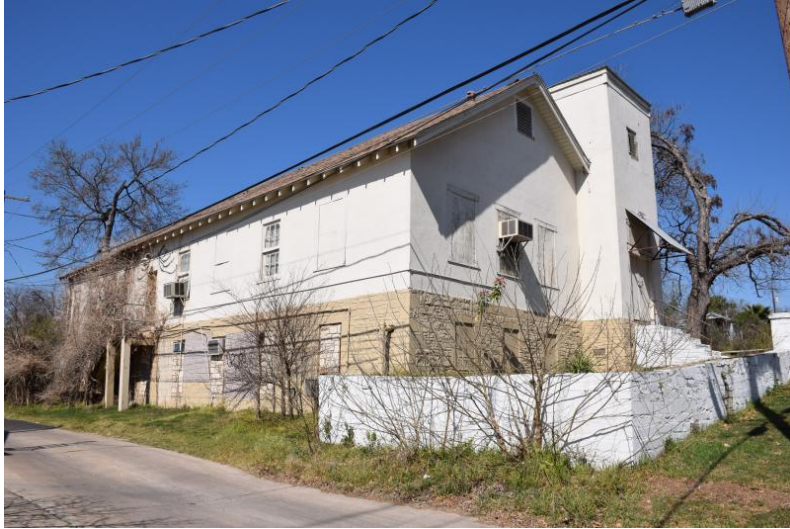
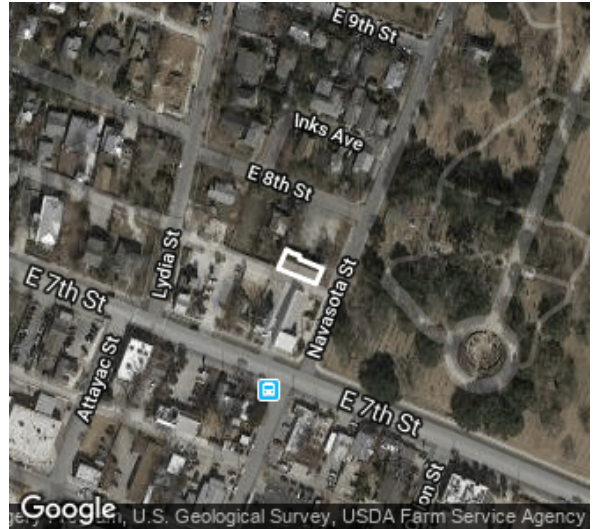
706 NAVASOTA ST

Alterations	Doors replaced, Demolition of accessory building in 1964 per permit, Windows infilled
Additions	Small frame rear/side addition in 1964 per permit
Relocations	None known
Integrity notes	None

Recommended local designations	Contributing
Justification for local recommendation	Retains integrity
Local recommendation notes	None

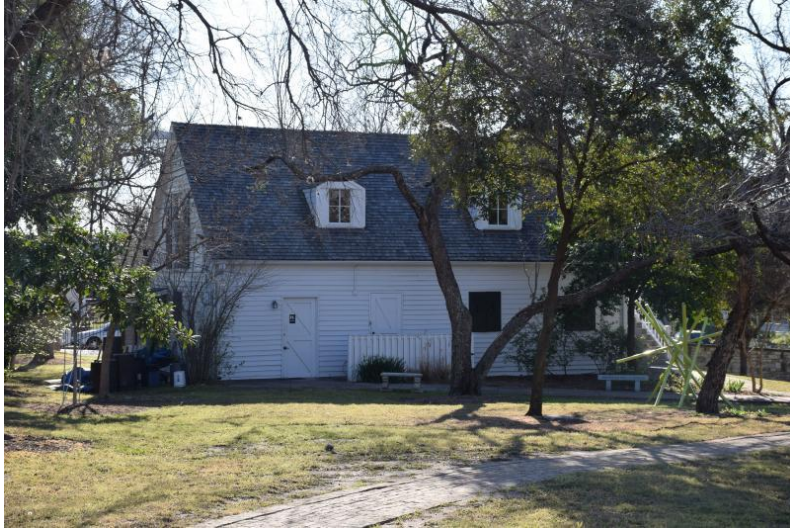
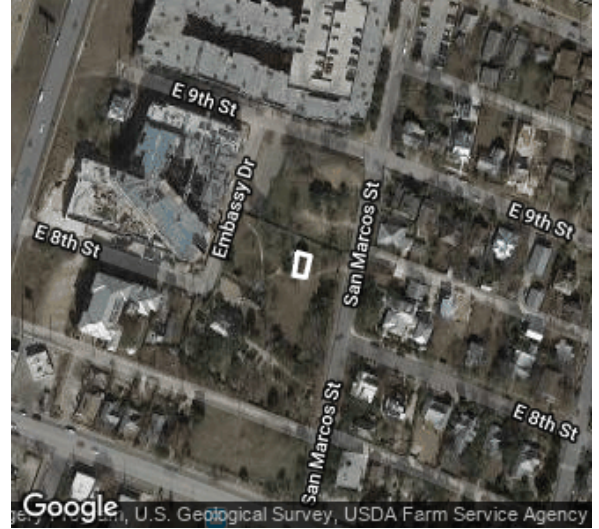
802 SAN MARCOS ST

Recommended local designations	Contributing
Justification for local recommendation	Retains integrity
Local recommendation notes	None

History notes	Conjectural reconstruction of ca. 1840 detached kitchen, completed ca. 1950
---------------	---

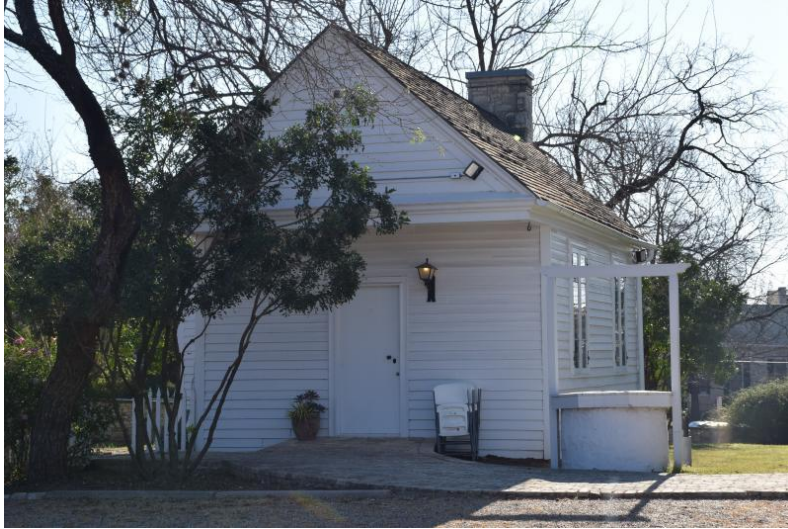
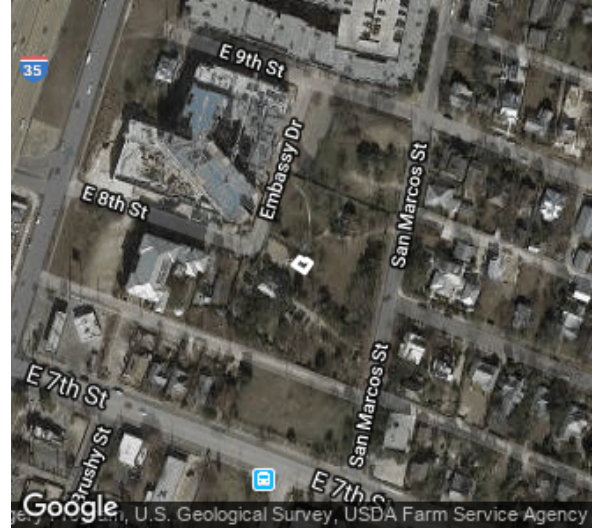
802 SAN MARCOS ST

Recommended local designations	Contributing
Justification for local recommendation	Retains integrity
Local recommendation notes	None

History notes	Conjectural reconstruction of ca. 1840 detached kitchen, completed ca. 1950
---------------	---

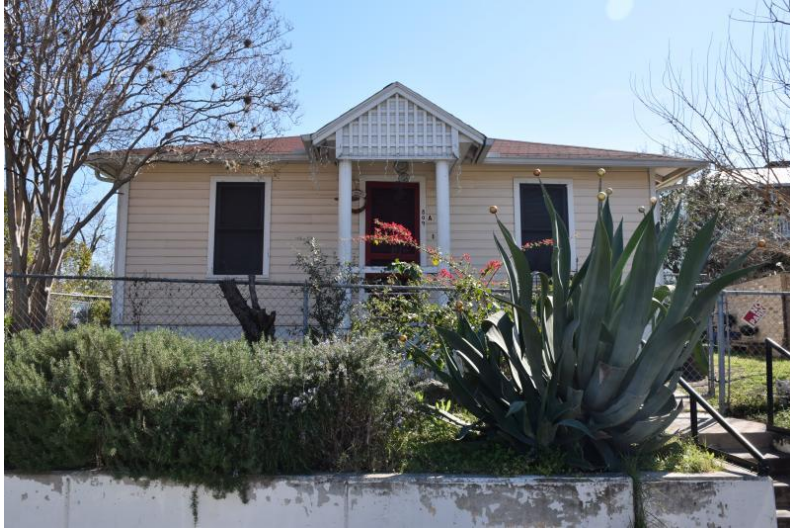
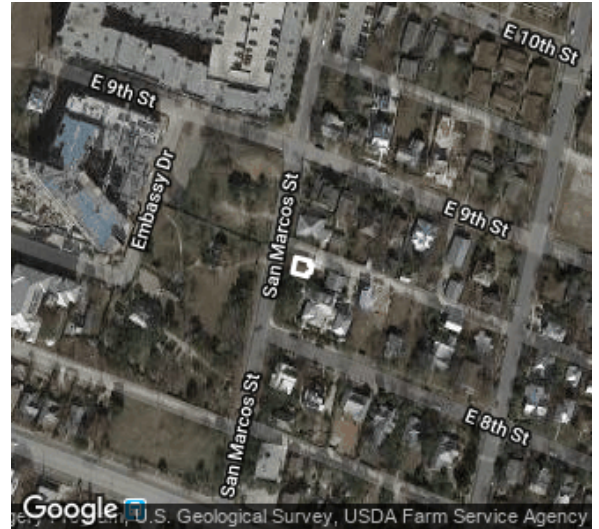
809 SAN MARCOS ST

Recommended local designations	Contributing
Justification for local recommendation	Retains integrity
Local recommendation notes	None

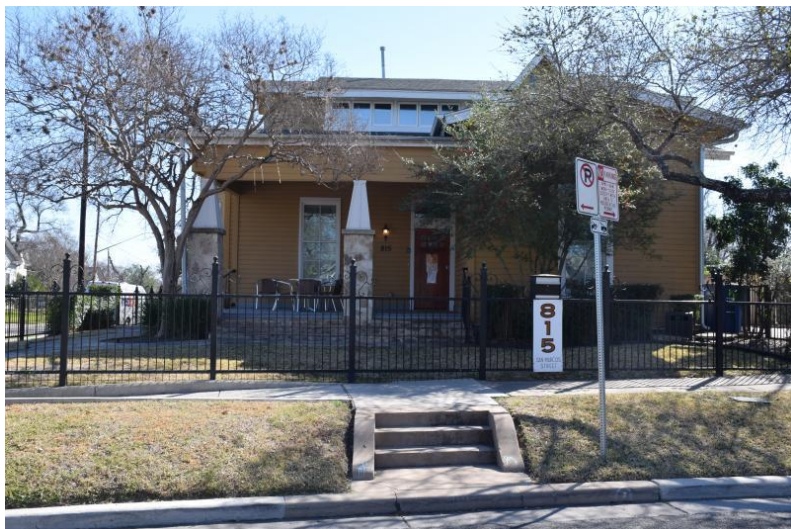
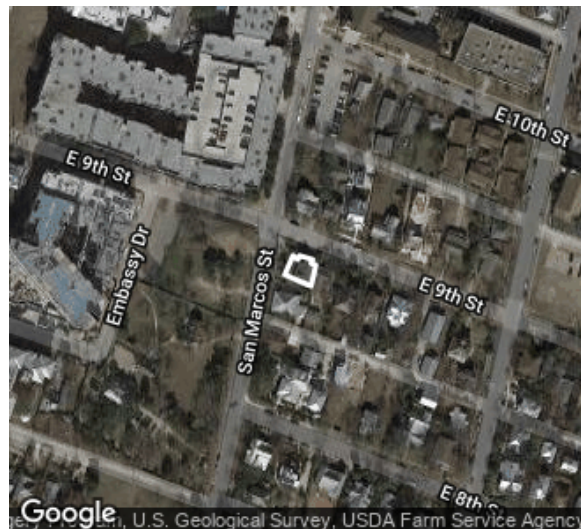
815 SAN MARCOS ST

Alterations	Windows replaced, Porch altered, Roof shape altered, Bay added
Additions	Rear addition, Additional story added
Relocations	None known
Integrity notes	None

Recommended local designations	Noncontributing
Justification for local recommendation	Lacks integrity
Local recommendation notes	None
