ITEM FOR ENVIRONMENTAL COMMISSION AGENDA

NAME & NUMBER OF PROJECT: 3801 Westlake
SP-2019-0243DS

REQUEST: Variance request is as follows:
Request to vary from LDC 25-8-281(C)(2)(b) to allow construction
of a boat dock and shoreline access within a 150-foot Critical
Environmental Feature (CEF) buffer for a Rimrock CEF.

3801 WESTLAKE DRIVE
PROPOSED CONDITIONS SITE PLAN
AND EROSION CONTROLS SHEET

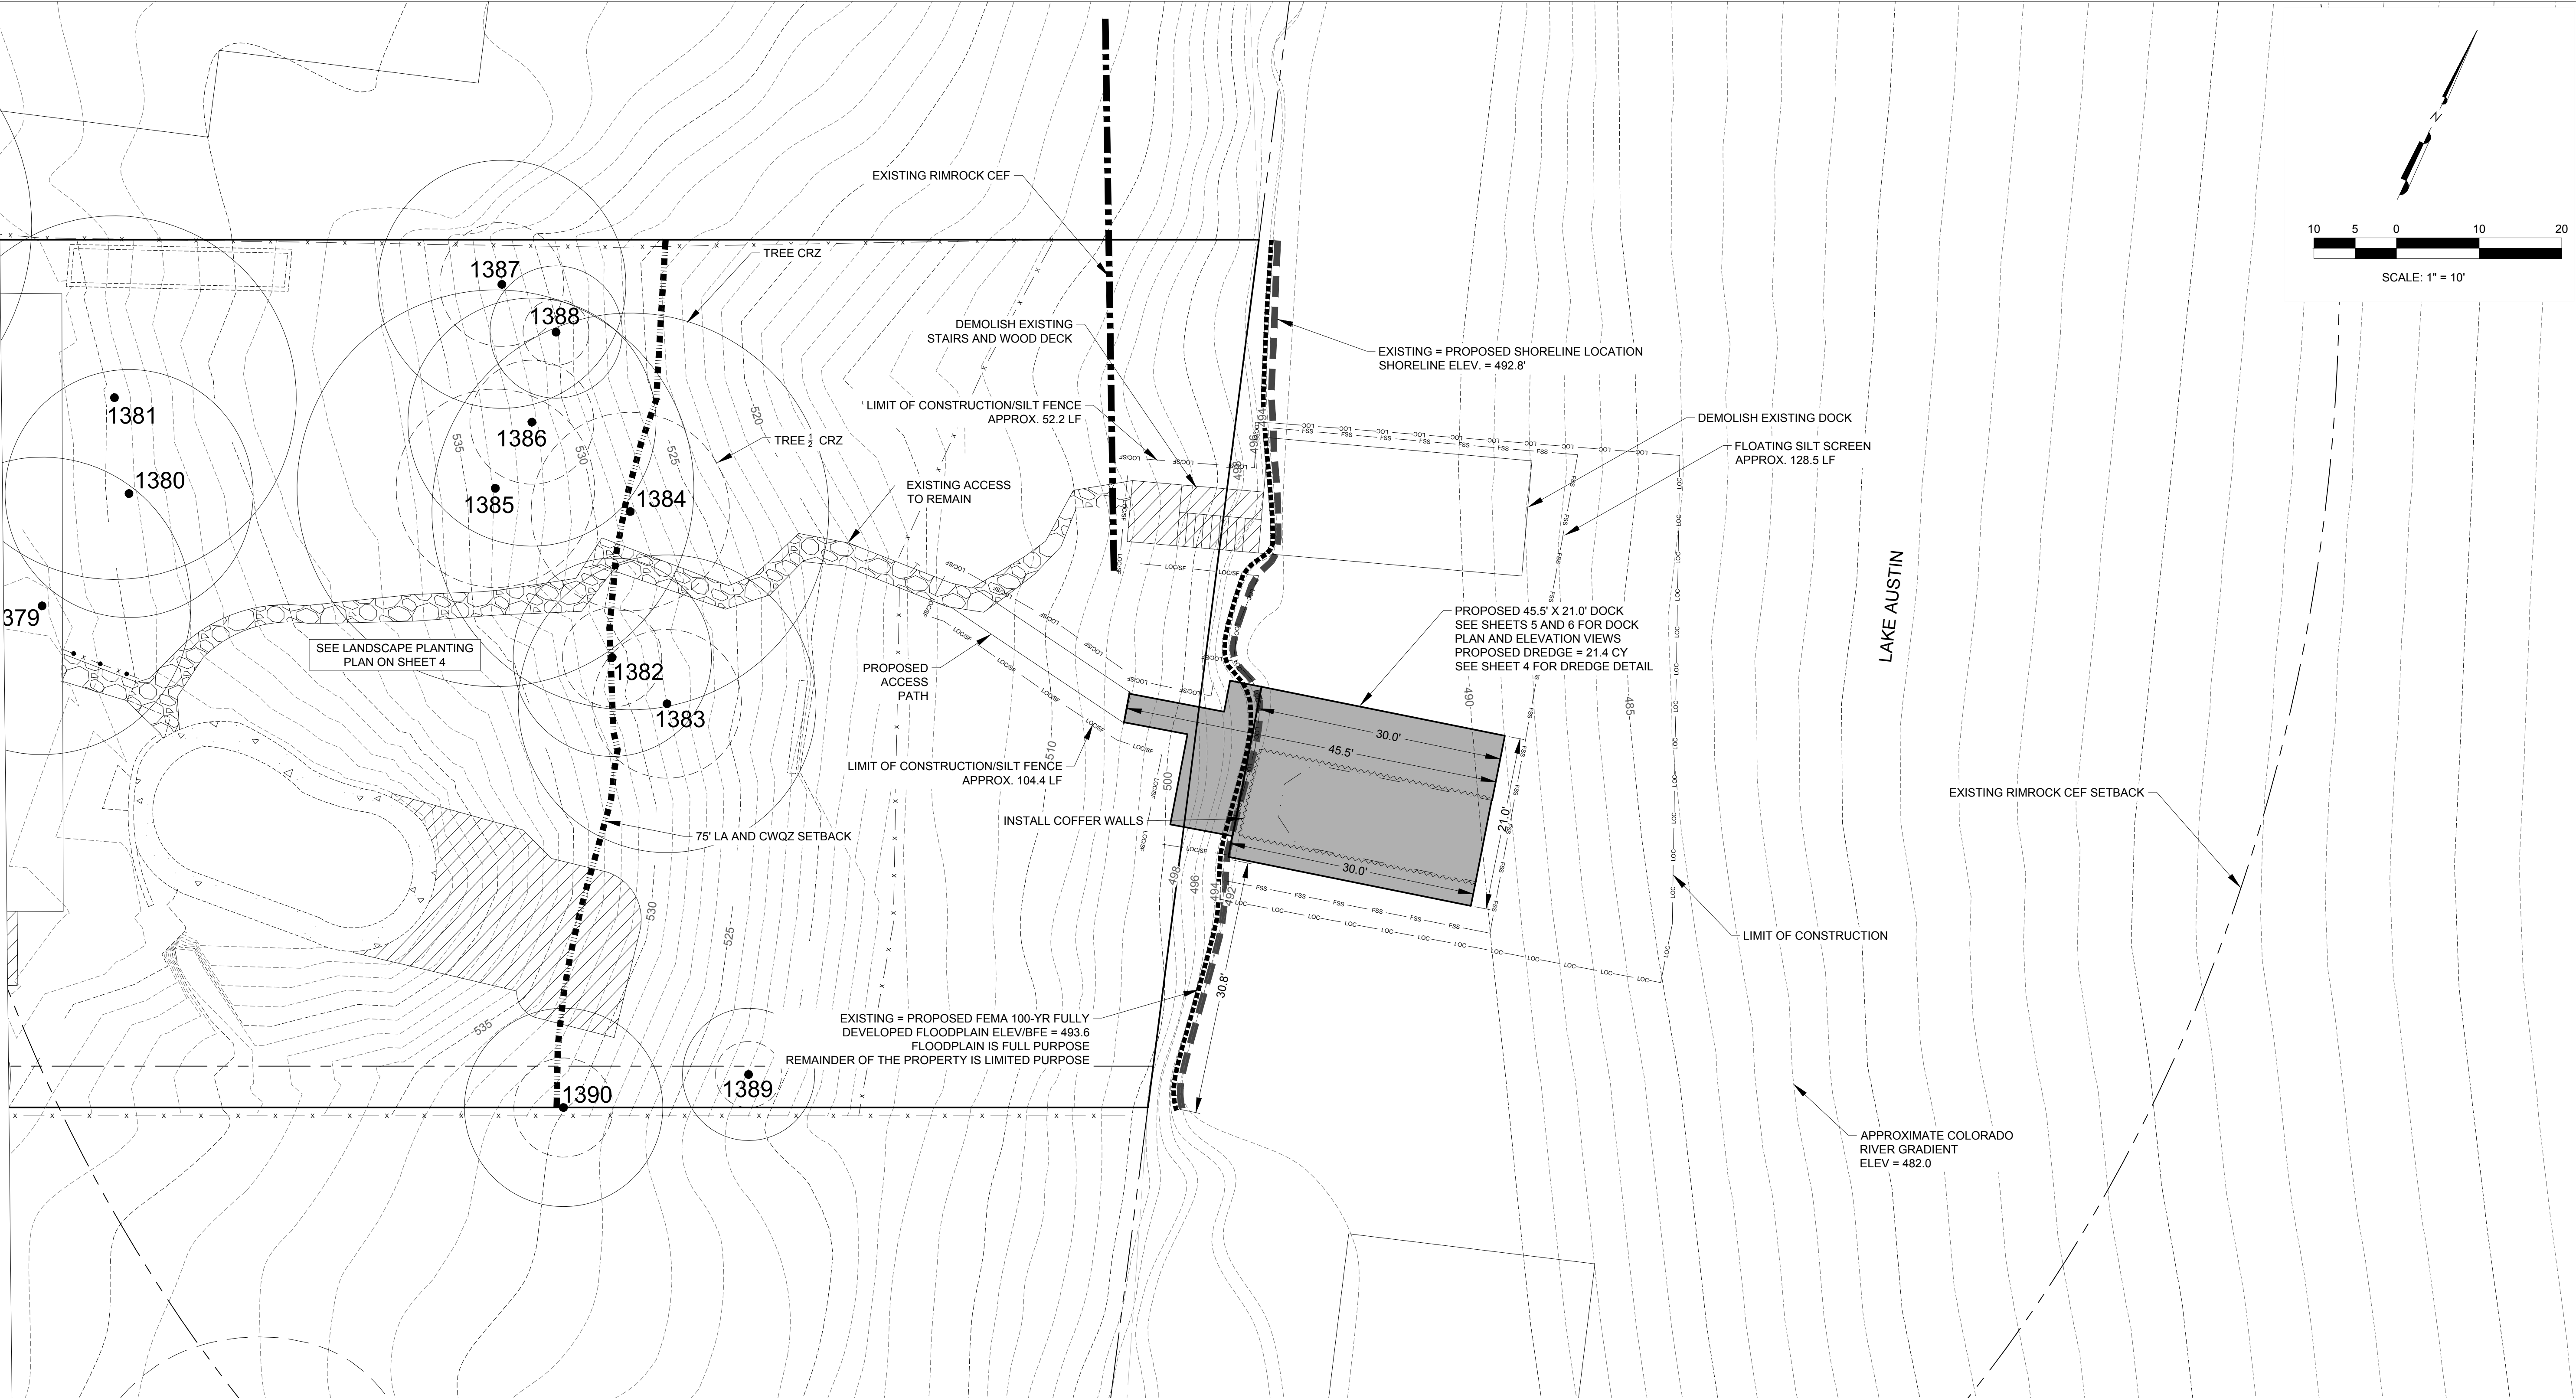
PROPOSED SITE PLAN

EXISTING SHORELINE LENGTH = 108.6'
ALLOWABLE DOCK WIDTH = 20% OF 108.6' = 21.7'
PROPOSED DOCK WIDTH = 21.0' = 19.3%
PROPOSED DOCK DEPTH = 48.5'
DOCK FOOTPRINT = 783.7 SF

NOTE:
THE PROPOSED BOAT DOCK MUST COMPLY WITH ALL REQUIREMENTS OF LDC 25-2-1174 ("STRUCTURAL REQUIREMENTS"), AND MUST COMPLY WITH CHAPTER 25-12, ARTICLE 1 (UNIFORM BUILDING CODE) AND THE BUILDING CRITERIA MANUAL.

| Clearly indicate in what way the proposed project does not comply with current Code (include maps and exhibits) | <i>This project proposes to demolish an existing dock and its access and construct a new dock and access route farther away from a rimrock. The demolition of the dock and access as well as the construction of the new dock and access are within 150 ft. of the rimrock. Please see Attachment 1 for the Proposed Conditions Site Plan and Erosion Controls Sheet.</i> |

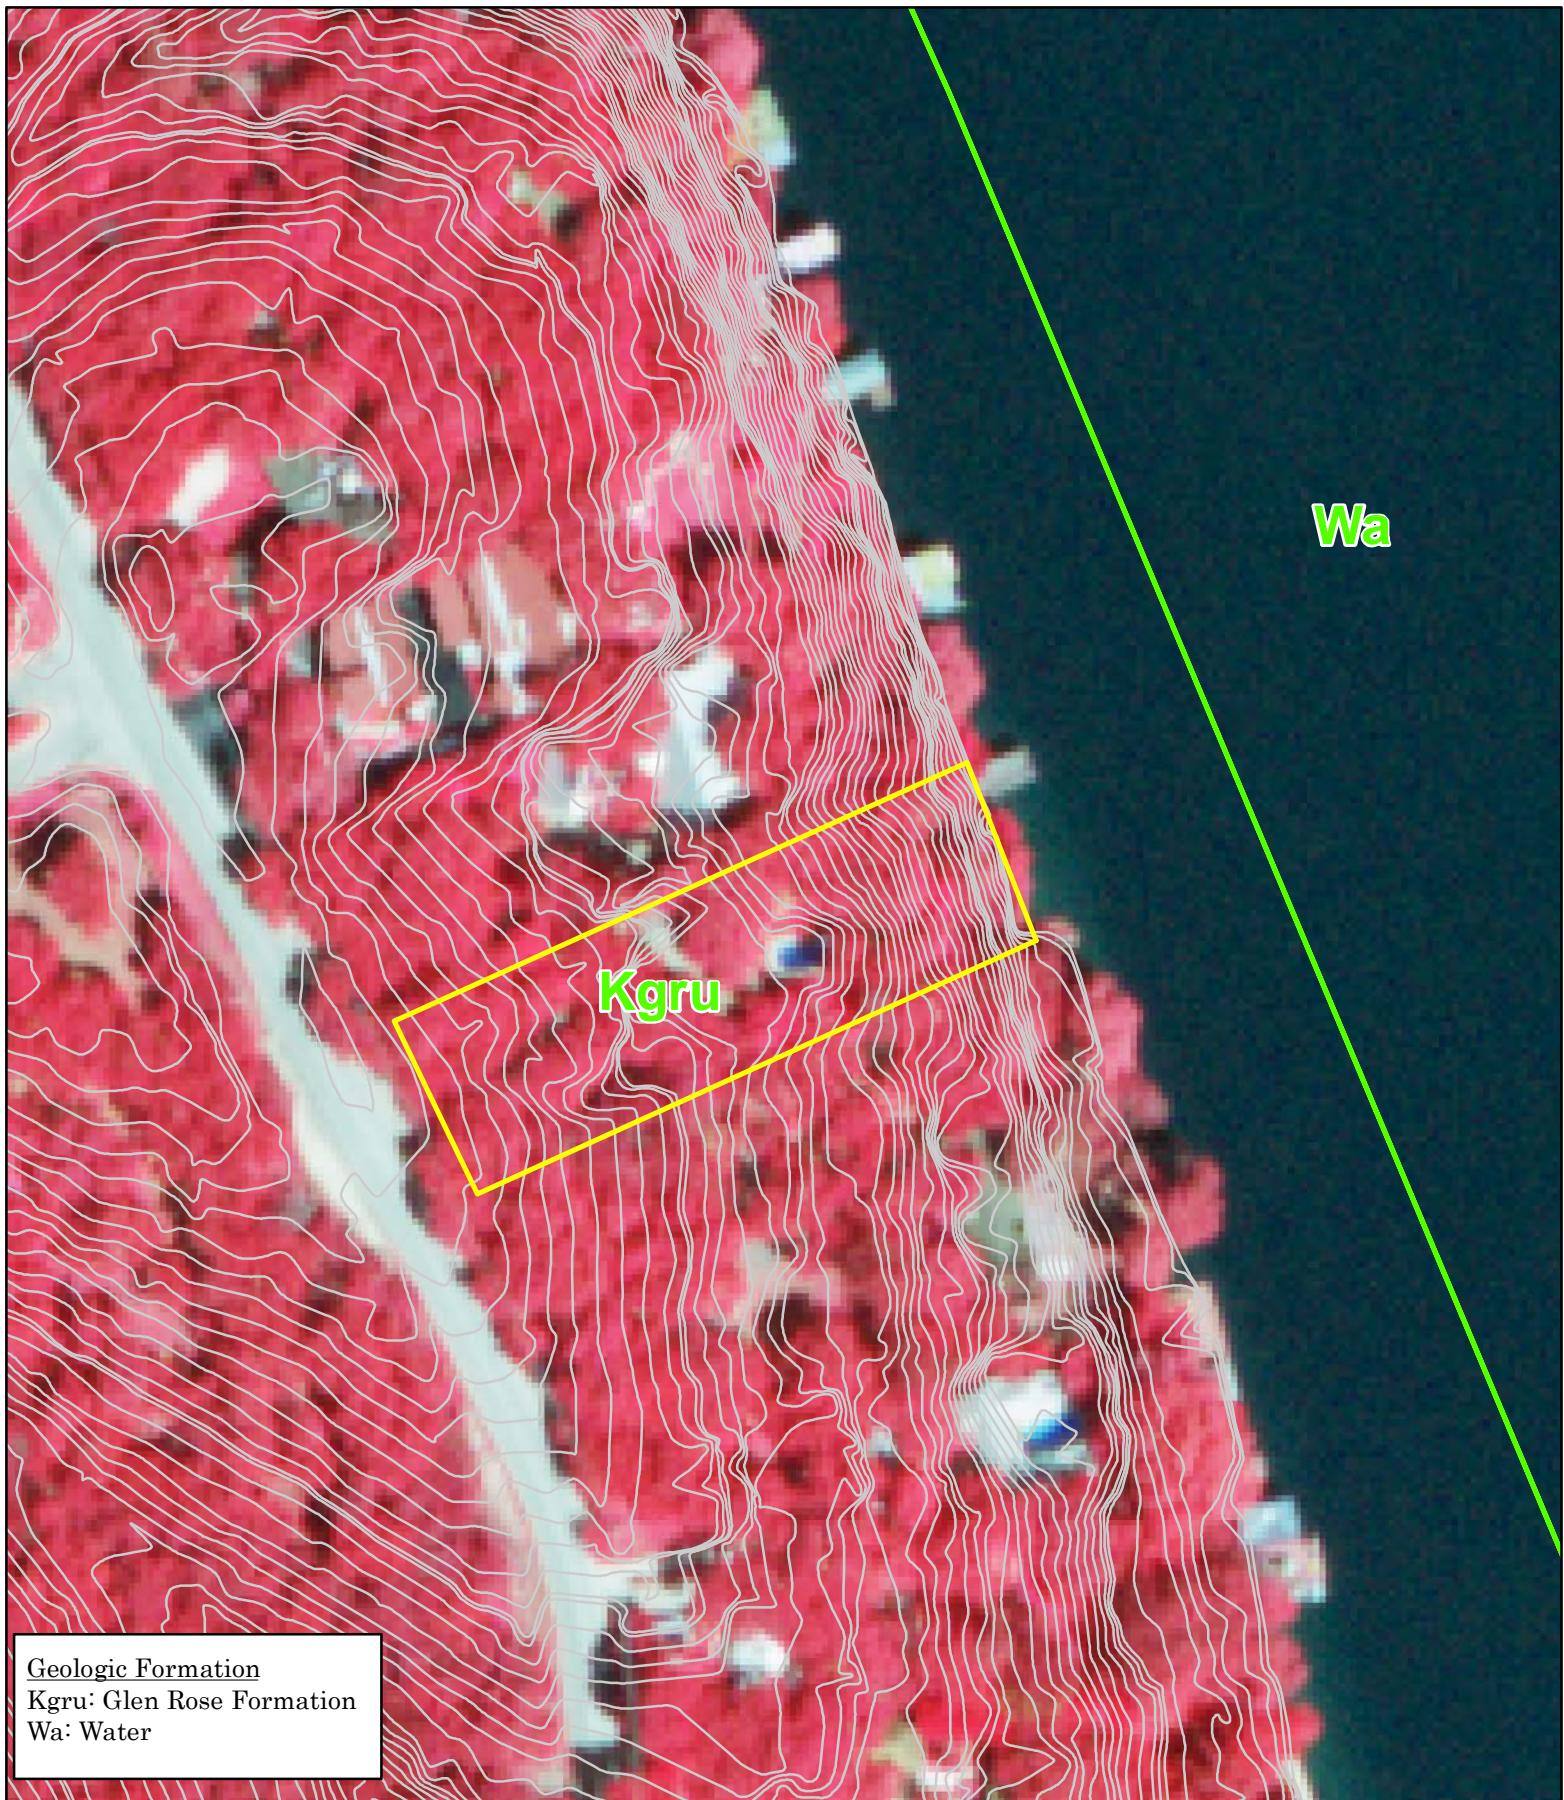
Figure 1: Site Specific Geologic Map with 2' Topography
 3801 Westlake Drive

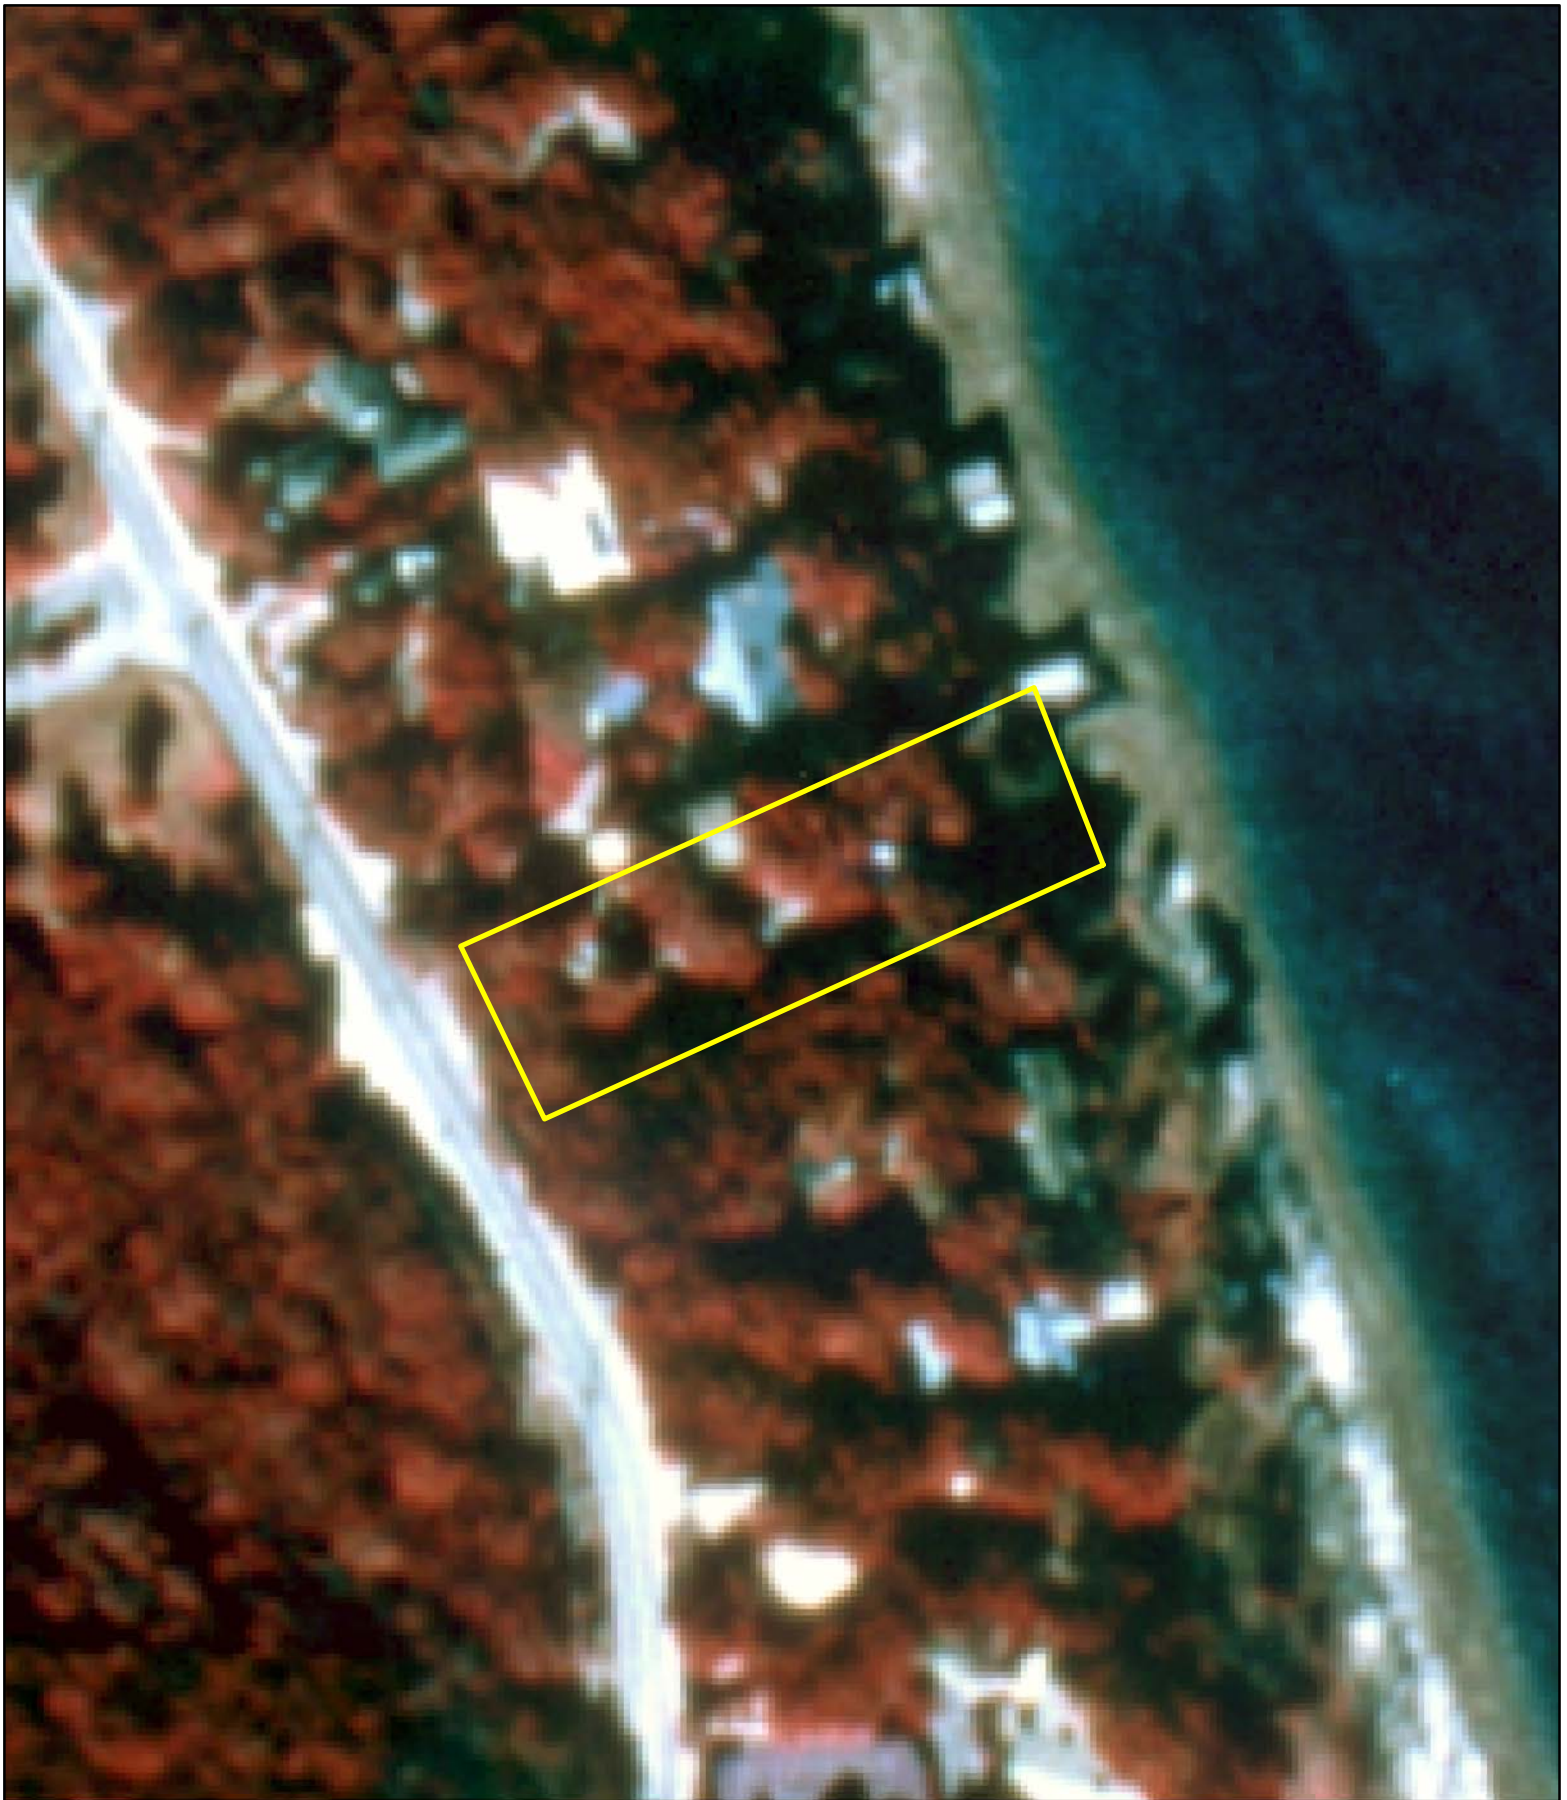
Figure 2: Historical Aerial Imagery
3801 Westlake Drive

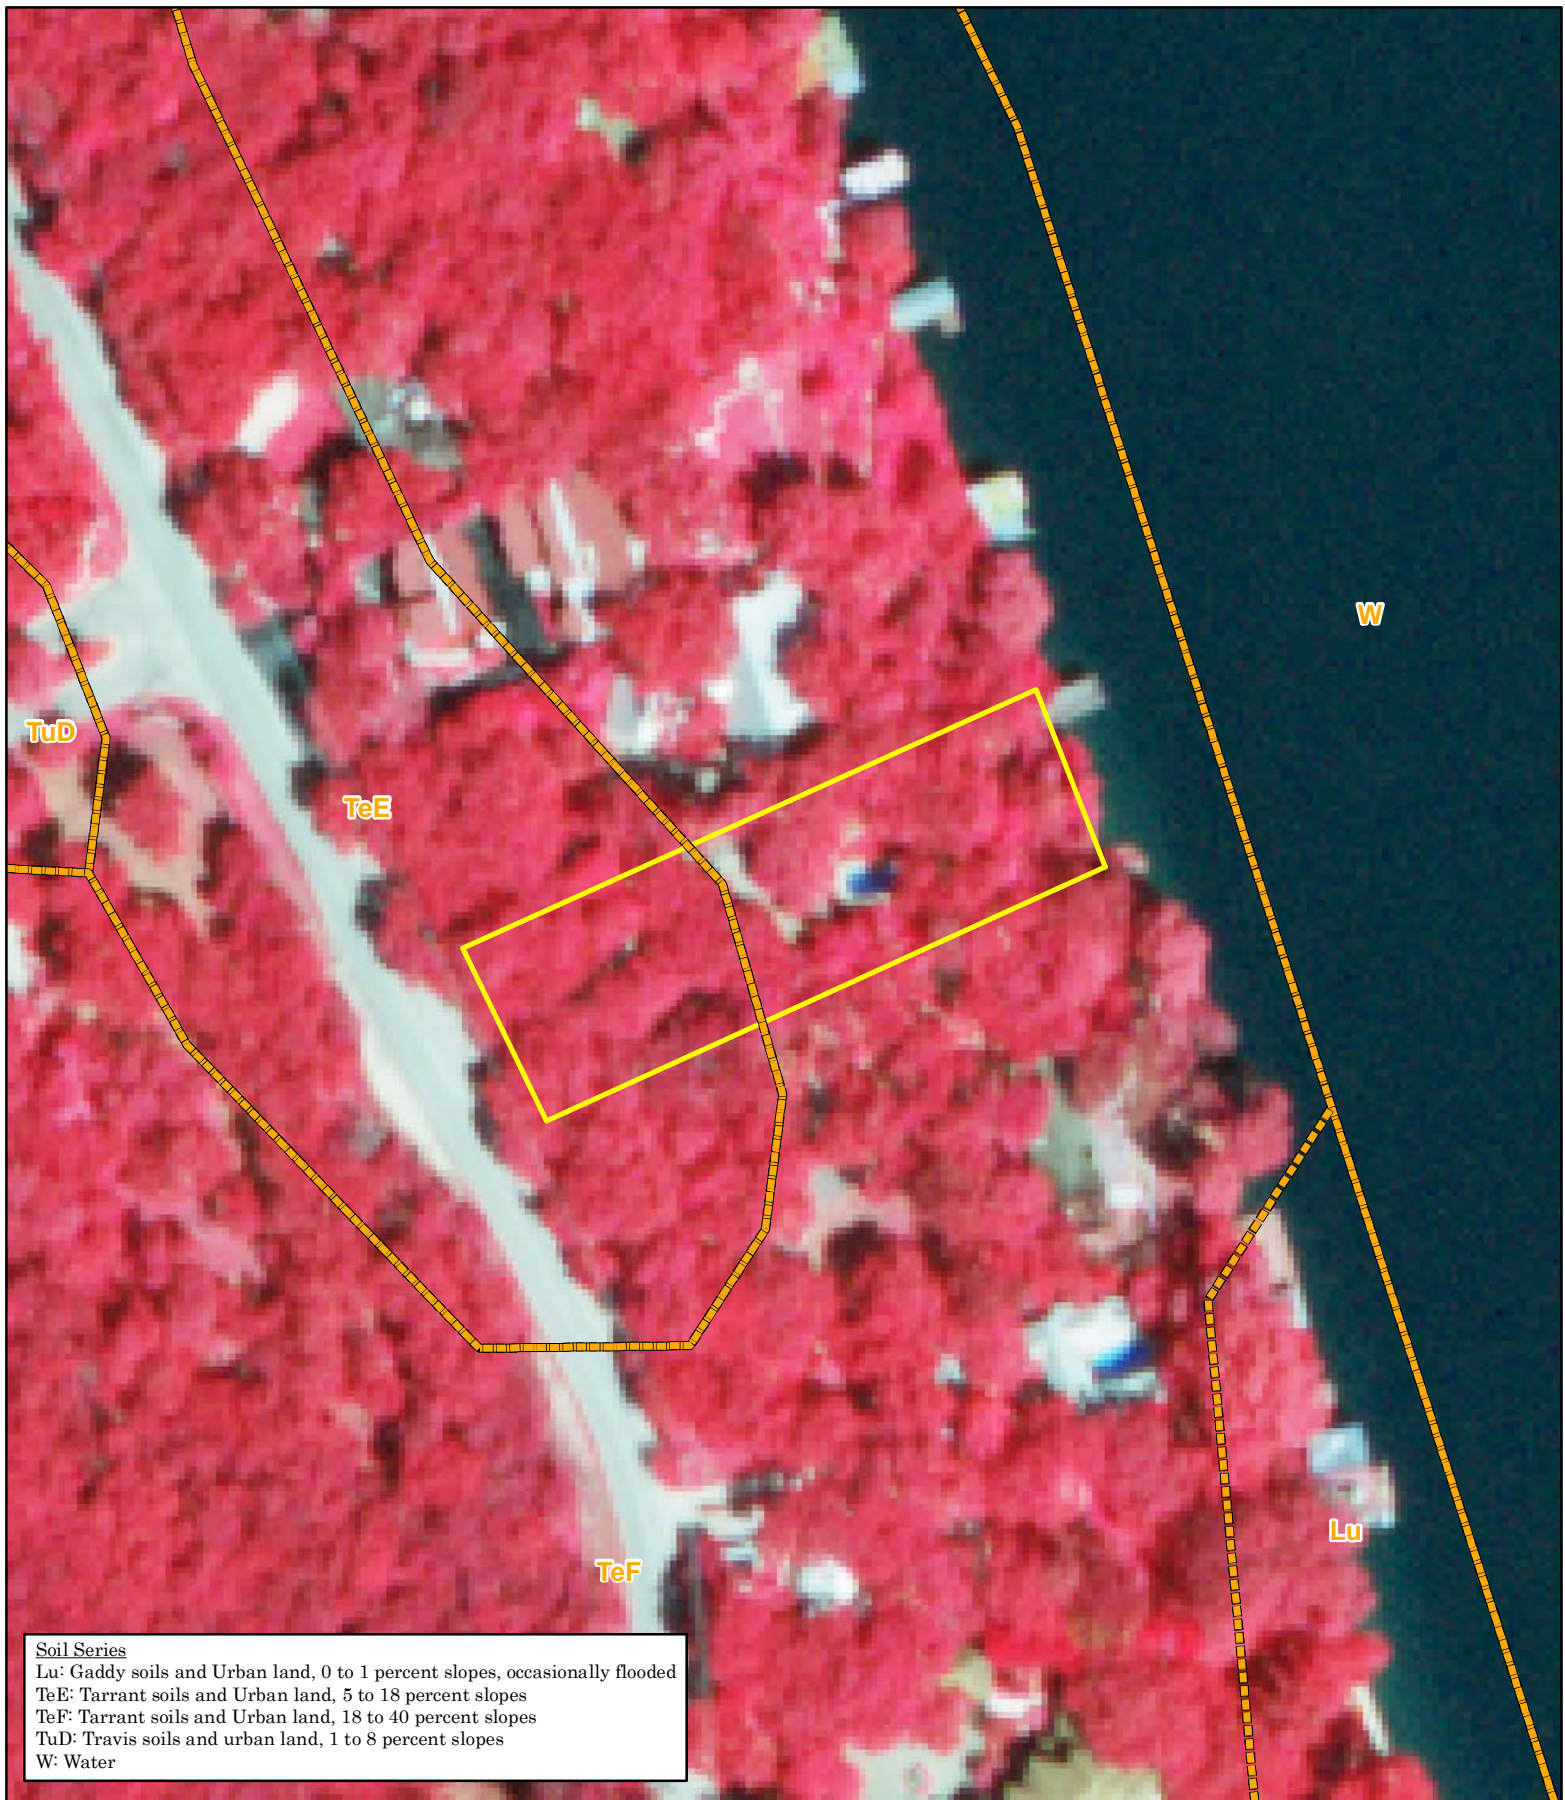
Figure 3: Site Soil Map
 3801 Westlake Drive

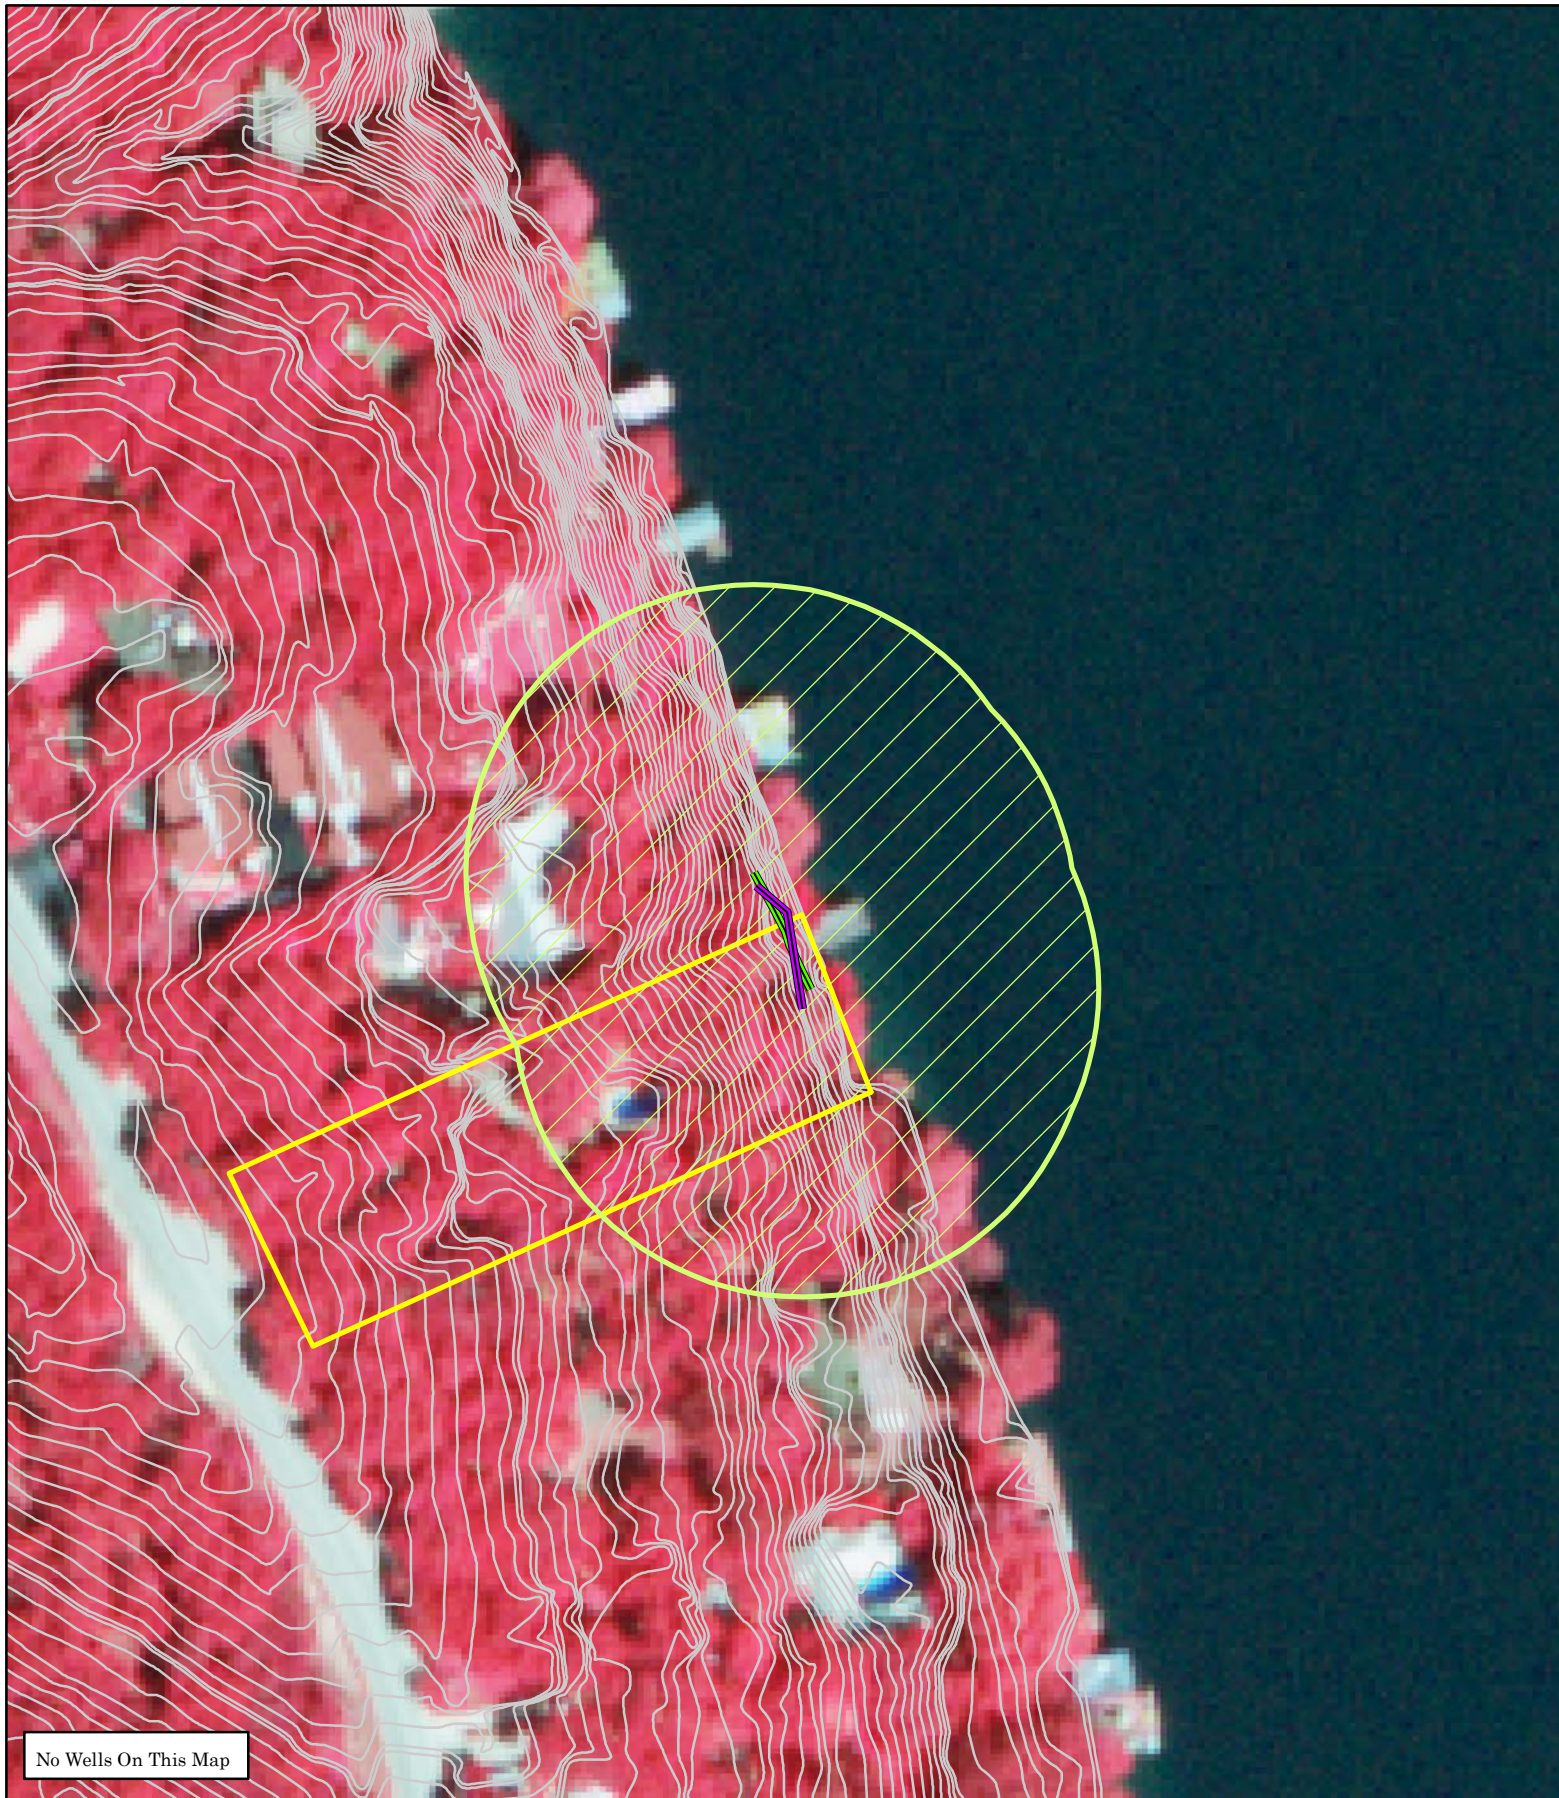
- 2' Contours (CoA)
- Rock Outcrop (CoA)
- Canyon Rimrock (DESCO)
- Parcel of Interest (CoA)
- 150' Buffer

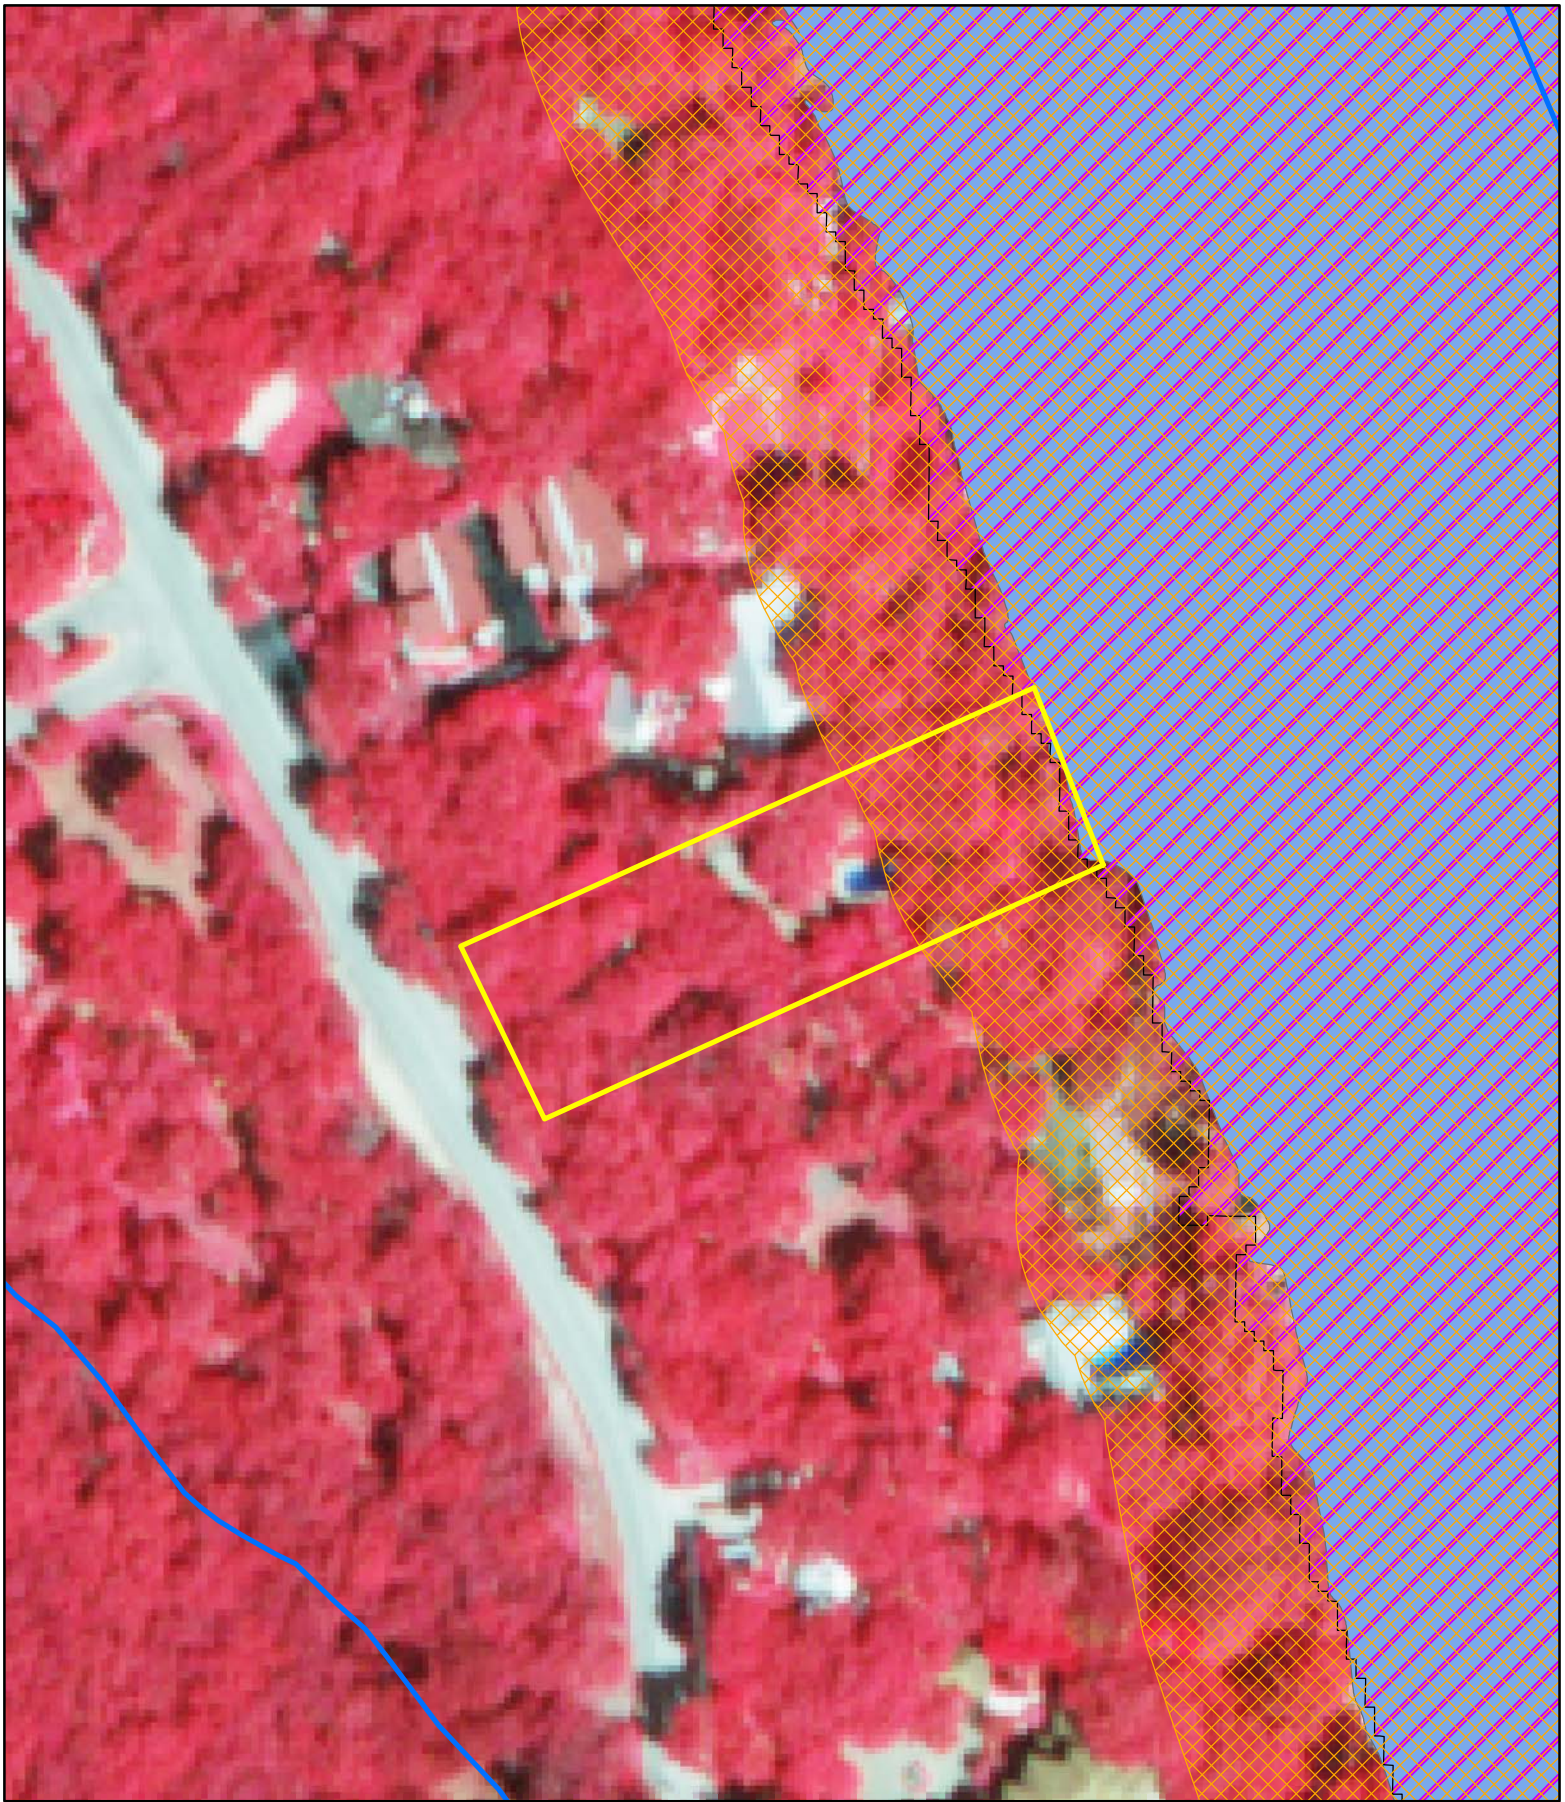
Figure 5: CWQZ and Fully Developed Floodplain Map
3801 Westlake Drive
Travis County, Texas

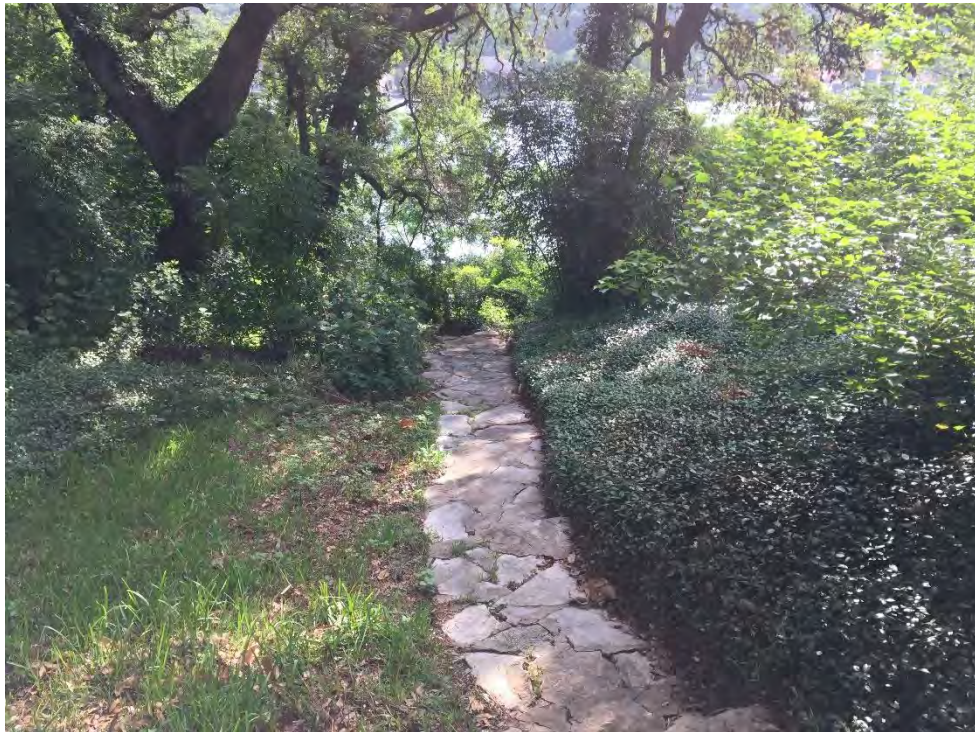
Photo 6: Path from residence down to the dock. Photo is facing the east northeast.

YES. The entire shoreline is within the CEF setback. The existing dock is rotting; it's unsafe and unusable; and the stairs and gangway to the dock cross the rimrock. The replacement dock will be built as far away as possible from the rimrock while making maximum use of the existing access route from the house in order to minimize the disturbance on the shoreline. Runoff from the limit of construction will not flow toward the rimrock.

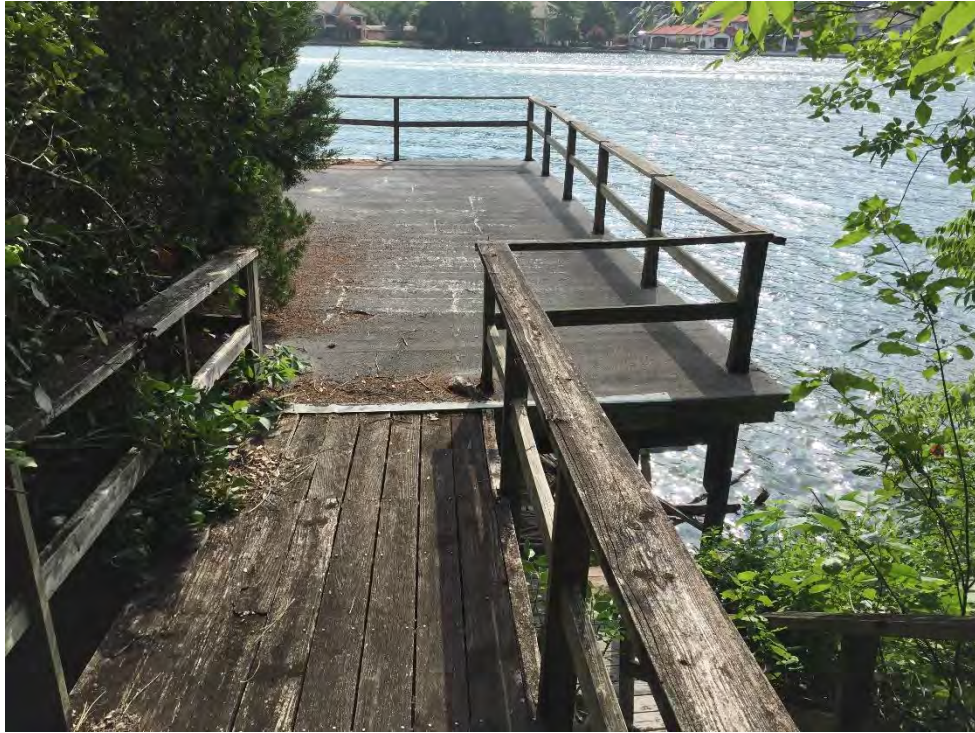
Photo 7: Dock over Lake Austin. Photo is facing the east northeast.

YES. The existing dock and access are crumbling with tar paper sloughing off of the roof of the dock into the lake. The structures are unsound, and it's not possible to construct a dock without the variance. All disturbed areas will be revegetated per the 609s specification.

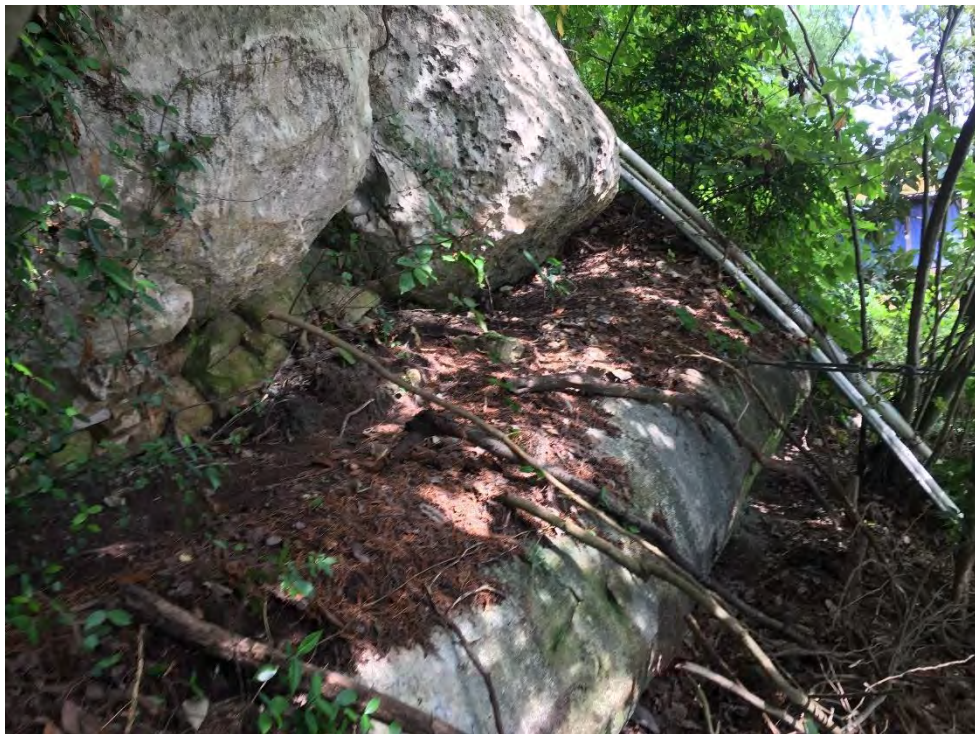
Photo 8: Canyon rimrock (CEF) adjacent to Lake Austin along the eastern boundary of the property. Photo is facing the north northwest.

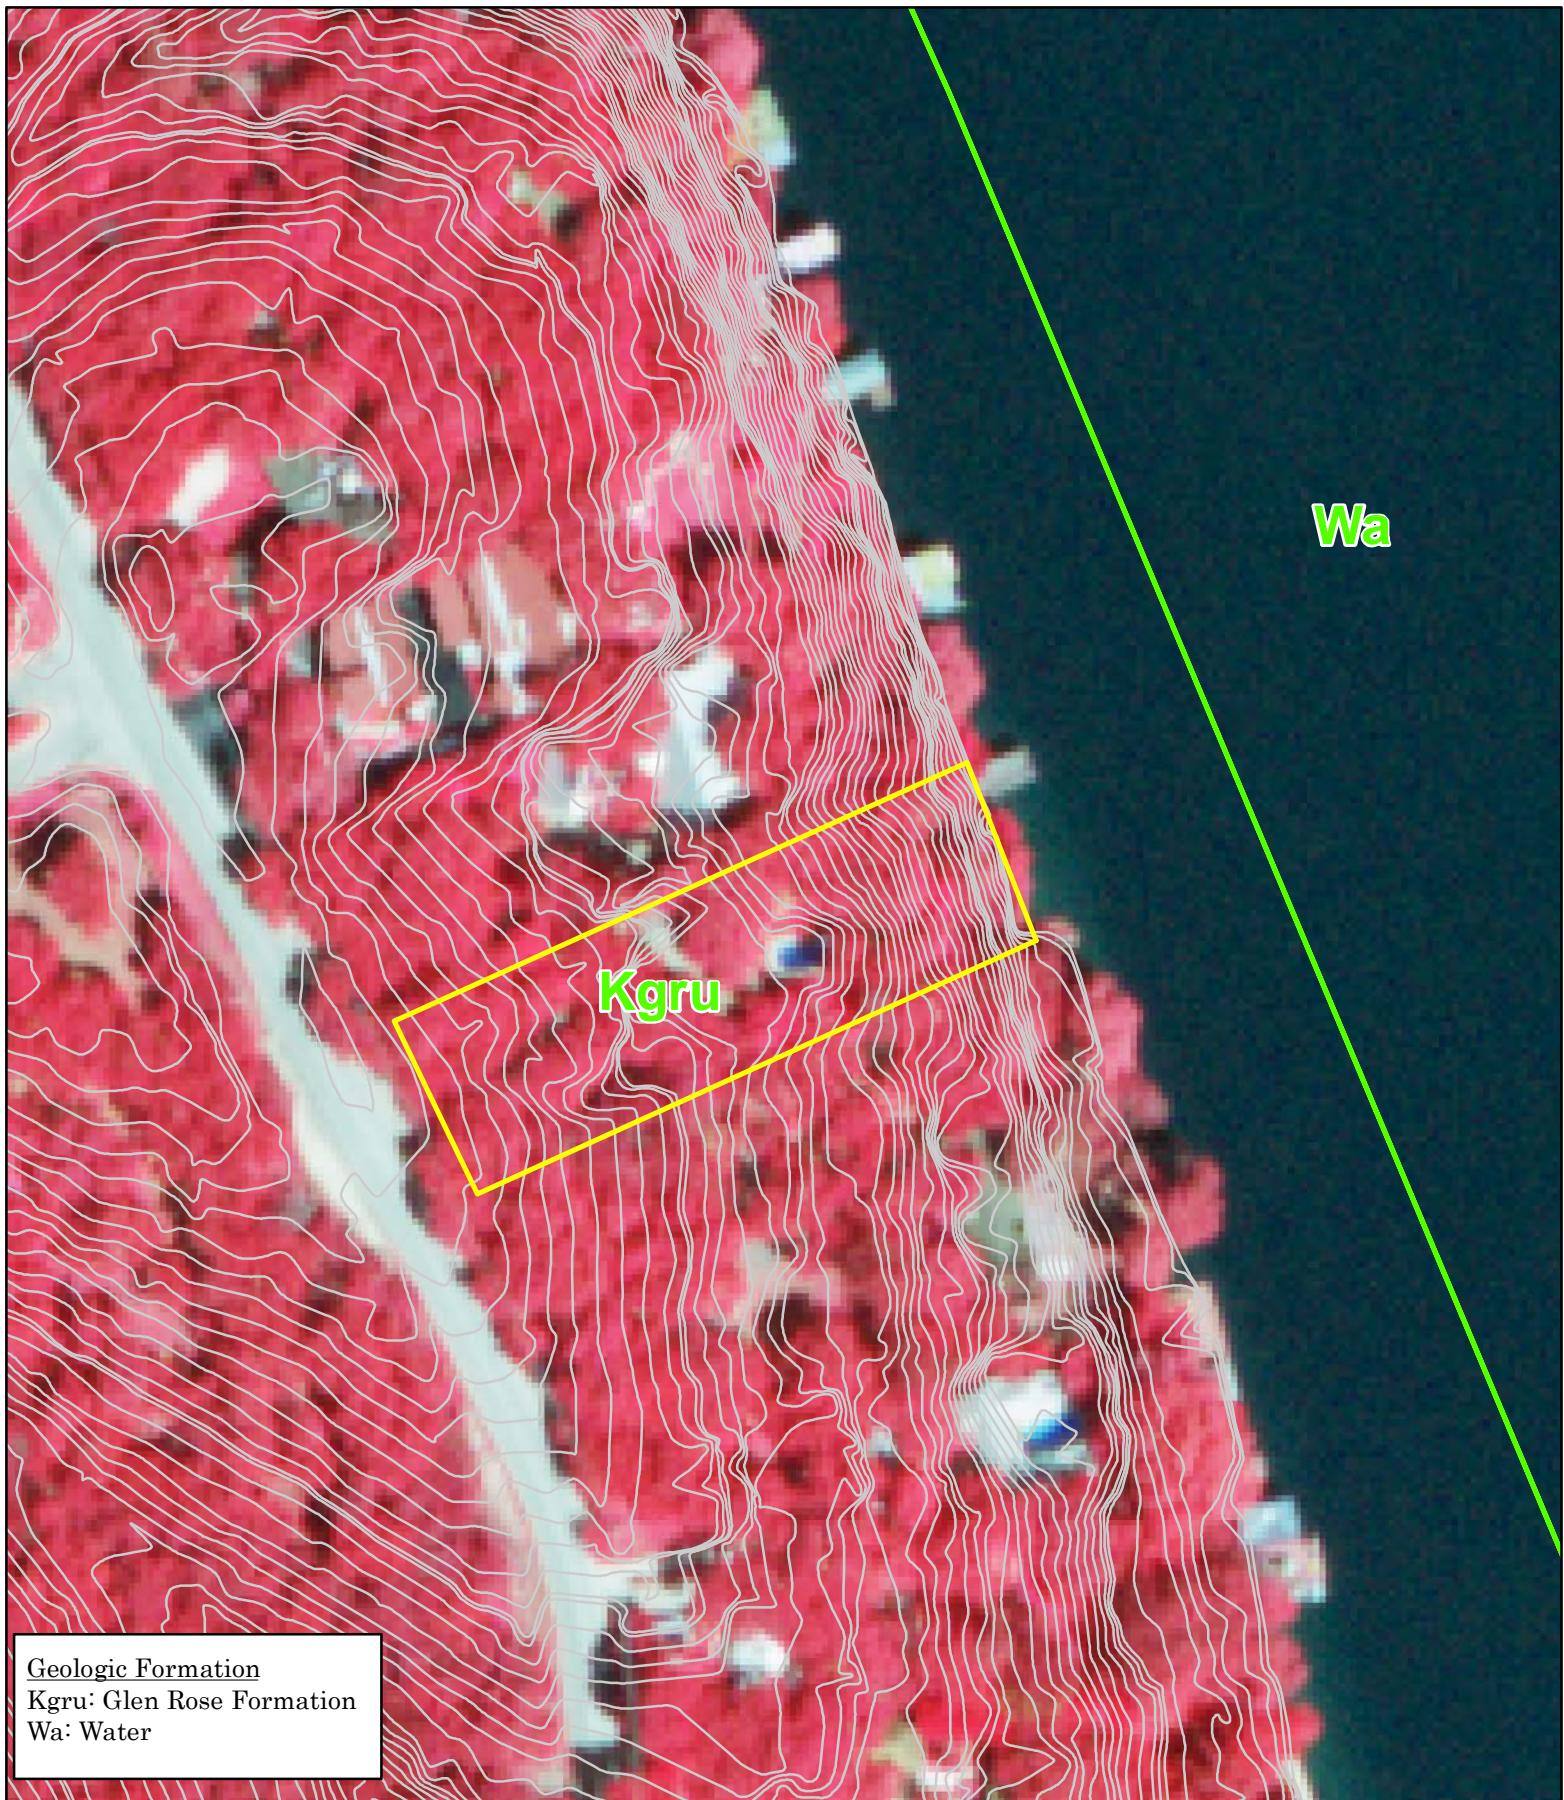
Figure 1: Site Specific Geologic Map with 2' Topography
 3801 Westlake Drive
