ITEM FOR ENVIRONMENTAL COMMISSION AGENDA

NAME & NUMBER OF PROJECT: 3801 Westlake
SP-2019-0243DS

REQUEST: Variance request is as follows:
Request to vary from LDC 25-8-281(C)(2)(b) to allow construction
of a boat dock and shoreline access within a 150-foot Critical
Environmental Feature (CEF) buffer for a Rimrock CEF.

3801 WESTLAKE DRIVE
PROPOSED CONDITIONS SITE PLAN
AND EROSION CONTROLS SHEET

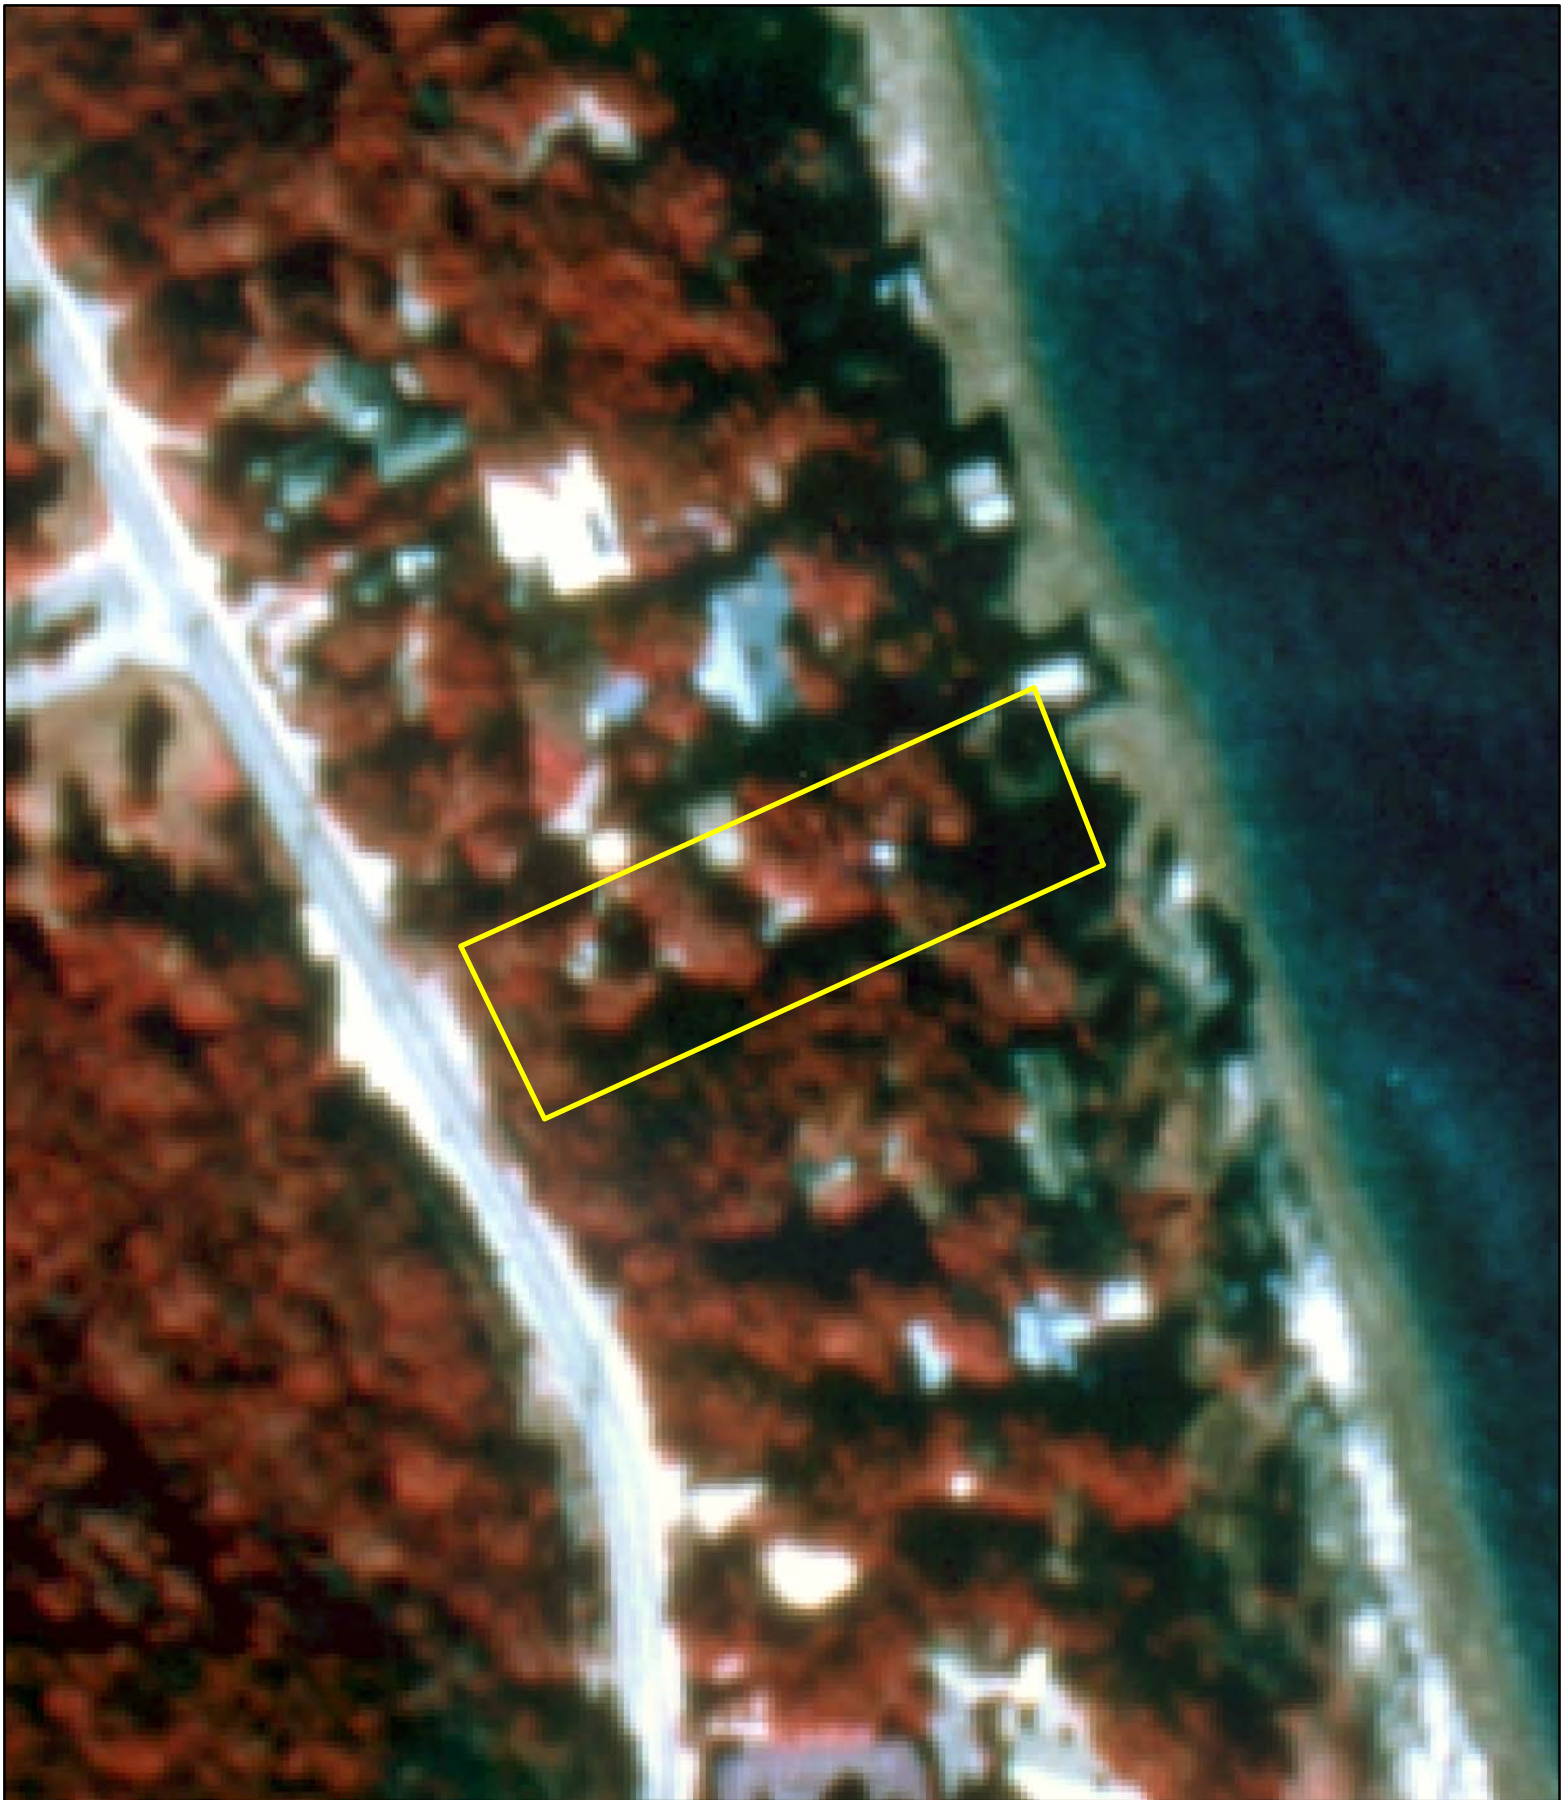
Figure 2: Historical Aerial Imagery
3801 Westlake Drive

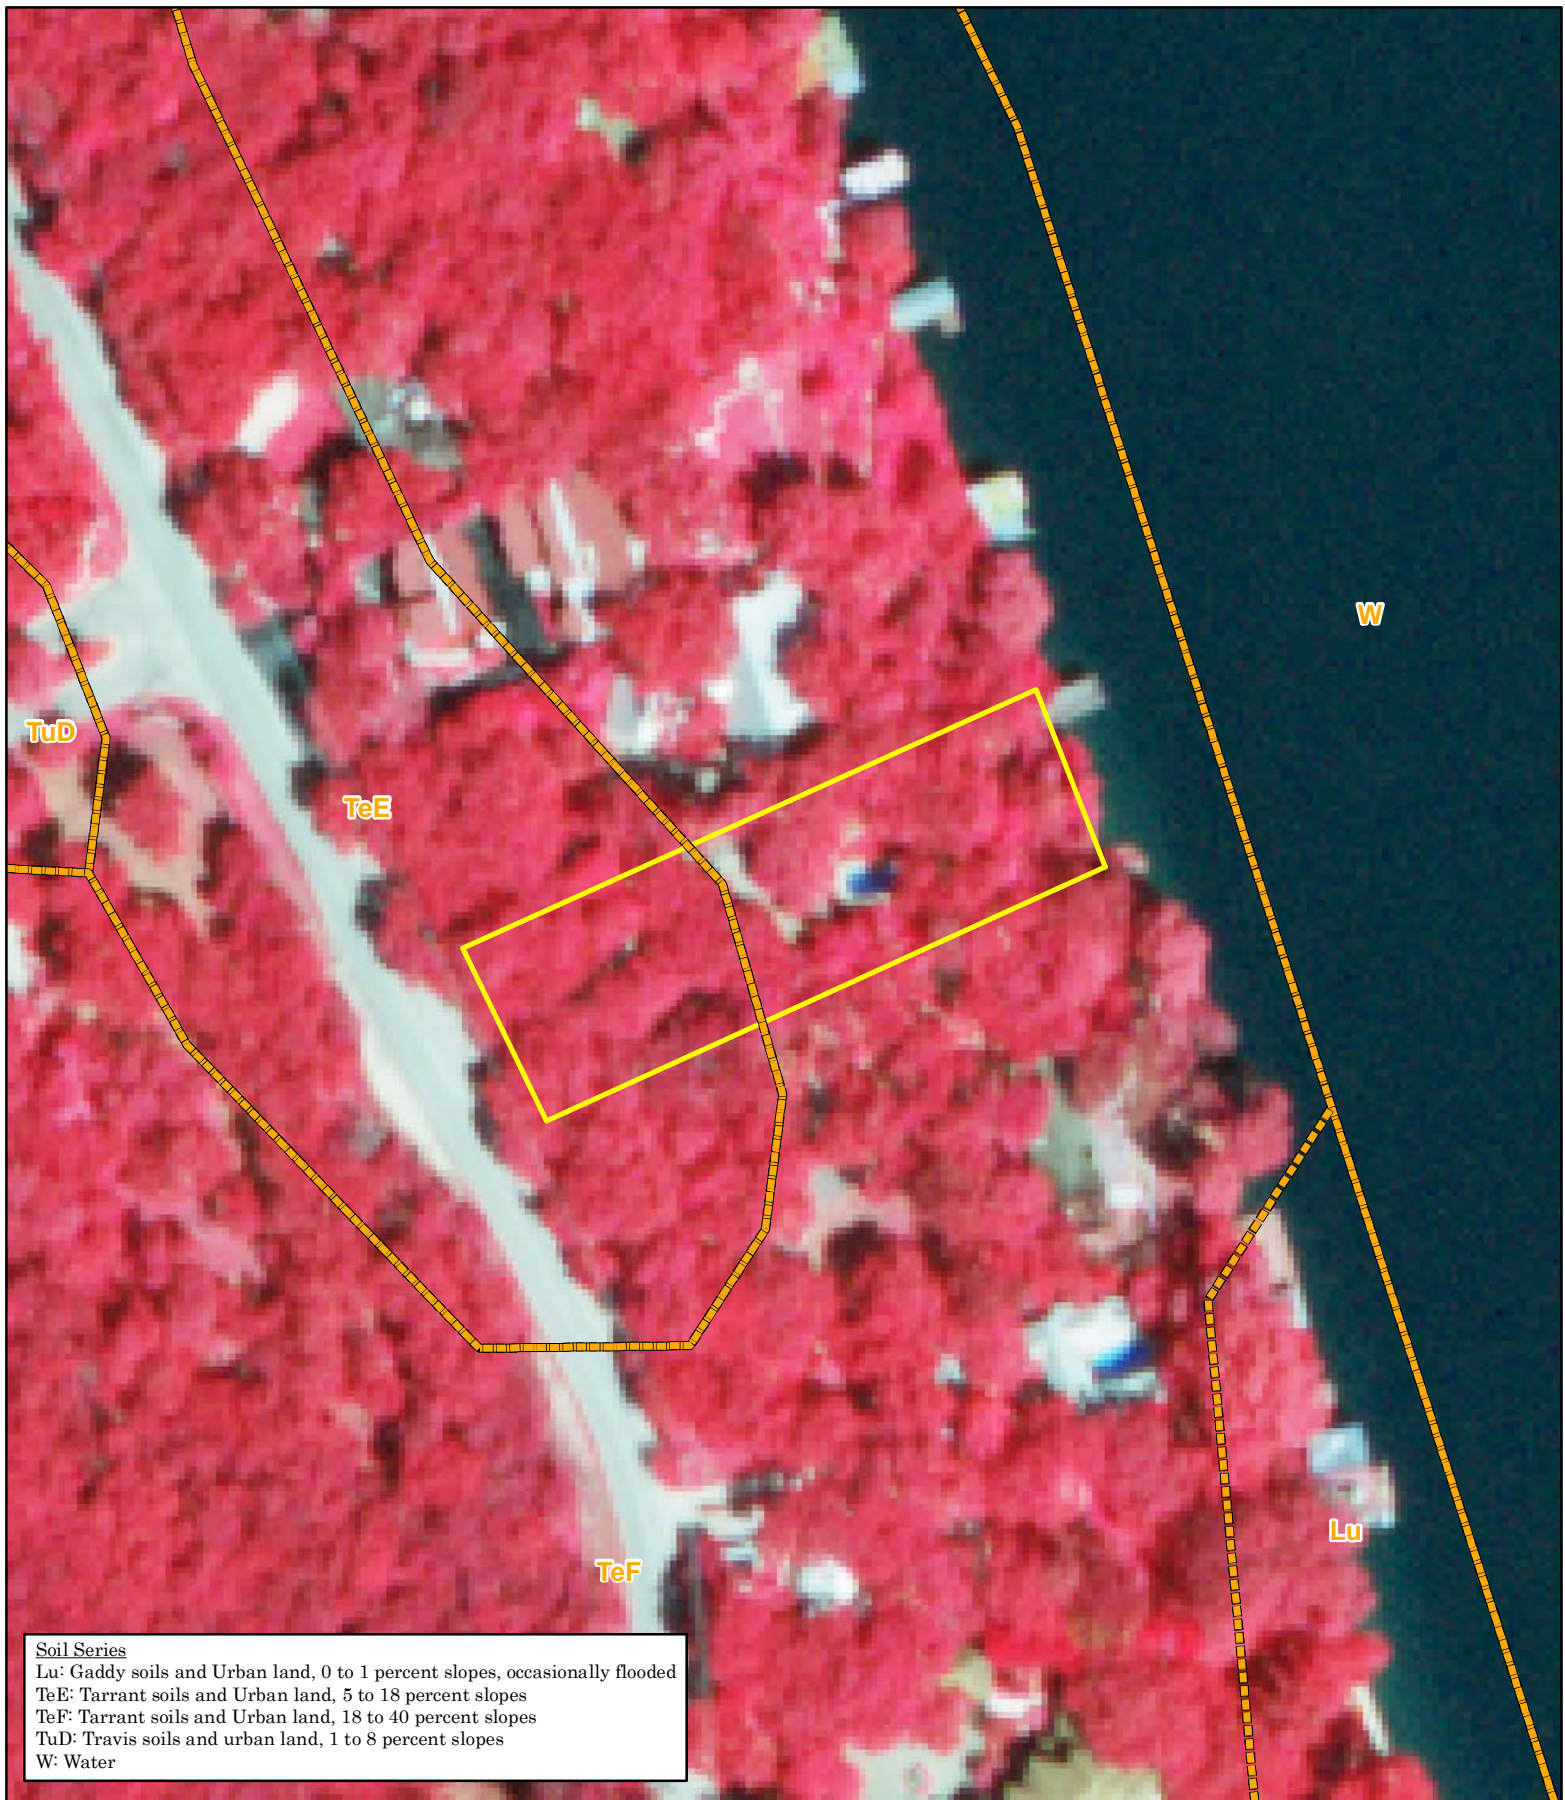
Figure 3: Site Soil Map
 3801 Westlake Drive

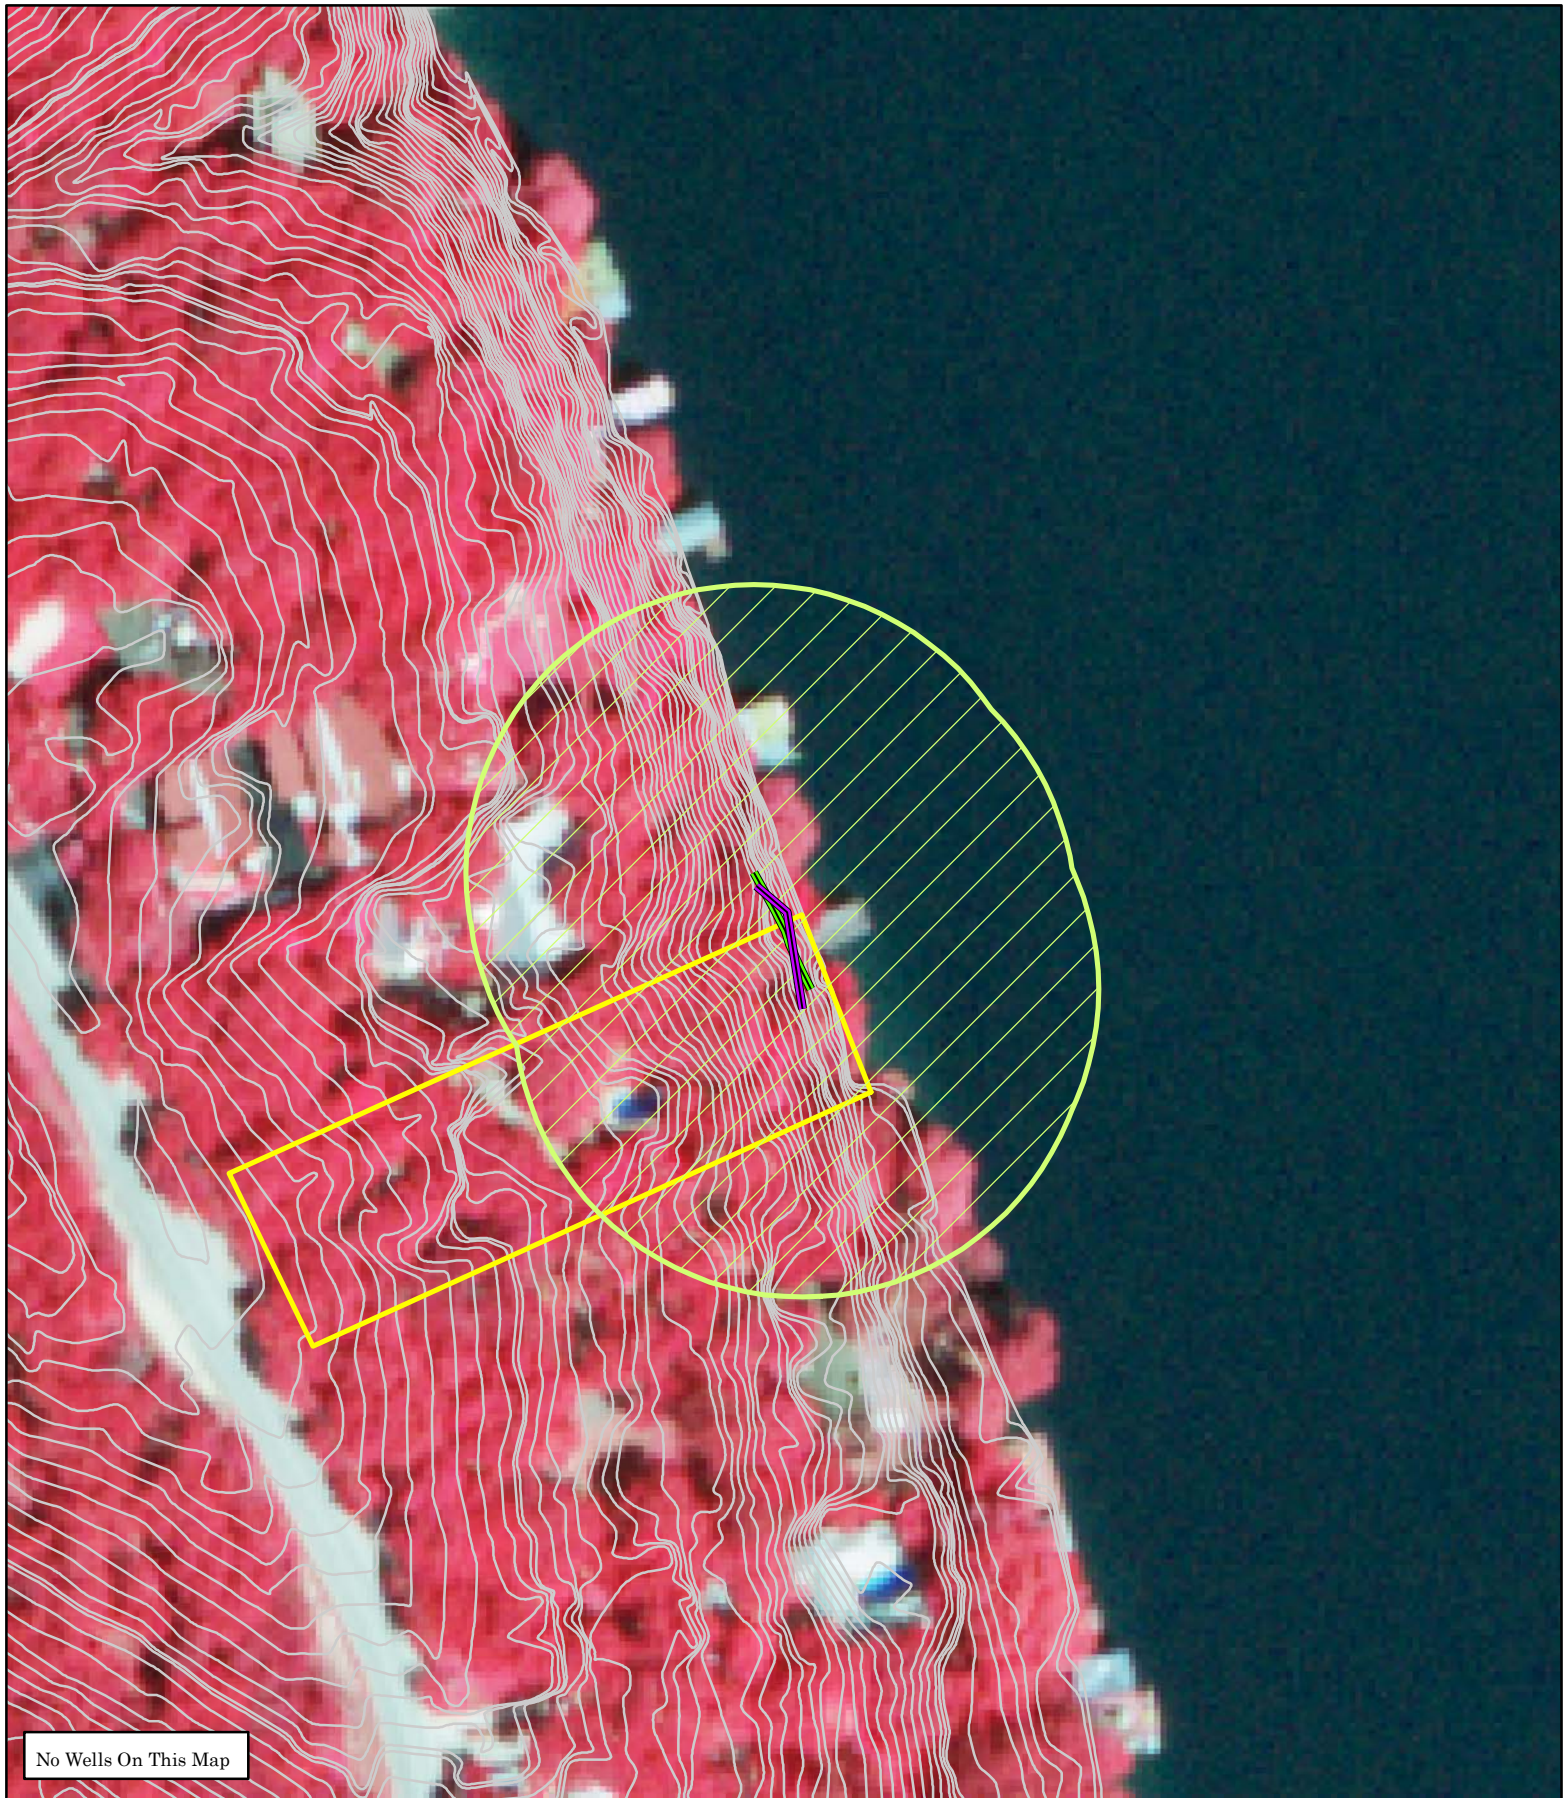
- 2' Contours (CoA)
- Rock Outcrop (CoA)
- Canyon Rimrock (DESCO)
- Parcel of Interest (CoA)
- 150' Buffer

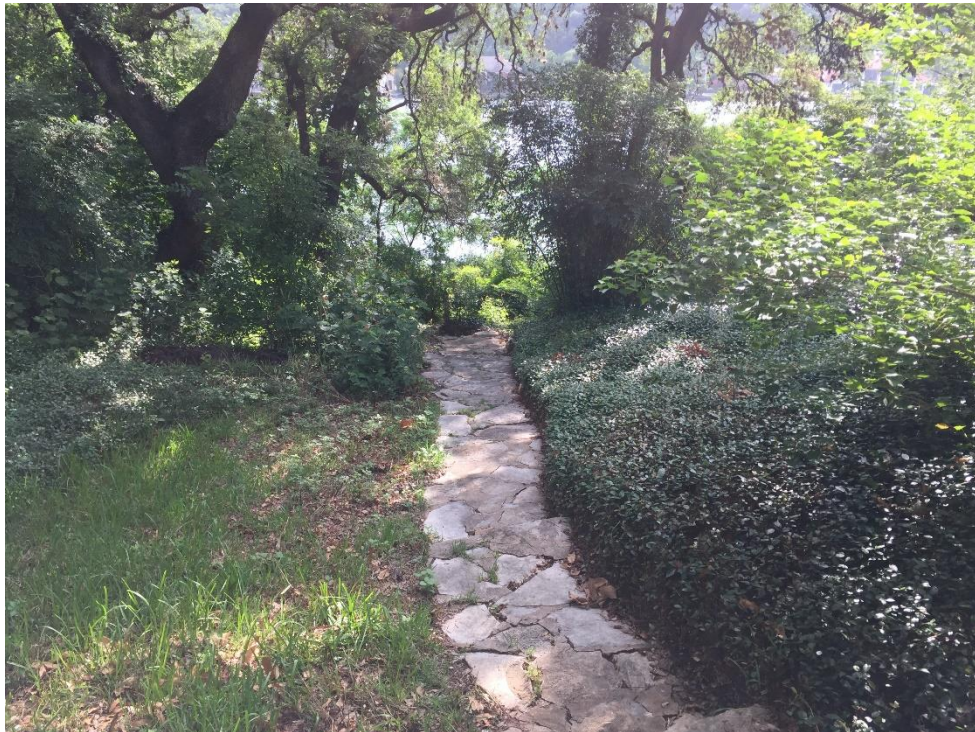
Photo 6: Path from residence down to the dock. Photo is facing the east northeast.

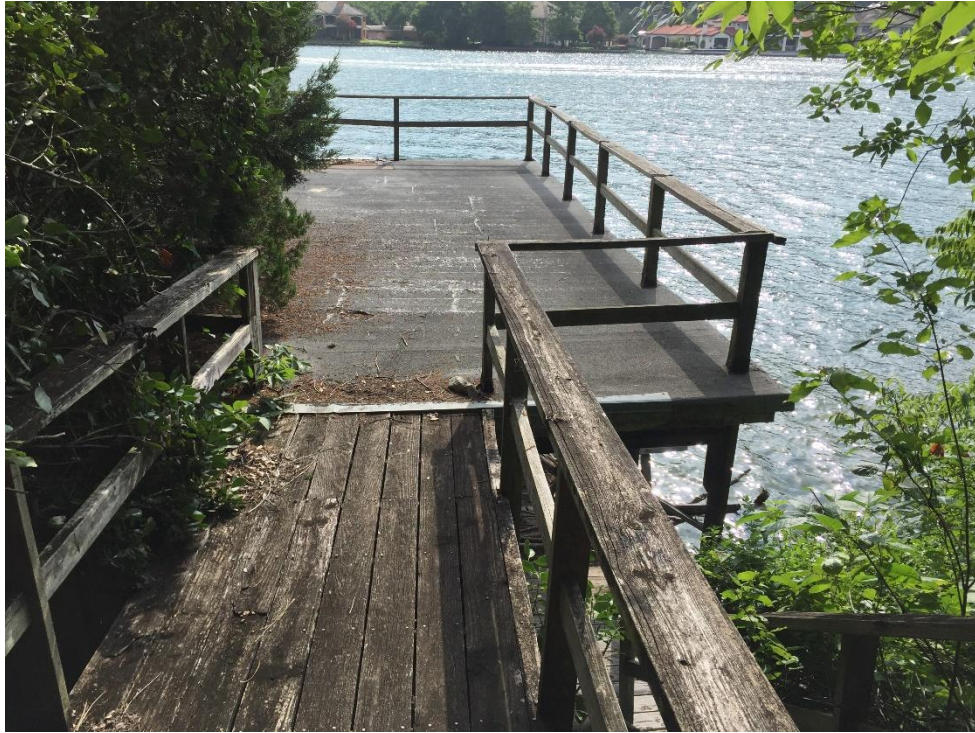
Photo 7: Dock over Lake Austin. Photo is facing the east northeast.

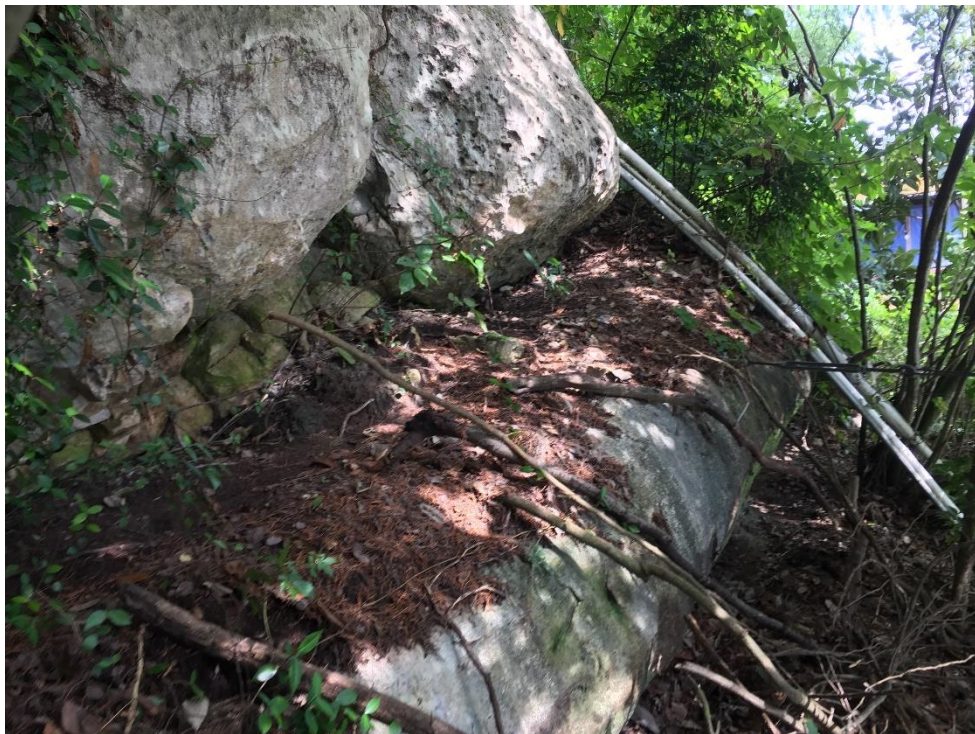
Photo 8: Canyon rimrock (CEF) adjacent to Lake Austin along the eastern boundary of the property. Photo is facing the north northwest.
