ENVIRONMENTAL COMMISSION MOTION 20191106 008a

Subject: 3801 Westlake Drive, SP-2019-0243DS (District 10)

City of Austin – Environmental Resource Inventory (ERI) 3801 Westlake Dr Travis County, Texas

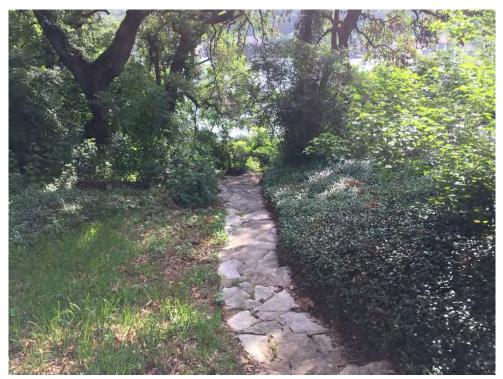
Photo 6: Path from residence down to the dock. Photo is facing the east northeast.

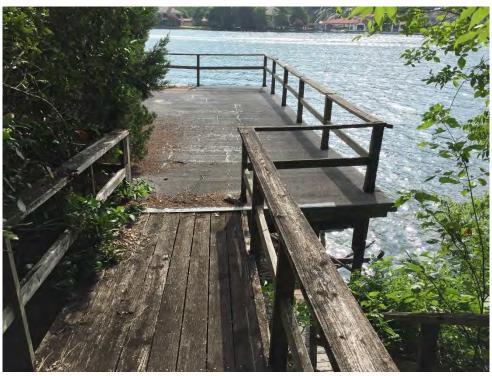
Photo 7: Dock over Lake Austin. Photo is facing the east northeast.

YES. The entire shoreline is within the CEF setback. The existing dock is rotting; it's unsafe and unusable; and the stairs and gangway to the dock cross the rimrock. The replacement dock will be built as far away as possible from the rimrock while making maximum use of the existing access route from the house in order to minimize the disturbance on the shoreline. Runoff from the limit of construction will not flow toward the rimrock.

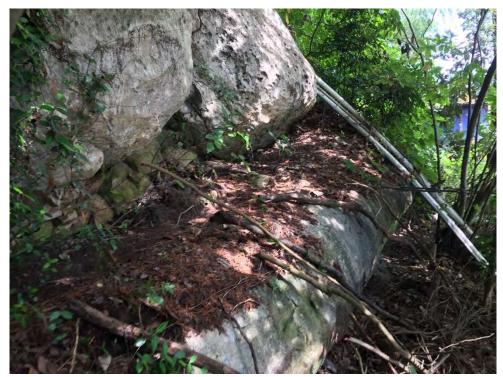
Photo 8: Canyon rimrock (CEF) adjacent to Lake Austin along the eastern boundary of the property. Photo is facing the north northwest.

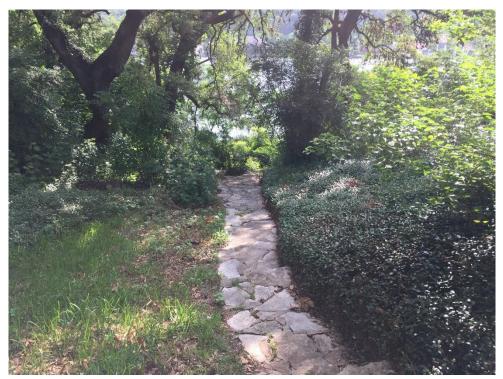
Photo 6: Path from residence down to the dock. Photo is facing the east northeast.

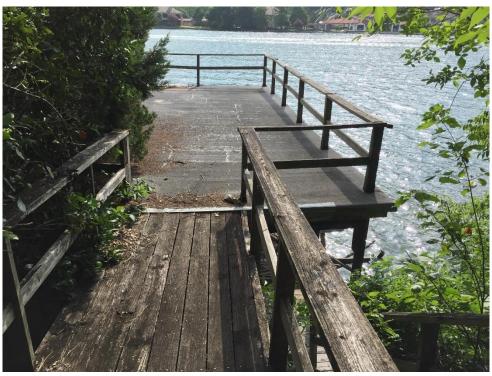
Photo 7: Dock over Lake Austin. Photo is facing the east northeast.

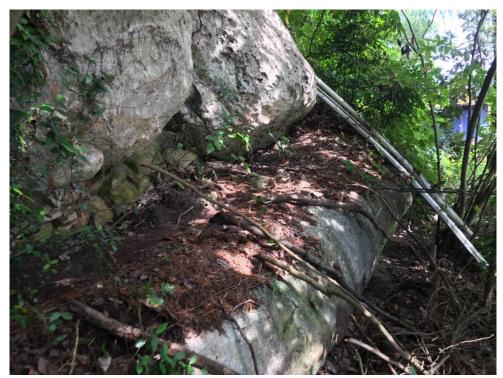
Photo 8: Canyon rimrock (CEF) adjacent to Lake Austin along the eastern boundary of the property. Photo is facing the north northwest.
