Question and Answer Report
Zoning and Platting Meeting May 5, 2020

3. Rezoning: [C14-2020-0012 - Plaza Volente Residential; District 6](#)

9.541-ACRE 11411 AND 11409 N FM620 ROAD TRACT CRITICAL ENVIRONMENTAL FEATURE MEMO

Subject: **Critical Environmental Feature (CEF) Memo**

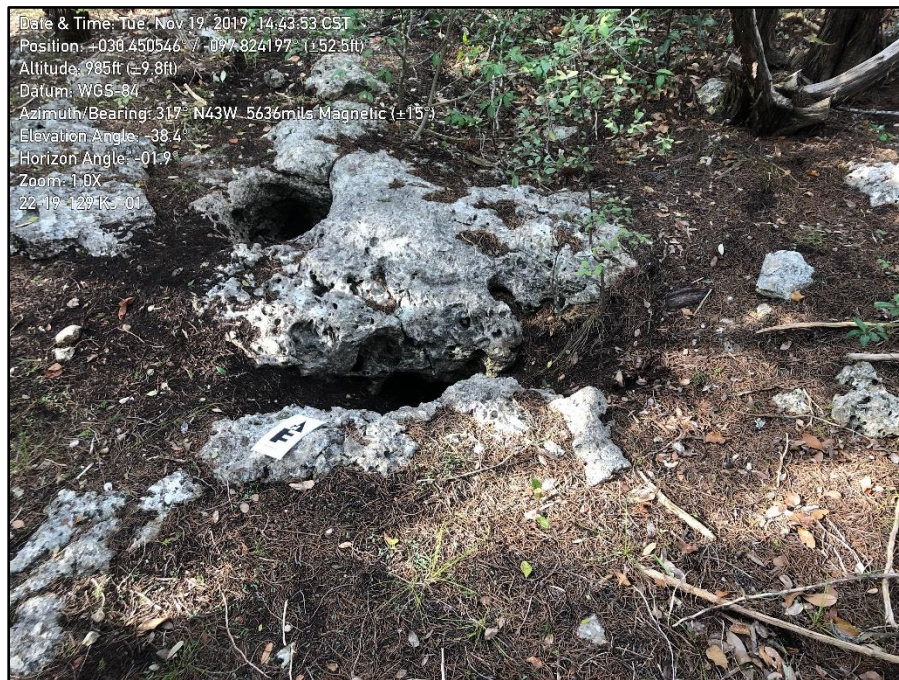
KJ-01 is solution-cavity within epikarst limestone. The feature consists of two connected apertures that appear to have been enhanced by animal burrowing. The first aperture is 1.5 feet in diameter and 3 feet deep. The second larger aperture is approximately 3 feet by 2 feet and extends downwards 3 feet as well. The infill materials consist of roots from a nearby persimmon as well as moderately compacted organic and clay rich soils, spines from ashe juniper, and loose leaf litter. The feature is located along a gentle hillside and has a catchment area less than 1.6 acres. Consistent with the rest of the site, the immediate area around the feature consisted of large limestone boulders and slabs suspended in soils that were detached from the underlying bedrock, as epikarst generally is in this area. Due to the lack of subsurface connection to bedrock and a direct pathway or conduit for point recharge, the feature is not considered a Critical Environmental Feature as defined by the City of Austin and does not warrant protective buffering.

View of KJ-01

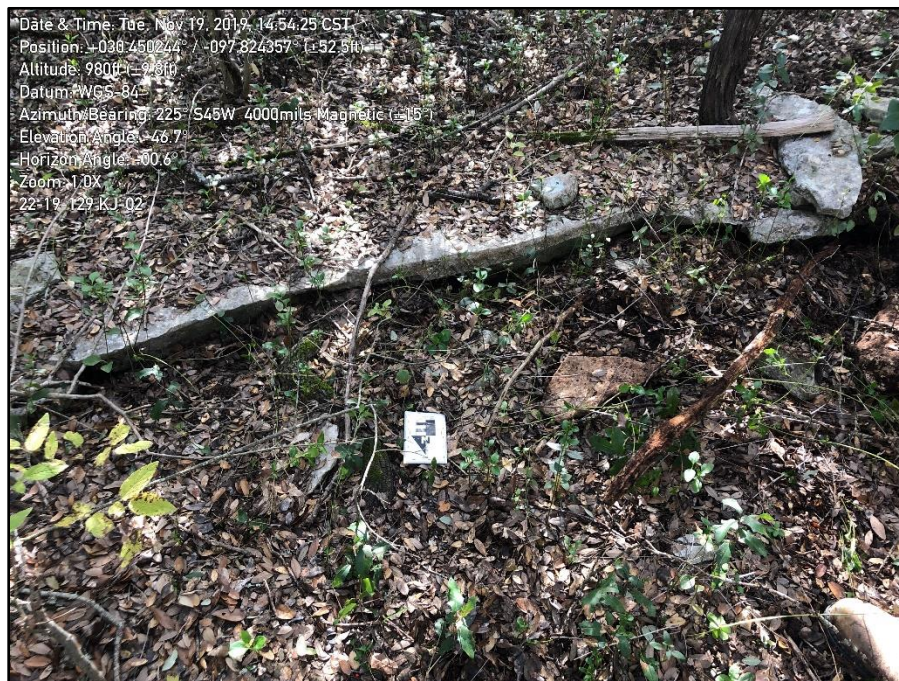
KJ-02 is an epikarst feature with limited subsurface development influenced by root heave (ashe juniper). The opening of the feature exists along the edge of a one-foot thick limestone slab that extends 10 feet along a trend of 120°. The opening and edges of the feature were lightly excavated by hand to investigate the origin of the feature. As a result of the light excavation the feature was determined to be a product of root heave where several large roots of an ashe juniper uplifted the limestone slab. Infill material below the slab consisted of loose leaf litter, moderately compacted soils rich in clay, and organic matter. As the feature lacked a subsurface connection to bedrock and a direct pathway or conduit for point recharge, it is not considered a Critical Environmental Feature as defined by the City of Austin and does not warrant protective buffering.

View of KJ-02

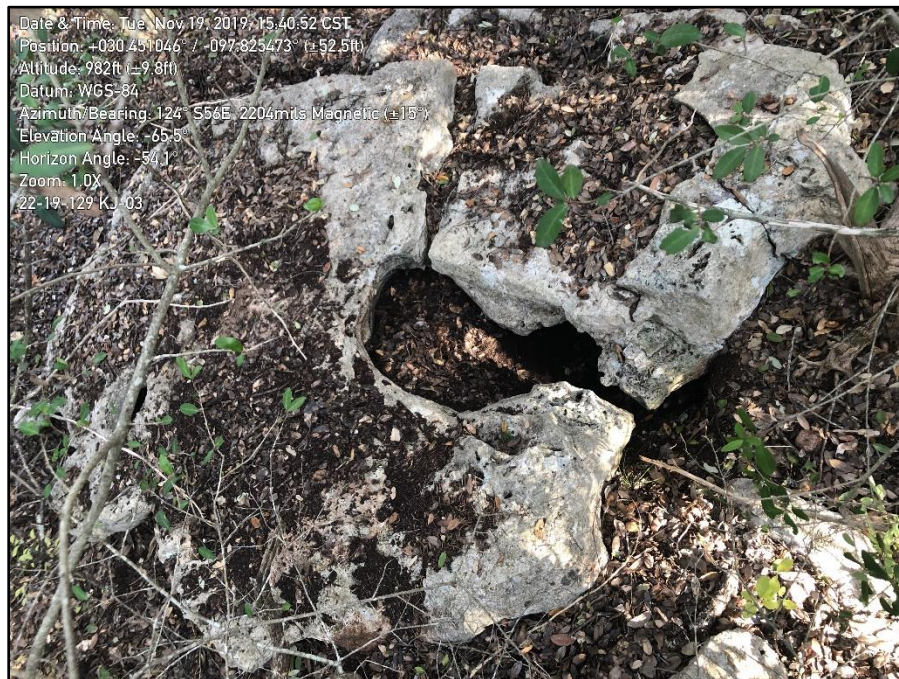
KJ-03 is a solution cavity in epikarst limestone with limited subsurface development. The dimensions of the feature are 2 feet by 1 foot by 3 feet deep. The infill materials consist of loose leaf litter, dark soils rich in clay, and organic material. The feature is located along a hillside and has small catchment area that is less than 1.6 acres. Due to the lack of subsurface connection to bedrock and a direct pathway or conduit for point recharge, it is not considered a Critical Environmental Feature as defined by the City of Austin and does not warrant protective buffering.

View of KJ-03

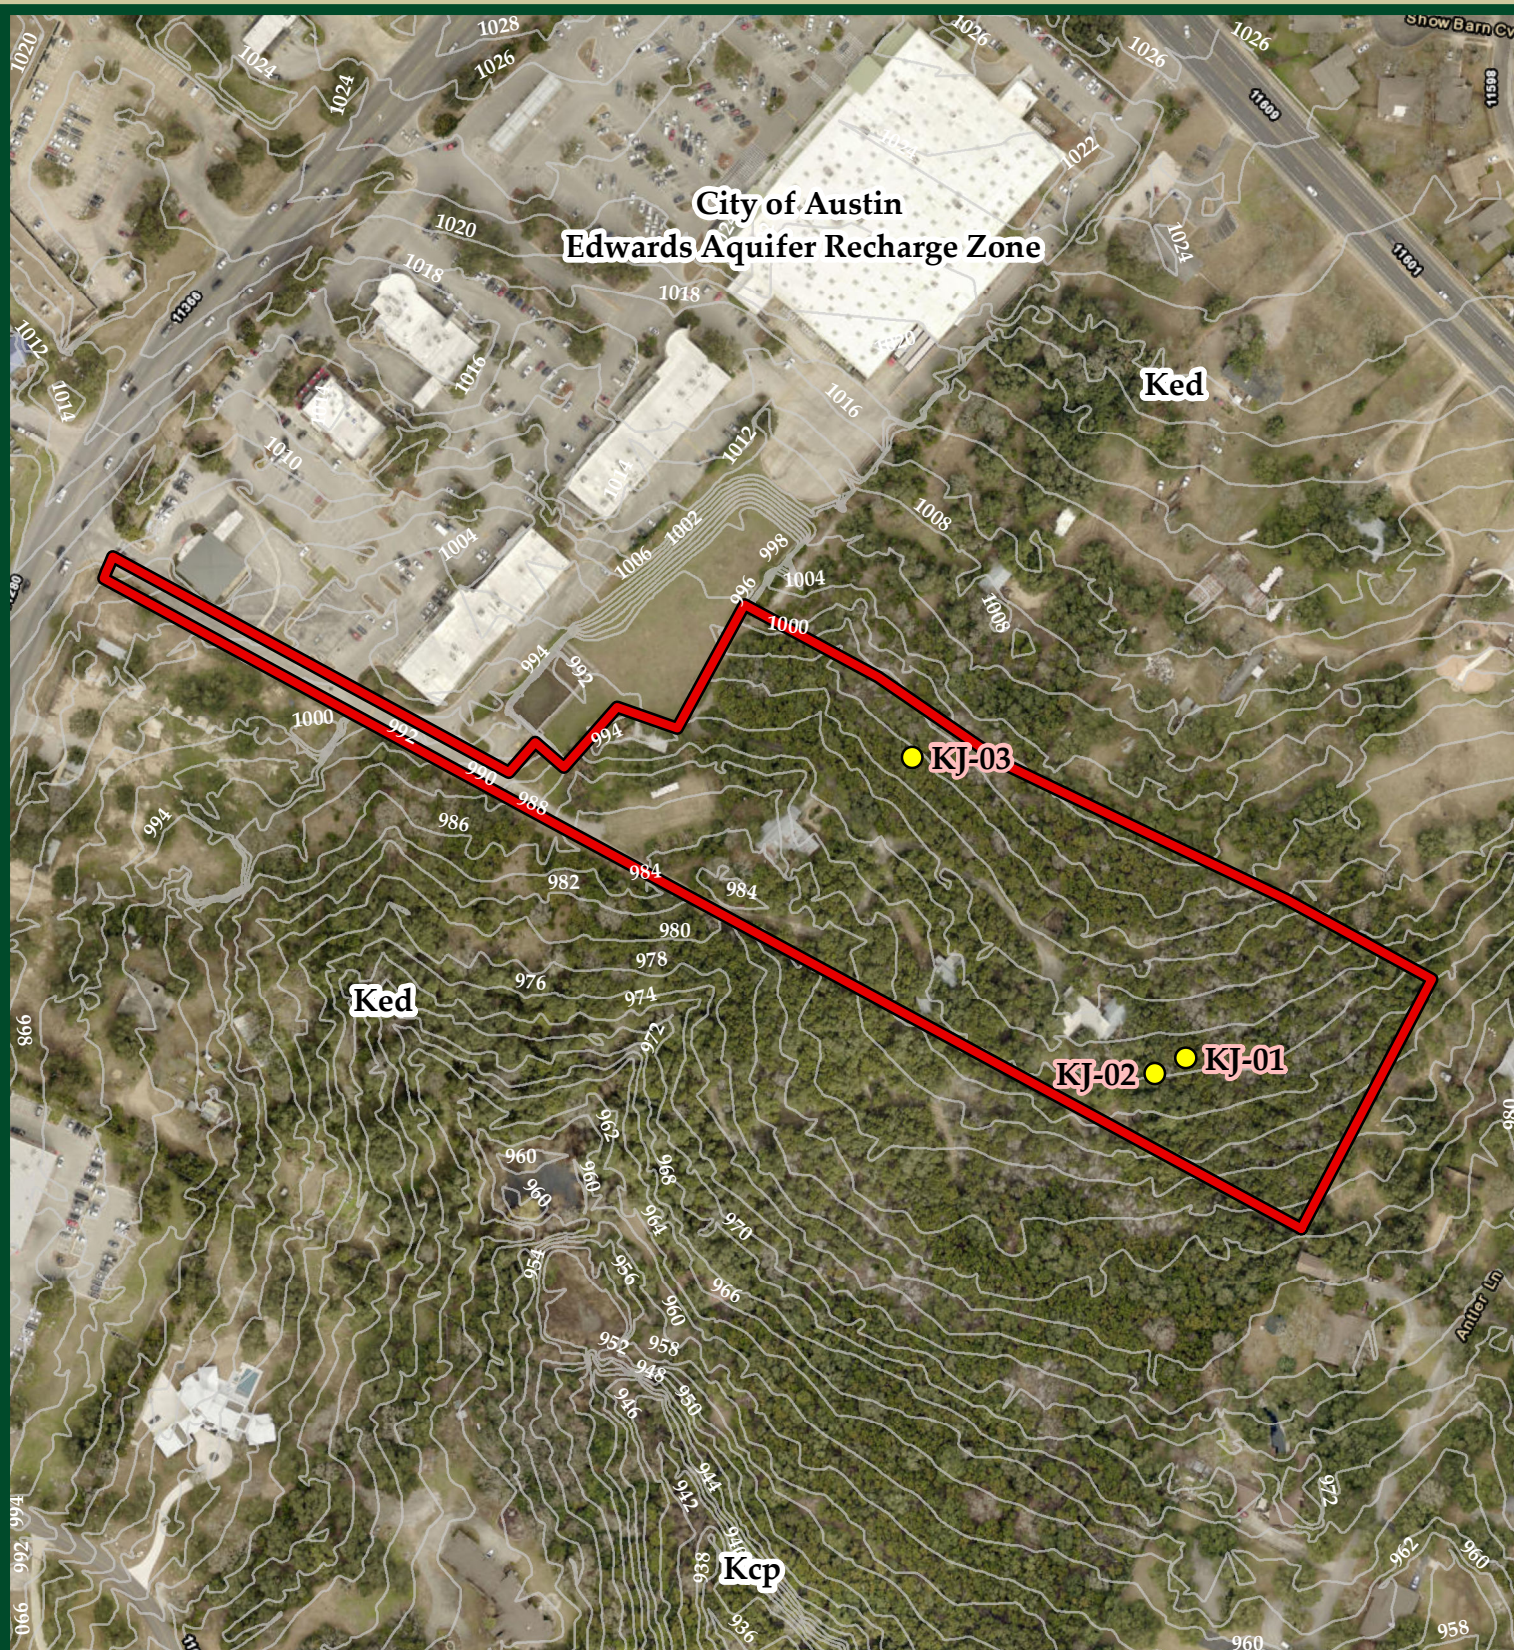
Site reconnaissance investigations were conducted by Luke Rome, P.G. and Kara Posso, G.I.T. of **aci consulting** on November 20, 2019. The field investigation identified three features related to karst geology. After thorough evaluation, these three features were determined to be non-sensitive regarding the potential to serve as a source of point recharge. There were no CEFs identified within the limits of the subject area. Included in this memorandum are the photographs, descriptions, and recommended buffers (when applicable) for each of the features. A map of the site and findings are displayed in **Figure 1**.

Subject Area

Features (Non-CEF)
