## BANDSTAND

## GRANDSTAND

## SITE

## REHABILITATION STRATEGIES SUPPLEMENT

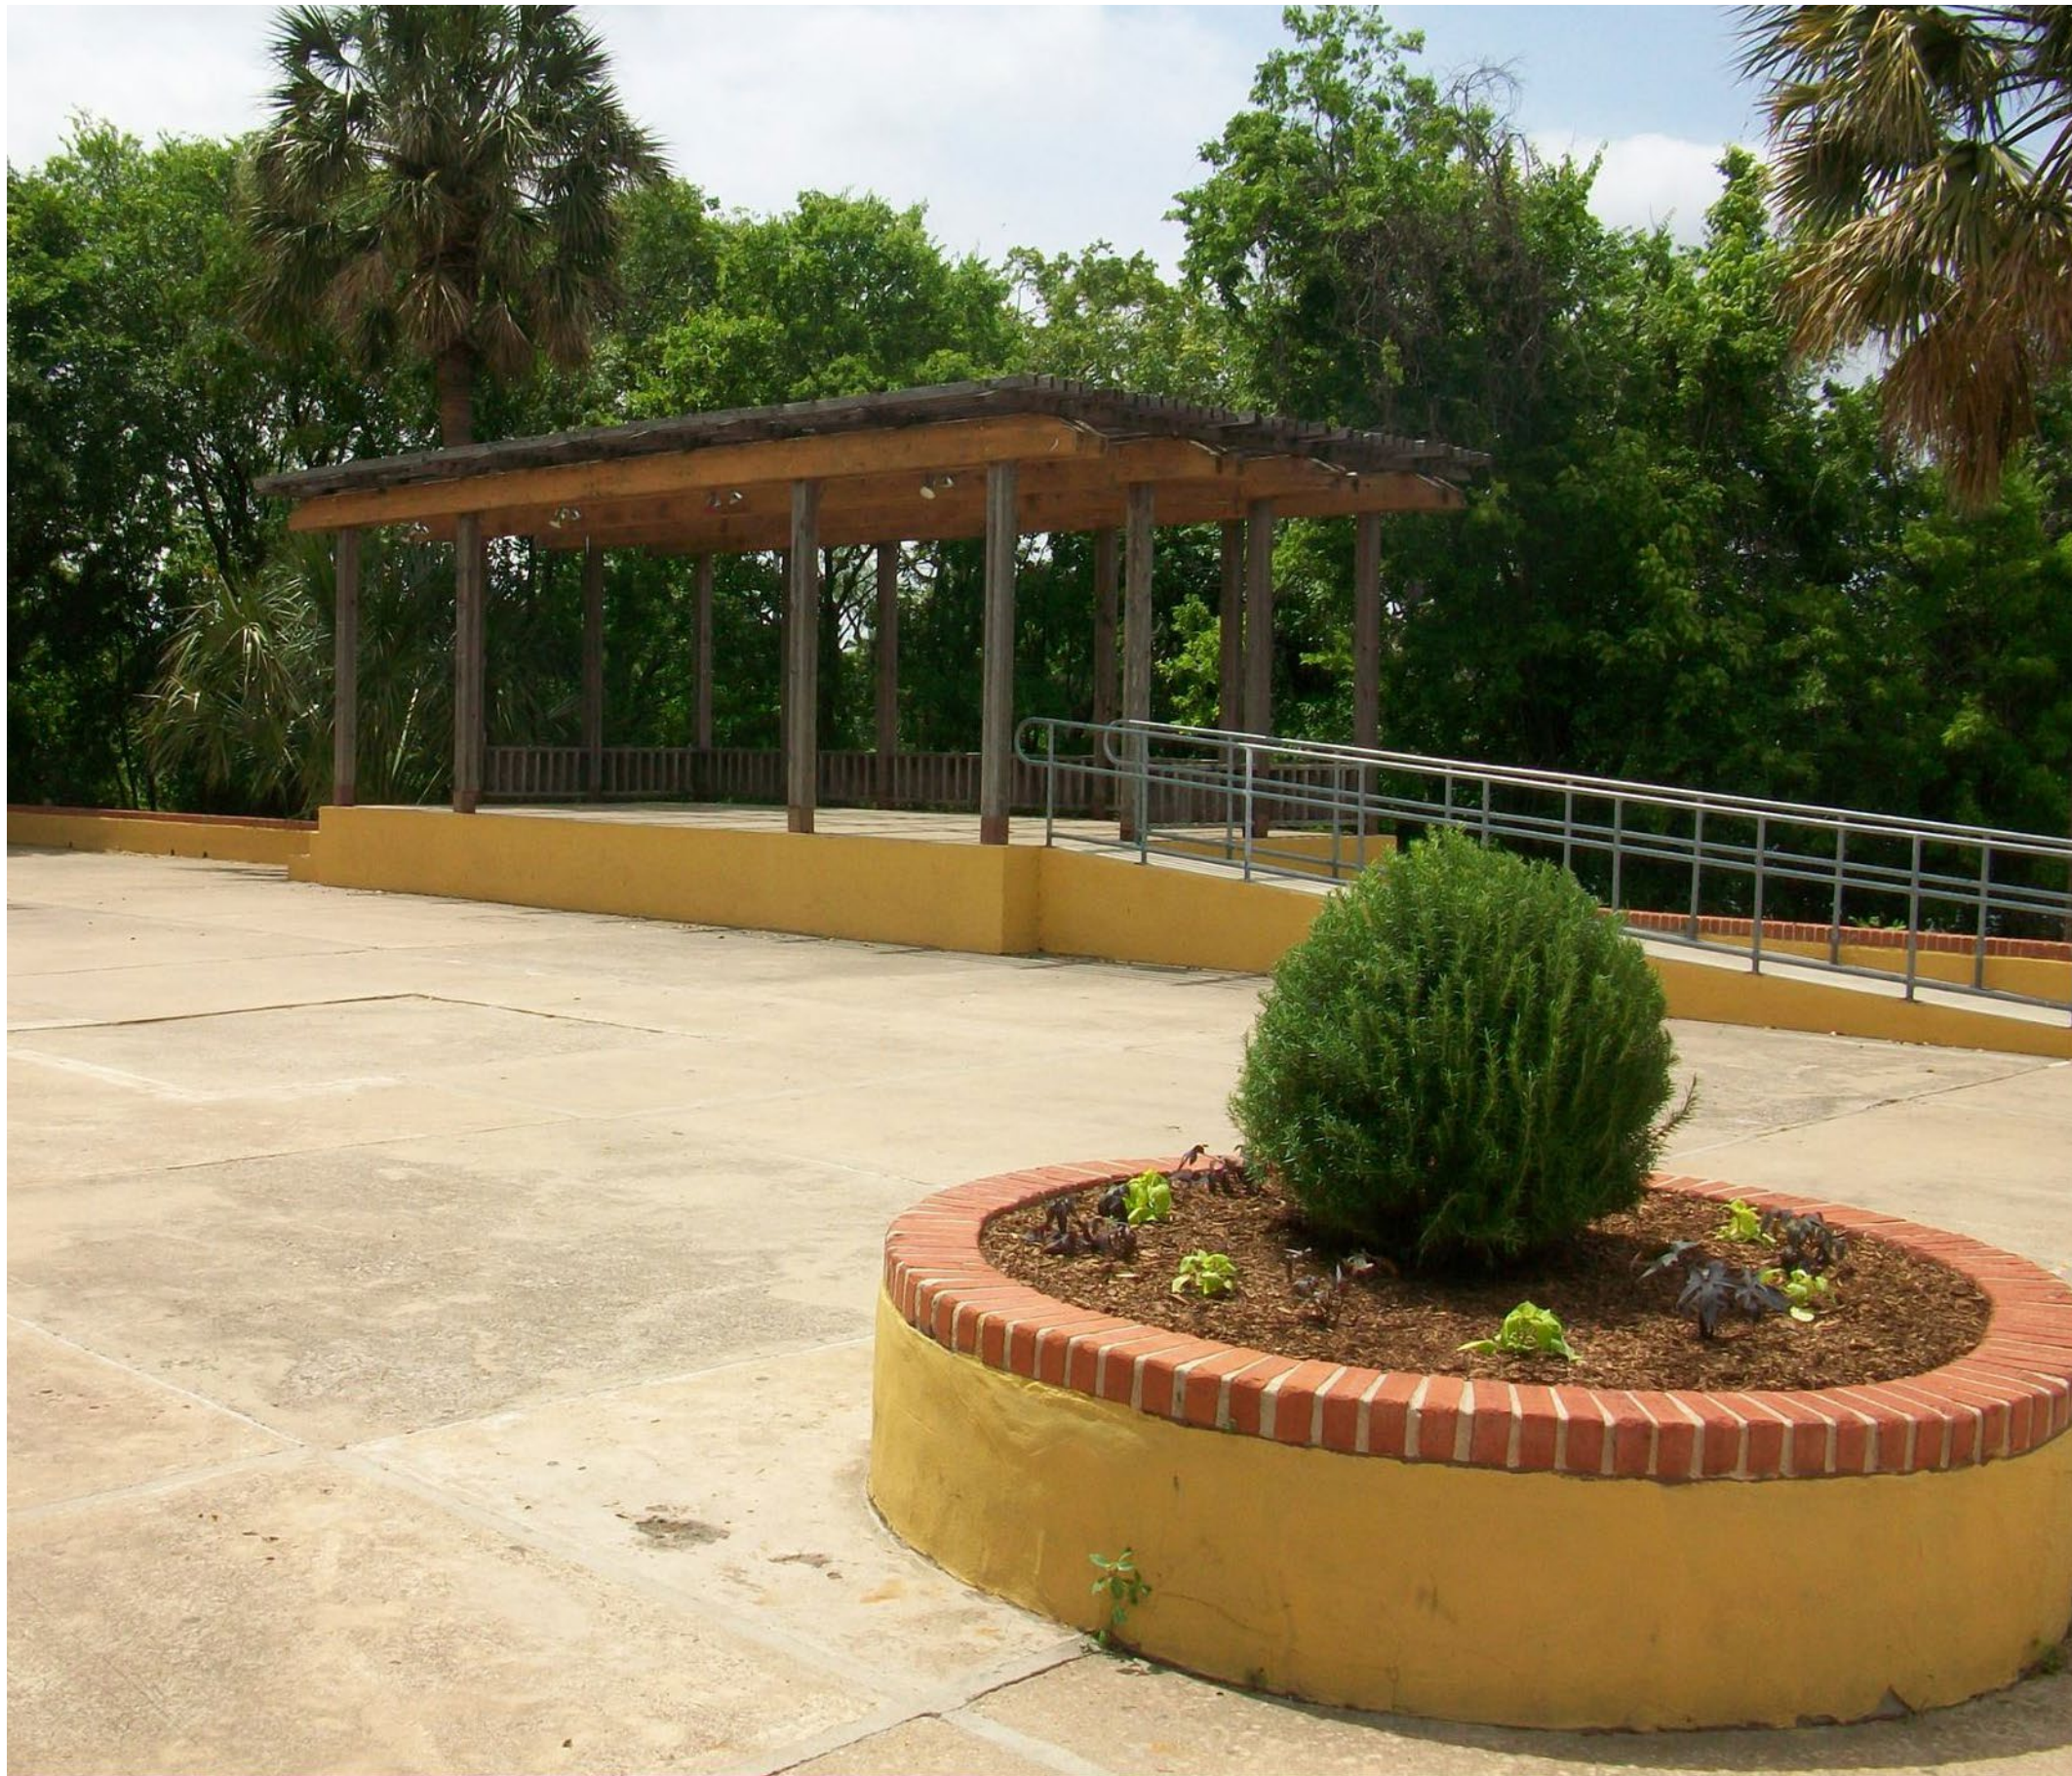
- Views behind structure limited

- Non-original yellow paint
- Concrete stage in good condition, but high
- Wood shade structure in poor condition
- Ramp not original; stairs lack handrails

- Limited power and lighting

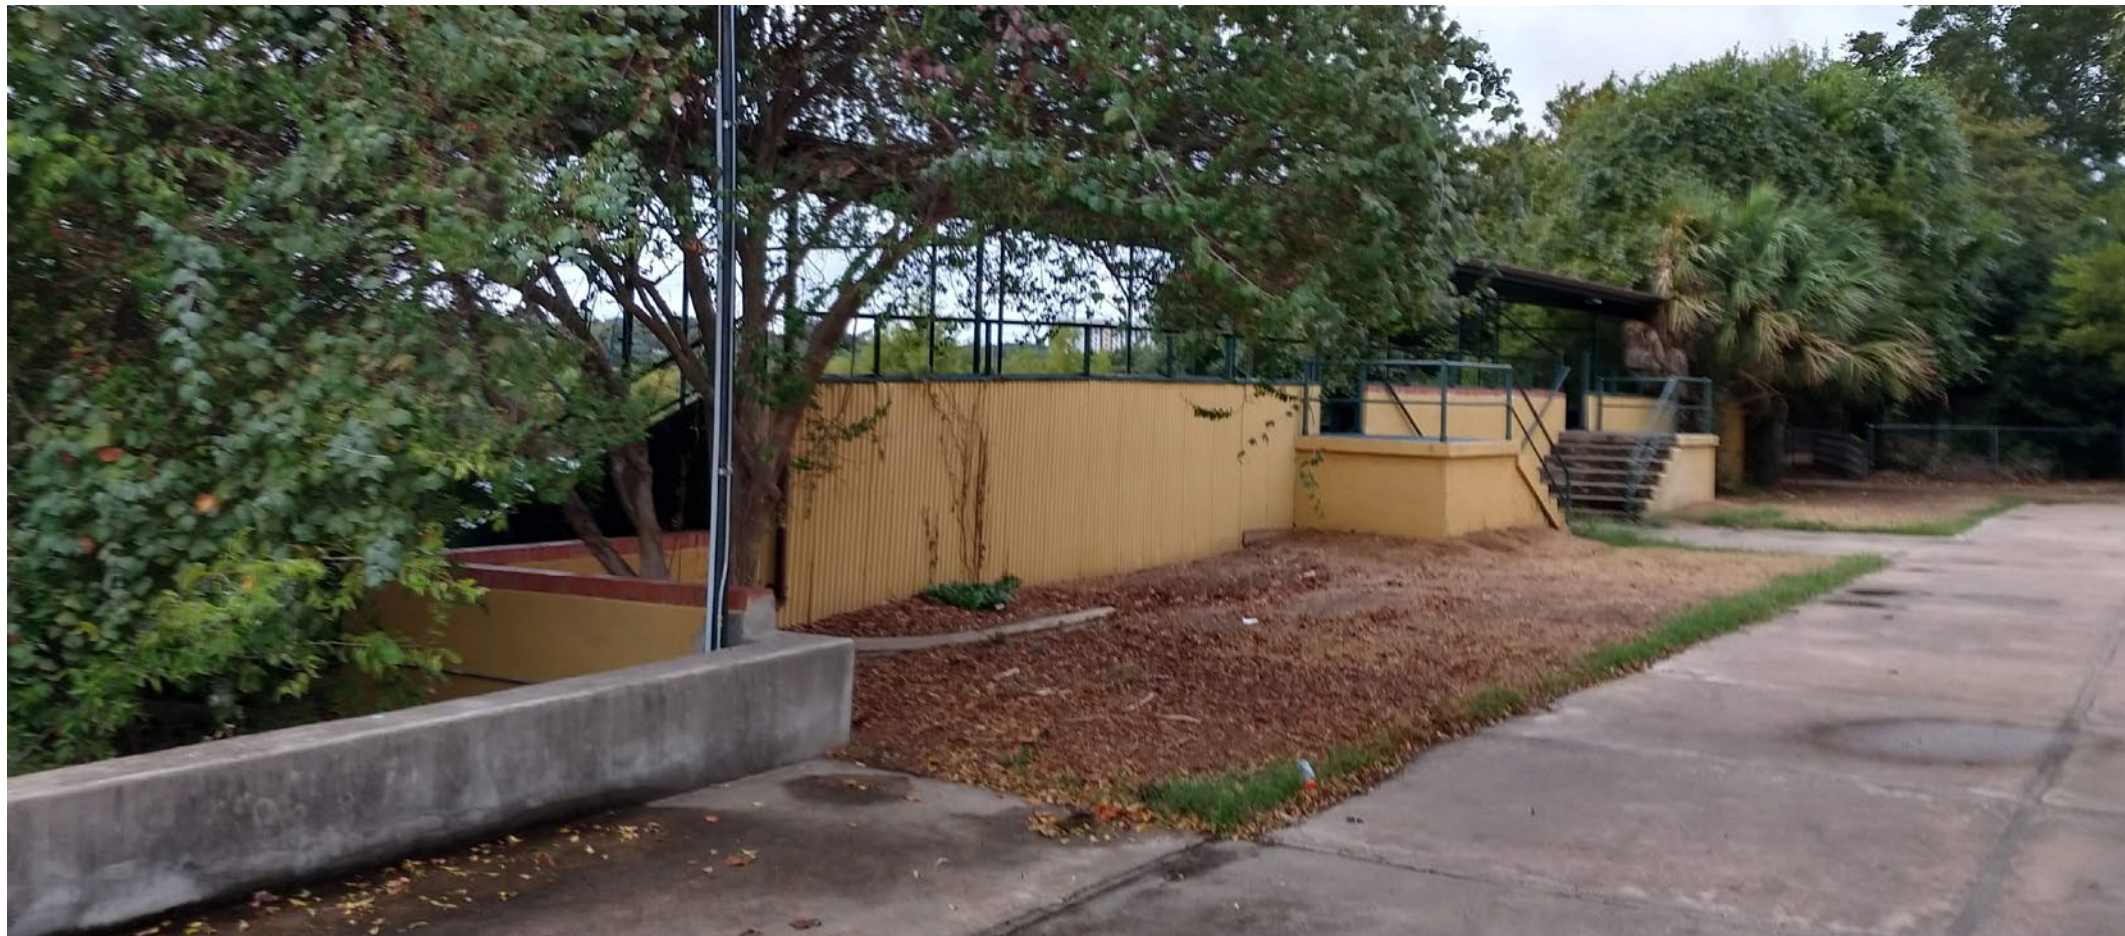
- Bald cypress trees are quickly growing at base
- Upper bleachers limit views across lake

- Non-original paint colors throughout
- Paint older, failing
- No accessible seating or approach
- Steel structure is in good condition

- Lighting is focused on security, not event use

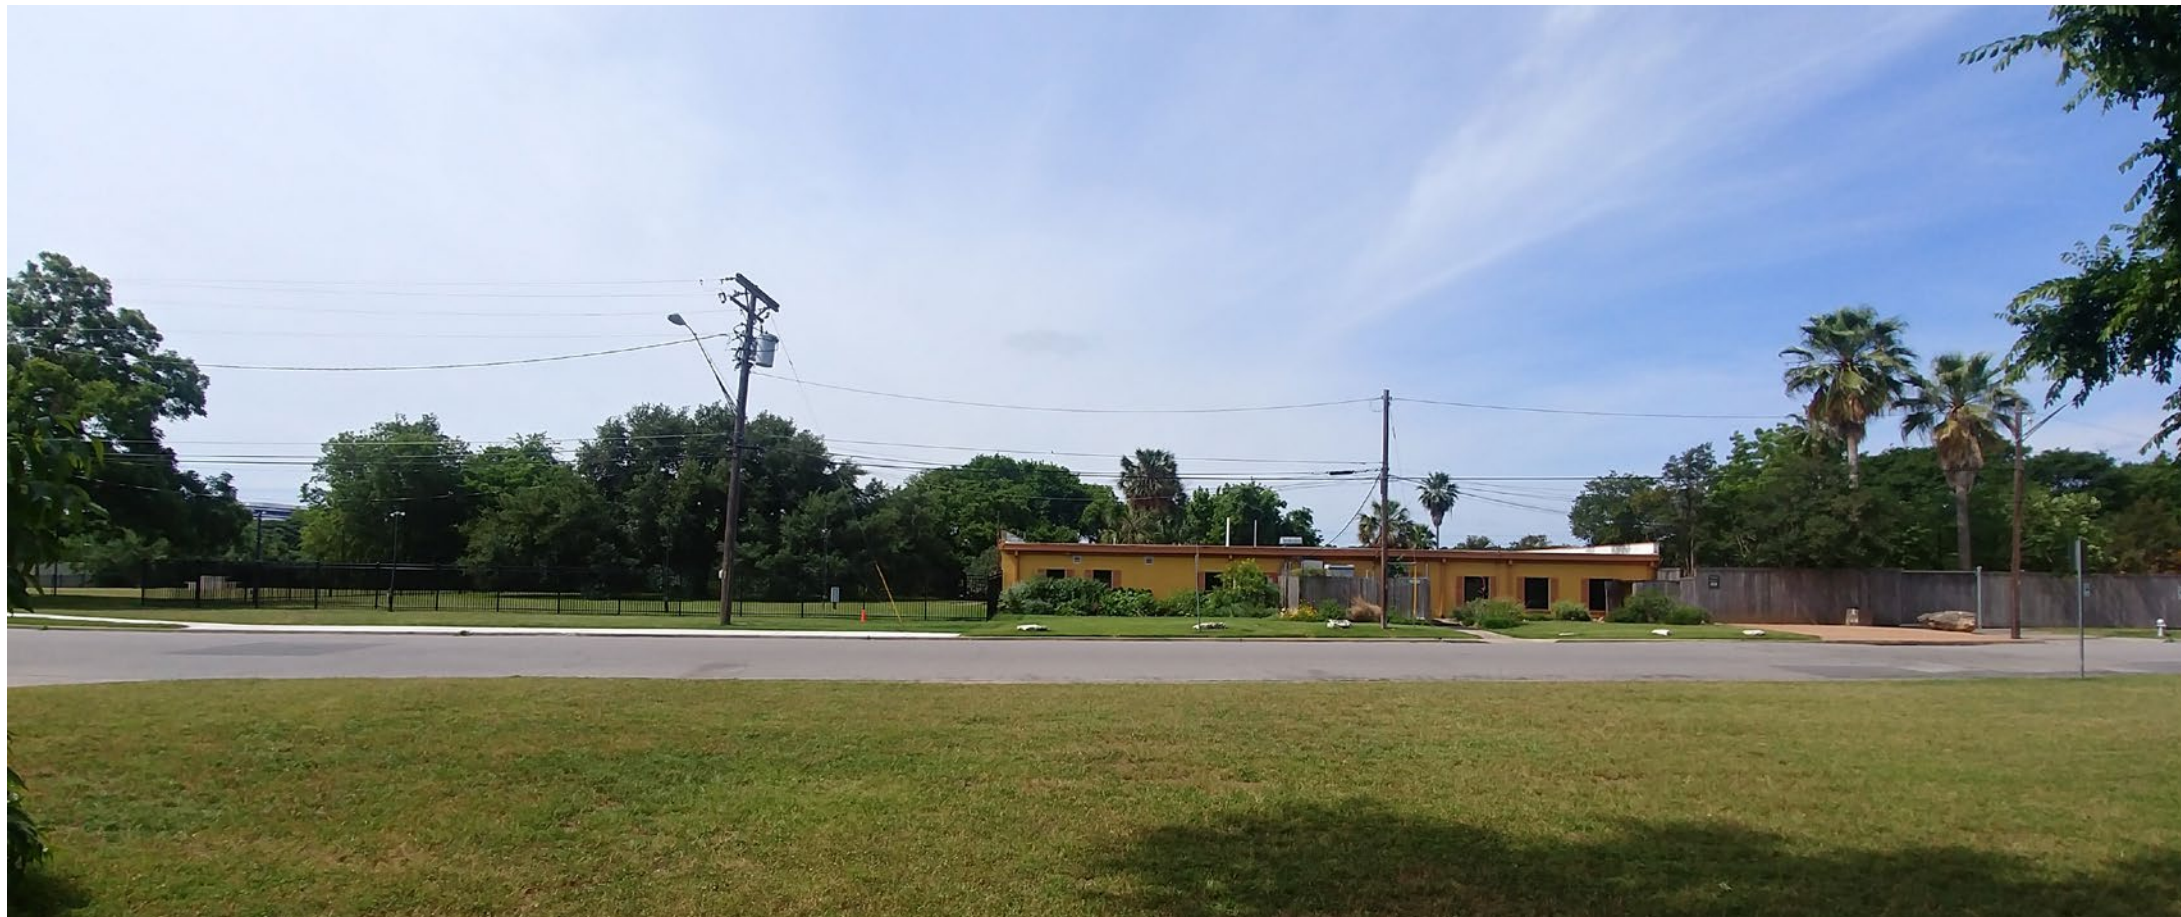
- Stucco finishes have non-original paint color and partial cracking across plaza
- Fencing uninviting

- Limited to 2 van-accessible spots
- Gravel parking lot and driveway is used by PARD staff
- No dedicated trash or loading areas

- Overhead utility lines and street lighting
- Outdoor lighting is insufficient and varies in quality
- Power outlets are insufficient

- Portions of site and buildings are within Lady Bird Lake restricted development areas
