NAME & NUMBER OF PROJECT: COA Fire & EMS Station - Davenport Village
SP-2021-0121D

REQUEST: Variance request is as follows:
Vary 25-8-302(A)(2) to allow construction of a parking area on a slope with a gradient of more than 15 percent.

**LAND USE COMMISSION VARIANCE
LDC 25-8-302(A)(S)**

RE: Land Use Commission Variance – Slope Requirements (*LDC 25-8-302 (A)(2)*)
COA Fire and EMS Station – Davenport Village (*SP-2021-0121D*)
4601 Westlake Drive
Austin, Travis County, Texas

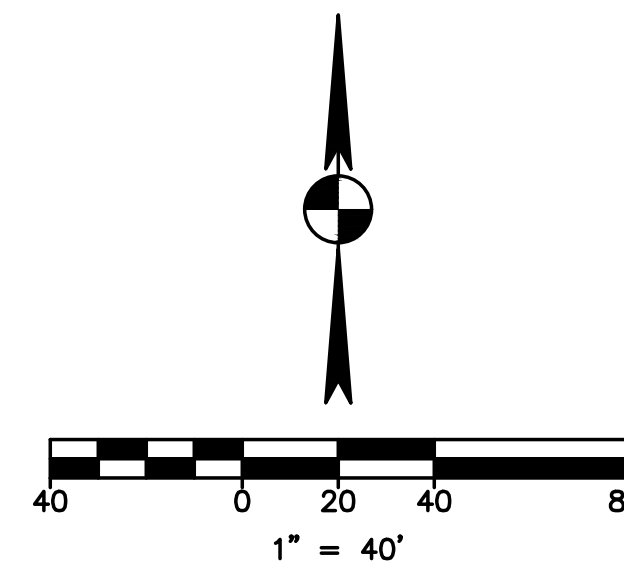
EXHIBIT 3
SLOPE MAP

Slopes Table				
Number	Minimum Slope	Maximum Slope	Area (Acres)	Color
1	0.00%	15.00%	1.2	
2	15.00%	25.00%	0.1

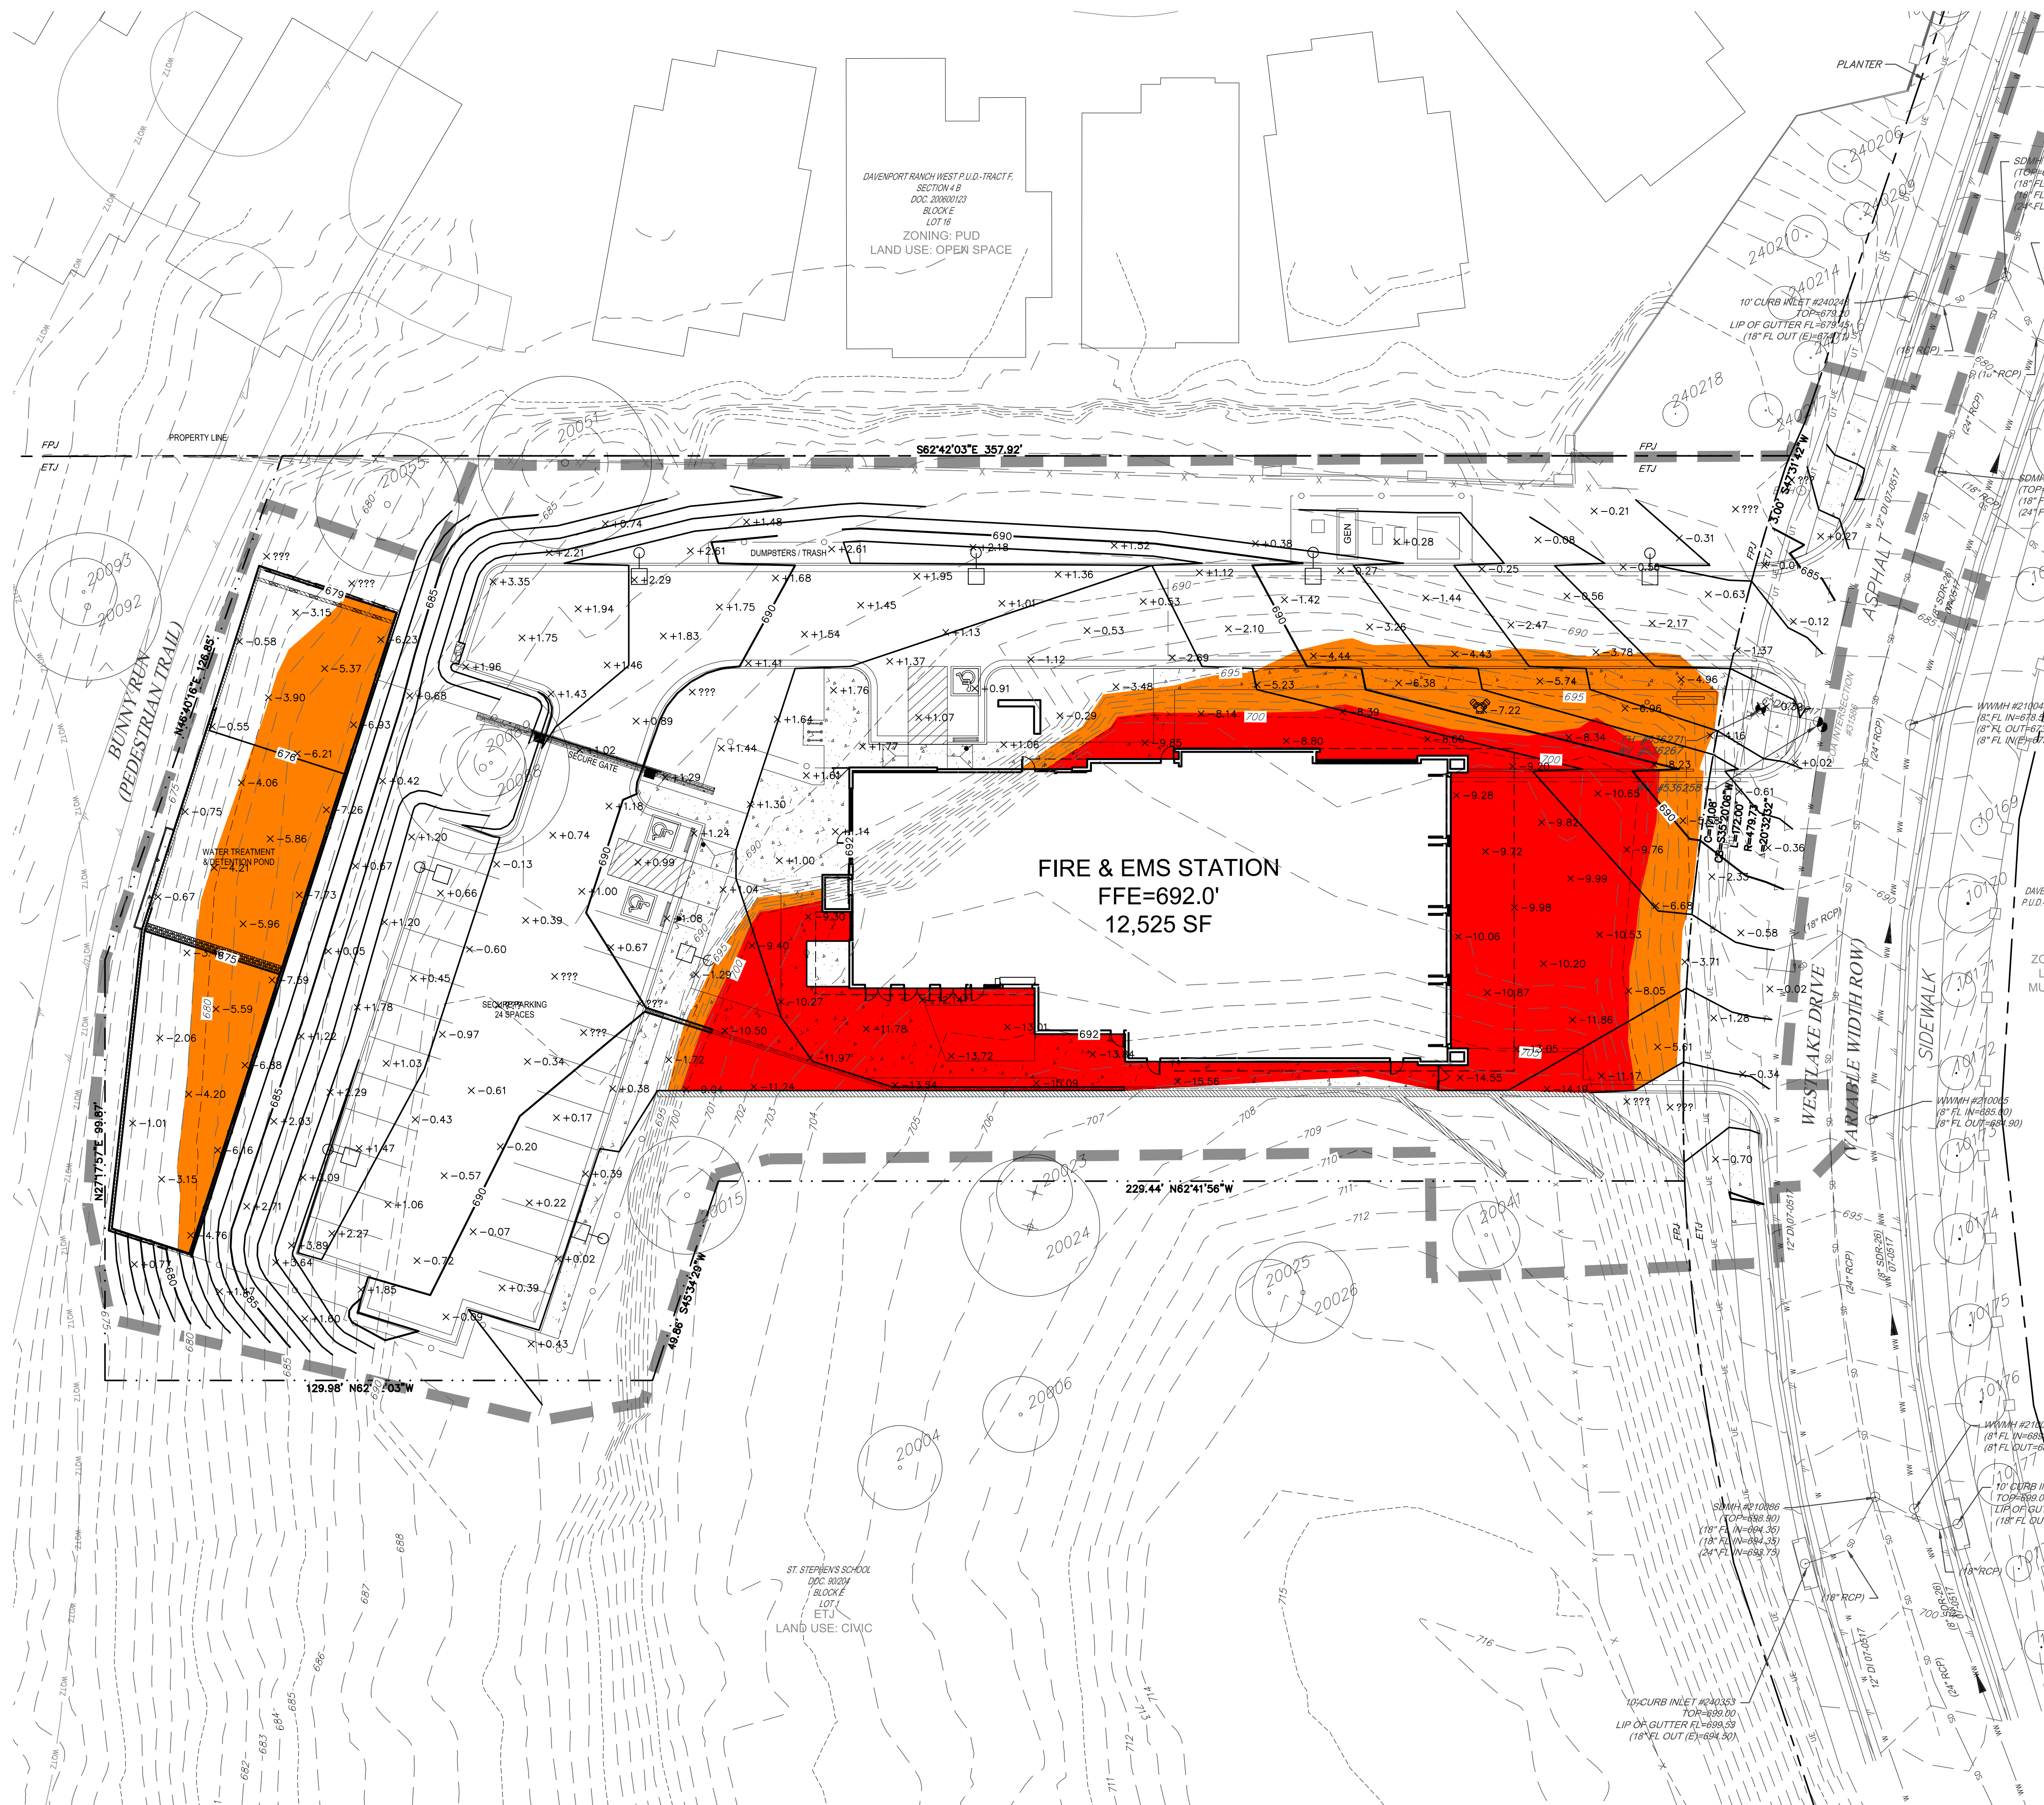
Number	Minimum Elevation	Maximum Elevation	Color
1	-20.000	-8.000

5	8.000	20.000

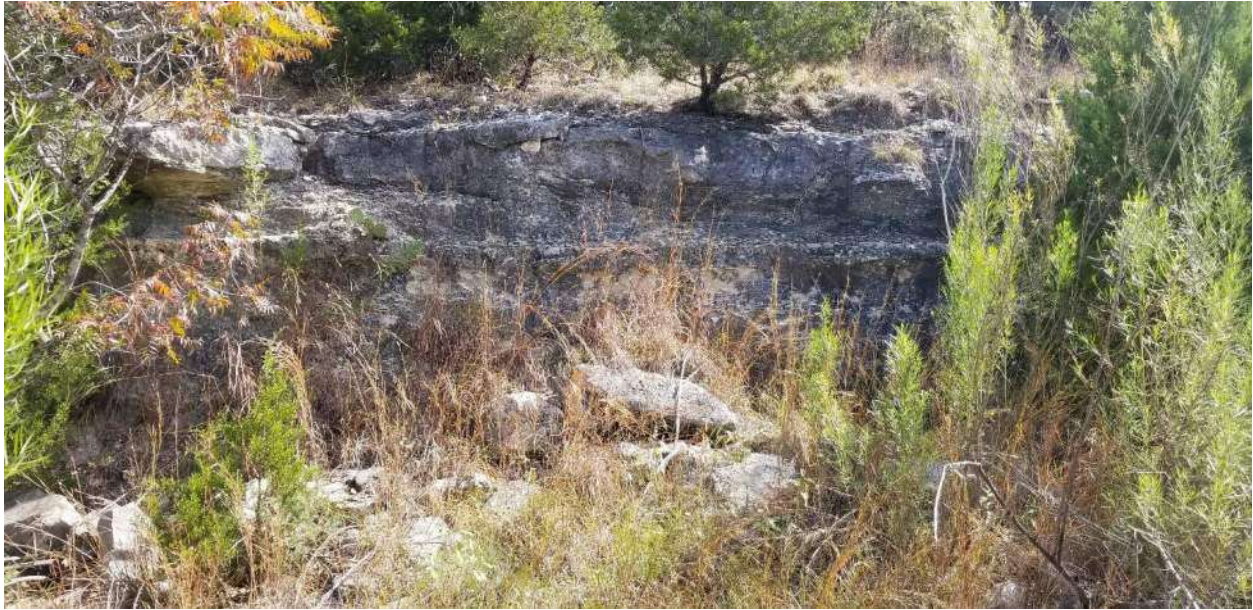
Photo 1. View of the middle of the outcrop facing South East. At this location, the outcrop is approximately 10 feet tall and has concrete debris along its base.

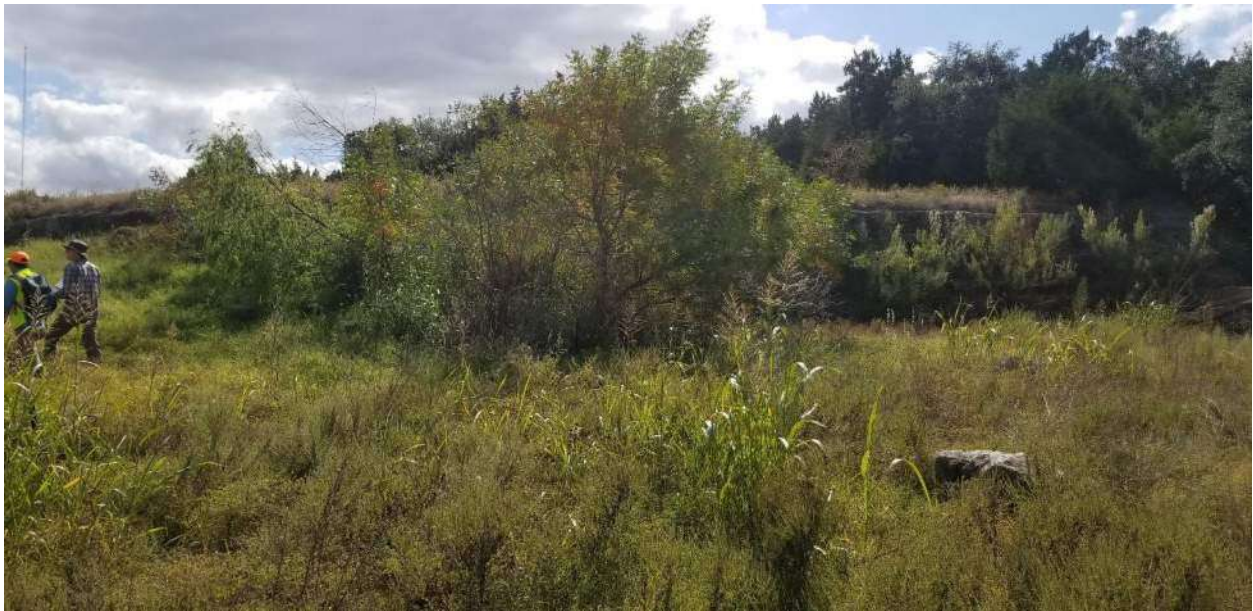
Photo 2. View facing south at the northern extent of the outcrop as it tapers and gradually ties into the ground surface (left side of the photo).

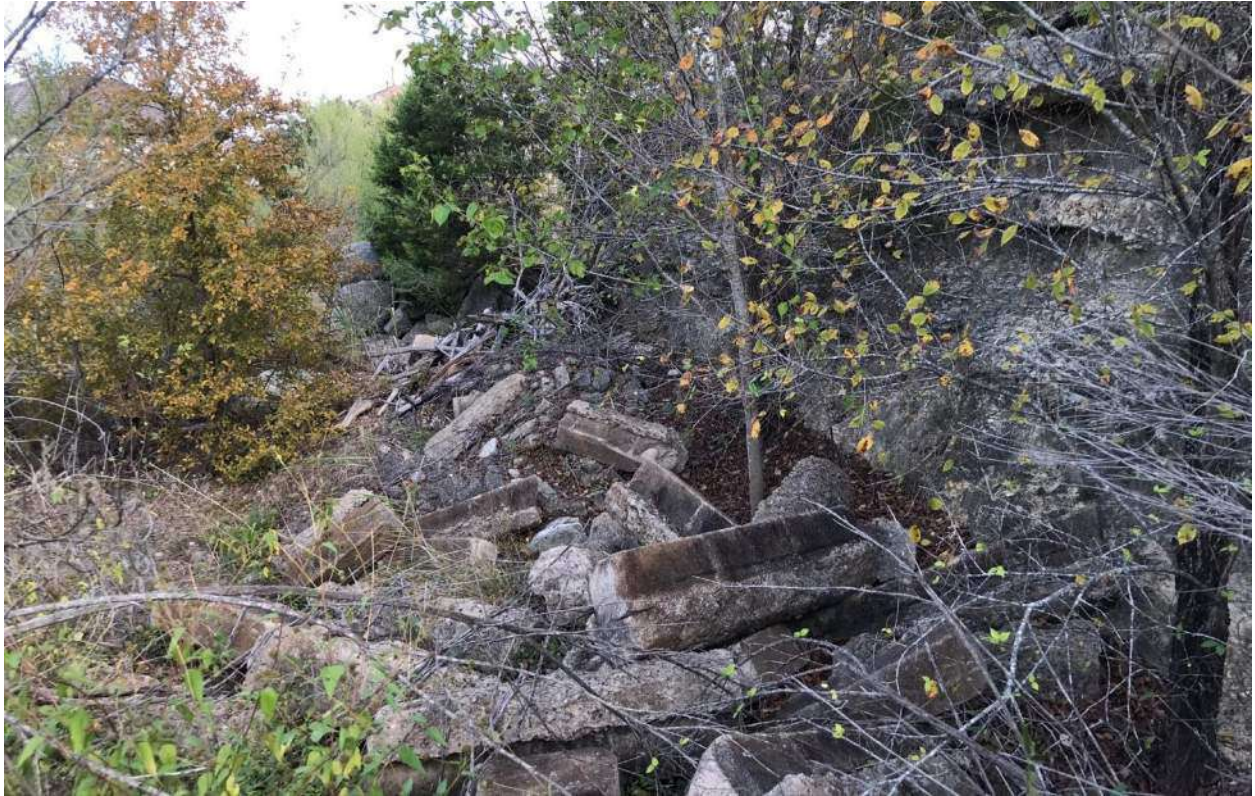
Photo 3. View of concrete debris along the base of the outcrop.

- Lastly, debris composed of concrete riprap and fallen bedrock talus is present at the toe of the bluff on the site. The bedrock present on-site are listed as moderately hard to hard rock (City of Rodda et al., 1970). This was also observed during the site visit. This means that it is unlikely that the bedrock was placed here by erosion or natural causes but during site development or quarrying.

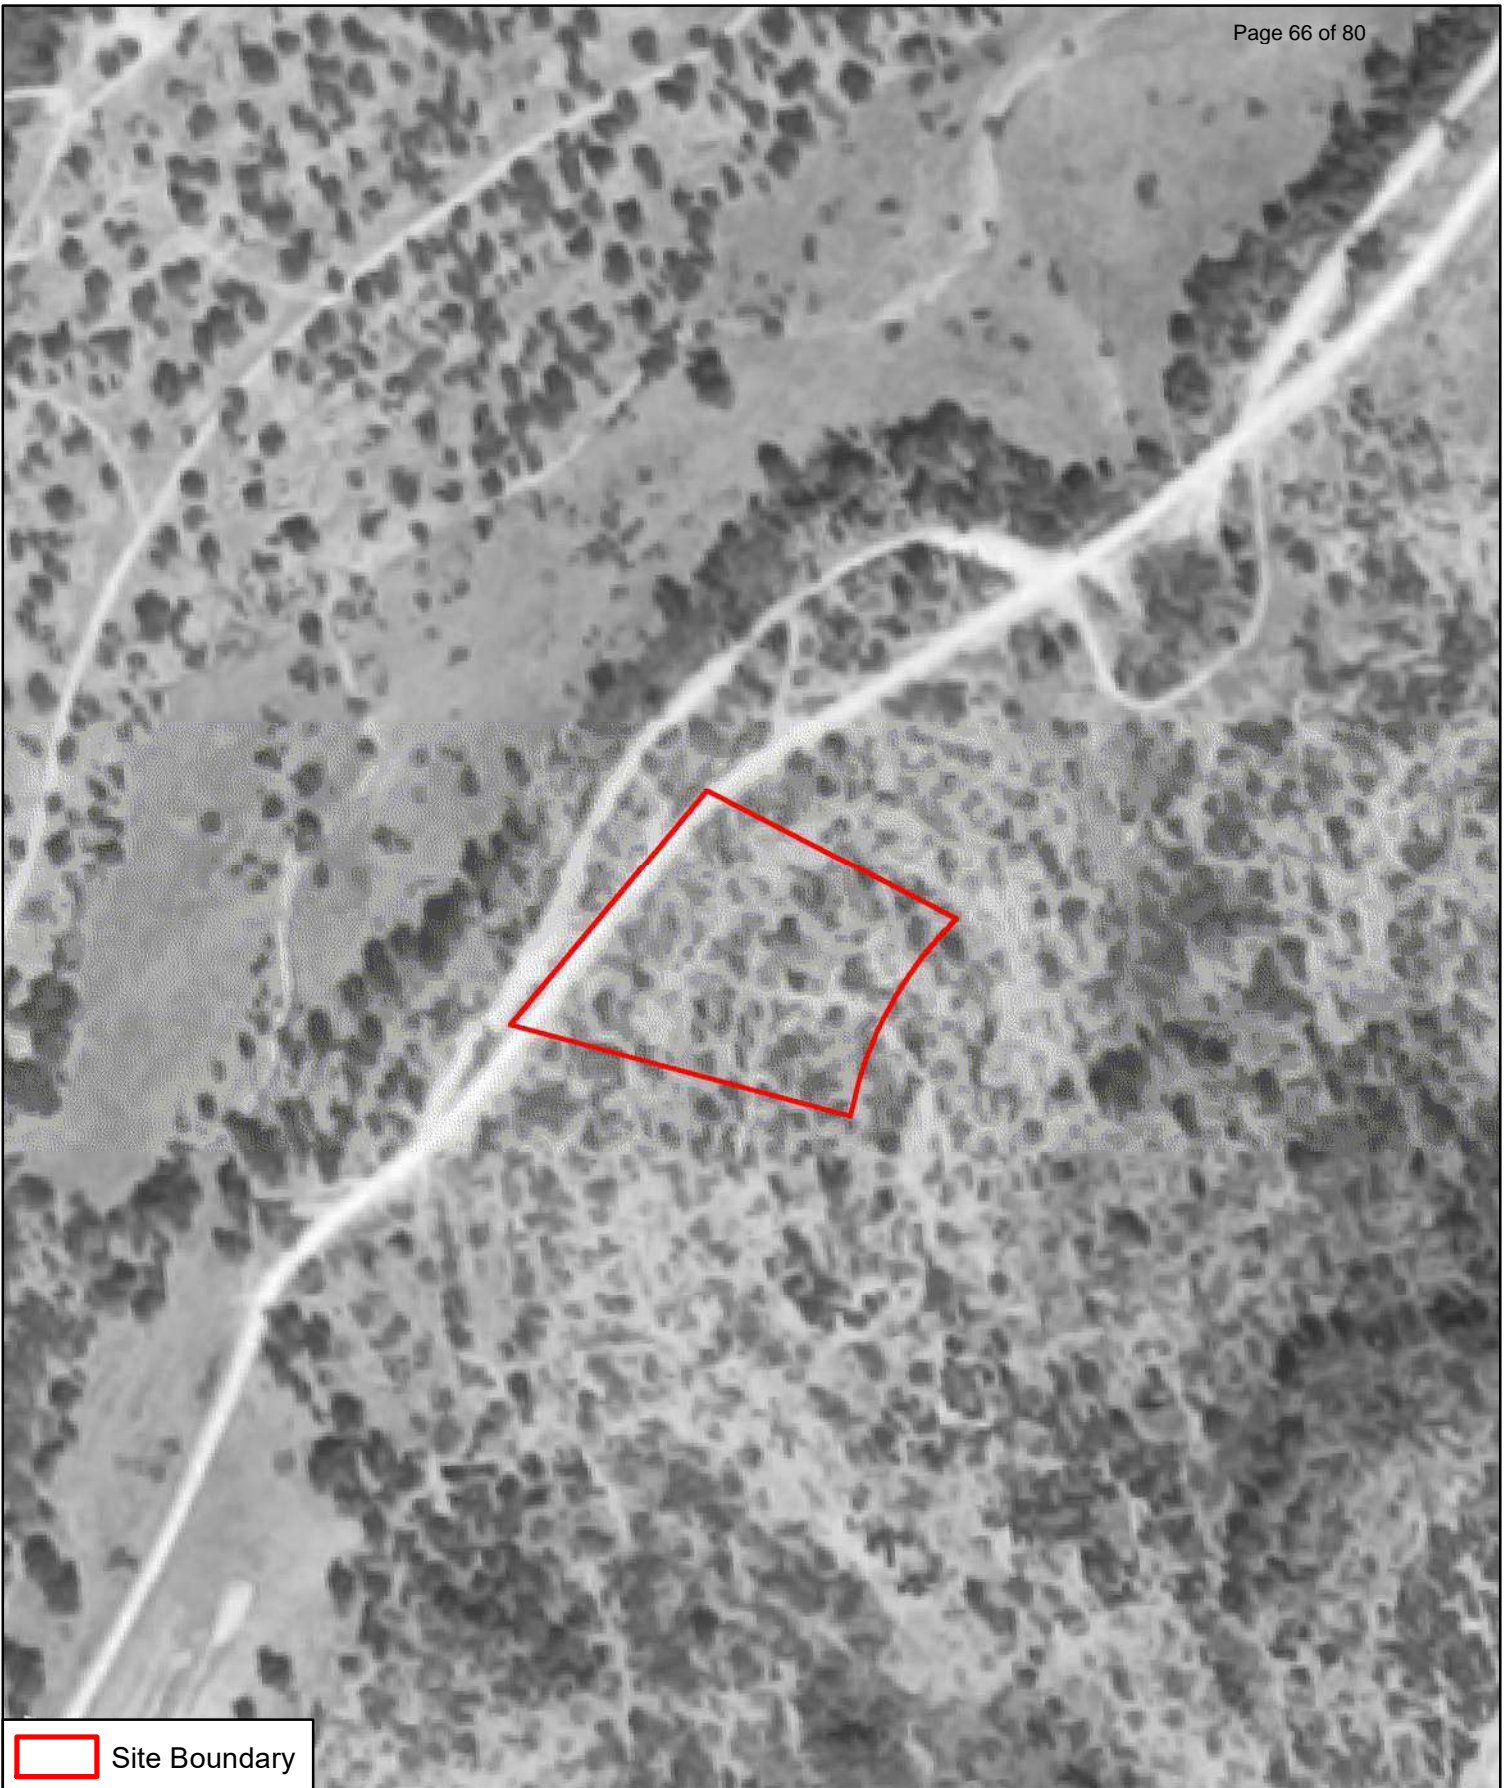
FIGURE
1

Figure 1 – Site Specific Geologic Map with 2-ft Topography

The site is underlain exclusively by shallow and exposed bedrock composed of the Glen Rose Limestone, a Cretaceous aged formation from the Trinity Group. This formation is typified by stair-step topography with oak-juniper vegetation. This unit has moderate to high slope stability and is difficult to excavate, often requiring blasting. Many units have high bearing capacity with exception to weak marl beds. This unit has moderate to low infiltration capacity with exception to some dolomitic beds.
