Feb 2022 Boil Water Notice

Austin Water and Wastewater Commission | February 16, 2022

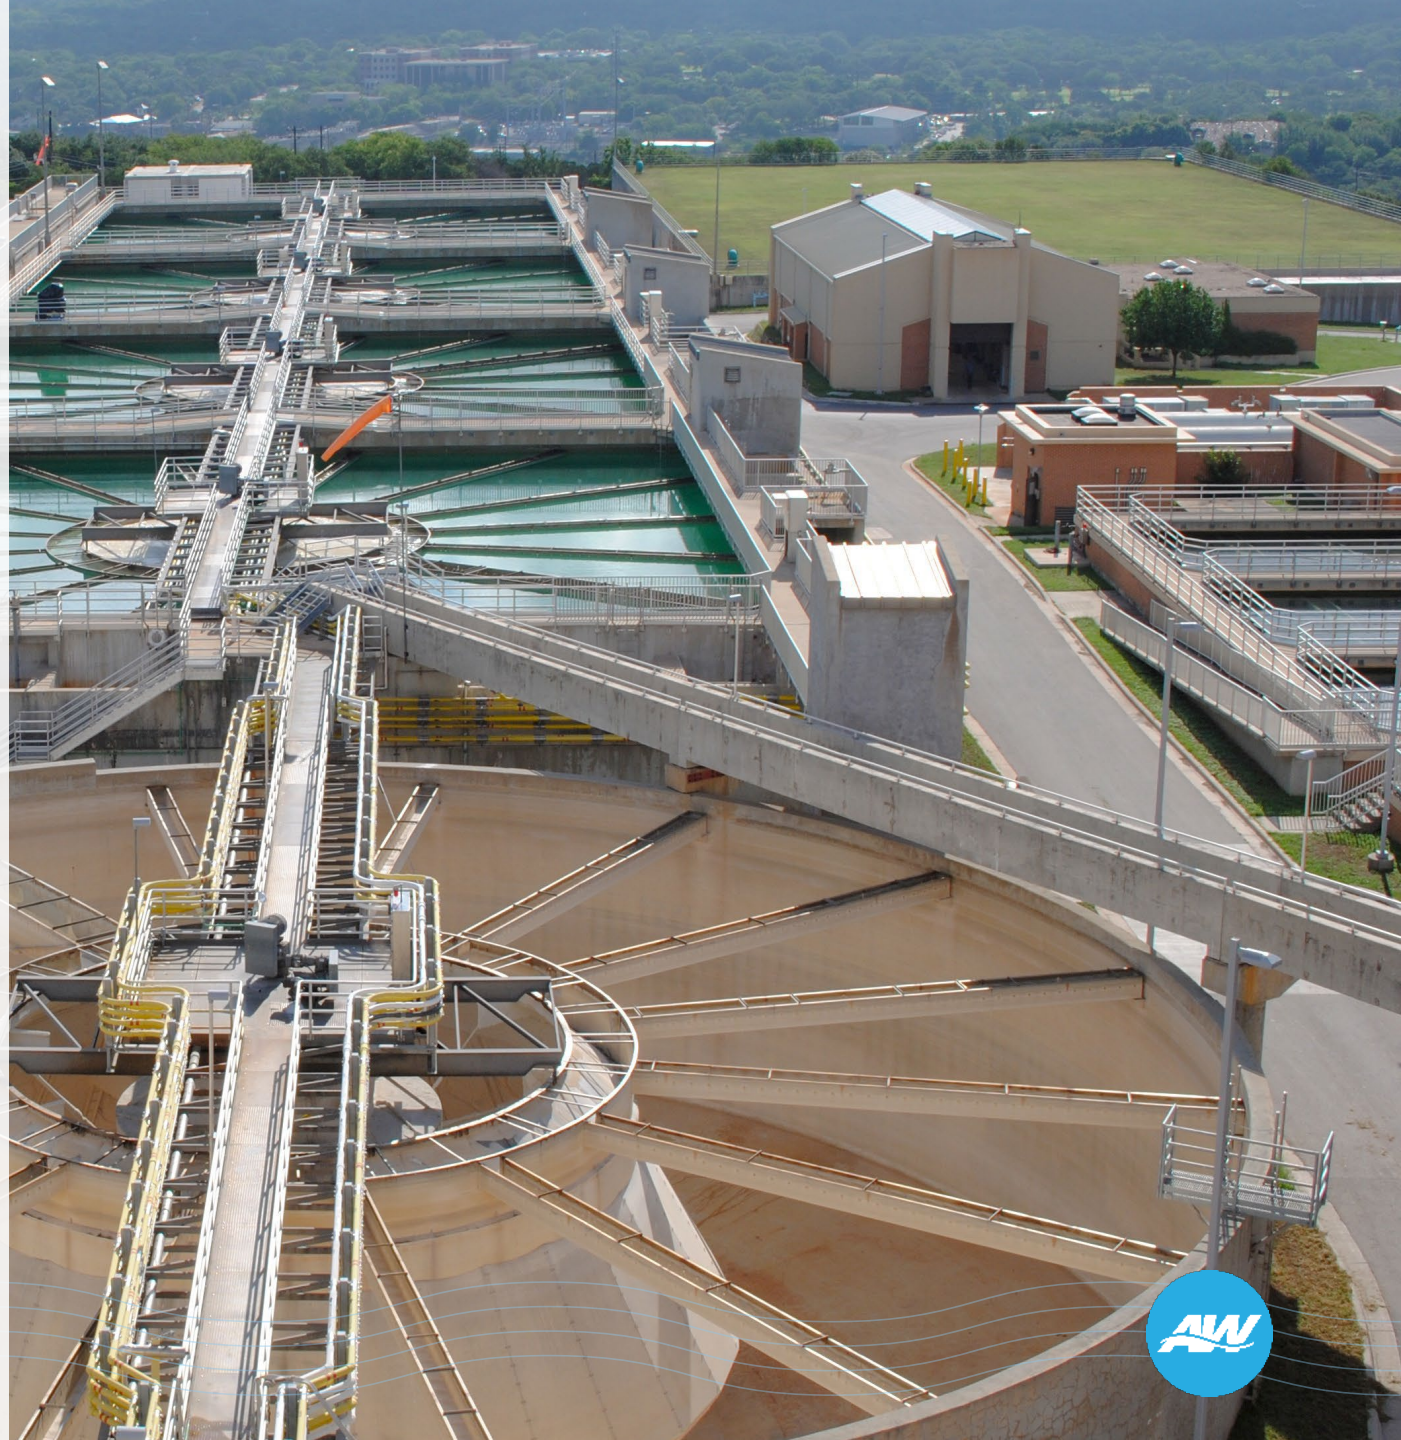
- 💧 Crews were filling a basin with water to begin treatment
 - A mixture of water and processed solids was added to “seed” the basin
 - This is a high turbidity mixture that is typically stopped after a few hours
- 💧 “Seeding” was not stopped and continued for most of the night
- 💧 Alarms and sample tests indicating high turbidity were recorded

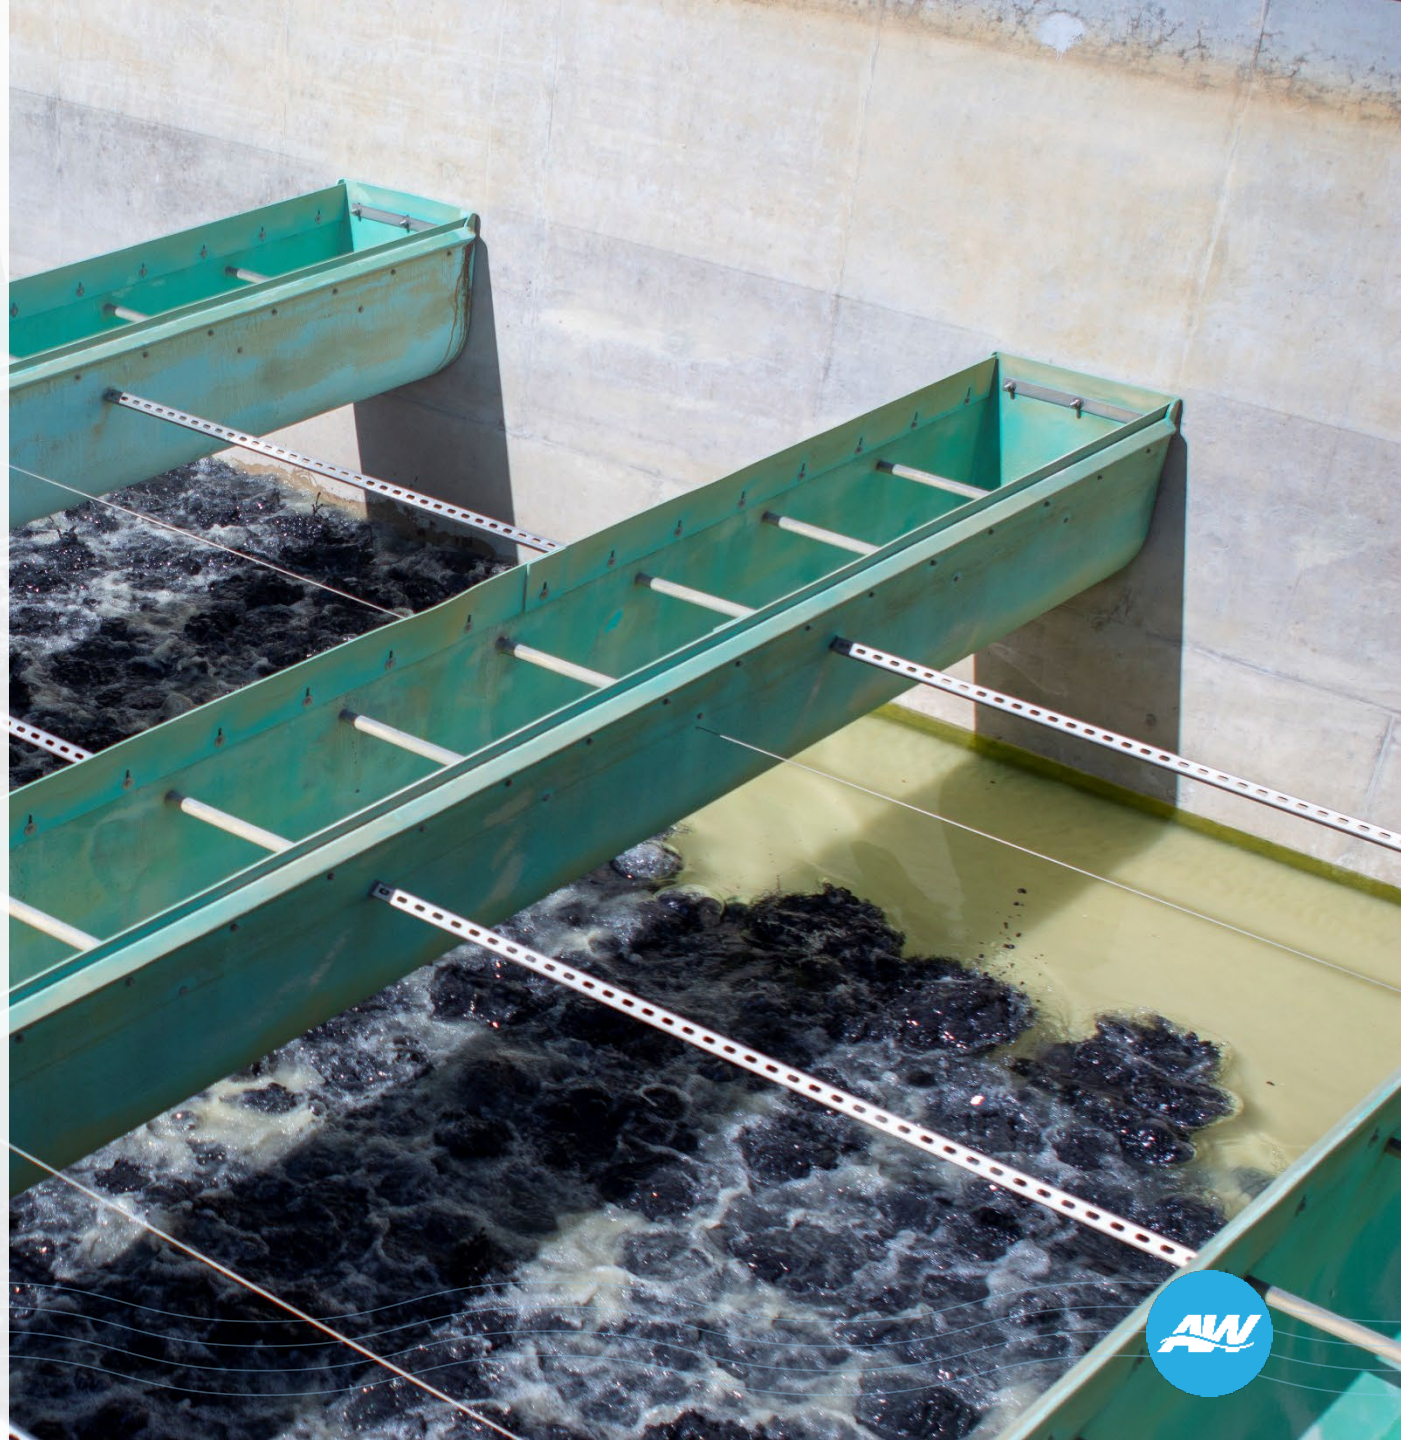
- High turbidity water moved into water filters
- Filters removed particles and produced water that met regulatory standards until they clogged
- Multiple filters exceeded turbidity standards and entered the clearwells (underground storage tanks)
