Case No. C8J-2021-0141.0A

Supporting Exhibits for Variance Applications

8020 PARMER/SH130 NW
AUSTIN, TEXAS

±14.34-ACRE PARMER MF Environmental Resource Inventory

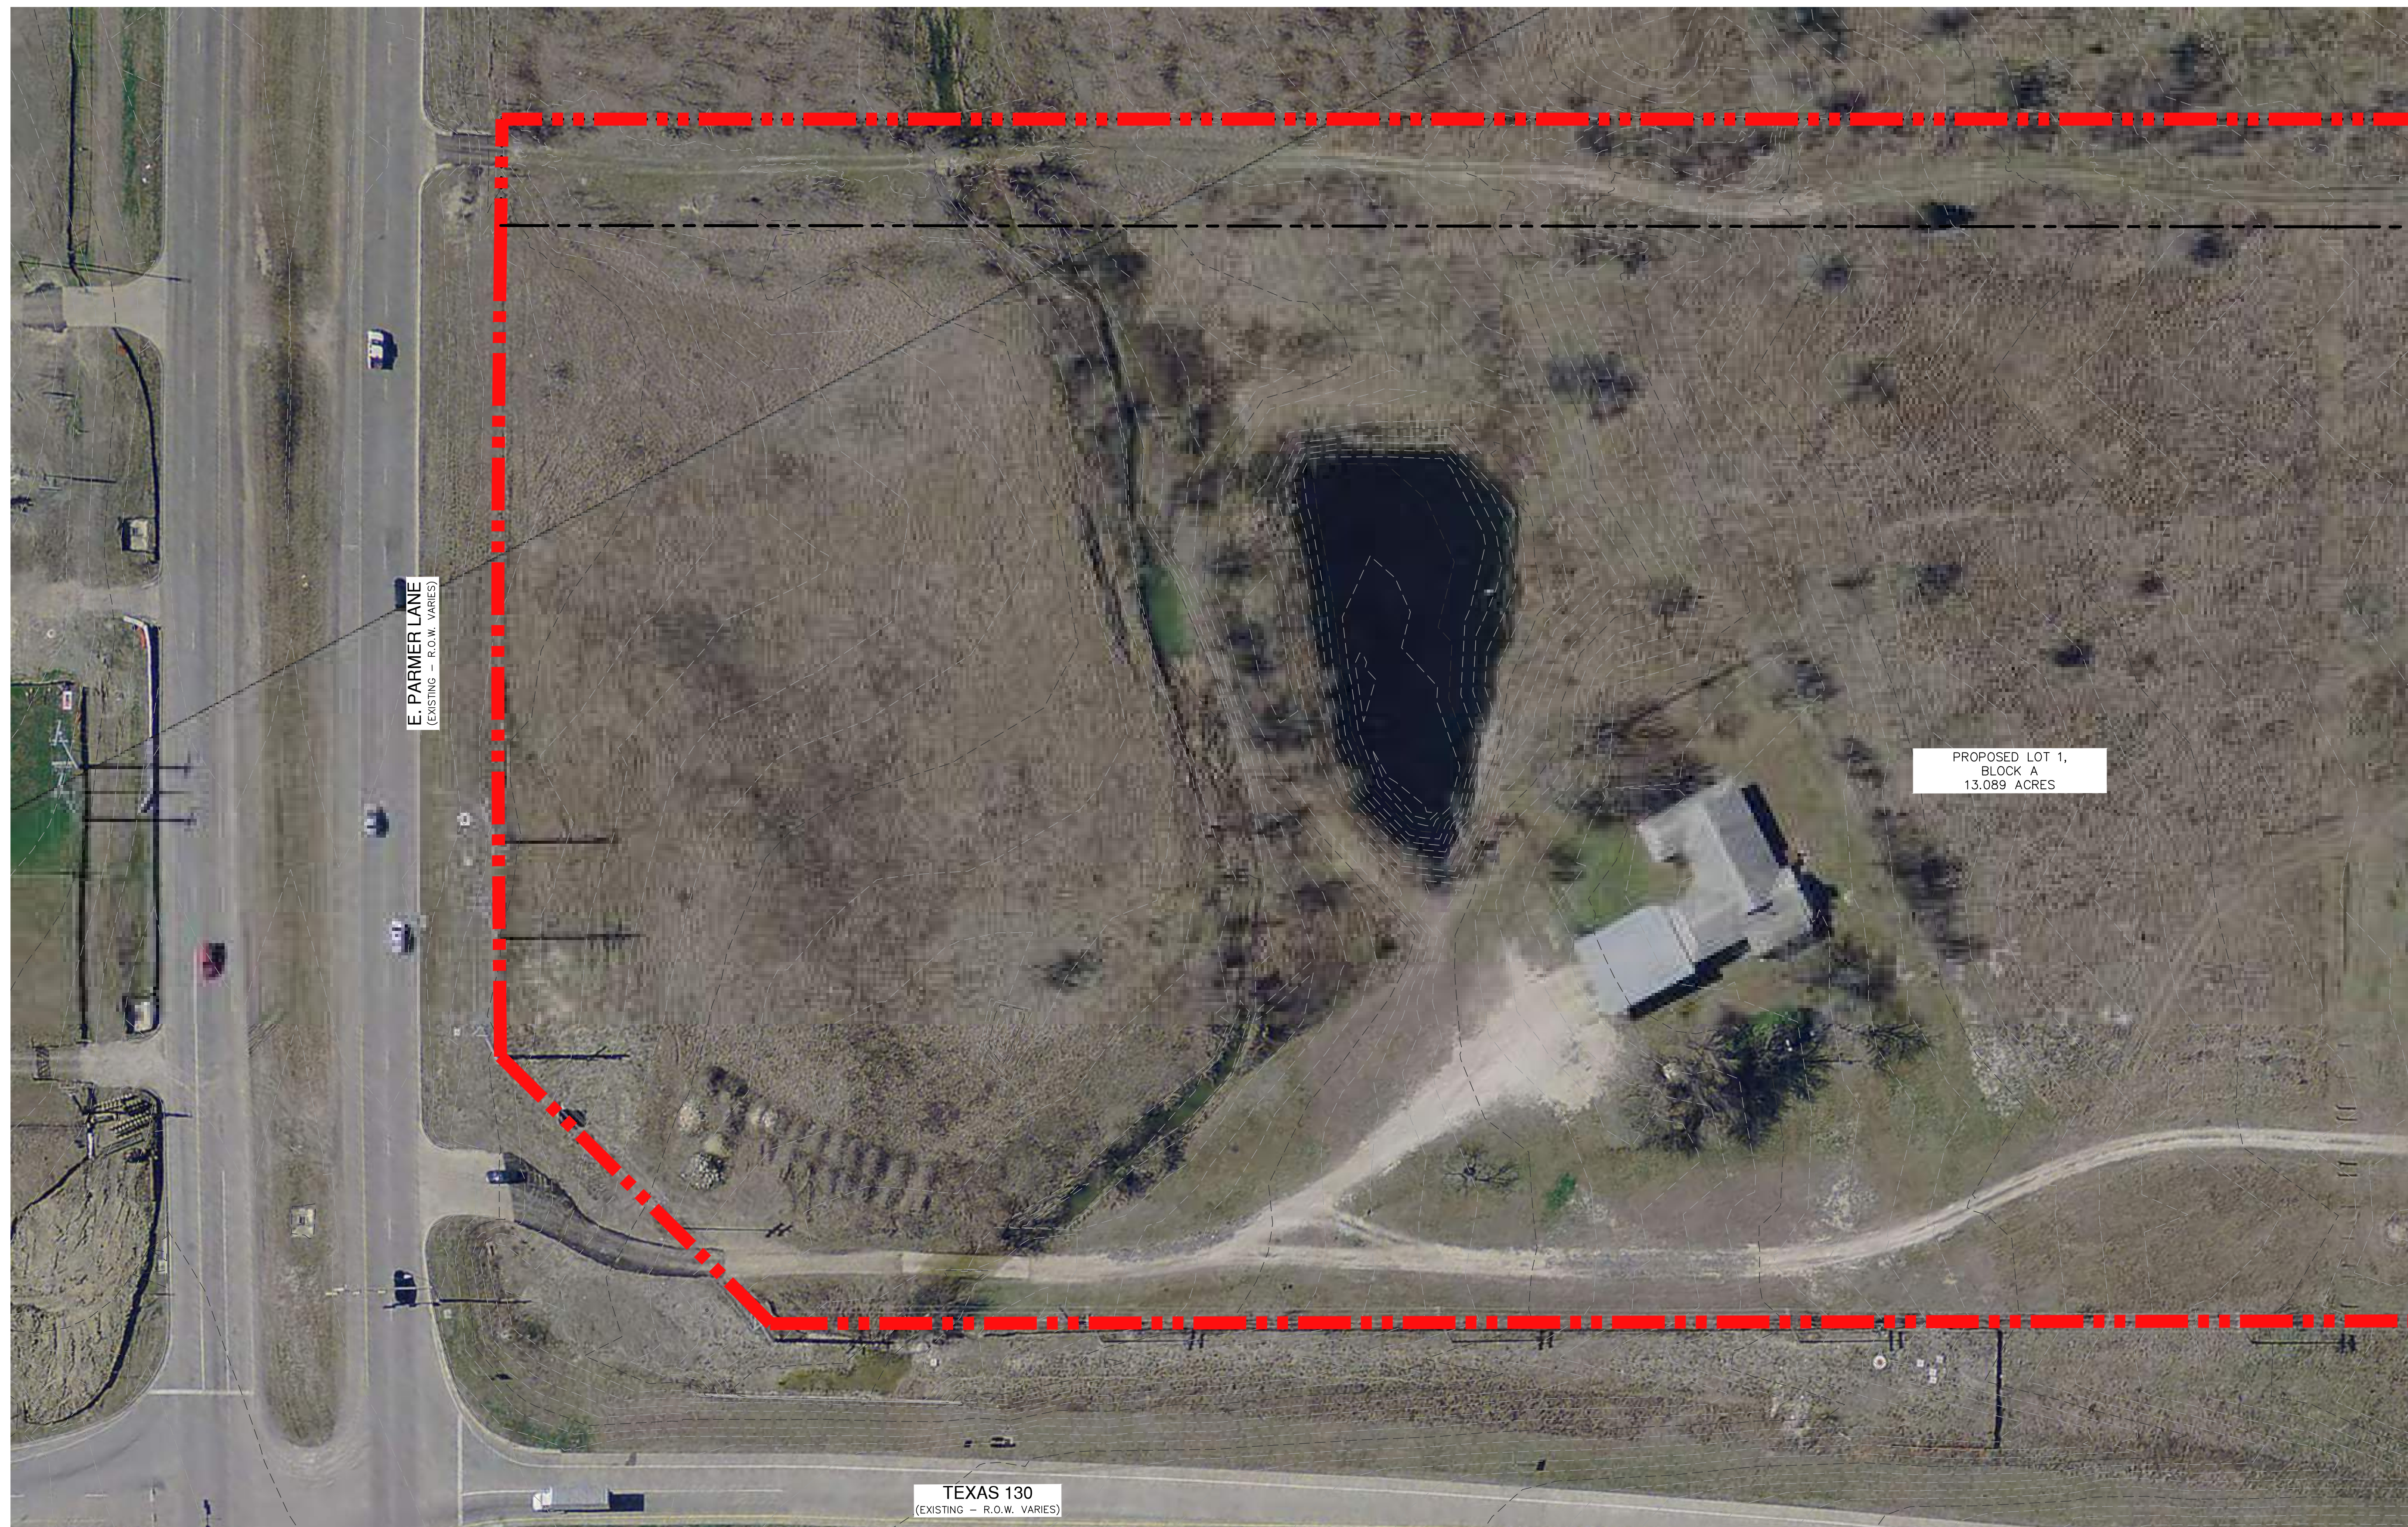
Photo No. 1	Date: 03-30-2021
Description: View of the paved portion of the project site facing southeast, on the southeastern corner of the project site.

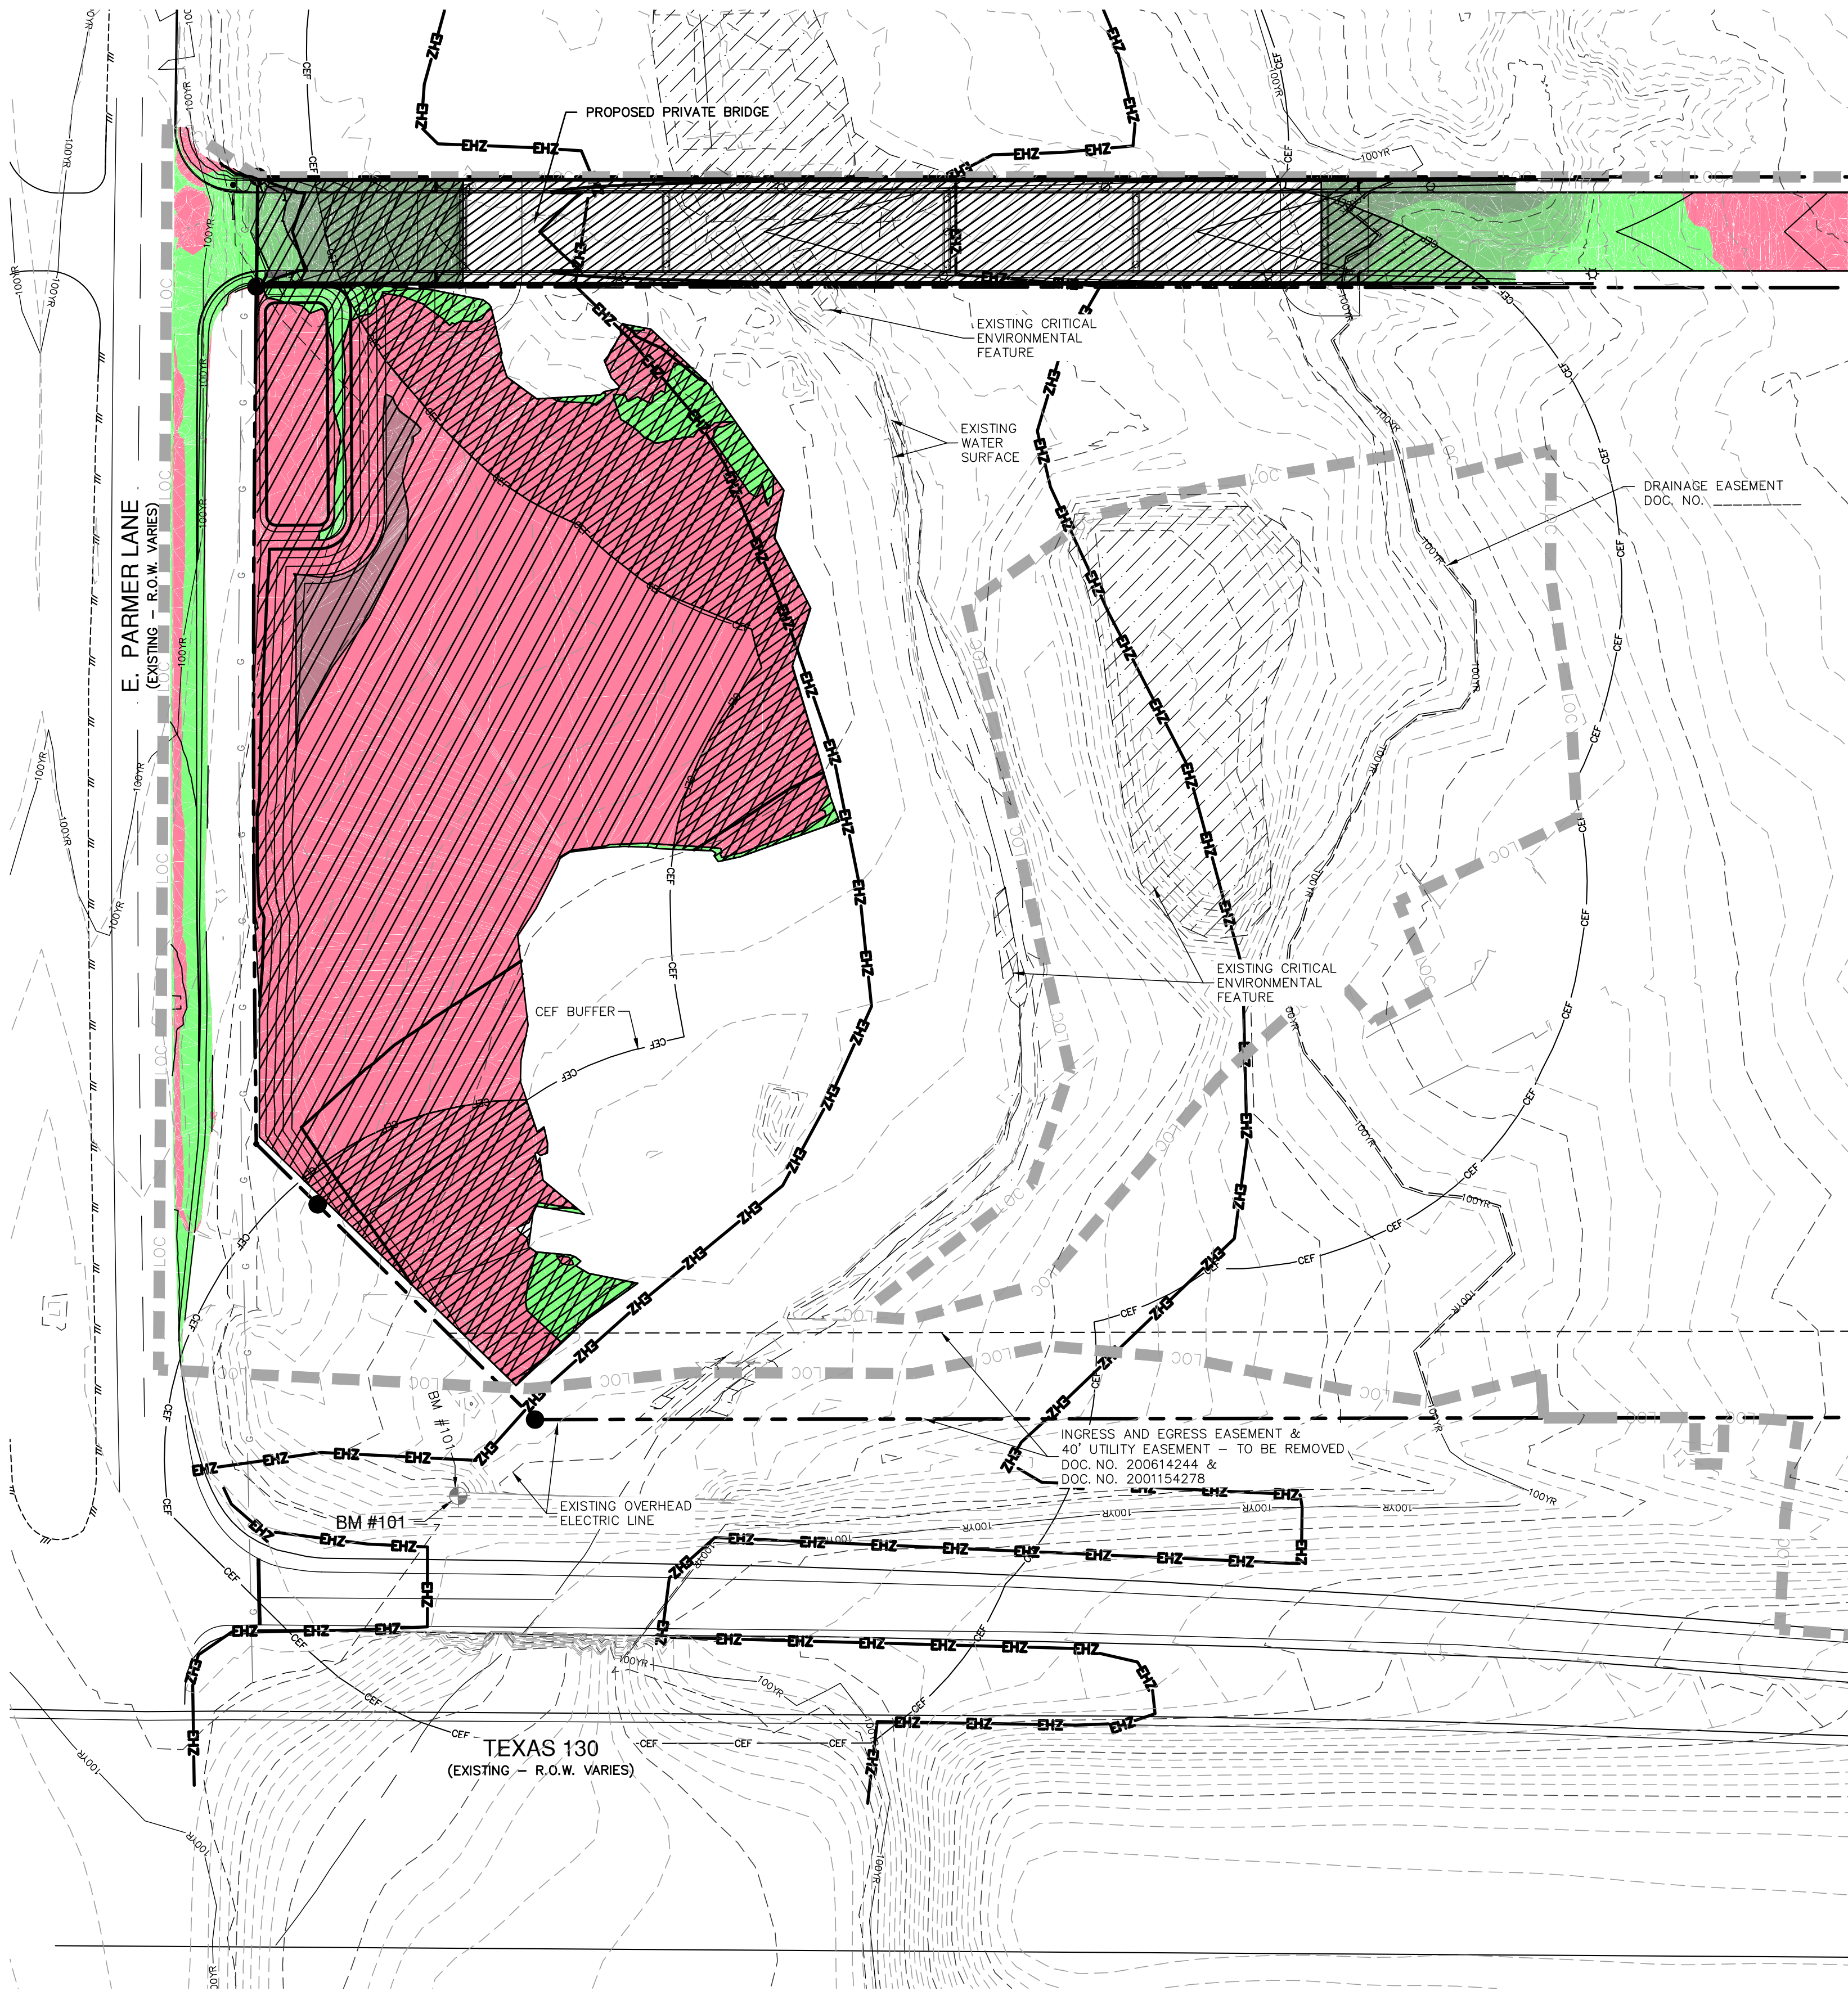
EXHIBIT 6 – CUT/FILL EXHIBITS

LEGEND	
	LOC
	LIMITS OF CONSTRUCTION
	PROPERTY BOUNDARY
	EXISTING CONTOUR LINE
	PROPOSED CONTOUR LINE
	CUT AREA: -8' TO -4' VOLUME: 24.33 CUBIC YDS
	CUT AREA: -4' TO 0' VOLUME: 4981.31 CUBIC YDS
	FILL AREA: 0' TO 4' VOLUME: 3,750.01 CUBIC YDS
	FILL AREA: 4' TO 8' VOLUME: 3,593.17 CUBIC YDS
	FILL AREA: 8' TO 15' VOLUME: 4,957.69 CUBIC YDS
	FILL AREA: 15' TO GREATER VOLUME: 386.65 CUBIC YDS

53,473.46 SF AREA GRADING DISTURBANCE WITHIN CEP BUFFER
	109,540.81 SF AREA GRADING DISTURBANCE WITHIN FLOODPLAIN

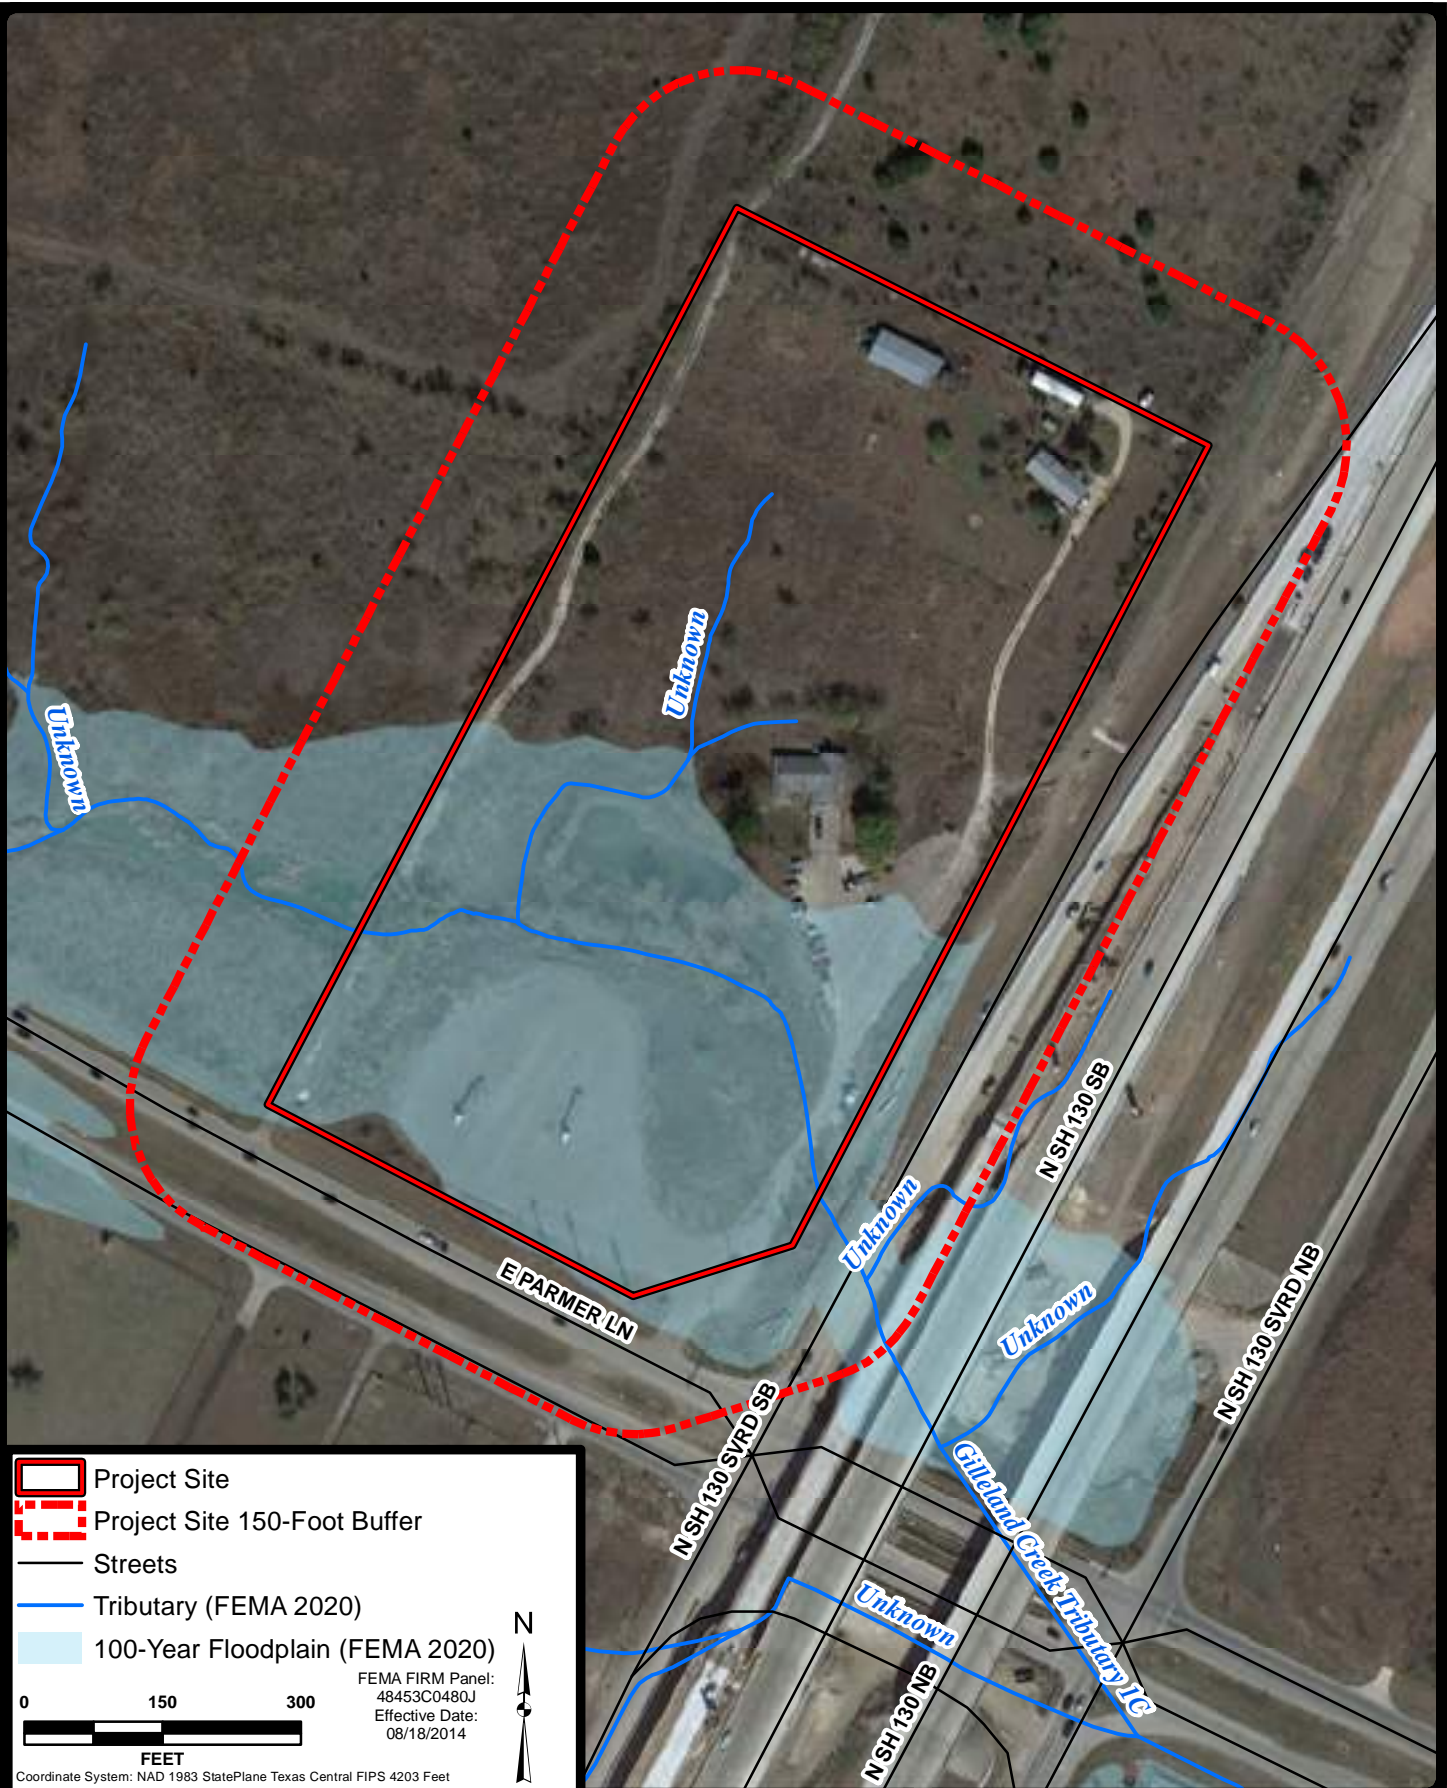
EXHIBIT 4

Floodplain Map

Project Site
Project Site 150-Foot Buffer
Streets
Tributary (FEMA 2020)
100-Year Floodplain (FEMA 2020)

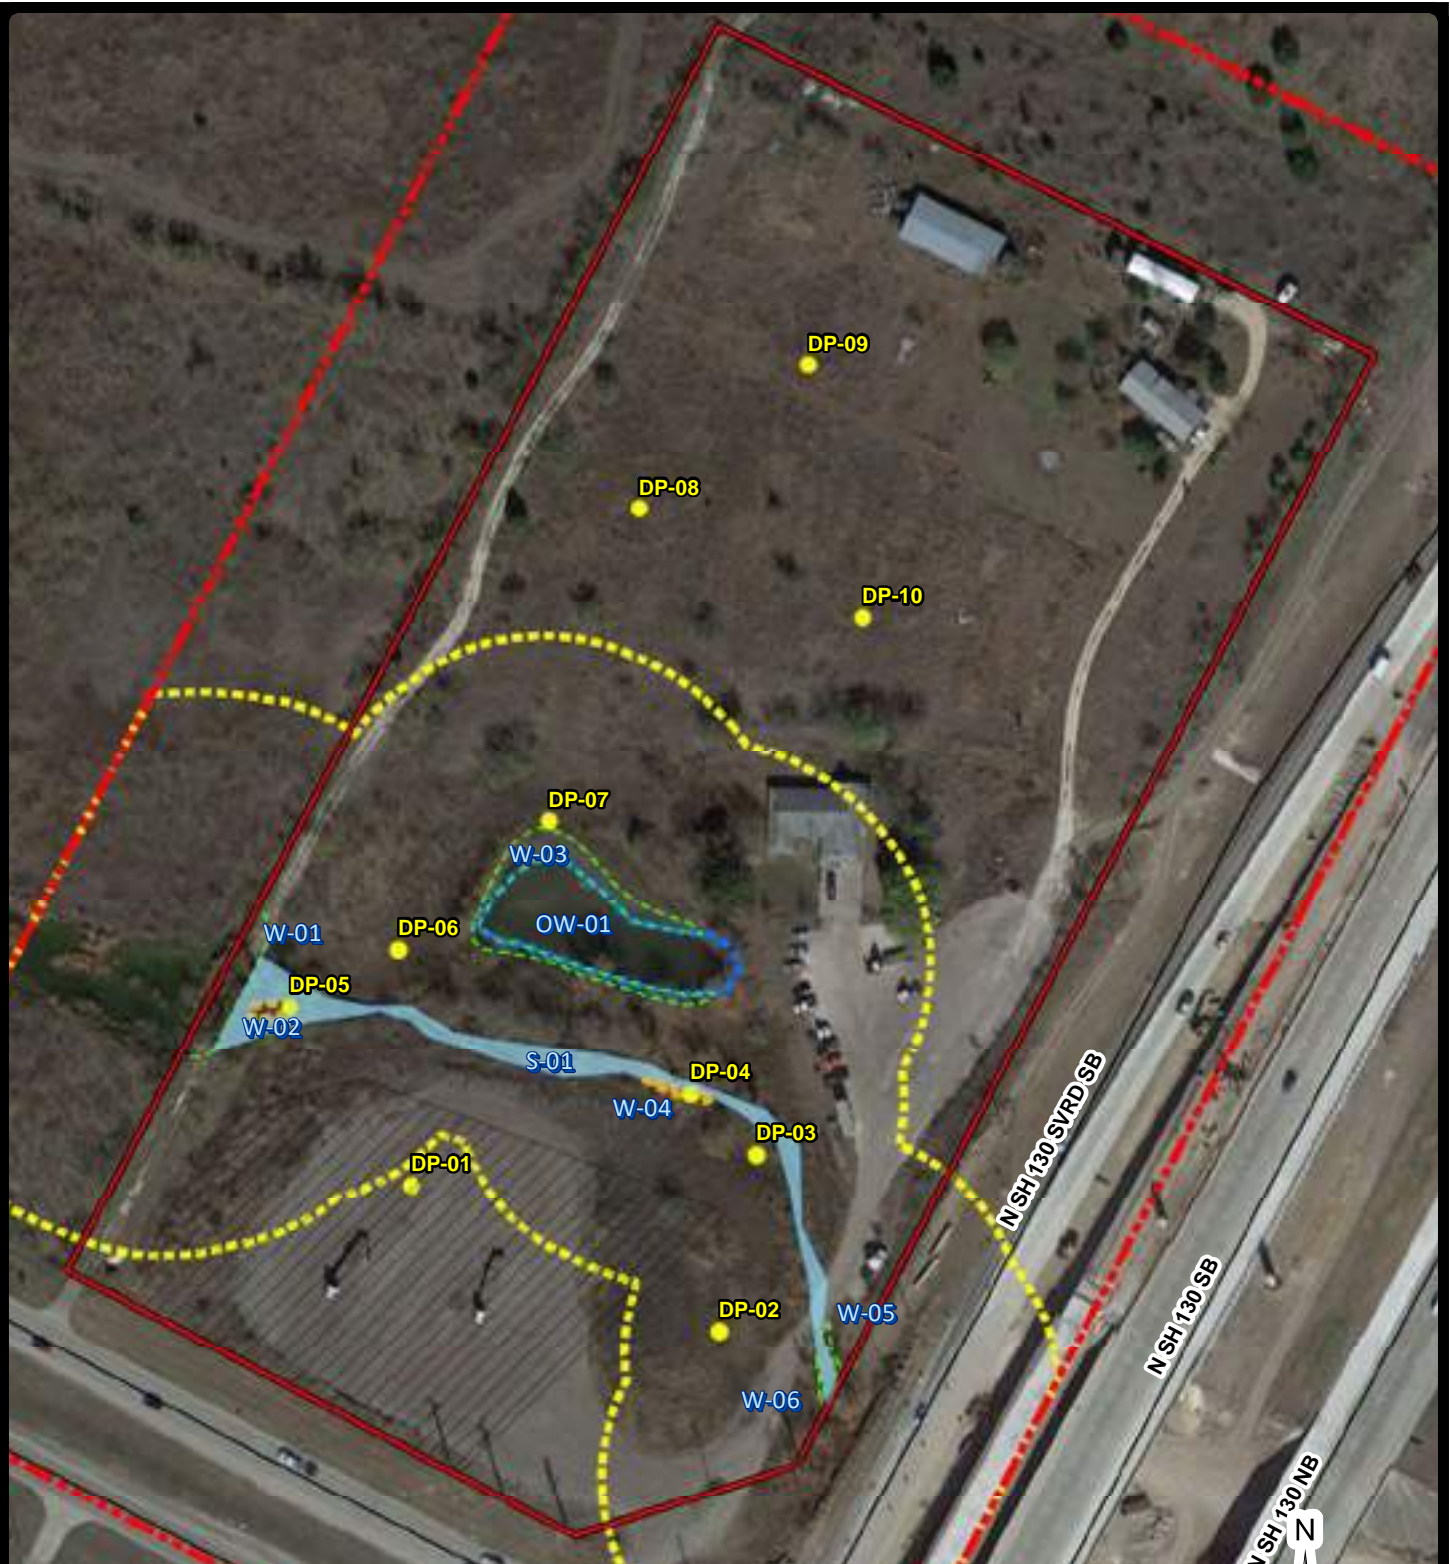
EXHIBIT 10

Delineated Critical Environmental Features Map

A freshwater pond (W-03) was identified within the project site. The freshwater pond is located approximately 75 feet north of S-01, near the center of the project site. This pond is separated by a natural berm. No direct channelized surface water connection was observed between the pond and S-01.

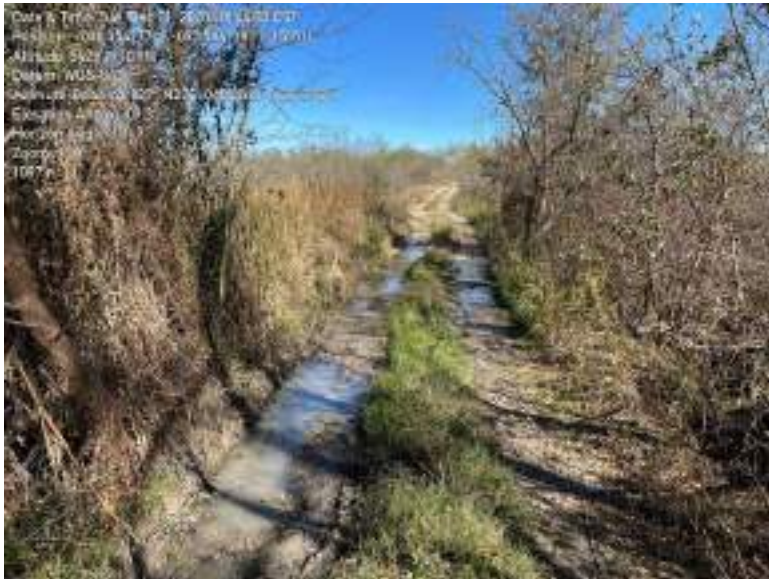
CEF-1 is an emergent wetland located in the southern portion of the subject area. CEF-1 was inundated at the time of the field visit. CEF-1 has wetland hydrology, hydric soils, and is dominated by hydrophytic vegetation such as spike rush and cattails. The boundary between CEF-1 and the adjacent non-wetland was identified based on changes in hydrology, dominant plant composition, and soils. The 1% Annual Chance FEMA Flood Hazard Zone extends on subject area at CEF-1. The total area of CEF-1 is approximately 1,012 square feet, or approximately 0.023 acre within the subject area (Photo 1).

8020 East Parmer ERI Tract Date: 12/1/2020	Feature	CEF-1	Photo 1
	Description	CEF-1 in the southern portion of the subject area	Direction: North
	Photographer	aci consulting

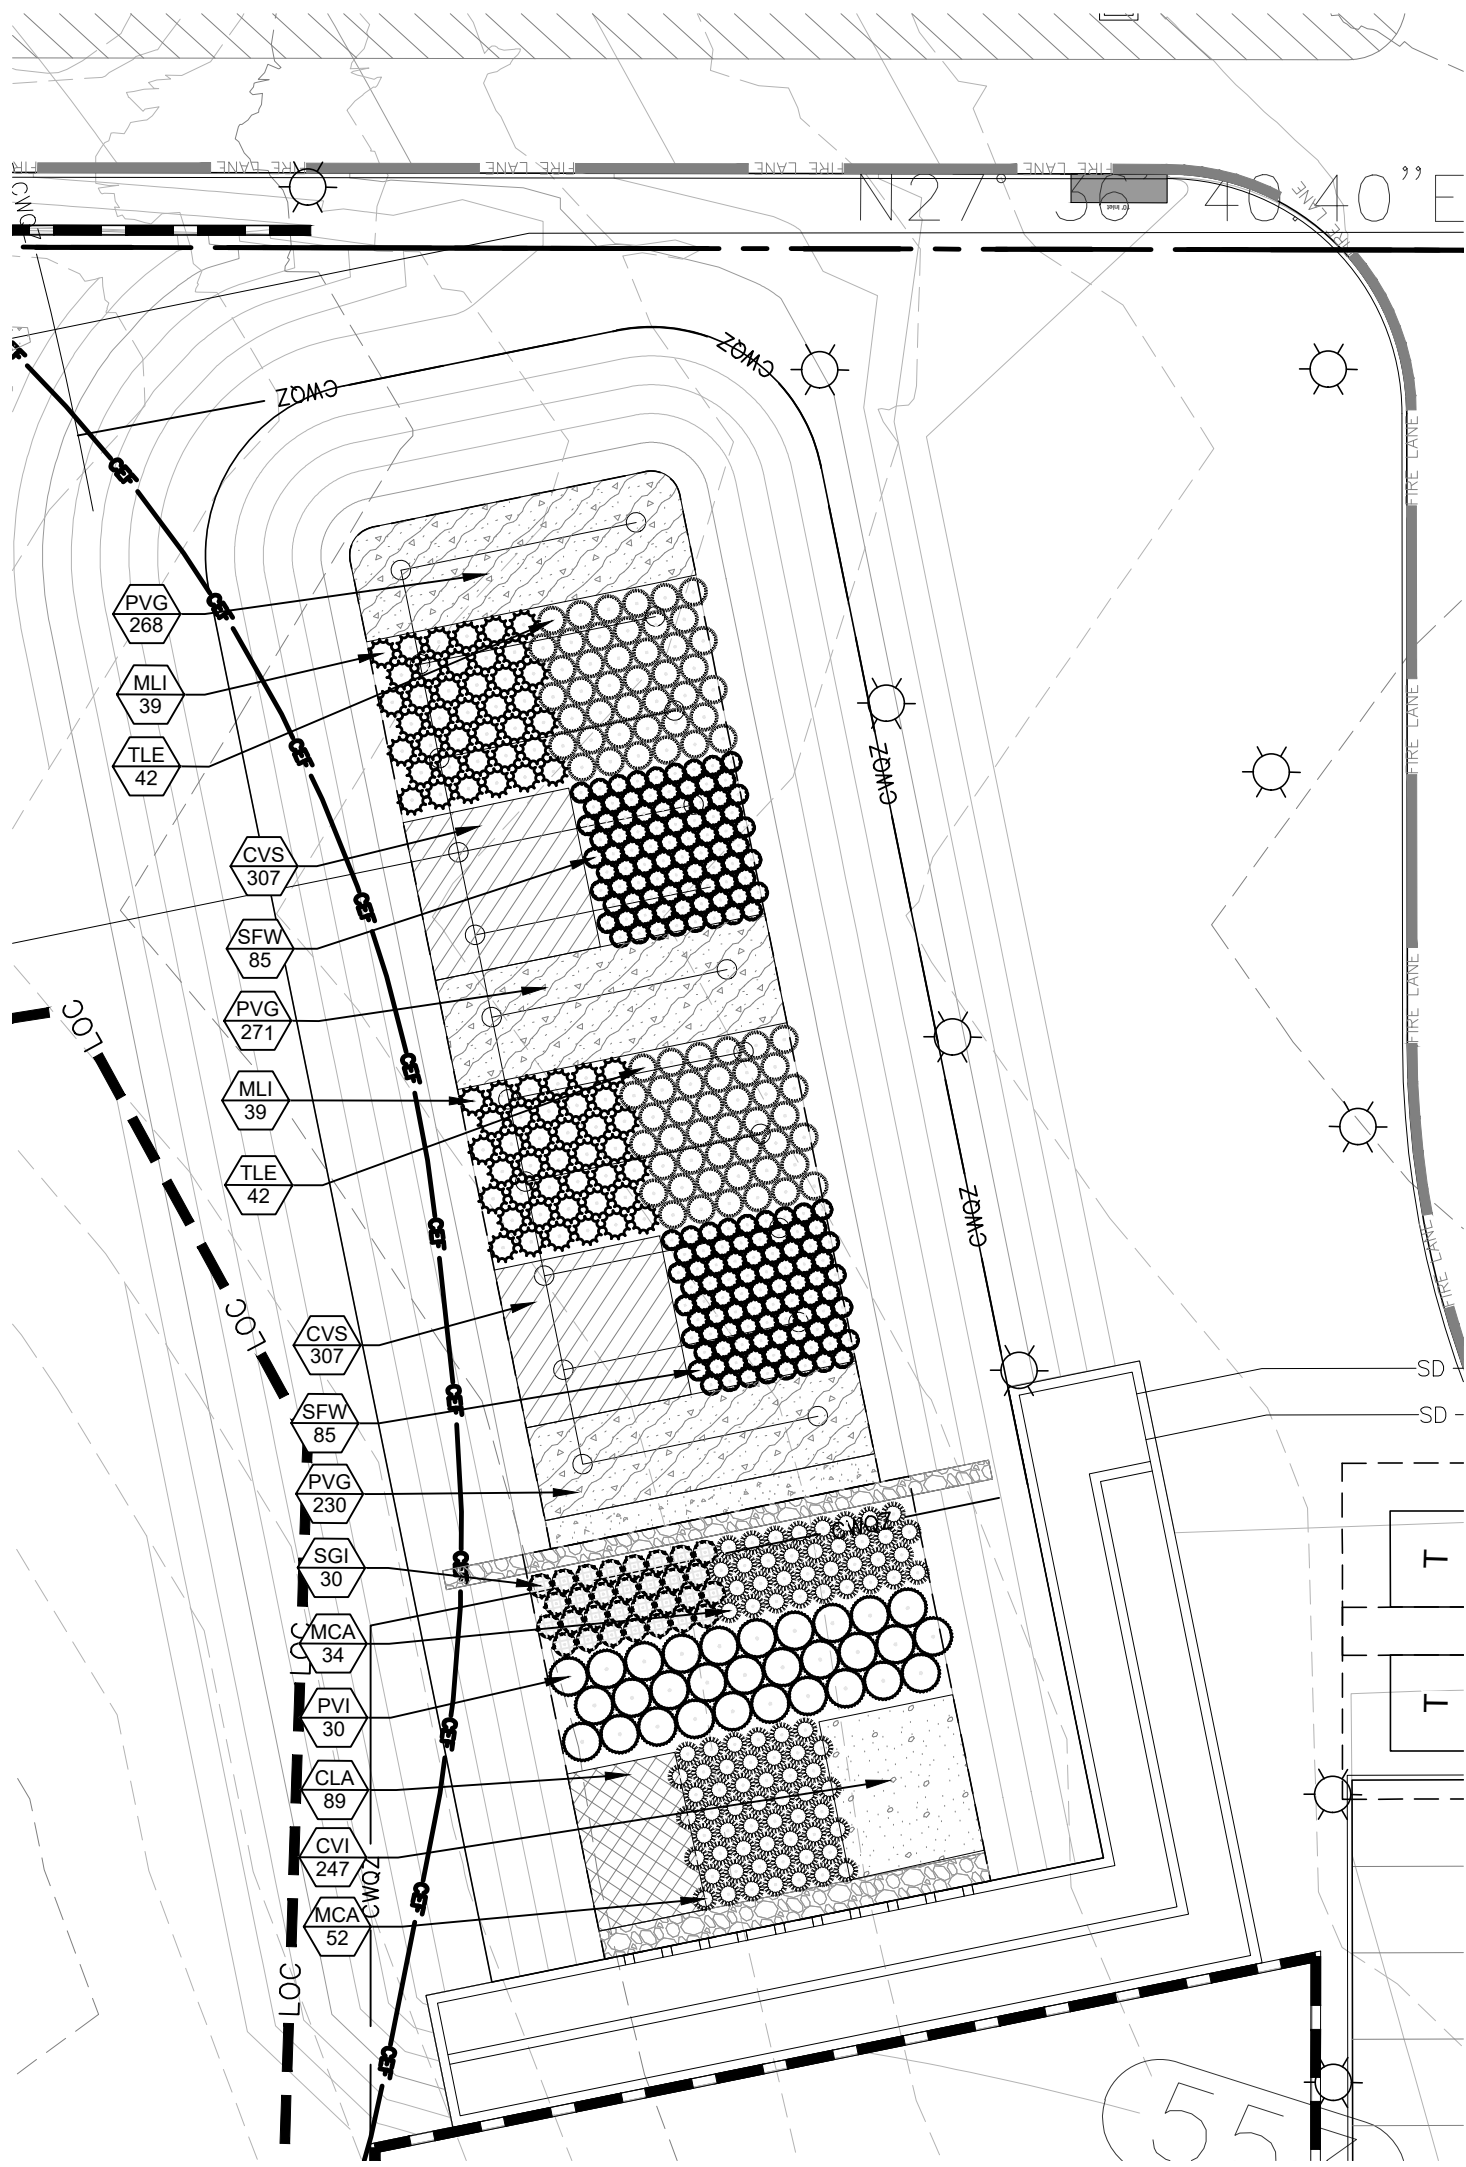
1 VEGETATED WATER QUALITY POND
1" = 20'-0"

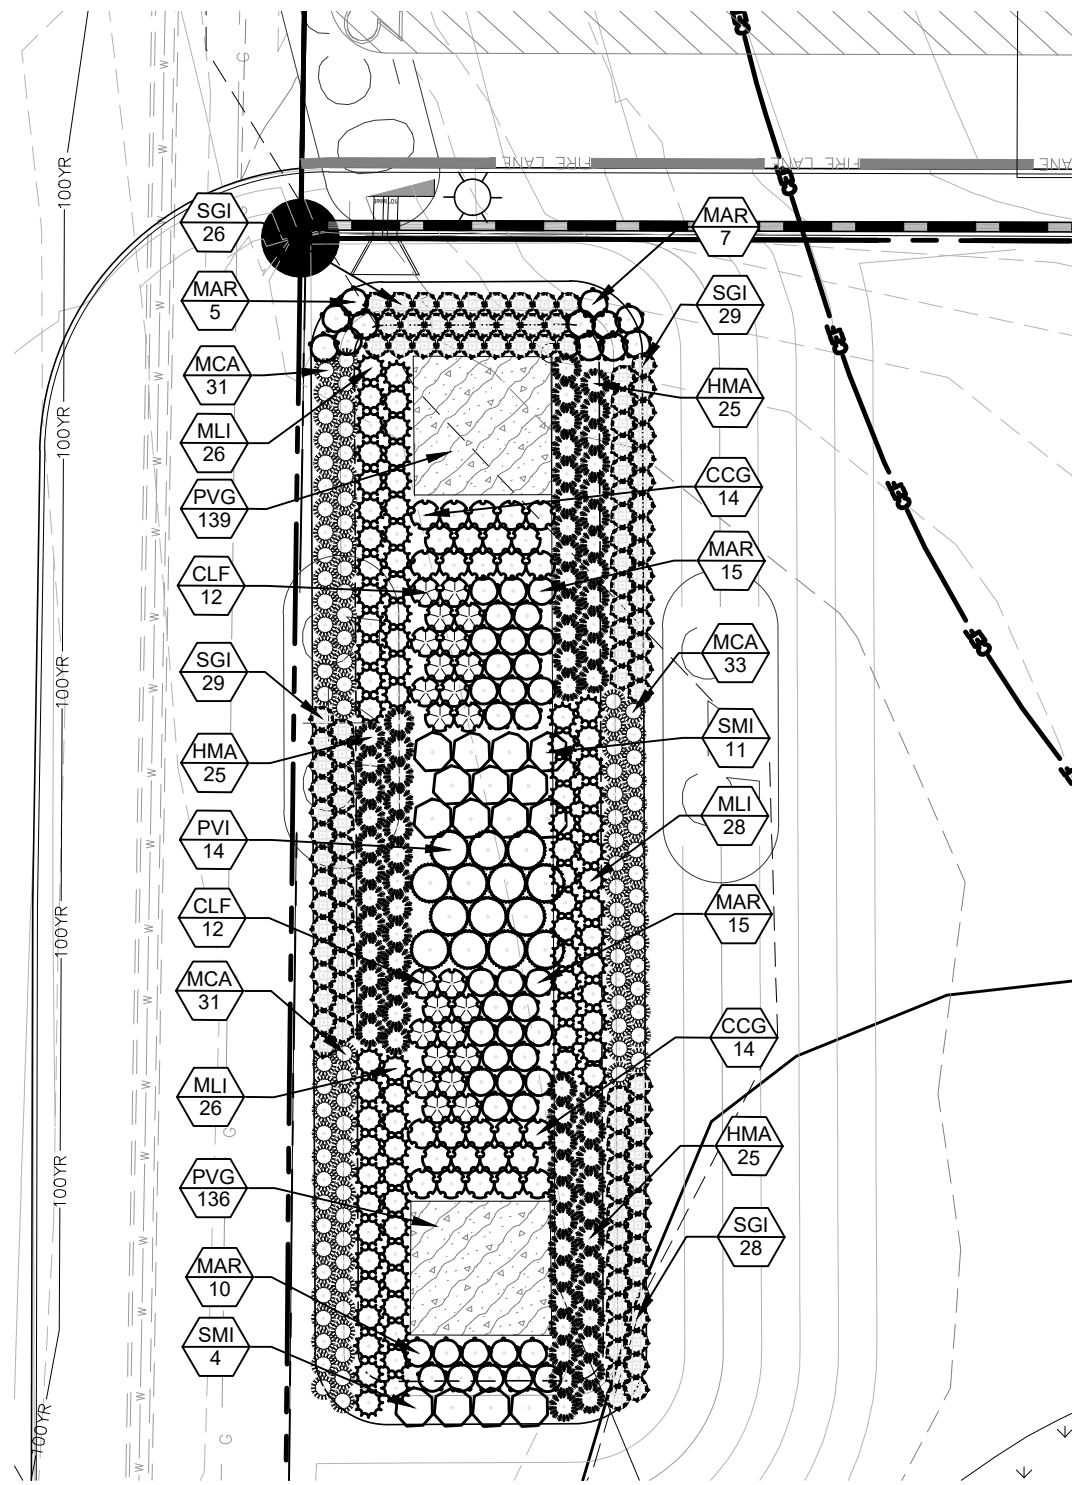
2 RAINGARDEN PLANTING
1" = 20'-0"

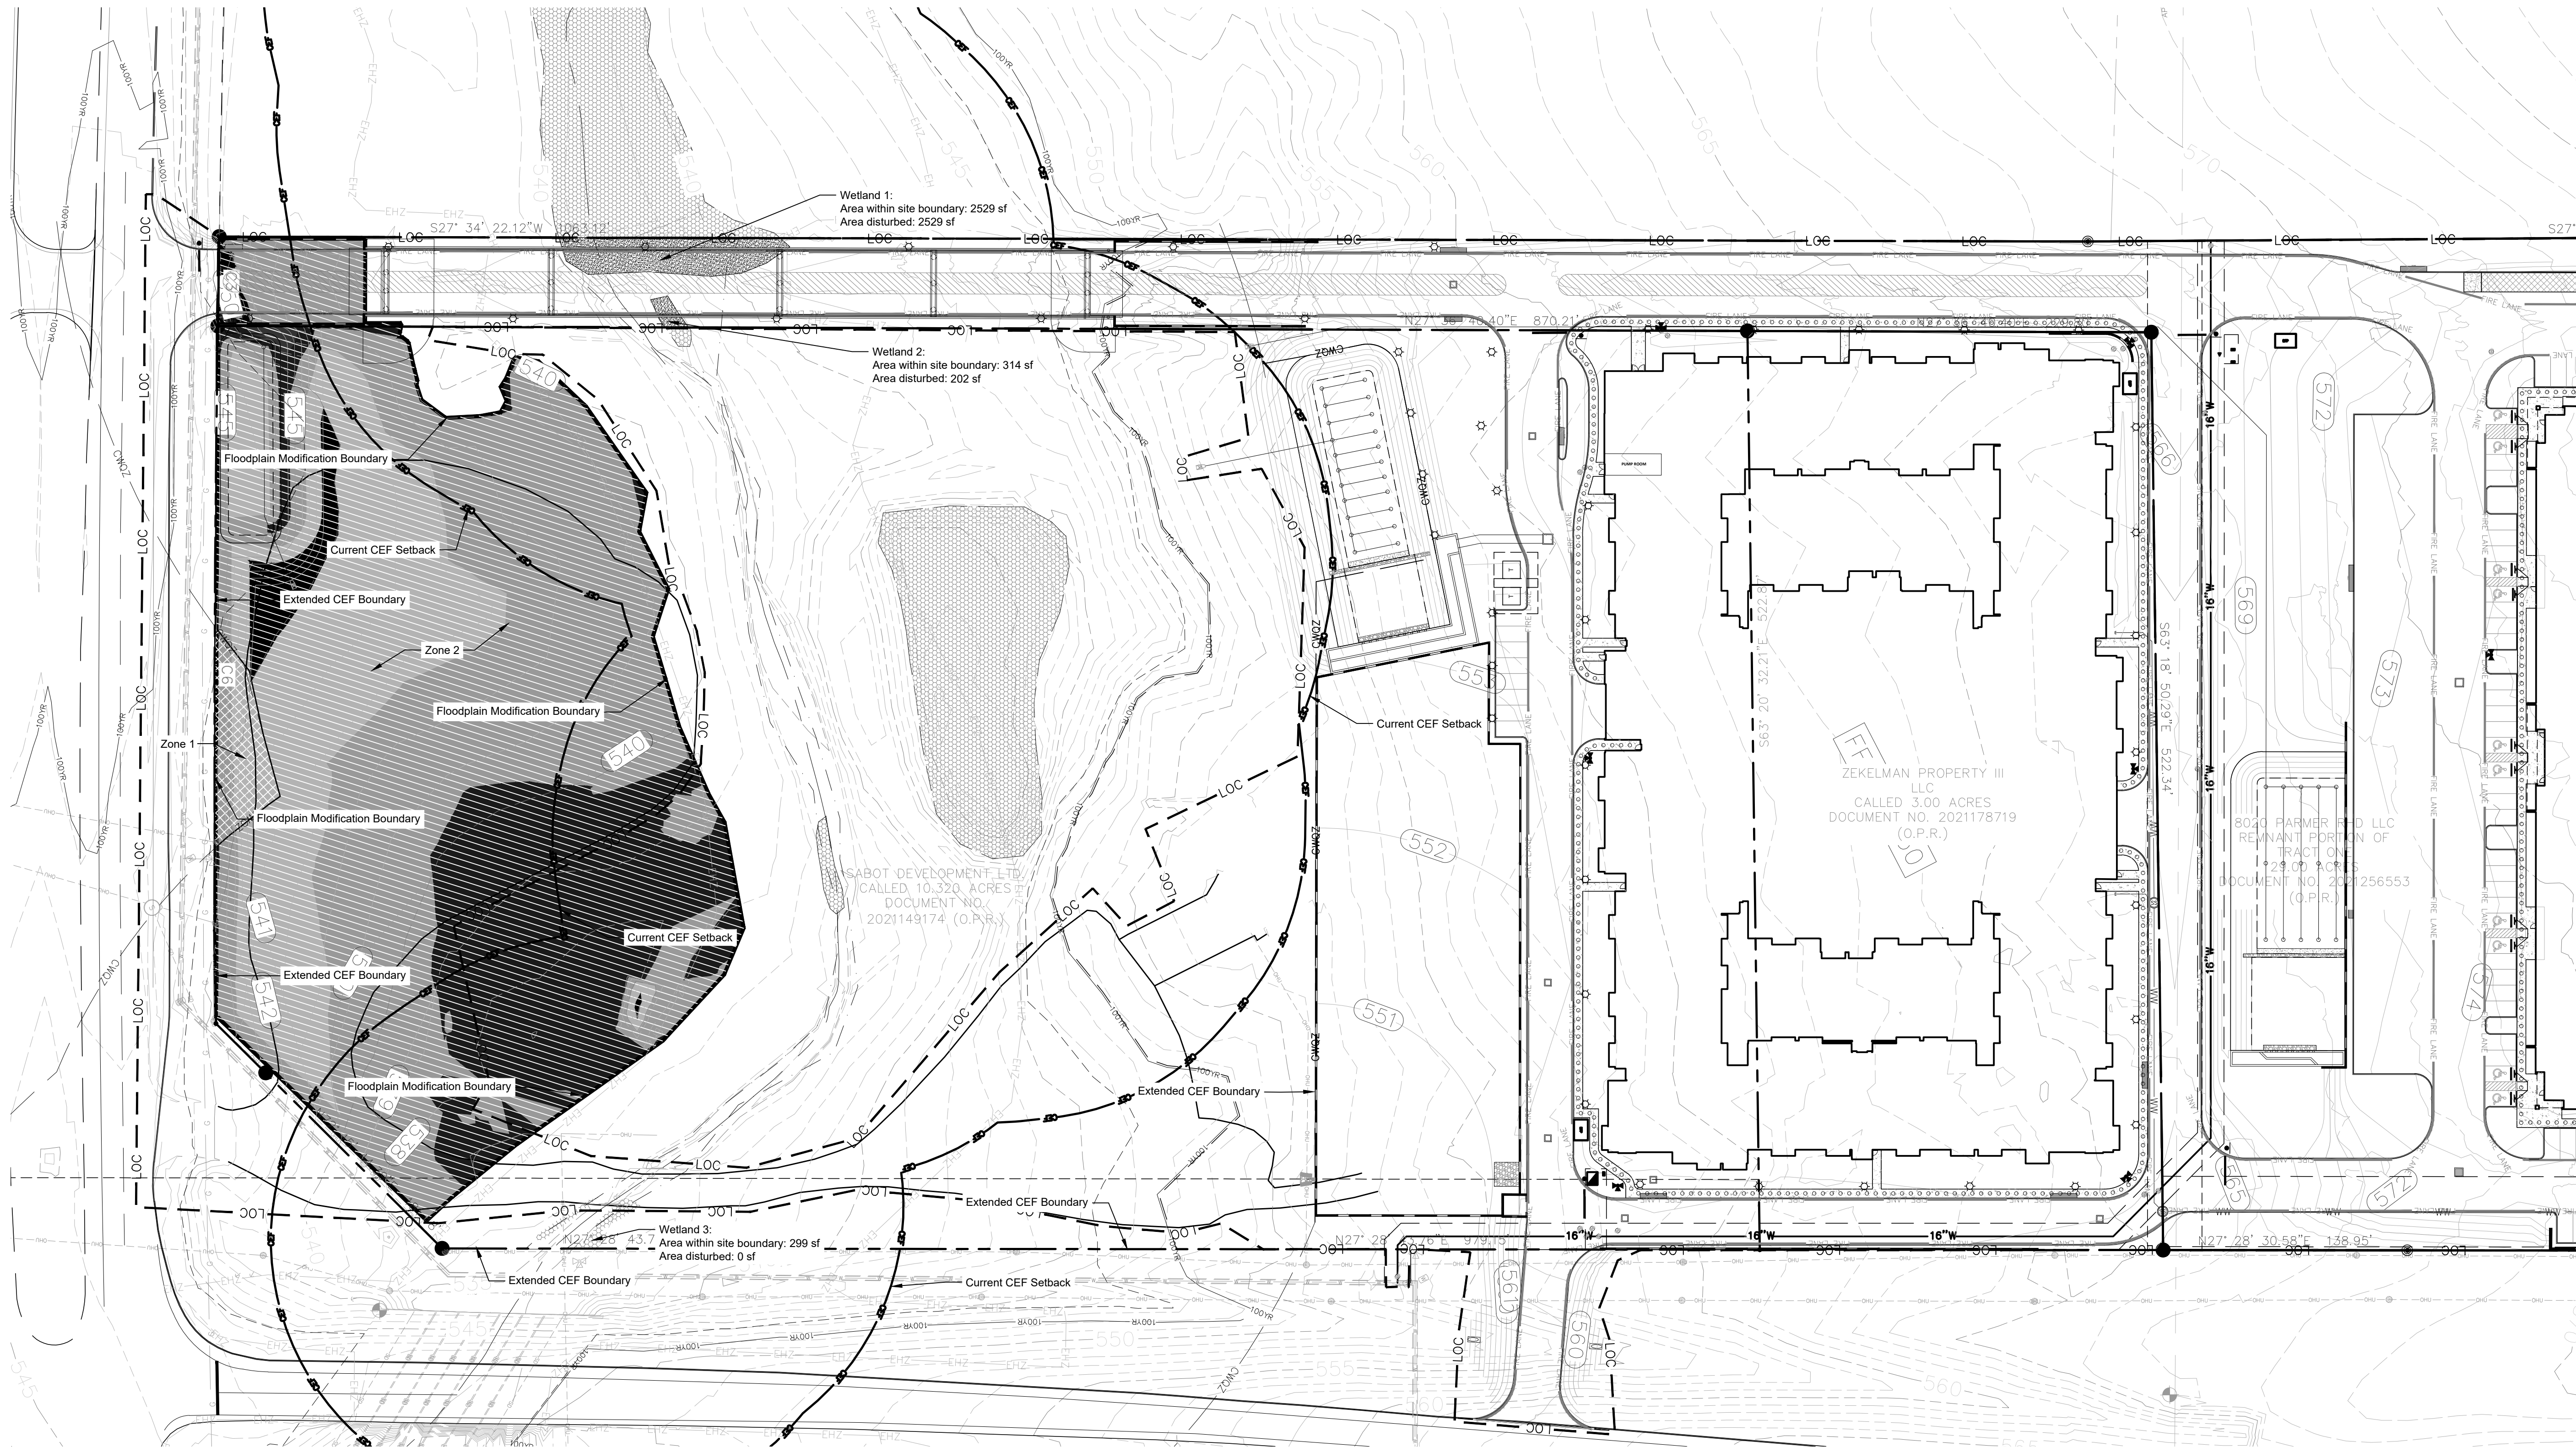
EXHIBIT 13 – FLOODPLAIN MODIFICATION SHEET

Floodplain Modification Calculations		
Area of Modification	2.69 AC	
Floodplain Mitigation Land Required	2.69 AC	
Floodplain Mitigation Land Provided	0.00 AC	
Restoration Ratio	1:3 for Zone 1, 1:6 for Zone 2	
Floodplain Mitigation by Payment	0.192 + 15.756 = 15.948 AC	
Base Fee	\$15,000	
Annual Adjustment Factor	7% Beginning Oct, 2008	
Adjusted Fee	15000*((100%+7%)^(2022-2008))	\$38,678.01
Total Fee	Mitigation by Payment x Adjusted Fee =	\$616,836.91

Floodplain Modification Calculations (Zone 1, FP outside the CWQZ, fair condition)		
Area of Modification	0.064 AC	
Floodplain Mitigation Land Required	0.064 AC	
Floodplain Mitigation Land Provided	0.000 AC	
Restoration Ratio	1:3	
Floodplain Mitigation by Payment	0.192 AC	
Base Fee	\$15,000	
Annual Adjustment Factor	7% Beginning Oct, 2008	
Adjusted Fee	15000*((100%+7%)^(2022-2008))	\$38,678.01
Total Fee	Mitigation by Payment x Adjusted Fee =	\$7,426.18
