Case No. C8J-2021-0141.0A

Supporting Exhibits for Variance Applications

8020 PARMER/SH130 NW
AUSTIN, TEXAS

±14.34-ACRE PARMER MF Environmental Resource Inventory

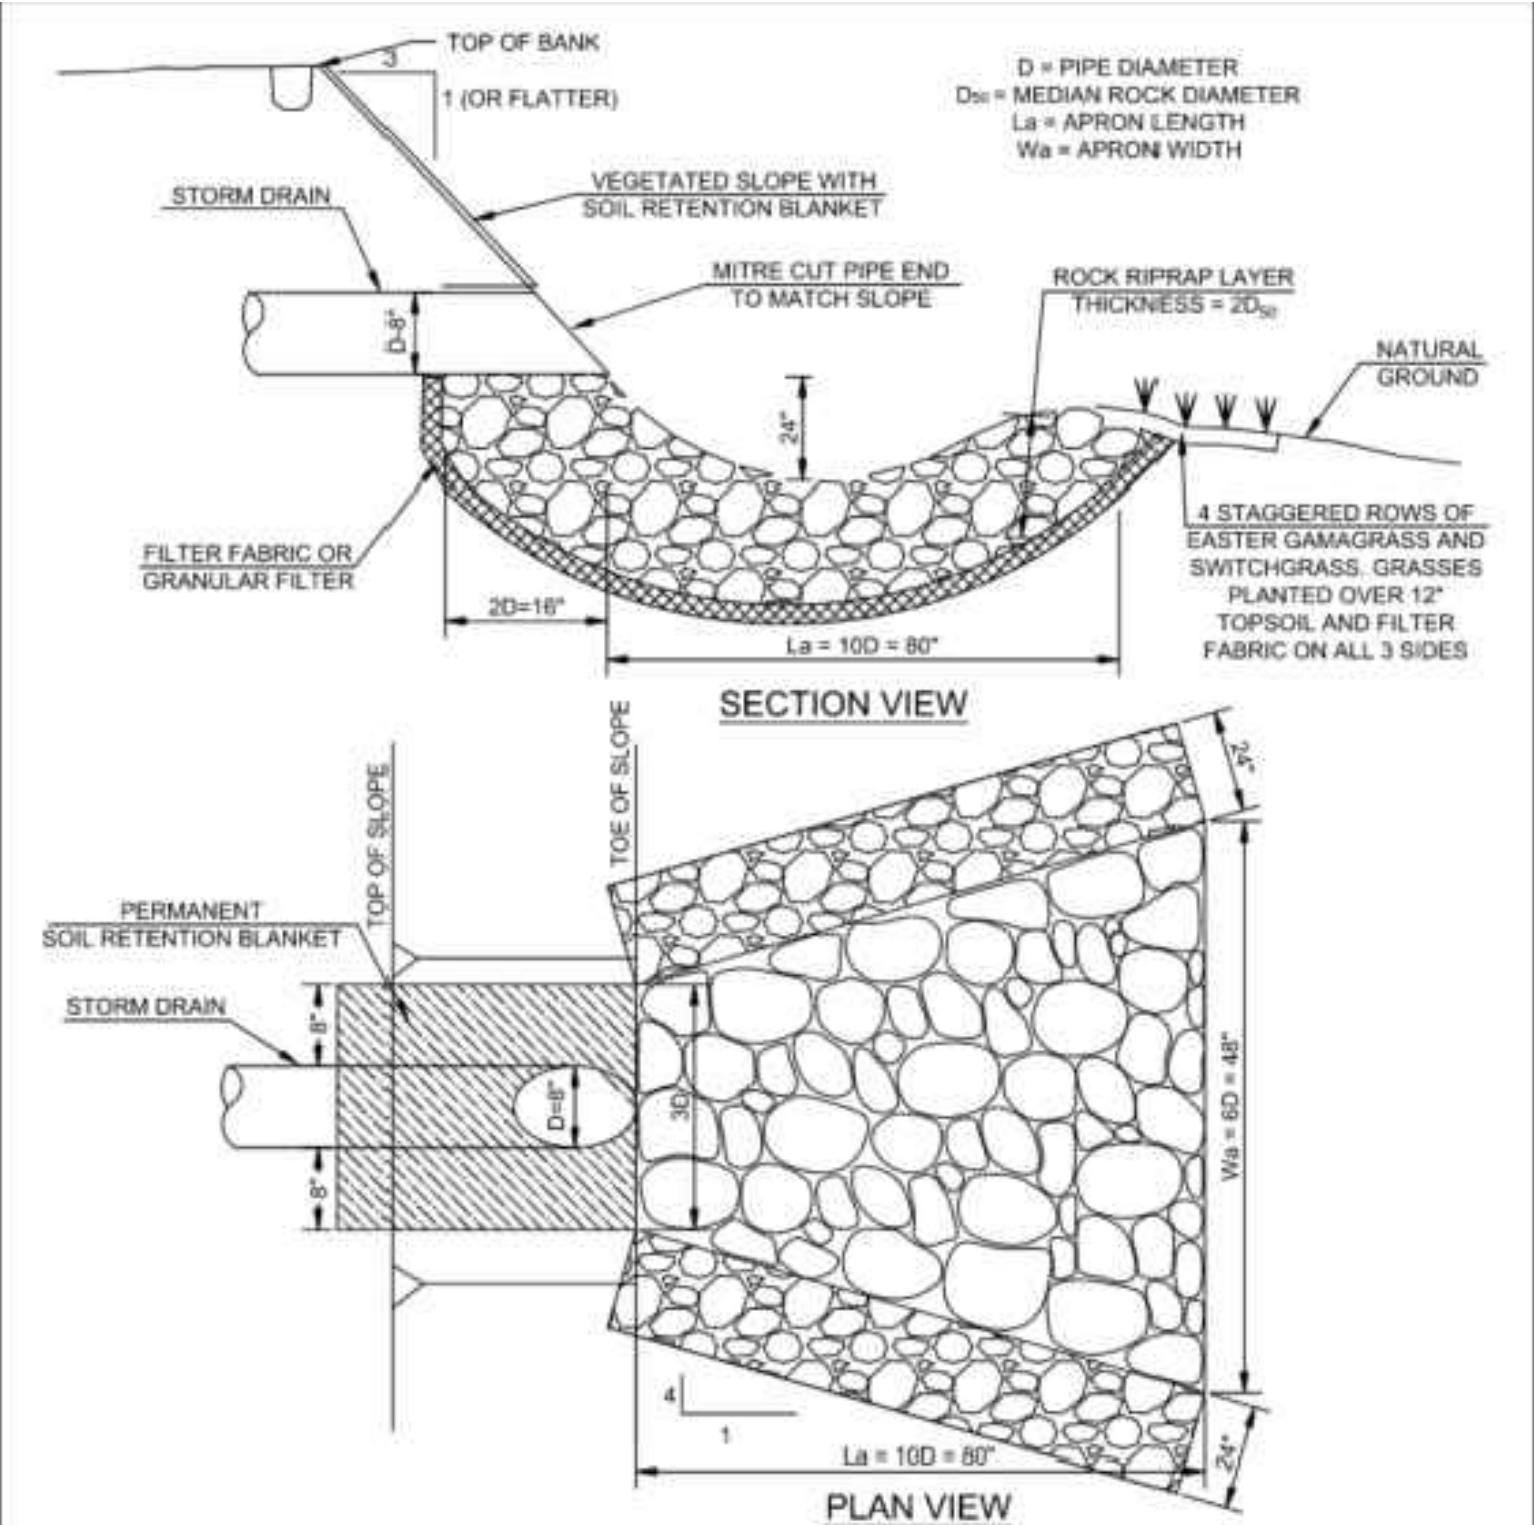
- NOTE:
- ROCK RIPRAP SHALL BE SOUND MATERIAL AND GRADED PER REQUIREMENTS SPECIFIED IN STANDARD SPECIFICATION ITEM NO. 591S.
 - ROCK SIZE (D₅₀) AND GRADATION SHALL BE STABLE FOR THE DESIGN HYDRAULIC CONDITIONS AND IN ACCORDANCE WITH THE ECM 1.4.6.D PERMANENT STRUCTURAL PRACTICES, STONE RIPRAP OR OTHER ENGINEERING STANDARD OF PRACTICE FOR SIZING ROCK RIPRAP. ROCK RIPRAP D₅₀ AND FILTER TYPE SHALL BE NOTED ON PLANS.
 - GEOTEXTILE FILTER FABRIC SHALL MEET THE REQUIREMENTS SPECIFIED IN STANDARD SPECIFICATION ITEM NO. 6205.
 - AGGREGATE FOR GRANULAR FILTER SHALL MEET THE REQUIREMENTS SPECIFIED IN STANDARD SPECIFICATION ITEM NO. 403. AGGREGATE SIZE CLASSIFICATION/GRADE, NUMBER OF LAYERS AND LAYER THICKNESS SHOULD BE NOTED ON THE PLANS.

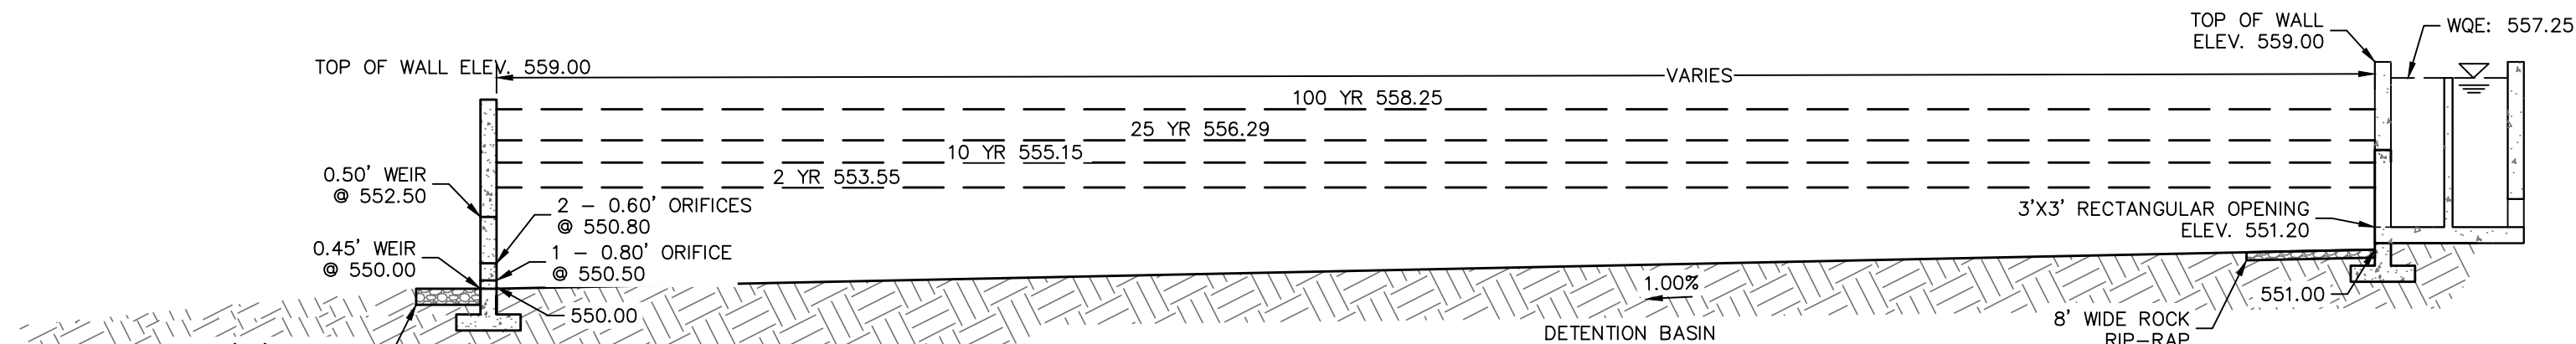
SECTION A-A
1" = 10'

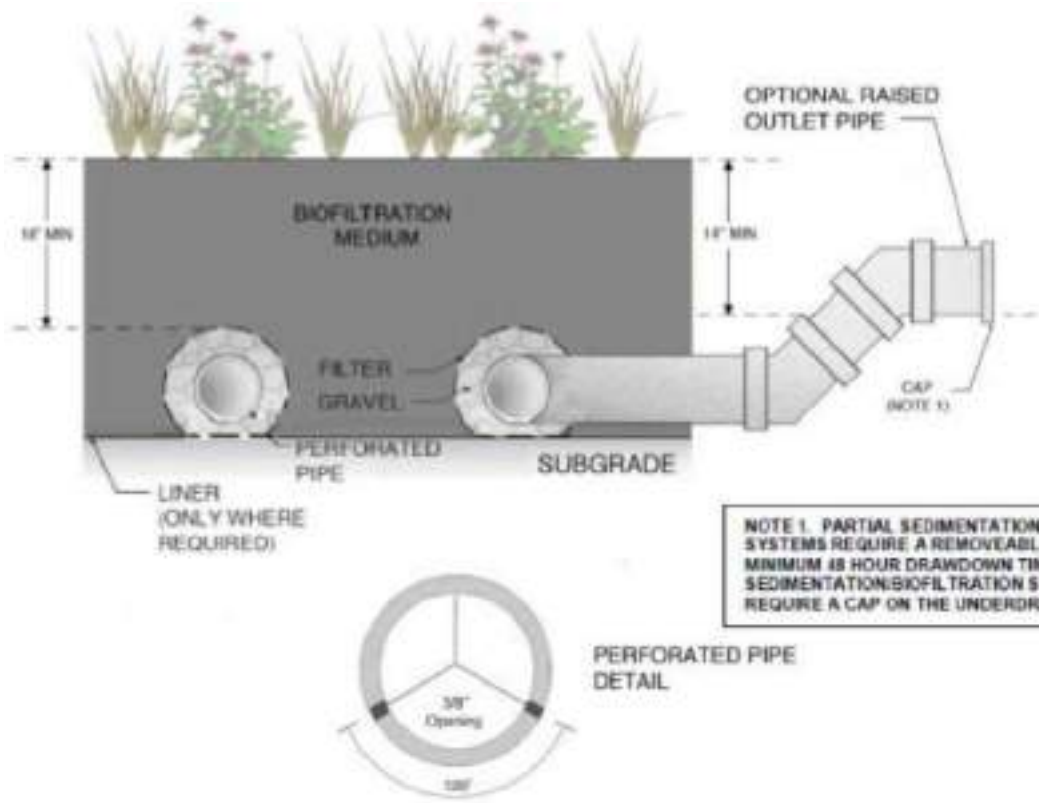
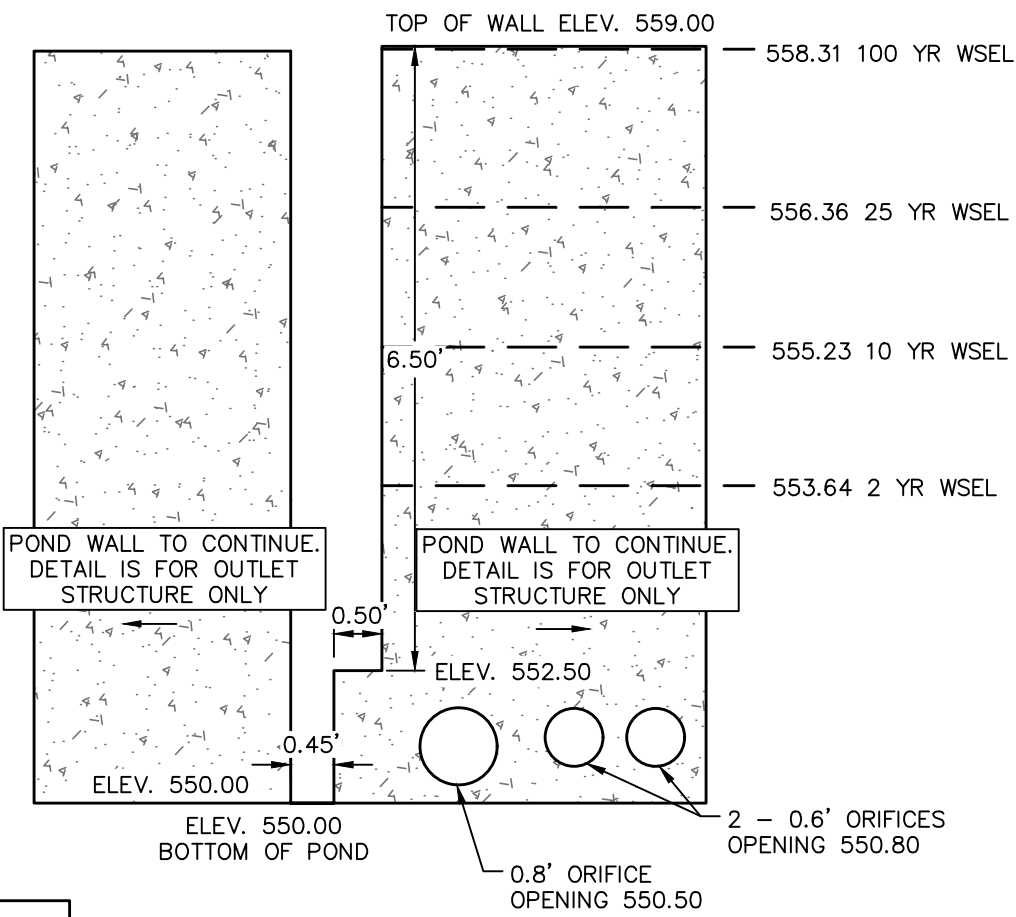
DETENTION POND 1 OUTFALL
1" = 1'

DETENTION POND 1 WSEL			
2 YEAR			553.55
10 YEAR			555.15
25 YEAR			556.29
100 YEAR			558.25
