Reference: - Supplemental Letter - 2715 Long Bow Trail - Case # C15-2022-0011

**NEW SINGLE-FAMILY HOME  
2715 LONGBOW TRAIL  
GRADING PLAN**

**NEW SINGLE-FAMILY HOME  
2715 LONGBOW TRAIL  
PROPOSED DRAINAGE PLAN**

## **Tree Condition Report - Lot 876 February 24, 2022**

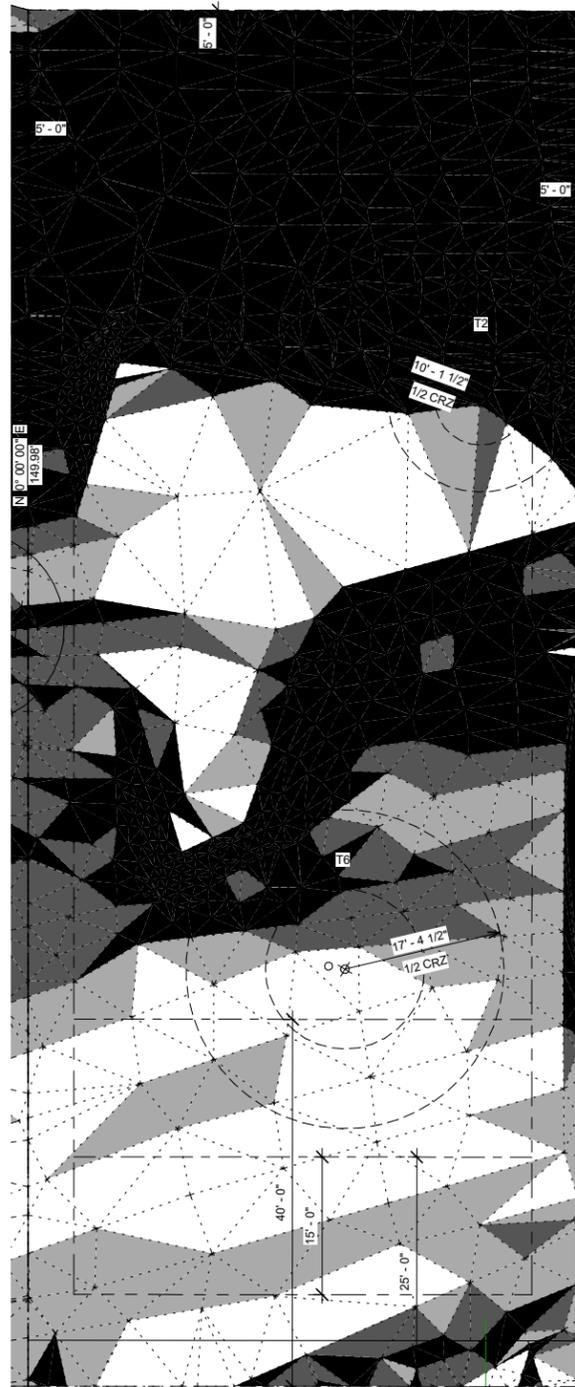
2 2715 - Slope  
1" = 10'-0"

2715 - Slope Analysis - Net Site Area	
Material: Range	Material: Area
0.00% to 15.00%	2,545 SF
15.00% to 25.00%	1,567 SF
25.00% to 35.00%	1,002 SF
35.00% to 4459.59%	4,958 SF

Allowed IC = 1,097.55 SF

1. Based on the slope analysis, the current site only allows for 1,097.55 sf of IC. We are requesting 2,000 sf of impervious coverage to meet the Apache Shores POA minimum living area requirements, a two-car garage for proper parking, and the required driveway using ribbon designs.

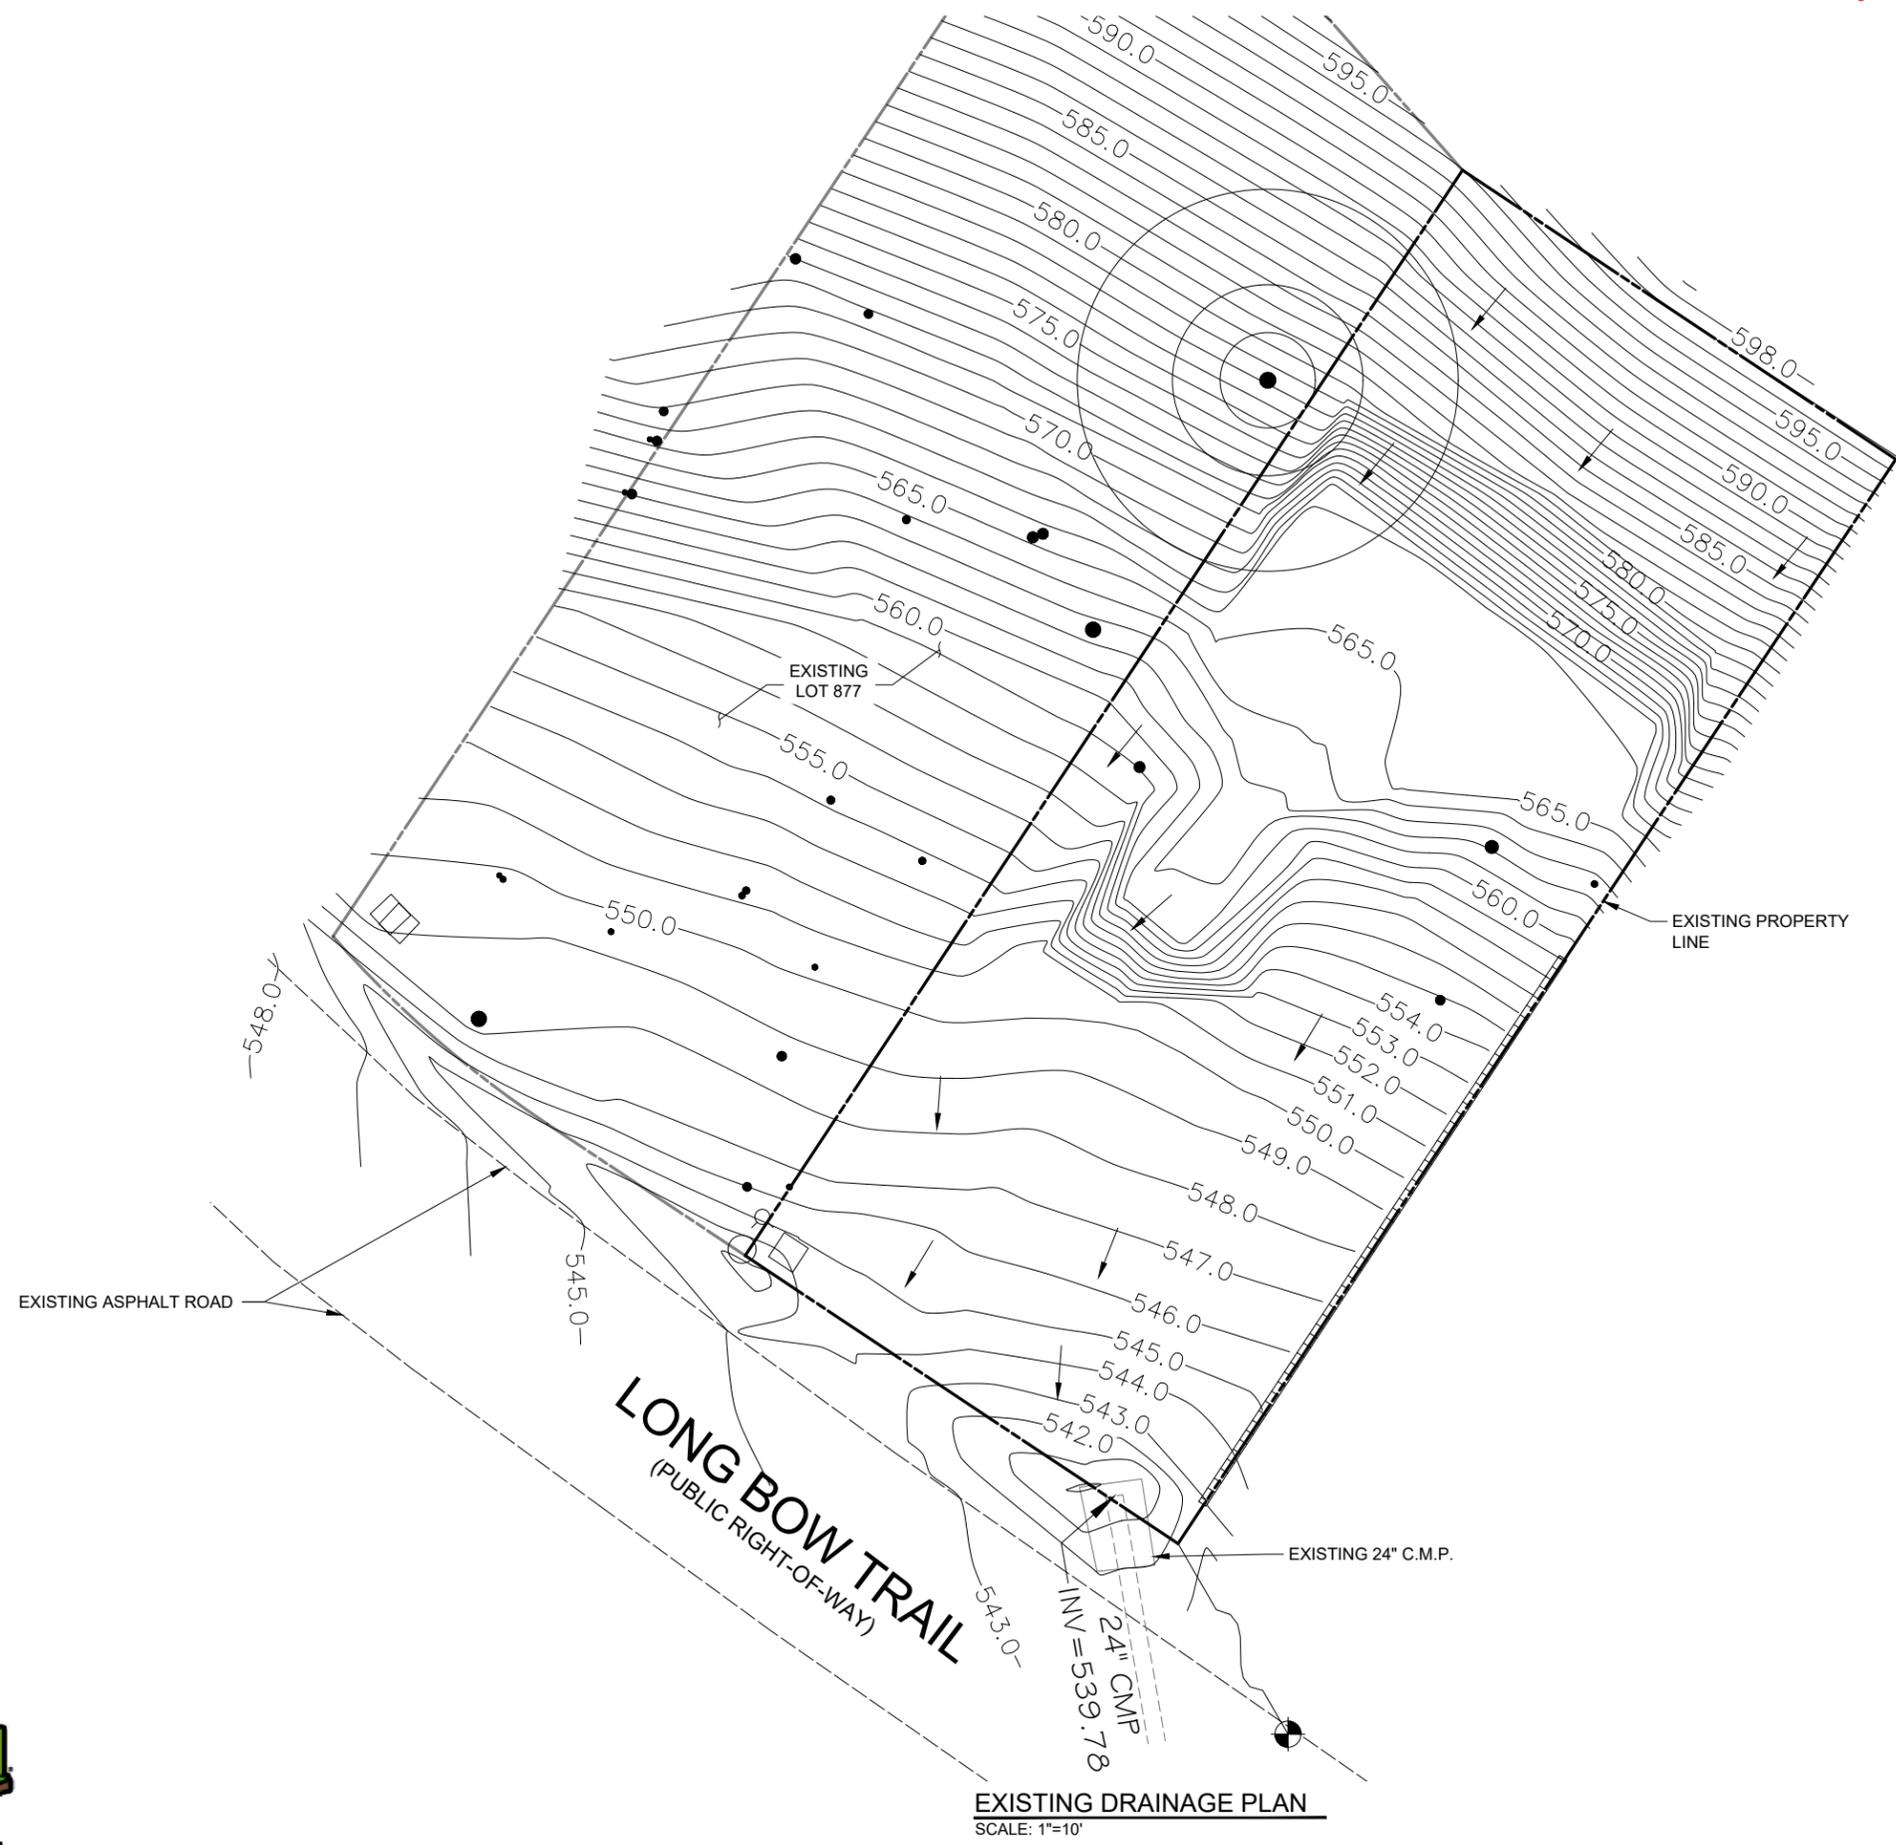
**EXISTING DRAINAGE PLAN**  
SCALE: 1"=10'

**NEW SINGLE-FAMILY HOME  
2715 LONGBOW TRAIL  
EXISTING DRAINAGE PLAN**

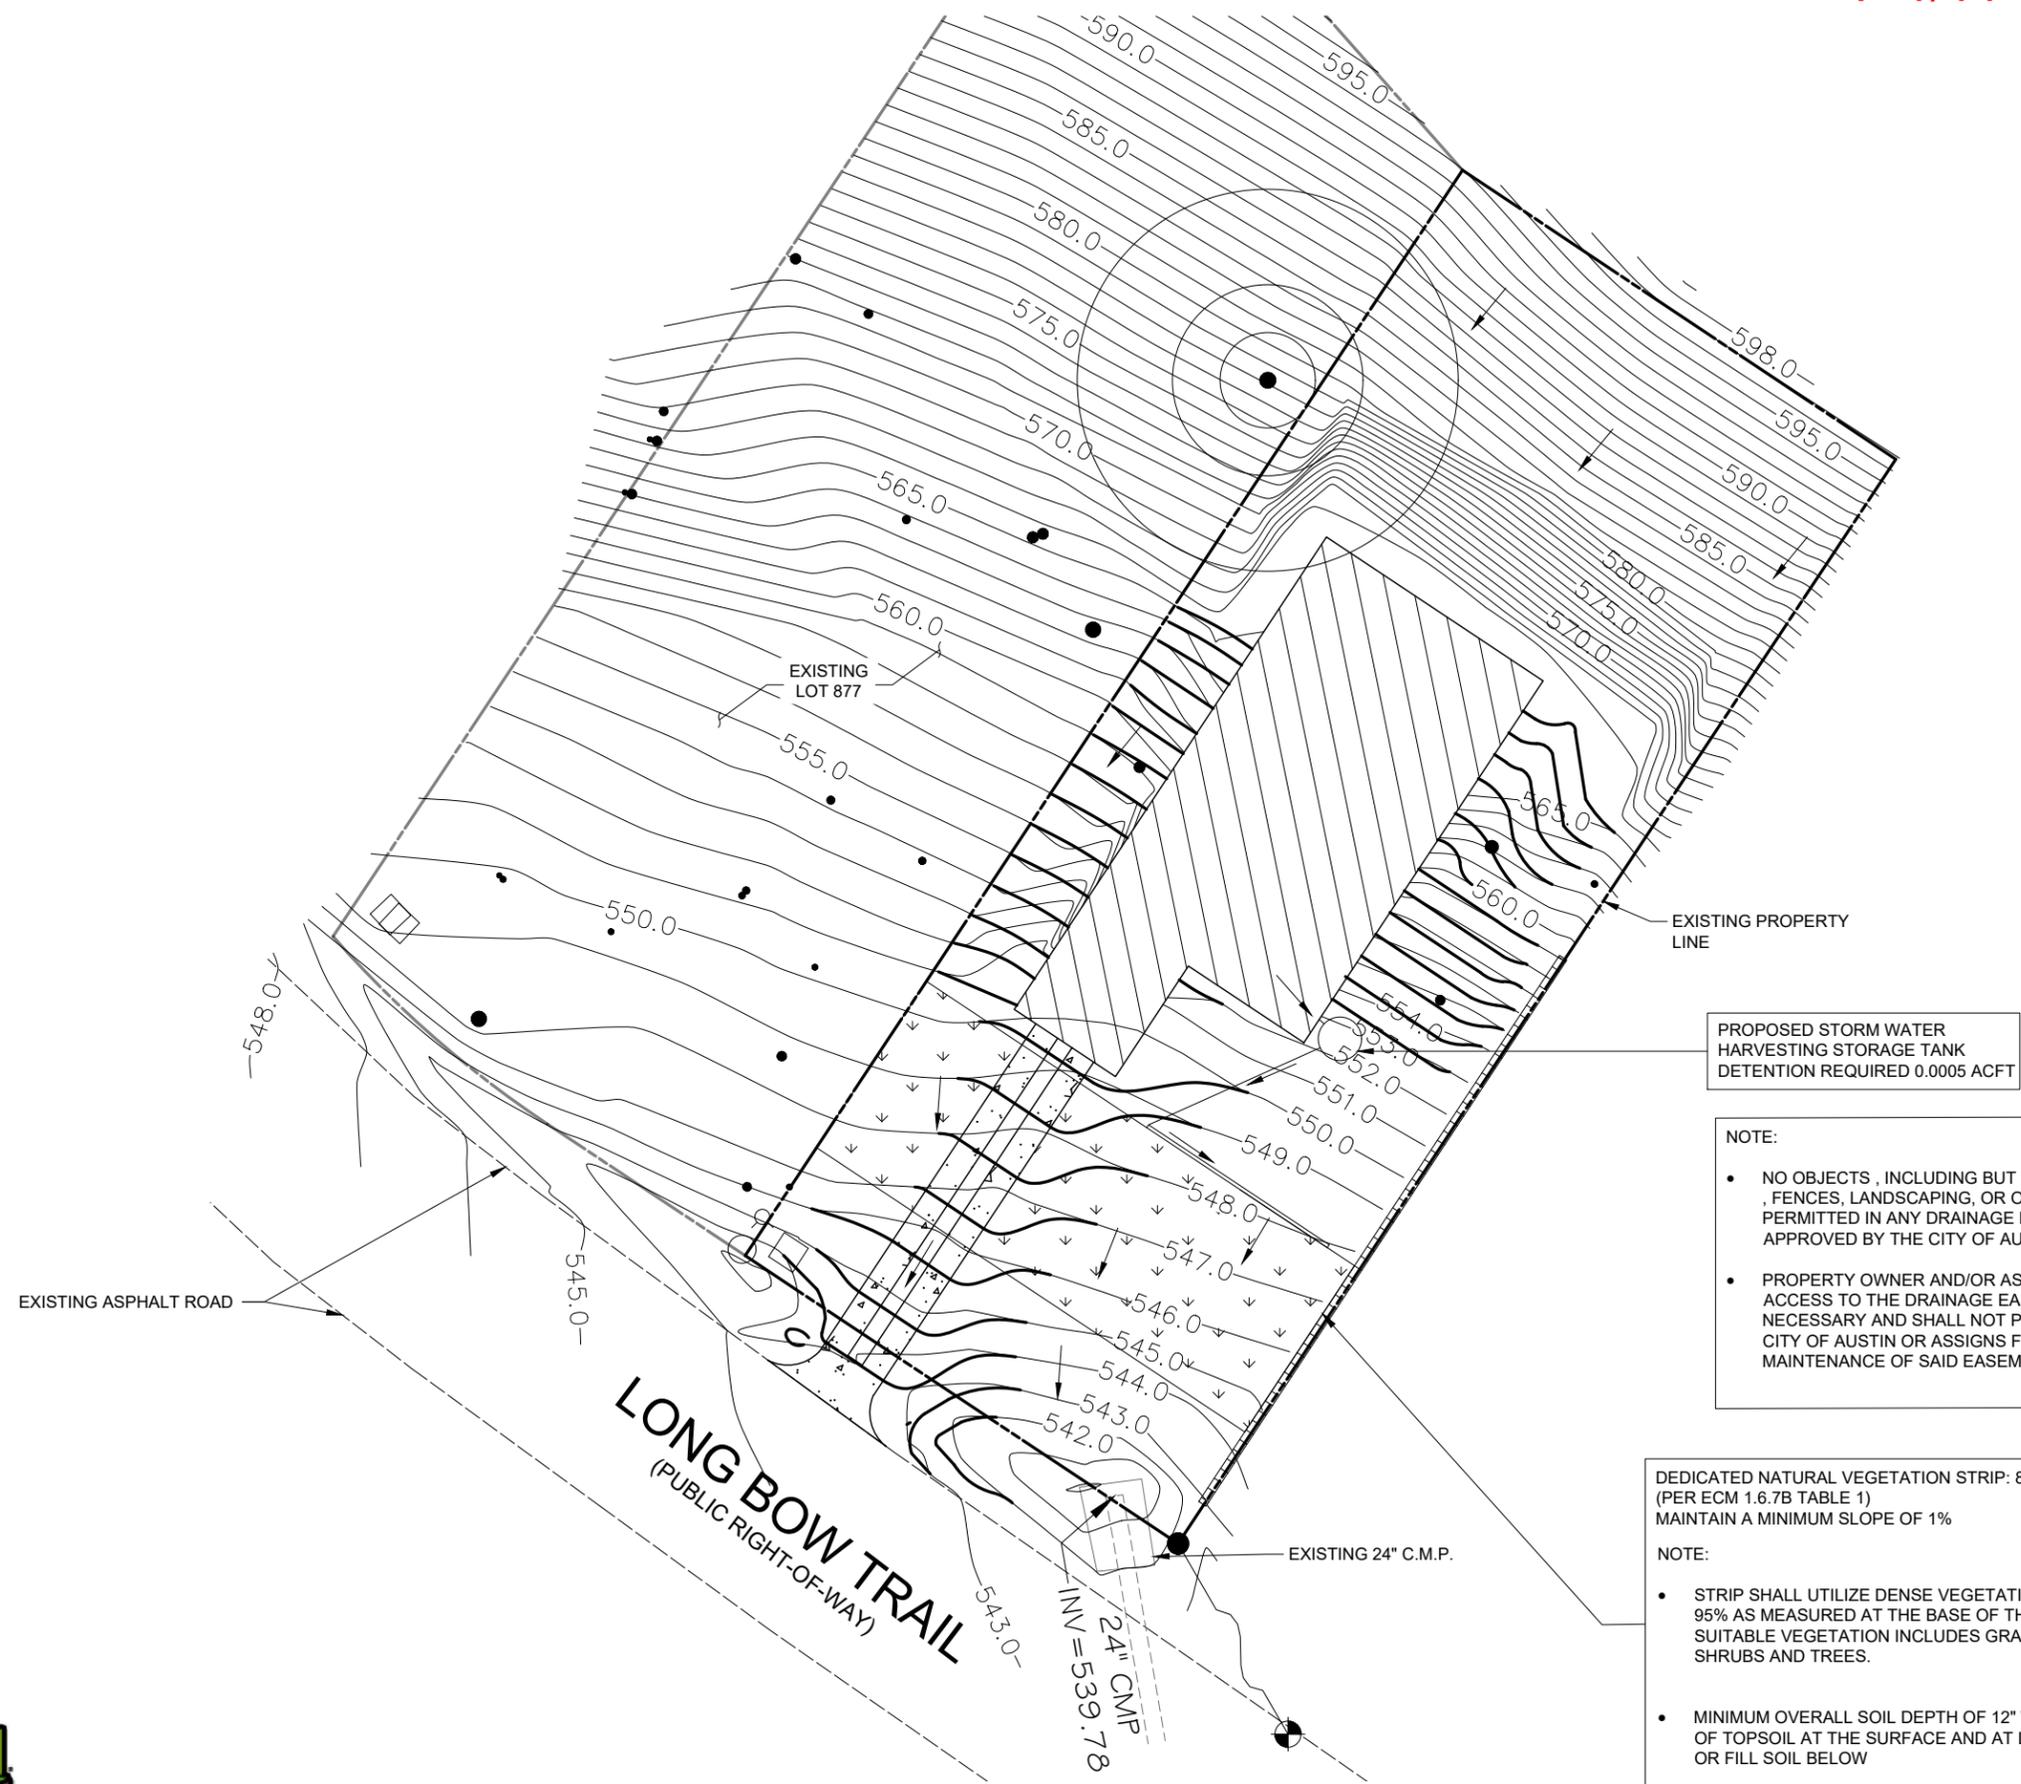
PROPOSED DRAINAGE PLAN  
SCALE: 1"=10'

PROPOSED STORM WATER HARVESTING STORAGE TANK  
DETENTION REQUIRED 0.0005 ACFT

DEDICATED NATURAL VEGETATION STRIP: 867 S.F. (PER ECM 1.6.7B TABLE 1)  
MAINTAIN A MINIMUM SLOPE OF 1%

3. Based on the engineering report and design provided by 3PX engineers, they created a drainage plan that will prevent any additional/adverse runoff created by the proposed development. This plan was created by using Vegetative Strips that are allowed under the ECM Section 1 - 1.6.7 (B)

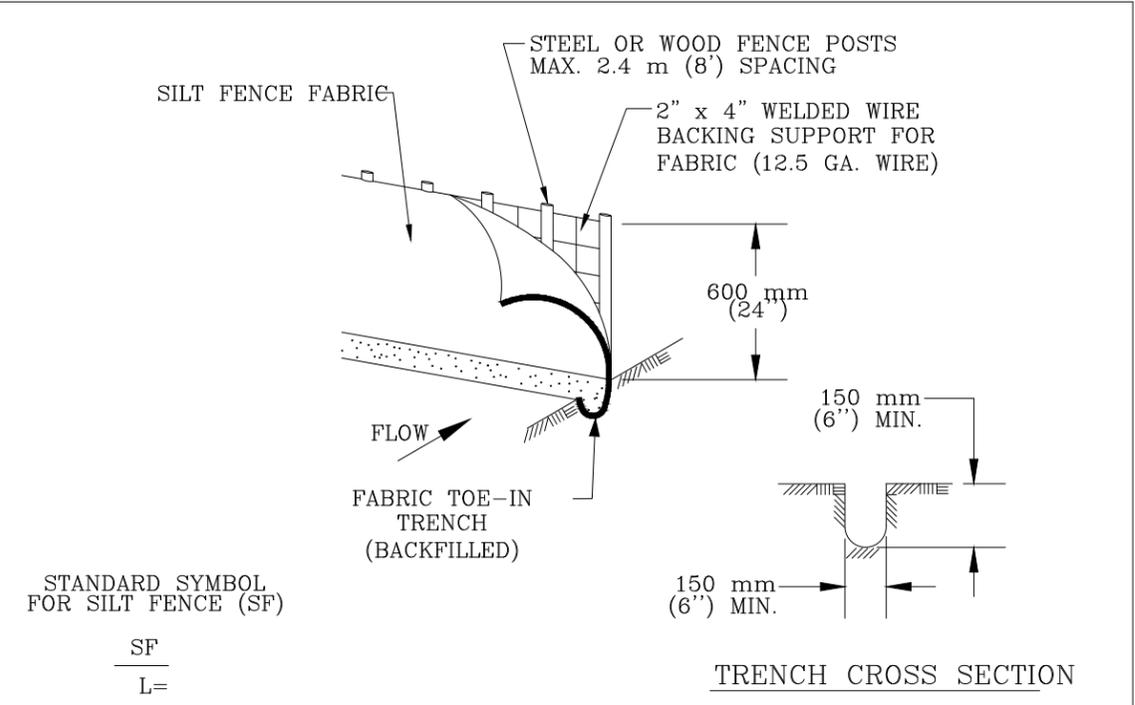
1 TYPICAL SILT FENCE DETAIL  
N.T.S.

1. STEEL OR WOOD POSTS WHICH SUPPORT THE SILT FENCE SHALL BE INSTALLED ON A SLIGHT ANGLE TOWARD THE ANTICIPATED RUNOFF SOURCE. POST MUST BE EMBEDDED A MINIMUM OF 300 mm (12 INCHES). IF WOOD POSTS CANNOT ACHIEVE 300 mm (12 inches) DEPTH, USE STEEL POSTS.

2. THE TOE OF THE SILT FENCE SHALL BE TRENCHED IN WITH A SPADE OR MECHANICAL TRENCHER, SO THAT THE DOWNSLOPE FACE OF THE TRENCH IS FLAT AND PERPENDICULAR TO THE LINE OF FLOW.

5. INSPECTION SHALL BE MADE WEEKLY OR AFTER EACH RAINFALL EVENT AND REPAIR OR REPLACEMENT SHALL BE MADE PROMPTLY AS NEEDED.
6. SILT FENCE SHALL BE REMOVED WHEN THE SITE IS COMPLETELY STABILIZED SO AS NOT TO BLOCK OR IMPEDE STORM FLOW OR DRAINAGE.

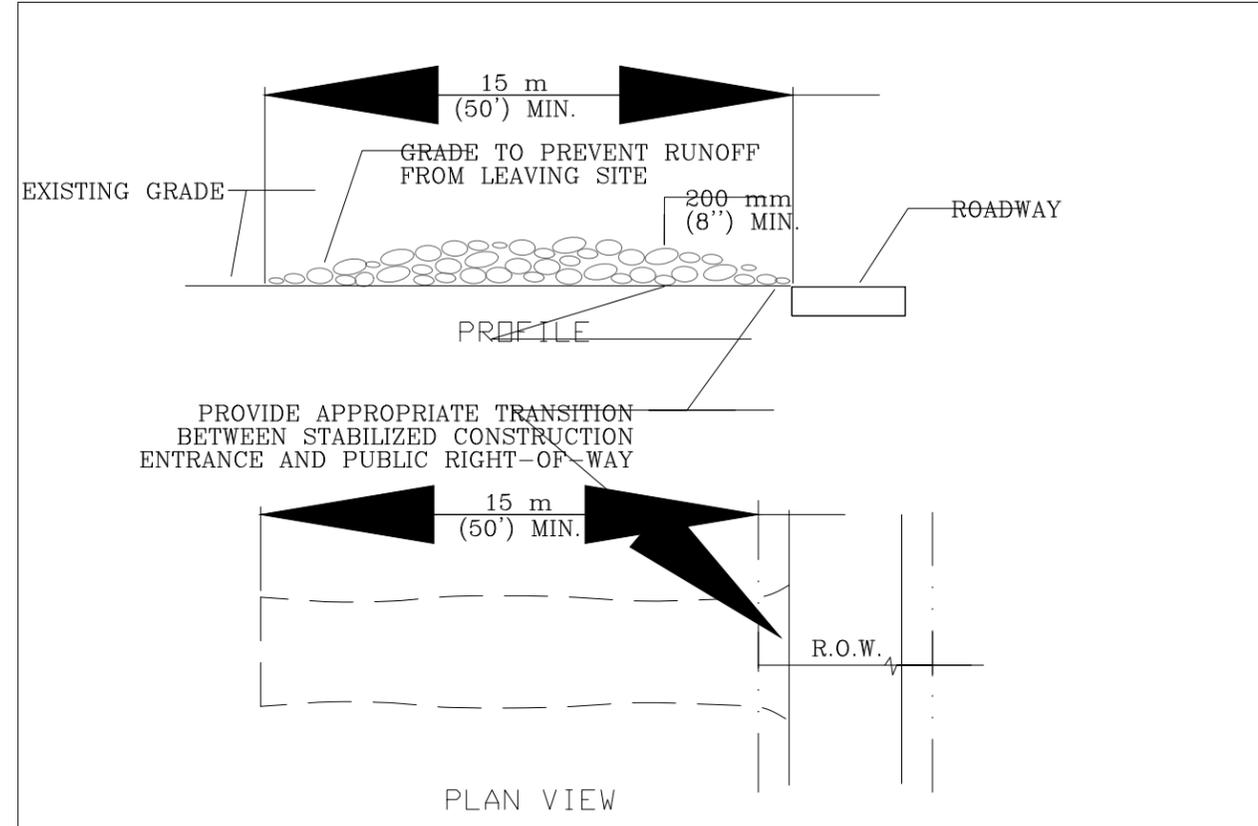
2 TYPICAL DETAIL FOR CONSTRUCTION ENTRANCE

- NOTES:
1. STONE SIZE: 75-125 mm (3-5") OPEN GRADED ROCK.
  2. LENGTH: AS EFFECTIVE BUT NOT LESS THAN 15 m (50').
  3. THICKNESS: NOT LESS THAN 200 mm (8").

4. WIDTH: NOT LESS THAN FULL WIDTH OF ALL POINTS OF INGRESS/EGRESS.
  5. WASHING: WHEN NECESSARY, VEHICLE WHEELS SHALL BE CLEANED TO REMOVE SEDIMENT PRIOR TO ENTRANCE ONTO PUBLIC ROADWAY. WHEN WASHING IS REQUIRED, IT SHALL BE DONE ON AN AREA STABILIZED WITH CRUSHED STONE AND DRAINS INTO AN APPROVED TRAP OR SEDIMENT BASIN. ALL SEDIMENT SHALL BE PREVENTED FROM ENTERING ANY STORM DRAIN, DITCH OR WATERCOURSE USING APPROVED METHODS.

6. MAINTENANCE: THE ENTRANCE SHALL BE MAINTAINED IN A CONDITION THAT WILL PREVENT TRACKING OR FLOWING OF SEDIMENT ONTO PUBLIC ROADWAY. THIS MAY REQUIRE PERIODIC TOP DRESSING WITH ADDITIONAL STONE AS CONDITIONS DEMAND, AS WELL AS REPAIR AND CLEAN OUT OF ANY MEASURE DEVICES USED TO TRAP SEDIMENT. ALL SEDIMENTS THAT IS SPILLED, DROPPED, WASHED OR TRACKED ONTO PUBLIC ROADWAY MUST BE REMOVED IMMEDIATELY.

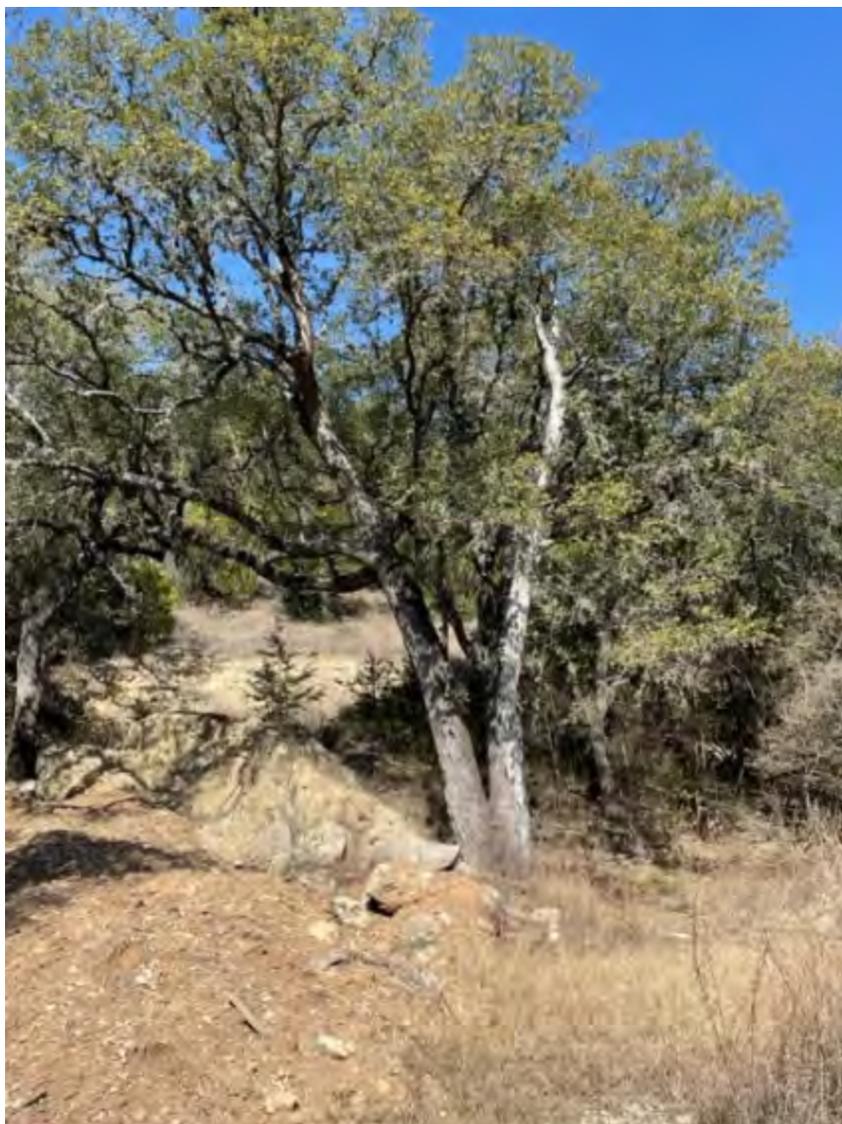
**DBH:** 23.5"/22.5" twin trunked and combined measurement of 34.75"

**Note:** General overview picture

The tree is designated as a "Heritage" tree by the City of Austin (see Appendix A, Photo 1). Heritage trees are a group of protected trees measuring 24" and larger. I observed multiple obvious defects in the tree and determined that the subject tree was in "Fair" condition. The eastern (or right side) leader of the tree has a significant column of dead wood protruding from the living leader (see Appendix A, Photo 2). This old column of dead wood was "Imminent" for failure. I observed another large column of dead wood that emerged from the upper canopy of the left trunk. This upper leader with the dead column of wood was also "imminent" for failure (see Appendix A, Photo 3).

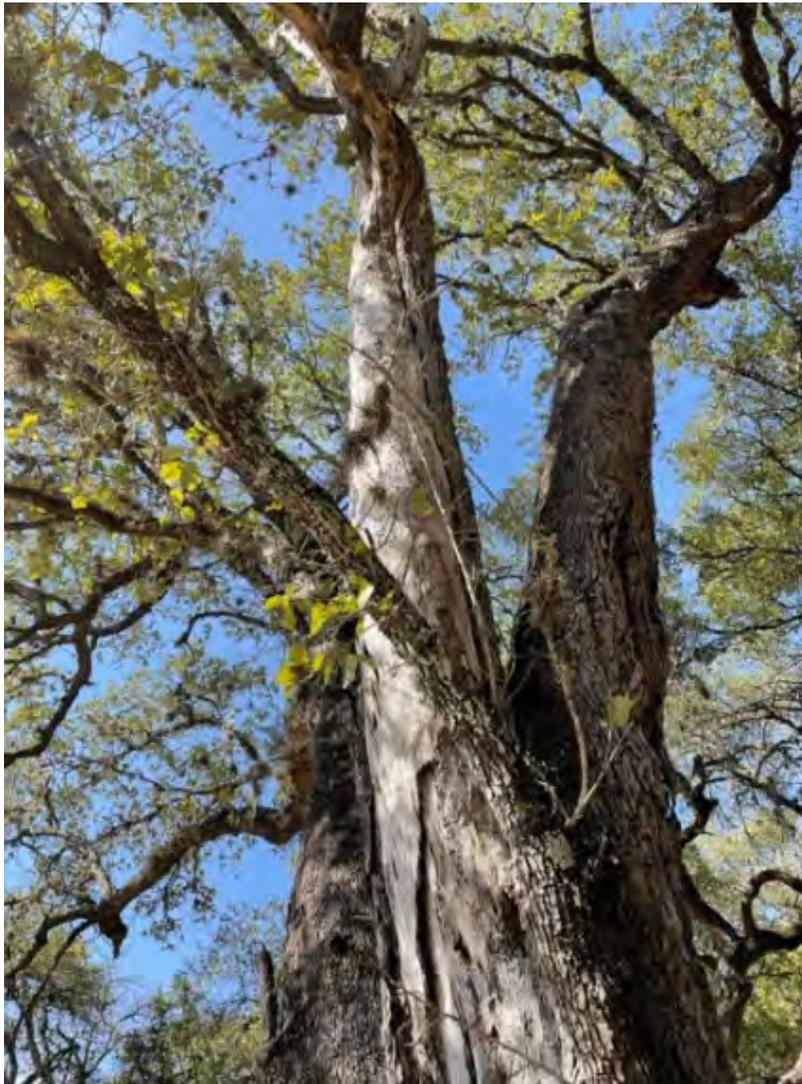
**DBH:** 23.5"/22.5" twin trunked and combined measurement of 34.75"

**Note:** The eastern (or right side) leader of the tree has a significant column of dead wood protruding from the living leader. This old column of dead wood was "Imminent" for failure.

The mitigation option with the lowest residual risk is removal of the large columns of dead wood. It is my opinion that the scaffold branches with the most significant decay pockets also need to be partially removed back to healthier sections of wood. I estimated that this could require pruning approximately fifty percent of the existing tree canopy and perhaps more. This would require a permit from the City of Austin and would exceed industry and municipal standards for pruning in a single year. Tree health

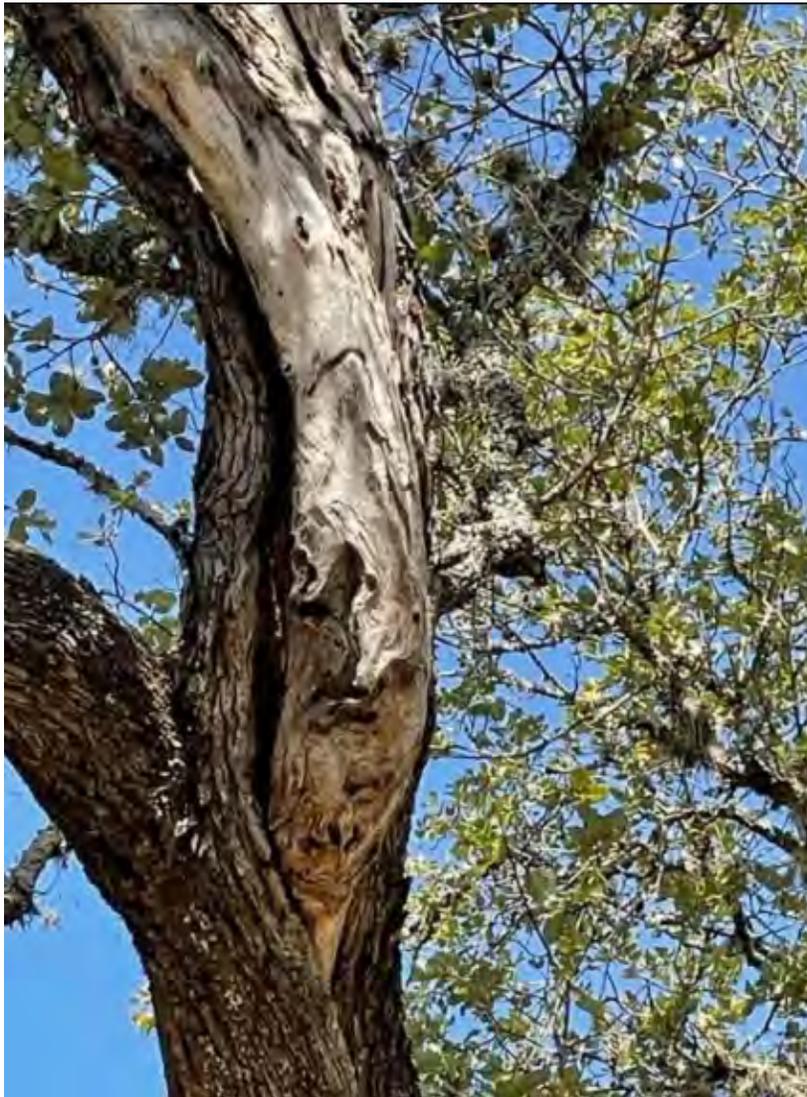
**DBH:** 23.5"/22.5" twin trunked and combined measurement of 34.75"

**Note:** Another large column of dead wood that emerged from the upper canopy of the left trunk. This upper leader with the dead column of wood was also "imminent" for failure.

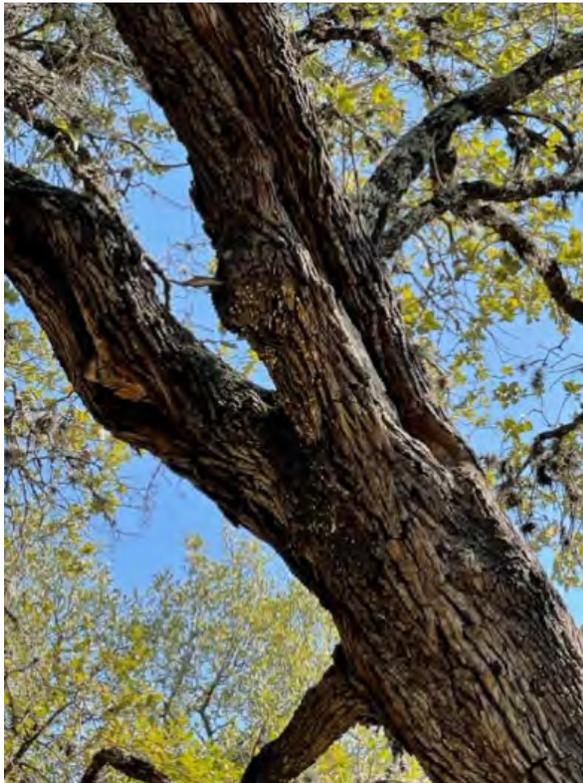
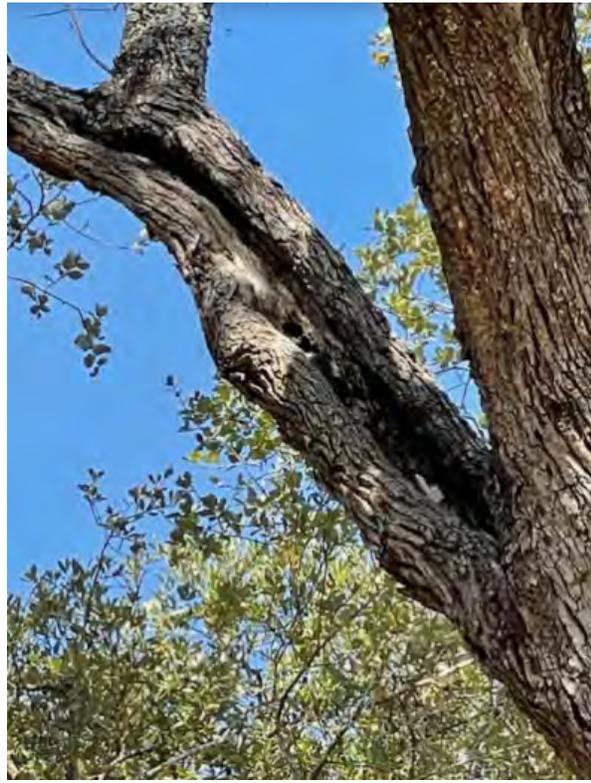
**DBH:** 23.5"/22.5" twin trunked and combined measurement of 34.75"

**Note:** Numerous large scaffold branches with significant decay pockets in both trunks. Most of the defects I observed were "Probable" for failure within an eighteen-month time frame.

I also observed numerous large scaffold branches with significant decay pockets in both trunks (see Appendix A, Photos 4 and 5). Most of the defects I observed were "Probable" for failure within an eighteen-month time frame.

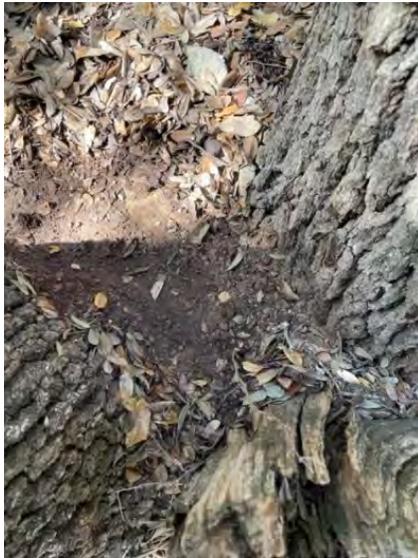
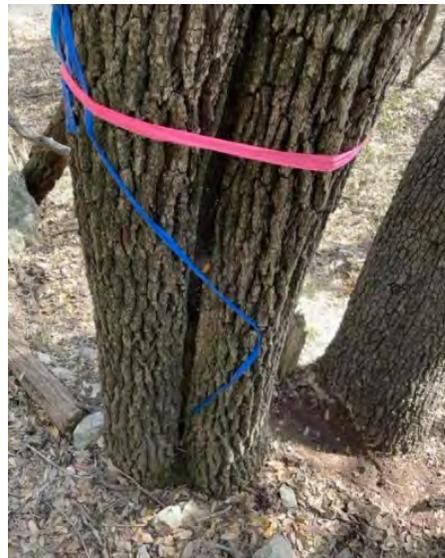
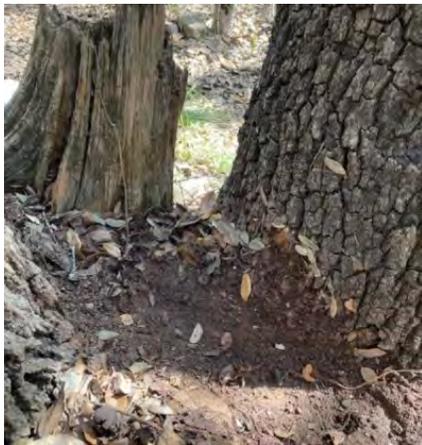
**DBH:** 14"

**Note:** Live oak number T23 is indicated as a single twin trunked tree, and the survey shows that each trunk measured 15." When I reviewed live oak number T23, I did not observe that the trees shared any common tissue, included bark, or juncture above grade. I performed minor excavation to the area between the trees, and still did not observe any common tissue. I measured each of these individual trees as 14" dbh and as such, they are not of protected size.

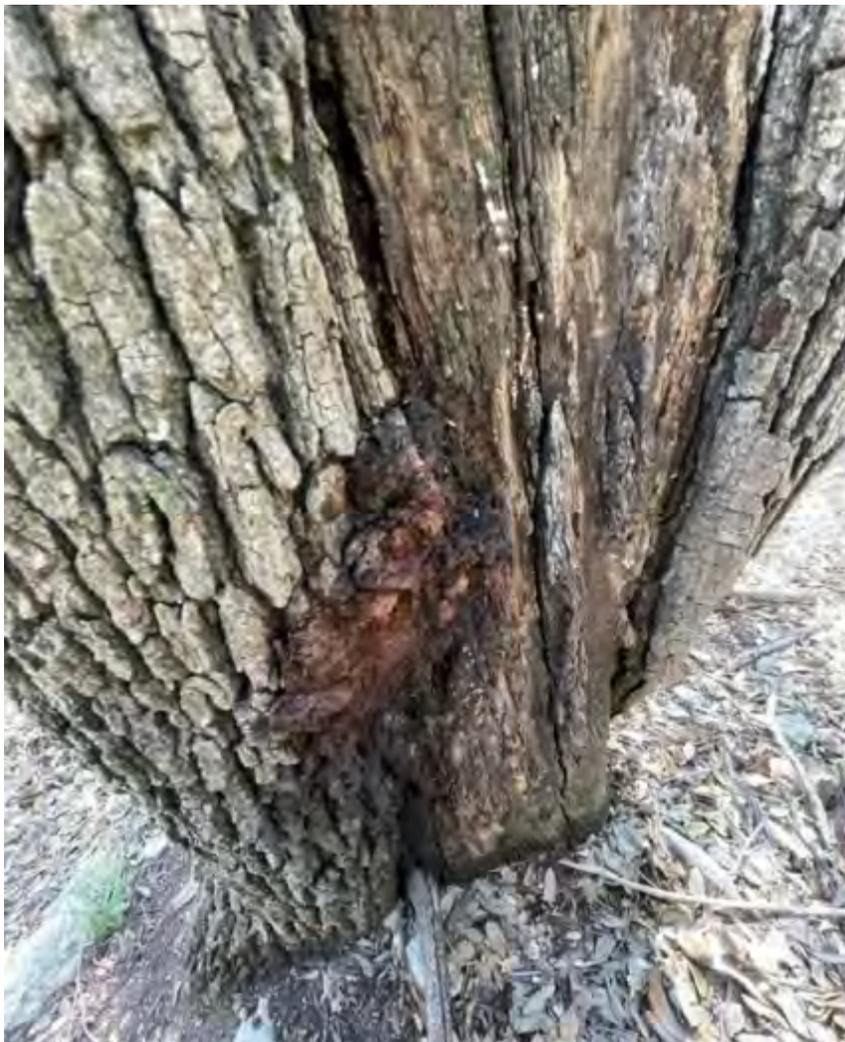
**DBH:** 21"

**Note:** Decay column in the trunk and basal area of the tree and a fungal fruiting body ordinarily associated with heartwood decay. The tree has numerous long branches and poor form. The overall condition of this tree is fair to poor.

I observed a decay column in the trunk and basal area of the tree and a fungal fruiting body ordinarily associated with heartwood decay (see Appendix A, Photo 4). The tree has numerous long branches and poor form. The overall condition of this tree is fair to poor.

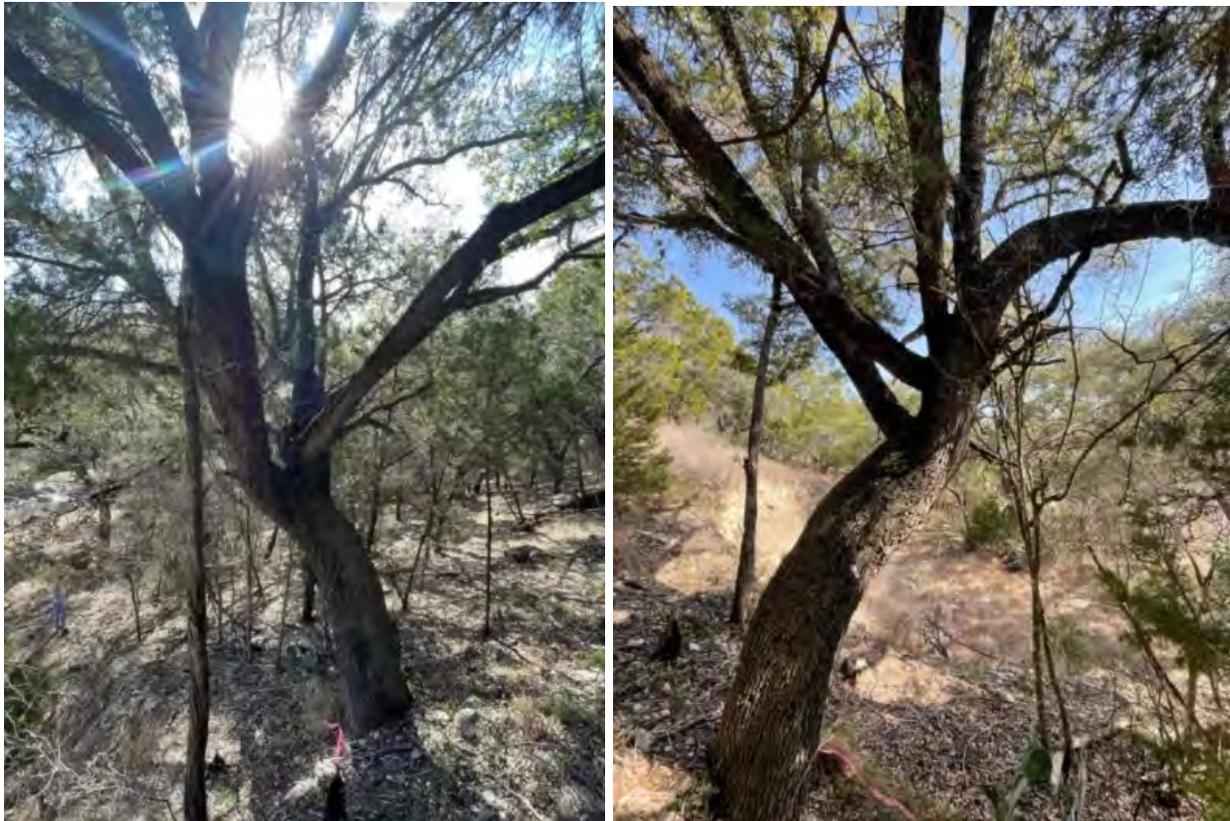
**DBH:** 20.75" measured from the high side of grade surrounding the tree

**Note:** I observed several co-dominant branch junctures in this tree, and in general, the tree had fair form.

I observed several co-dominant branch junctures in this tree, and in general, the tree had fair form (see Appendix A, Photos 5 and 6). While I observed several leaning and over-extended branches, the canopy appeared to be evenly distributed (see Appendix A, Photo 7). The overall condition of the tree was good. Proper pruning can begin to correct form issues and should be within the protection limits of no more than 25% removed in a calendar year.

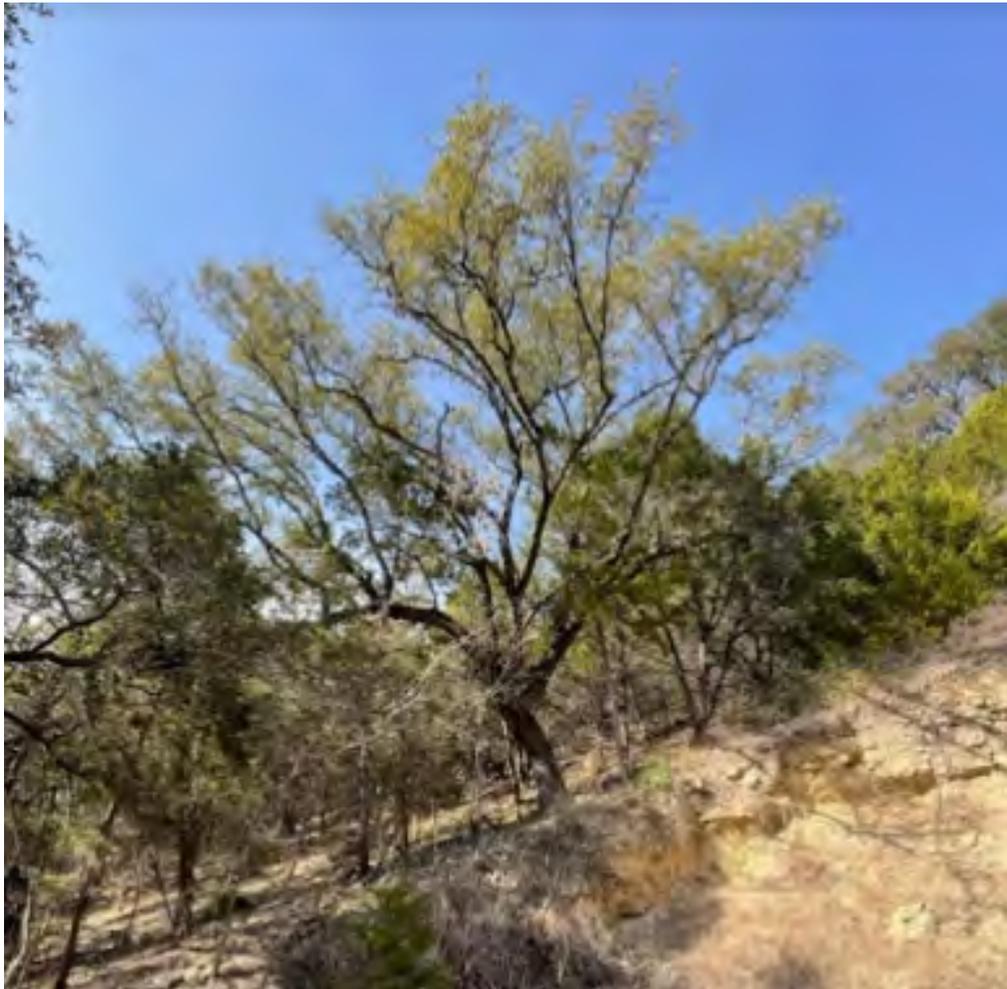
**DBH:** 20.75" measured from the high side of grade surrounding the tree

**Note:** While I observed several leaning and over-extended branches, the canopy appeared to be evenly distributed. The overall condition of the tree was good. Proper pruning can begin to correct form issues and should be within the protection limits of no more than 25% removed in a calendar year.
