ITEM FOR ENVIRONMENTAL COMMISSION AGENDA

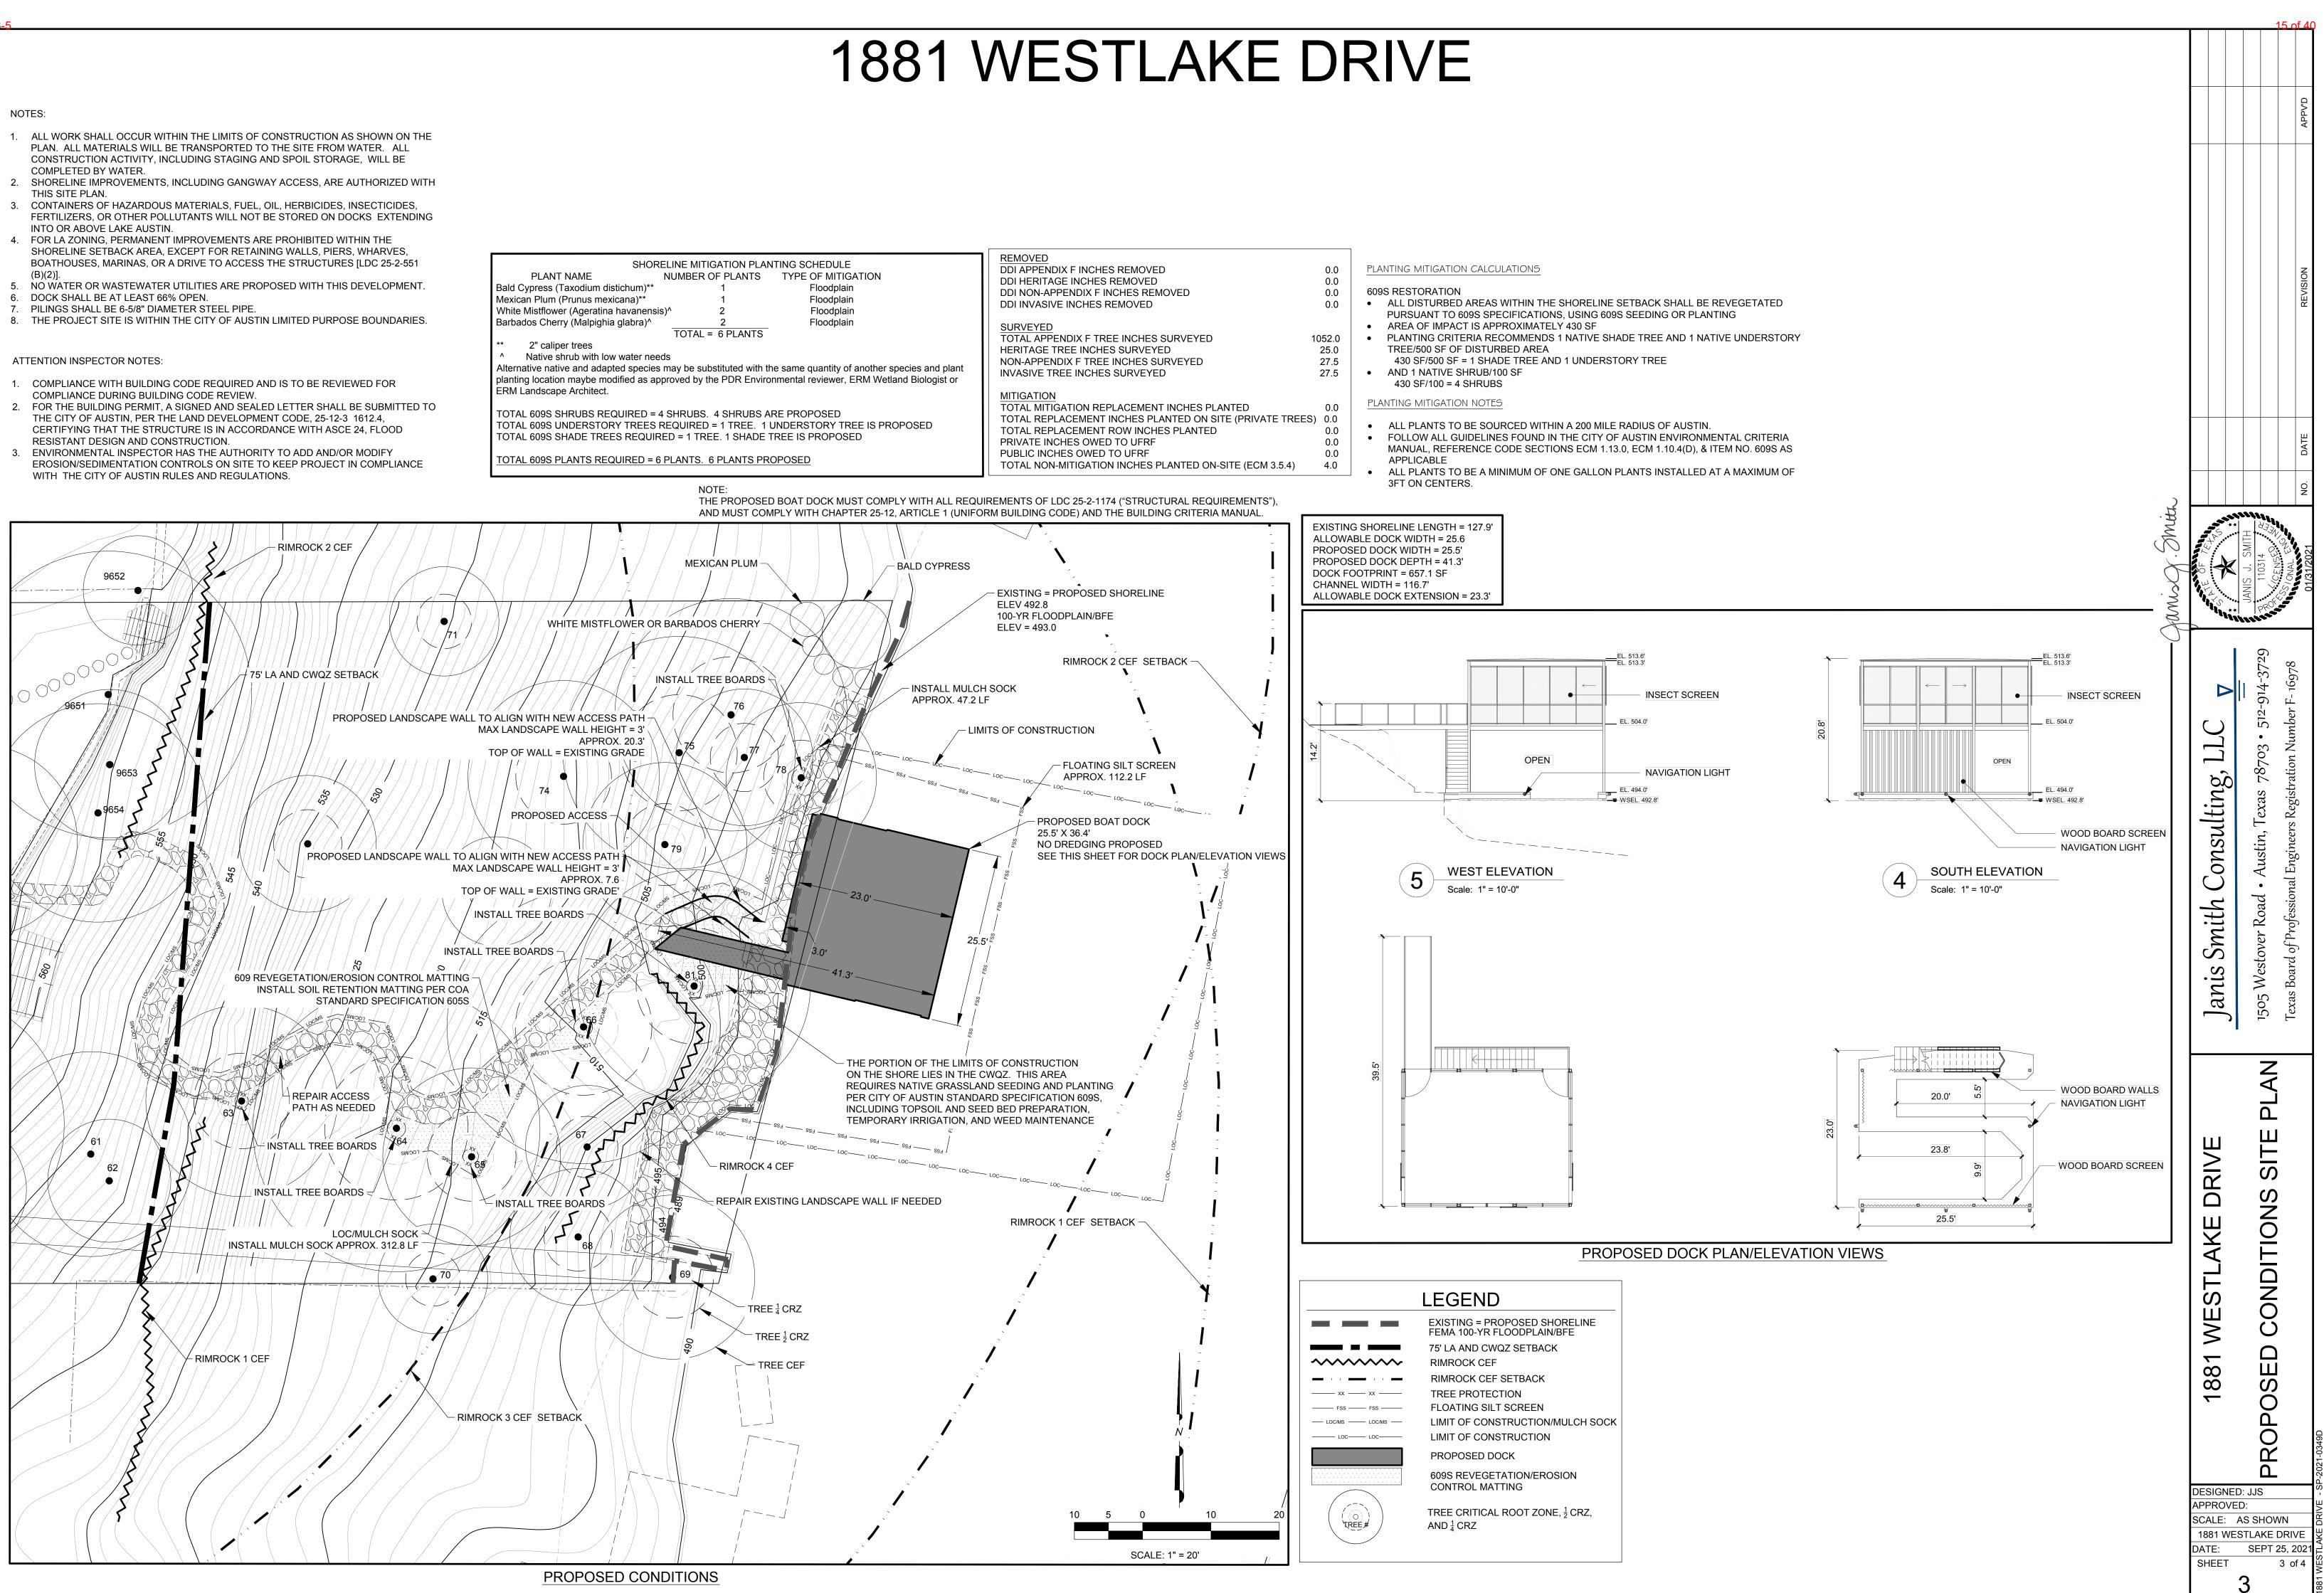
PROPOSED CONDITIONS SITE PLAN SHEET AND EROSION CONTROLS

- PLAN. ALL MATERIALS WILL BE TRANSPORTED TO THE SITE FROM WATER. ALL CONSTRUCTION ACTIVITY, INCLUDING STAGING AND SPOIL STORAGE, WILL BE
- THIS SITE PLAN.
- FERTILIZERS, OR OTHER POLLUTANTS WILL NOT BE STORED ON DOCKS EXTENDING INTO OR ABOVE LAKE AUSTIN.
- SHORELINE SETBACK AREA, EXCEPT FOR RETAINING WALLS, PIERS, WHARVES, BOATHOUSES, MARINAS, OR A DRIVE TO ACCESS THE STRUCTURES [LDC 25-2-551 (B)(2)].

Clearly indicate in what	
way the proposed project does not comply with current Code (include maps and exhibits)	The limit of construction for the proposed dock and access repairs fall within the rimrock CEF setbacks. Please see Attachment 2 for the Proposed Conditions Site Plan Sheet; Attachment 3 for the Basis of Determination for the Findings of Fact; and Attachment 4 for the Environmental Resource Inventory.

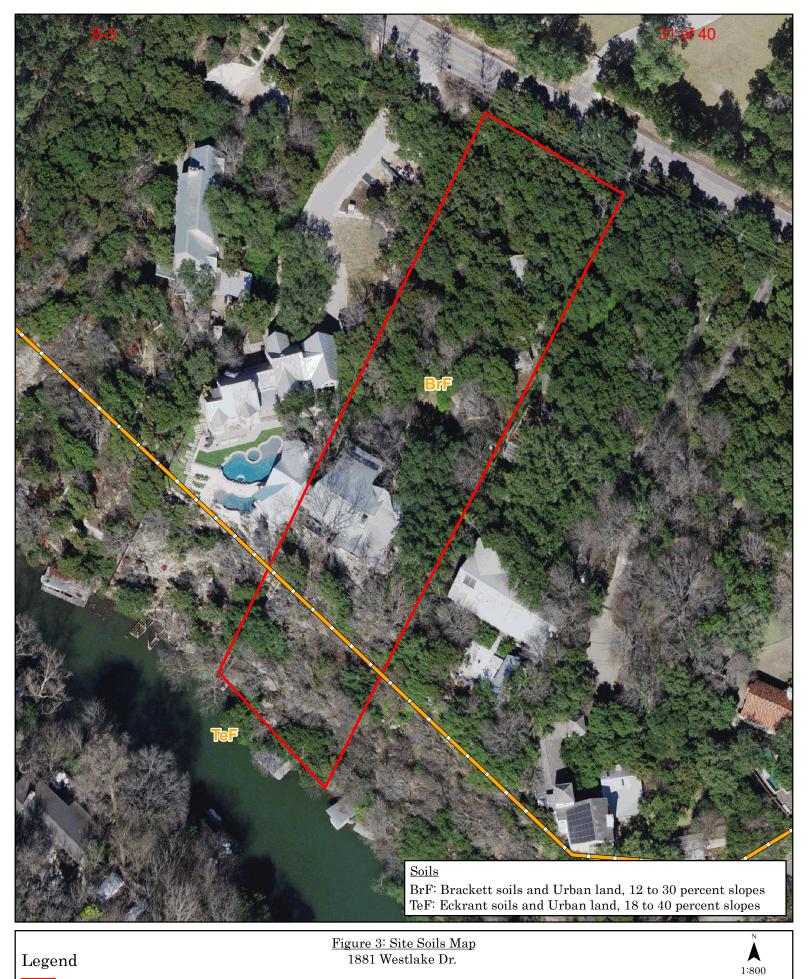
Soils (USDA/NRCS)

Soil Series Unit Names, Infiltration Characteristics & Thickness			
Soil Series Unit Name & Subgroup**	Group*	Thickness (feet)	
Brackett soils and Urban land, 12 to 30 percent slopes	D	1.5	
Eckrant soils and Urban land, 18 to 40 percent slopes	D	0.67

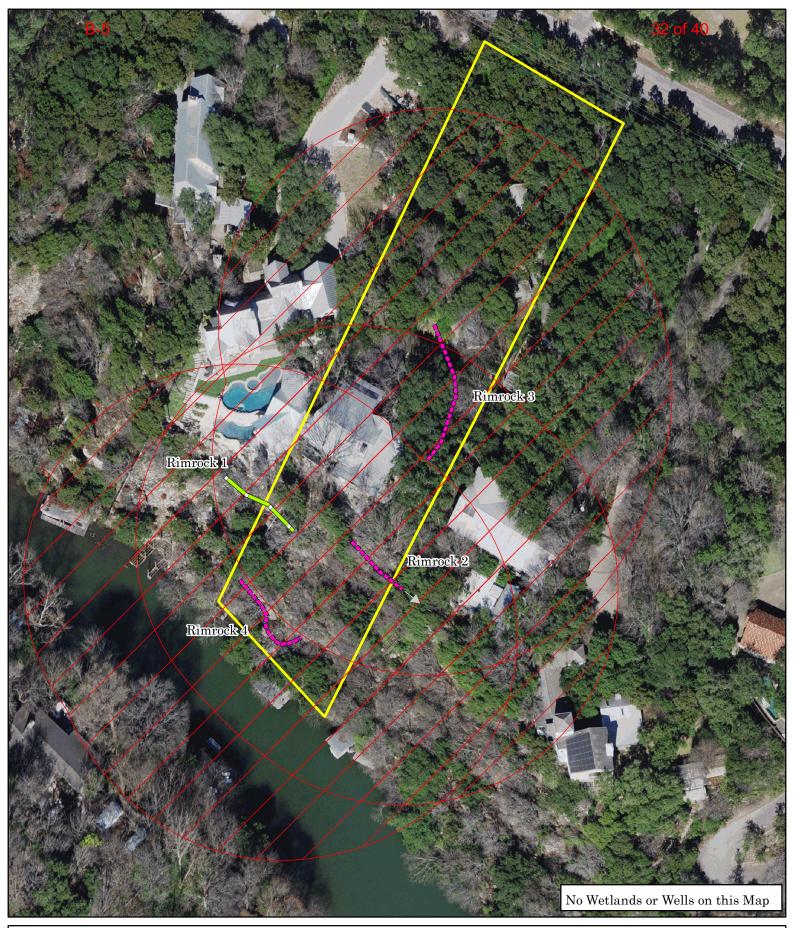
Rimrock (CoA) Rimrock (DESCO) Parcel of Interest (CoA) 150' Rimrock Buffer Figure 4: Critical Environmental Features and Well Locations 1881 Westlake Dr. N 1:800 €€€€€€€€ 0 25 50 100 Feet

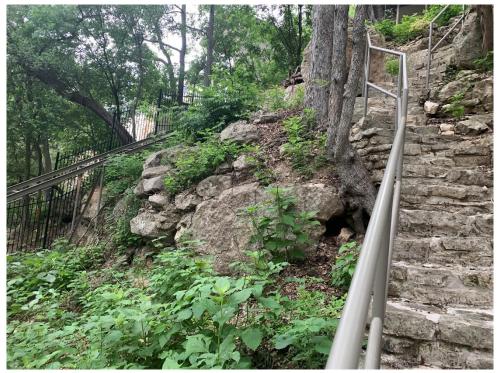
Photo 4: Photo of Rimrock 1 which had previously been documented by the City of Austin and verified by DESCO during the site visit. Photo was taken from near the east end of the rimrock facing northwest.

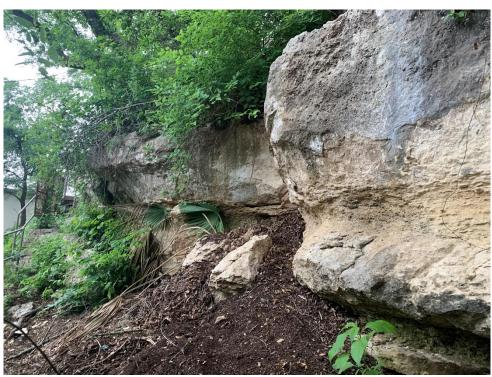
Photo 5: View of Rimrock 2 which extends further southeast than mapped. Photo was taken near the eastern property boundary facing northeast.

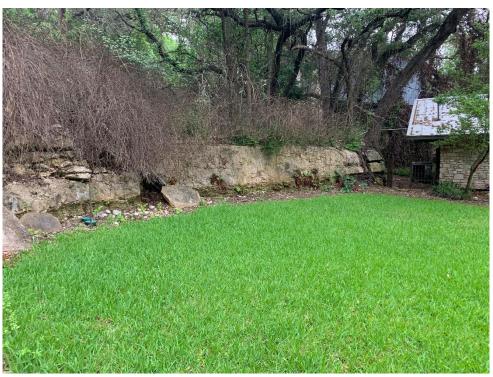
Photo 6: View of Rimrock 3, just above the main residence facing southeast.

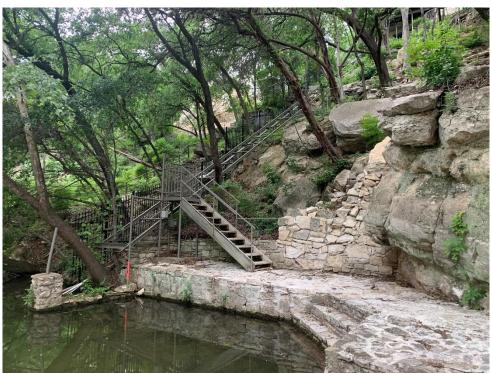
Photo 7: View of western shoreline and Rimrock 4 from boat dock with no fringe wetlands facing northwest.

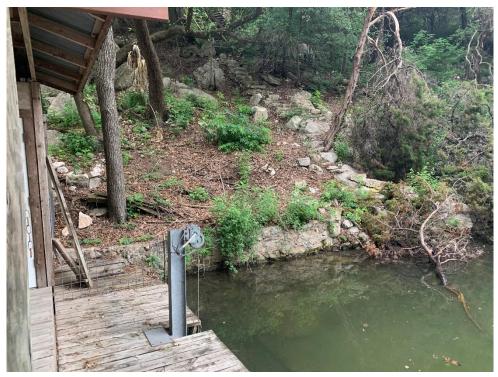
Photo 8: View of eastern shoreline from boat dock with no fringe wetlands facing east.
