## MEMORANDUM

**SUBJECT:** Slope Failure Lower Shoal Creek

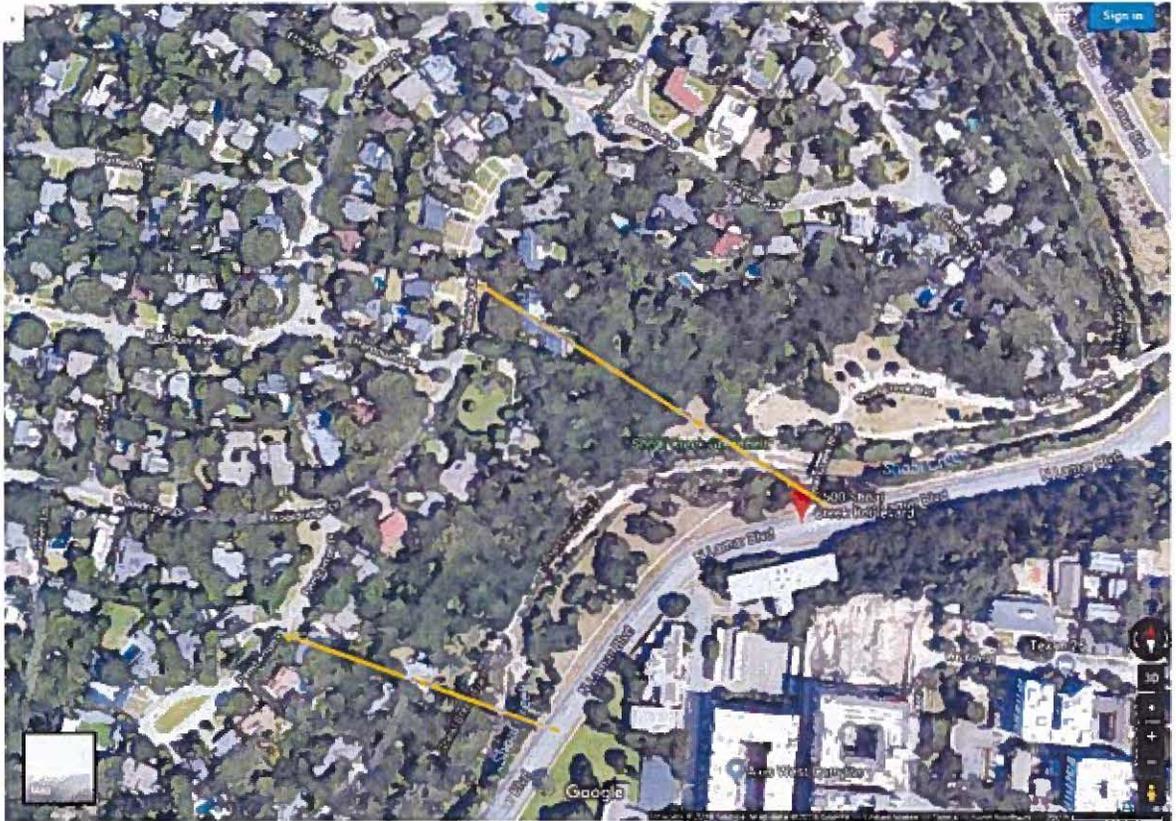
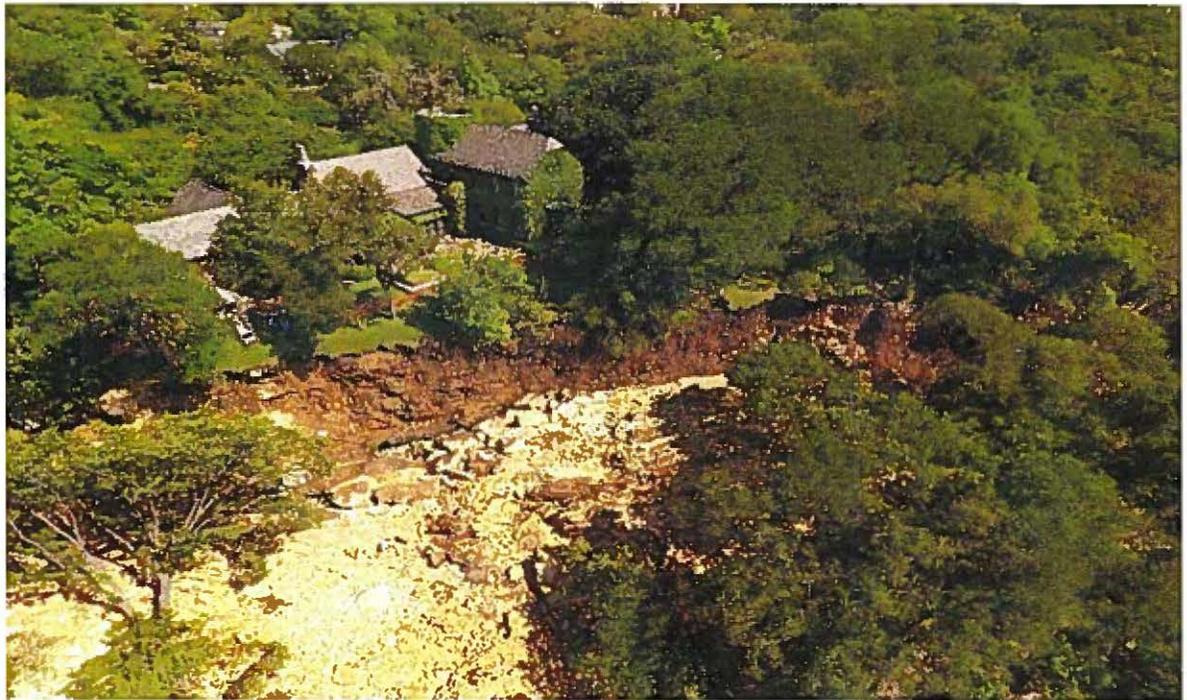
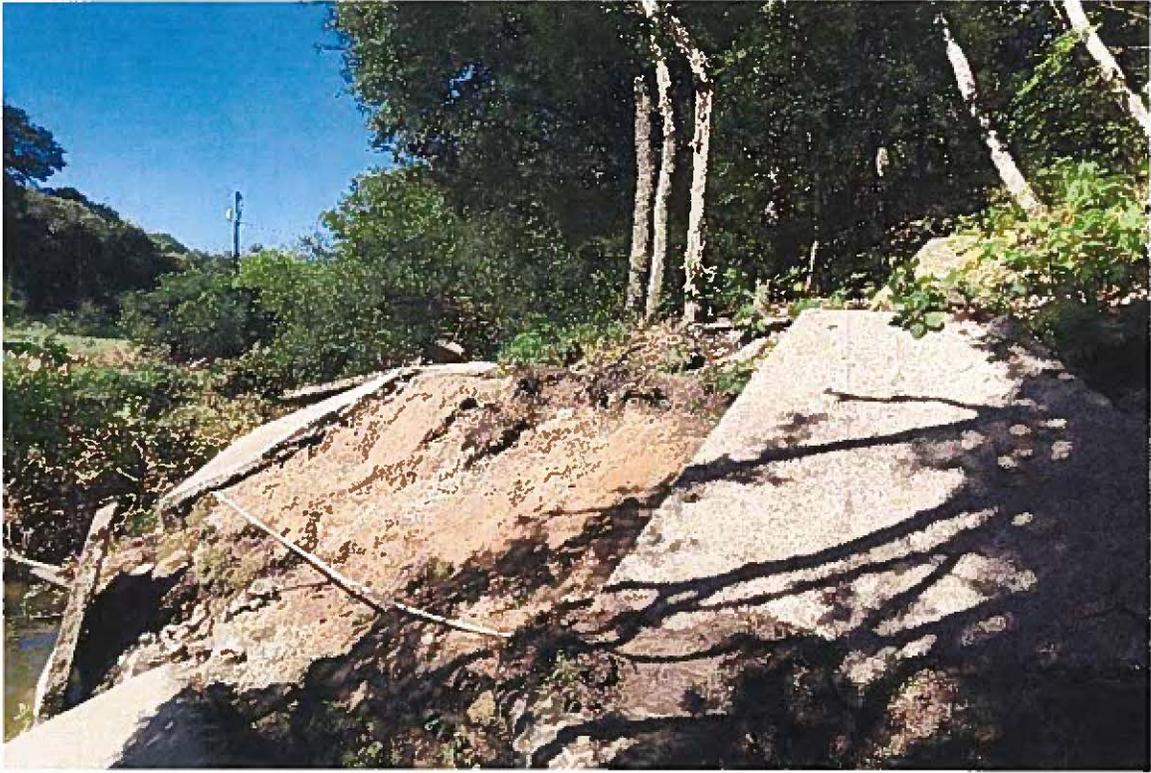
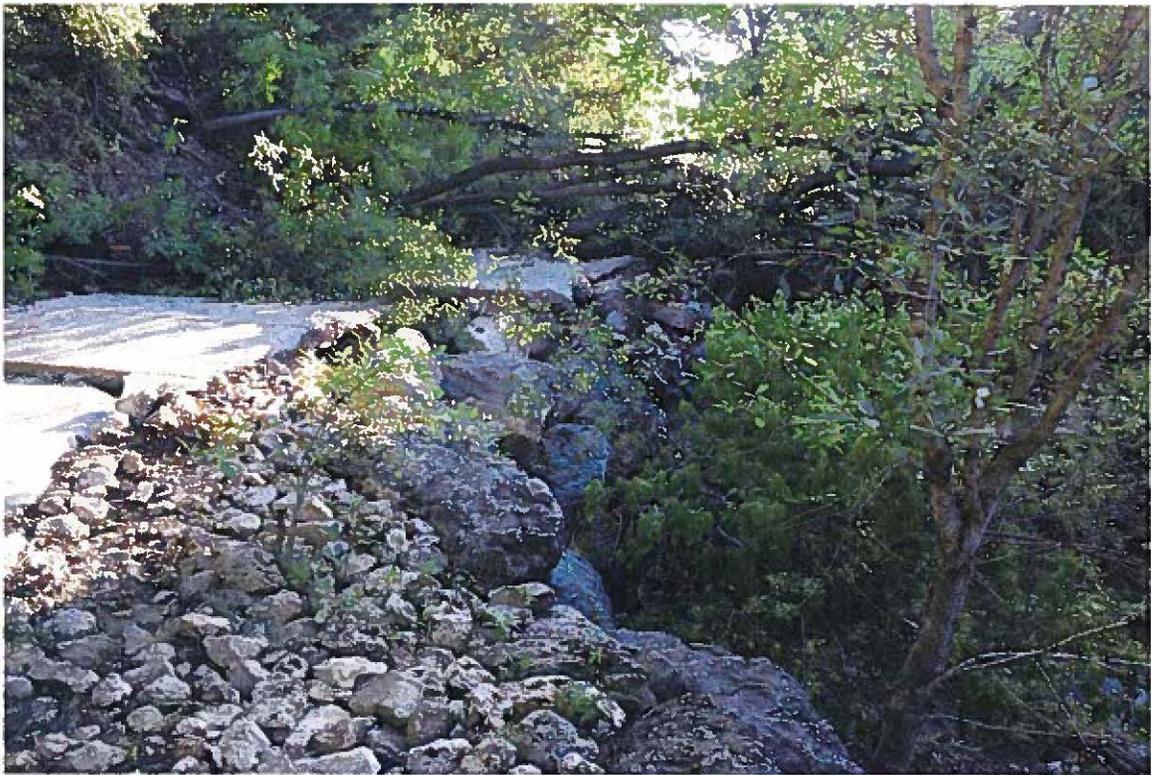
On Friday, May 4, 2018, following the severe weather that moved through the Austin area, a slope failure occurred on the west bluff overlooking Shoal Creek adjacent to the 2500 block of North Lamar Blvd. There were no injuries to persons or pets along the hike and bike trail. The trail was immediately cordoned off from 24th Street to Shoal Creek Boulevard. There have been no reports of injury from private homeowners atop the bluff in the 2400 block of Wooldridge Drive, although the backyards of several homes overlooking the bluff were visibly impacted. City of Austin parkland and approximately 300 feet of the hike and bike trail along Shoal Creek were damaged by this slope failure. A boulder wall, constructed by the Watershed Protection Department (WPD) in 1999 to stabilize the channel bank, was also severely damaged. Of immediate concern is the large quantity of soil, rock and debris in the creek channel from the slope failure. This could pose a problem with conveyance of flood flows within the creek.

There appears to be a history of slope failures in this area, with the most recent having occurred in 1998. The bluff above Shoal Creek is comprised of Buda Limestone overlying an unstable Del Rio Clay formation. Fractures can develop in the limestone and large masses slide off, riding on top of the clay. The fracturing is the result of movement in the clay beneath the limestone. Similar historical failures have been noted by geologists along the bluff just north of last Friday's slope failure. While the specific cause of this slope failure is unknown at this point, the heavy rains that occurred prior to the failure may have played a role. Mass movement of soil like this is typically a combination of geology, water and topography (steep slopes). Please note that the hike and bike trail improvements were very likely not a contributing factor in the cause of this massive slope failure, but were impacted by it. No recent stream stabilization work has occurred in the impacted stream reach.

- As noted, the trail has been closed and PARC is considering options to reroute pedestrian and bike traffic;
- AW is conducting a TV inspection of the wastewater line to determine if there has been structural damage;

- WPD is conducting aerial video reconnaissance of the site to better assess the extent of the slope failure;
- WPD engineers will obtain new survey data and perform modeling to determine the degree to which the flood conveyance capacity of the creek channel has been impacted;

- WPD engineers and field operations personnel are assessing measures that might be employed to mitigate obstruction of flood flows (e.g., removal of materials from the channel and vegetation from the floodplain) and provide temporary stabilization;

- The WPD Safety Office is assessing potential work hazards and will develop a safety plan prior to any work commencing at the site;
- A forensic geotechnical analysis will be conducted to determine cause and extent of slope failure and likelihood of further soil movement; and
