Barton Springs Pool

General Grounds Improvements

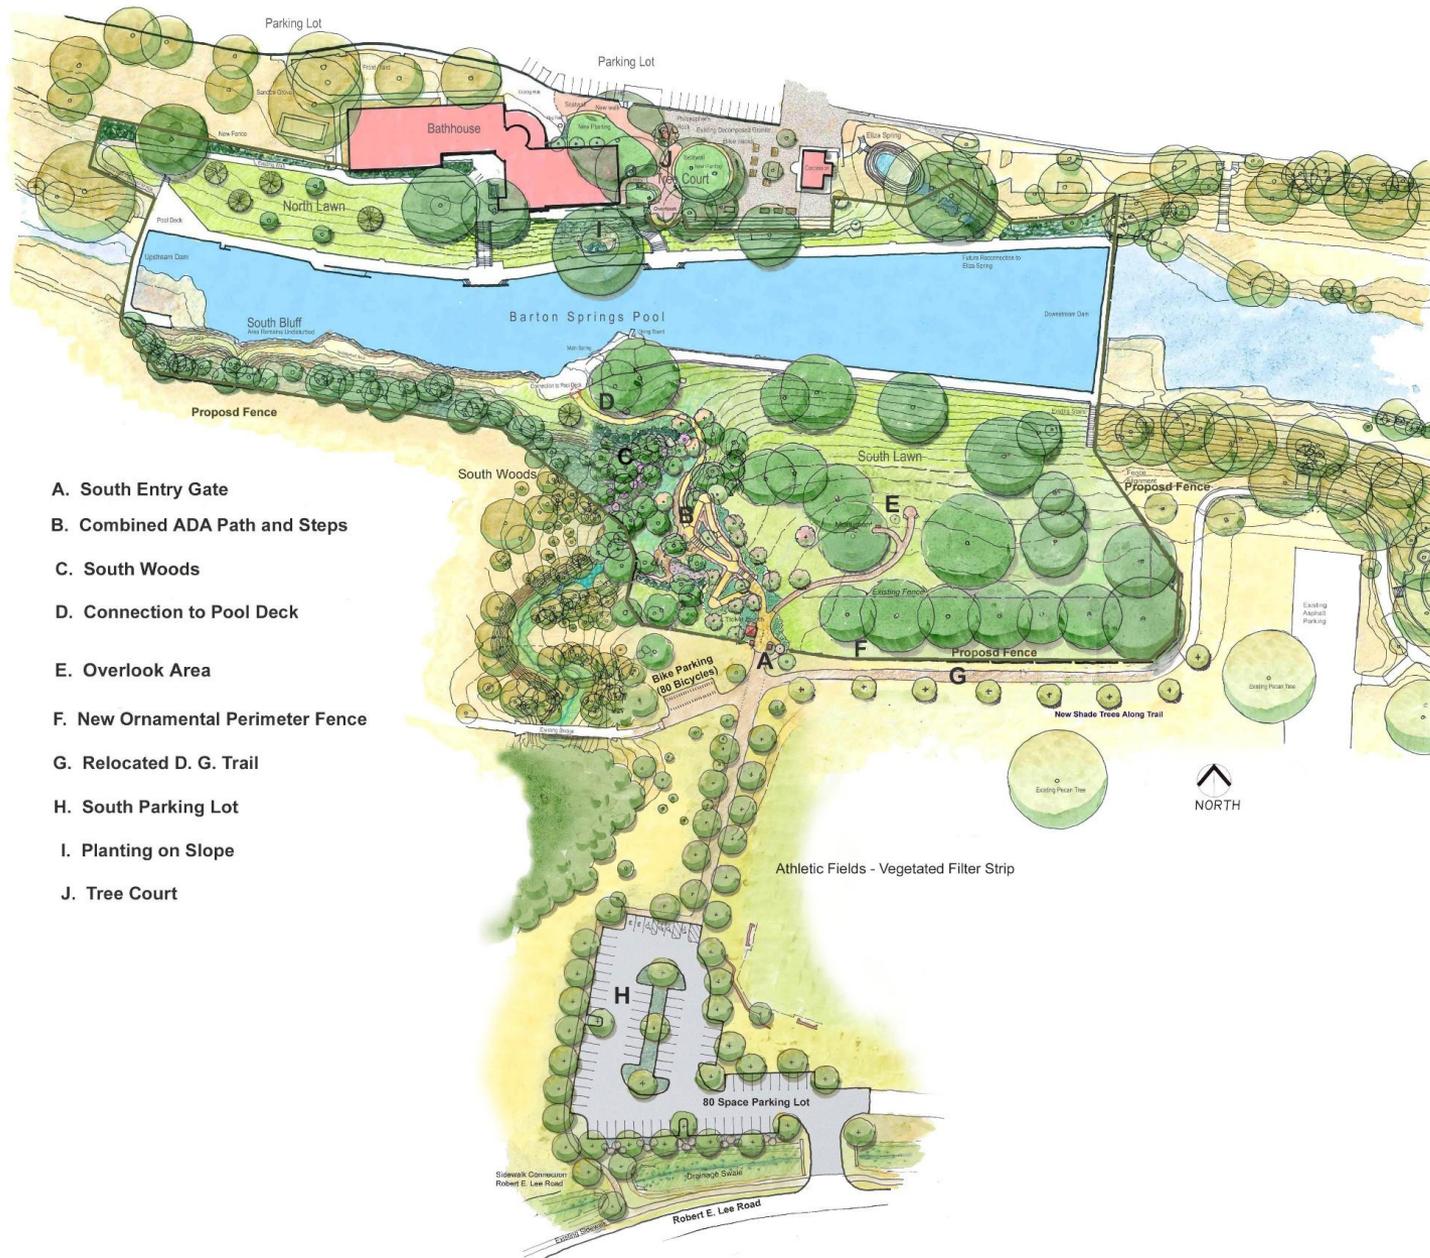
- A. South Entry Gate
- B. Combined ADA Path and Steps
- C. South Woods
- D. Connection to Pool Deck
- E. Overlook Area
- F. New Ornamental Perimeter Fence
- G. Relocated D. G. Trail
- H. South Parking Lot
- I. Planting on Slope
- J. Tree Court

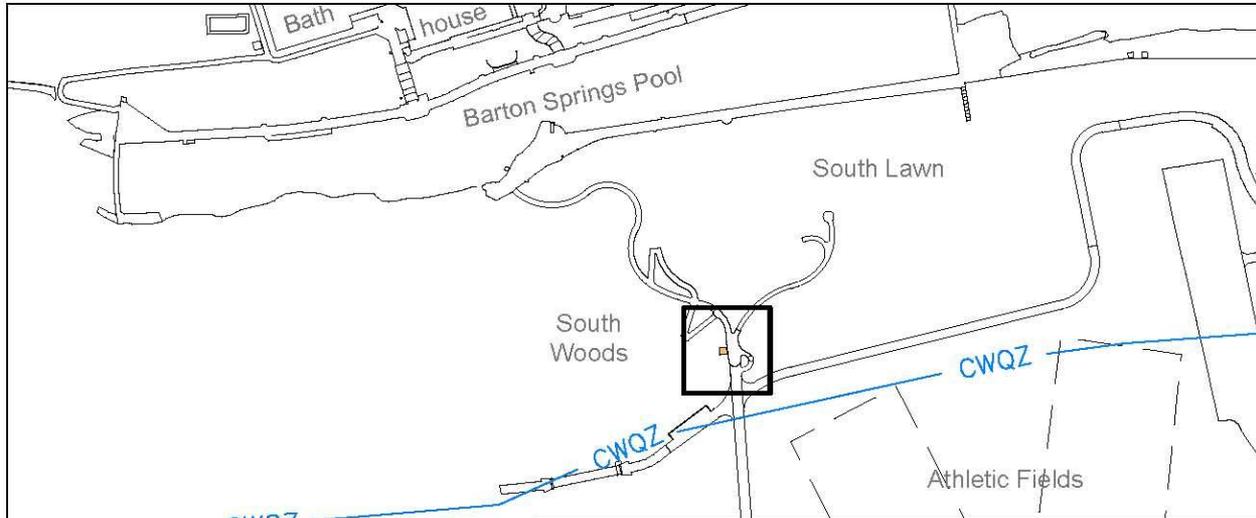
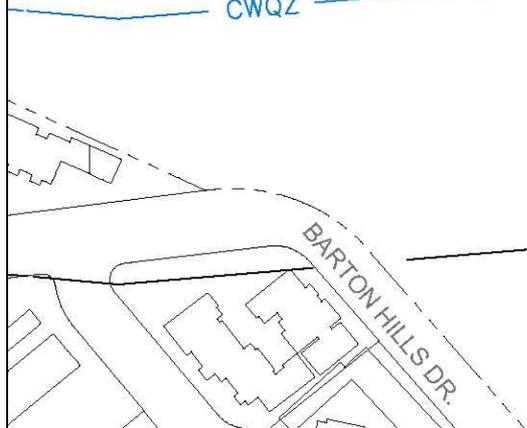
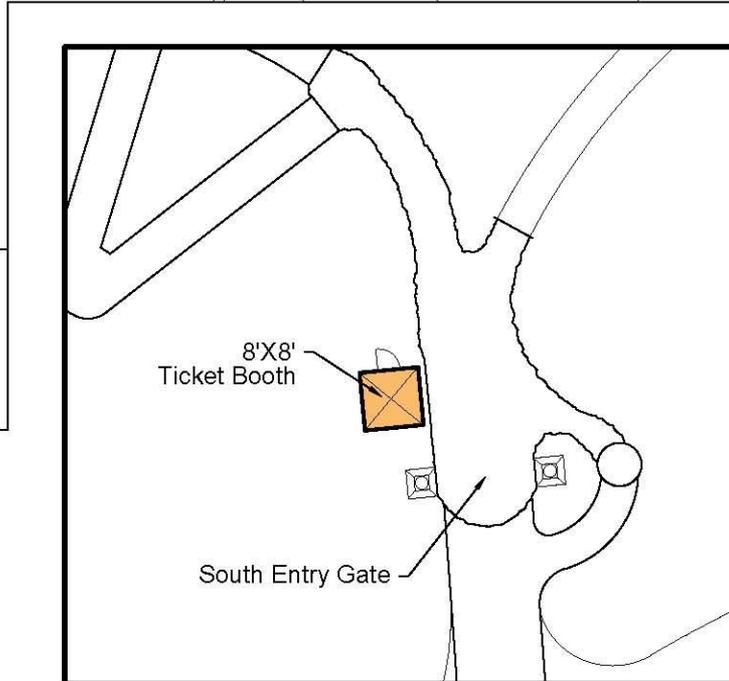
EXHIBIT C - South Gate Ticket Booth

Ticket booth requiring amendment & variance

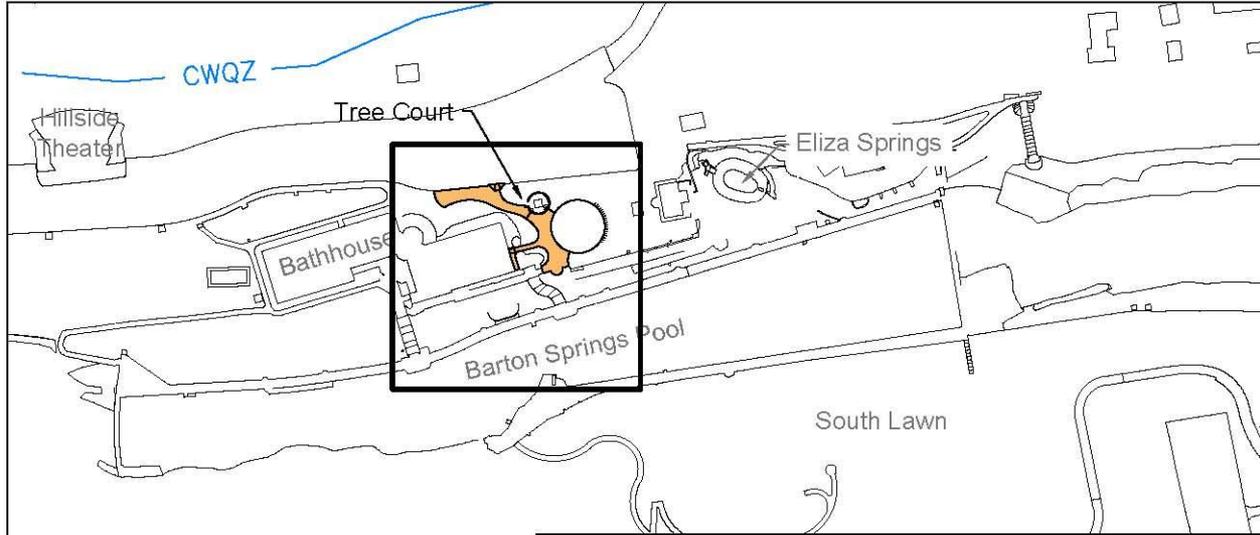
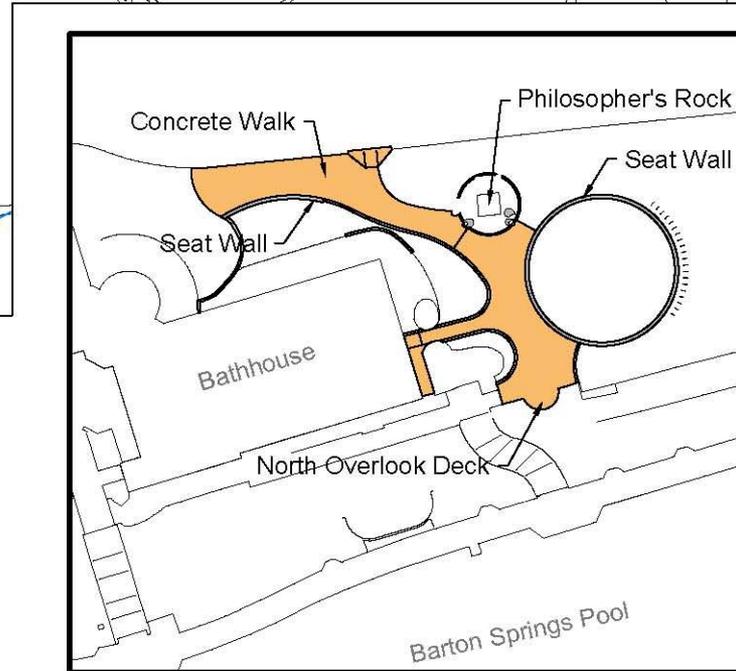
EXHIBIT D - Tree Court Improvements

Elevated concrete walkway requiring amendment & variance

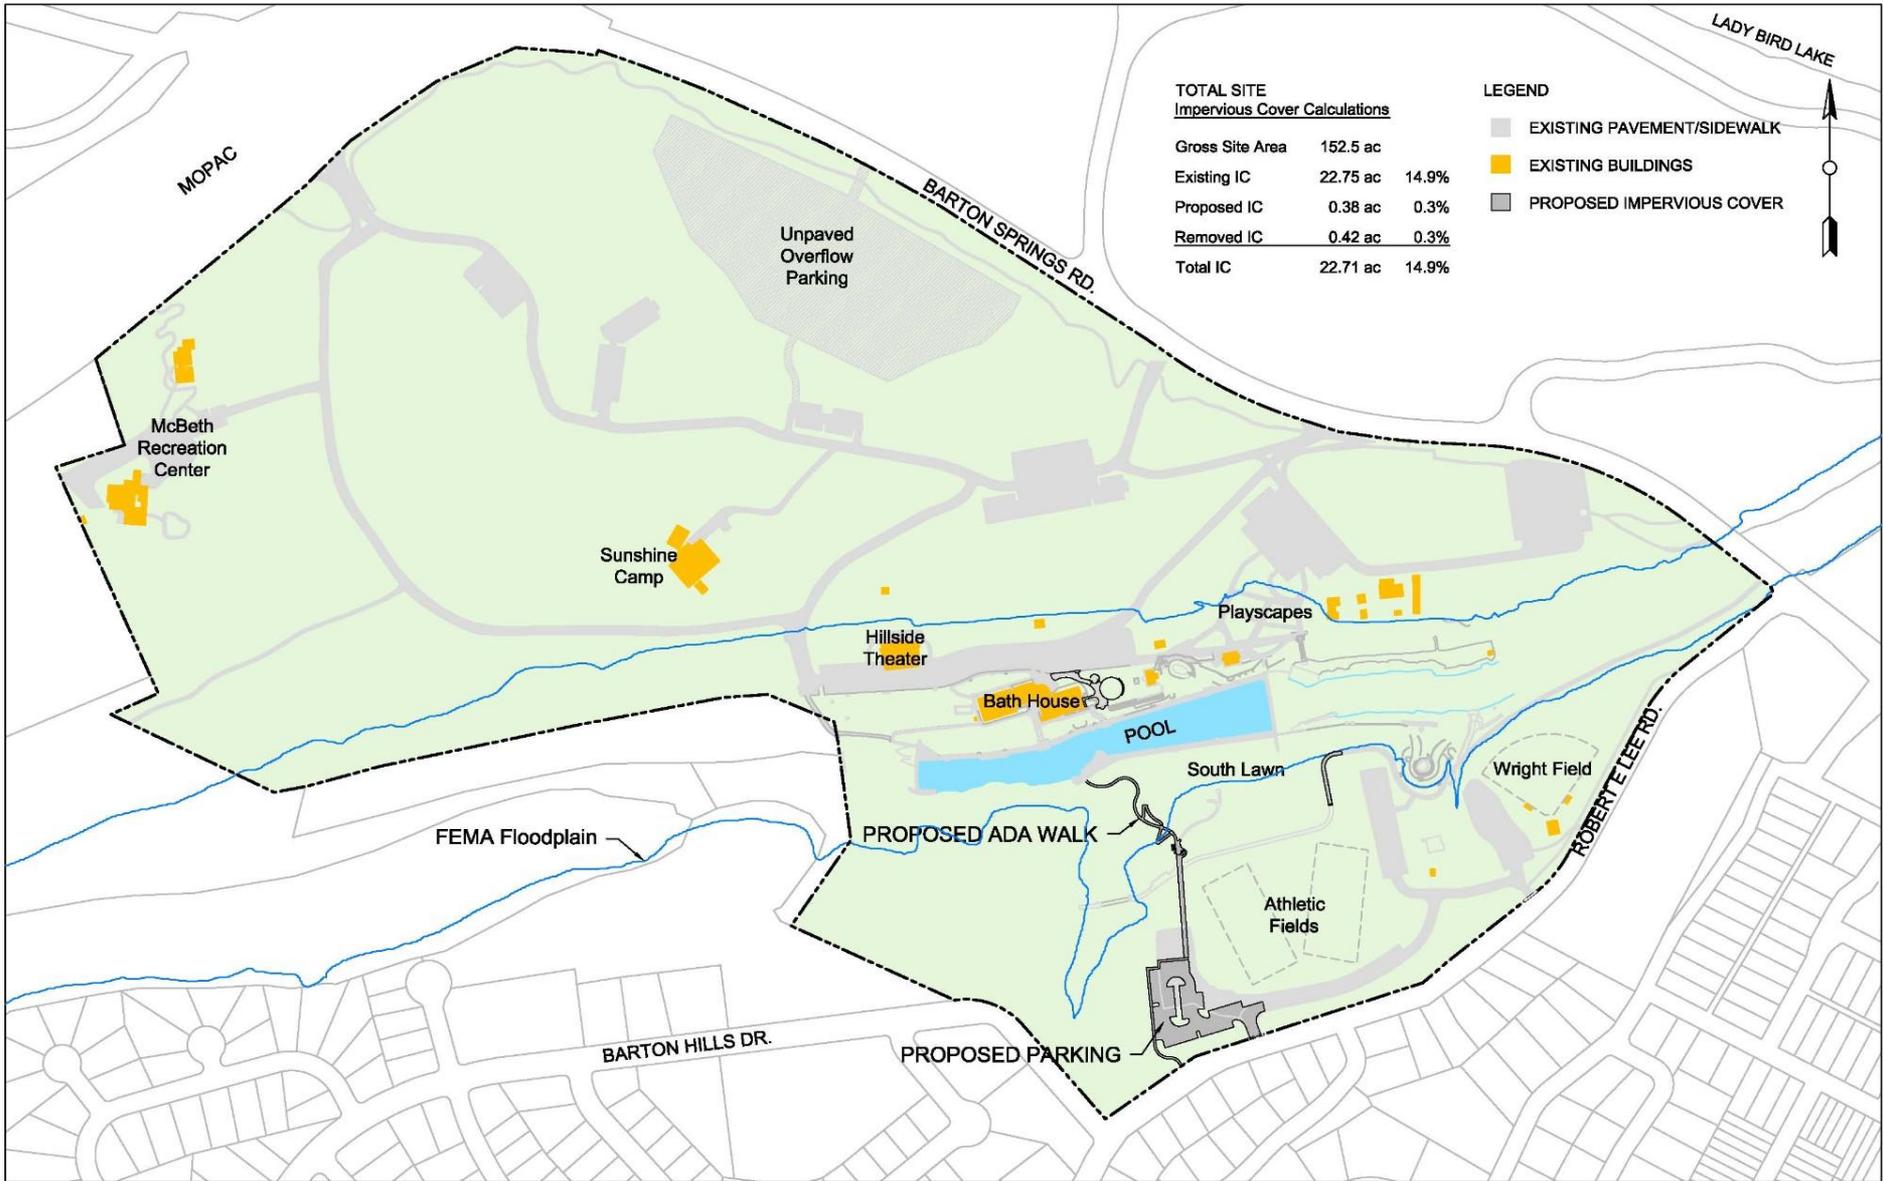
**TOTAL SITE
Impervious Cover Calculations**

Gross Site Area	152.5 ac	
Existing IC	22.75 ac	14.9%
Proposed IC	0.38 ac	0.3%
Removed IC	0.42 ac	0.3%
Total IC	22.71 ac	14.9%

- EXISTING PAVEMENT/SIDEWALK
- EXISTING BUILDINGS
- PROPOSED IMPERVIOUS COVER

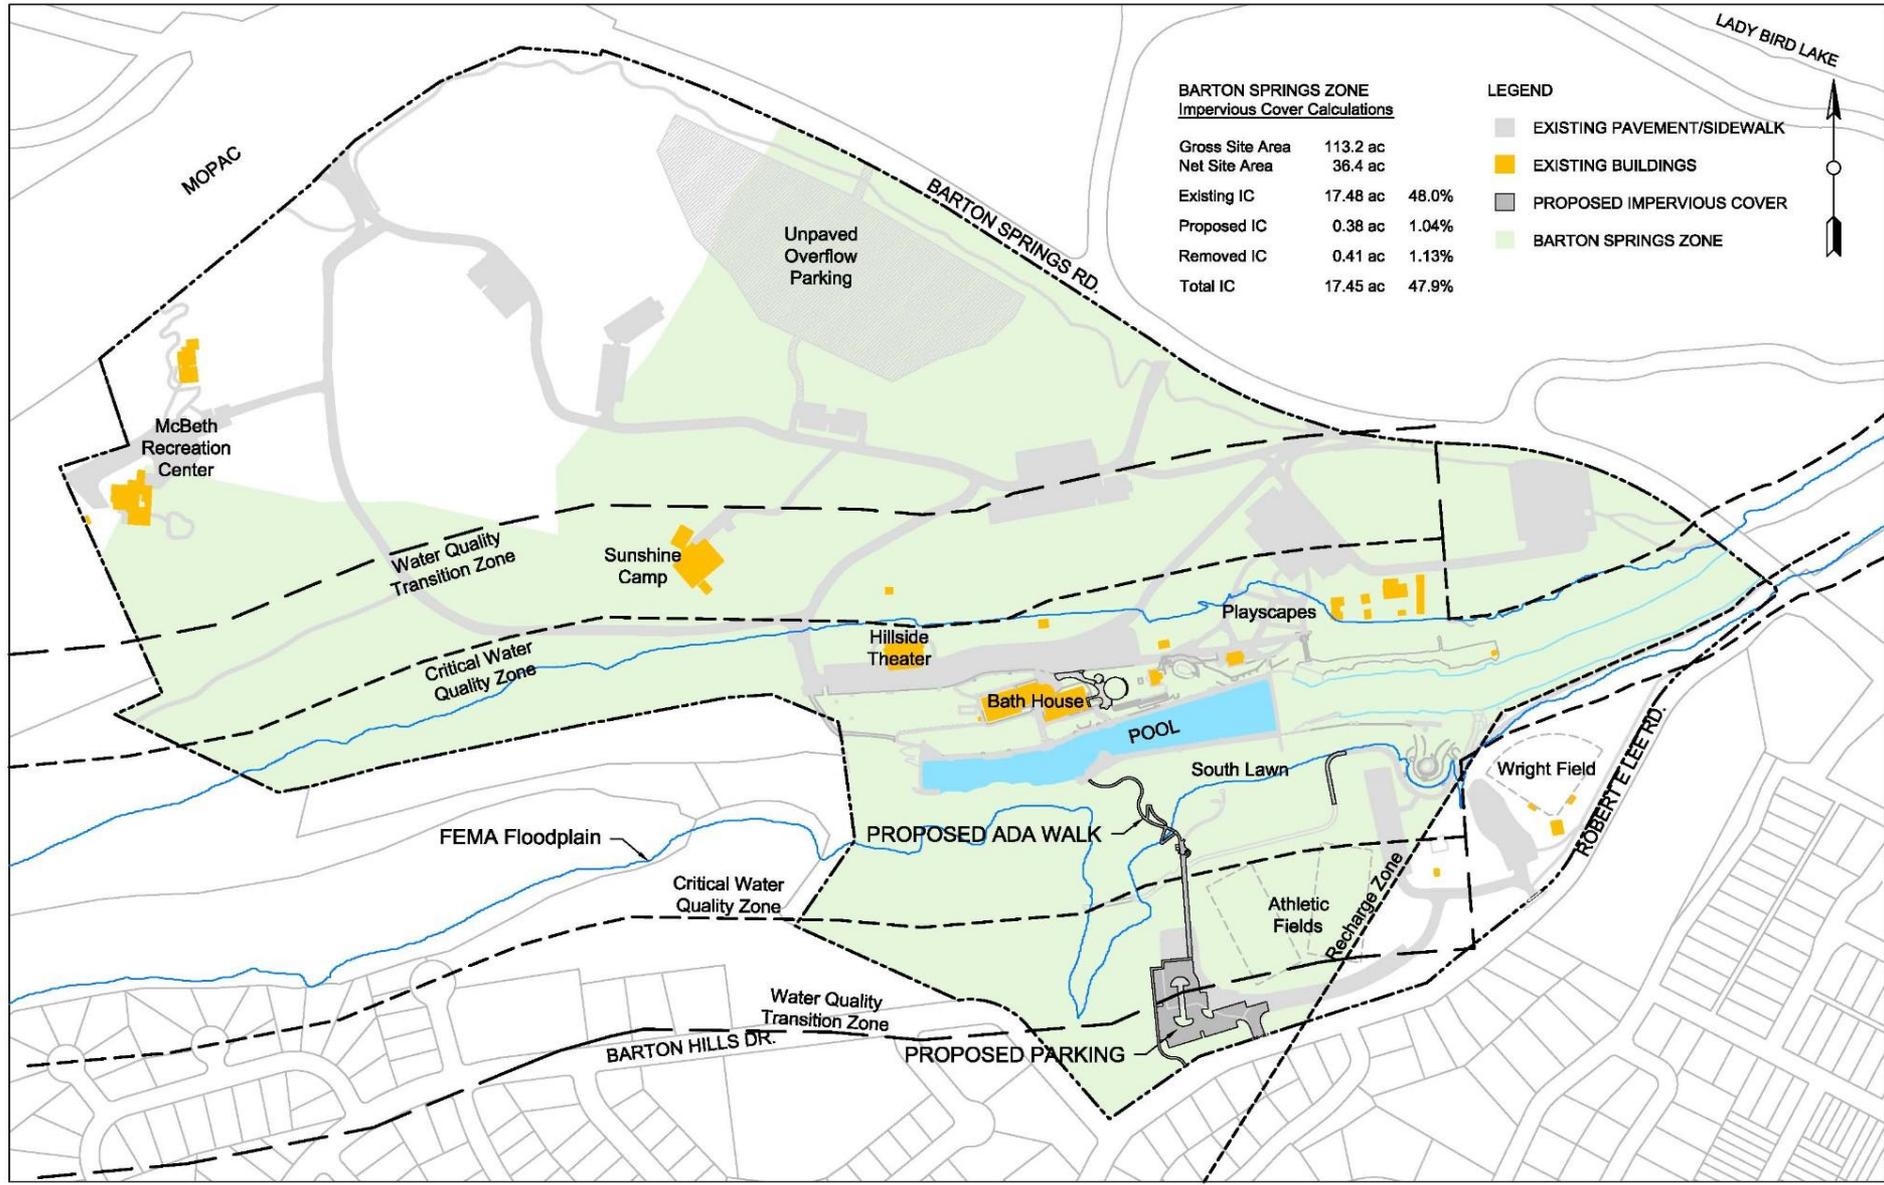
BARTON SPRINGS ZONE
Impervious Cover Calculations

Gross Site Area	113.2 ac	
Net Site Area	36.4 ac	
Existing IC	17.48 ac	48.0%
Proposed IC	0.38 ac	1.04%
Removed IC	0.41 ac	1.13%
Total IC	17.45 ac	47.9%

- EXISTING PAVEMENT/SIDEWALK
- EXISTING BUILDINGS
- PROPOSED IMPERVIOUS COVER
- BARTON SPRINGS ZONE

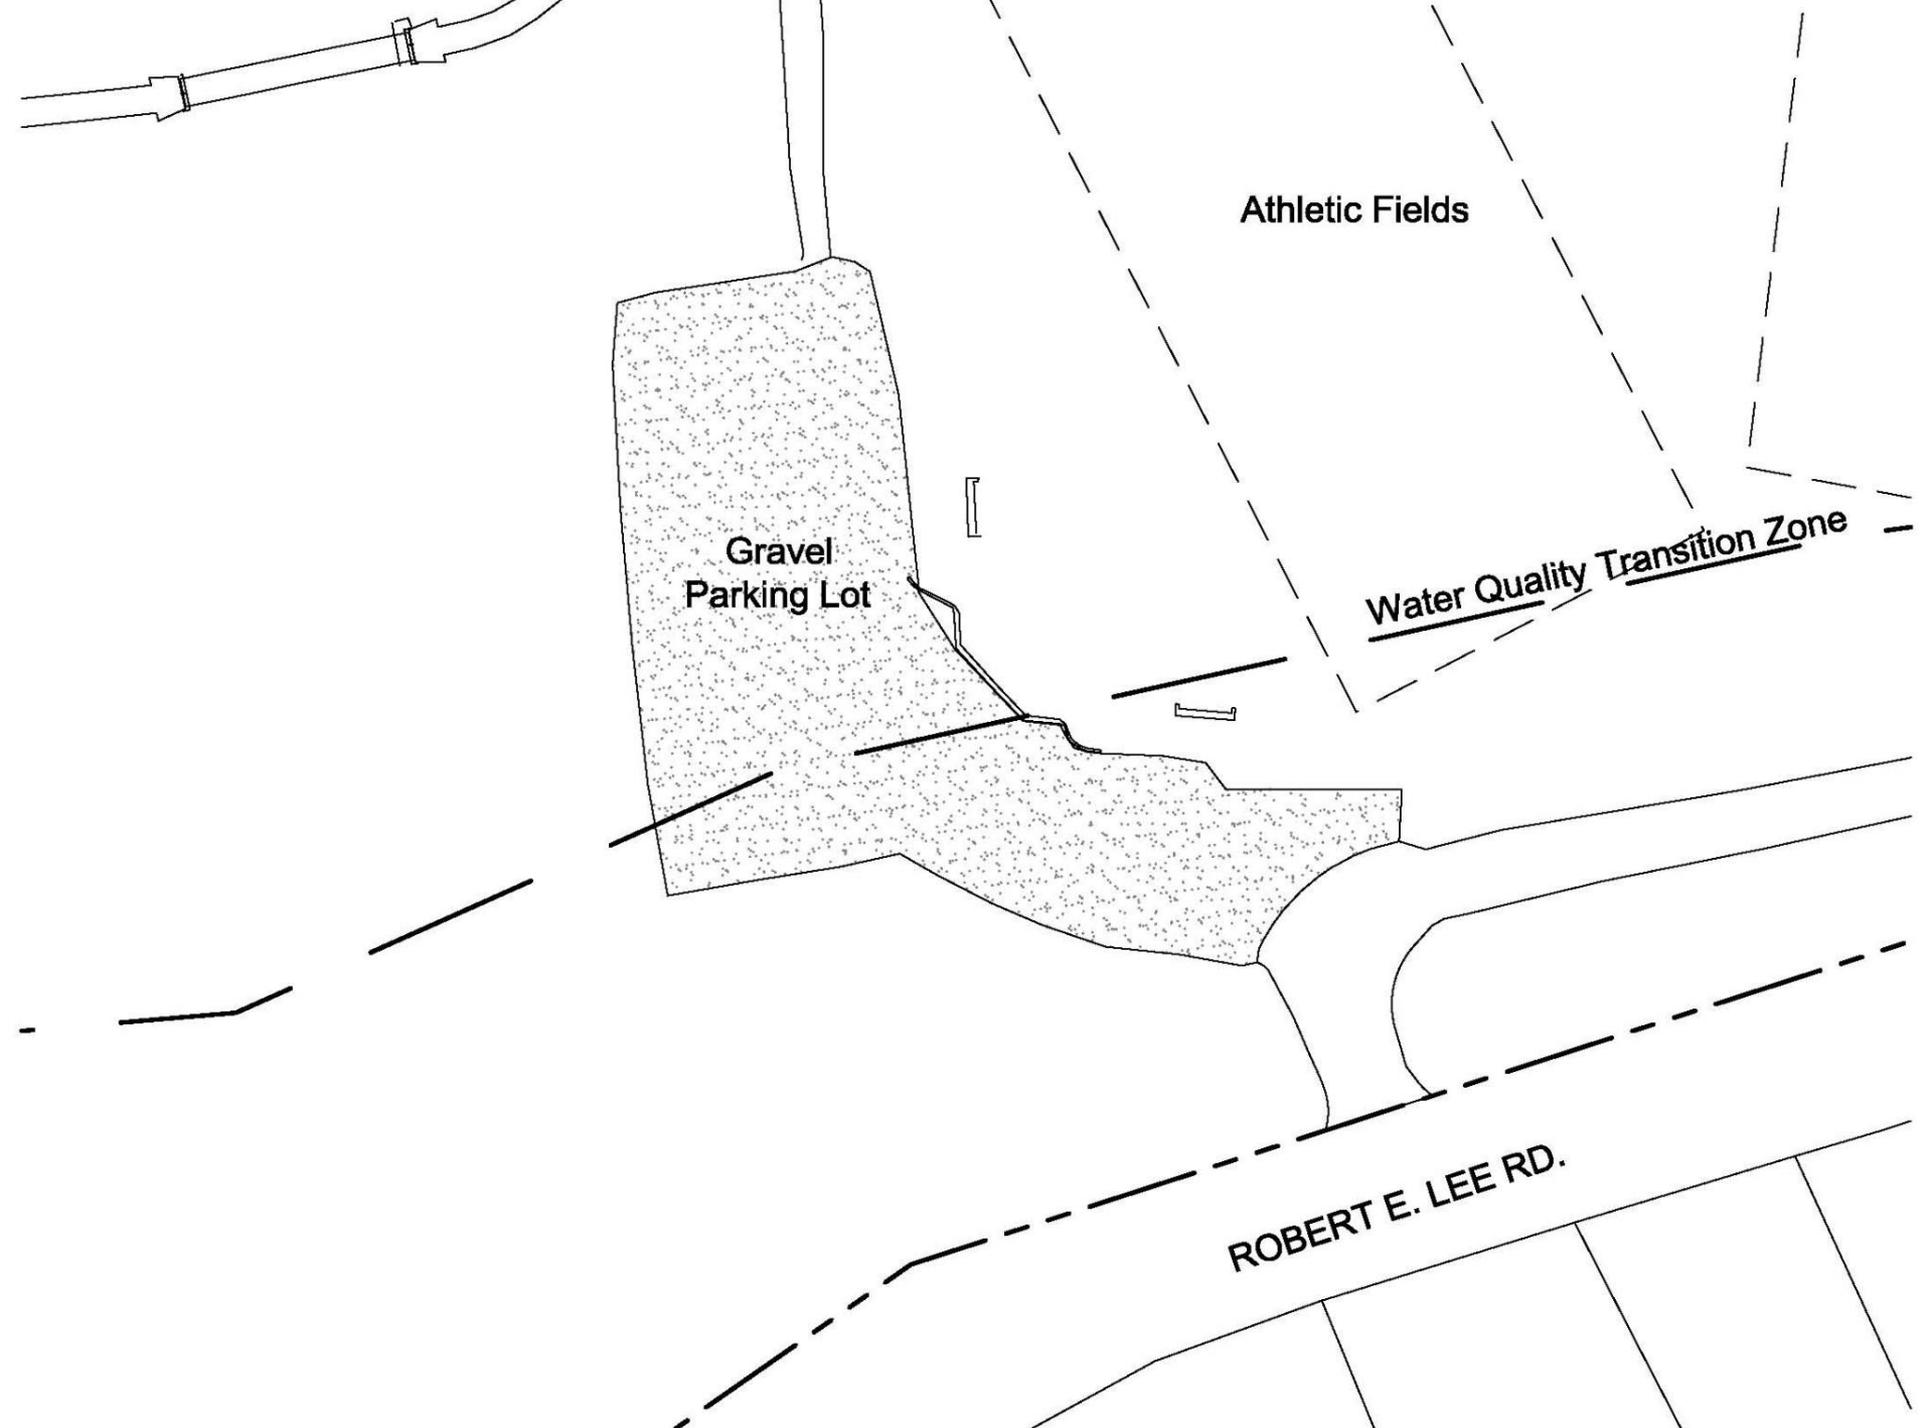
Gravel
Parking Lot

Water Quality Transition Zone

- Existing gravel parking lot does not meet current code
- Stormwater runoff and dust issues
- Multiple options considered as part of stakeholder process
- 124 space parking lot selected by the Joint Parks/Environmental Board Committee

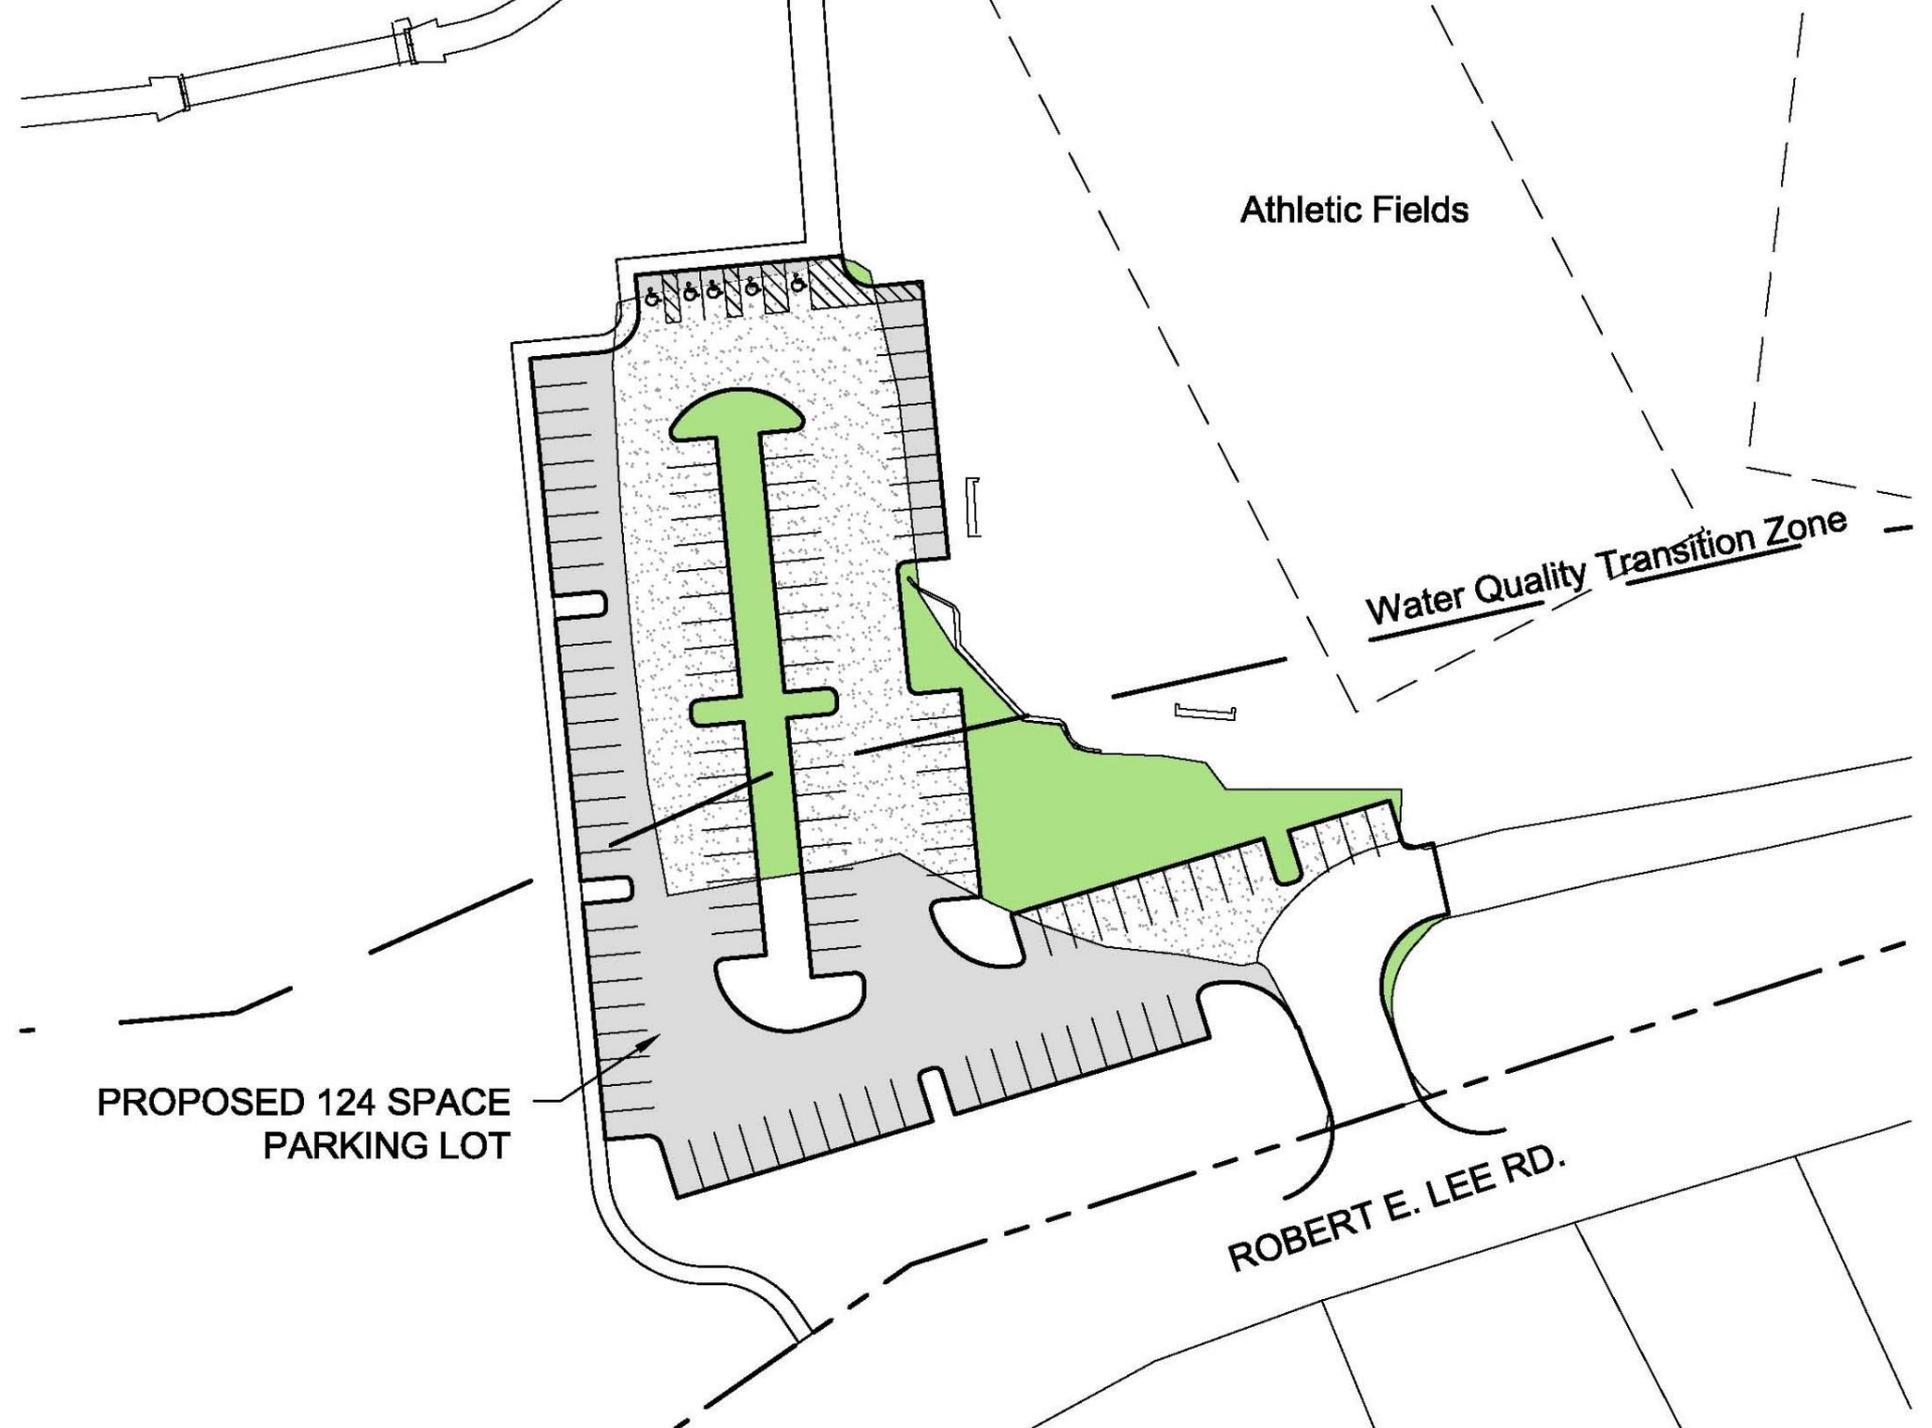
PROPOSED 124 SPACE
PARKING LOT

PROPOSED 80 SPACE
PARKING LOT

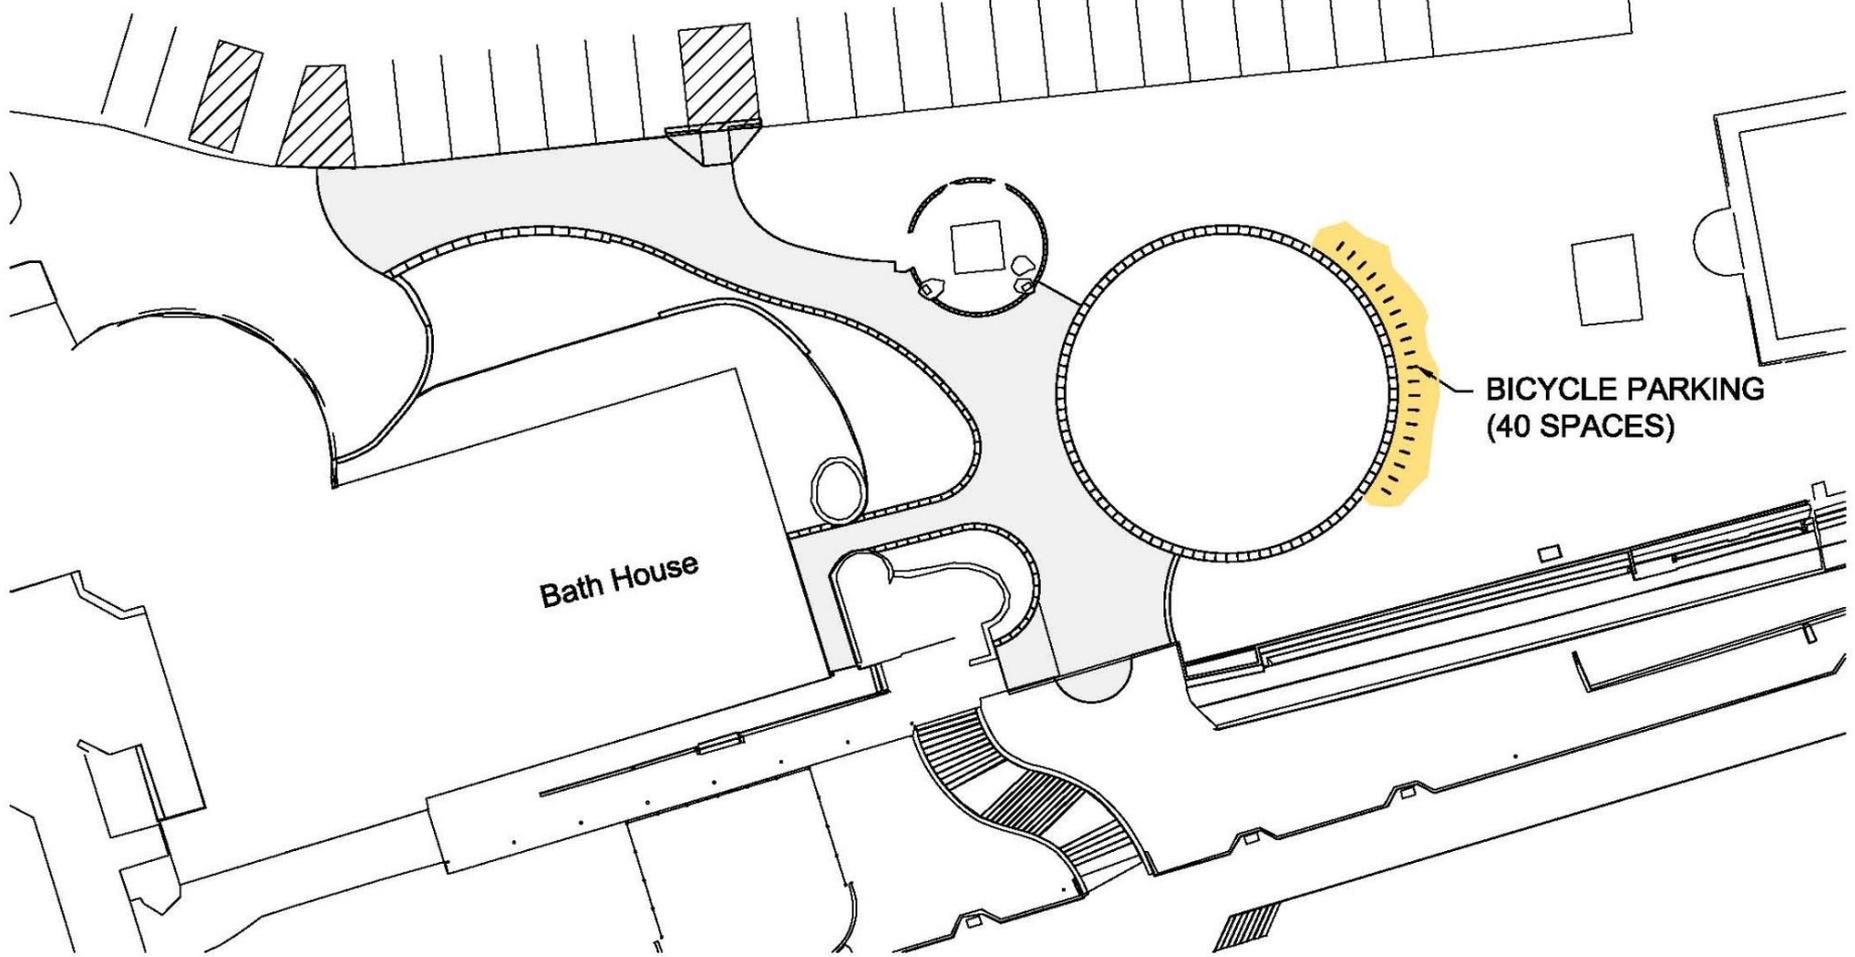
BICYCLE PARKING
(40 SPACES)

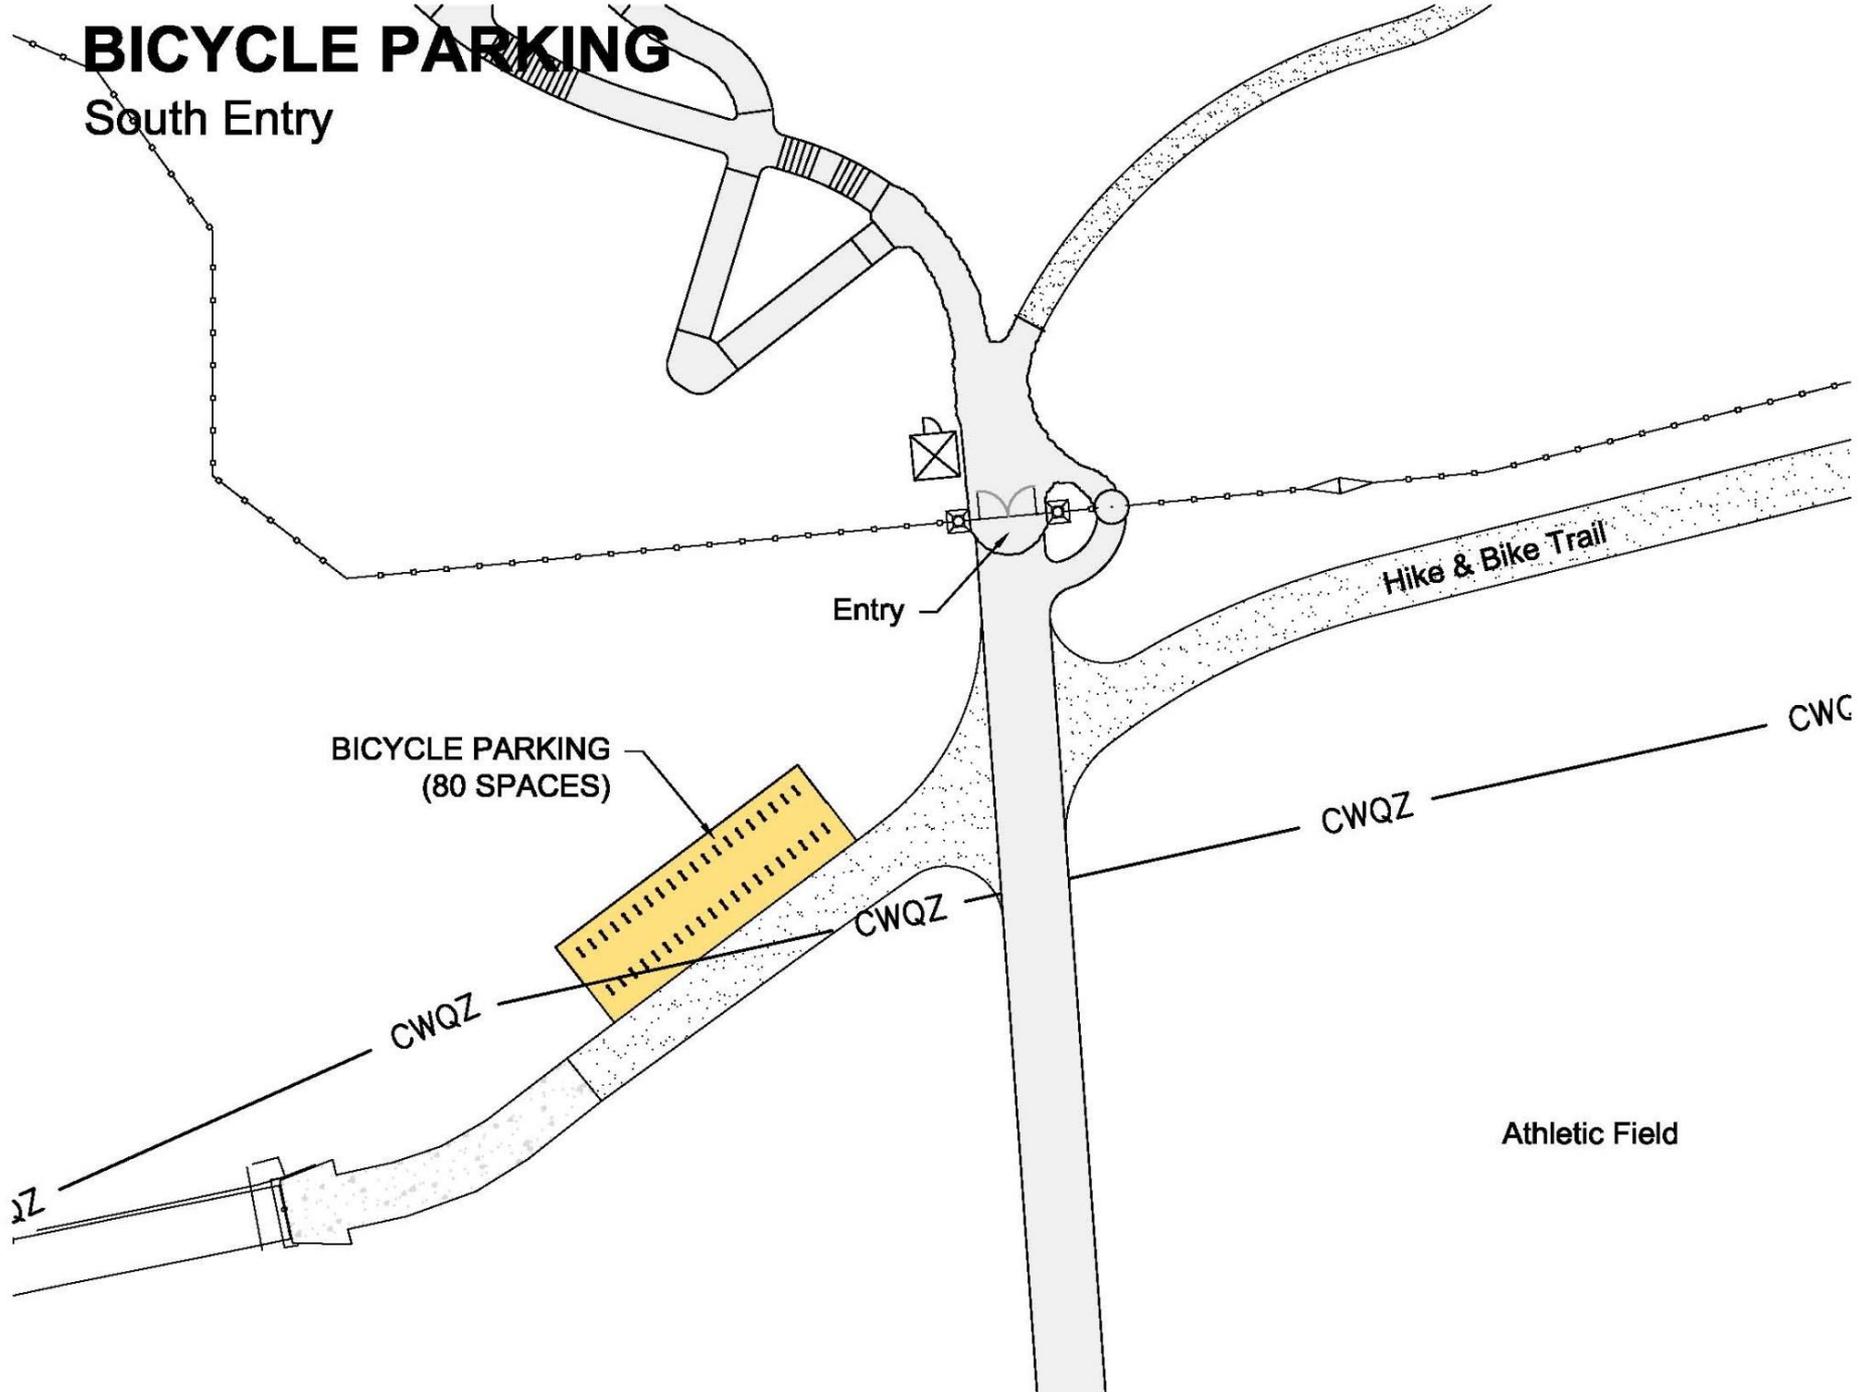
BICYCLE PARKING
(80 SPACES)
