Barton Springs Pool

General Grounds Improvements

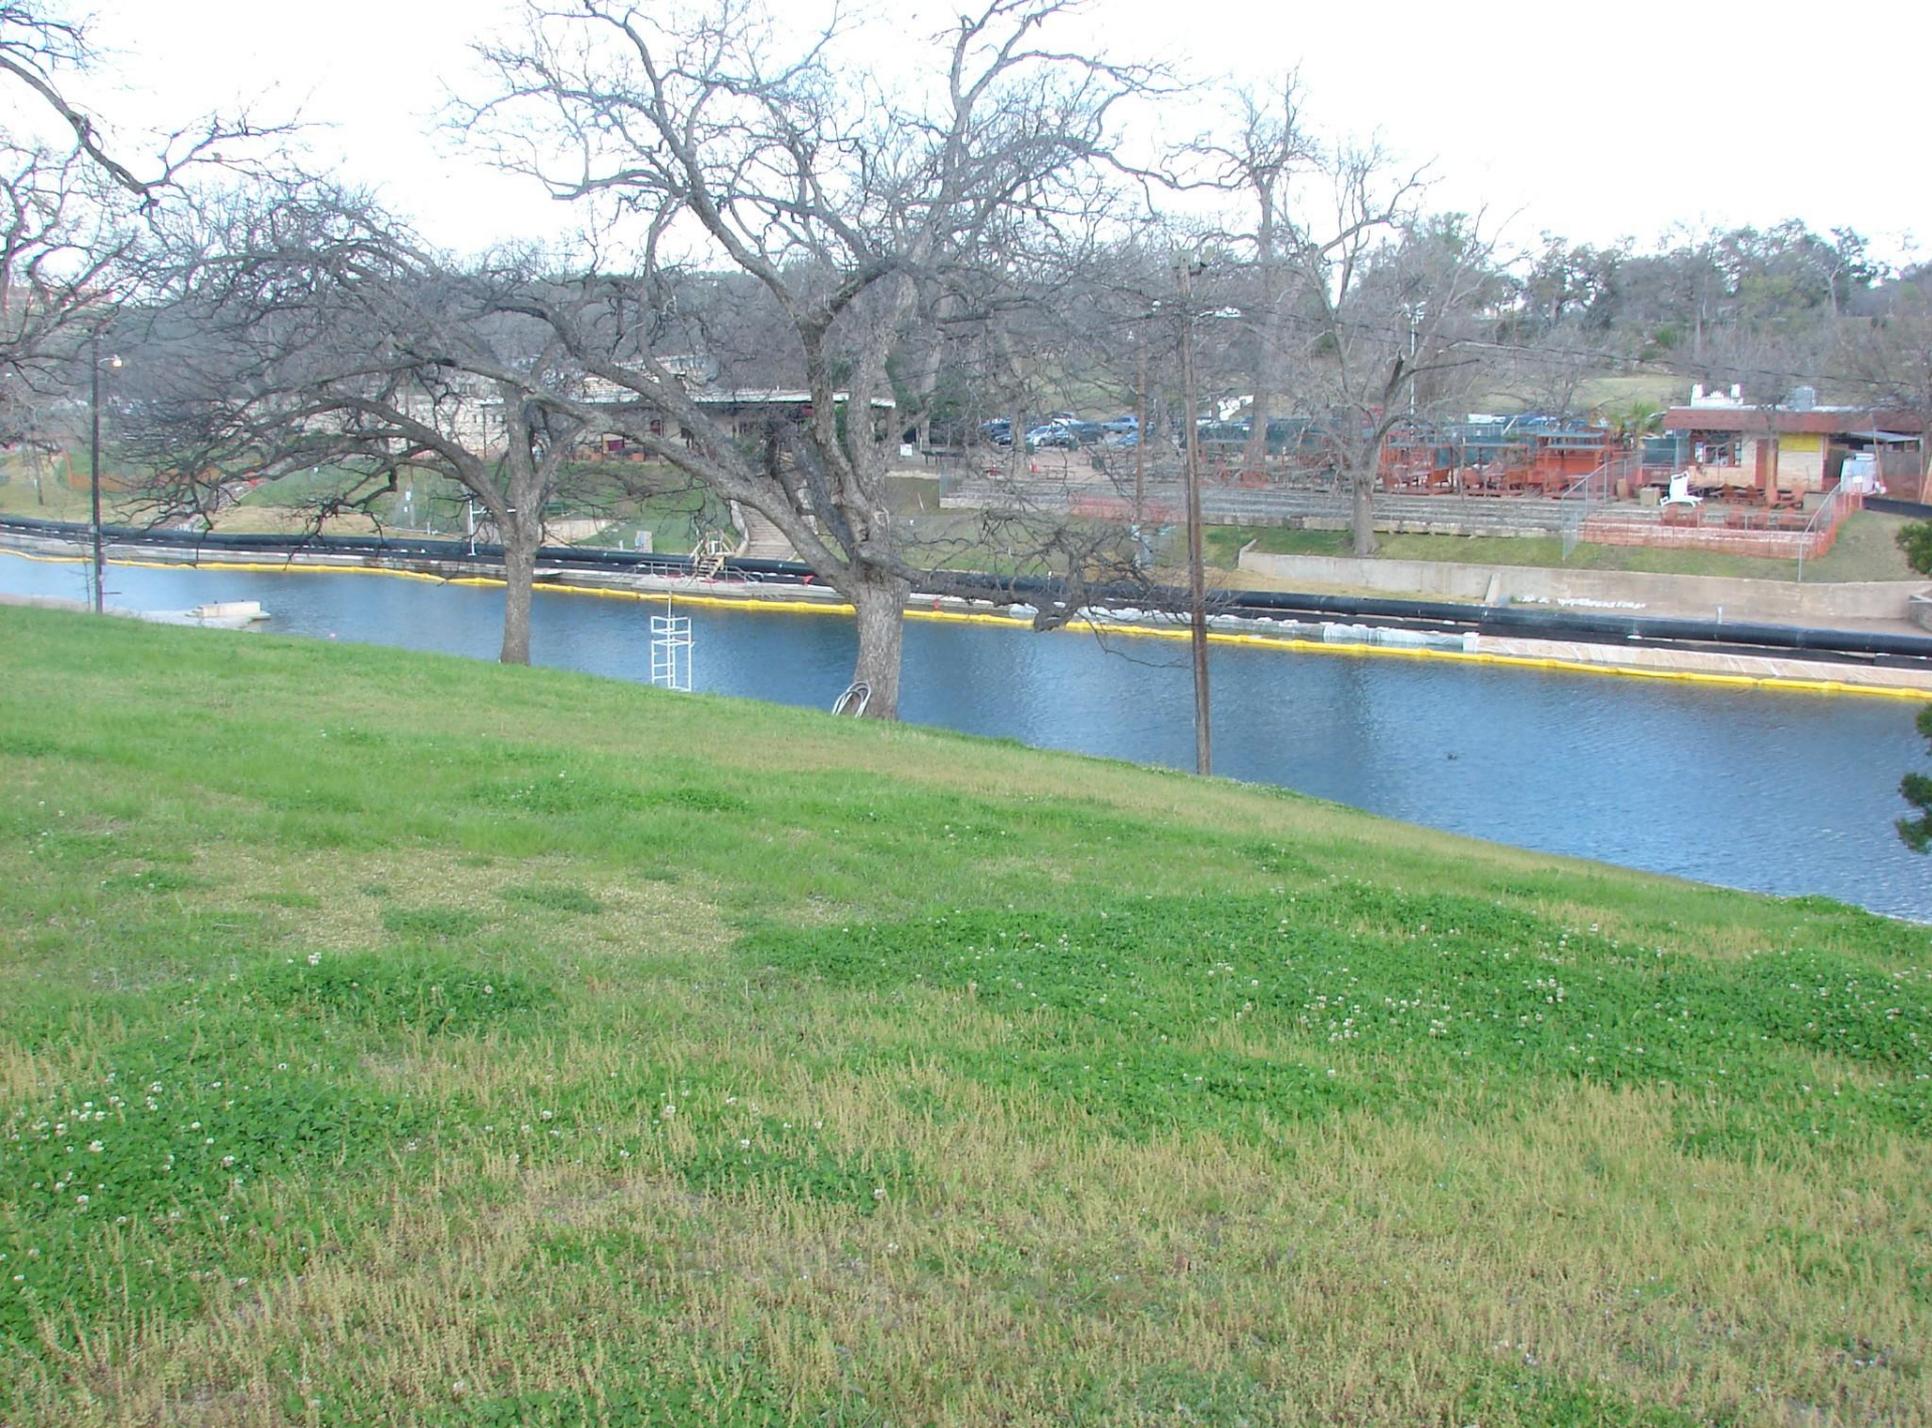
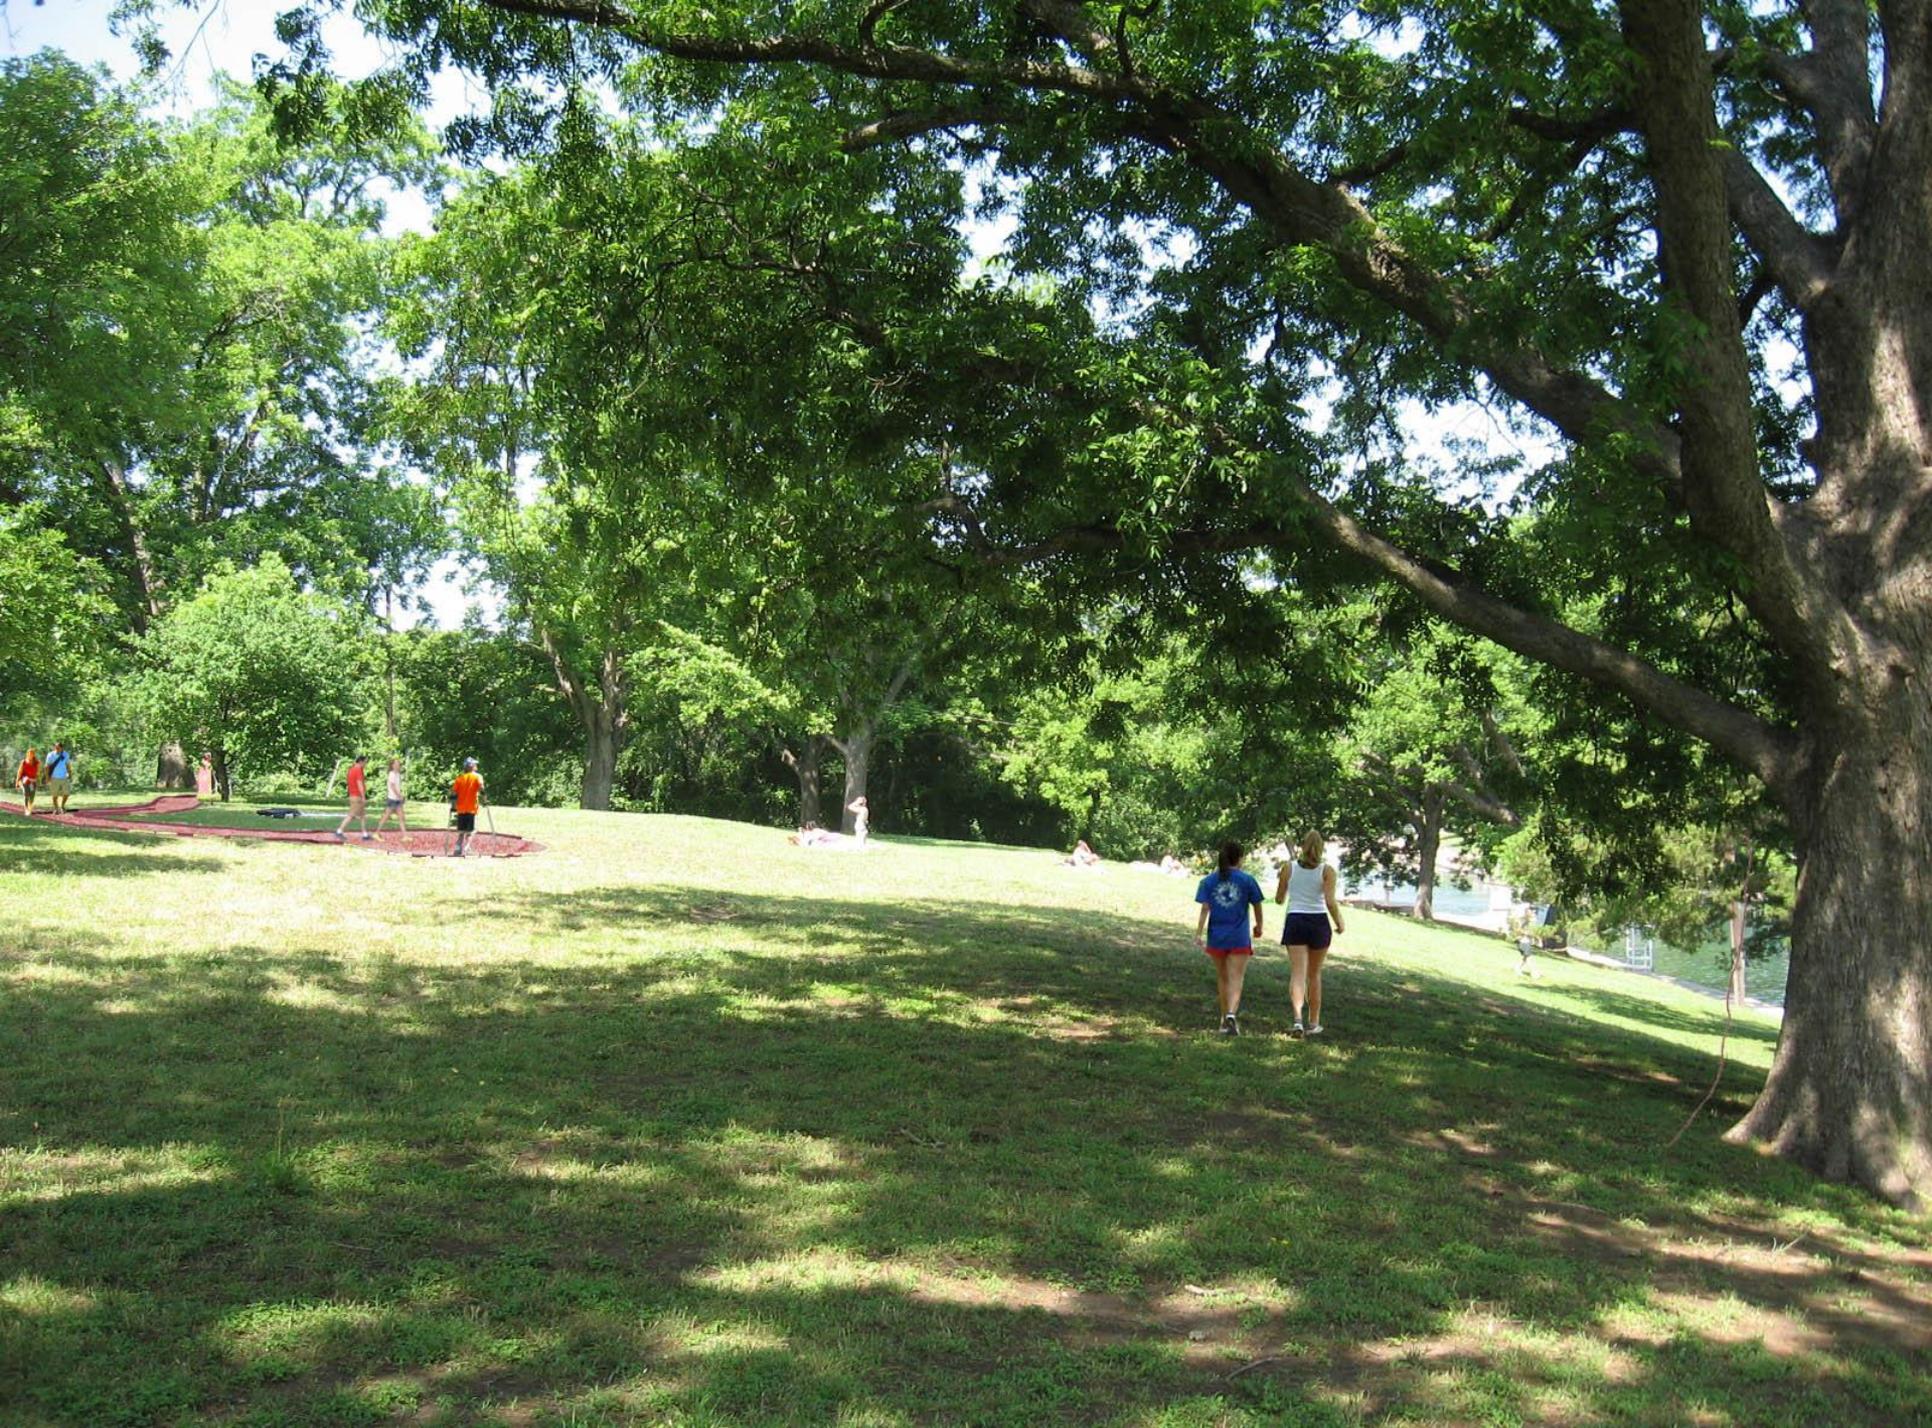
Environmental & Safety Concerns

- Eroded south side trail to pool
- Runoff and dust from gravel parking lot
- Declining health of heritage trees
- Pool cleaning uses chlorinated water
- Safety concerns - fencing, overhead electric, and lighting

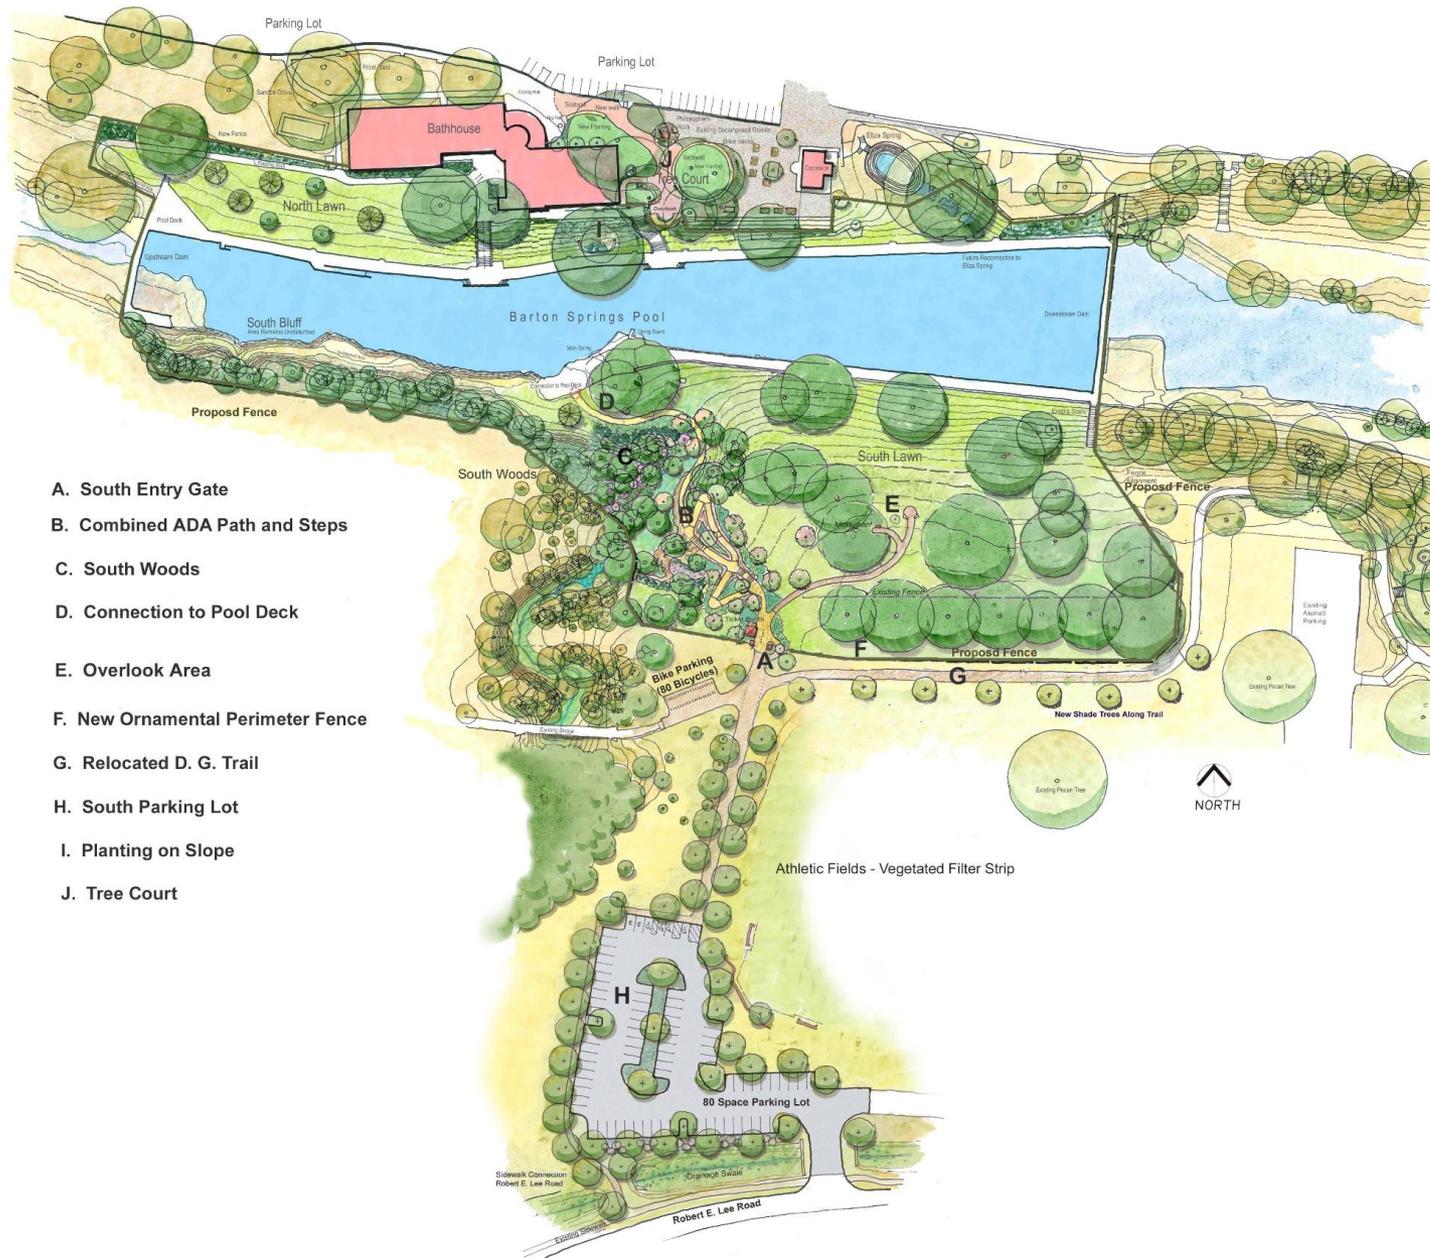
- A. South Entry Gate
- B. Combined ADA Path and Steps
- C. South Woods
- D. Connection to Pool Deck
- E. Overlook Area
- F. New Ornamental Perimeter Fence
- G. Relocated D. G. Trail
- H. South Parking Lot
- I. Planting on Slope
- J. Tree Court
