Elisabet Ney Museum CIP Project

#7551.002 Elisabet Ney Museum Building ADA Accessibility and Landscape Improvements

Project Goals

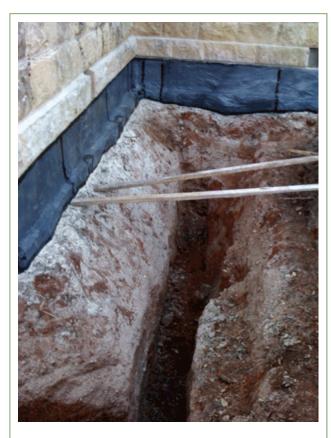
Parge coat applied to foundation footing.

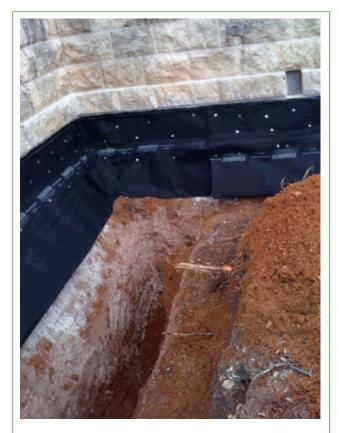
Waterproof membrane installed onto parge coat.

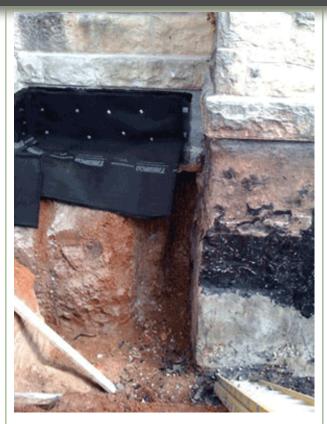
Drainage mat installed to cover waterproofing membrane material.

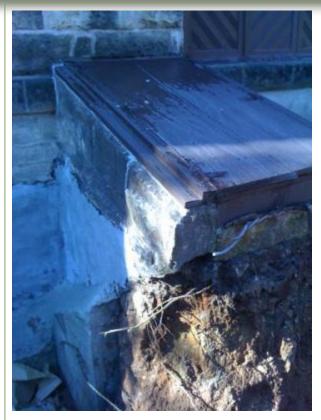
Installation of window wells and drain on north side of studio.

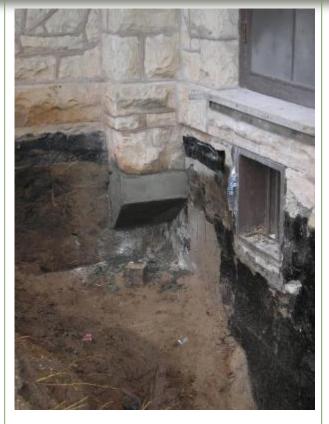
Underpinning of column

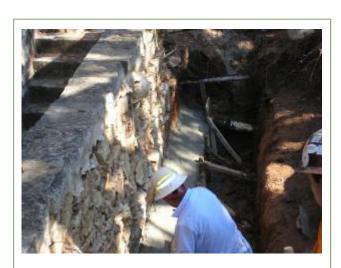
East wall excavated
