# Boat Ramp and Water Access Area

November 2015

**Central Lawn, Swimming and Day Use Area**

**Infrastructure, Utilities and Operations**

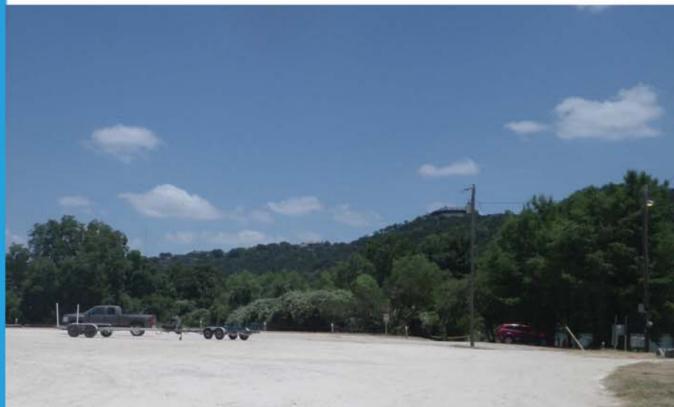
- Parking lot circulation issues include:
- Unpaved parking areas and drive lanes do not allow for striping
  - Parking lot layout could be more efficient with angled parking
  - There is no separation between the driving lane and the backing lane for the ramp

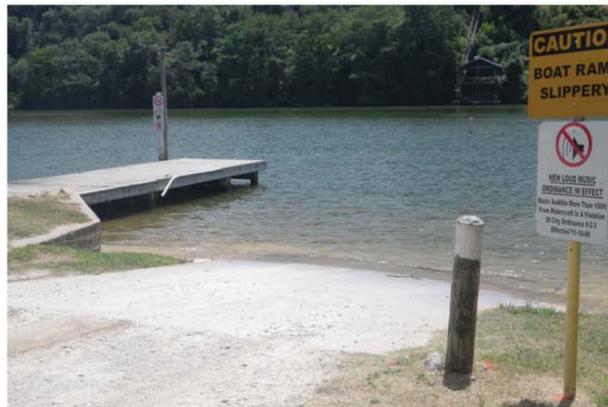
- Single bay ramps are easier to use than multi-bay ramps
- The boat docks need to be repaired or replaced
- There are no buoys separating the ramps from the swimming area
- Commercial vehicles use this area without permission which adds to the maintenance issues

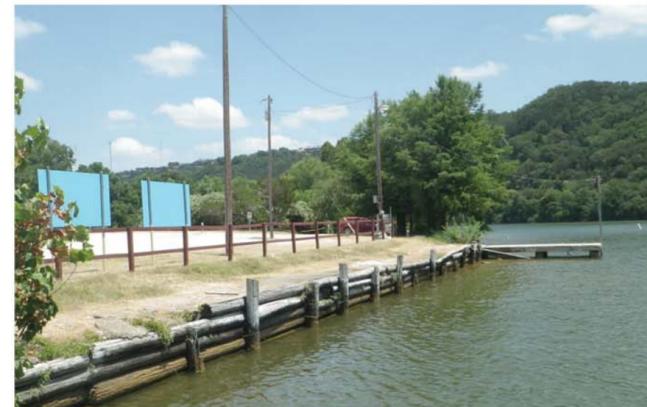
- Area acts as emergency access for all watercraft emergencies
- Bumpers may be needed to protect the boats
- Boat dock access is difficult after sunset due to inadequate lighting
- Erosion control improvements will soon be implemented between the boat ramps

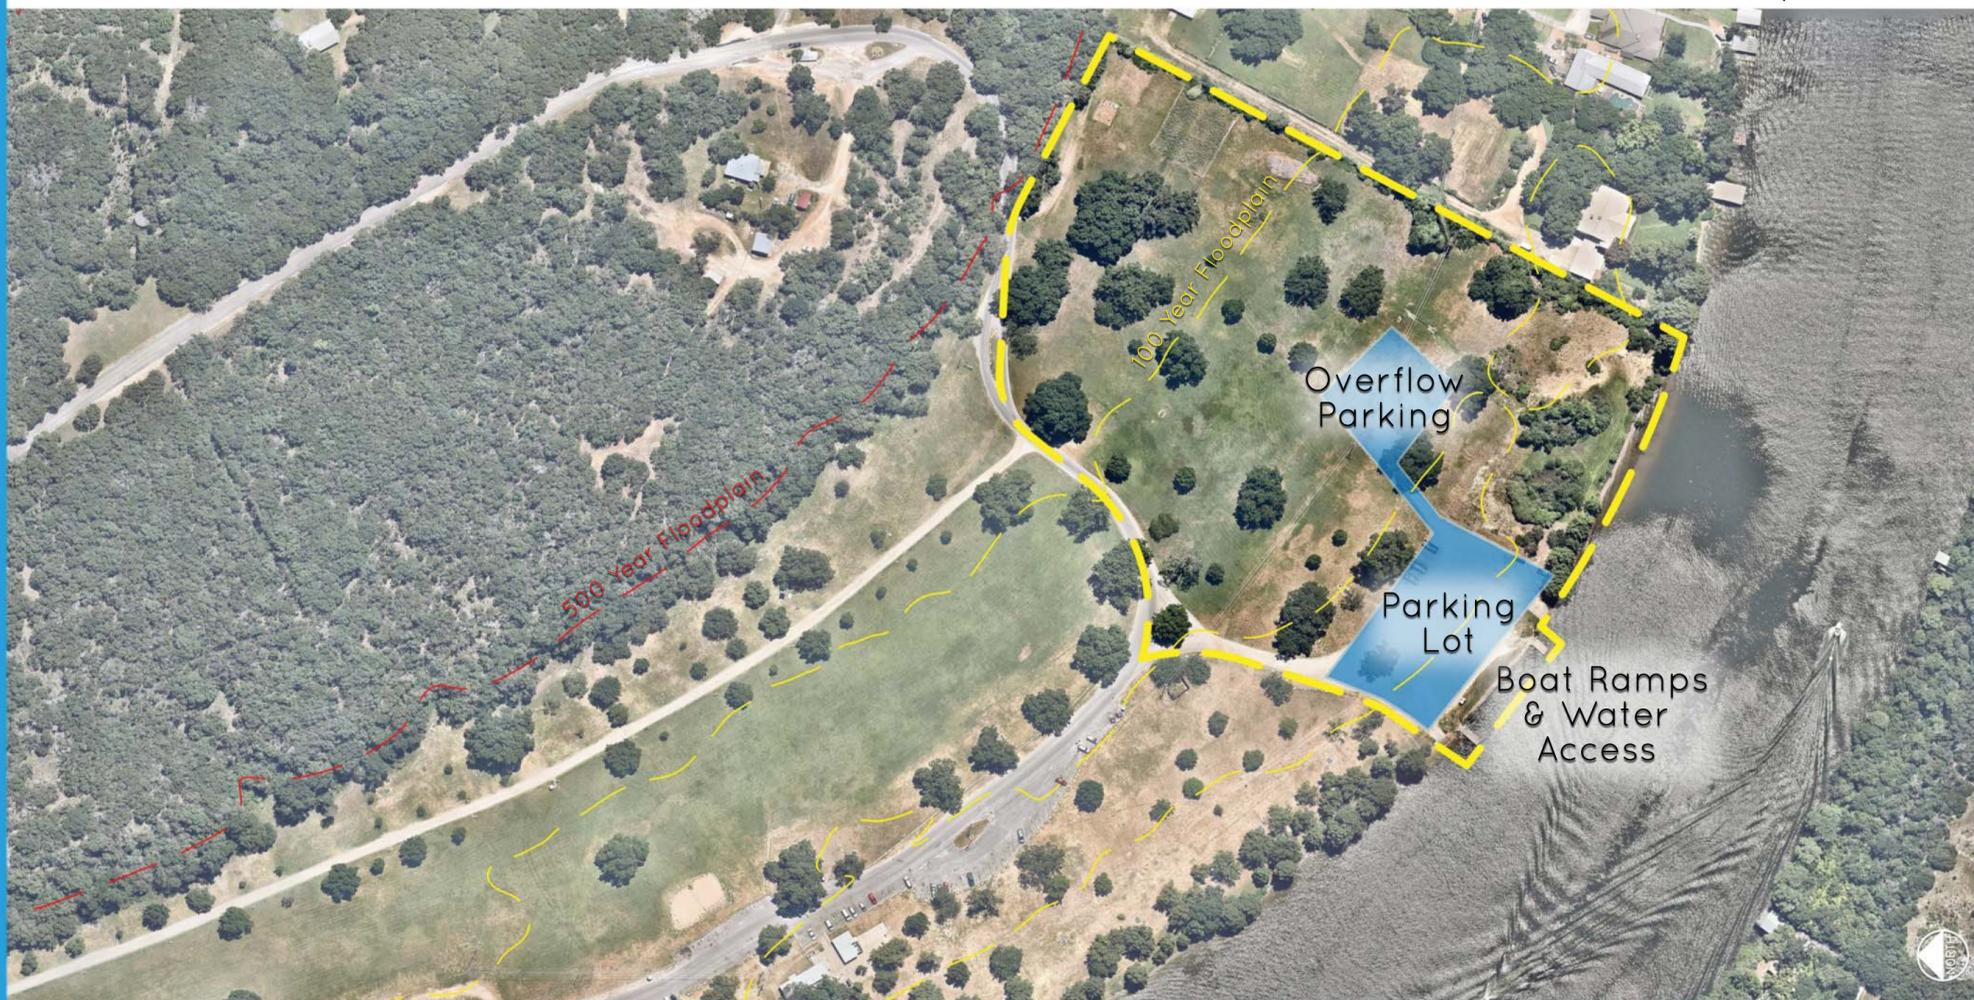
- There are 2 paved boat ramps
- The ramps become slick with algae buildup, causing poor traction on pavement
- Erosion control issues at the ramp

- There are 2 boat docks with minimal lighting
- The bank is showing signs of destabilization

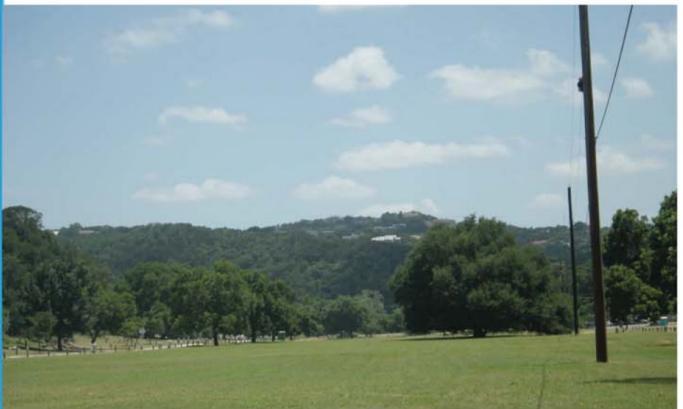
- Great views toward Lake Austin
- Lacks a community space and children's play area
- There is a limited amount of shade in this area
- Additional overflow parking could be beneficial
- The relatively flat area provides opportunities for multiple program elements

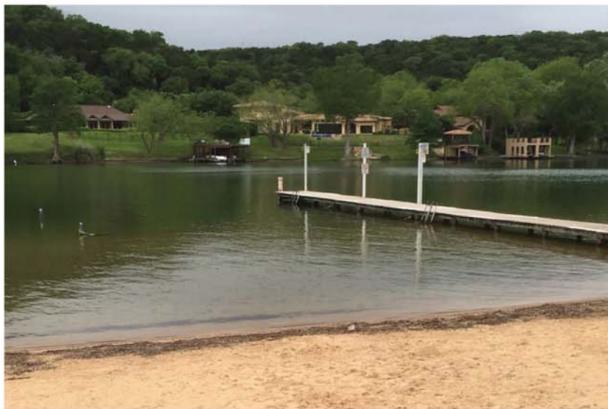
- Sand beach utilizes about 10 percent of the lakefront
- Buoys demarcate swimming area from boating area
- Existing Bald Cypress trees are helping stabilize the bank
- Ladder access onto the docks is becoming challenging

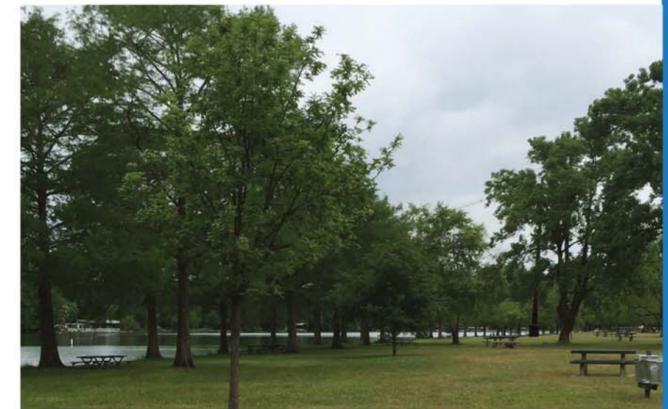
- Portable restroom facilities, trash receptacles and dumpsters are located throughout the area
- There are very few sidewalks which causes accessibility issues throughout the site
- Most of the parking is not striped which leads to inefficient parking

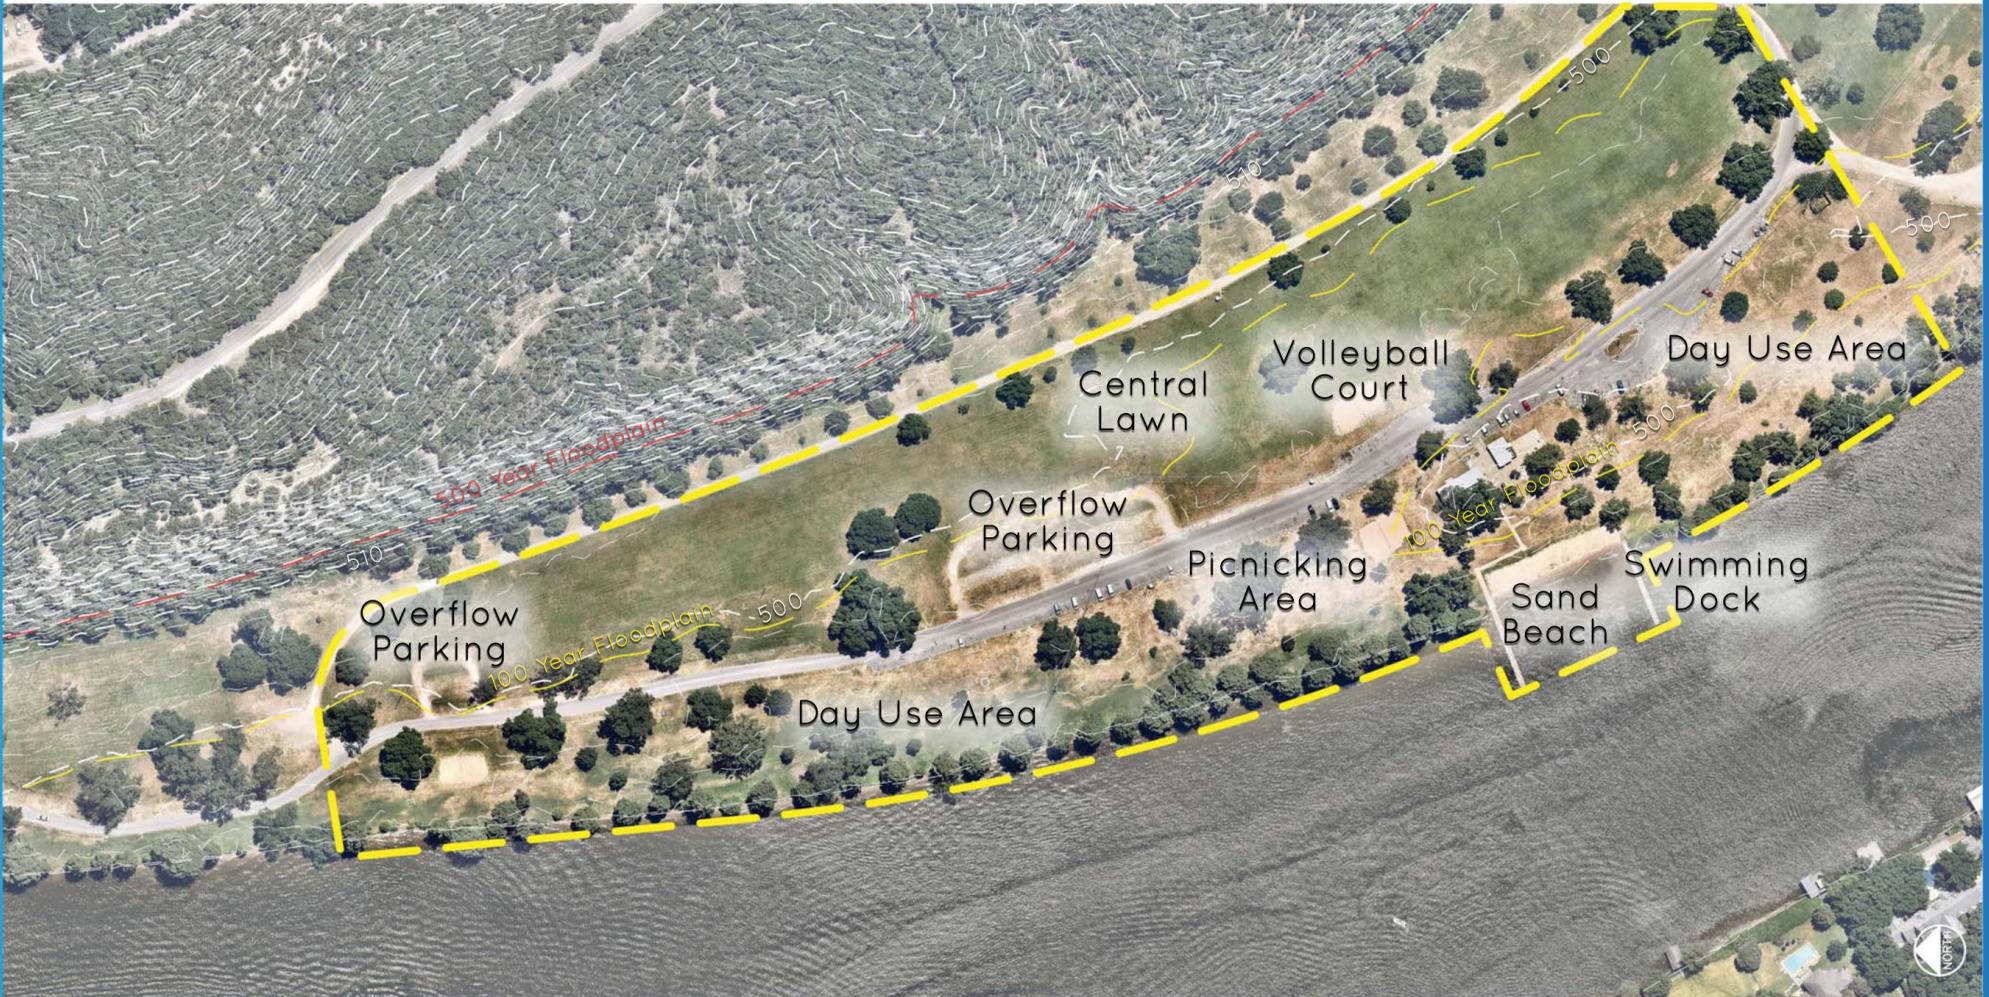
- The central lawn encompasses over 13 acres of the site
- Area for picnicking, sports, or just relaxing
- Parts of the central lawn are utilized for overflow parking
- Sandburs are very prevalent in this area

- Maximum number of park users along the shoreline is approx. 2,000 individuals
- One mile of lake front
- 250' long sand beach area
- 2 swimming docks
- This area is not patrolled by lifeguards

- Provides group picnicking opportunities
- Multiple grills are located throughout the area
- Restroom building
- 3 volleyball courts
- 1 basketball court
- Parking located along the road

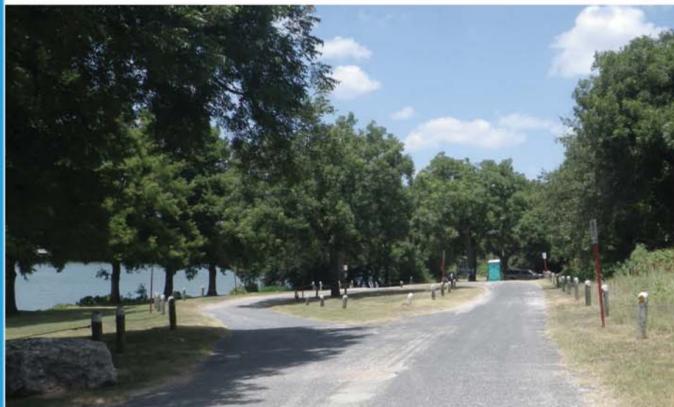
- Better signage at the one way drive could help alleviate tent campers from missing their turn
- If the park is at capacity, turning around with a boat trailer or RV is difficult
- RV camping area occupies the most remote site within the park
- Parking spaces are undersized for some RV's

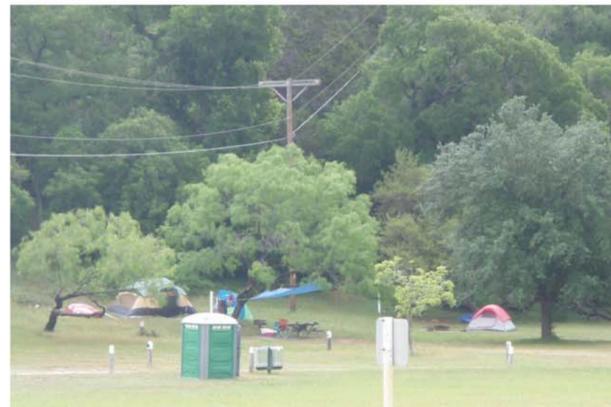
- Tent campers occasionally set up in the RV area to be near the water
- The location provides great morning shade from the trees
- Blocking the afternoon sun can be challenging in this location
- Opportunity to provide multiple tent camping locations that cater to different users

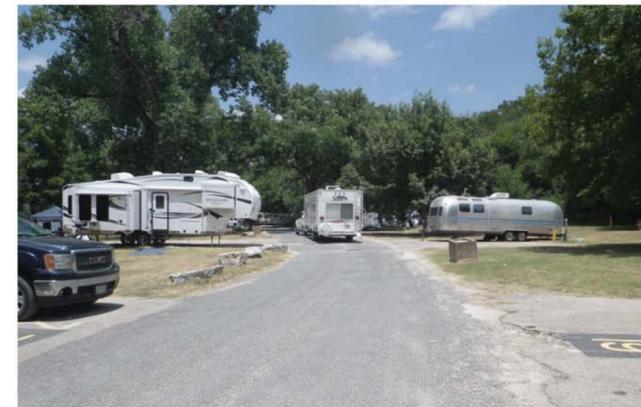
- RV camping location requires people to drive across the entire park to access the area
- Online reservations coming soon
- There is not a strong connection between this area and the rest of the park
- Providing larger angled spaces would help make parking easier

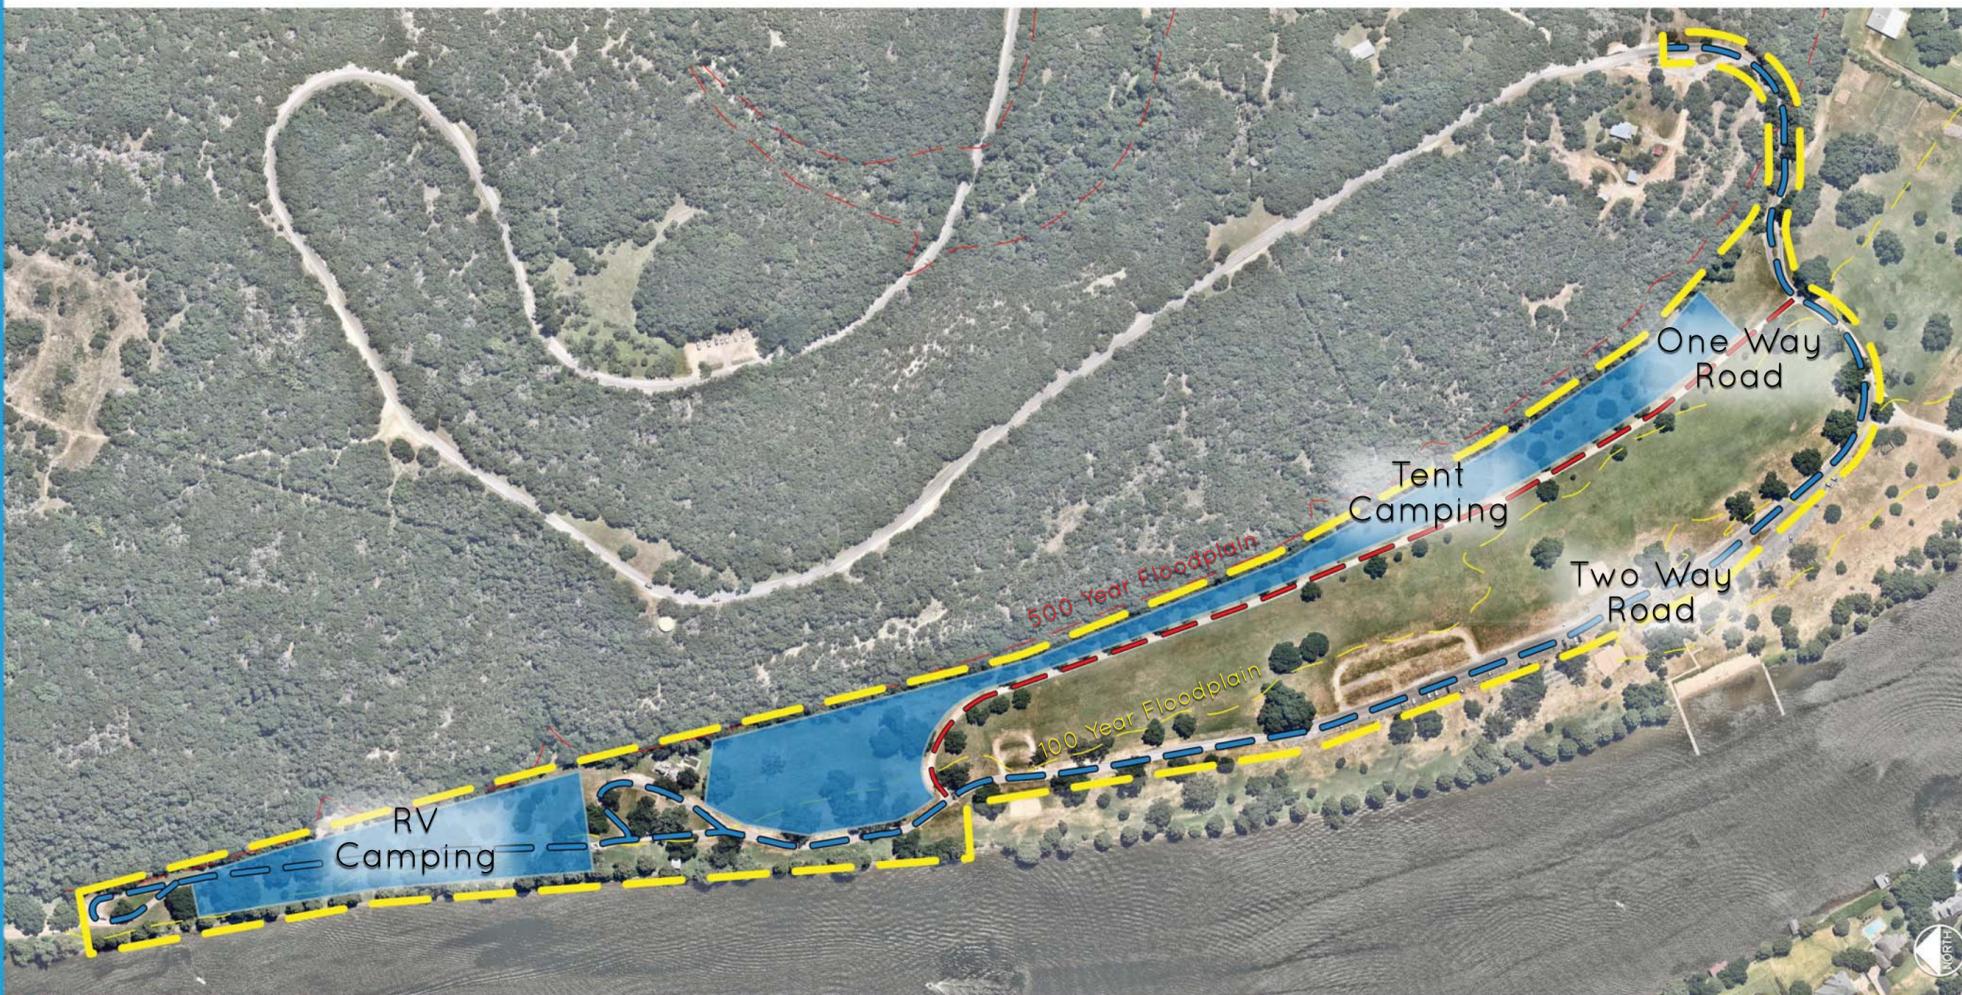
# Circulation, Tent and RV Camping Use Area

- Tent camping is accessed by a one way gravel road
- The RV camping area is accessed by a two lane paved road and has 2 turnaround locations

- There are 46 tent camping spaces
- Primitive camping includes spaces with no utilities and spaces with water
- All tent camping is located together along the treeline

- There are 20 RV camping spaces
- A restroom building is located by the RV area
- 20 and 30 Amp electrical pedestals and water hookups are provided
- RV spaces are provided on a first come first serve basis
- The RV site is located near the water which provides easy access to Lake Austin

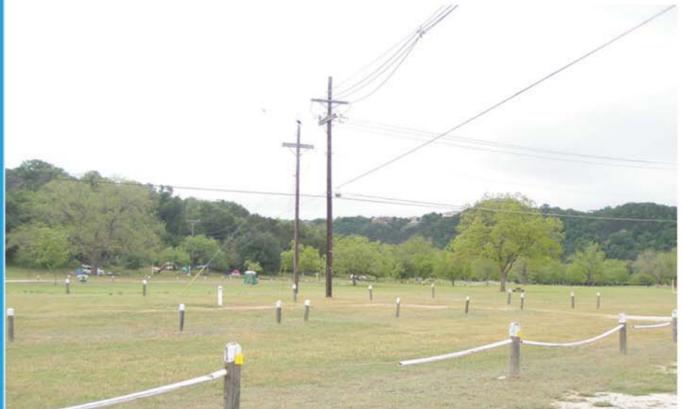
- Overhead poles and lines are visible throughout park area
- Modern RV's are not served with proper electrical requirements
- Electrical capacity at restroom buildings should be upgraded
- Site lighting is sparse and provides minimal coverage for overnight users

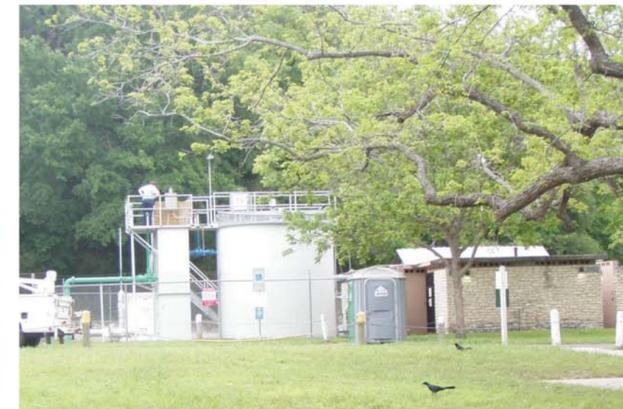
- Due to the age of the water and wastewater systems, corrosion has become an issue
- Opportunity to tie into the City water system may exist
- Water line is provided at every third tent camp site
- Opportunity to add septic hookups for the RV area may exist
