Eligible Activity: Infrastructure Improvements to Reduce Flood Risks

The Fallwell Lane Capital Renewal Project is located in the City of Austin, in Travis County. The project area is located approximately one (1) mile northeast of the intersection of State Highway 71 (SH 71) and SH 130, and is bounded by the Colorado River to the north and east, the Onion Creek to the south, and SH 130 northbound frontage road to the west, as shown in Figure 1 – Project Location Map. The project is affected by two watersheds:

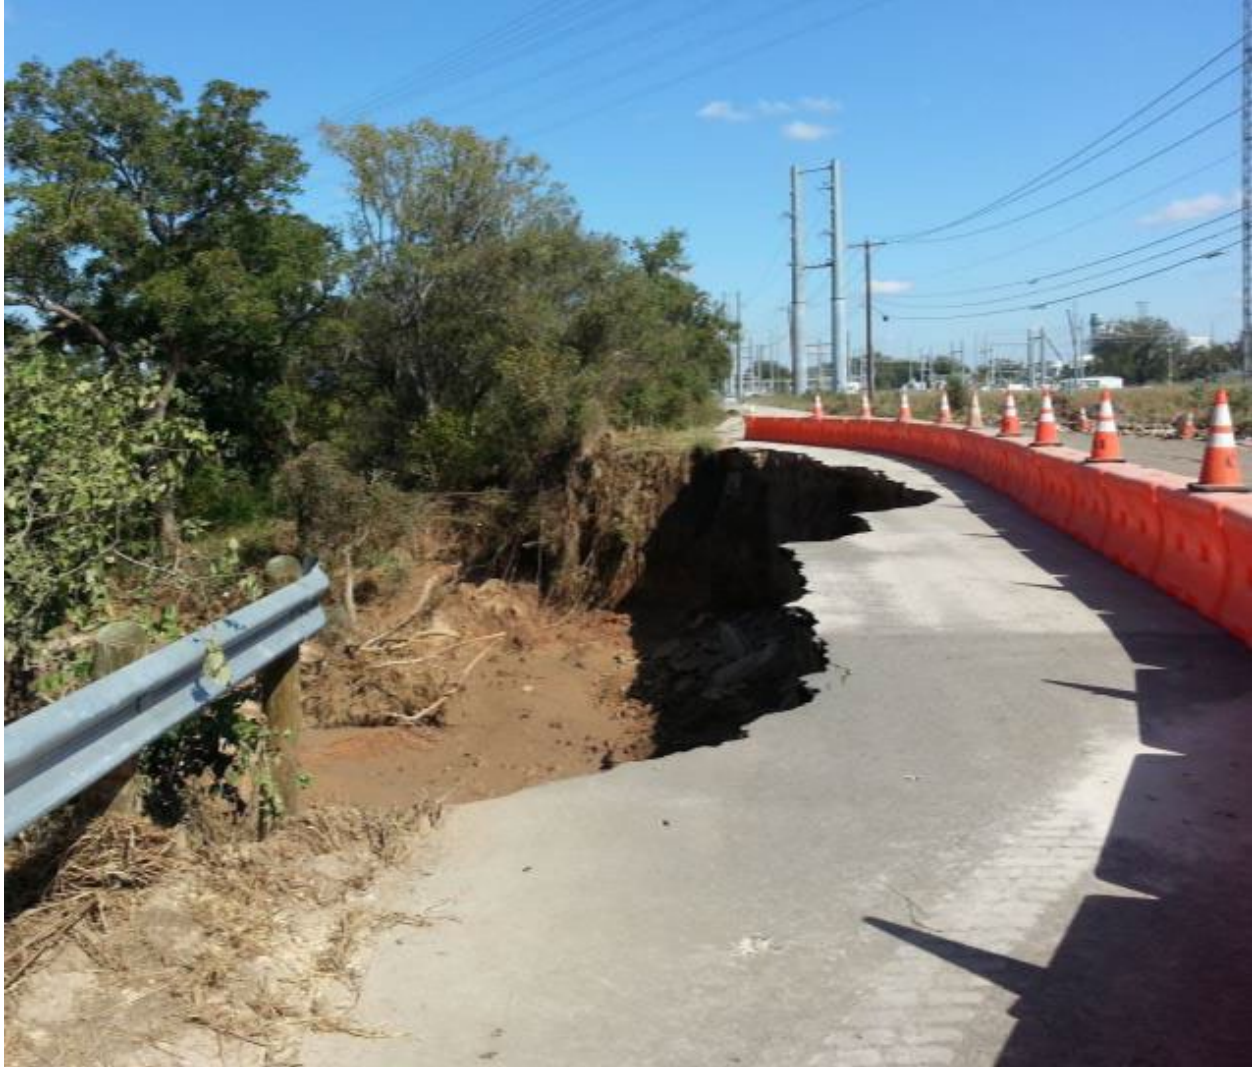
Figure 3: Fallwell Lane Failure

The study area experienced severe flooding with damages from the October 2013 and October 2015 flood events. Fallwell Lane was inundated by overflows from Onion Creek, which washed over the road and into the Colorado River. These massive overflows were approximately 3-feet deep and damaged portions of the road, exposing critical utilities. These flows also caused severe erosion of the Colorado River bank, including the portion of river bank where the Austin Energy raw water intake structure is located. Additionally, the Onion Creek overflows came close to over-topping the existing earthen berm located to the south of Austin Energy SHEC and SAR Wastewater Treatment Plant (WWTP).

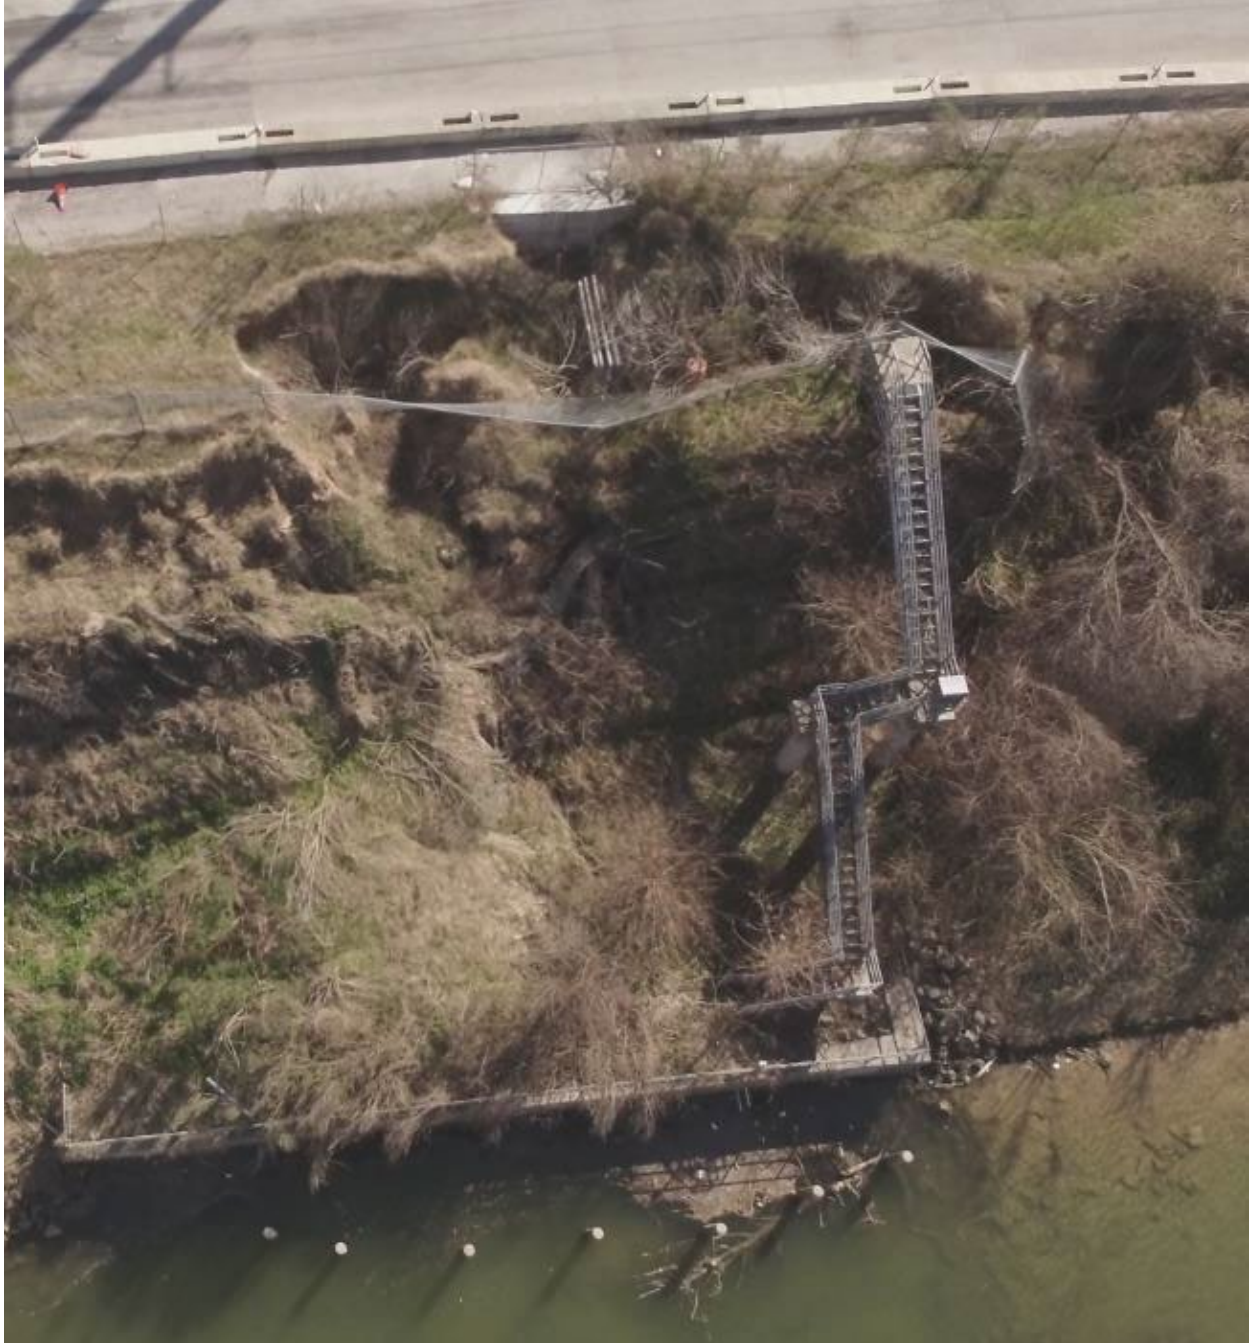
Figure 4: Fallwell Lane Failure and Colorado River Failure near Raw Water Intake

Austin Energy Raw Water Intake Facility: In 2003, Austin Energy constructed a raw water intake on the south bank of the Colorado River to provide an alternate source of cooling water to the plant. This intake structure is located directly north of the Austin Energy SHEC and is currently damaged to the extent that it is not functional. During the October 2015 flood event, flood waters from Onion Creek caused significant erosion to the streambank at the raw water intake. This erosion and bank degradation exposed the intake conduit and piping, damaged the access stairways to the intake structure, and destroyed the stairway landing, as can be seen in Figure 4 below. The intent of this project is to repair the erosion damage at the site of the intake, not to repair the intake itself. Austin Energy may repair the intake at a later time or abandon it for a more suitable site in the future.

Colorado River Streambank: The streambank erosion was not limited to the location of the raw water intake structure; rather, it was common to the stretch of river bank along Fallwell Lane, between SH 130 north-bound frontage road, to an area just east of the Austin Energy Onion Creek Substation. Temporary repairs have been made to stabilize these eroded locations; however, it is evident that a long-term, sustainable solution is required to prevent future significant bank failures.

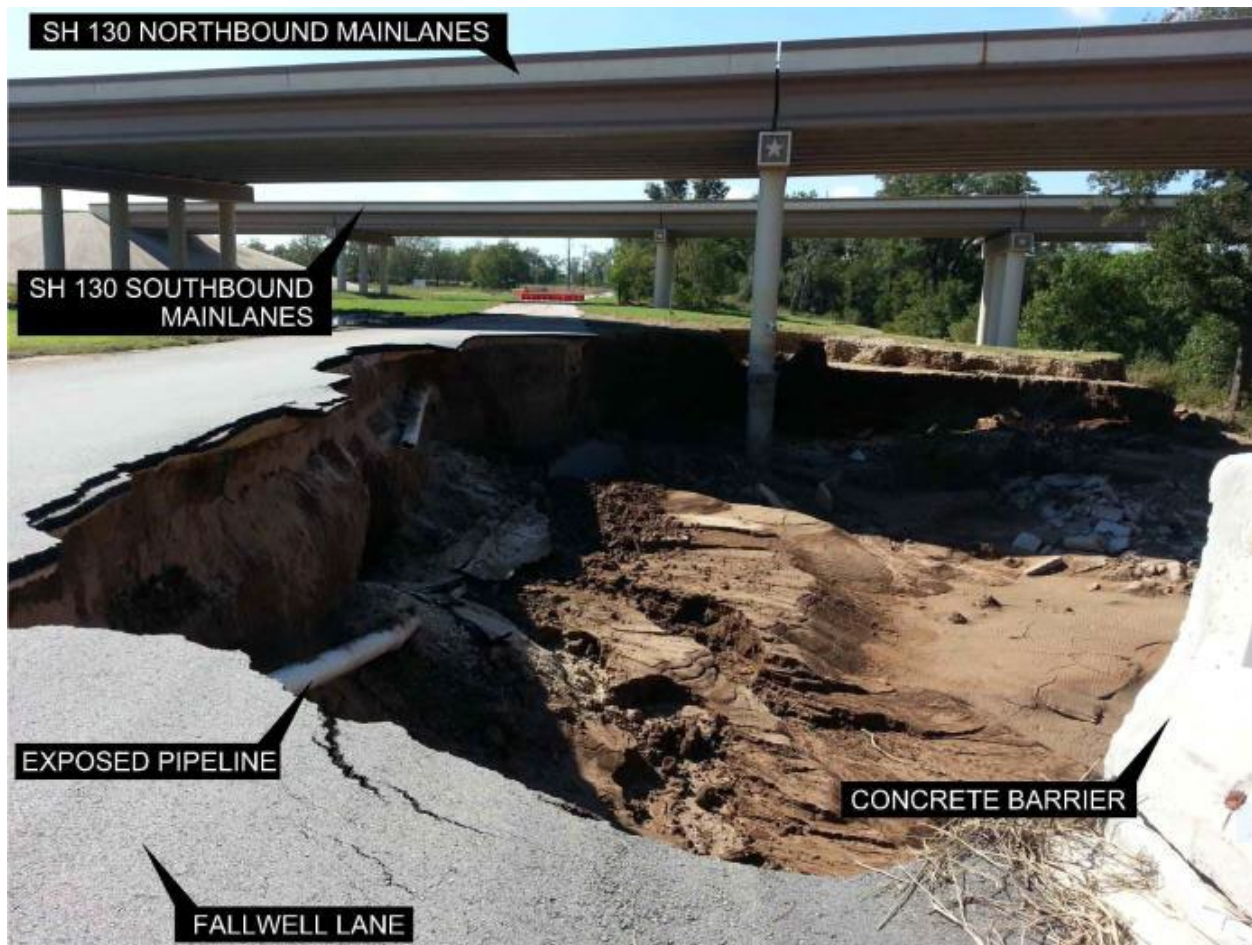
Figure 6: Fallwell Lane Damages Under SH 130 Looking West

In the October 2013 and October 2015 flood events (approximate 50-year to 75-year flood events compared to the Atlas 14 100-year event), flood water from Onion Creek left its normal channel and flowed overland to the Colorado River, submerging and damaging Fallwell Lane, and isolating both critical facilities. The damage also included severe erosion of the Colorado River bank and destroyed the raw water intake. Austin Water's emergency planning targets having the SAR WWTP back on line within a few hours to avoid untreated discharges that may occur within as little as 24 hours from start of the disaster. With access to the plants cut off, helicopters from the City of Austin Fire Department were required to ferry crews in and out of the plants. Approximately six weeks were required to restore Fallwell Lane each time.
