This profile summarizes the characteristics of the watersheds in District 6; provides an overview of flooding, erosion, and water quality problems; and discusses past, current, and upcoming solutions.

Watershed Protection District 6 Profile

January 1, 2015

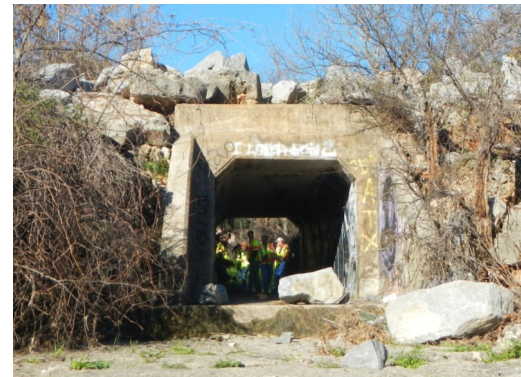
Photos of a culvert proposed for upgrade on Walnut Creek (above) and mats of Hydrilla on Lake Austin (below). A vegetation survey of Lake Austin in September 2013 found no Hydrilla. While Hydrilla is currently under control, it is probably not eradicated entirely.

- **Capital Improvement Projects:** Watershed Protection has completed the construction of a regional stormwater pond in the Walnut Creek watershed, a culvert upgrade in the Rattan Creek watershed, and channel modifications in partnership with Williamson County to improve flood conveyance in Lake Creek. Projects are also planned for the next five years to upgrade a creek crossing and install storm drains to resolve flooding issues in the Walnut Creek watershed as well as to restore native aquatic vegetation along Lake Austin.
