Buttermilk Branch Watershed

Summary Sheet

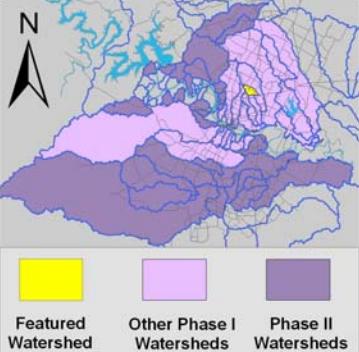
Catchment	Total area		2 square miles
