East Bouldin Creek Watershed

Summary Sheet

Data Summary Graphs – Dissolved Oxygen and Temperature (Downstream to Upstream by Year)

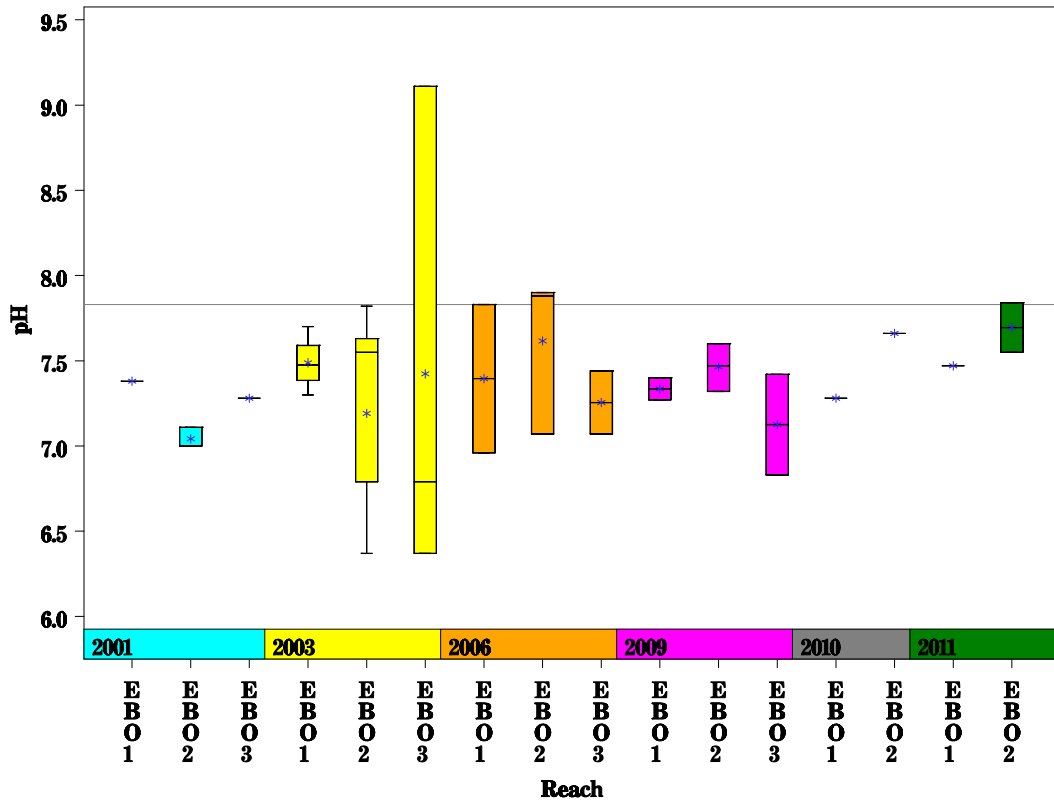
Parameter=PH Unit=Standard units Watershed=East Bouldin Creek

Summary	Parameter	Mean	Max	Min	Discussion
Physicochemical	D.O. mg/l	3.9	6.8	1.0	Below average to low concentrations.
	pH st.units	7.56	7.84	7.28	Low values at site 1338.
	Cond uS/cm	783	889	585	Within normal range.
Nutrients	NH ₃ mg/l	0.114	0.320	0.011	Above average to high values at both sites.
	NO ₃ mg/l	0.014	0.040	0.008	Within normal range, generally low.
	Ortho P mg/l	0.156	0.280	0.100	Mostly within normal range with some high values.
Sediment Load	TSS mg/l	3.6	6.1	1.8	Some above average values, but within normal range.
	Turbidity ntu	3.99	7.09	1.55	Some above average values, but within normal range.
Biology	E.Coli /100ml	965	2420	41	Wide range with some very high values at site 119.
	Benthic Macroinvertebrates and Diatoms: evaluations are provided in the introduction of this report

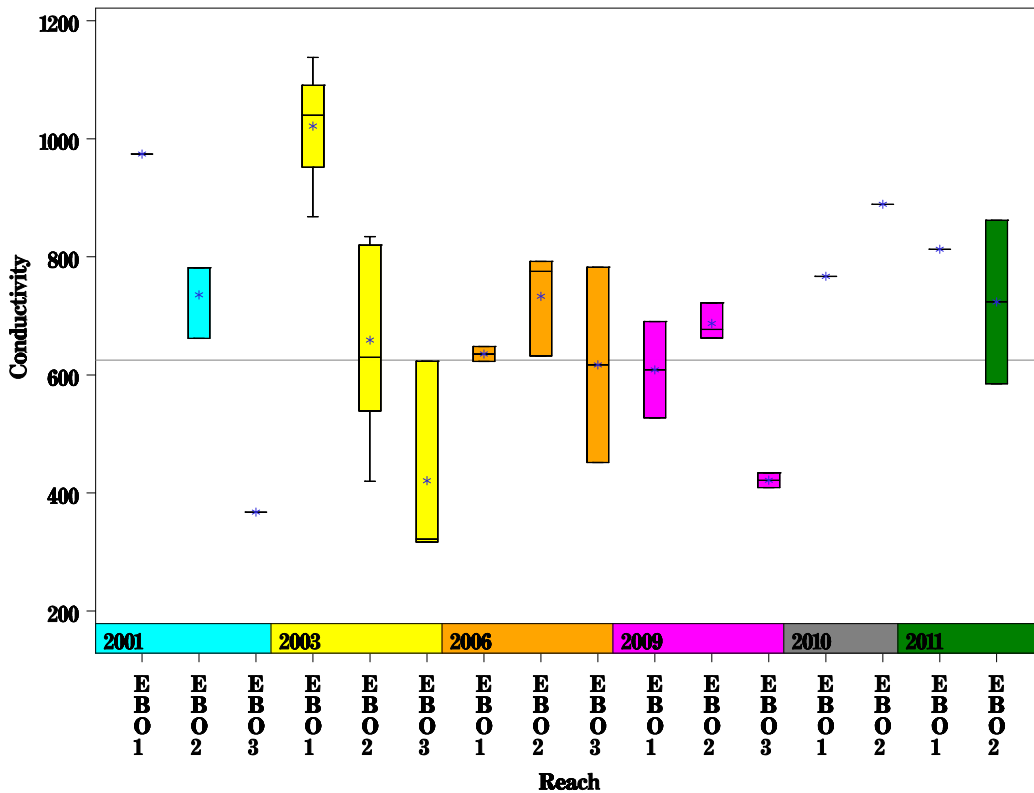
Parameter=CONDUCTIVITY Unit=uS/cm Watershed=East Bouldin Creek

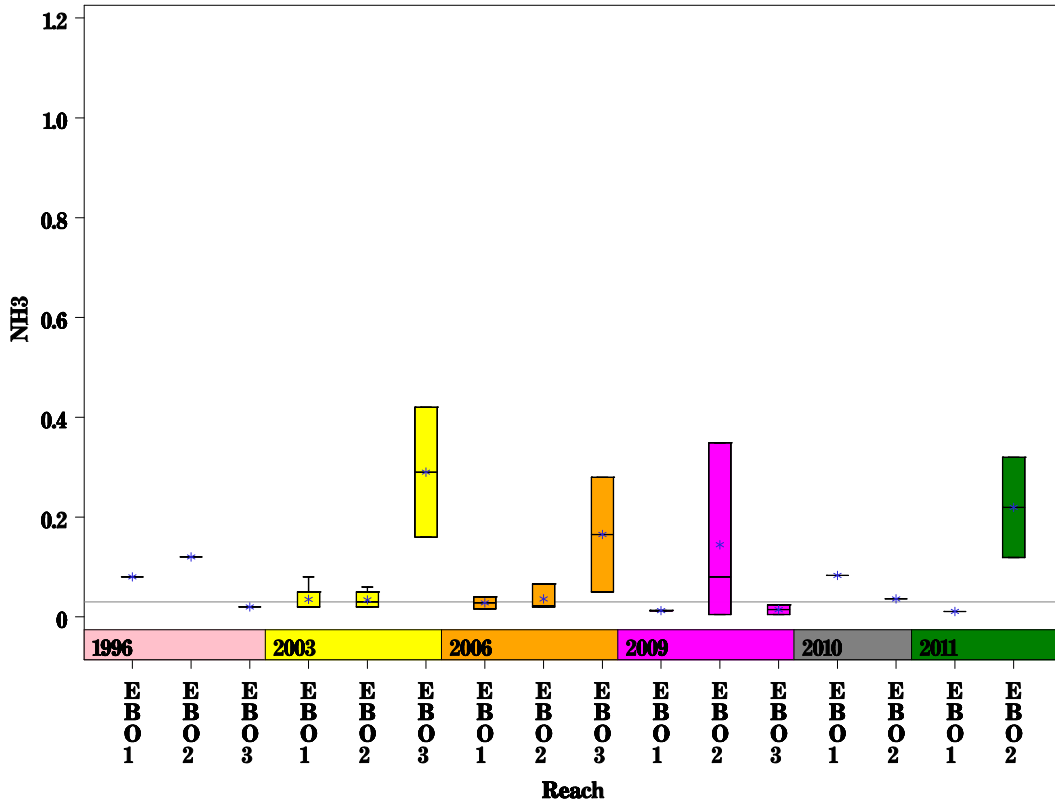
Parameter=AMMONIA AS N Unit=MG/L Watershed=East Bouldin Creek

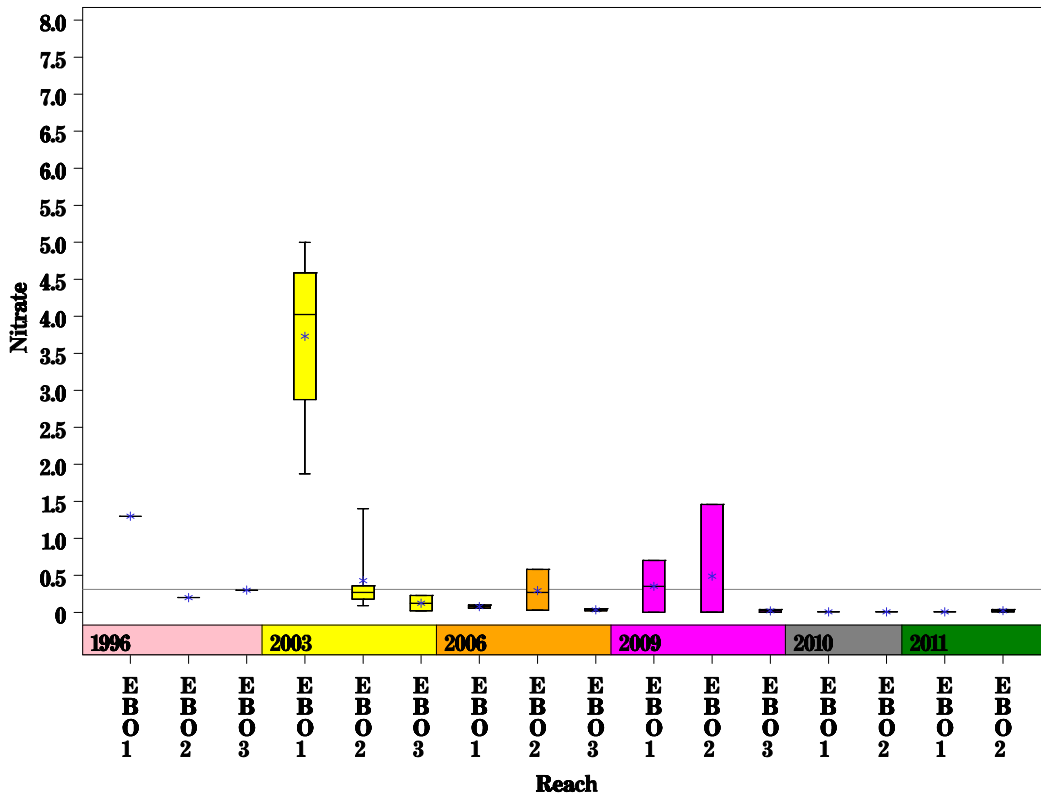
Parameter=NITRATE AS N Unit=MG/L Watershed=East Bouldin Creek

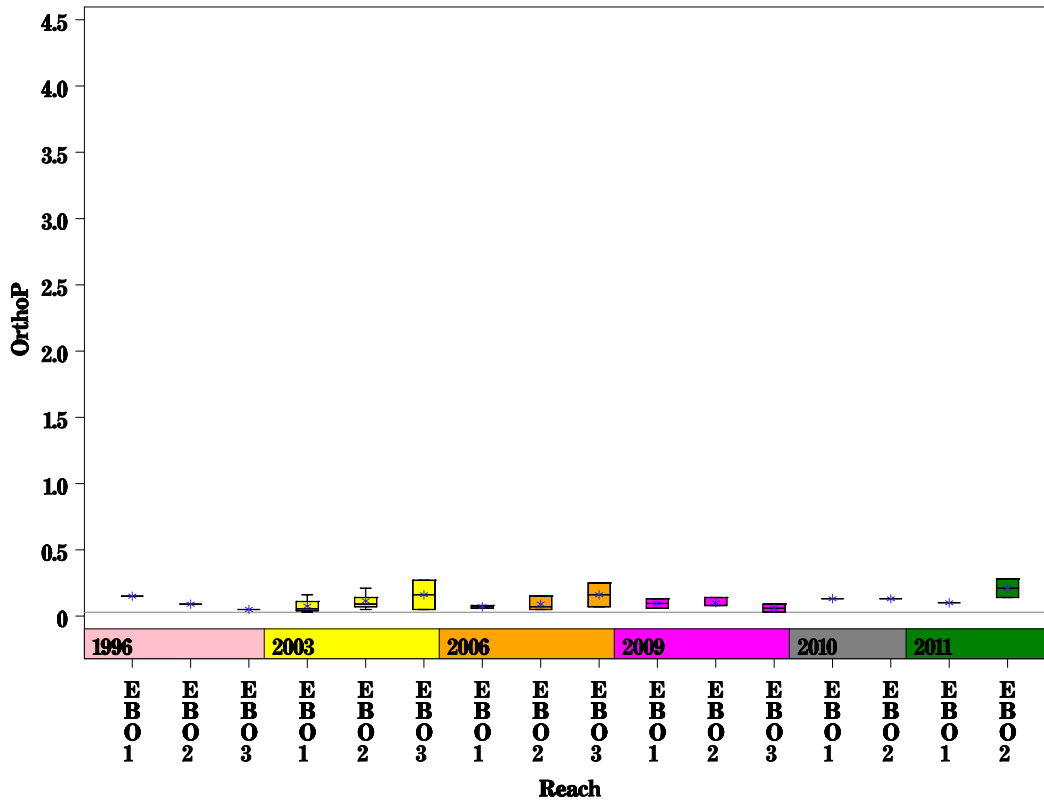
Parameter = ORTHOPHOSPHORUS AS P Unit = MG/L Watershed = East Bouldin Creek

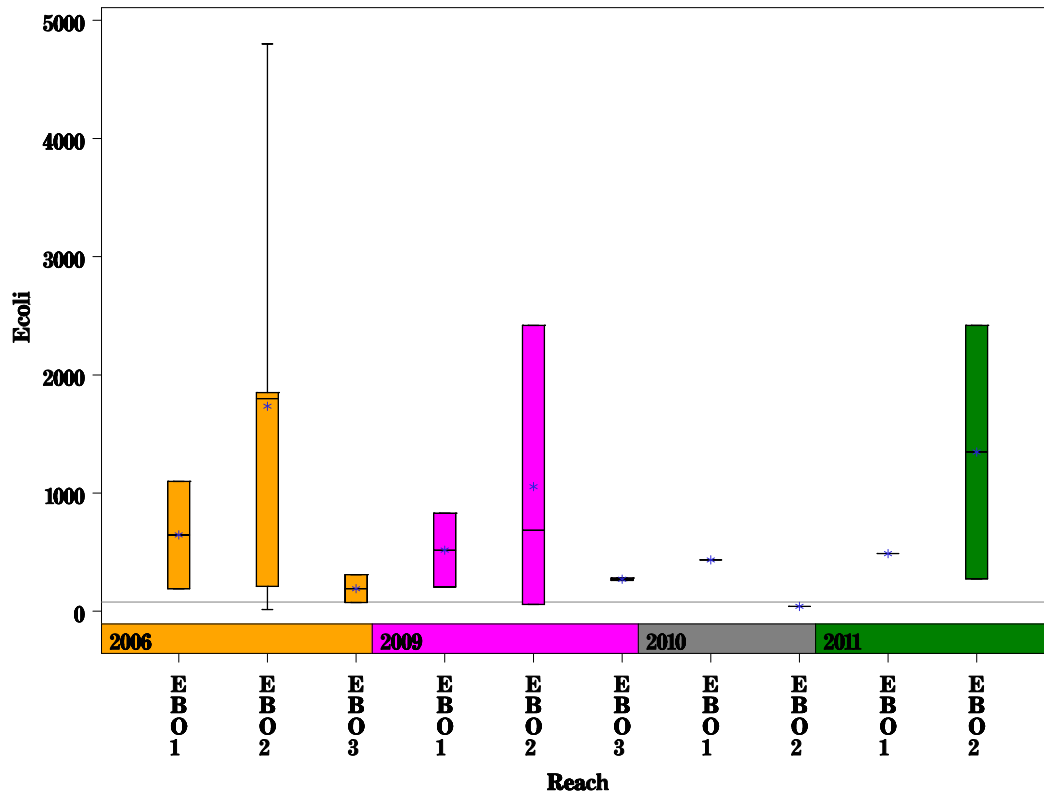
Parameter = E COLI BACTERIA Unit = MPN/100ML Watershed = East Bouldin Creek

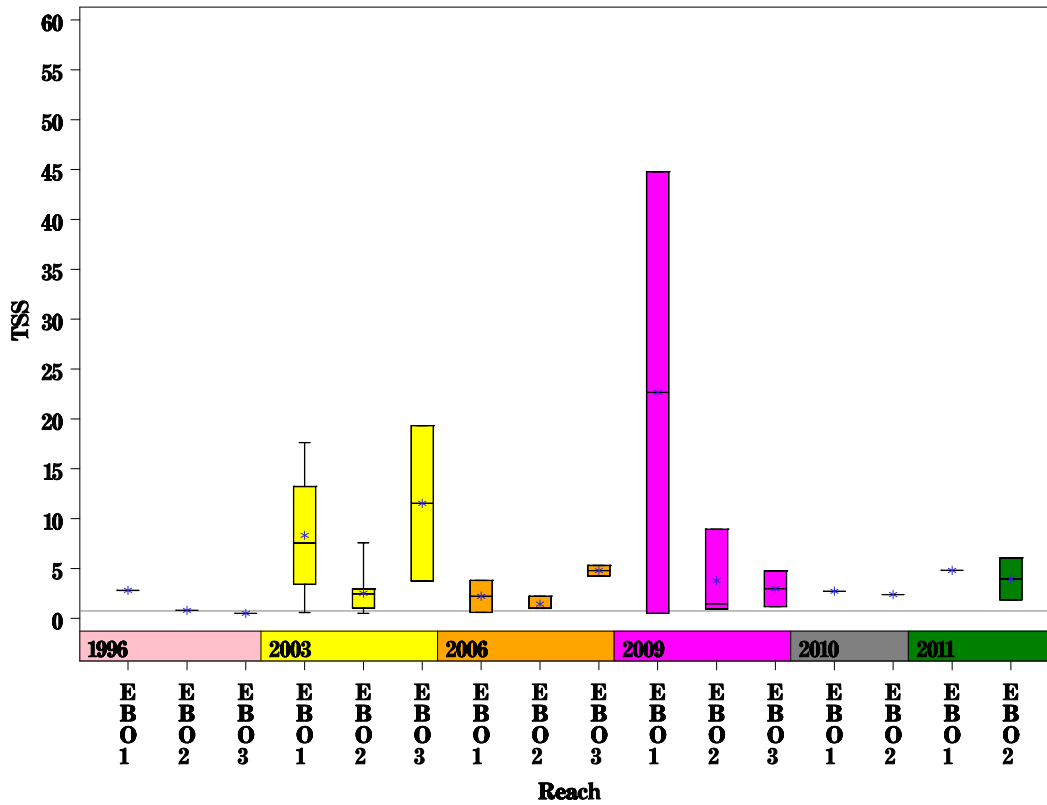
Parameter=TOTAL SUSPENDED SOLIDS Unit=MG/L Watershed=East Bouldin Creek

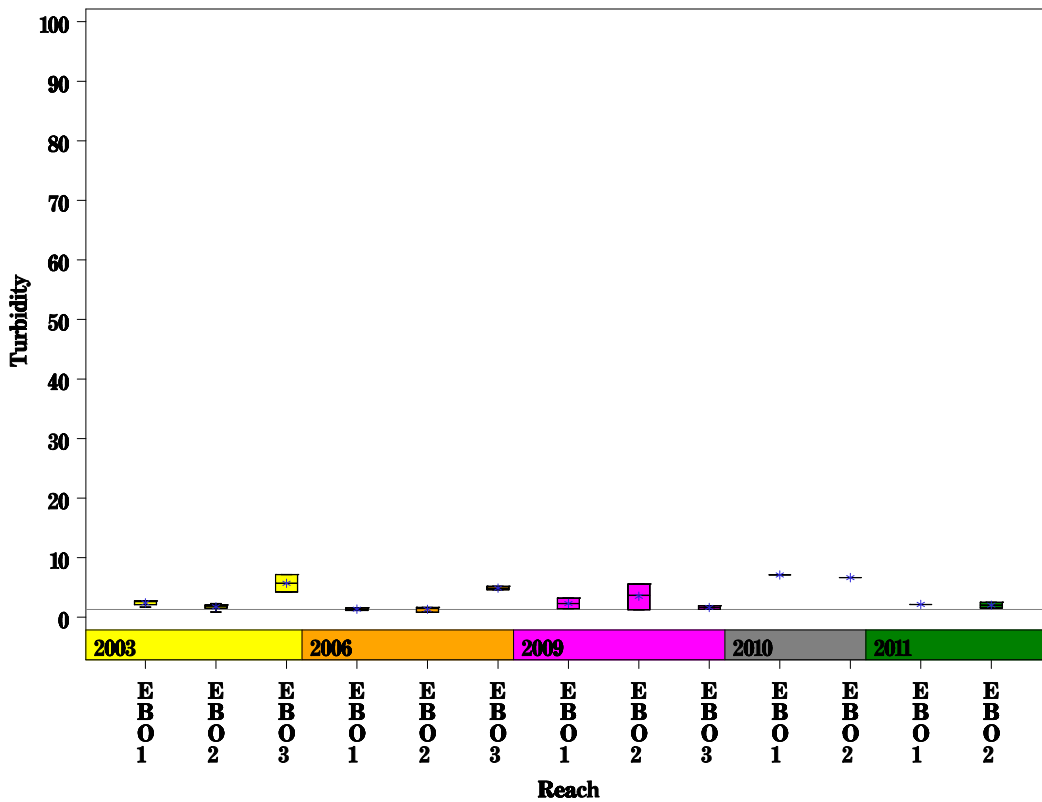
Parameter=TURBIDITY Unit=NTU Watershed=East Bouldin Creek
