# Lake Creek Watershed

## Summary Sheet

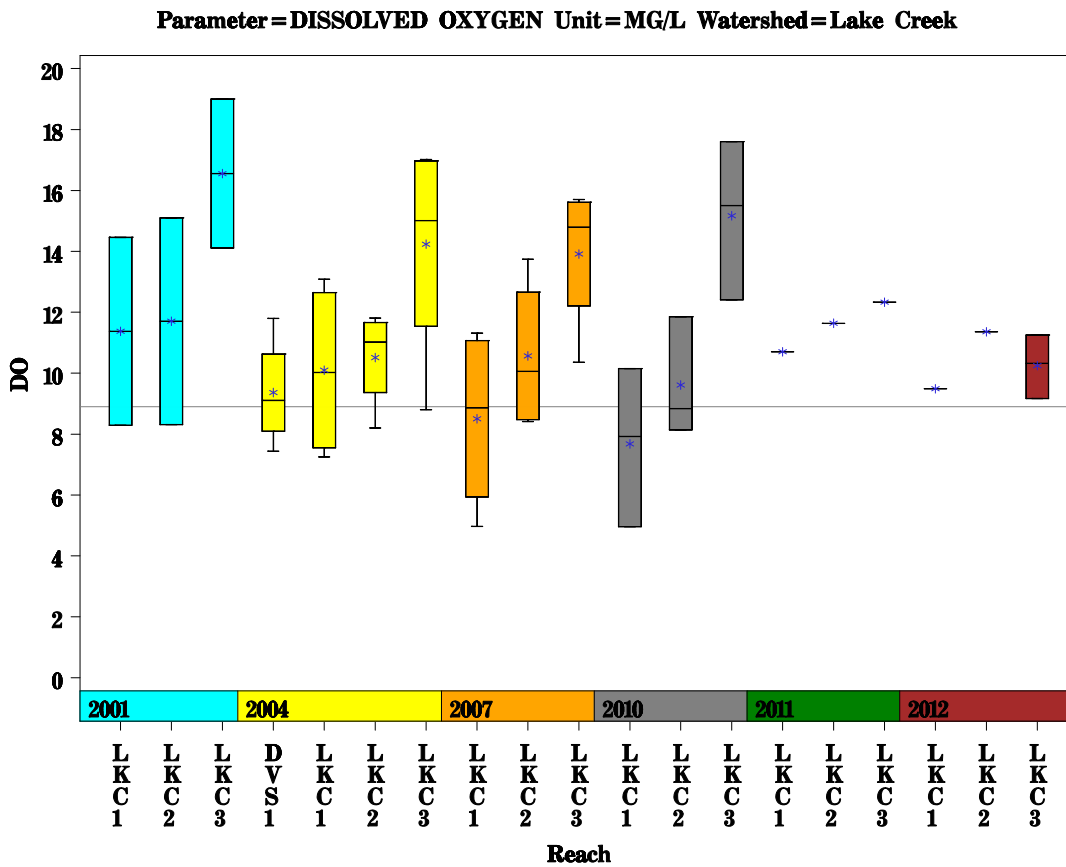
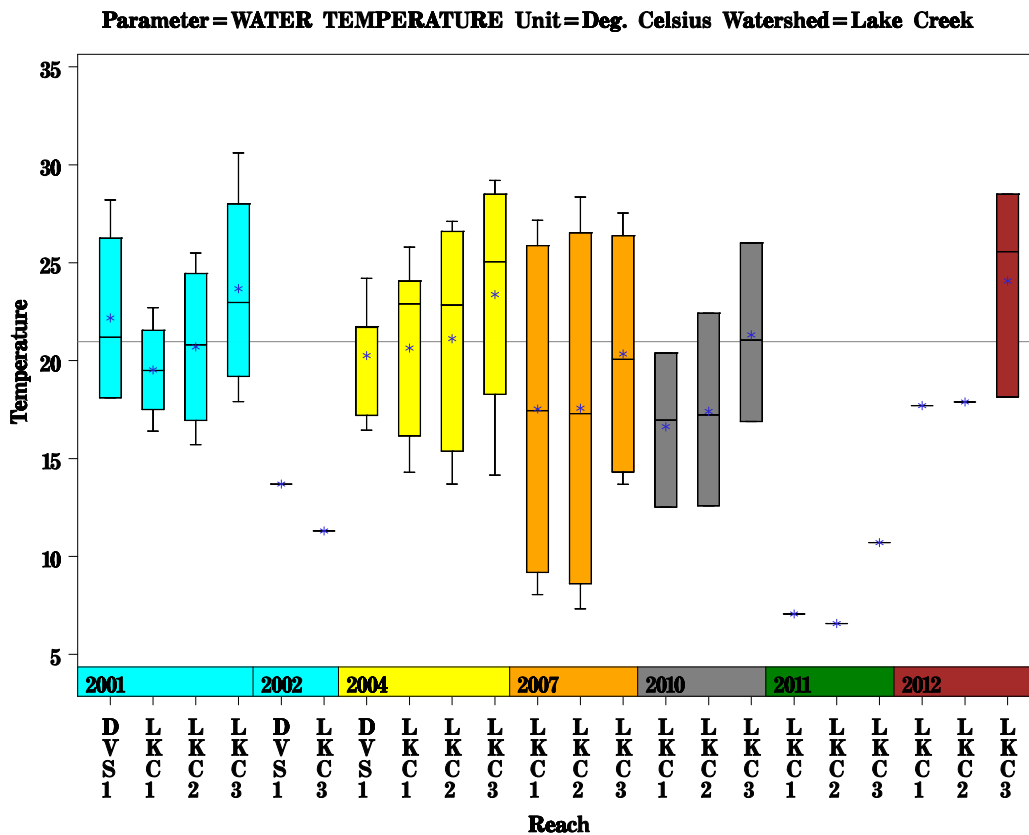
Data Summary Graphs – Dissolved Oxygen and Temperature (Downstream to Upstream by Year)

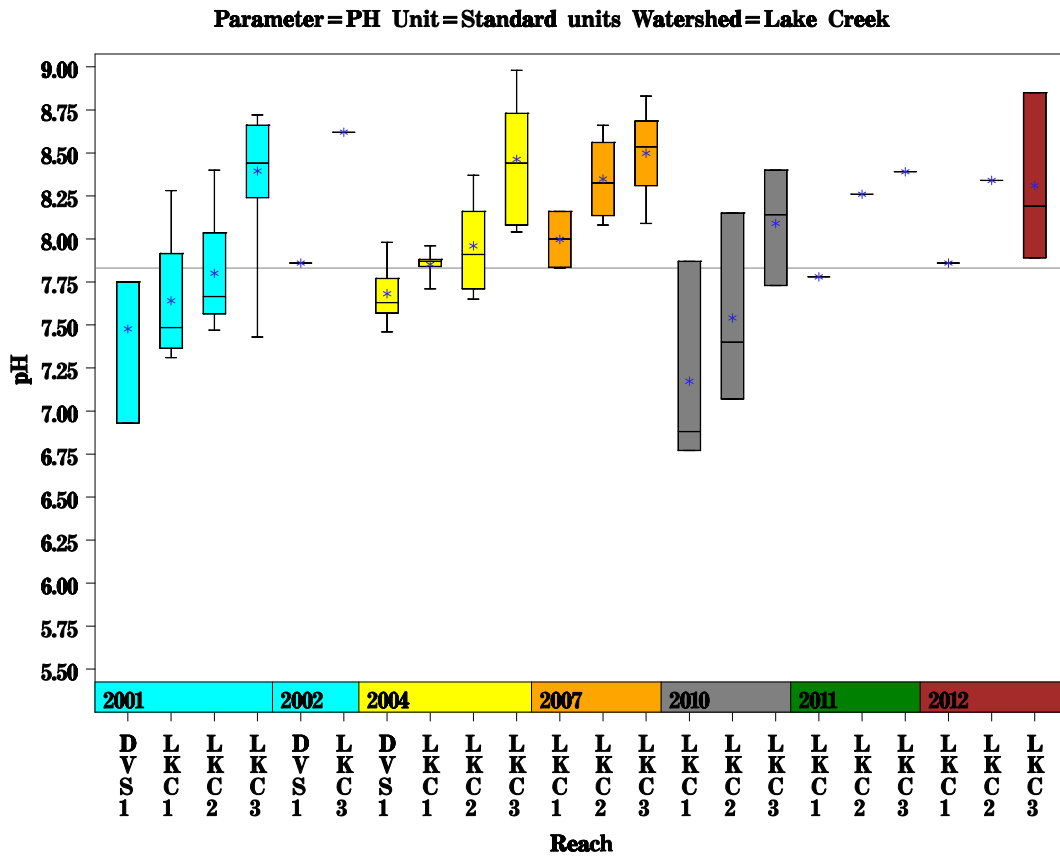
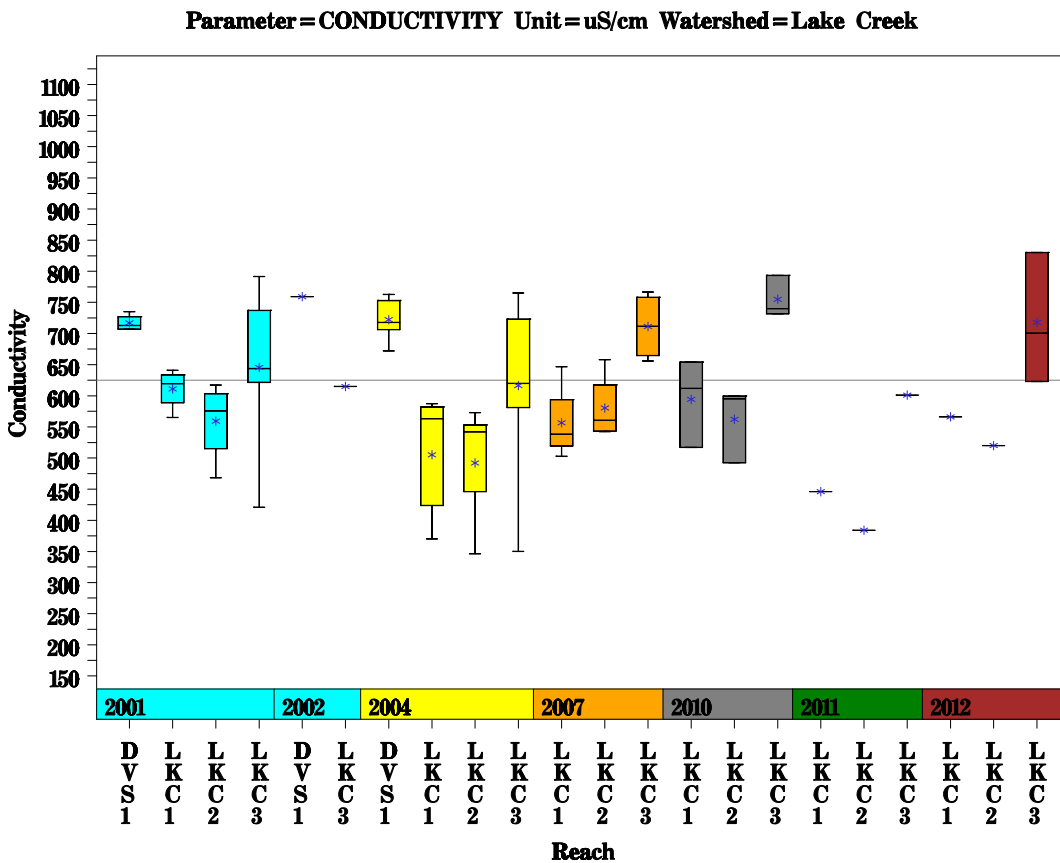
Data Summary Graphs – pH and Conductivity (Downstream to Upstream by Year)

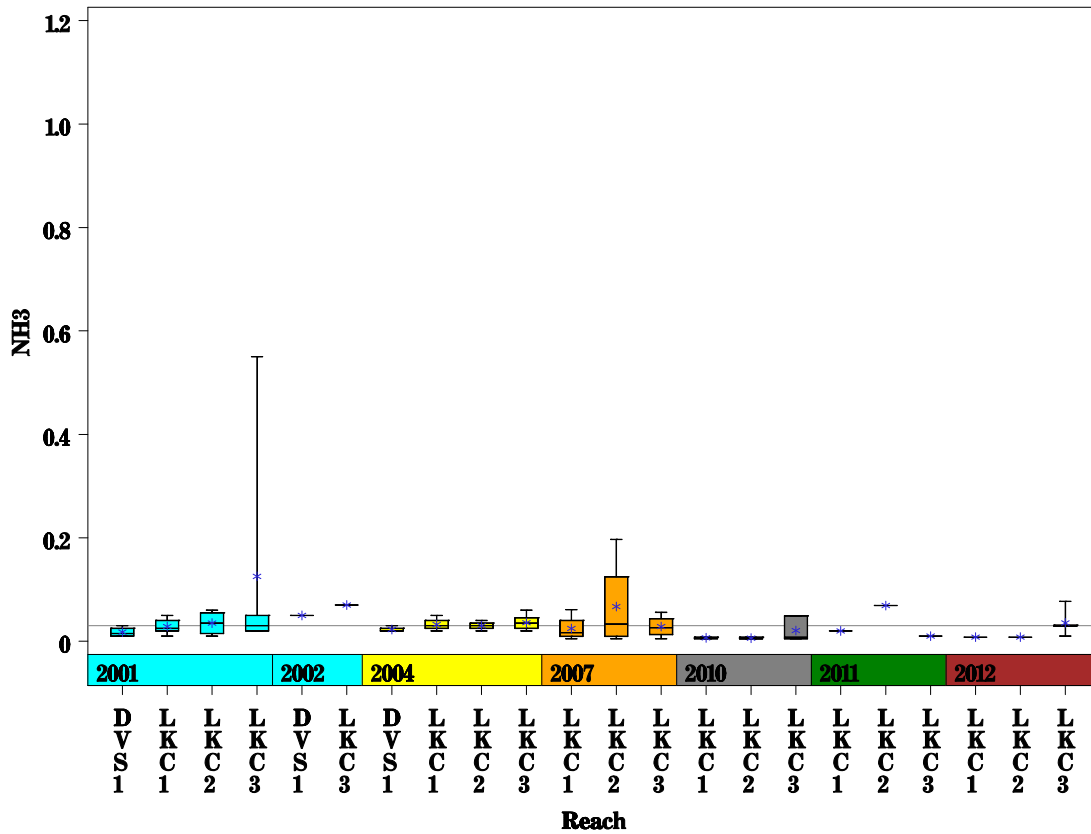
Data Summary Graphs – Ammonia and Nitrate/Nitrite (Downstream to Upstream by Year)

Parameter=AMMONIA AS N Unit=MG/L Watershed=Lake Creek

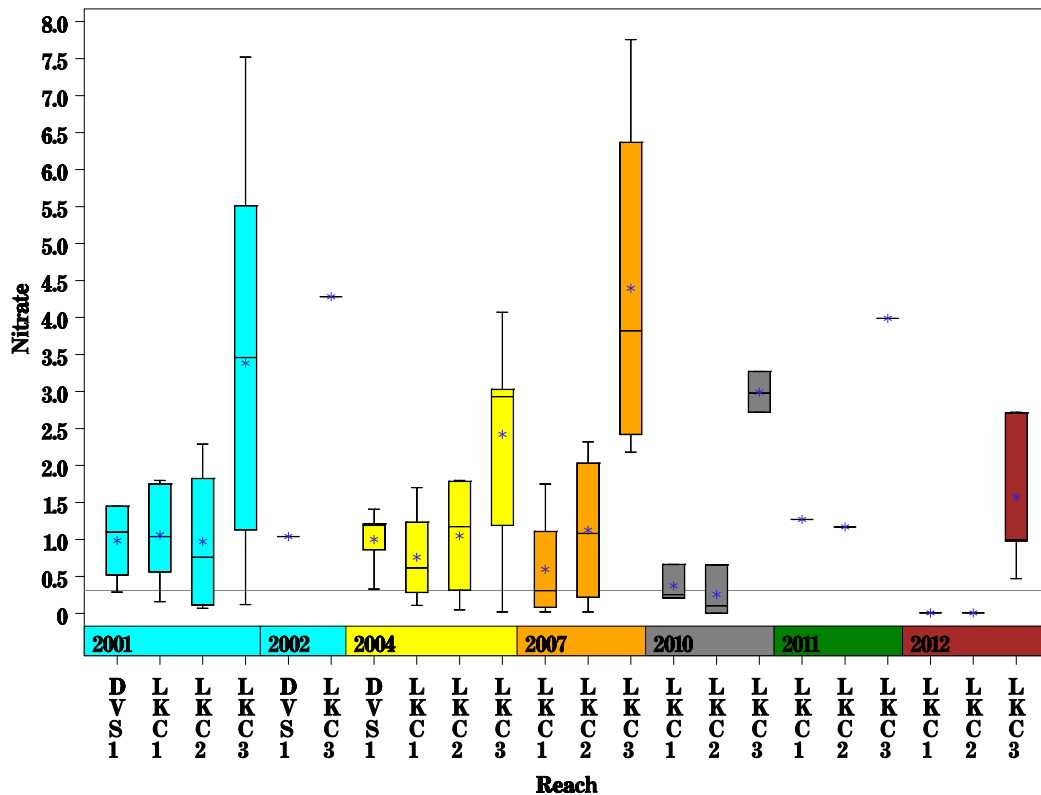
Parameter=NITRATE AS N Unit=MG/L Watershed=Lake Creek

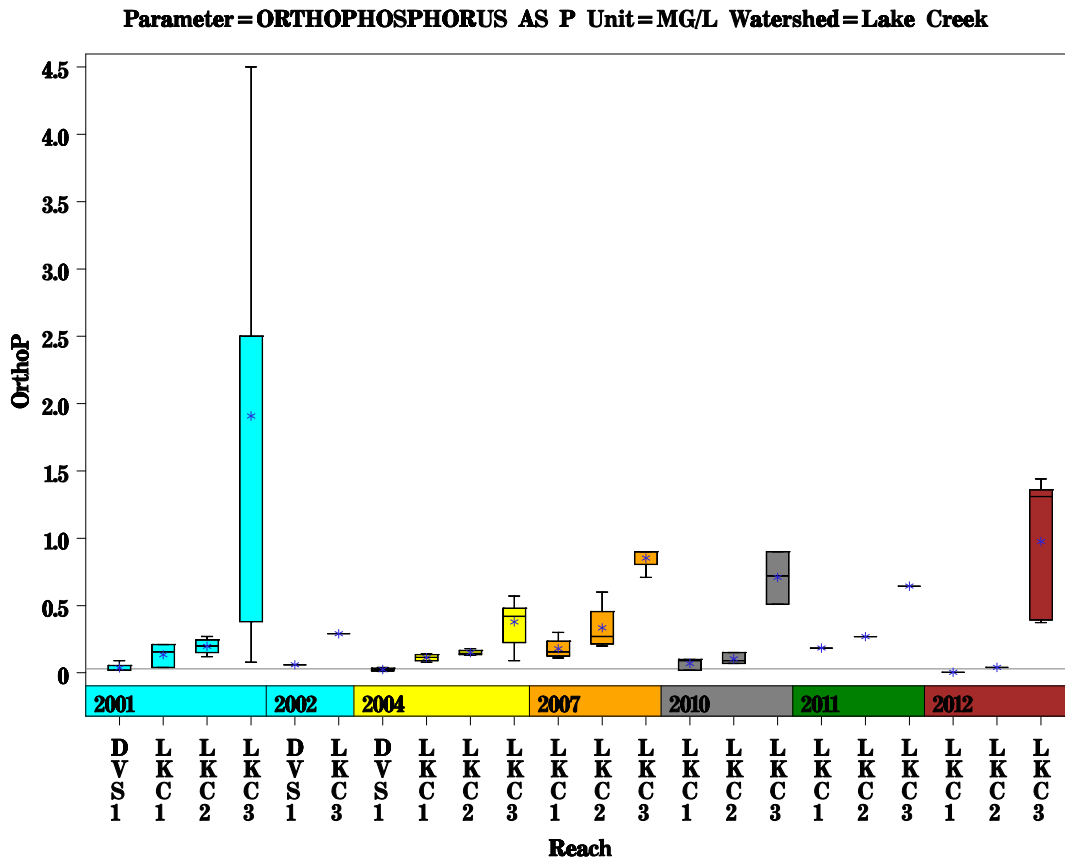
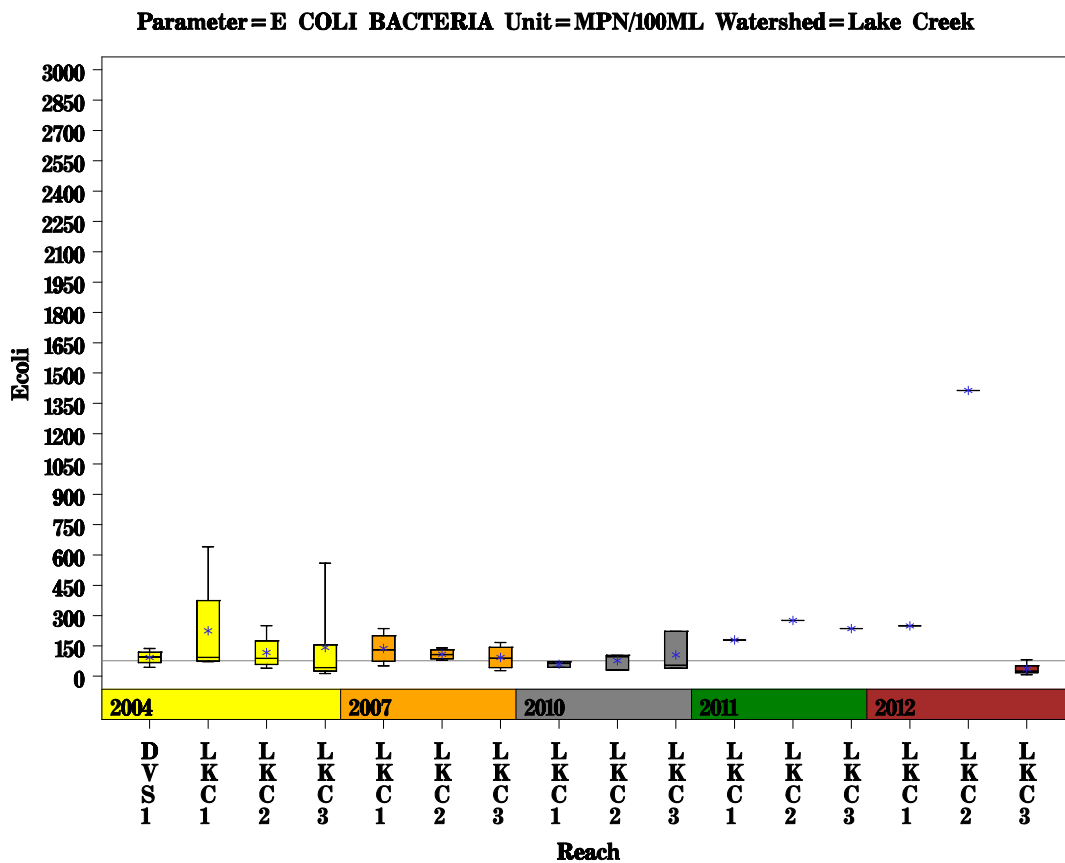
Data Summary Graphs – Orthophosphate and E.coli (Downstream to Upstream by Year)

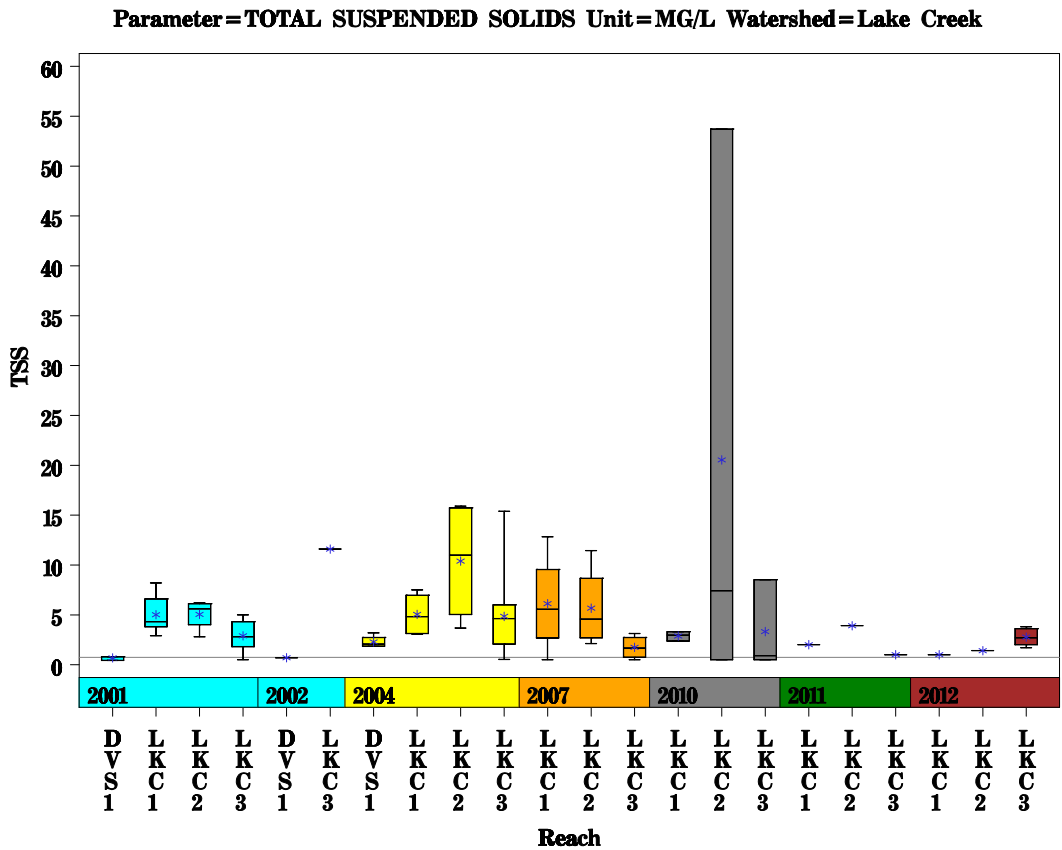
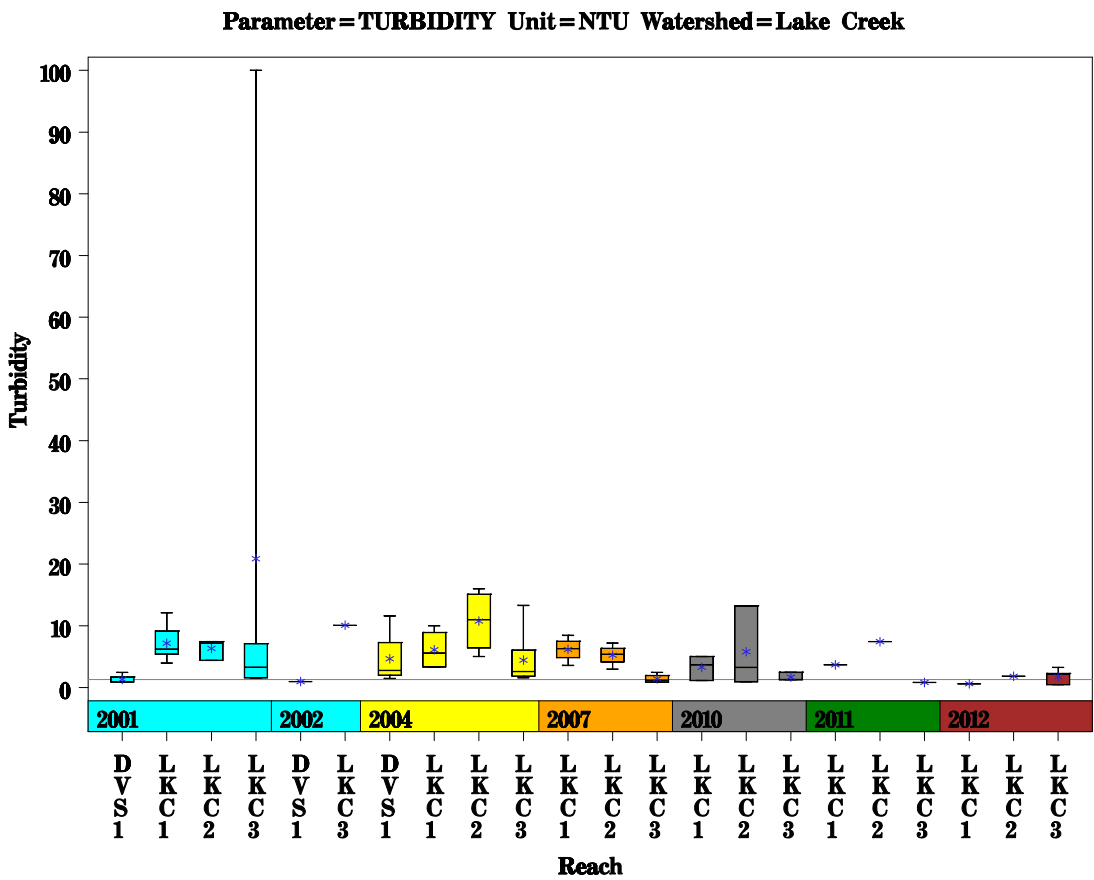
Data Summary Graphs – Total Suspended Solids and Turbidity (Downstream to Upstream by Year)

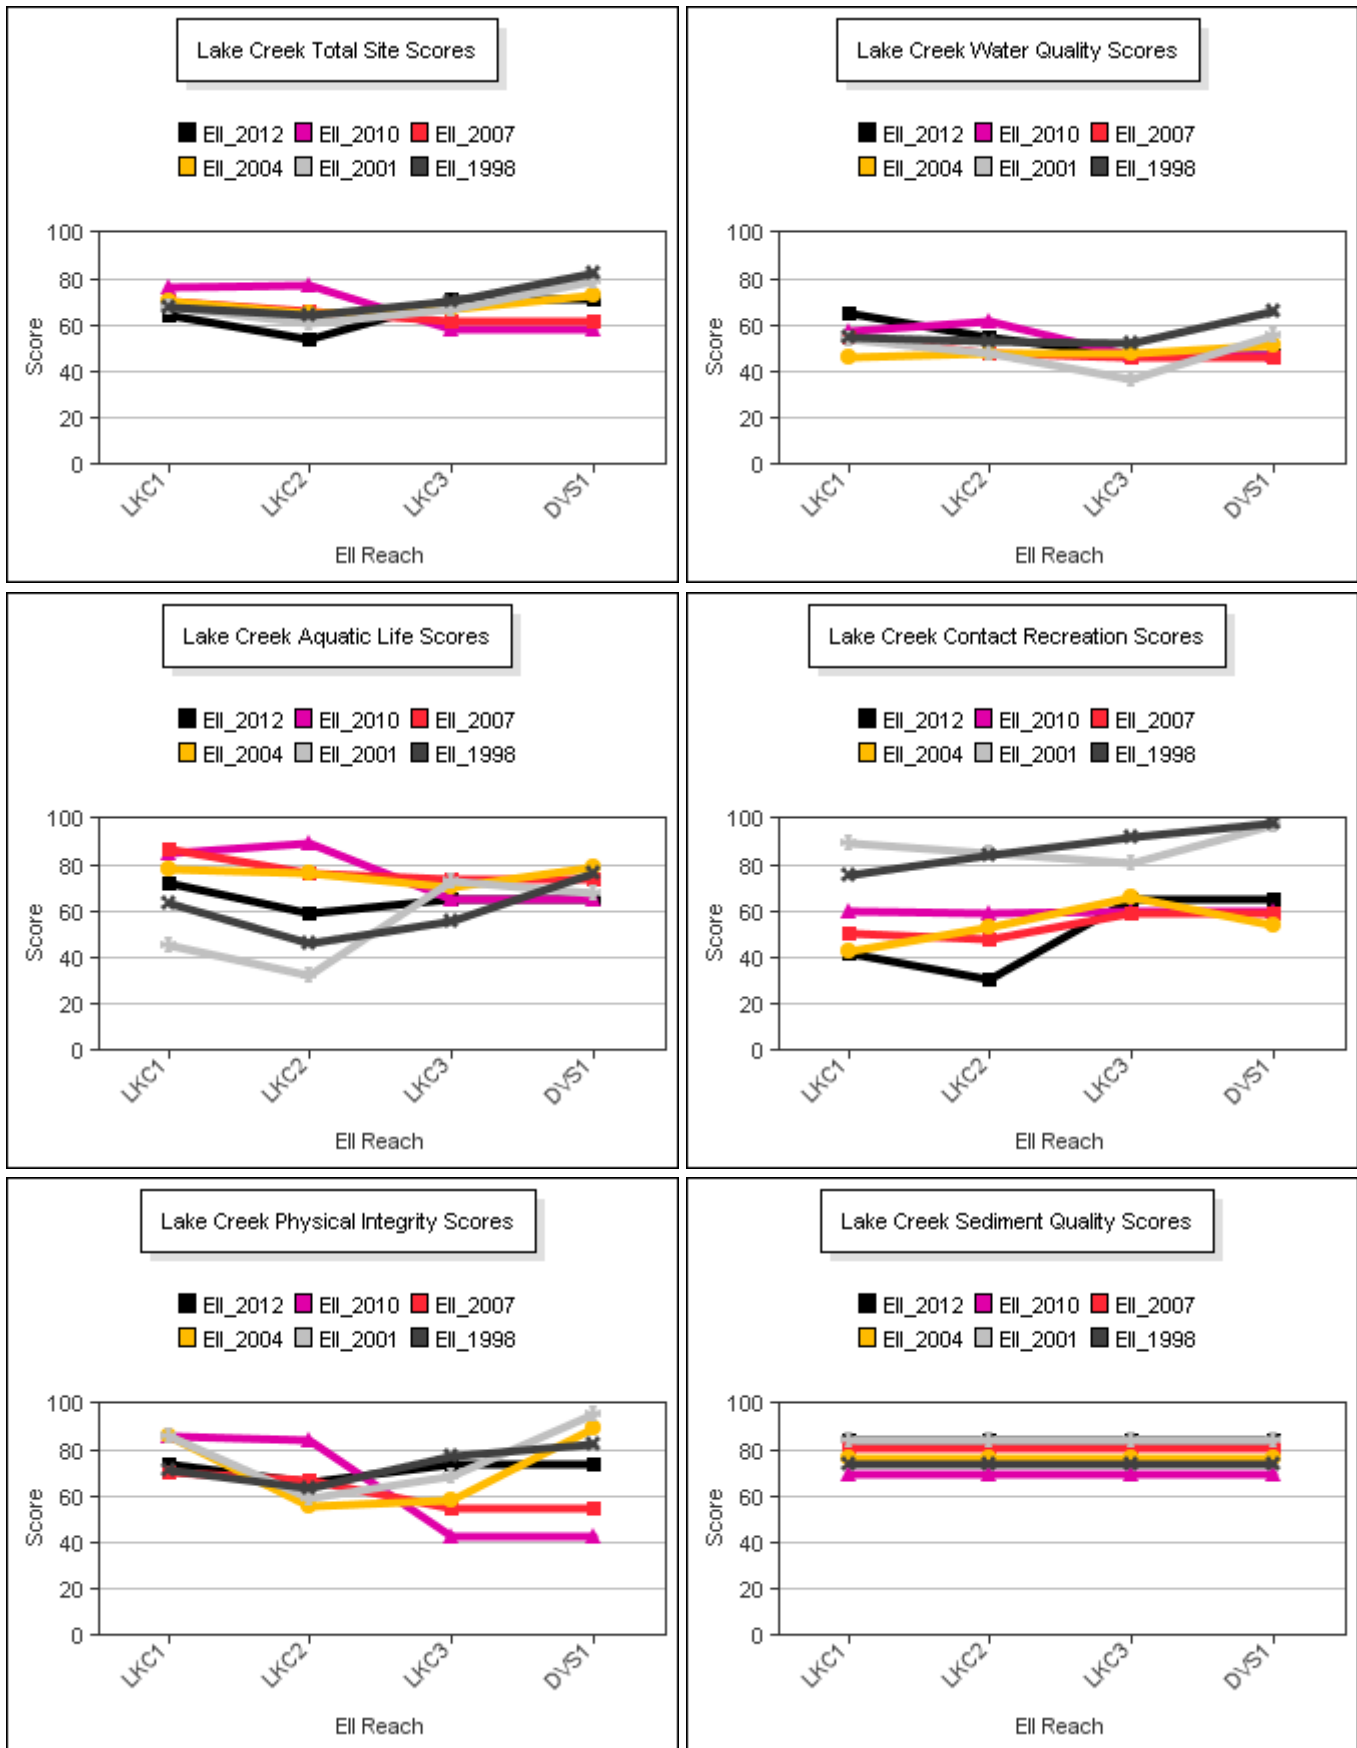
## Score Summary – Reach scores for each sample year
