Lake Austin Hydrilla Management Plan

Lake Austin Hydrilla Task Force:
Lower Colorado River Authority
Texas Parks and Wildlife Department
Travis County
City of Austin

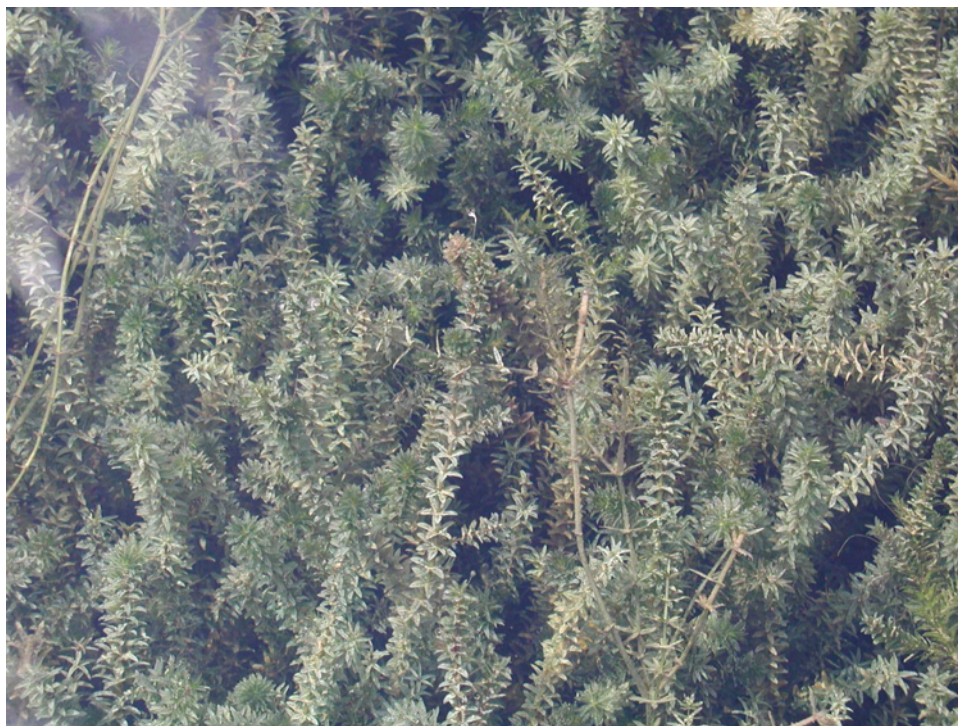
Figure 1
Photograph of Hydrilla

As shown in Figure 1, hydrilla has small pointed leaves arranged in whorls around the stem. It grows rapidly (up to one inch per day) and forms dense surface mats of vegetation that restrict a wide variety of lake uses. Once hydrilla becomes established, it is readily spread by fragments carried by waterfowl, boating activities, harvesting operations and downstream flow.

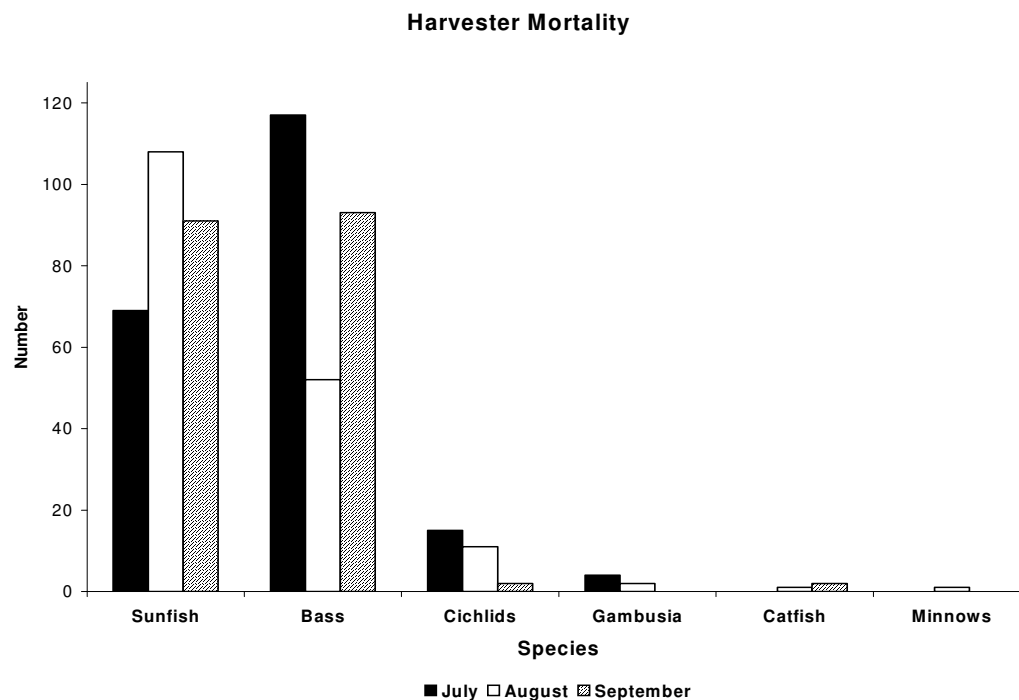
Figure 6. Fish mortality from Lake Bastrop harvester, 1999

One concern with mechanically harvesting aquatic vegetation is the potential to adversely affect fish populations. During normal harvesting operations, small fish are incidentally caught and removed by the harvester. On three occasions during the 1999 summer season at Lake Bastrop, LCRA biologists quantified the size, number and species of fish caught in the harvested hydrilla (see Figure 1). The average collateral catch for the three samples was 189 fish per load of harvested hydrilla, or less than 2 percent of the calculated fish population at Lake Bastrop. At an average of 7 loads per acre, these data indicate that harvesting has the potential to kill 1300 fish per harvested acre.

The Lake Bastrop fish mortality numbers generally correspond to those in scientific literature. Mechanical harvesting removed between 2 and 8 percent of the juvenile fish from harvested areas in Saratoga Lake, New York (Mikol 1985) and 32 percent of the fish population in harvested areas in Orange Lake, Florida (Haller et al. 1980). Harvesting removed 21,000 to 31,000 fish per year, representing 25 percent of the fry from Lake Halverson, Wisconsin (Engel 1990). Harvesting removed about 39,000 fish, predominantly bluegill, from Lake Keesus, Wisconsin (Booms 1999). In the Wisconsin study, largemouth

In Lake Bastrop, sunfish (47 percent) and juvenile bass (46 percent) represented 93 percent of the fish removed as collateral catch (see Table 2). Of the estimated 130,640 fish removed by the harvester, about 61,640 were bluegill, 60,260 were juvenile bass, 6,440 were Cichlids, and 1,380 were Gambusia. TPWD estimated the replacement value for these fish at \$62,700.
