Results of Tracing for Lanier and Hog Wallow Springs in the Balcones Canyonlands Preserve, Bull Creek

SR-15-02, January 2015

Rosemary L. Hatch, Graduate Intern
David A. Johns, P.G.
Watershed Protection Department
City of Austin

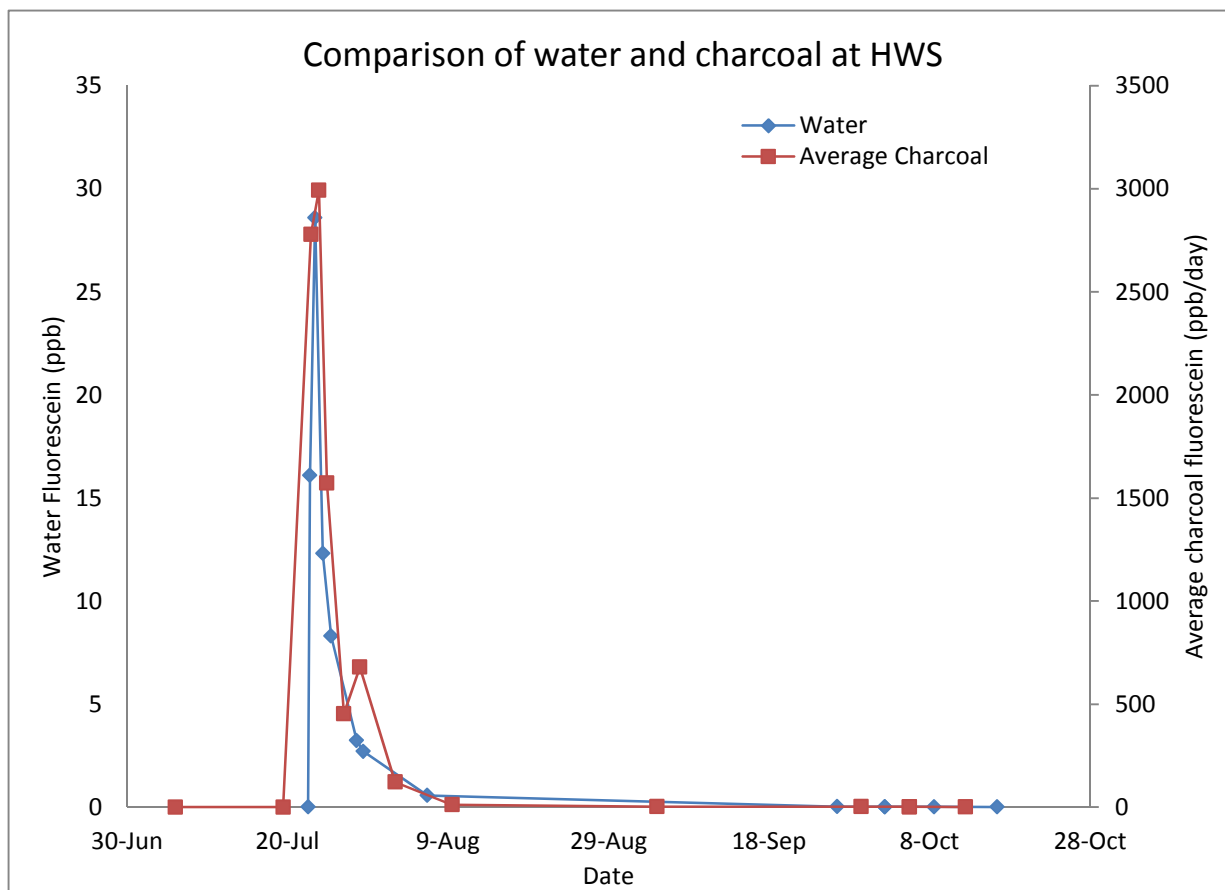
Figure 5. Comparison of charcoal and water dye concentrations at Hog Wallow Spring (HWS). Note the two y-axes show differences in scale of concentrations. The charcoal date is the mid-date between collection and deployment of the packet, while the water date is the date of collection.

spring than T7DH, but still upstream of the confluence with Bull Creek. Both water grab and charcoal samples showed a similar timing of peak concentrations that spike in concentrations within 24 hours of injection (Fig. 5). Assuming a straight-line distance from the injection point to Hog Wallow Spring, the approximate groundwater velocity is 70 ft/hr.

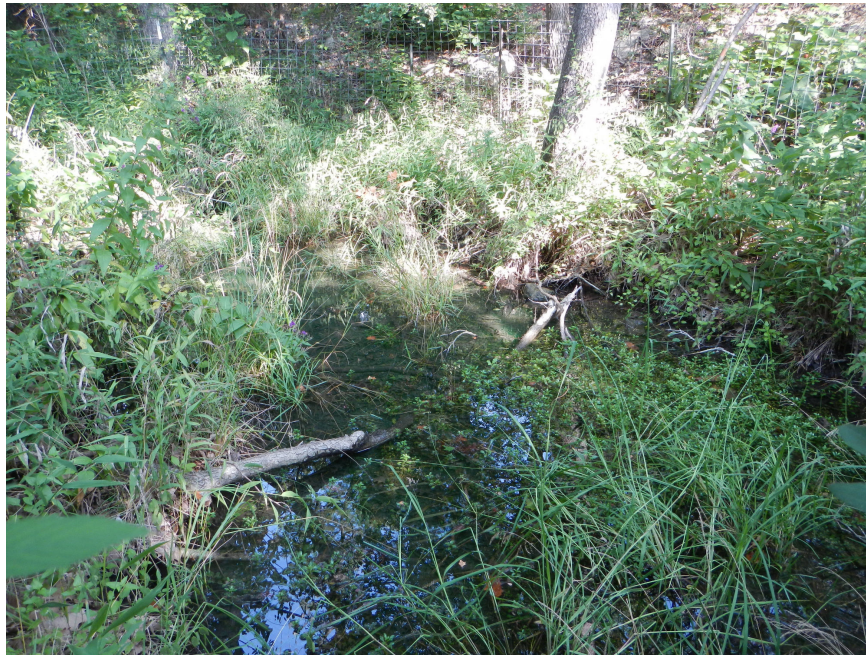
Photo 1: Inside the fence at Hog Wallow Spring. The fence was constructed to keep wild hogs out of the spring area.

Hog Wallow Spring discharges directly into Tributary 7 of Bull Creek upstream of the confluence with the main channel in the BCP (Fig. 2). As of July 2014, the spring was discharging approximately 76.4 gallons per minute (gpm) into Tributary 7 (Photo 1), which is a significant contribution to the overall stream flow. Approximately 600 feet upstream of Hog Wallow Spring, Tributary 7 stream flow drops to zero. At this point, water appears to be infiltrating into alluvial sediments in the creek bed (Photo 2). The water daylights again just upstream of Hog Wallow Spring, however the water at this site was pooled and stagnant for each visit in the study period.

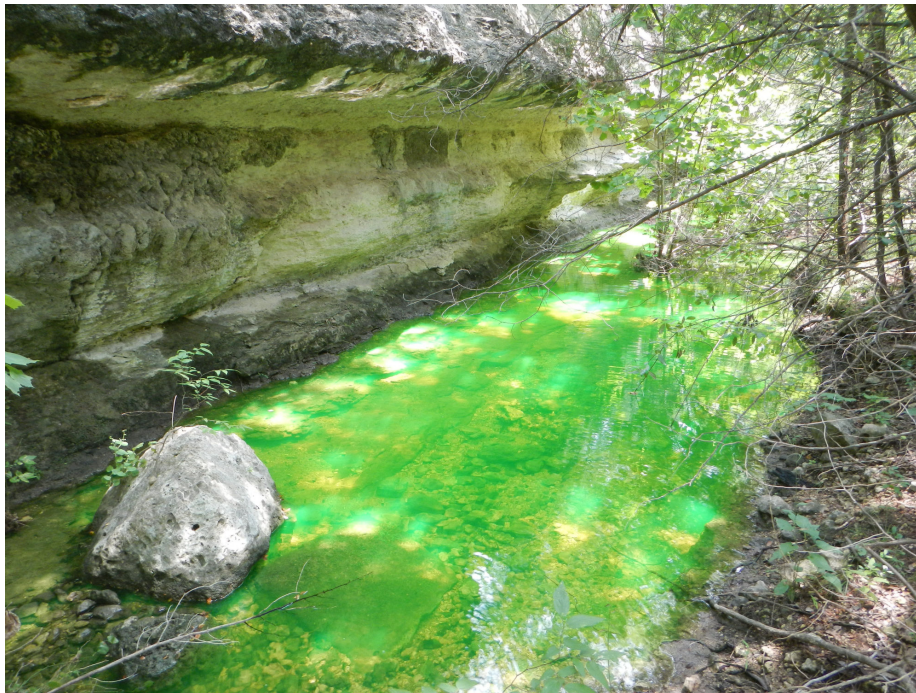
Photo 2: Outcrop of the Glen Rose limestone formation downstream of Hog Wallow trace injection point. Green is visible fluorescein dye from the injection immediately upstream.

The exposed geology in the study area is composed of Glen Rose limestone bedrock overlain by alluvial deposits. Glen Rose limestone is typically considered a non-karstic formation with few solution conduits and slow groundwater movement relative to Edwards aquifer formations. Although there is relatively little elevation change in the study area, there is a Glen Rose outcrop just downstream of the injection point for the Hog Wallow Spring trace on Tributary 7.

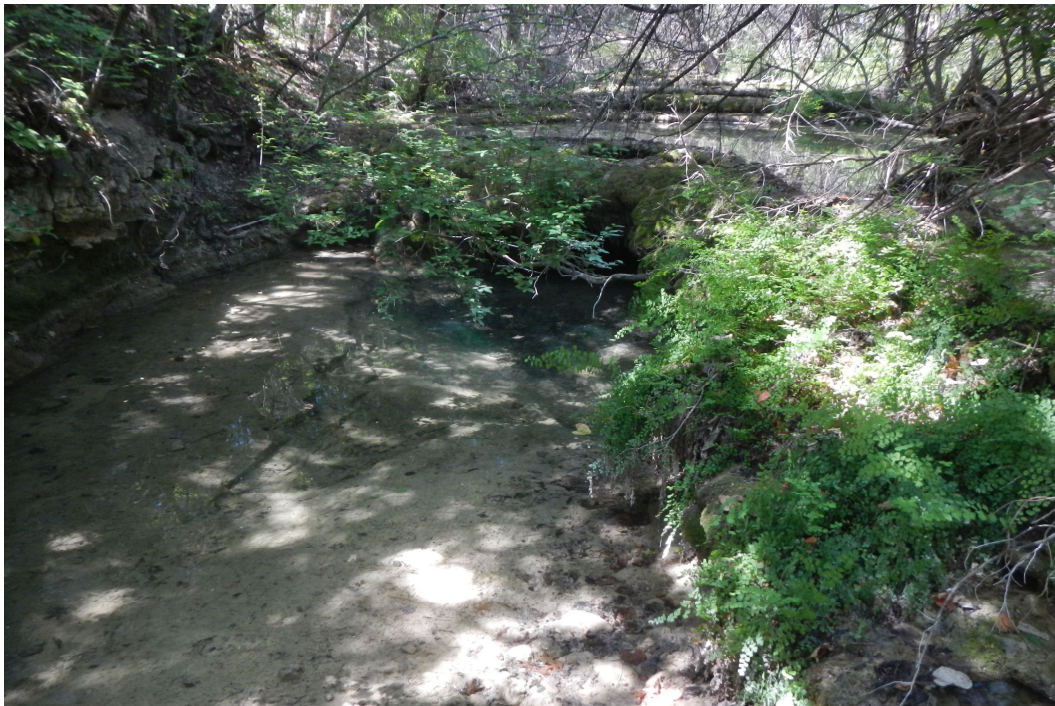
Photo 4. Bull Creek upstream of Lanier Springs where flow ceases due to water moving through alluvial deposits in creek bed.

Lanier Spring is adjacent to the main stem of Bull Creek downstream of the confluence with Tributary 8 (Fig. 2). Flow entering Bull Creek from the spring was measured at 38 gpm in July 2014 (Table 3). Bull Creek, approximately 800 feet upstream of Lanier Spring, disappears under the alluvium in the channel, similar to Tributary 7, and daylights further downstream adjacent to the spring. The area along Bull Creek where the surface flow decreases to zero consists of travertine/tufa dams that create a small grotto and pool

(Photo 4). Throughout the study period, the point of recharge to the alluvium migrated further upstream due to decreasing stream flow.

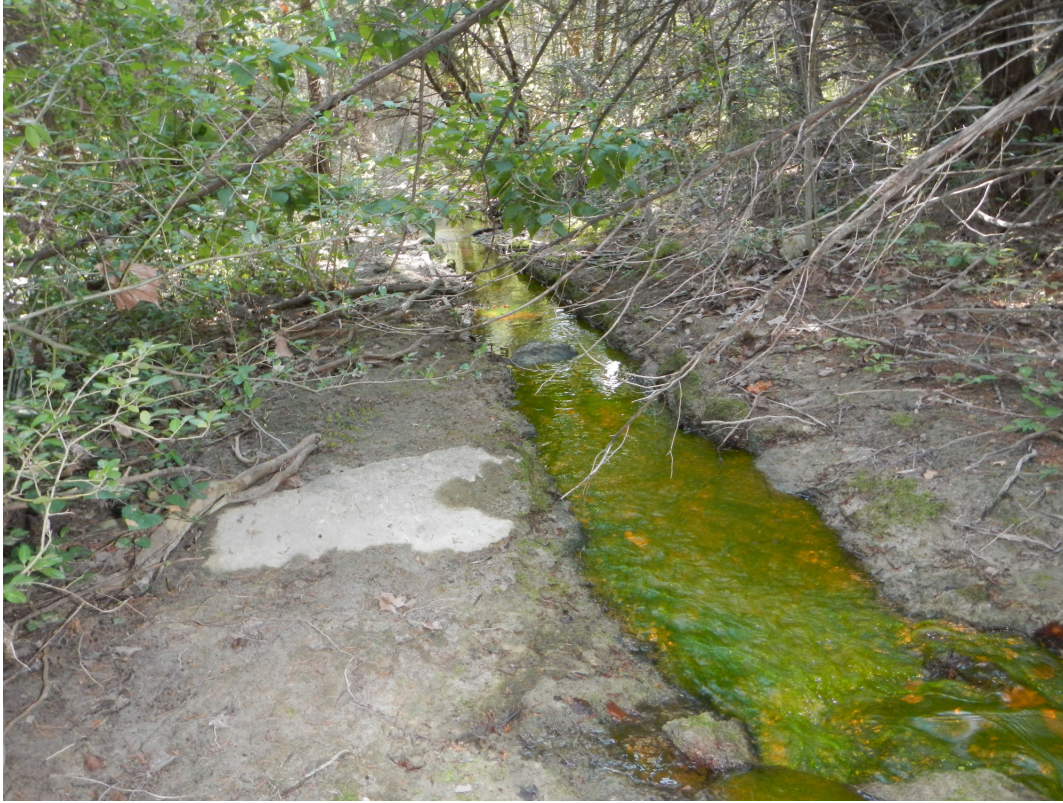
Photo 5. Injection point of eosine dye for Lanier Springs trace.

stem of Bull Creek upstream of the confluence with Tributary 8. The point of injection is approximately 500 feet upstream of a section of the creek covered in travertine deposits and dams (Photo 5). The injection area has flowing water through a narrow possibly channelized section of the stream where surface water disappears when it reaches the travertine deposits. Sites downstream of Lanier were monitored daily for 5 days after injection, followed by weekly monitoring visits for 6 weeks.

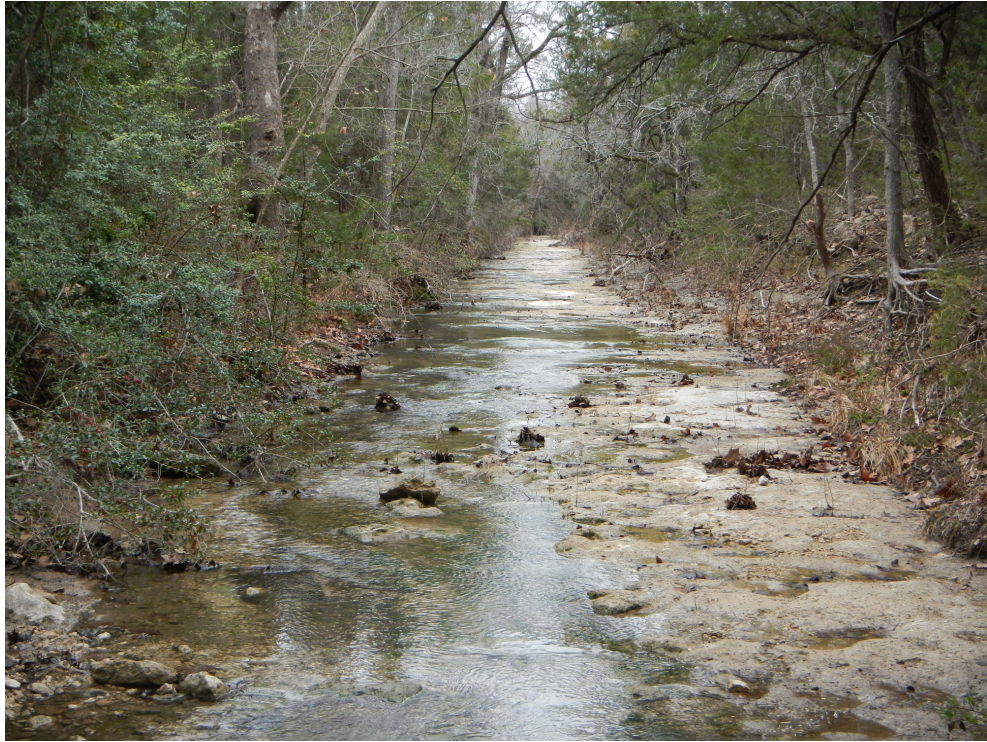
Photo 6. Image of Pit Spring looking upstream. The left bank has alluvial outlets discharging water, while water is also coming out of fractures and openings in the Glen Rose bedrock channel.
