## MEMORANDUM

**Subject:** State of City of Austin Bridges

City of Austin  
Street & Bridge Operations  
**State of Bridges Report**  
**2022**

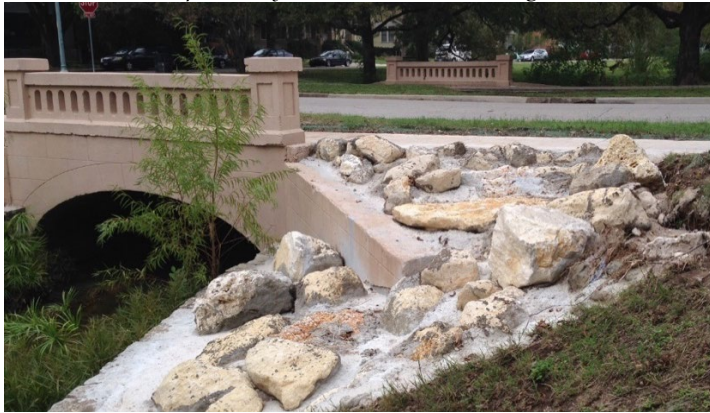
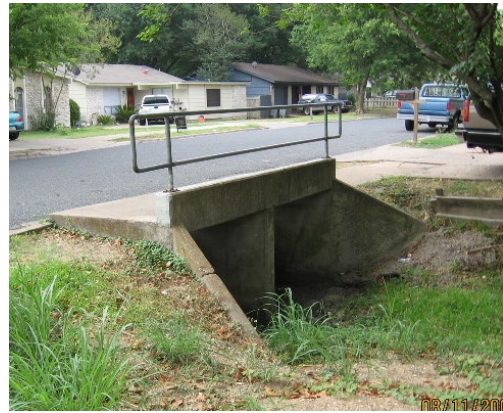
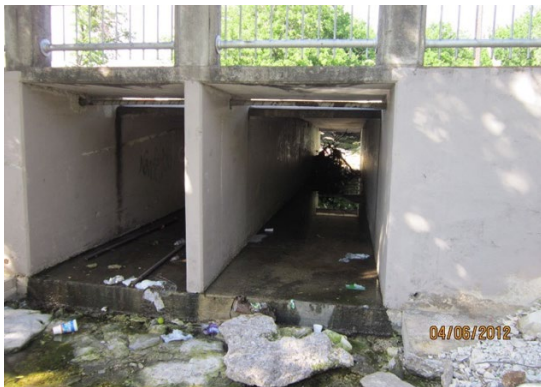
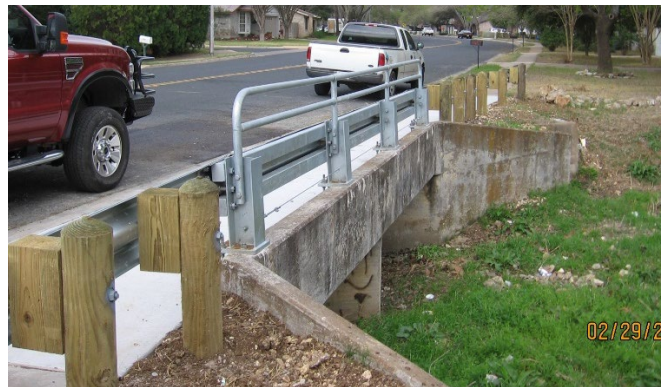
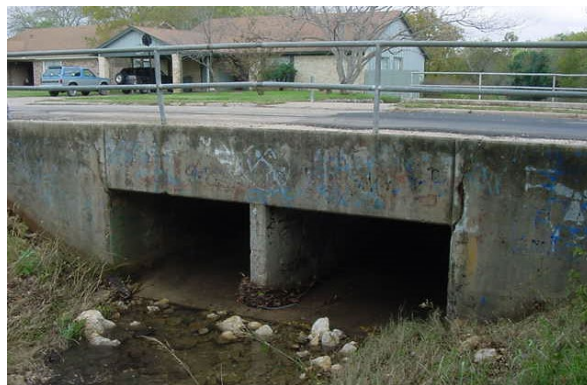
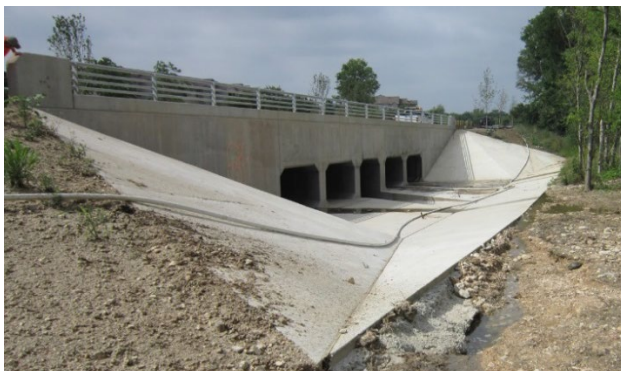
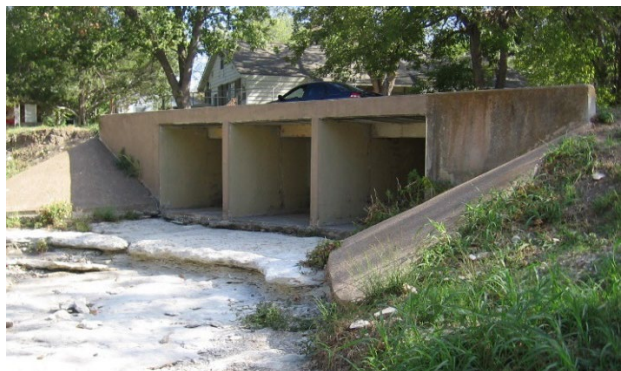
Figure 7. Typical box culverts

Small culverts have an opening less than 20 feet along the center of the roadway. These structures are not inspected by TxDOT and reported to the National Bridge Inventory System (NBIS). Figures 7 and 8 show the examples of typical box culverts and smaller pipe culvert crossing structures.

**(a) Small Box Culvert Structures**

*(these are not inspected by TxDOT as NBIS bridges)*

**(b) Large Box Culvert Structures**

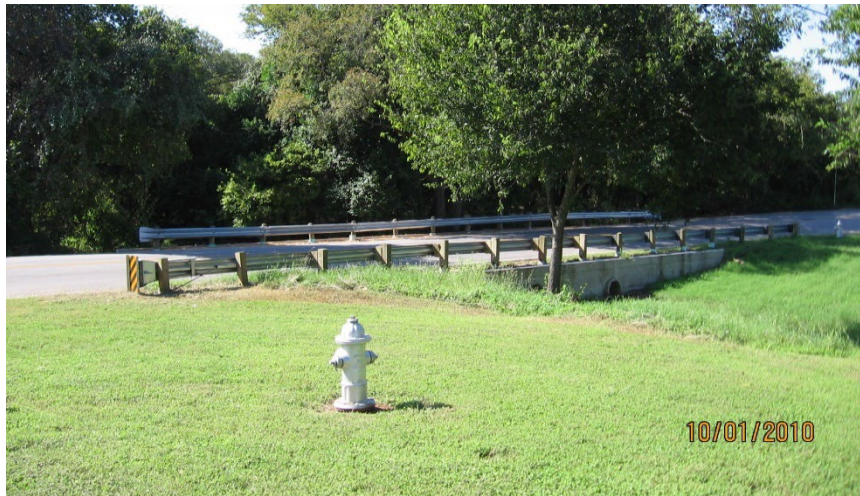
**(a) Standard Pipe Culvert Crossing in Good Condition**

Small multi-pipe crossing with headwalls, guardrailing, and SETs. Abrupt roadway edge drop-off condition, although relatively shallow, warrants guardrailing protection.

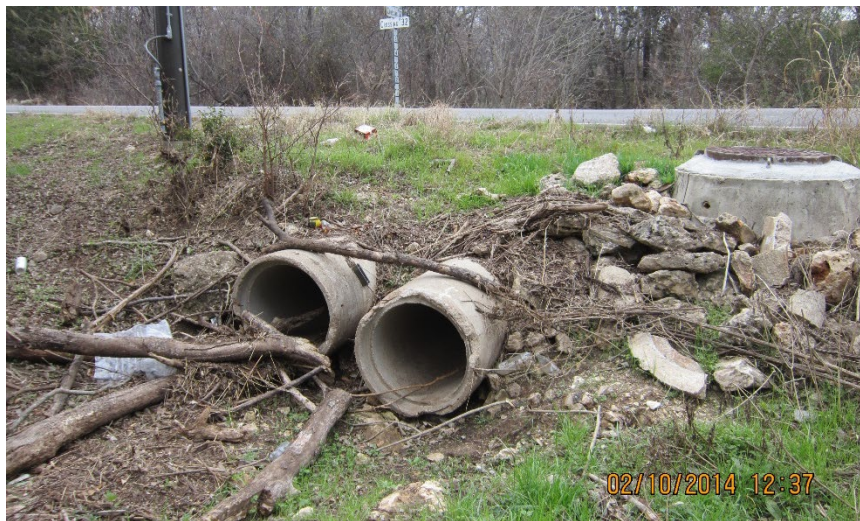
**(b) Non-Standard Multi-pipe Culvert Crossing – Needs Maintenance**

Small, extended multi-pipe crossing with no roadway elements at all. Pipe ends are far outside the roadway clear zone. Shallow bury, small diameter pipes only create a shallow edge drop-off which does not cause a concern for the roadway.

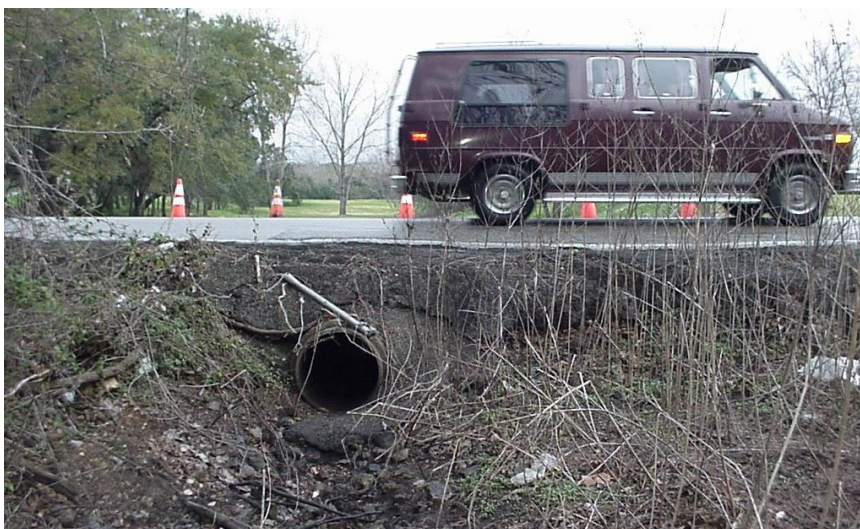
**(c) Non-Standard Pipe Culvert Crossing – Needs Improvement**

Small single pipe crossing with no roadway elements at all. Pipe end is within the roadway clear zone and should probably be protected or the slope extended and improved. Deeper small diameter pipe creates an edge drop-off which may cause a concern for the roadway.

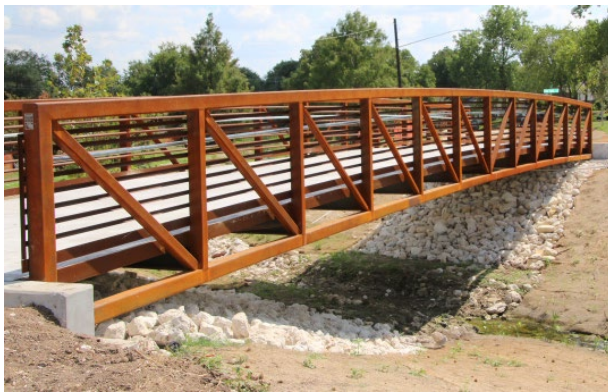
#### (a) Pedestrian Bridge in Good Condition

A prefabricated steel truss frame with a concrete deck located in the J.J. Seabrook Greenbelt Trail. Replacement was completed in 2015.

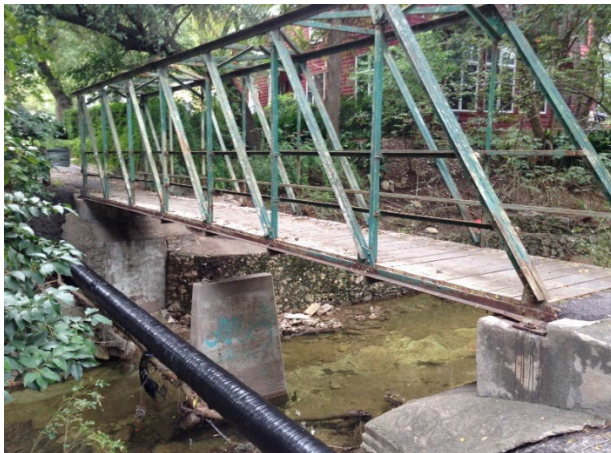
#### (b) Pedestrian Bridge in Poor Condition

A steel truss frame with wooden planks between Sparks Avenue and 31st Street at Waller creek. Rock retaining wall was damaged due to flood events. Steel plank supports and trusses were rusted.

- Barton Parkway
- Landon Lane at Lee Elementary
- Bethune Avenue
- 2 bridges on Johnson Creek Mobility Trail
- Sparks and 31<sup>st</sup>

Replacing a pedestrian bridge can range from \$400,000 to \$1,000,000, depending on span length and foundation depth.
