# SUNKEN GARDEN

### Sunken Garden

### ***Notes on Masonry Restoration***

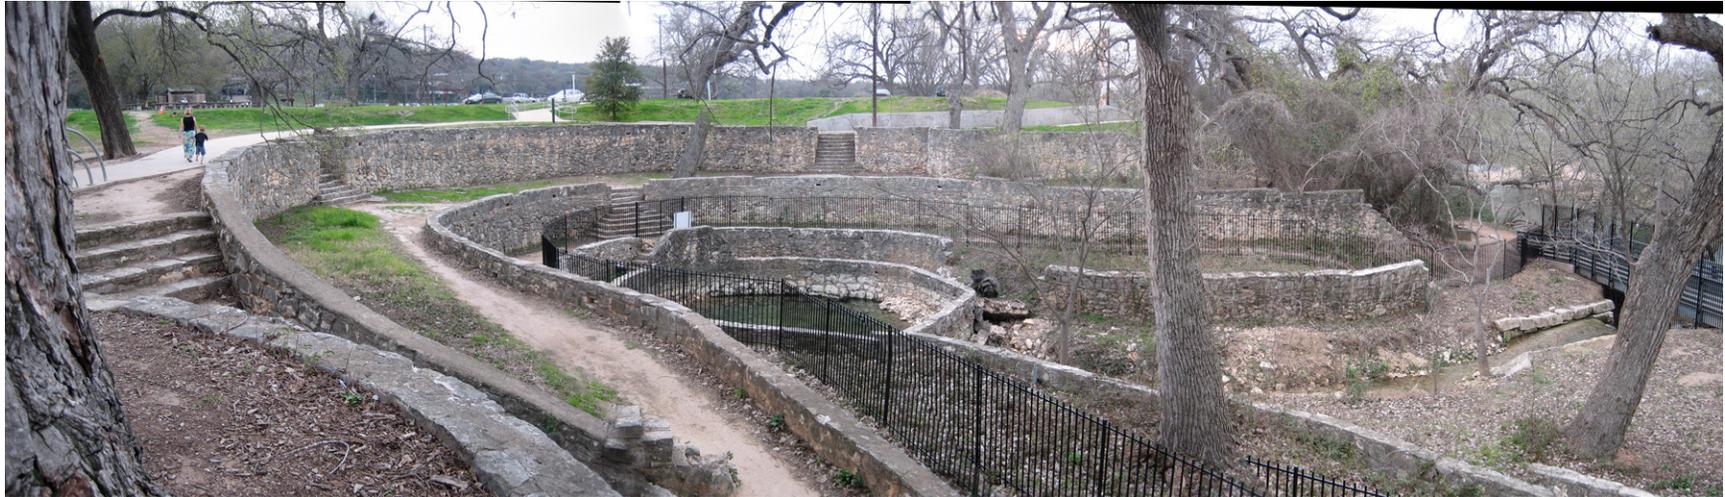
The stone walls are generally 12" thick unreinforced masonry; their heights range from 6 ft. to 12 ft. tall. While some of the walls are relatively straight and in good repair, others are cracked and out of plumb; sometimes by as much as 12". Much of this failure can be traced to structural inadequacy; walls too narrow and tall, and inattention to hydrostatic pressure. Some of it can also be traced to tree roots.

*Sunken Garden as it appears today. Walls have collapsed, some trees are in poor health and the limestone paving stones are concealed by soil and weeds.*

This work should include cleaning silt and debris from the bottom of the vessel and repairing its walls. An operable gate should be installed at the outflow to provide a tool for the biologists in the management of the habitat. A new fence should be installed, located so that it balances the security of the habitat with needs for visitor comfort and enjoyment. The fence should have conveniently located gates to facilitate maintenance, and the new fence should be shorter if possible to facilitate more comfortable viewing. This work should include landscape additions to complement the riparian landscape work already in place, and it should include landscape attention to the understory in the fenced area to either side of the spring run. Additional pecans can be planted within the spring fence as spots of sunlight emerge. The planting of riparian vegetation inside the spring fence, including coralberry, river fern, pigeonberry, beautyberry and inland sea oats, should continue. Above the spring walls near the Zilker Trail, a row of larger caliper (4"-5") trees, such as cedar elms or chinquapin oaks could be added, following the line of the retaining wall, to replace the large pecans that have been lost.

- F. Repair and/or rebuild the historic stone walls. Reconstruction should use modern techniques to promote long service life. Coordinate the construction efforts with tree replacement to minimize disruption.

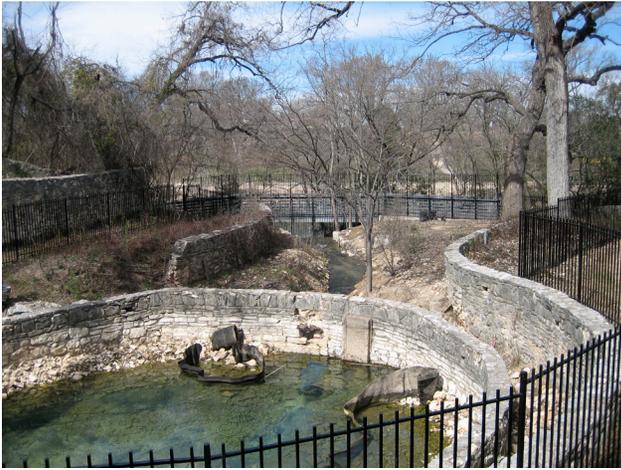
*Sunken Garden in 2007. Some walls have collapsed, and the landscape is less organized. The fence is to protect the salamander habitat.*

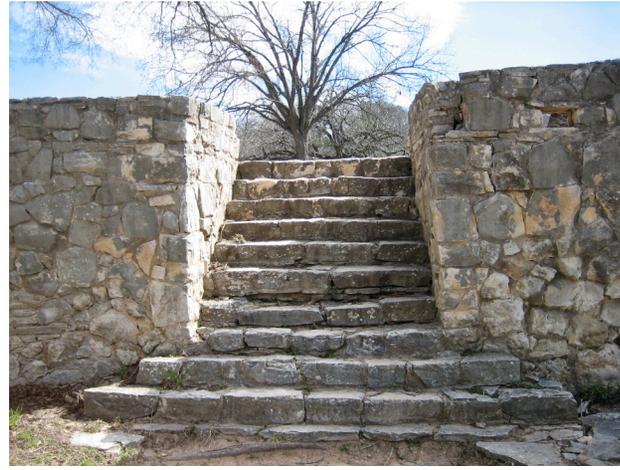
*Stone stairs are in disrepair (above and right). Steps should be rehabilitated to improve footing, handrails should be added.*

The stairs are defining features of the place, and, obviously, they are the clearest way to negotiate the level changes. But the tread surfaces are uneven and with some stones missing, they present a hazard. The stairs should be rebuilt with new, even treads. Steel handrails should be added for visitor safety and convenience. During the design process, the architect should coordinate with City of Austin code officials regarding provisions in the Uniform Code for Building Conservation governing the reconstruction of historic elements that do not comply with today's codes.

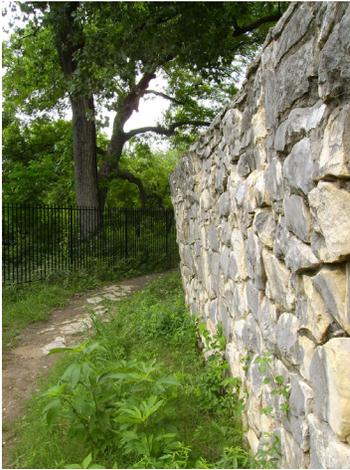
*Some walls are leaning precipitously. Strategy for stabilization should account for historic preservation, long-term service and public safety.*

The stone walls of Sunken Garden are built of unreinforced masonry, which are cracking and leaning in places, and in some cases have failed completely and have collapsed.

These kinds structural problems are probably caused by a number of factors; tree roots too close to the back of the walls, soil pressure causing walls to topple and in some instances the walls are simply too tall and slender. At stair locations, corners can be seen to be pulling apart, which is likely due to insufficient “keying” of stones across the intersection. The challenge for the historic preservation architect is to find solutions that restore the walls in minimally intrusive ways, which takes on special significance in cases like this, where the repairs to the failing parts must be integrated seamlessly with adjacent walls that are structurally intact.

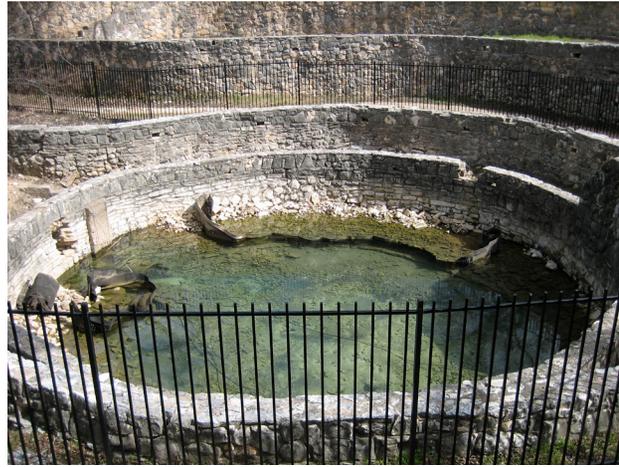
*One short-term goal is to repair the walls of the spring vessel. In the same effort, add an operable sluice gate and remove sediment.*

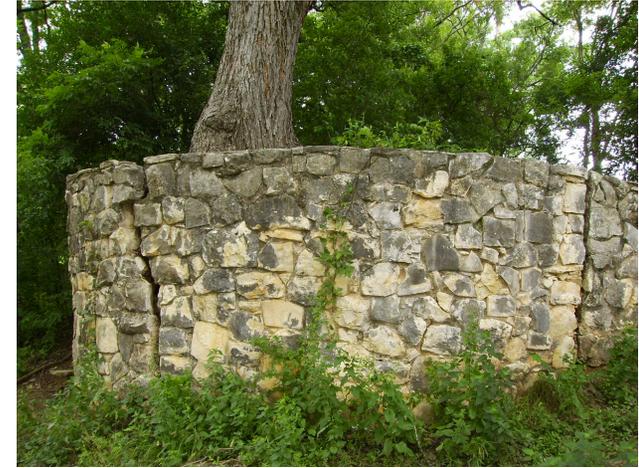
*Repairing and stabilizing this crack will require the removal of the tree.*

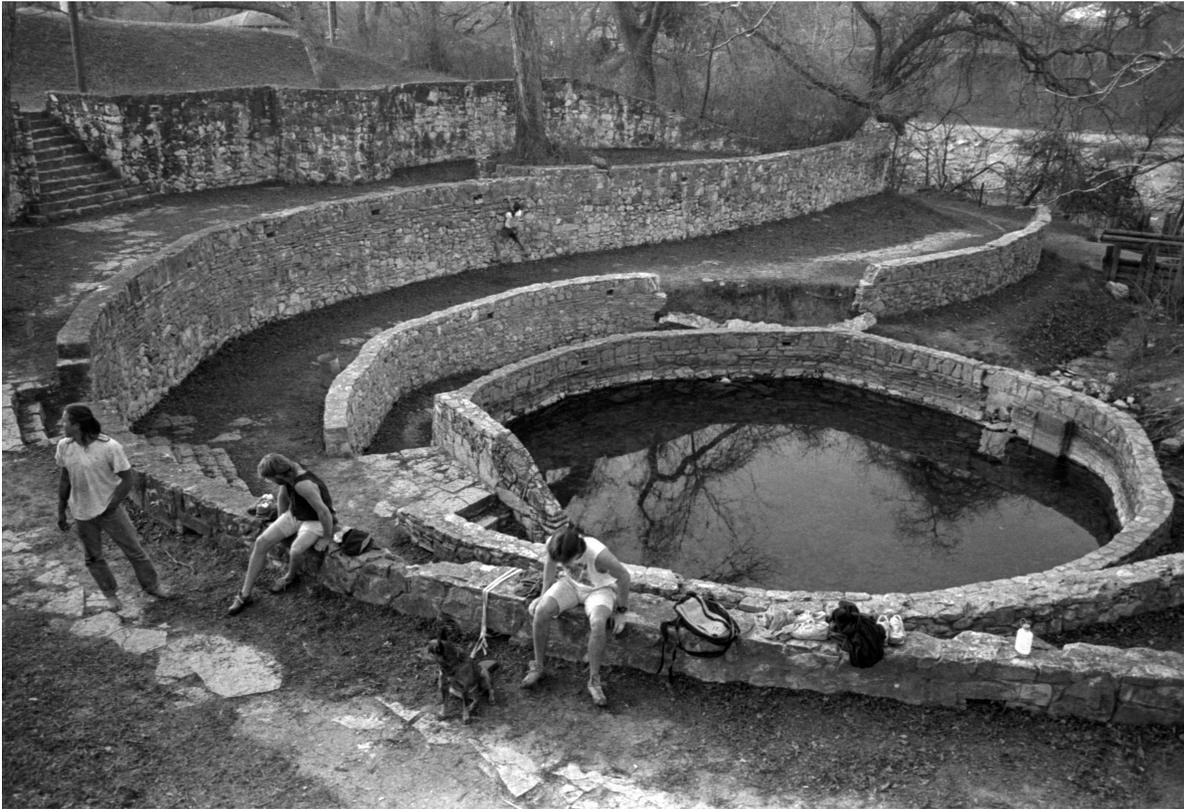
*A dozen years later, Sunken Garden on February 19, 1993. The landscape is still nicely groomed and the flagstone paving stones are not yet obscured by overgrowth. According to photographer Alan Pogue, the wall section collapsed in the flooding of 1991. Note that the wall section to its right appears to be leaning as does the wall above it.  
Photo: Alan Pogue*

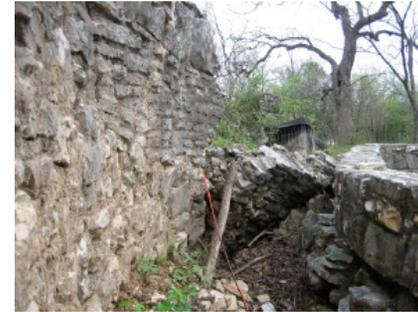
Openings are made in the walls for helical screws, which are driven horizontally back into the soils about five feet. A steel compression plate would then be affixed to the exposed end of the screw, securing the wall in position. These screws would likely be placed 48” apart horizontally, with two rows required; one at the one-third height and the other at the two-thirds height.

This technique would likely limit the need to dismantle walls and rebuild them. Further, some leaning parts might be pushed back into level before installing the screws. In any event, it would require digging a trench behind the wall to relieve soils pressure and to allow for pushing the walls back if required. Once the walls are repointed and repaired, new soils would be installed.
