Chapter 6

Plummers Cemetery

Plummers Cemetery was established in 1898 as a private cemetery serving Austin’s African American community. This chapter contains a historical narrative of Plummers Cemetery’s development, an examination of its historic integrity and significance, a discussion of existing conditions observed in the cemetery during the master plan team’s site evaluations, specific treatment recommendations, and a list of potential projects with cost estimates.

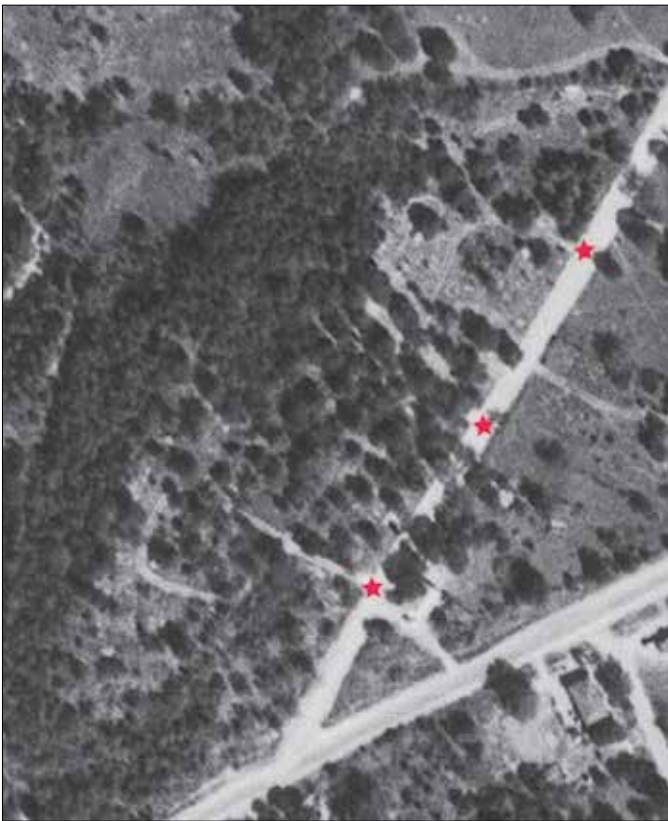
An aerial photograph taken in 1952 (Figure 291) shows that the cemetery had three access points: one being today's entrance, the second being located approximately 210 feet northward along Springdale Road, and the third being located approximately 160 feet farther north along the road. The second driveway entrance connected to the internal cemetery drive and may have created a second loop. The third cemetery entrance appears to have also served as a driveway for a house that was located close to the road and may have served as the sexton's residence.

Figure 291. Aerial photo of Plummers Cemetery as it appeared in 1952, with the addition of stars to indicate the locations of the three cemetery entrances (City of Austin)

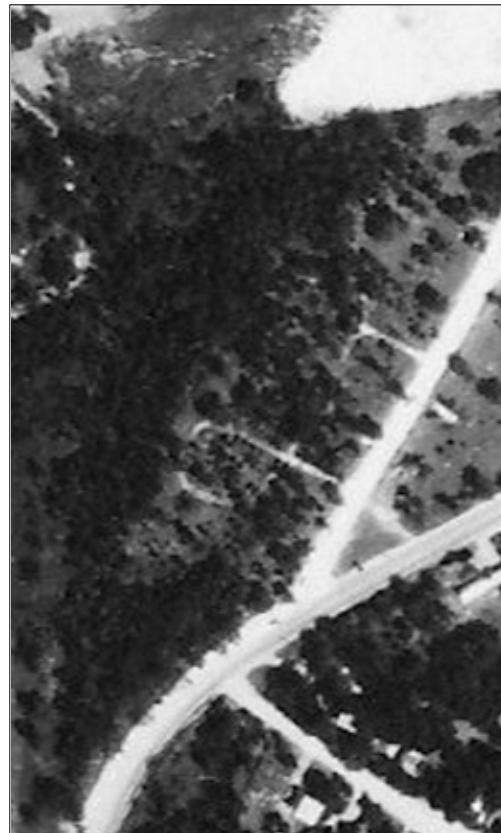
The severe drought of the 1950s may have contributed to the loss of trees in the cemetery, as shown in an aerial photo from 1969 (Figure 292). However, rows of trees parallel to grave sections are still visible, although a comparison of later maps indicates that many of these trees were removed in the 1970s.

Figure 292. Aerial photo of Plummers Cemetery as it appeared in 1969 (City of Austin)

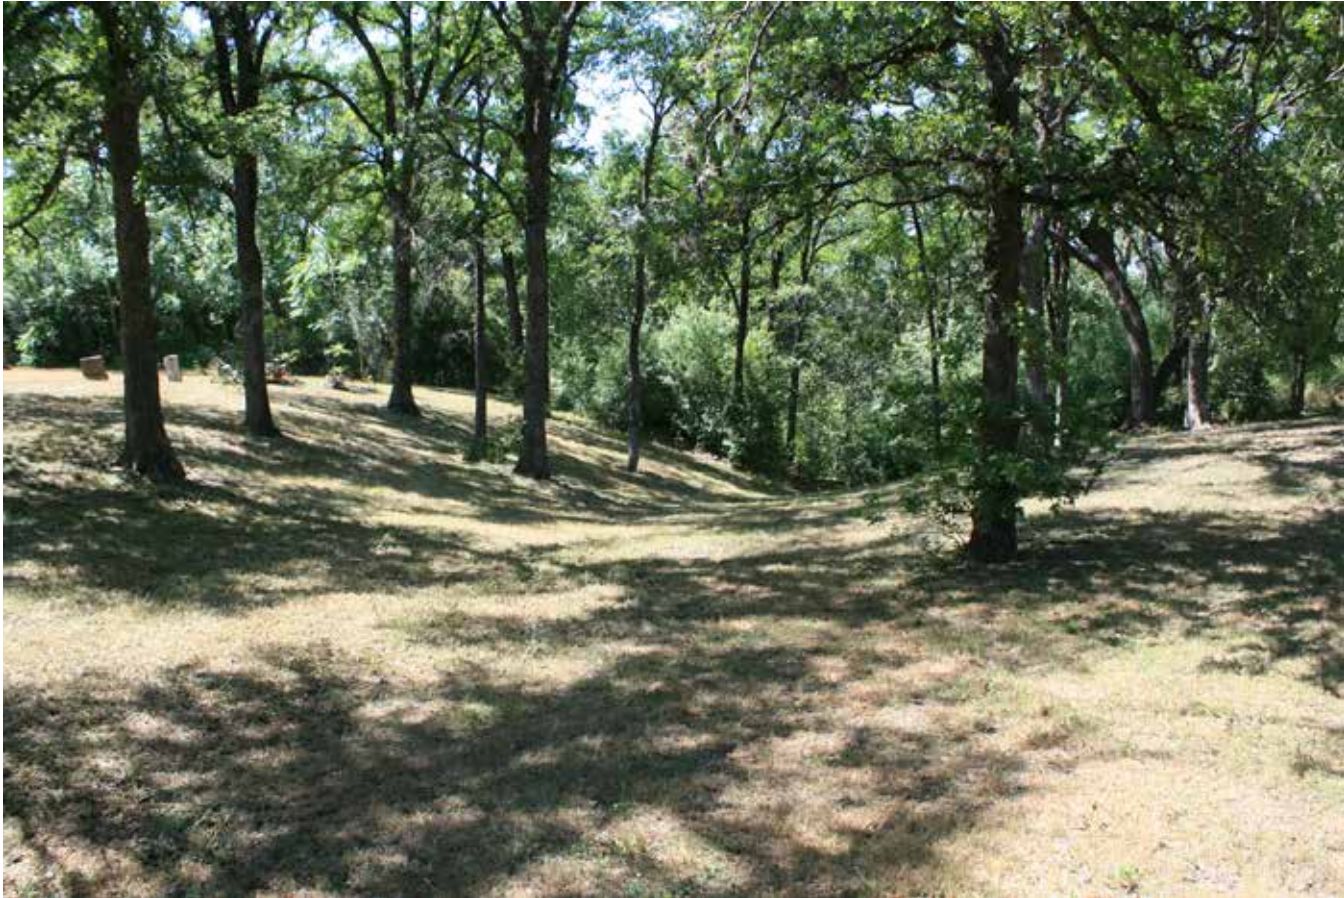
Figure 294. A drainage channel divides the cemetery (John Milner Associates)

The primary issue affecting the topography of Plummers Cemetery is the potential for soil erosion on the steeper slopes of the two drainage valleys that extend into the cemetery, as well as around grave markers and family plot curbs. Soil erosion occurs most frequently in the cemetery when reduced tree cover is combined with the current intensive mowing regime. In addition, erosion occurs locally where trimming activity removes vegetative ground cover. To reduce the occurrence and extent of erosion in the cemetery, the following actions are recommended:

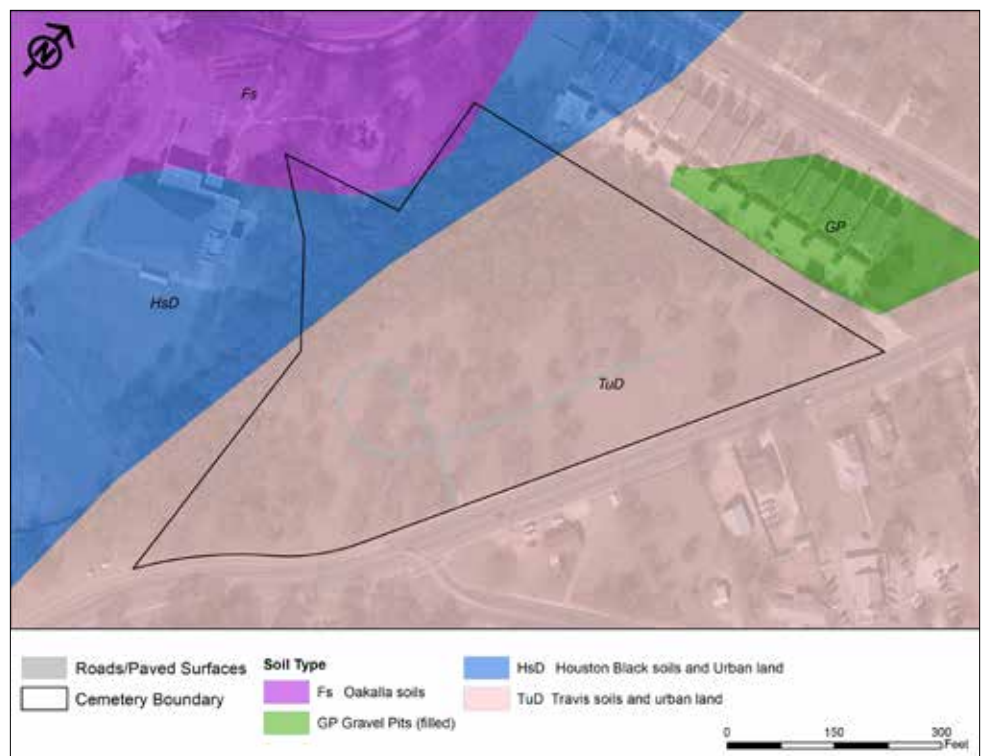
Of the first type, Travis soils make up about 45 percent, urban land makes up about 35 percent, and other soils about 20 percent. Travis soils have a surface layer of gravelly fine sandy loam about 18 inches thick, with a second layer of red gravelly sandy clay to a depth of 50 inches. Urban soils are made up of a mixture of native and imported soils and other material, and cannot be described unless specifically tested. The Travis soils and urban land in Plummers Cemetery are characterized by 1–8 percent slopes.

The second type of soil present in a small area of Plummers Cemetery consists of about 56 percent Houston Black clay, 30 percent urban land, and 14 percent other soils, including Heiden clay and Burleson clay. Houston Black soils have a surface layer of very dark gray clay or gravelly clay about 30 inches thick, with a secondary layer of dark gray clay to a depth of 75 inches, underlain by mottled clay. The urban land is of an unknown composition. The portion of the cemetery where these soils occur is entirely wooded and has no known burial sites.

Figure 295. Plummers Cemetery soils (Plummers Soils; Project Team)

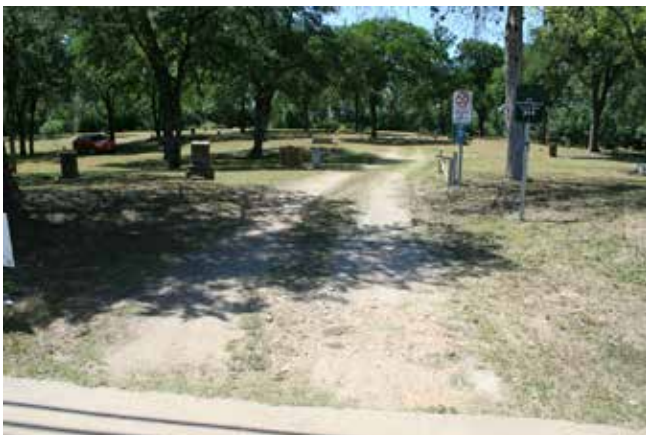
Within the cemetery, vehicular circulation is provided via a narrow gravel and dirt drive that extends west into the site up onto the southern knoll before making a counterclockwise loop and crossing itself to extend north through the cemetery, parallel to Springdale Road (Figure 299 on page 240).

Figure 299. A narrow gravel and dirt drive provides the only vehicular circulation through the cemetery. (John Milner Associates)

- Provide for pedestrian circulation via the cemetery drive trace, which should be maintained as a regularly-mowed path, 10 feet wide (Figure 337).
- Include visitor wayfinding tools in the informational kiosk, including a graphic plan of the cemetery, including a grave location map, if possible; a brief account of its history and significance; visitor registration; and operational or maintenance rules.

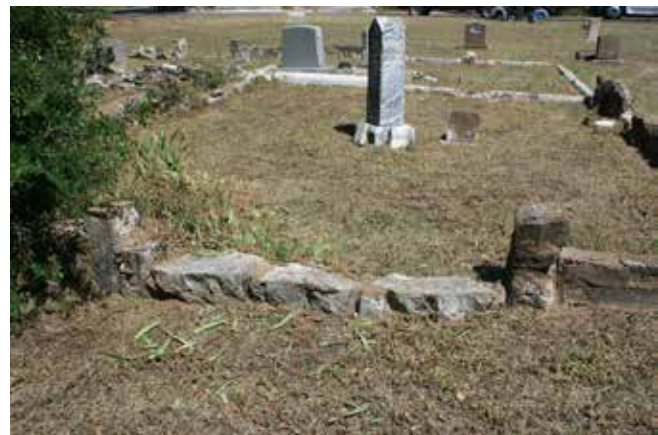
Figure 300. Access to family plot via a low stone threshold (John Milner Associates)

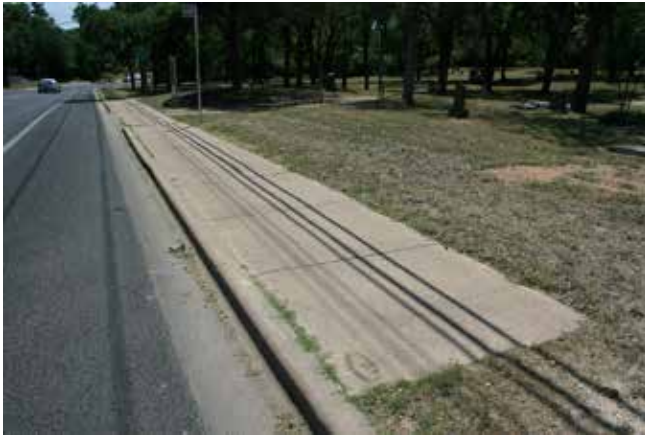
Figure 301. Concrete sidewalk along the east side of the cemetery on Springdale Road (John Milner Associates)

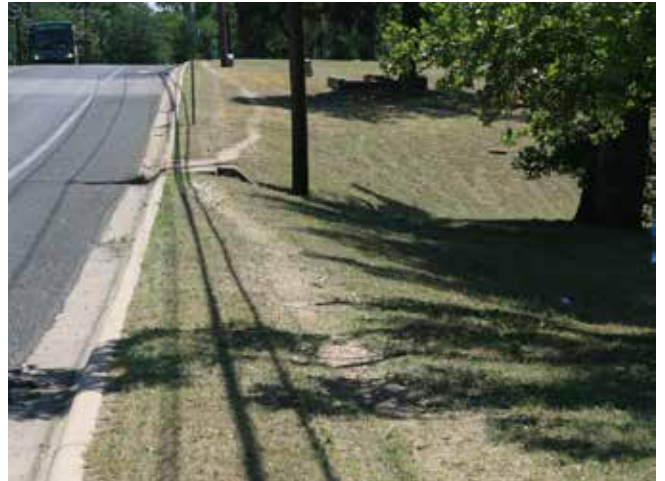
Pedestrian circulation is not defined within the site, but can occur along the loop road and in spaces between burial plots. Formal access, into the few family plots defined by curbs or walls, is usually defined by low thresholds set into the curb or wall (Figure 300). A city bus stop on Springdale Road required the installation of a short section of concrete sidewalk along a portion of the eastern edge of the cemetery (Figure 301). Social trails extend from both ends of this sidewalk to parallel Springdale Road along the cemetery boundary (Figure 302).

Figure 302. Social trail on cemetery grounds along Springdale Road (John Milner Associates)

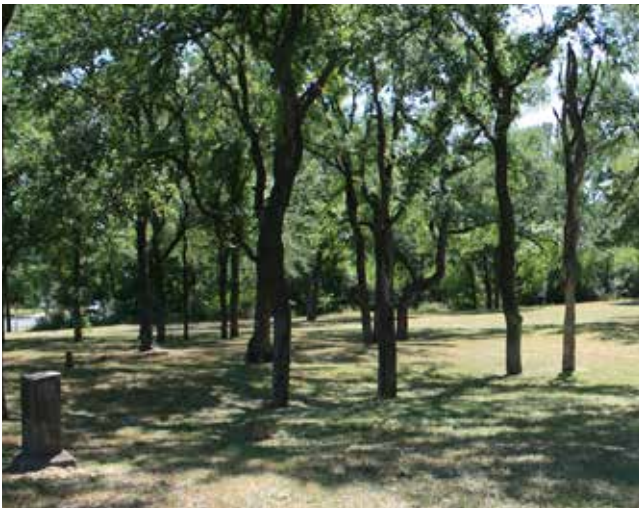
The burial area of Plummers Cemetery is generally characterized by an open, rolling grass lawn dominated by a mature grove of cedar elm (*Ulmus crassifolia*) (Figure 303). A few other species are present in this grove, including post oak (*Quercus stellata*), chinaberry (*Melia azedarach*), American elm (*Ulmus americana*), ashe juniper (*Juniperus ashei*), live oak (*Quercus virginiana*), blackjack oak (*Quercus marilandica*), pecan (*Carya illinoensis*), and honey mesquite (*Prosopis glandulosa*). Most of these trees are in fair condition and exhibit some portion of dead wood (Figure 304).

Figure 303. A grove of cedar elm dominates the cemetery.
(John Milner Associates)

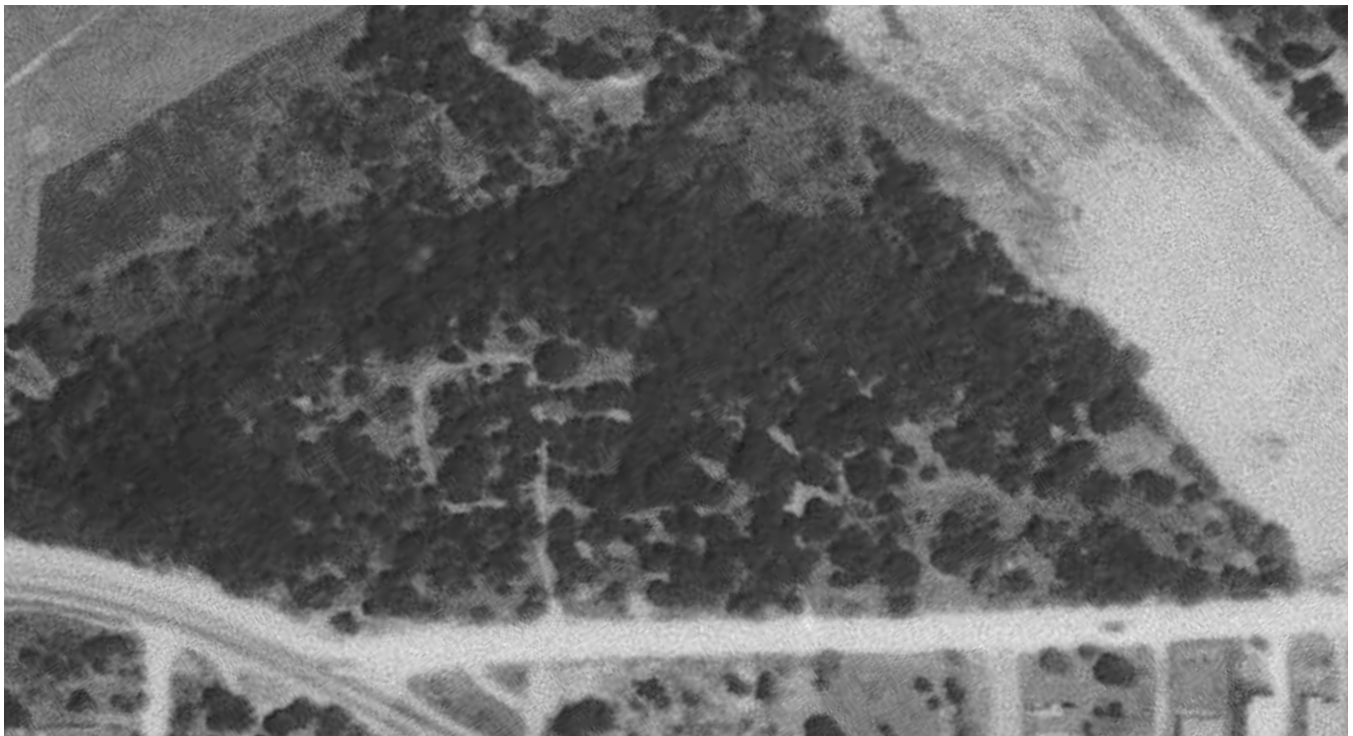
Historic aerials of Plummers Cemetery indicate that, earlier in the twentieth century, trees had been planted in rows parallel to the arrangement of burial plots (Figure 305). This pattern is no longer evident in the cemetery, due to the removal of numerous trees sometime between 1967 and 1973, as seen in a comparison of historic aerial photographs on the website HistoricAerials.com.

Figure 305. Aerial photograph of Plummers Cemetery, 1966 (Plummers 1966, City of Austin)

- Develop a construction phase planting plan to replace trees that have been lost from the cemetery, based on the 1966 aerial and any ground-level evidence, such as stumps. Determine species and location by further close study of historic aerials and identification of stumps and other vegetative remnants. It is possible that shrubs or perennials may mark the location of a tree.

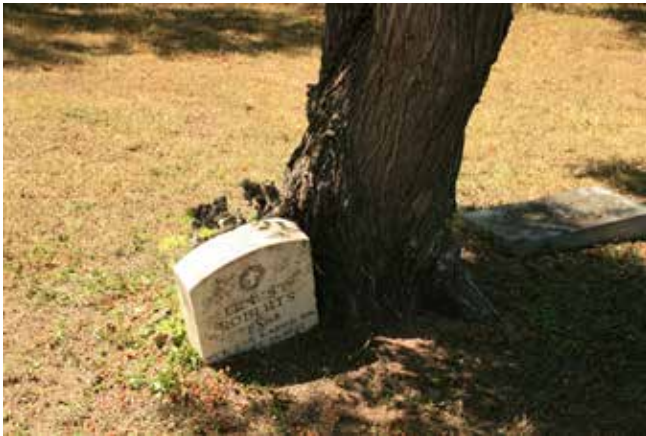
In a number of instances, a mature tree is growing directly adjacent to or behind a grave marker, in line with the Upland South folk cemetery tradition of planting trees (typically Eastern red cedar) in family plots or next to individual graves. In a few cases, the tree has caused damage or lifting to adjacent grave markers or plot enclosures (Figure 306).

Figure 306. Tree roots causing damage to adjacent markers (John Milner Associates)

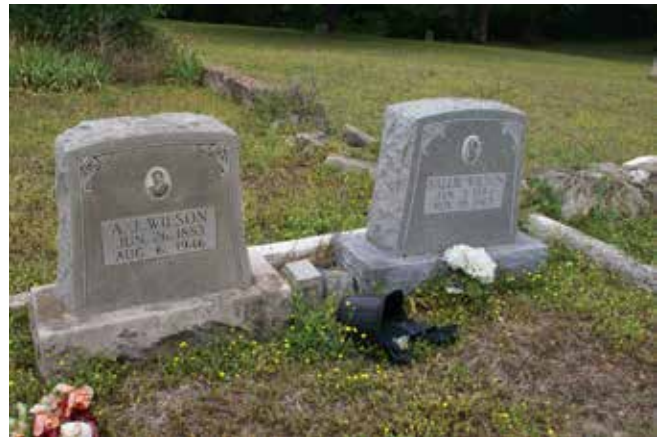
Figure 311. Granite markers with ceramic photographs (McDoux Preservation)

Most grave markers in Plummers Cemetery are made of either concrete, granite, or marble (Figure 310, Figure 311). A few limestone markers are present, as are individual examples of brick, bronze, and steel markers (Figure 312). No above-ground tombs are present. Several infant graves are located in the cemetery, some identified by lamb motifs, but there is no separate infant section.

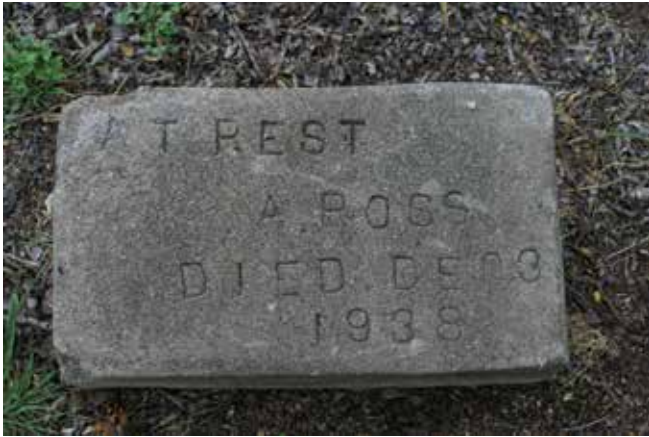
Figure 313. Handmade concrete marker (McDoux Preservation)

Most markers feature carved, pressed, or molded inscriptions, some of which are worn and hard to read. Many are clearly handmade of concrete or other materials; some are embellished with inlaid tile.

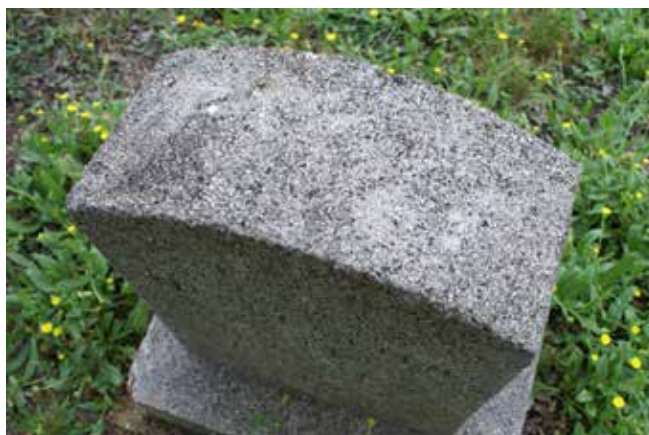
Figure 317. Concrete grave marker with distinctive mica aggregate (McDoux Preservation)

Many of the concrete markers appear to be made by the same person or company; these distinctive pieces feature larger pieces of mica and other decorative applied aggregate (Figure 317). A series of stone markers enframed in concrete are also present (Figure 318–Figure 320).

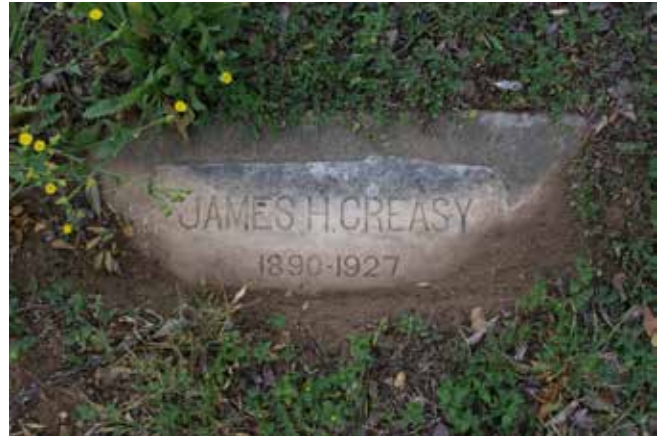
Figure 320. Stone marker in concrete; the marker is sunken and shows mower damage (McDoux Preservation)

- Protect, preserve, repair, and conserve cemetery markers, including unique works of art and craft.
- Monitor mowing and trimming practices to identify methods causing damage.
- Limit cemetery mowing, except on the cemetery drive, to once or twice a year, to reduce mower and trimmer damage to markers and plot enclosures. Mow the cemetery drive as needed for daily access.
- Avoid using riding mowers and metal core trimmers within 12 inches of markers and plot enclosures. Finish using trimmers with nylon whips only.
- Encourage the establishment of groundcovers within curbed or walled family plots, to reduce the amount of mowing and trimming required.
- Clean, reset, and conserve markers as recommended in Chapter 3, General Management Guidelines.

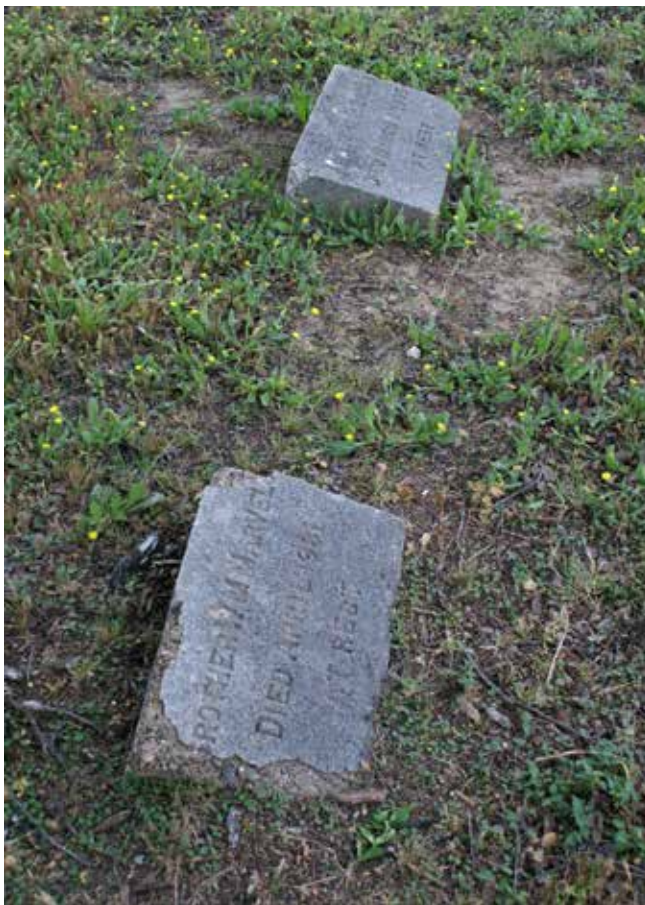
Figure 321. Mower damage (McDoux Preservation)

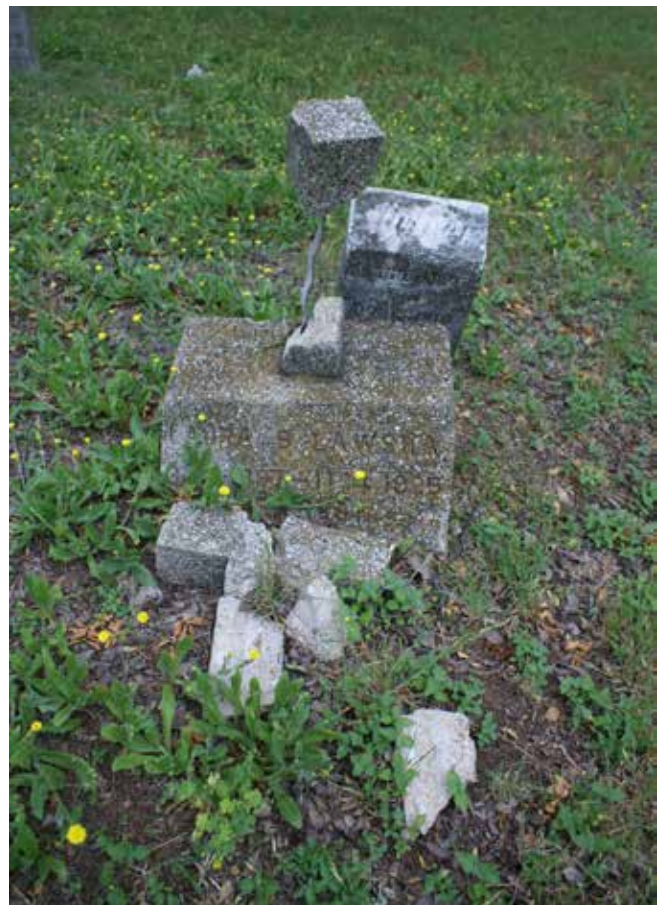
Figure 322. Broken concrete cross (McDoux Preservation)

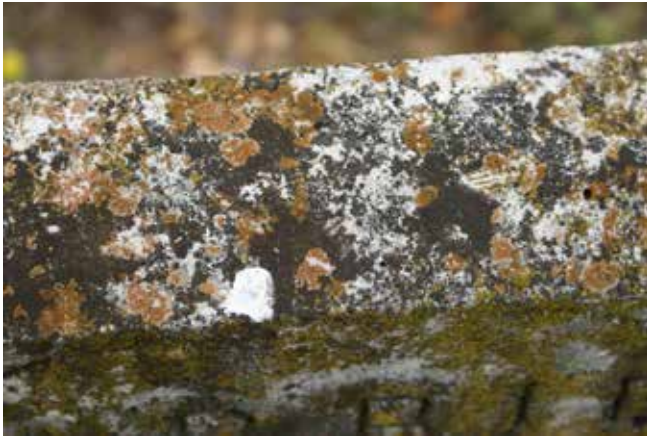
Figure 323. Biological growth (McDoux Preservation)

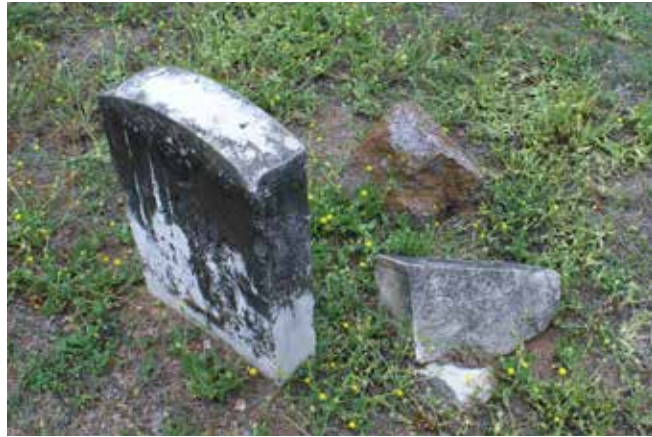
Figure 324. Biological growth (McDoux Preservation)

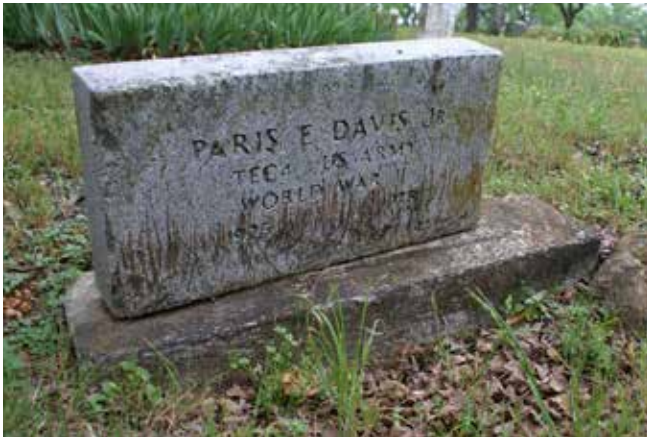
Figure 325. Marker displaced by contact with a mower and severely damaged by trimmers (McDoux Preservation)

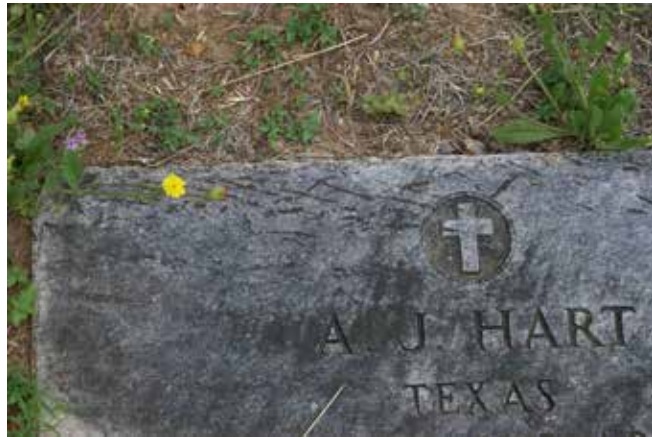
Figure 326. Mower damage to a flush marker (McDoux Preservation)

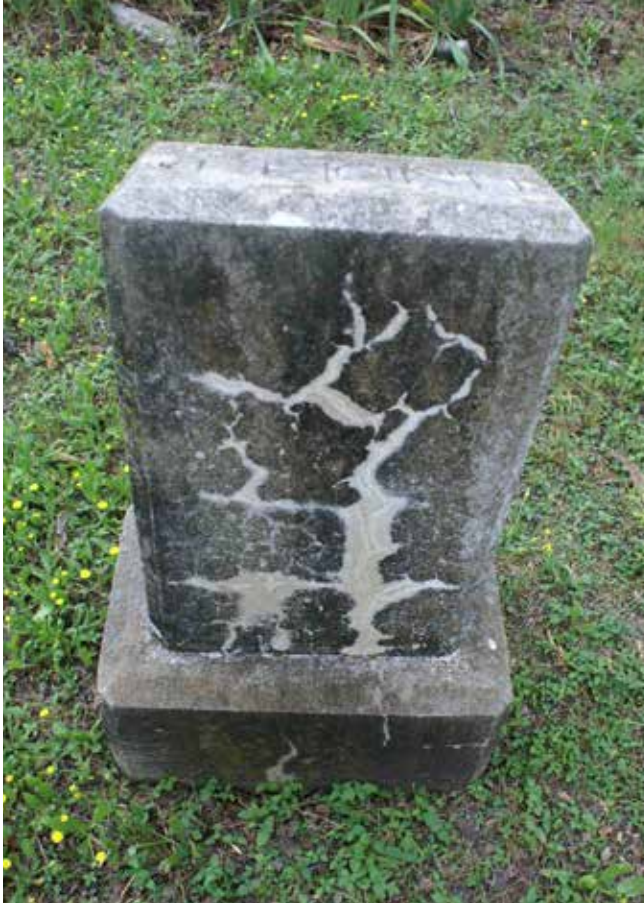
Figure 327. Repaired cracks (McDoux Preservation)

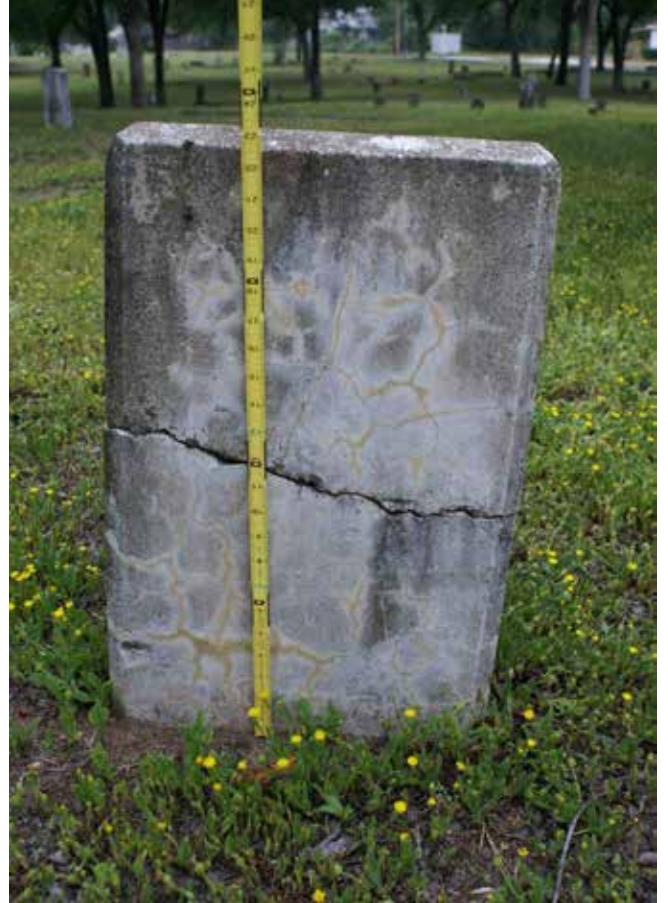
Figure 328. Cracked marker with visible repairs (McDoux Preservation)

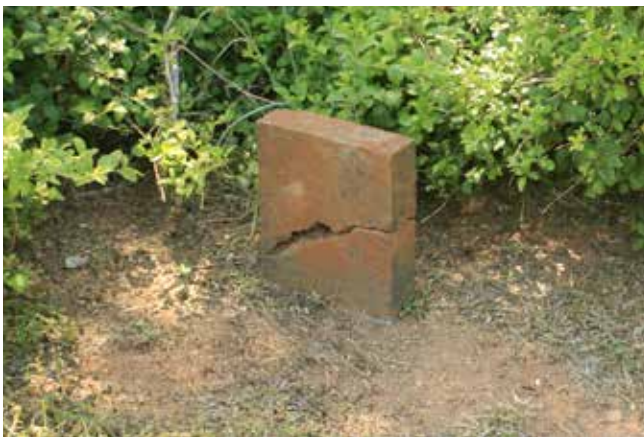
Figure 329. Cracked marker (John Milner Associates)

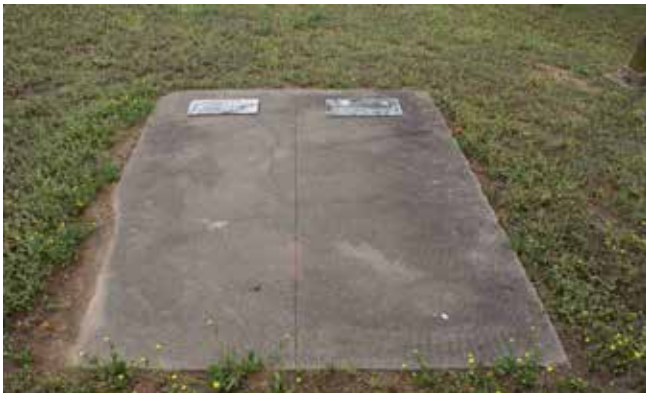
Most burial sites in Plummers Cemetery feature a covering of mowed grass; however, in a few instances, plots have been covered with poured concrete slabs (Figure 330). These range in appearance from simple concrete pads set flush with the ground, to more ornamental coverings. A row of burial sites in the north part of the cemetery is paved with rounded concrete units outlined in brick (Figure 331). This feature is in fair condition, with some cracking of the concrete, and the loss and displacement of some bricks.

Figure 330. Family plot covered with a poured concrete slab (McDoux Preservation)

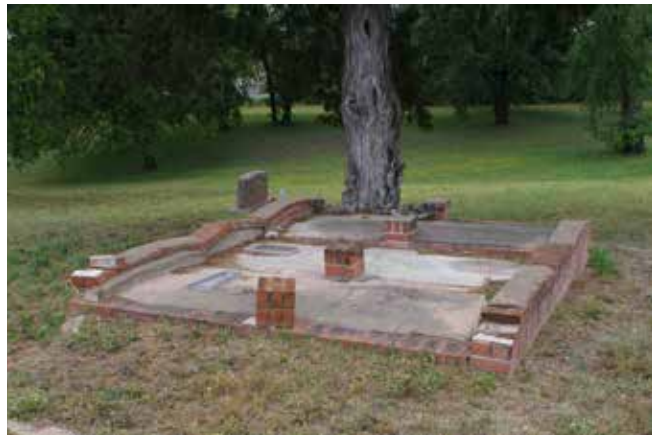
Figure 331. Family plot covered with concrete and outlined in brick (McDoux Preservation)

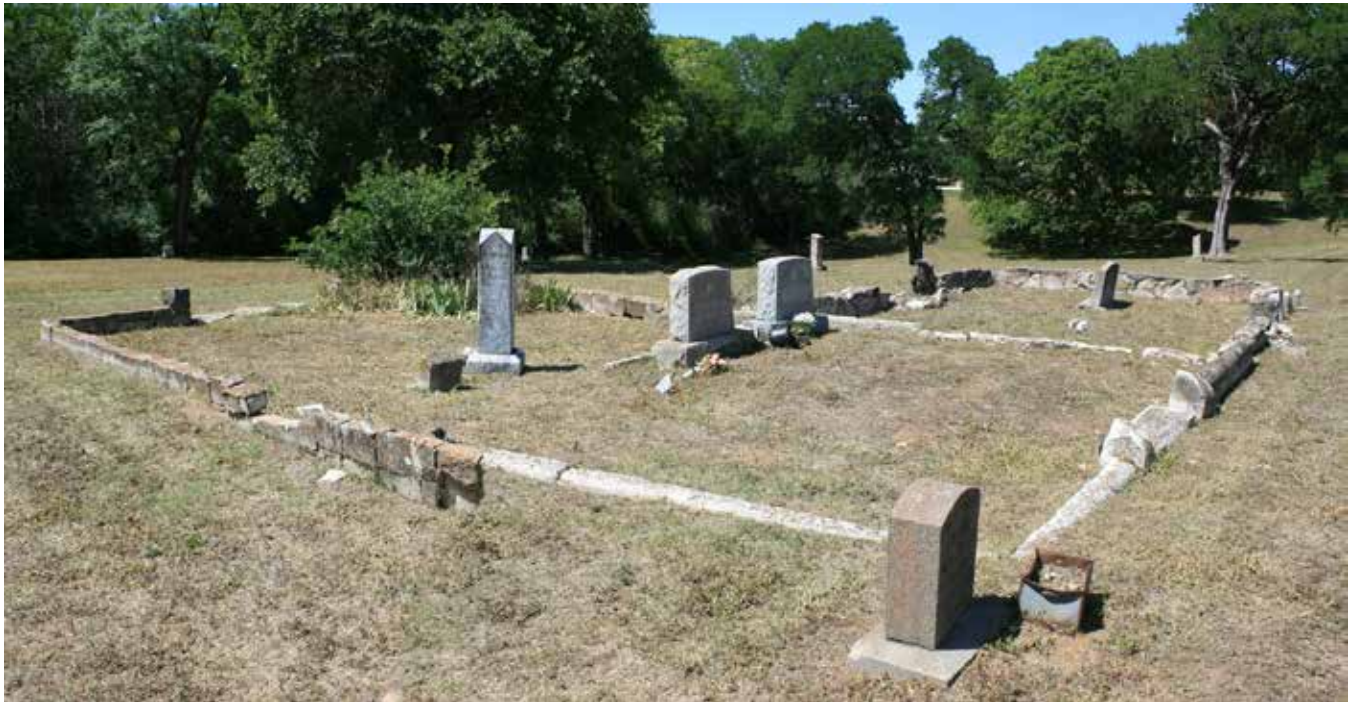
Figure 332. Family plot enclosures (John Milner Associates)

Only a handful of family plots in Plummers are bounded by curbs marking their extents. Curb materials vary, ranging from simple poured concrete to low mortared brick or limestone walls (Figure 332). The curbs are often punctuated by upright stones on either side of a low stone or concrete threshold, marking the formal plot entrances (see Figure 300 on page 240). In addition to the family plot enclosures, there are also a few instances of enclosures around individual graves (Figure 334).

Most of the plot and grave enclosures are in poor condition, with broken, displaced, or missing material, and damage from tree roots (Figure 333). Other problems include subsidence damage and maintenance problems such as damage from mowers and string trimmers.

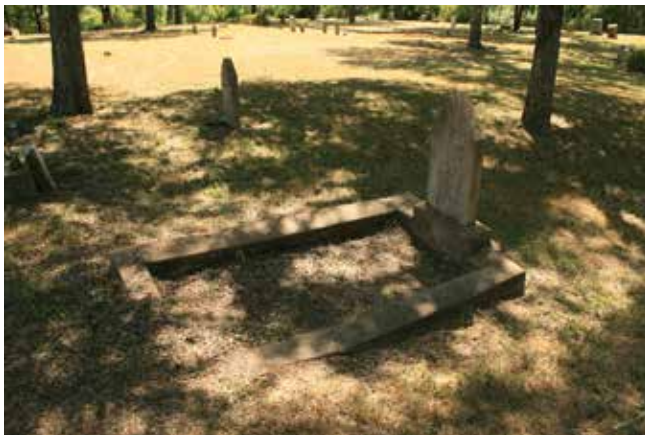
Figure 334. The curb surrounding this individual burial is slightly sunken at one corner (John Milner Associates)

- Protect plot and grave enclosures by limiting mowers to areas away from these features.
- Document all curbs and wall enclosures, noting materials, dimensions, and locations, and recording conditions with photographs. Curbs made from limestone or marble are more vulnerable to deterioration and should take priority over those of granite or concrete unless individual features are particularly threatened.
- Stabilize enclosures by resetting loosened units using a mortar that matches the original.
- Repair enclosures by replacing missing units with materials in-kind, and repointing failing joints. Refer to Chapter 3, General Management Guidelines, for more details regarding masonry repair.

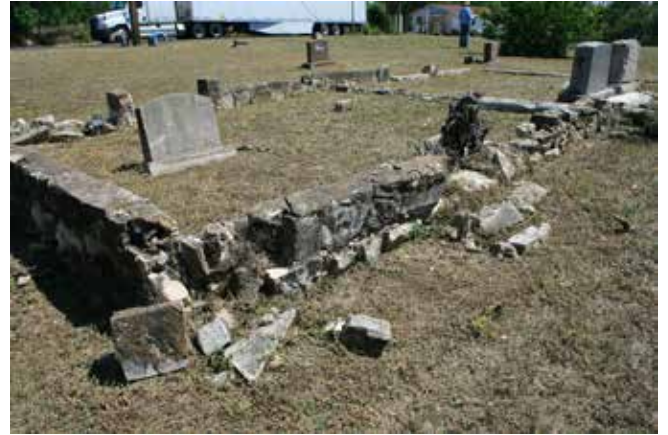
Figure 333. A severely damaged plot enclosure (John Milner Associates)

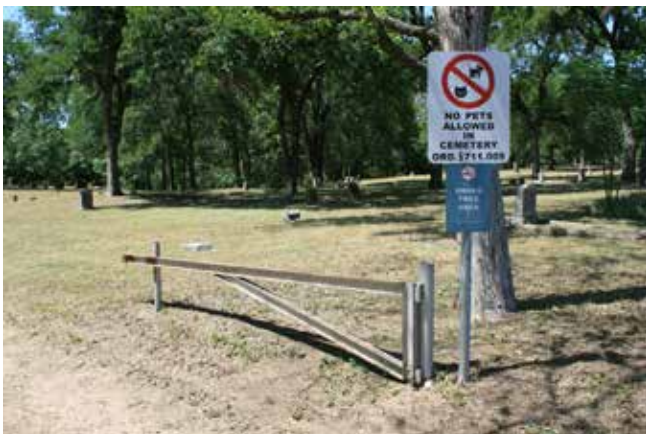
Figure 335. A metal gate controls access to the cemetery. (John Milner Associates)

Unlike the other four historic Austin cemeteries, Plummers Cemetery does not have an enclosing boundary fence. Access to the cemetery loop drive from Springdale Road is restricted by means of a simple metal swing gate (Figure 335).

- Erect a visible boundary along Springdale Road that will also function to prevent vehicles from entering except at the designated access point. Instead of erecting a fence, consider using large, native stone boulders or other barrier, such as bollards, spaced closely enough to prevent or discourage vehicles from entering. If boulders are used, they should be partially buried so that at least $\frac{1}{3}$ of their height is below the ground surface for a naturalistic appearance, rather than placed on the ground surface (Figure 338 and Figure 339). Site boulders or bollards approximately five feet inside the Springdale Road curb, spaced at 10-20 feet on center, taking care to avoid existing known burials. Conduct appropriate archeological investigation prior to any excavation in this area to avoid disturbing any unmarked graves.

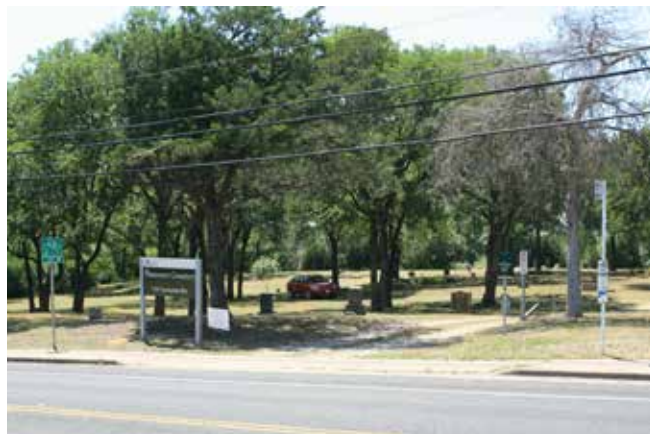
Figure 336. Signs clustered at the cemetery entrance (John Milner Associates)

No site furnishings are provided for visitor use within Plummers. Signs at the entrance to the cemetery include a large cemetery identification sign and informational signs citing cemetery rules and regulations (Figure 336). A few city signs, including a sign denoting the bus stop, have been installed along the edge of the cemetery on Springdale Road. Other city features along Springdale Road include manholes and poles for overhead electrical and telephone lines.

- Create an access point for visitors, to include a low cemetery identification sign, a single parking space, and a low kiosk or interpretive sign exhibiting historical information (Figure 340). The parking space should be universally-accessible.

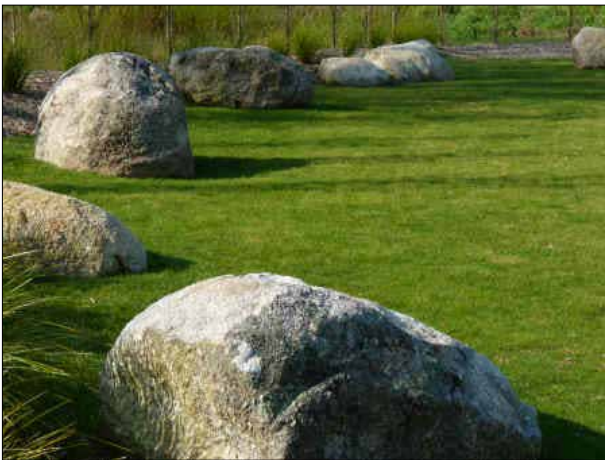
Figure 339. Example of native stone boulders set in turf with at least one-third of their height below ground (boulders-in-lawn-tailrace--ntlandscapes.com.au.jpg)
