APPENDIX B CULTURAL RESOURCES

Appendix B1: Cultural Resources Inventory

Appendix B2: Cultural Resources Proposed Structures

CULTURAL RESOURCES INVENTORY

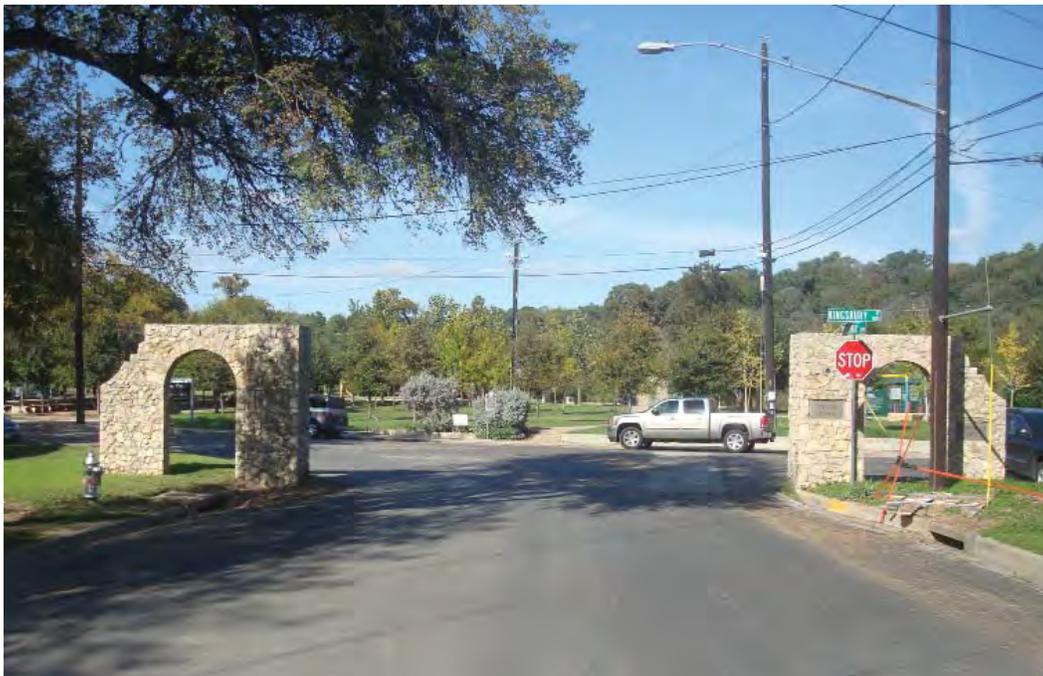
Pease Park Memorial Gates: a pair of uncoursed semi-dressed rubble limestone arches, flanking Parkway at the intersection with Kingsbury Street. Designed by Giesecke & Harris, the gates were built in 1926 as part of the Austin Kiwanis Club's beautification project. Construction drawings show wrought iron gates within the arches and lanterns atop the pilasters, neither of which are present in the existing structure. Historic documents also include a sketch depicting an arch with lantern between the two gates. New bronze plaques were installed by the Pease Park Conservancy in 2012.

Condition: The gates are in good condition and in no need of immediate work, but crowded by a stop sign and utility pole.

Looking north on Parkway, Kingsbury Commons visible beyond gates

Recommendation: No work necessary at this time. Future work may include addition of missing elements from drawings.

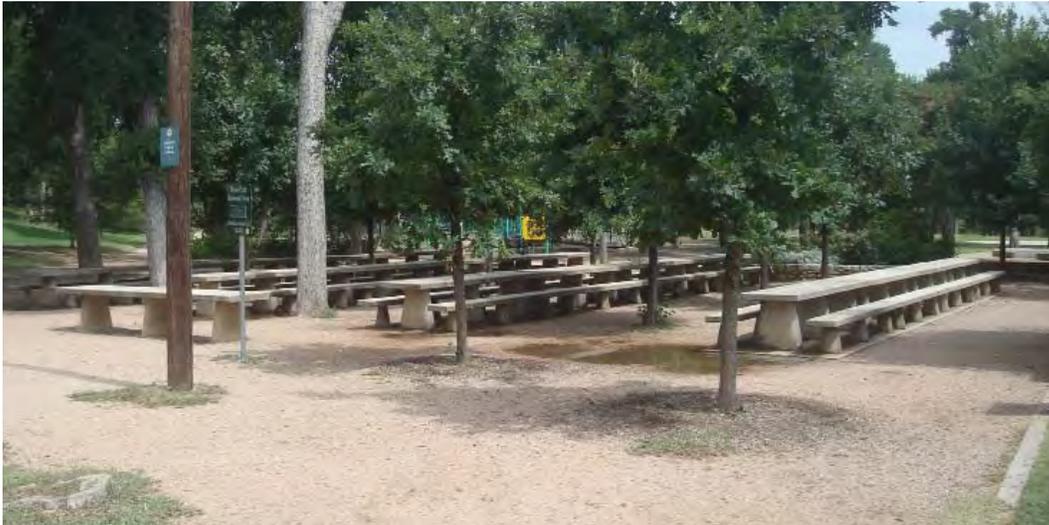
Condition: The tables and benches have benefited from recent restoration work and now appear in good condition.

Picnic Tables at Kingsbury Commons looking North

Recommendation: Clean and monitor for cracks.

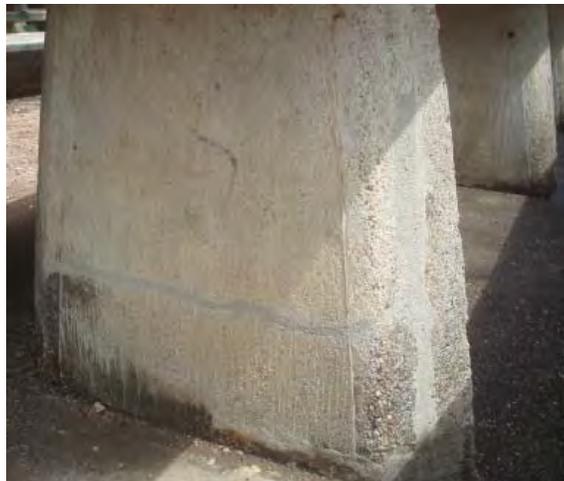
Detail at tapered, chamfered leg

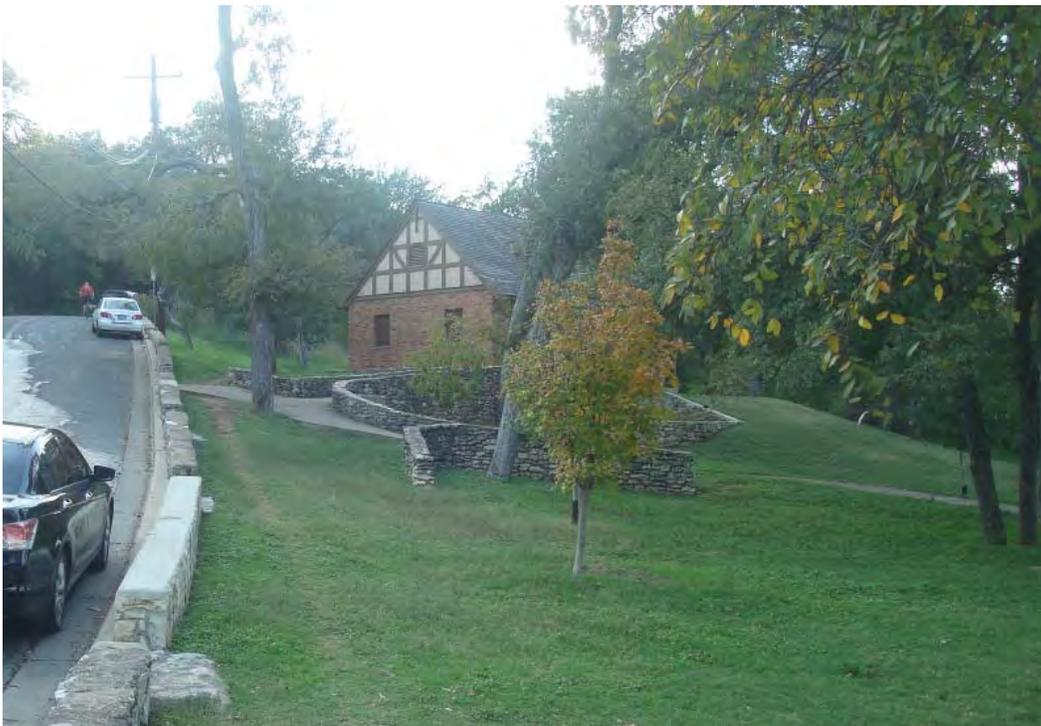
Condition: Portions of the wall have been recently repaired and are in good condition. The new cement wash appears to differ significantly from the existing, both in color and texture. The portions of the wall not part of the recent repairs are in fair condition. There are numerous small cracks in the mortar and cement wash. At a few limited locations the cracks pass through the entire wall and several stones are missing.

Looking west along Kingsbury. Lighter colored cement wash is recent work.

Recommendation: Small cracks should be re-pointed. Large cracks will require a limited amount of select stone removal and re-installation/ re-pointing. This repair work should be done in the near future to avoid further decay.

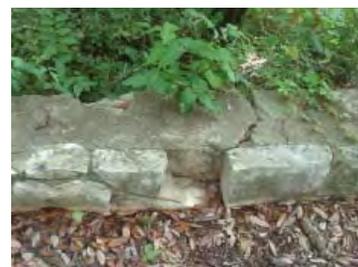
Typical cracks and missing stone

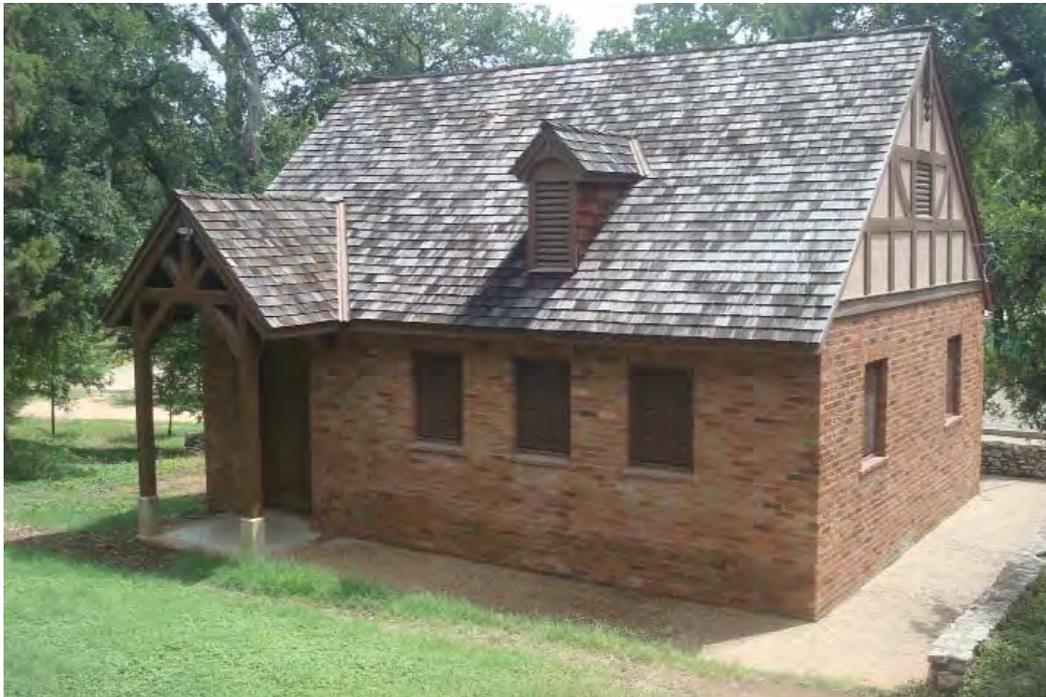
Condition: Exterior is in good condition, with recent brick repointing and a new roof. Interior is in poor condition.

Tudor Cottage as seen from Kingsbury, looking northeast

Recommendation: Continue on-going maintenance and renovate use as a Community Room, as described elsewhere in this document.

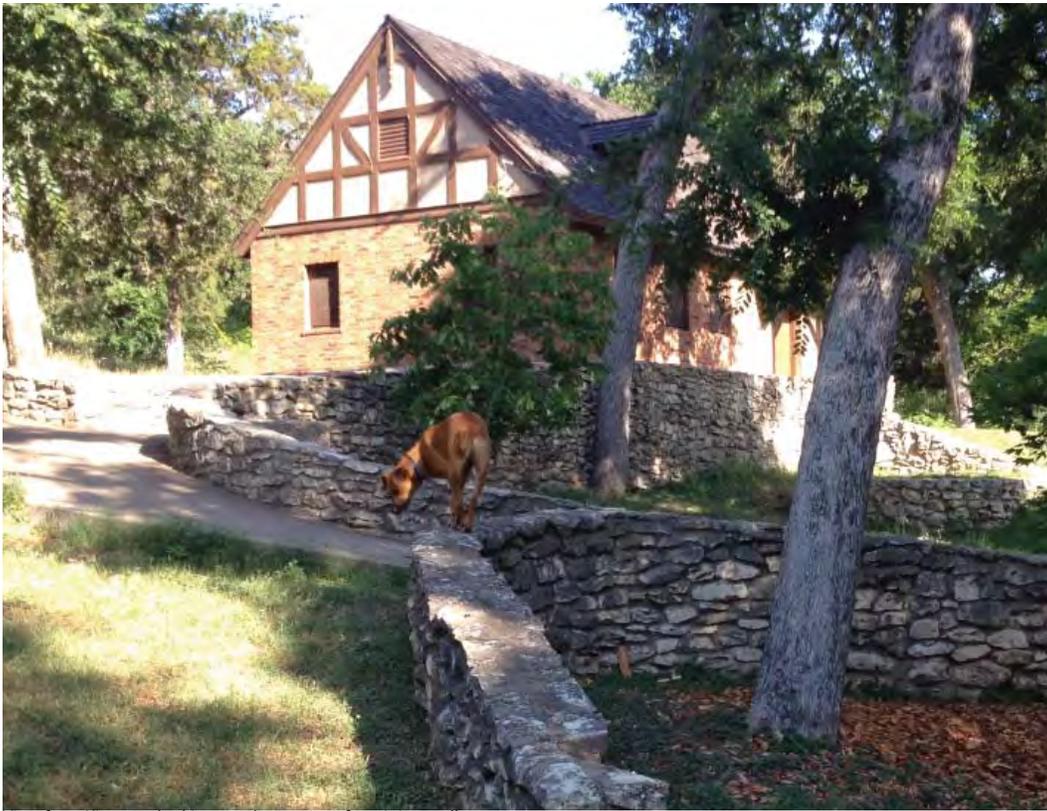
Condition: Generally good condition, with evidence of earlier repairs, and some isolated cracking.

View from Kingsbury looking north at series of retaining walls

Recommendation: Existing walls require spot repointing and graffiti removal. Remove some walls to accommodate adaptive re-use of Tudor Cottage.

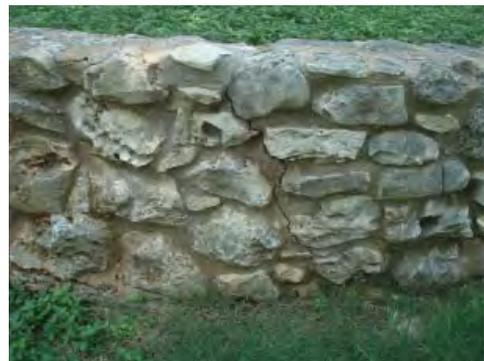
Typical cracking in wall

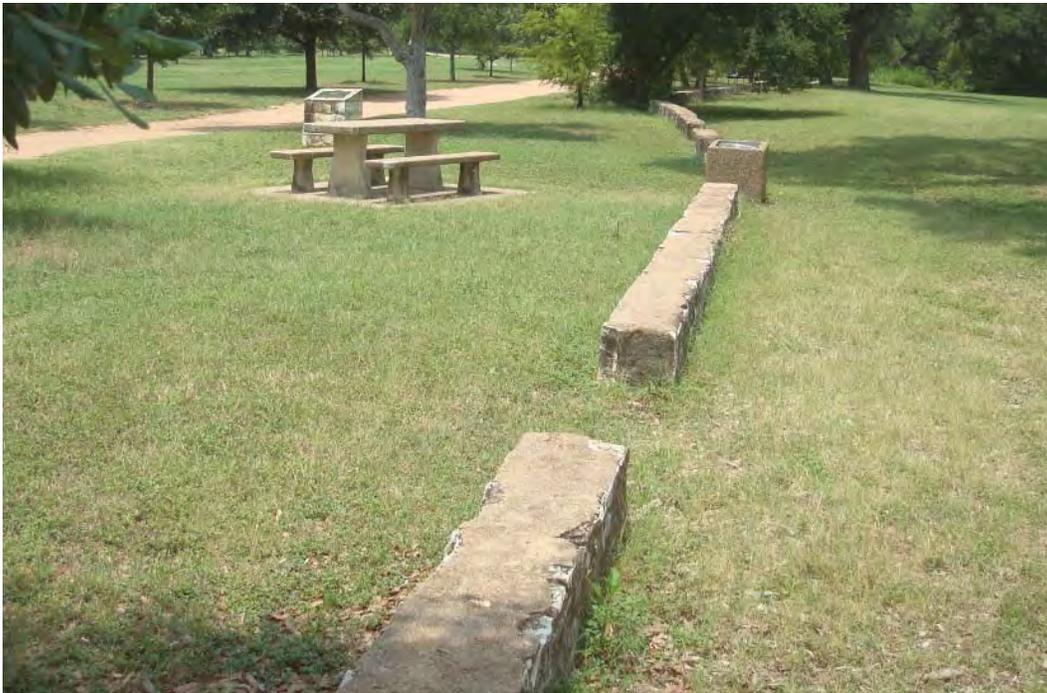
Condition: These walls are in fair condition. Small cracks are evident throughout, with several areas of larger through wall cracks and several missing stones.

Looking north from south end of wall system

Recommendation: Rebuild damaged portions of wall. Spot repointing and repair of cement

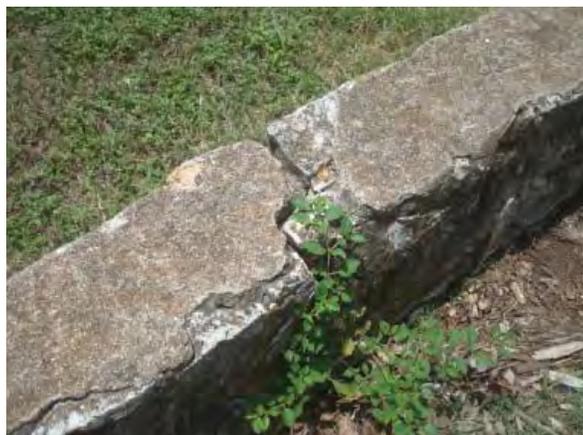
Typical through-wall crack

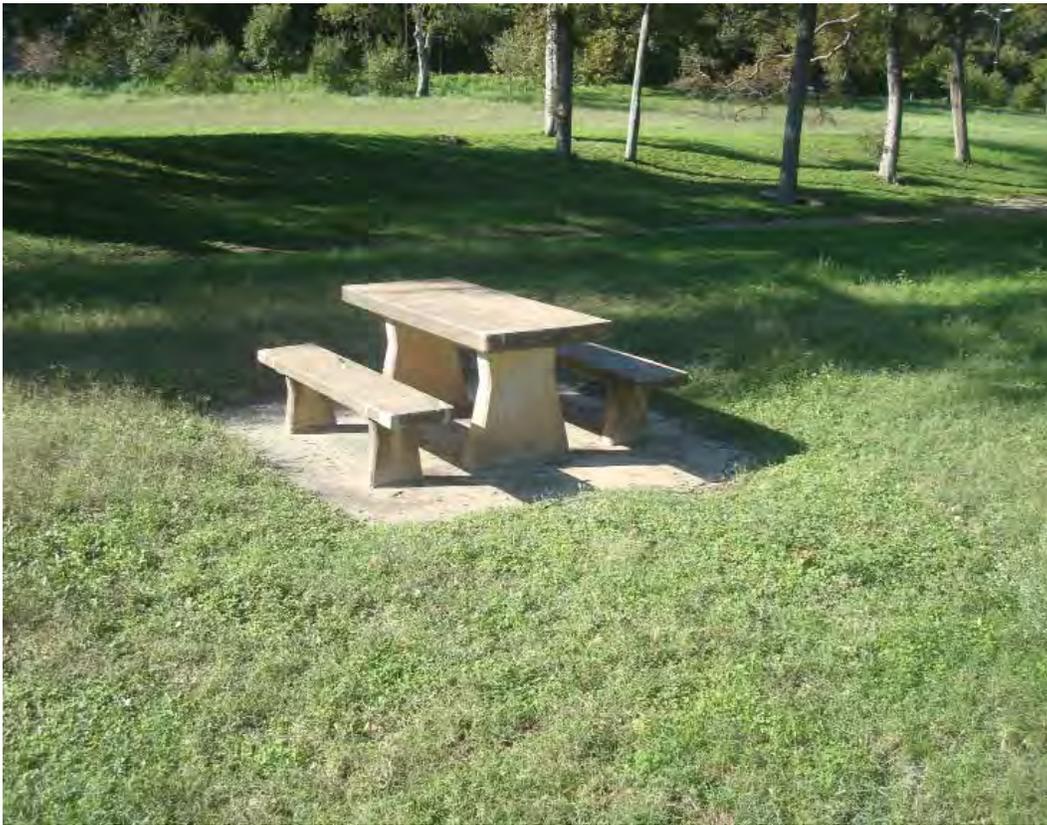
Condition: All of the tables and benches show evidence of recent repair work and are in good condition. There are isolated instances of graffiti.

Picnic table at Custer's Meadow

Recommendation: Clean graffiti. No other repair work required at this time.

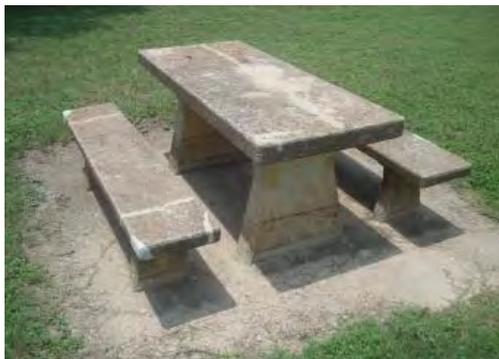
Table showing typical patchwork

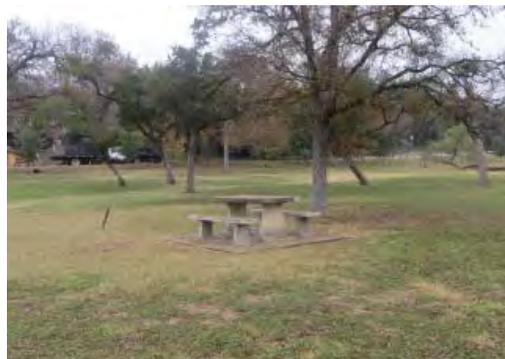
Sunny location at Custer's Meadow

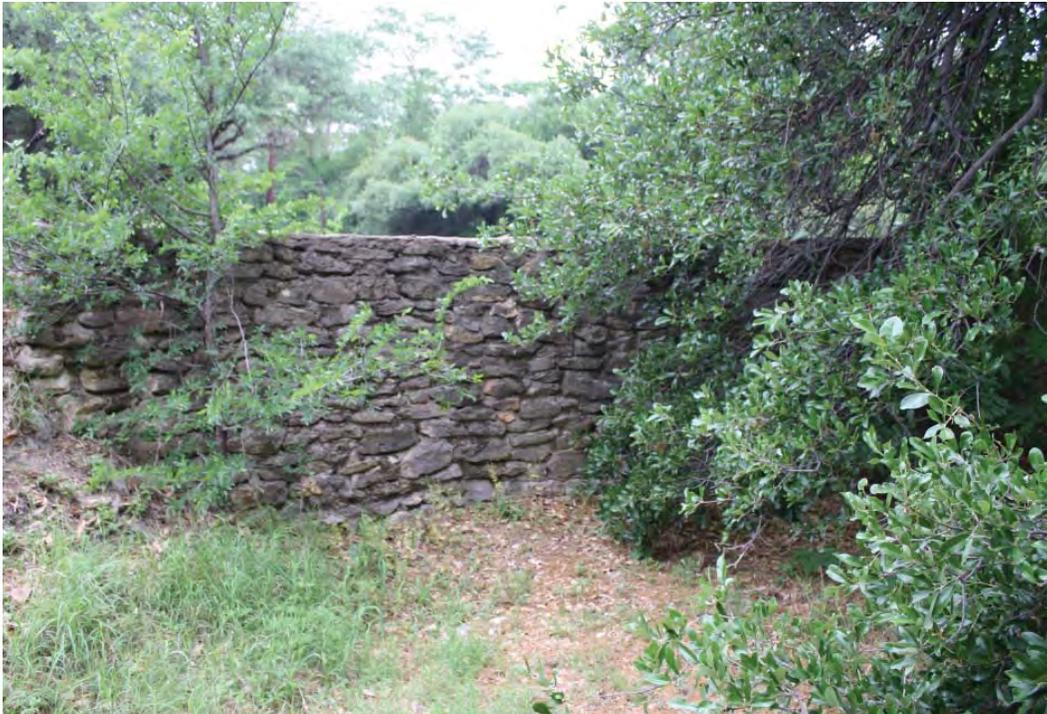
Approximately 6-ft tall uncoursed rubble limestone retaining wall with cement wash, retaining grade along the park's western perimeter at the corner of Parkway and West 24th St. Provenance unknown.

Condition: Good condition. No major deficiencies evident.

Looking west at wall. Parkway is immediately above wall.

Recommendation: No work at this time.

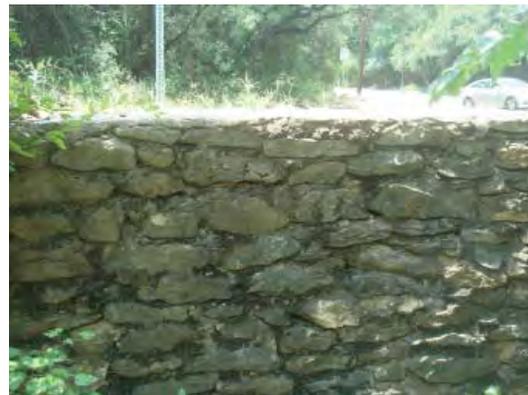
Detail of wall construction

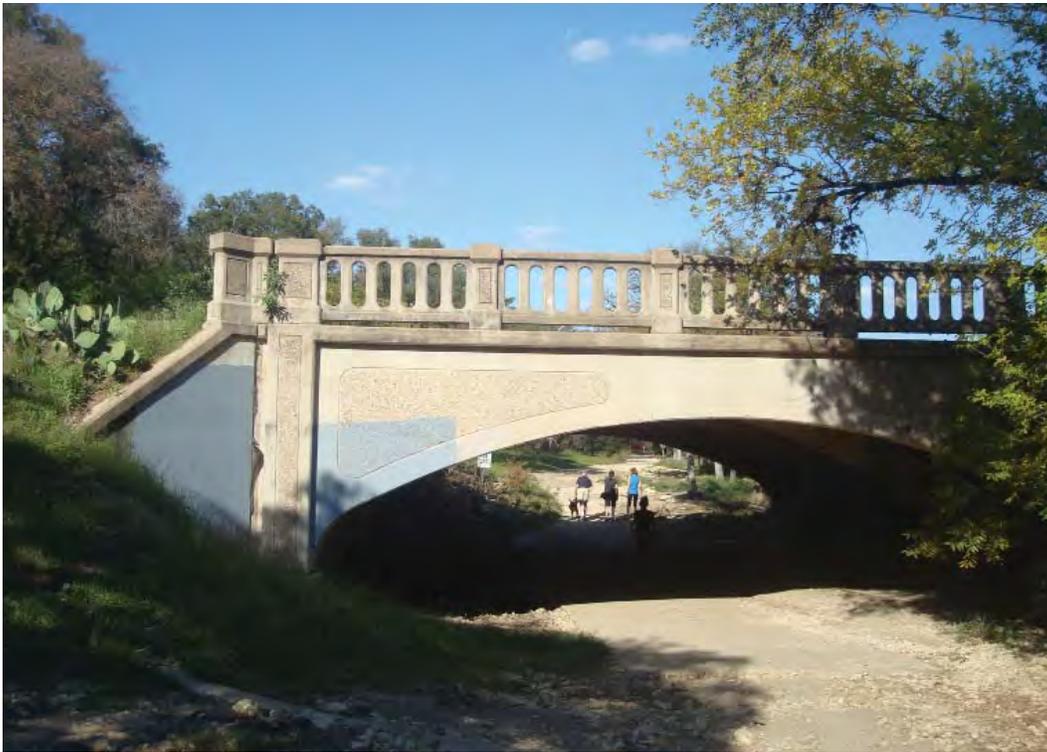
Condition: The structural condition of the bridge was not evaluated. The concrete generally appears to be in good condition, but has been painted in many places (to obscure graffiti).

View from trail looking north

Recommendation: Remove graffiti and paint. Provide new lighting under the arch at the path.

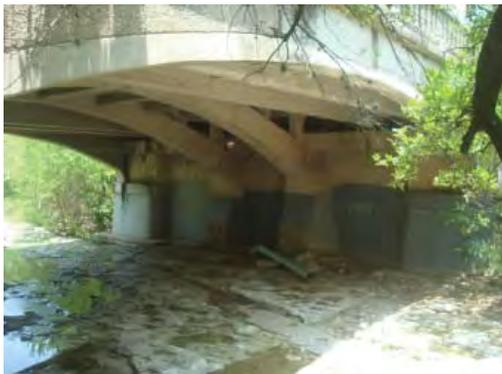
View under bridge looking southwest

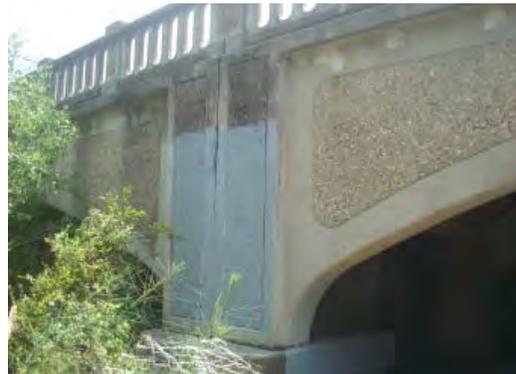
View from trail looking southeast

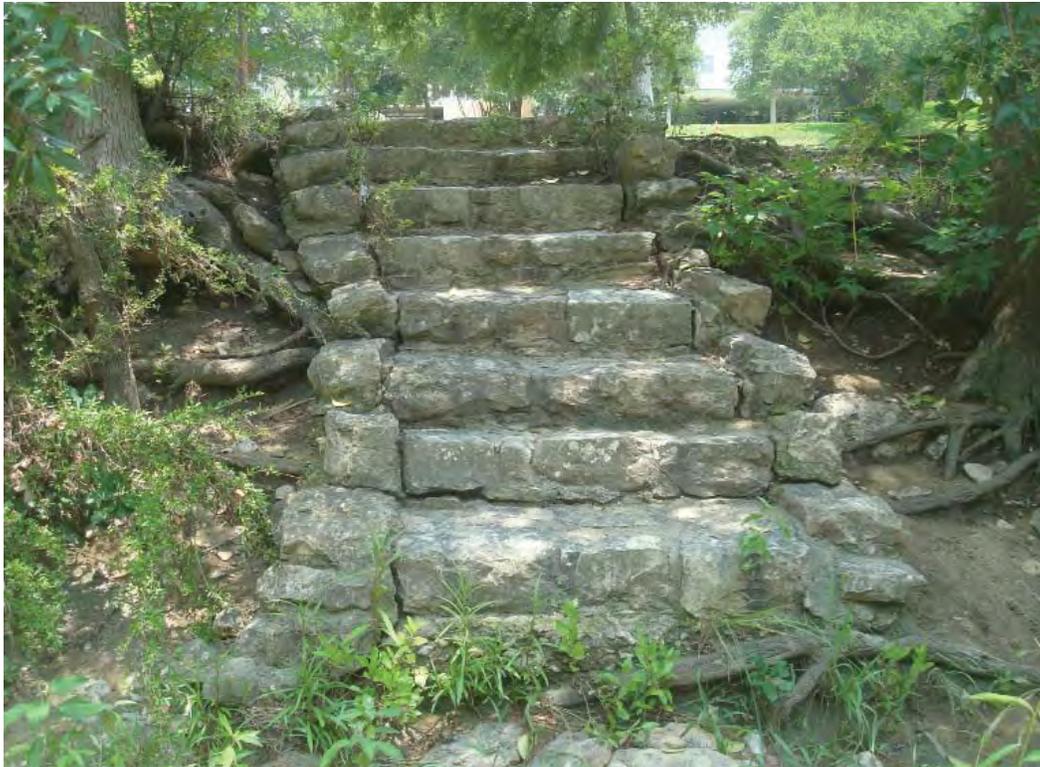
Condition: Poor. Sides are significantly undermined, and perimeter stones have separated from the body of the stair. The bottom step is approximately 2-ft above current grade.

View from creek looking east

Recommendation: Stabilize undermined sides and rebuild perimeter stones. Retain intact steps as is. Provide new boulder steps at base of stair.

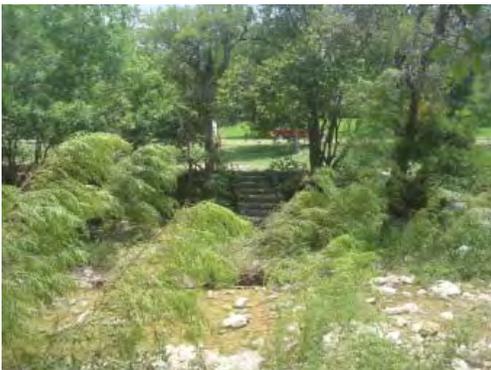
View from across creek looking east

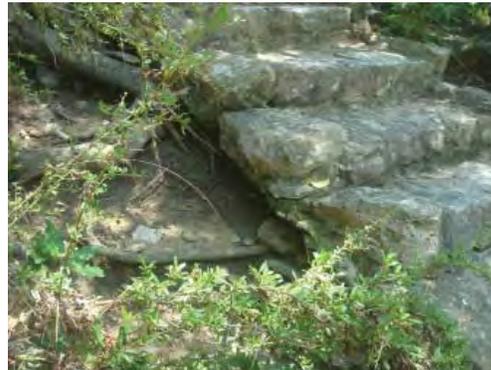
Detail of undermining on steps

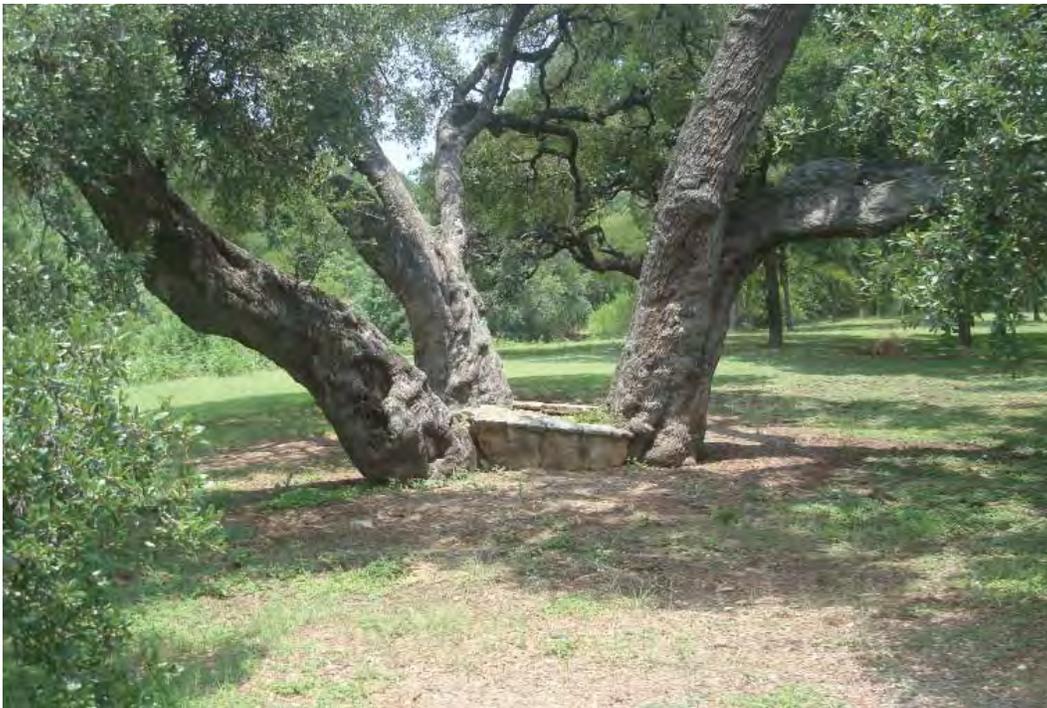
Condition: Poor. Two of the sides have massive upheaval, throwing the walls out of level and plumb. Several stones are displaced and some are missing.

View looking north

Recommendation: Major work at the trees is not recommended. Replace missing stones and secure displaced and loose stones. Do not correct for plumb and level. This is an artifact that is harmful to the heritage trees and is not recommended for restoration.

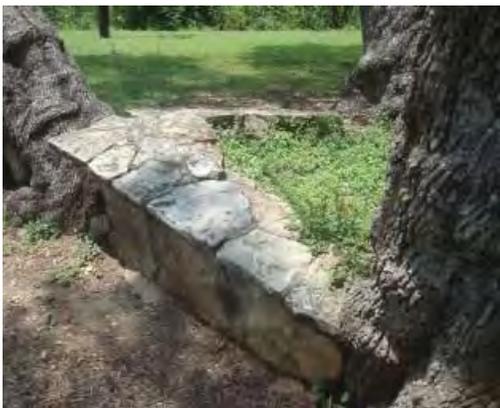
View looking north

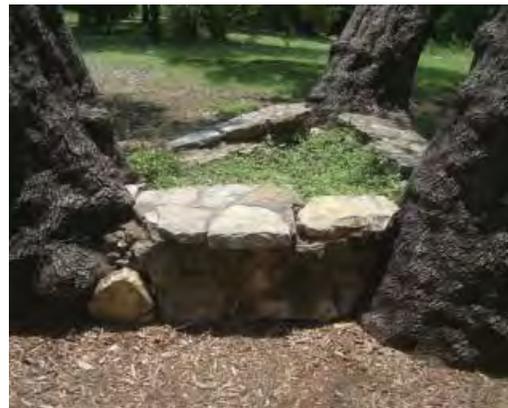
View looking south

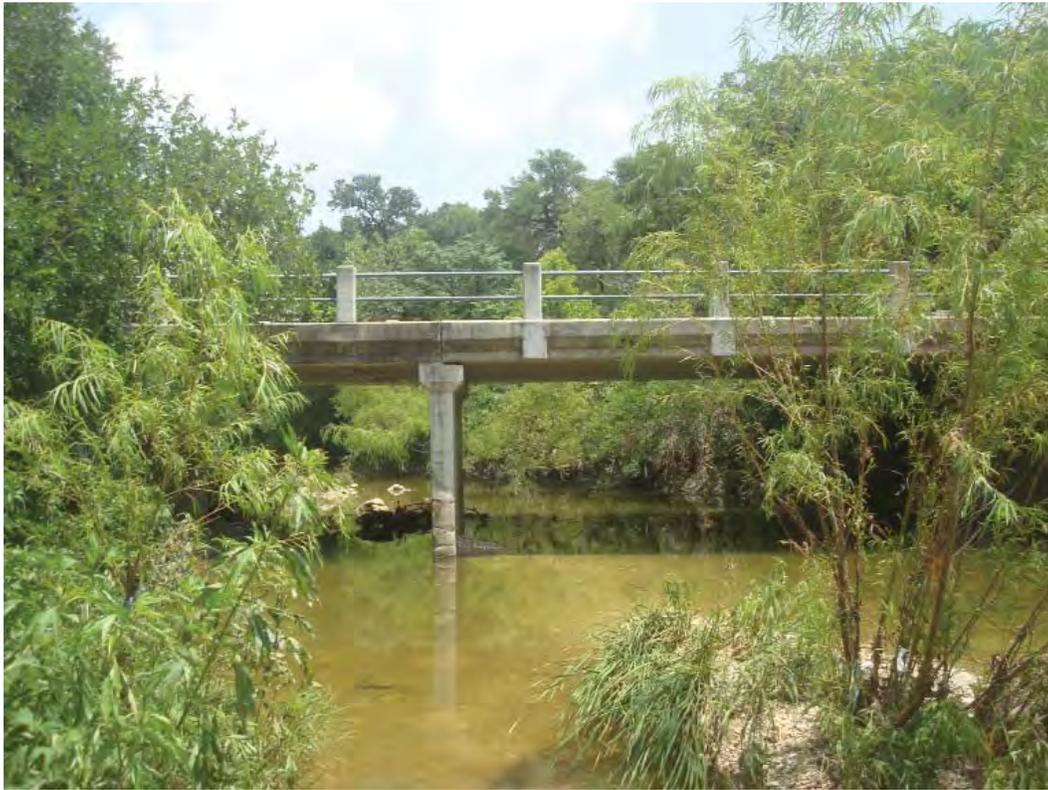
Condition: The structural condition of the bridge was not evaluated. The concrete generally appears to be in good condition, but has been painted in many places (to obscure graffiti).

Lower Shoal Creek Bridge viewed from creek looking east

Recommendation: Remove graffiti, clean and seal. Light bridge and area beneath bridge.

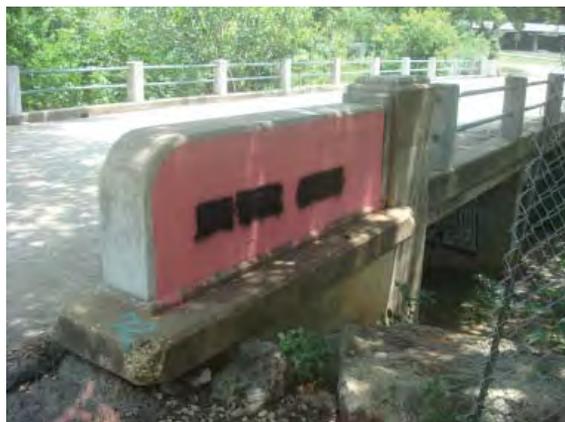
Northwest corner of bridge from trail

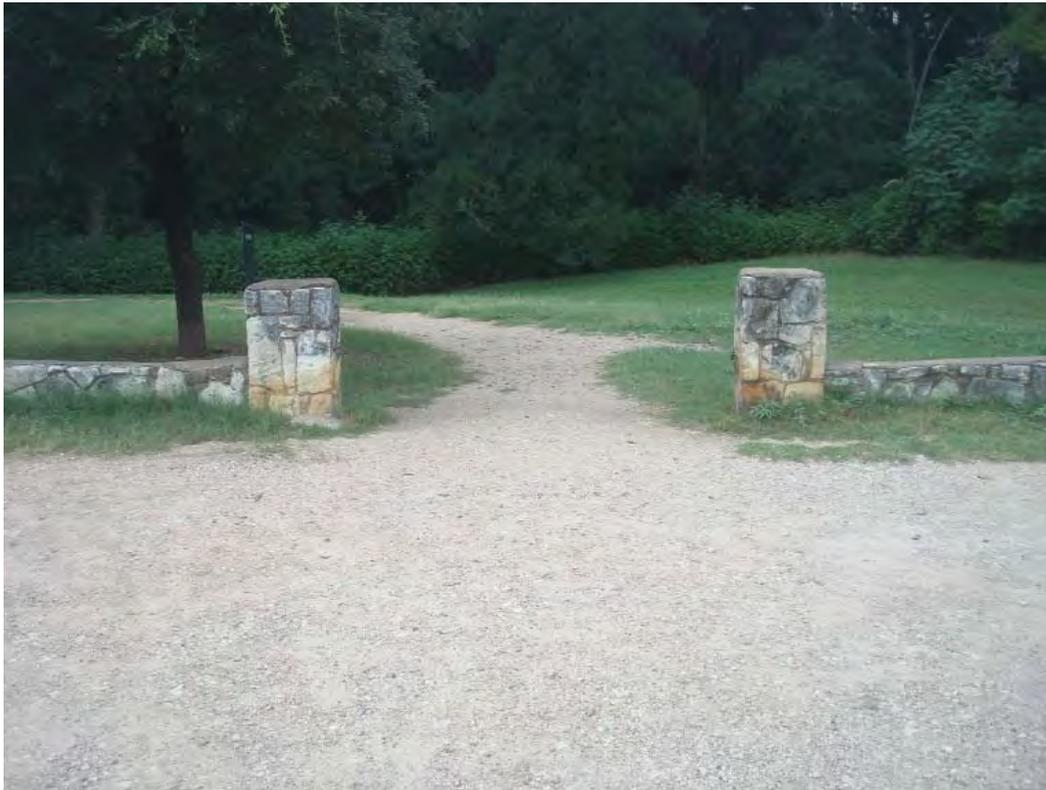
Condition: Poor. Much of the cement wash is missing and areas of the wall are crumbled.

Stone wall looking north at trailhead

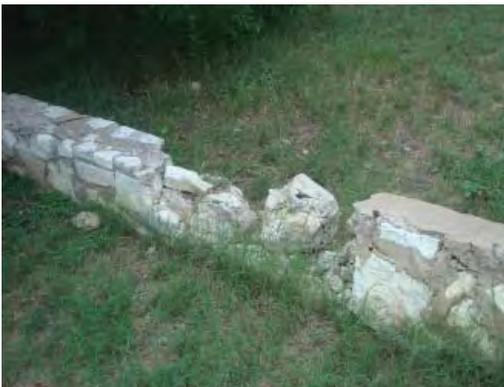
Area of crumbled wall

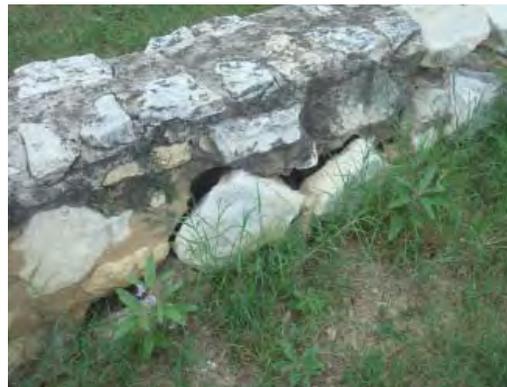
Typical cracking and stone displacement

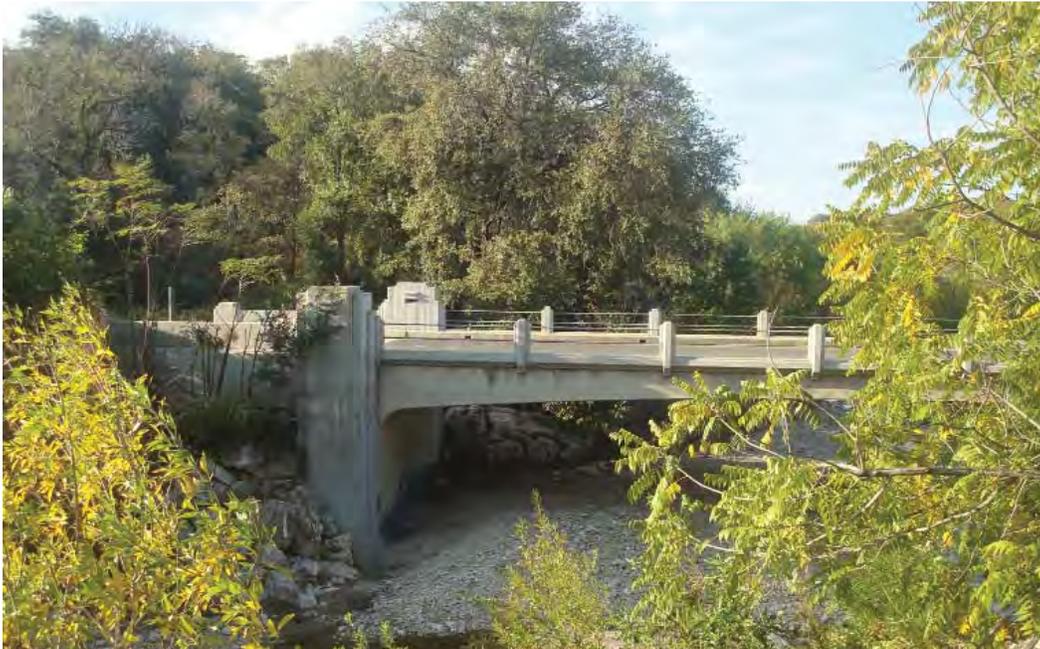
Condition: The structural condition of the bridge was not evaluated. The concrete generally appears to be in good condition, but has been painted in many places (to obscure graffiti).

Upper Shoal Creek Bridge looking north

Recommendation: Remove graffiti. Provide planters or covers at the open piers. Consider replacing pipe guard rails if further investigation indicates original rails were smaller. Light bridge and area beneath

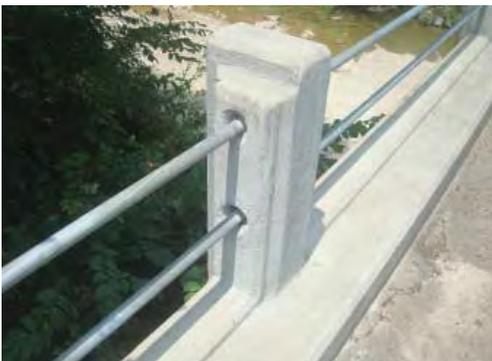
Detail of guard rail

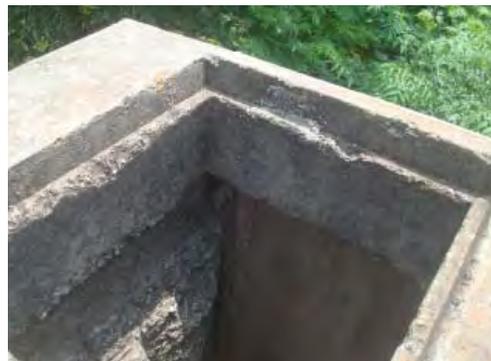
Detail of hollow pier top

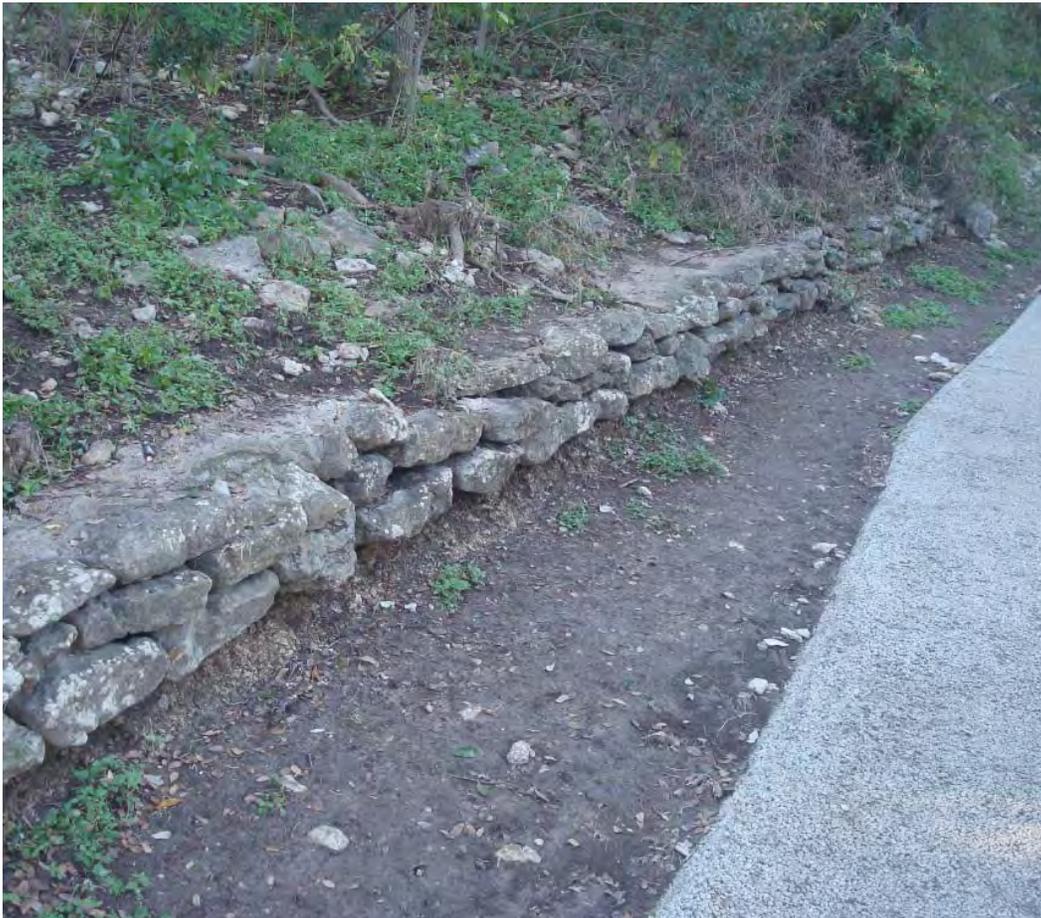
Condition: Good.

Stone wall on west side of trail

Recommendation: No work necessary at this time.

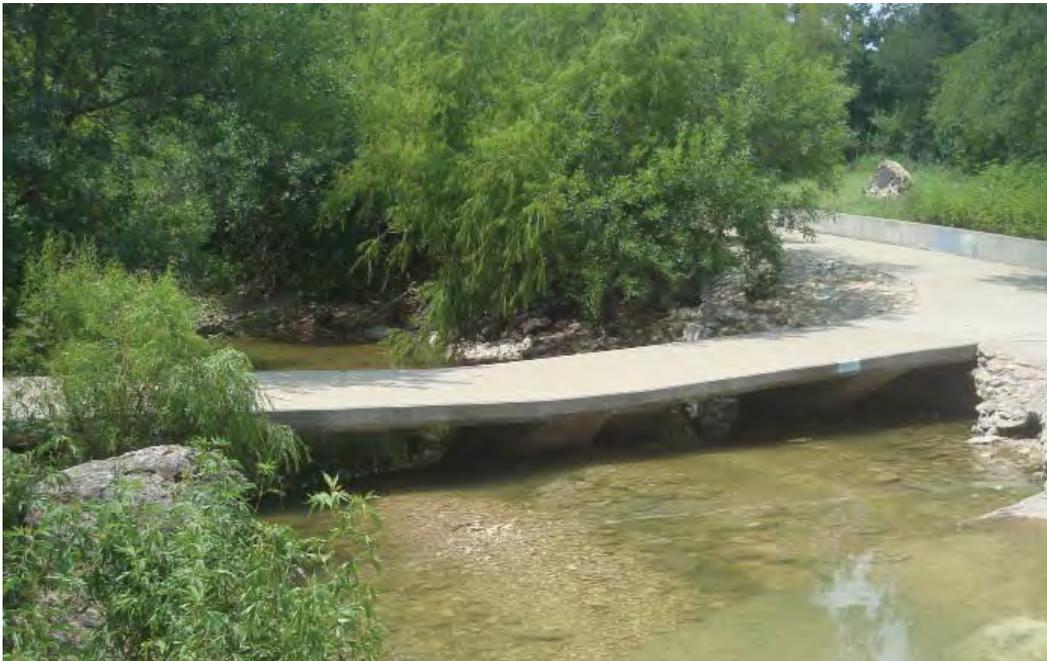
Condition: Good

Janet Fish Pedestrian Bridge viewed from edge of creek looking northwest. The memorial is visible beyond the bridge.

Recommendation: No work necessary at this time.

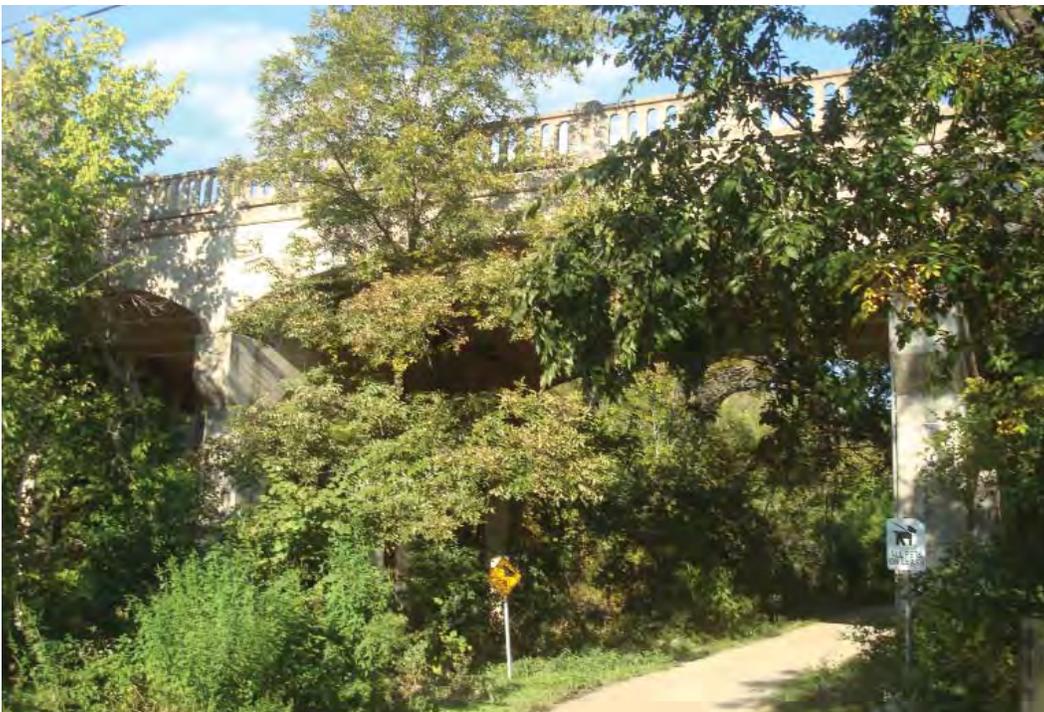
Condition: The structural condition of the bridge was not evaluated. The concrete generally appears to be in fair condition, with some limited spalling. Graffiti is present in accessible locations.

West 29th Street Bridge viewed from trail looking northeast

Recommendation: Remove graffiti. Spot patch concrete. Light bridge and area beneath bridge.

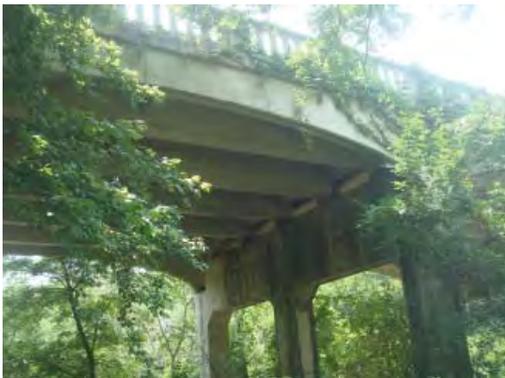
View from trail looking west

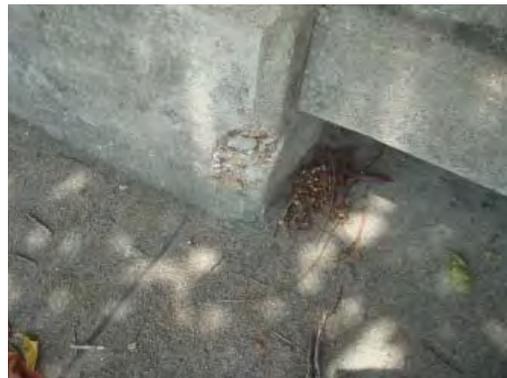
Detail of concrete spalling at guard rail

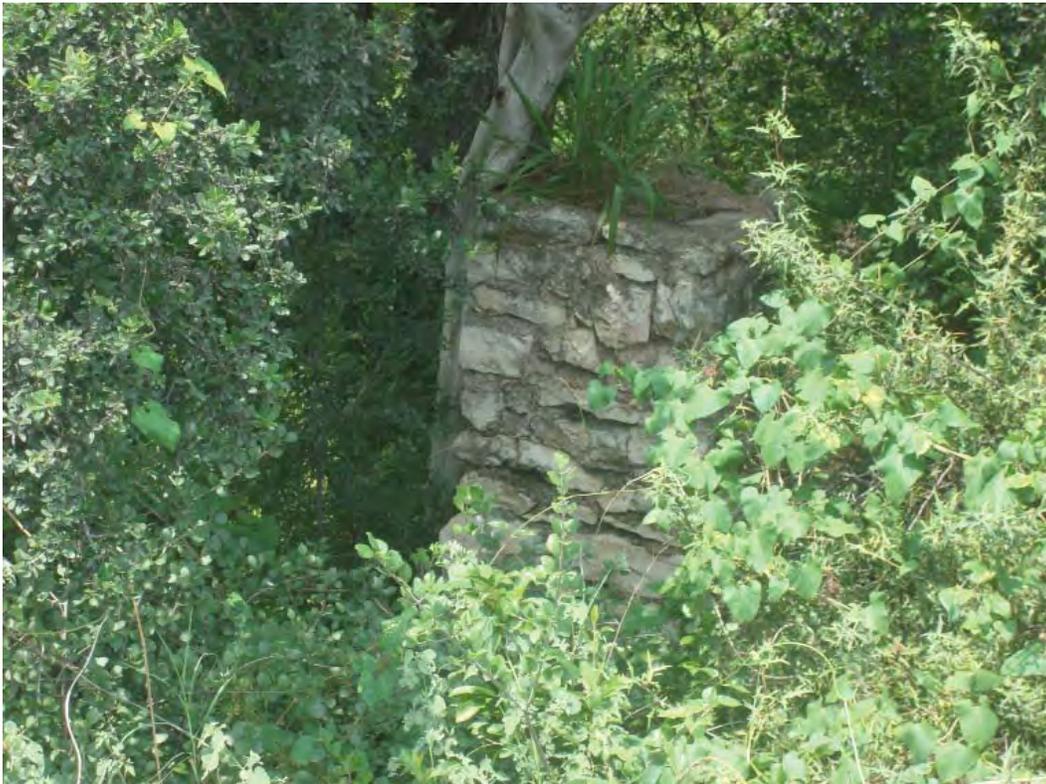
Condition: Poor. Some piers are cracked and out of plumb, others are almost completely crumbled.

Stone pylon viewed from Lamar sidewalk looking west

Recommendation: Rebuild piers and install new steel guard rail for potential new overlook.

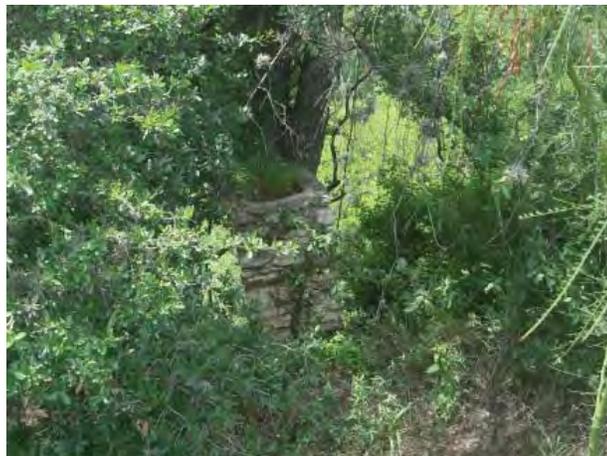
Tree behind the pylon at edge of bluff.

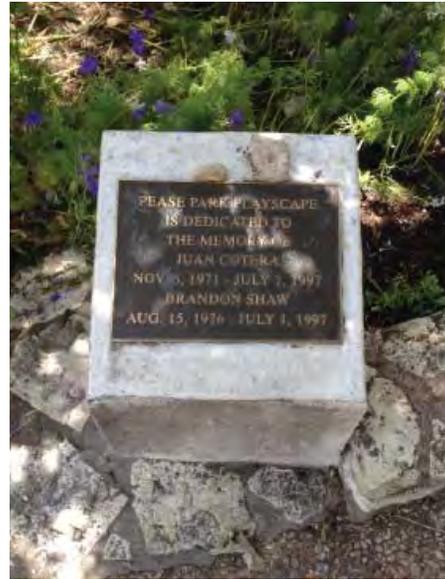
Condition: Plaque and base are both in good condition.

Memorial at Kingsbury playscape

Recommendation: Light cleaning required for both plaque and base. The memorial should be retained in any park reconfiguration. If the playscape is relocated the memorial should be relocated as well.

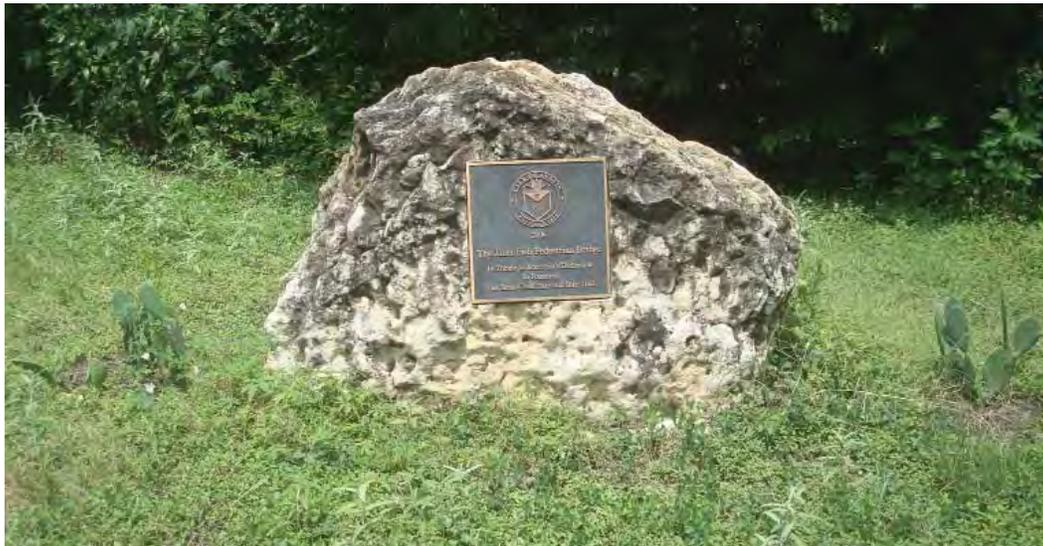
Condition: Plaque and base are both in good condition.

Memorial on east side of trail

Recommendation: No work needed at this time.

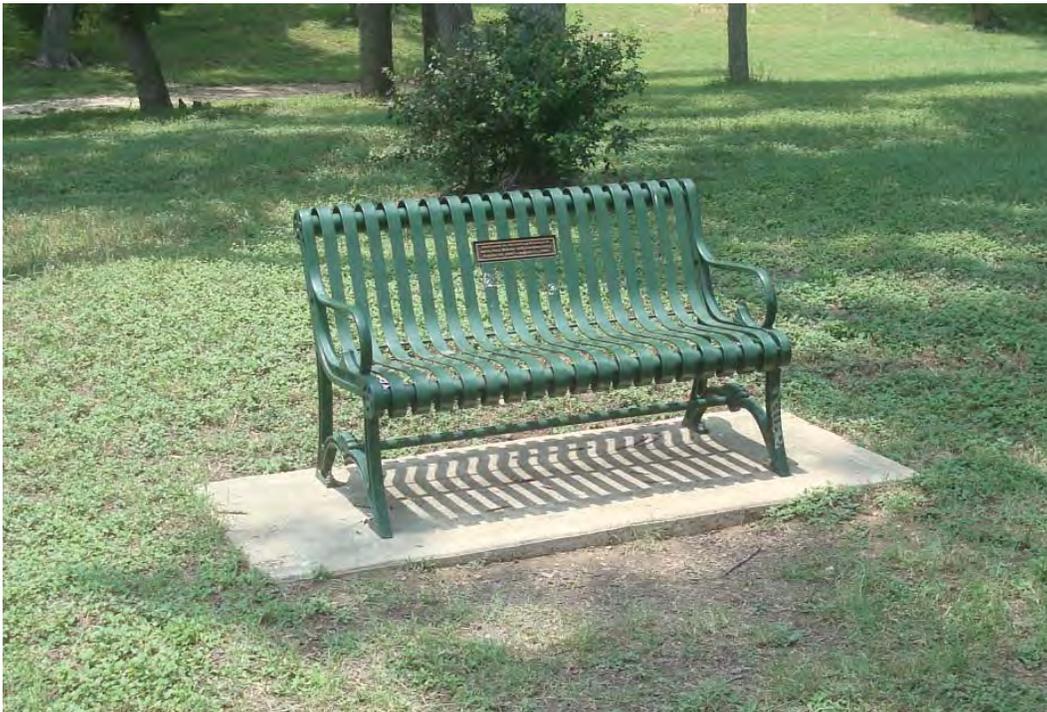
Condition: Good to excellent condition. There are a few minor blemishes in the paint.

Typical memorial bench at Custer’s Meadow

Recommendation: Touch up paint.

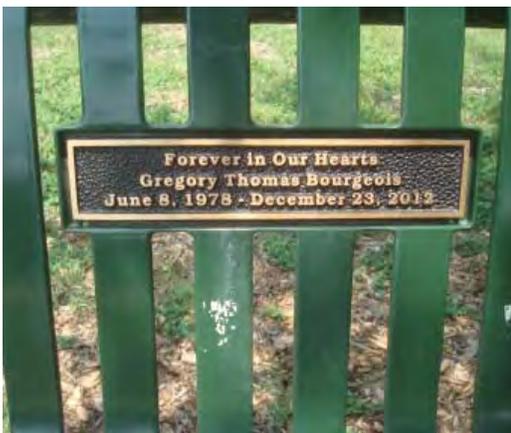
Typical memorial bench plaque

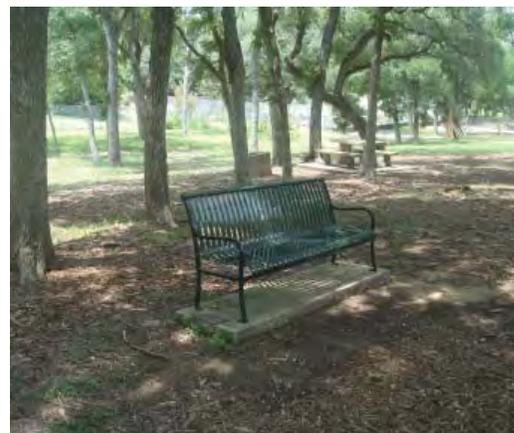
Memorial bench of different size, style & plaque location

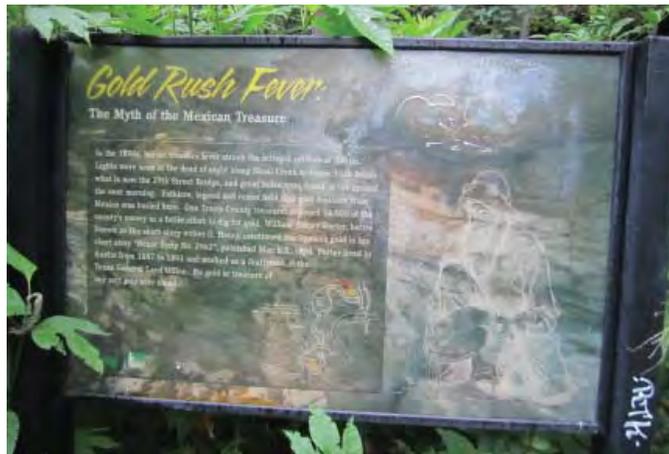
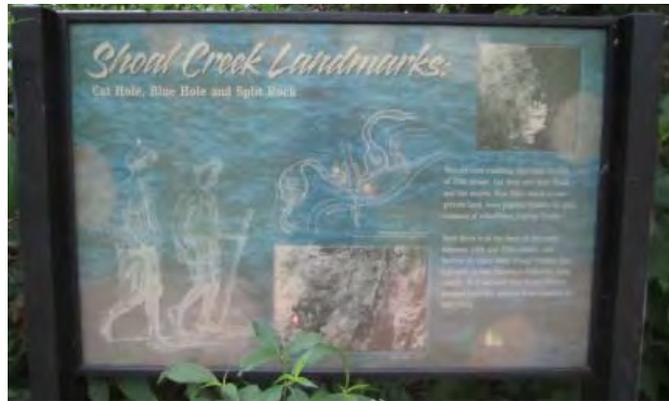
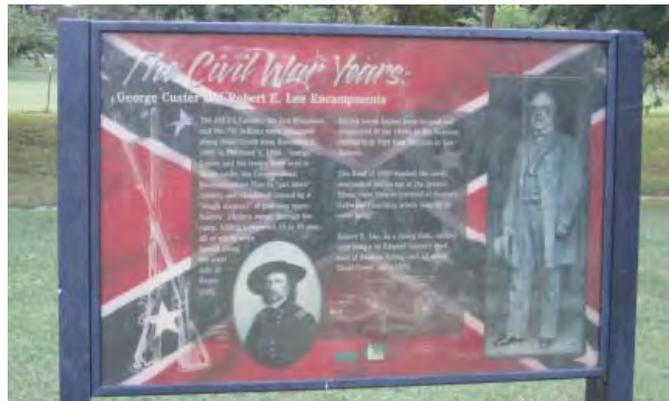
Condition: Signs are in good condition, suffering principally from graffiti. Images are somewhat faded and text is difficult to read.

Signs in Pease Park

Recommendation: No immediate work is needed. A new Interpretive Plan should be developed, including new signage throughout the park.
