APPENDIX B CULTURAL RESOURCES

Appendix B1: Cultural Resources Inventory

Appendix B2: Cultural Resources Proposed Structures

CULTURAL RESOURCES INVENTORY

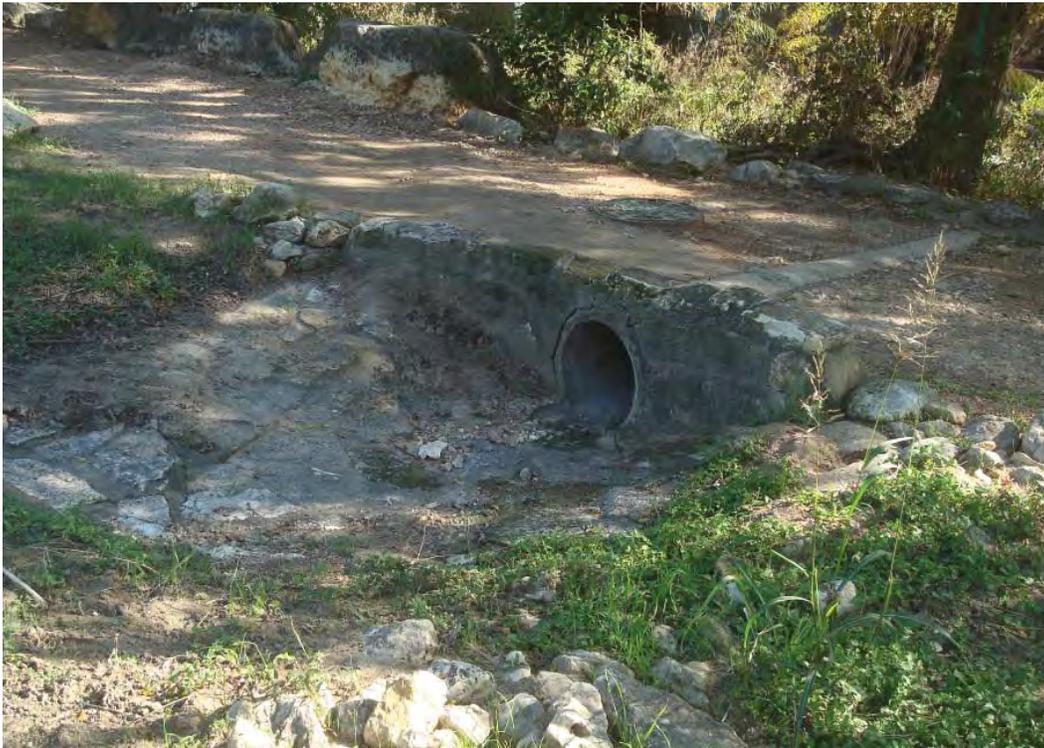
Condition: Culverts of all ages are in fair to good condition. Small cracks along mortar joints are typical.

Concrete pipe culvert in Wooten Woods

Recommendation: Spot repointing of stonework.

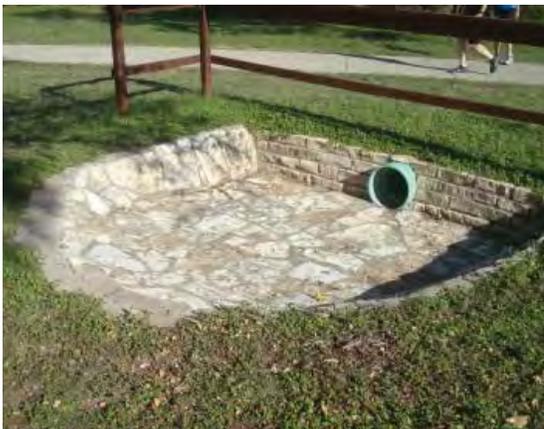
Concrete culvert near Custer's Meadow

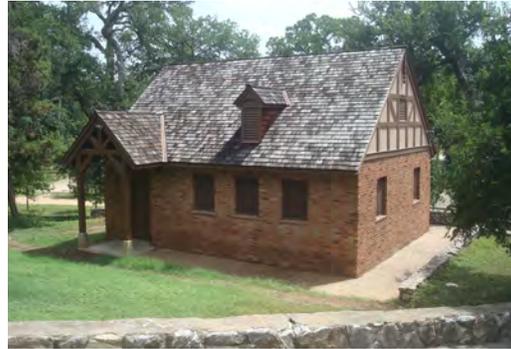
TUDOR COTTAGE - WEST/SOUTH ELEVATION 2014

“The Tudor Cottage Restrooms building in Pease Park is one of the earliest buildings constructed in Austin as a park facility. The restrooms were designed in the mid-1920s. While the link is not yet fully substantiated, it is widely thought that Hugo Kuehne, a prominent architect, designed the restrooms. Kuehne designed the Oakwood Annex restrooms, the Zilker Caretaker Cottage, and several early park shelter houses. Kuehne was very active in the early development of Austin’s park system. The iron-spot red brick, one-story restroom building has a rectangular plan and a steeply gabled wooden shingle roof. The gable ends feature non-structural decorative half-timbering and gable dormers with louvered vents puncture the west and east facades of the building. The gabled entry porches on both the east and west facades feature supporting wooden members in a distinctive pattern, which is influenced by the half-timbering decoration of the Tudor Revival Style. A limestone retaining wall that was constructed in the 1970s lies to the east of the building and is currently fenced-off for safety reasons. The building is not currently in use.”

The Tudor Cottage is an architectural gem that should be renovated to support safe, year-round community use. Its location near the hub of park activity makes it ideally situated to house more formalized activities and events. A rentable venue is a desirable amenity that will produce income and become a destination within the park.

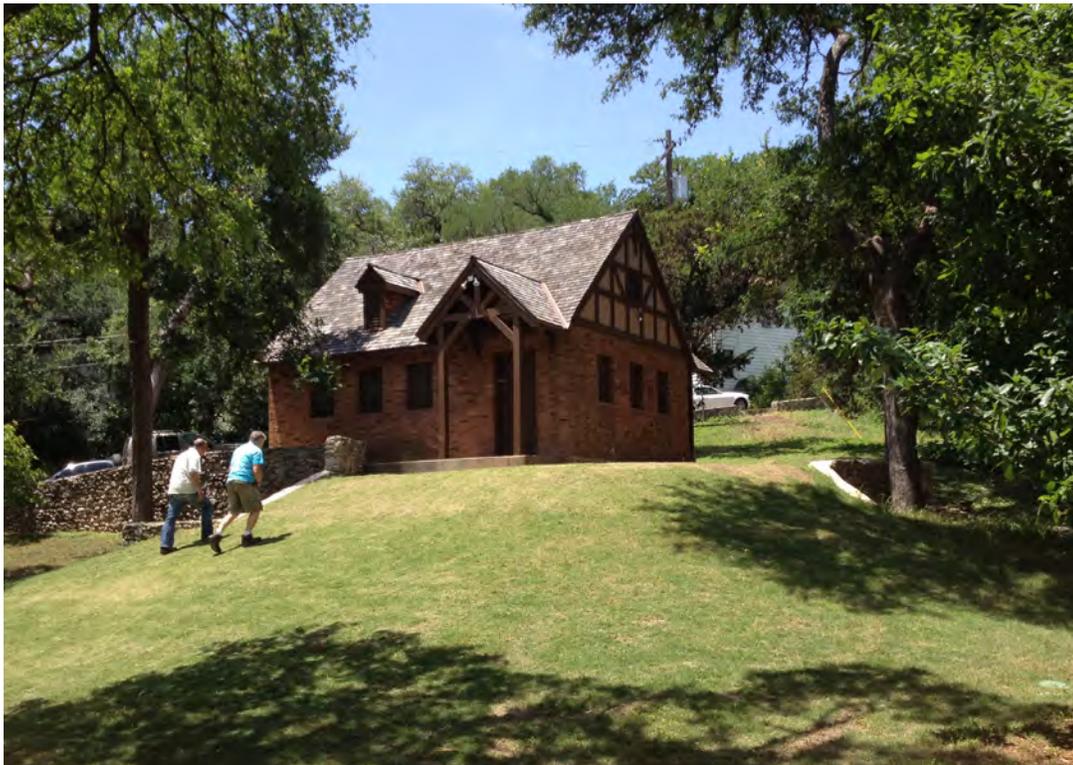
TUDOR COTTAGE - EAST & NORTH ELEVATION 2014

To create a functional community room, the louvered screened openings should be replaced by windows. New openings should be considered on the north wall for increased natural light and ventilation as well as creating a visual connection to the park. The interior should be opened up to create a single large room; perfect for small conferences, community meetings, lectures and gatherings.

- Minor exterior repair including spot repointing at brick
- Upgrade electrical system
- Upgrade plumbing system
- Install HVAC system
- Re-use existing concrete slab, for finished floor
- New ceramic tile walls
- Restore pressed tin ceiling
- Replace existing screened louvers with operable windows
- Replace door hardware
- Make thresholds accessible
- New lighting at interior and exterior
- Include interpretive display on the history of Pease Park

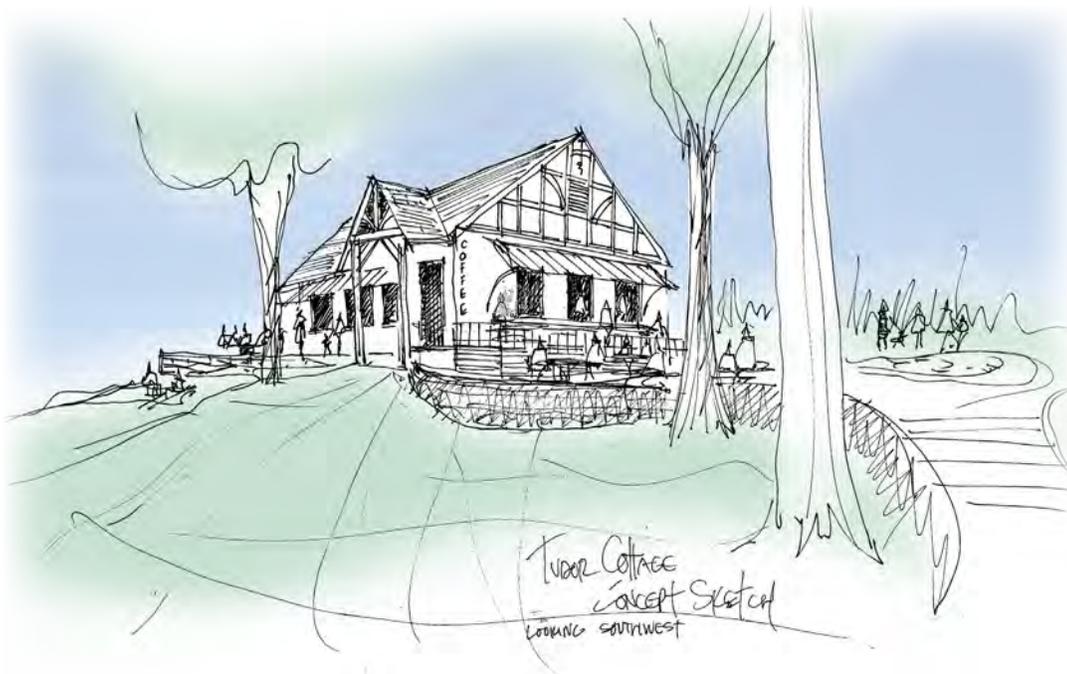
TUDOR COTTAGE CONCEPT SKETCH

**PLAN DIAGRAMS**
ROOM SIZE 20' X 28'

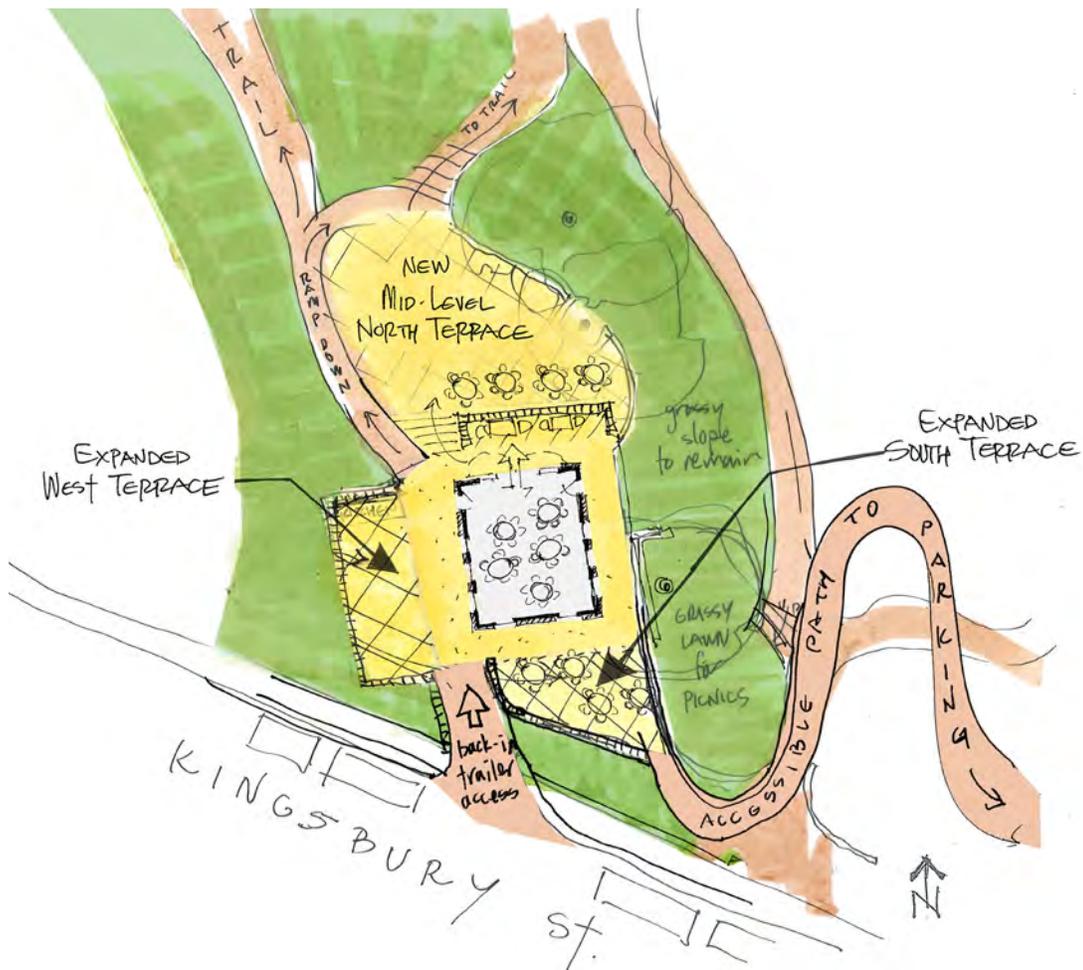
- Add a new accessible path from designated parking area.
- Create extended southern patio to link the Tudor Cottage to the accessible path.
- Expand the western patio to create an exterior support zone that could accommodate an outdoor catering kitchen.
- Build mid-level north terrace with stone retaining walls and steps to connect the park path below to Tudor Cottage level above.

TUDOR COTTAGE TERRACES CONCEPT SKETCH

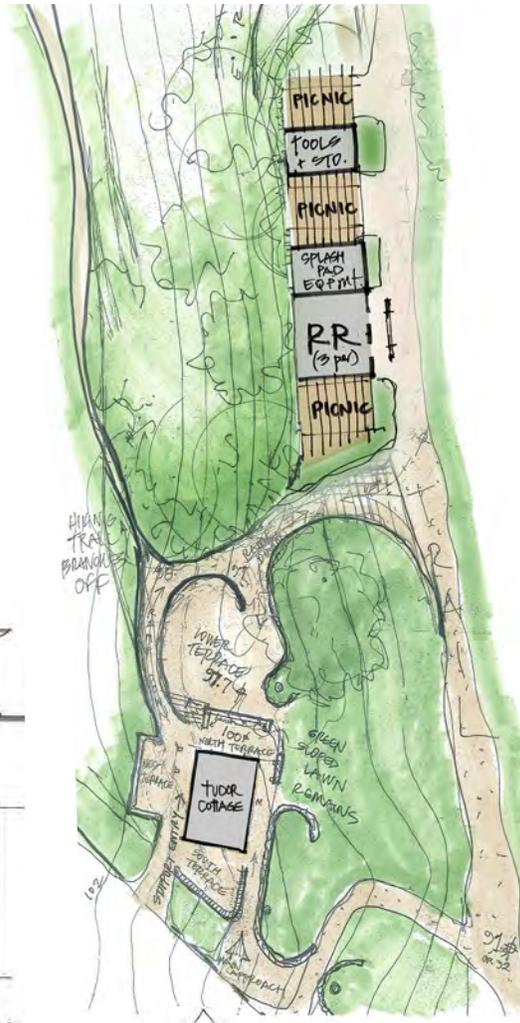
KINGSBURY PAVILION PLAN SKETCH

Once renovated, the Tudor Cottage will be a viable, rentable event facility – something that will become even more popular and usable if restrooms are in close proximity. Kingsbury Pavilion is proposed immediately to the north of Tudor Cottage. The Pavilion will house restrooms, tool storage and shaded picnic areas, with expansion potential. The Kingsbury Pavilion will be a linked chain of support elements woven between the trees on the existing hillside and facing the park trail.

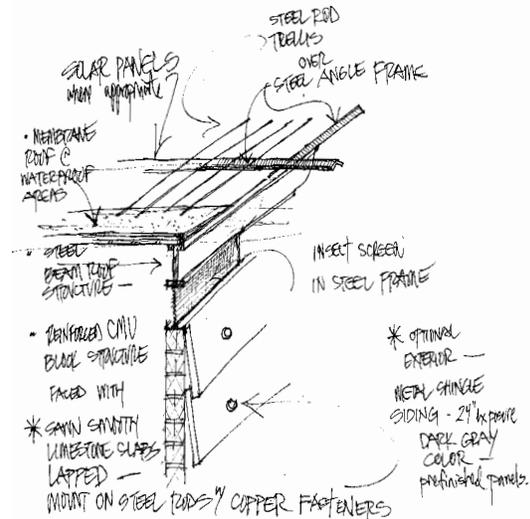
SHINGLE DETAILING SKETCH

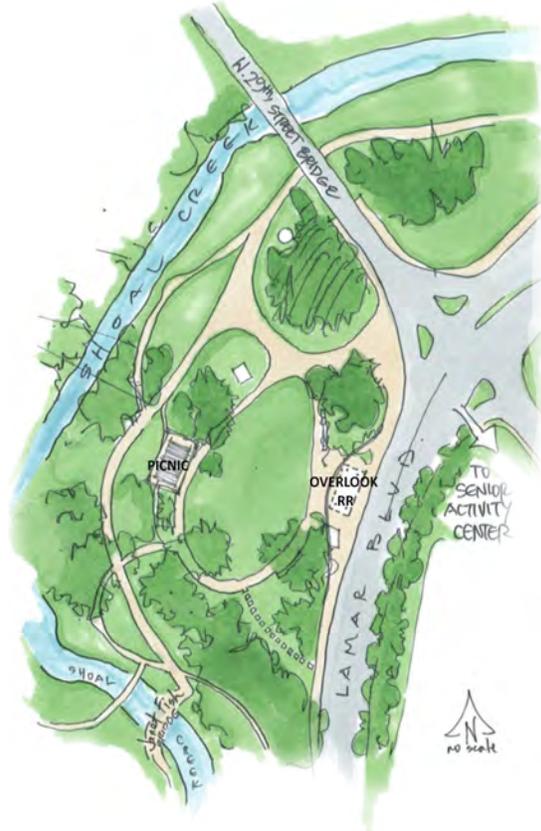
Public input calls for a restroom facility to be provided at the West 29th Street park entry across the street from the Senior Activity Center. The sunken level of the Park as it abuts the southwest corner of the intersection at West 29th and North Lamar Blvd. provides a natural spot for a roof deck overlook with a restroom building beneath.

W. 29TH STREET SITE PLAN SKETCH

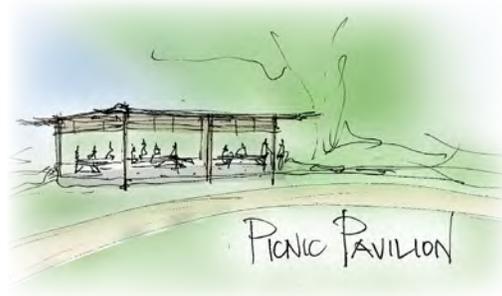
W. 29TH STREET PICNIC PAVILION CONCEPT SKETCH

The Picnic Pavilion is skeletal in design and made of steel for minimal maintenance. The low-profile structure will have minimal visual impact on the surrounding natural beauty. Deep eaves provide shade and protection and the floor is concrete slab.

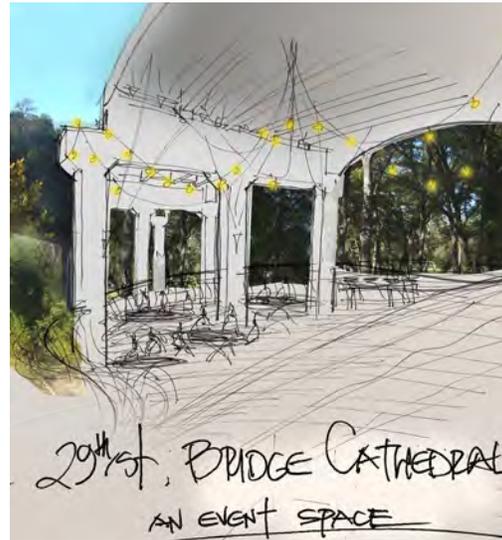
W. 29TH STREET BRIDGE CONCEPT SKETCH

The 29th Street bridge, originally built in 1939, can become another event space. Beneath the bridge are soaring, cathedralesque concrete vaults. This is dramatic, celebratory space begs to be cleaned, properly lit and activated.

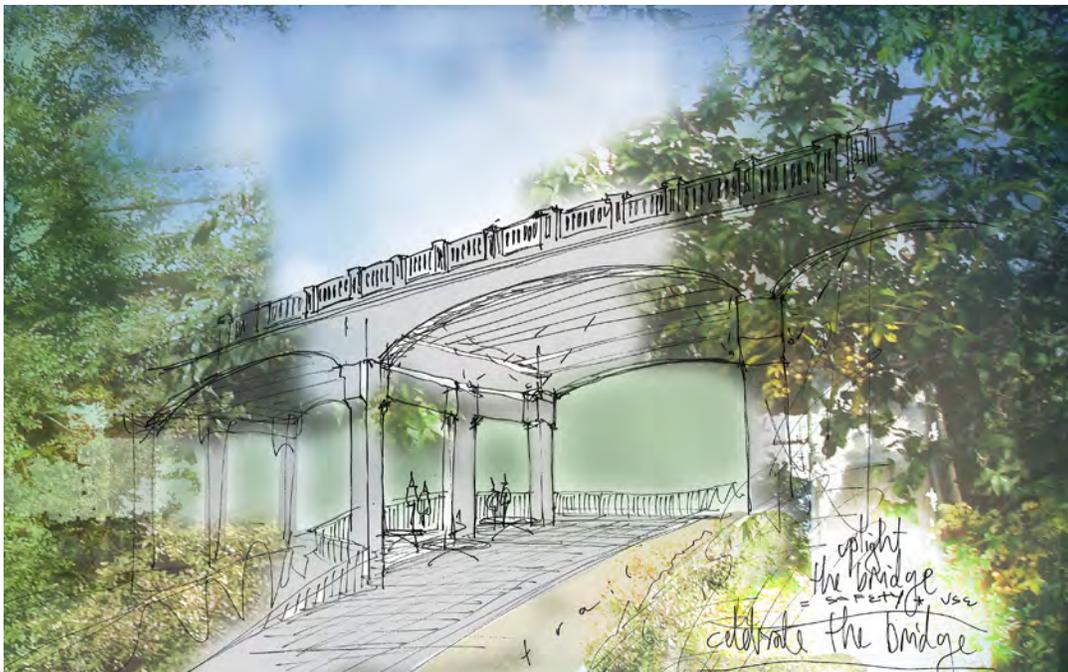
W. 29TH STREET BRIDGE CONCEPT SKETCH

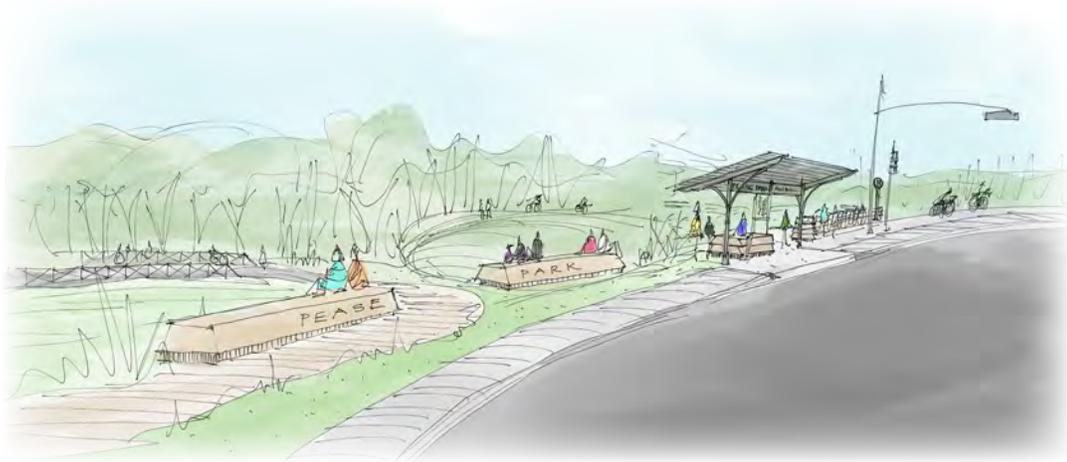
MLK GATEWAY CONCEPT SKETCH : LOOKING NORTHWEST

The new entry at MLK which will feature a sheltered bus stop with a sawn limestone base. At the gateway, two simple chiseled stone benches flank the sides of the new enlarged path into the park. These create simple signage, functional benches and an understated entrance into the park.
