This profile summarizes the characteristics of the watersheds in District 1; provides an overview of flooding, erosion, and water quality problems; and discusses past, current, and upcoming solutions.

Watershed Protection District 1 Profile

January 1, 2015

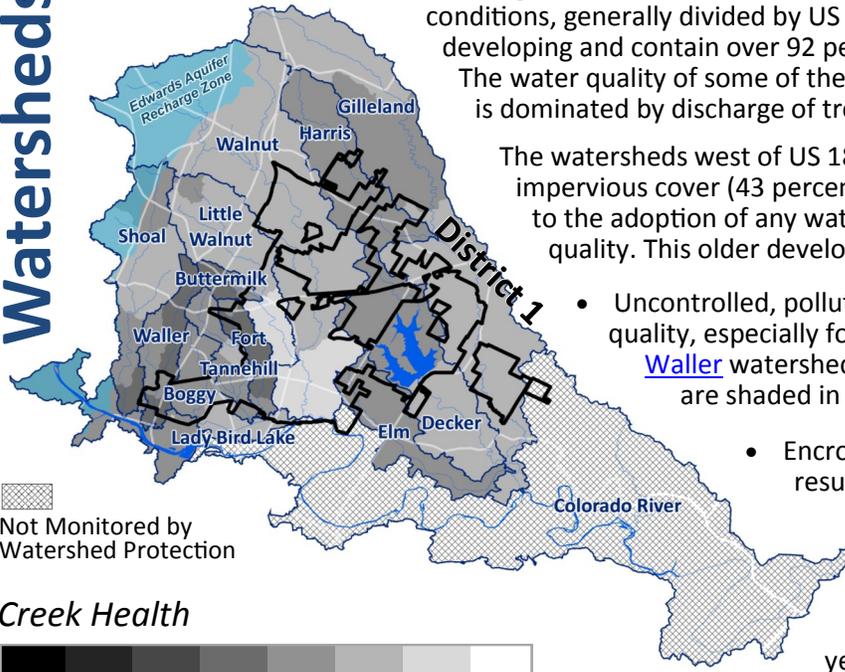
- Uncontrolled, polluted stormwater runoff and significant degradation of water quality, especially for the portions of [Buttermilk](#), [Little Walnut](#), [Tannehill](#), and [Waller](#) watersheds within this district. High priority water quality problems are shaded in green on the map below.

- Encroachment and alteration of natural waterways, which results in eroding stream banks and threatened property. High priority erosion problems are indicated in yellow on the map below. The portion of Boggy Creek south of Manor Road is one of the worst erosion problems in the city.

- Placement of structures within harm's way in the 100-year floodplain, with high priority flooded structures and roadways shown in red on the map below.

- Undersized, deteriorating storm drain systems, which contribute to localized flooding of buildings, streets, and yards. Major clusters of drainage complaints are shown in blue on the map below.

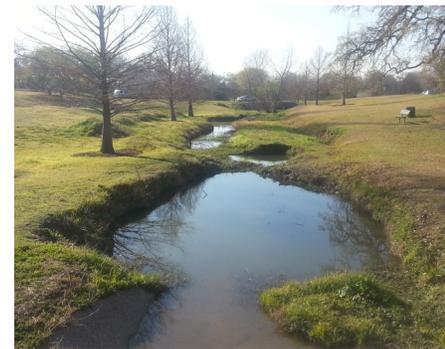
Photo of Tannehill Branch in the J.J. Seabrook Greenbelt (above). A project, in partnership with Public Works and Parks and Recreation, will restore the stream, reduce pollution with rain gardens, and build urban trails. Graphic of project design (below).

- **Capital Improvement Projects:** The watersheds west of US 183 were largely developed before watershed regulations were in place, and thus capital solutions are a key tool. Watershed Protection has already completed numerous projects in this district, including upgrading multiple storm drain systems and constructing a floodwall in the Crystalbrook neighborhood that removed more than 150 homes from the 100-year floodplain of Walnut Creek. Projects to repair eroding streambanks are currently under construction along Boggy Creek and Fort Branch. Projects are planned for the next five years as well, including storm drain upgrades, restoration of degraded streams, water quality pond retrofits, and the enhancement of the J.J. Seabrook Greenbelt (shown below).
