# Country Club Creek Watershed

## Summary Sheet

Catchment	Total area	5 square miles			
	Area in recharge	none			
	Creek length	7 miles			
	Receiving water	Colorado River			
Demographics	2000 population	14,620			
	2030 projected population	15,903			
	30 year projected % increase	9 %			
Land Use	Impervious cover (2003 est.)	East 18.96 %		West 30.47 %	
Overall EII Scores	west 2000 east	west 2003 east	west 2006 east	west 2009 east	
	60	55	54	47	51 42 51 47

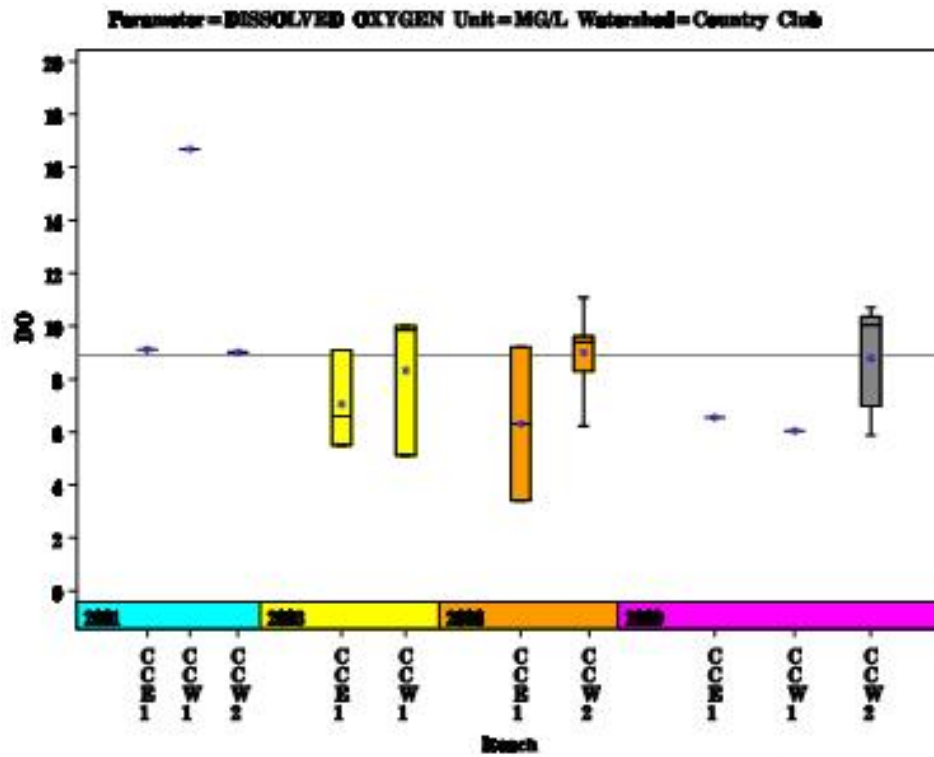
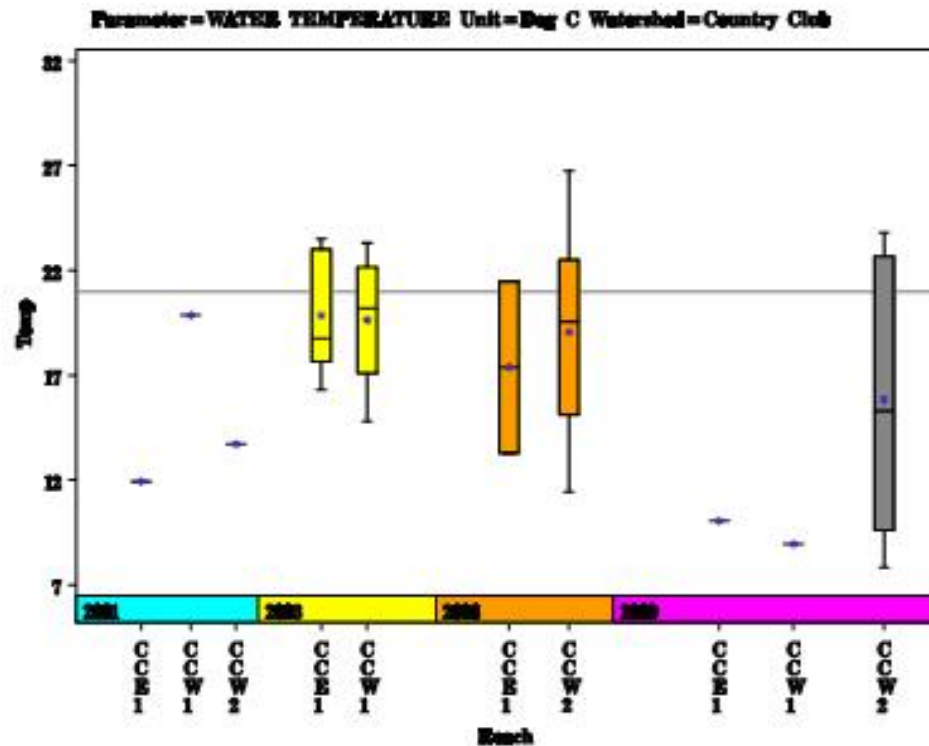
Data Summary Graphs – Dissolved Oxygen and Temperature (Downstream to Upstream by Year)

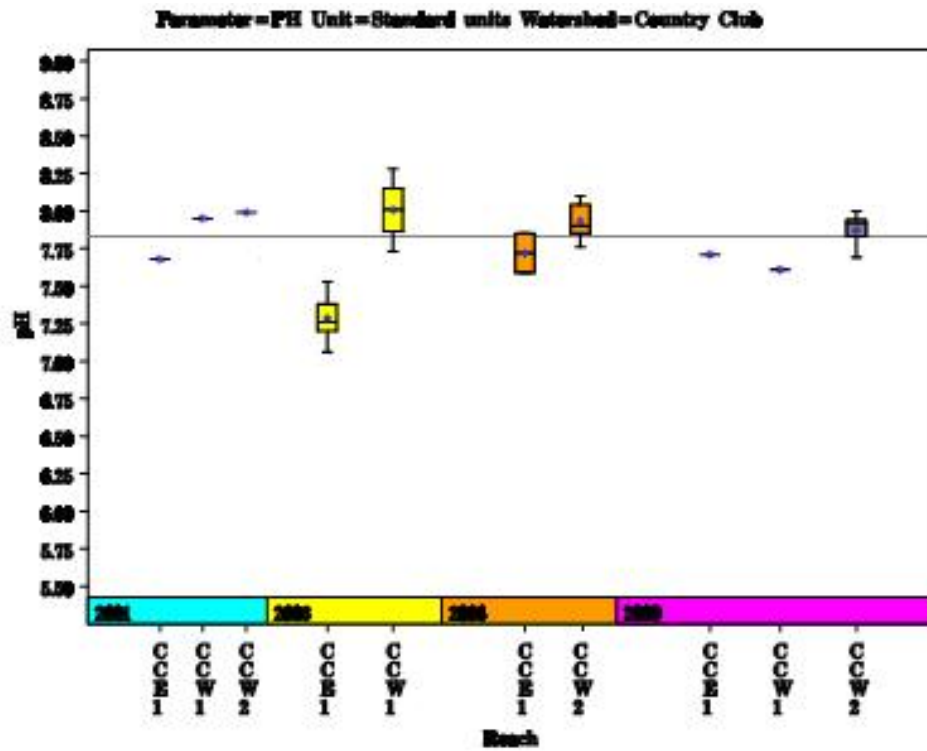
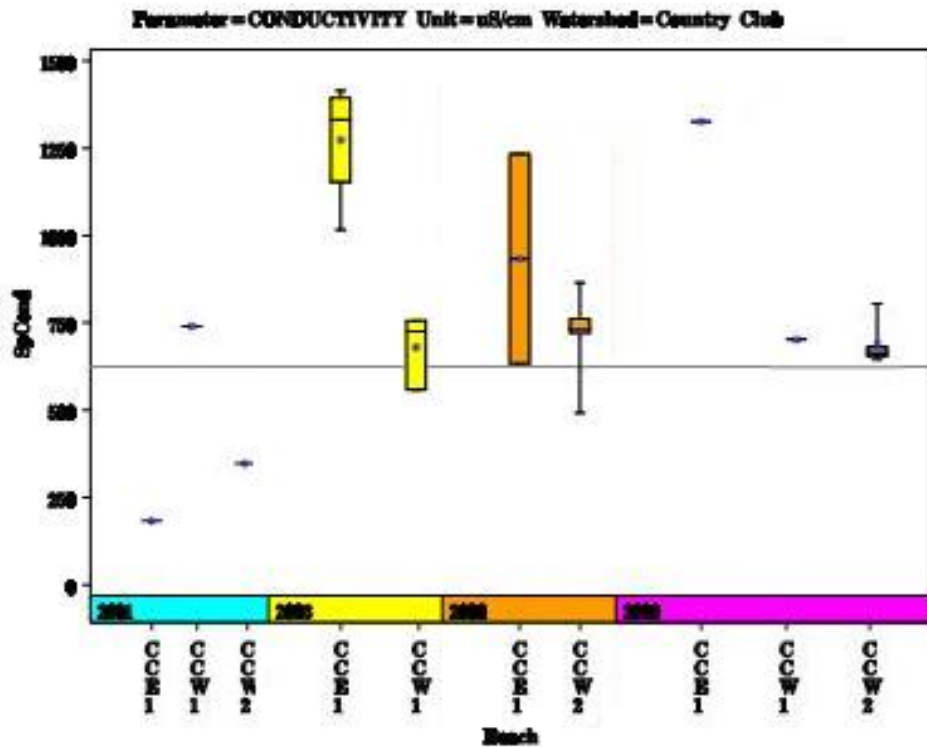
Data Summary Graphs – pH and Conductivity (Downstream to Upstream by Year)

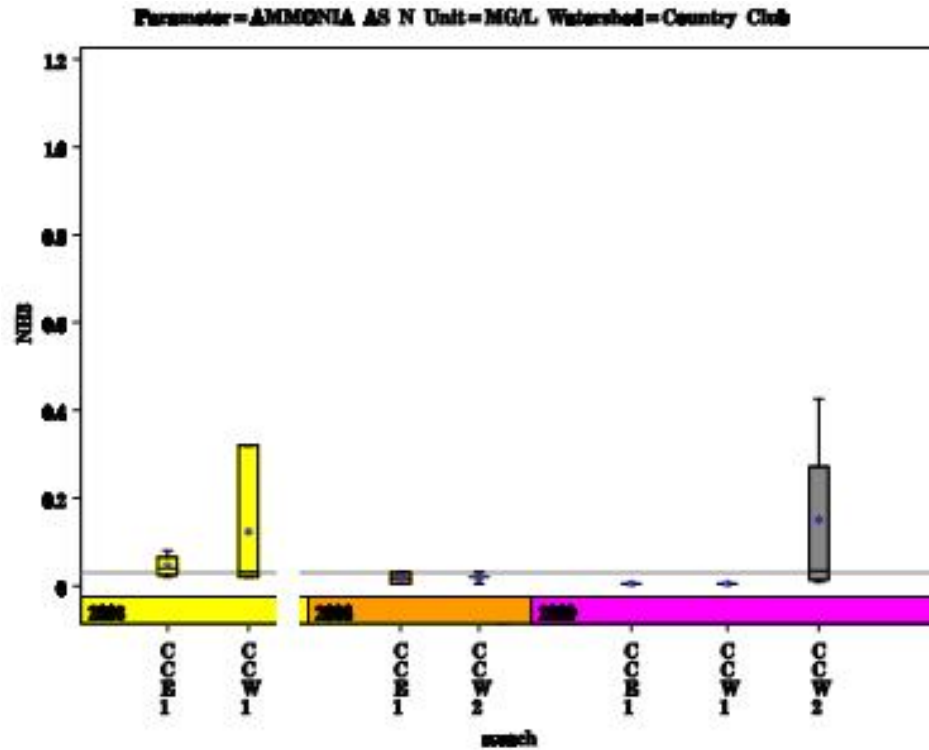
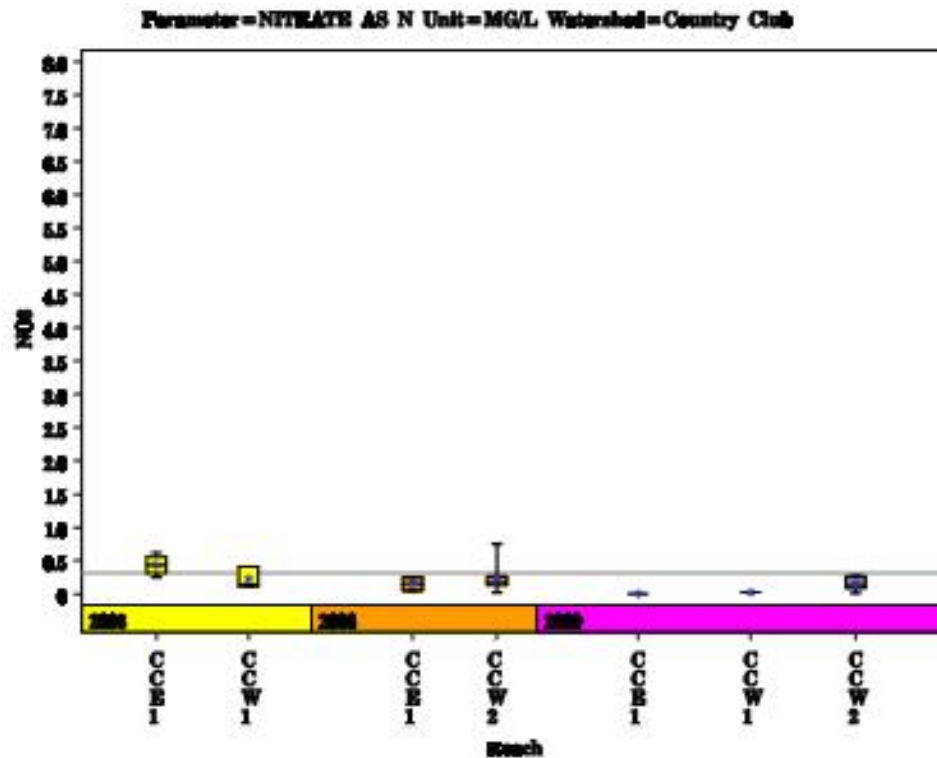
Data Summary Graphs – Ammonia and Nitrate/Nitrite (Downstream to Upstream by Year)

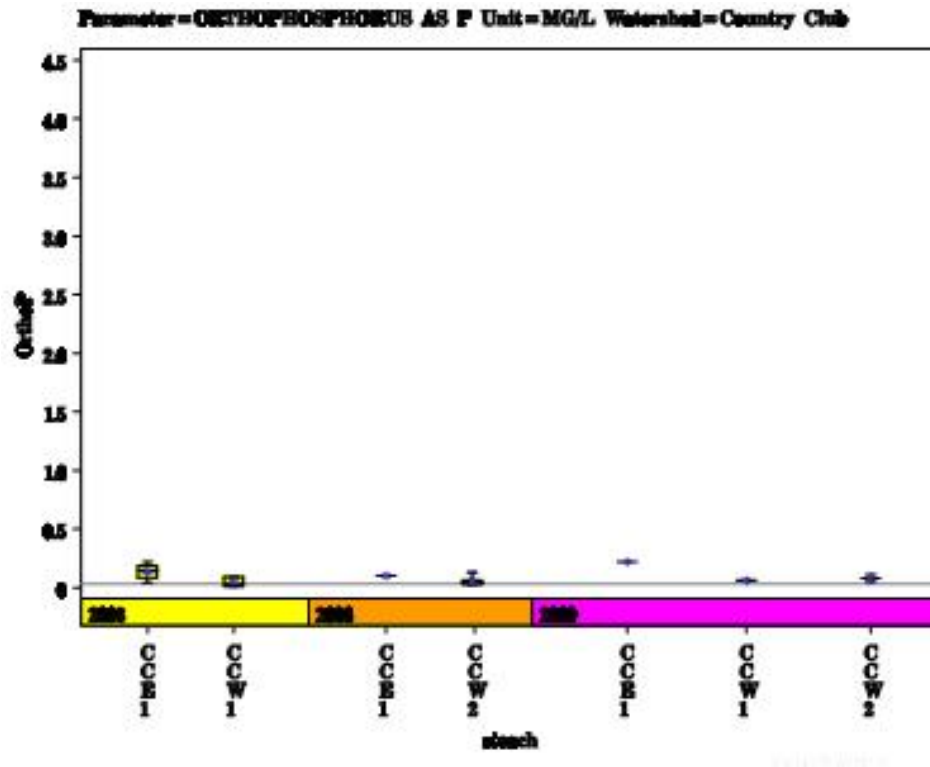
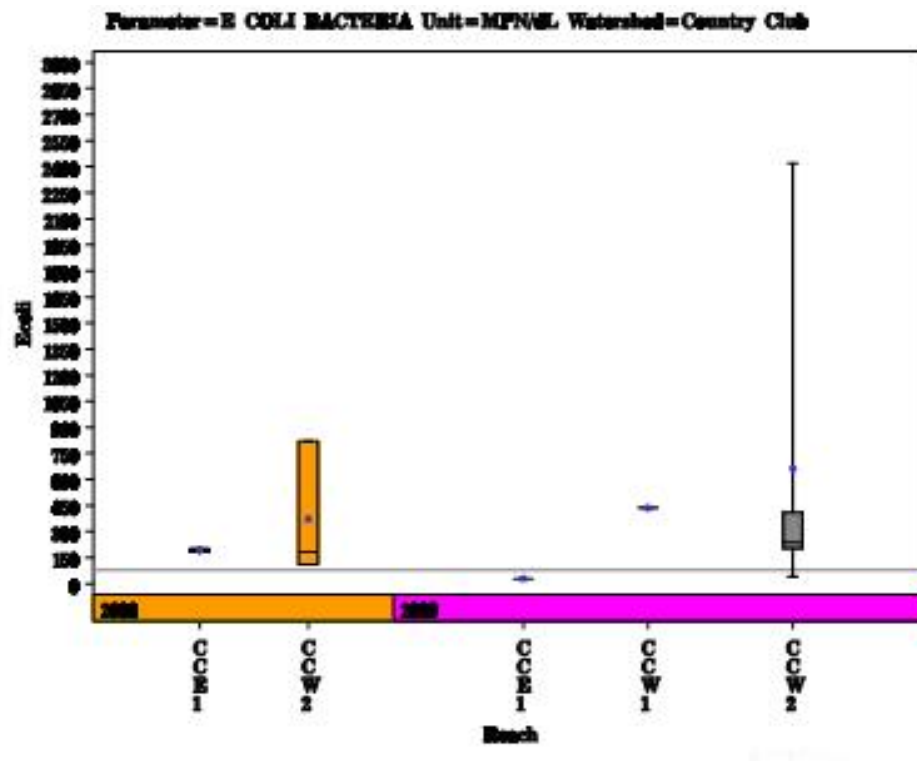
Data Summary Graphs – Orthophosphate and E.coli (Downstream to Upstream by Year)

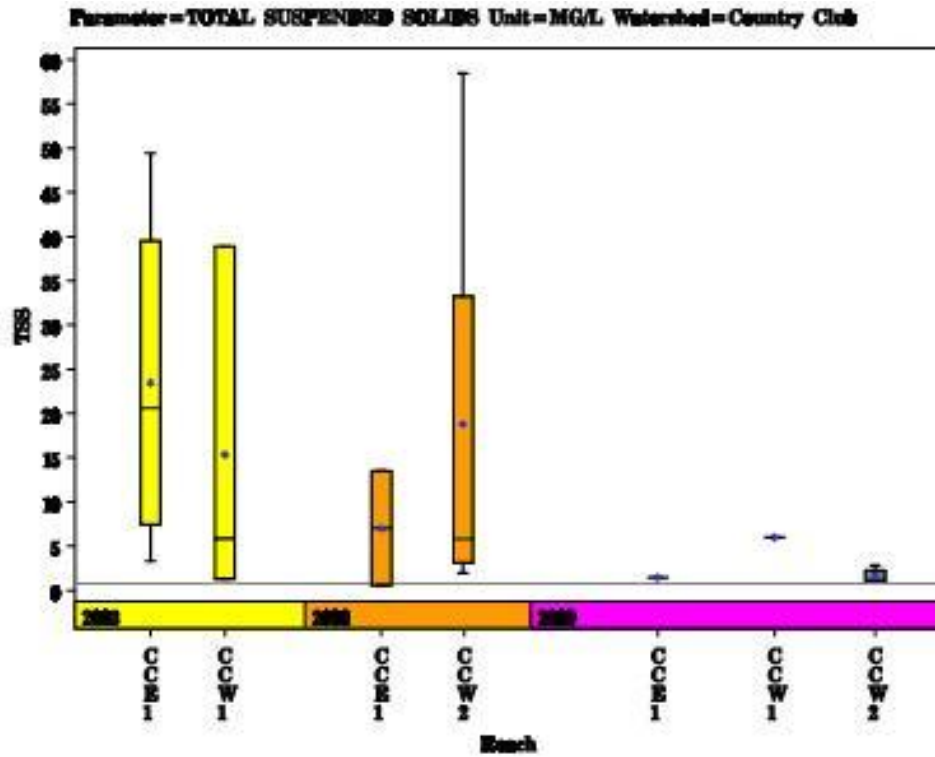
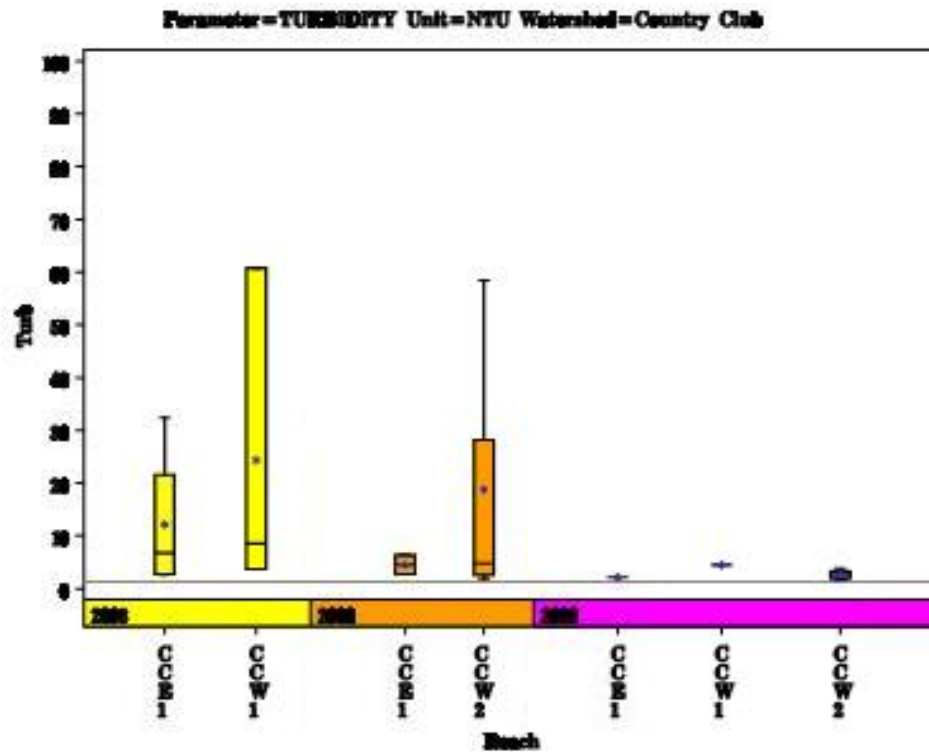
Data Summary Graphs – Total Suspended Solids and Turbidity (Downstream to Upstream by Year)

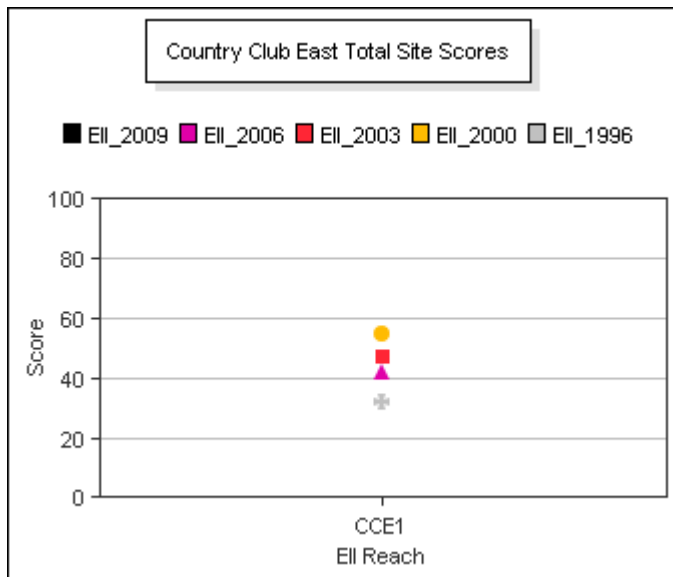
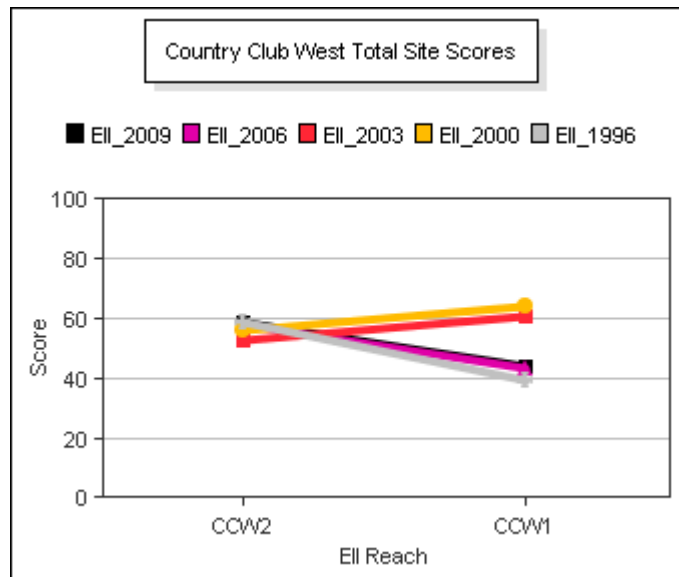
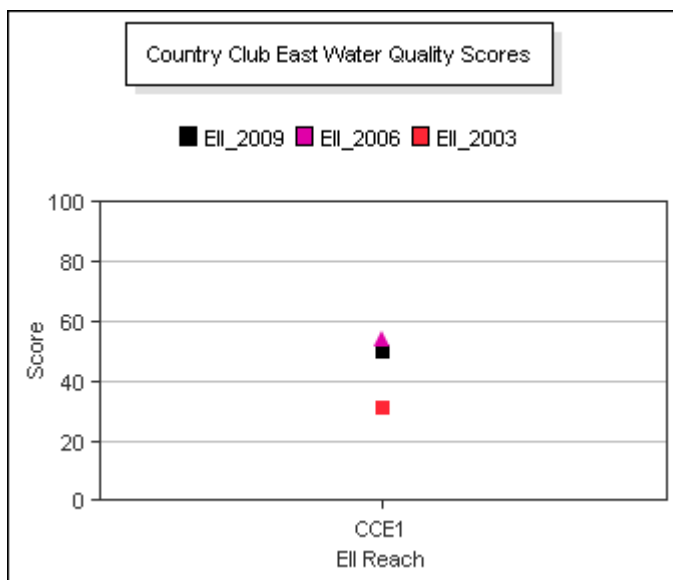
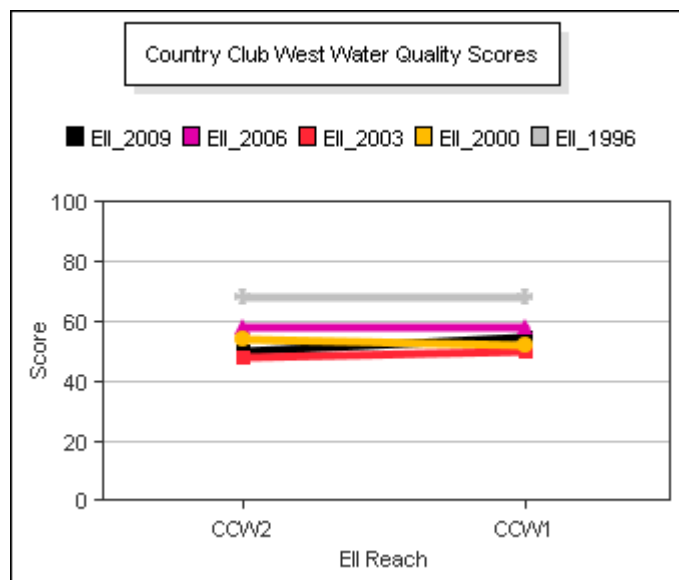
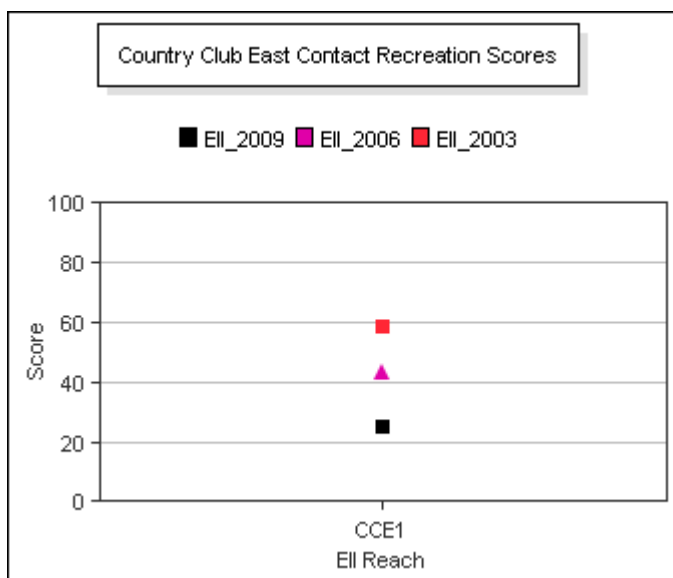
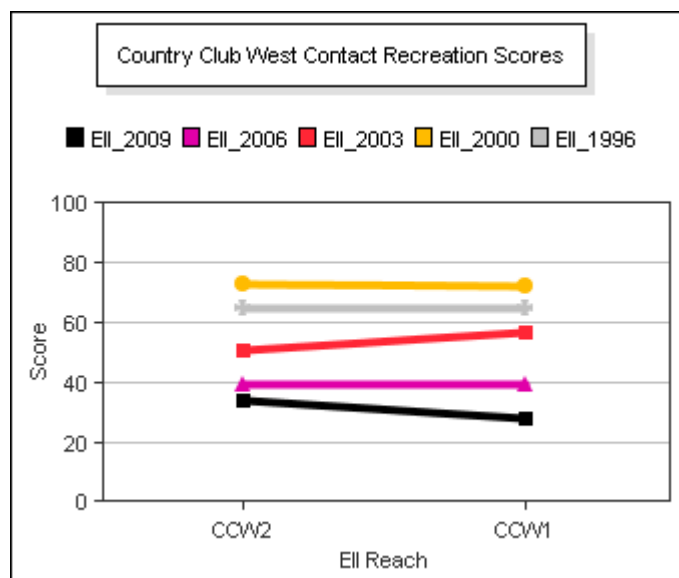
Score Summary – Reach scores for each sample year

Reach	Site	Site Name	Year	Water Quality	Sediment**	Contact Recreation	Non-Contact Recreation	Physical Integrity	Aquatic Life	Benthic subindex	Diatom subindex	Total EII Score
CCE1	848	East Country Club Below Grove Dr	2000		87		53	31	48	53	43	55
CCW1	1474	West Country Club @ Krieg Fields	2000	52	87	72	78	52	43	44	42	64
CCW2	850	West Country Club @ East Oltorf	2000	54	87	73	71	28	22	29	14	56
CCE1	848	East Country Club Below Grove Dr	2003	31	70	59	58	33	29	20	37	47
CCW1	1474	West Country Club @ Krieg Fields	2003	50	70	57	81	57	49	35	63	61
CCW2	850	West Country Club @ East Oltorf	2003	48	70	51	54	55	42	36	48	53
CCE1	1475	East Country Club @ ACC	2006	54	85	43	45	24				42
CCW1	1474	West Country Club @ Krieg Fields	2006		66		53	52				43
CCW2	850	West Country Club @ East Oltorf	2006	58	66	39	78	59	46	41	51	58
CCE1	1475	East Country Club @ ACC	2009	50	79	25	45	60	23	23		47
CCW1	1474	West Country Club @ Krieg Fields	2009	55	69	28	58	53				44

100-87.5 Excellent 87.5-75 V. Good 75-62.5 Good 62.5-50 Fair 50-37.5 Marginal 37.5-25 Poor 25-12.5 Bad 12.5-0 V. Bad
