Lake Austin – Meredith Storm Drain Improvement Project

Neighborhood Meeting
April 21, 2015

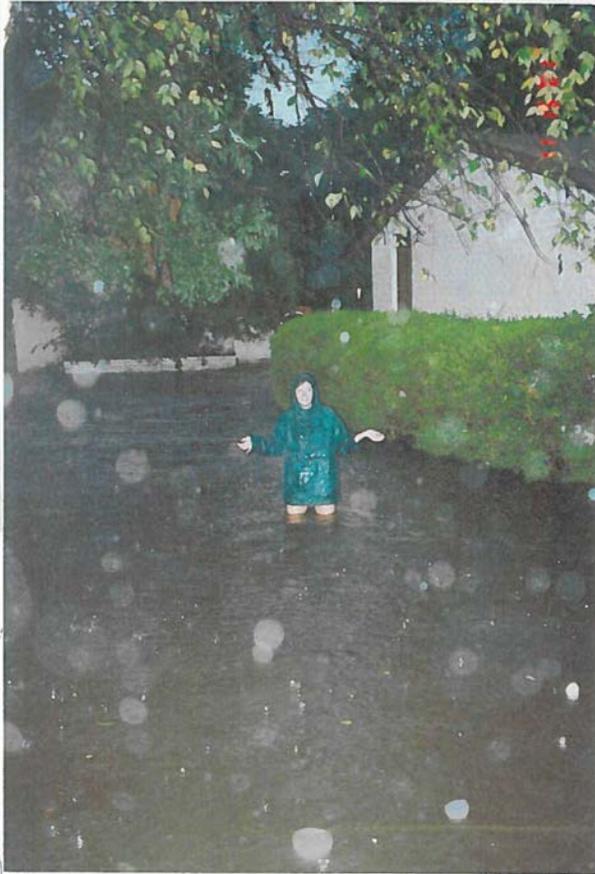
Flooding on Meredith St.,
November 2001

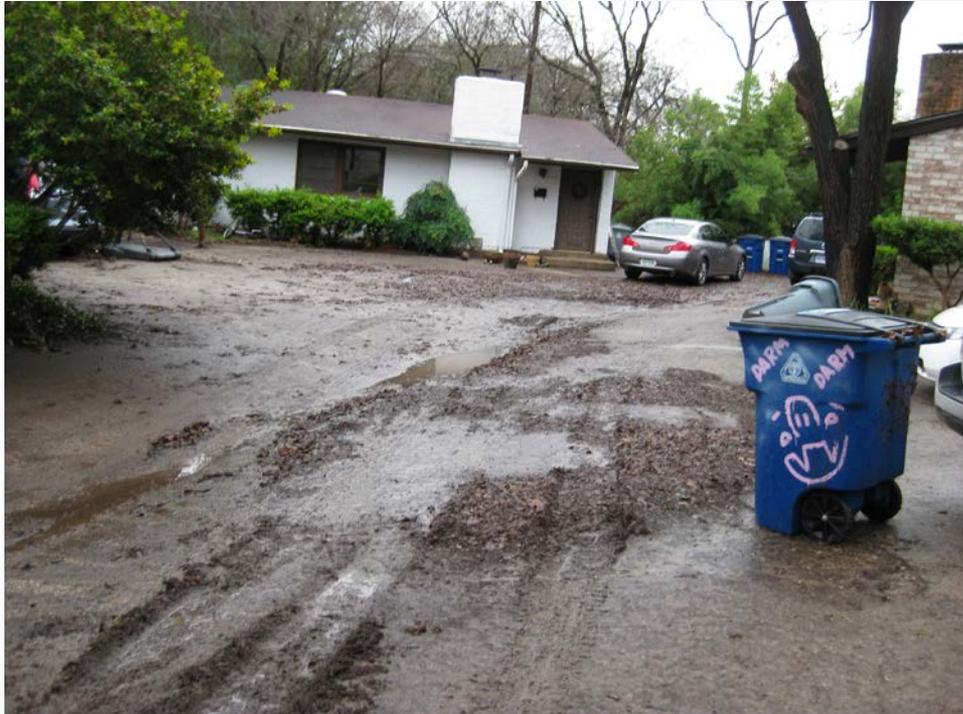
After Flooding on Meredith St.,
January 2012

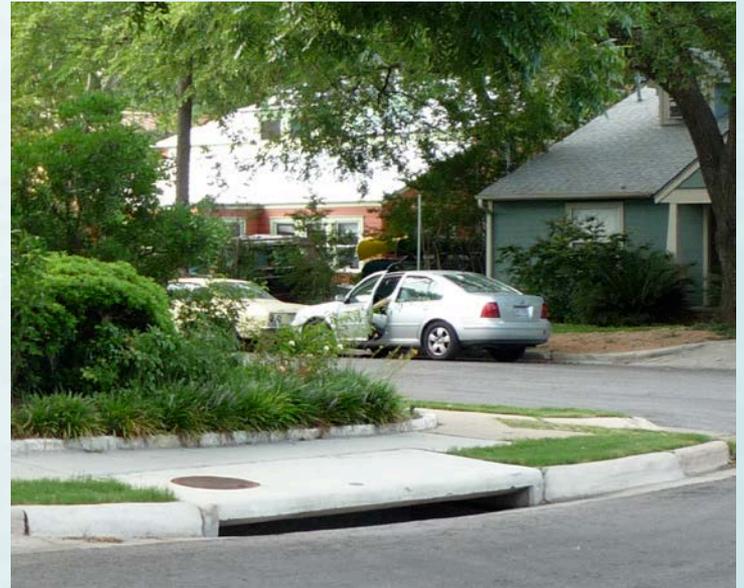
Typical Storm Drain System

- ❖ System of ditches, pipes and culverts
- ❖ Drains rainfall from streets to prevent flooding
- ❖ Inlets are placed along curb to catch rainfall

- ❖ Rain water is carried underground through pipes
- ❖ Water is usually released into a creek or lake.

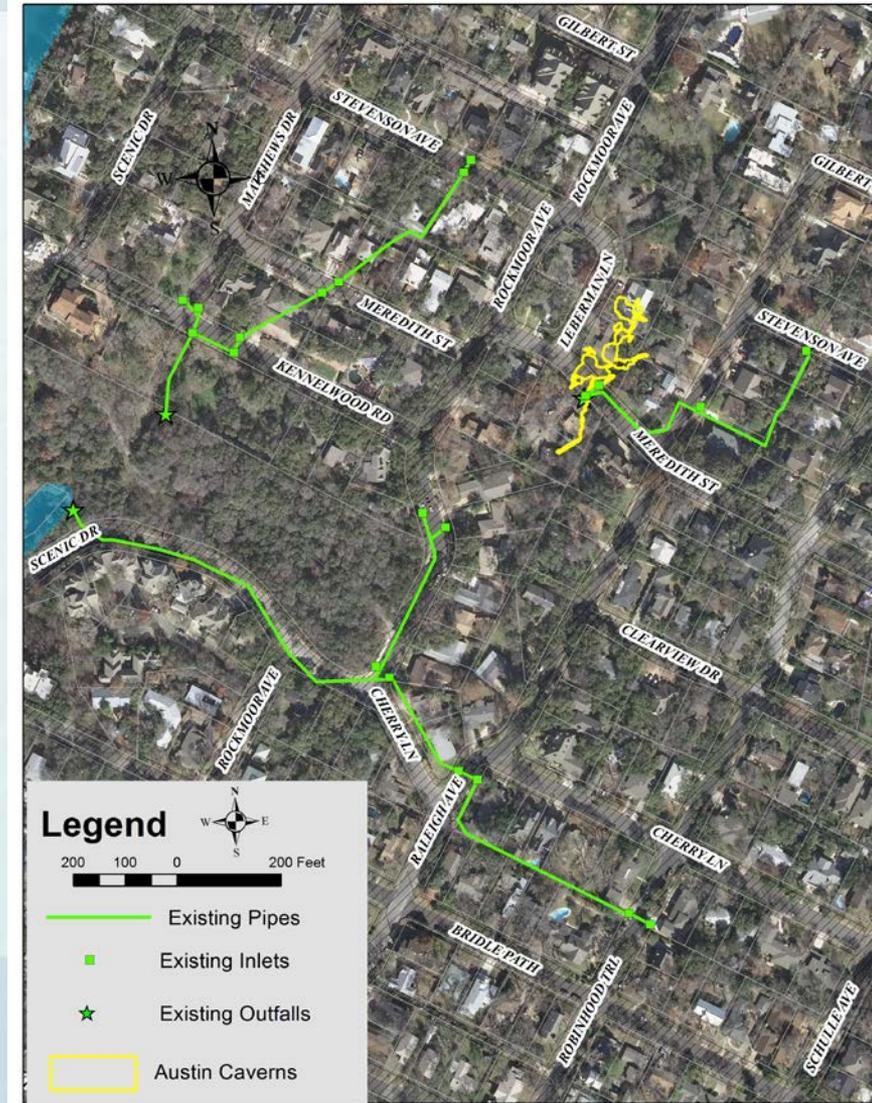
Meredith Storm Drain System

- ❖ Built in 1960s under a different set of standards
- ❖ Is old, undersized and deteriorating
- ❖ Releases rain water into a cave
- ❖ Cave has partially collapsed due to discharge

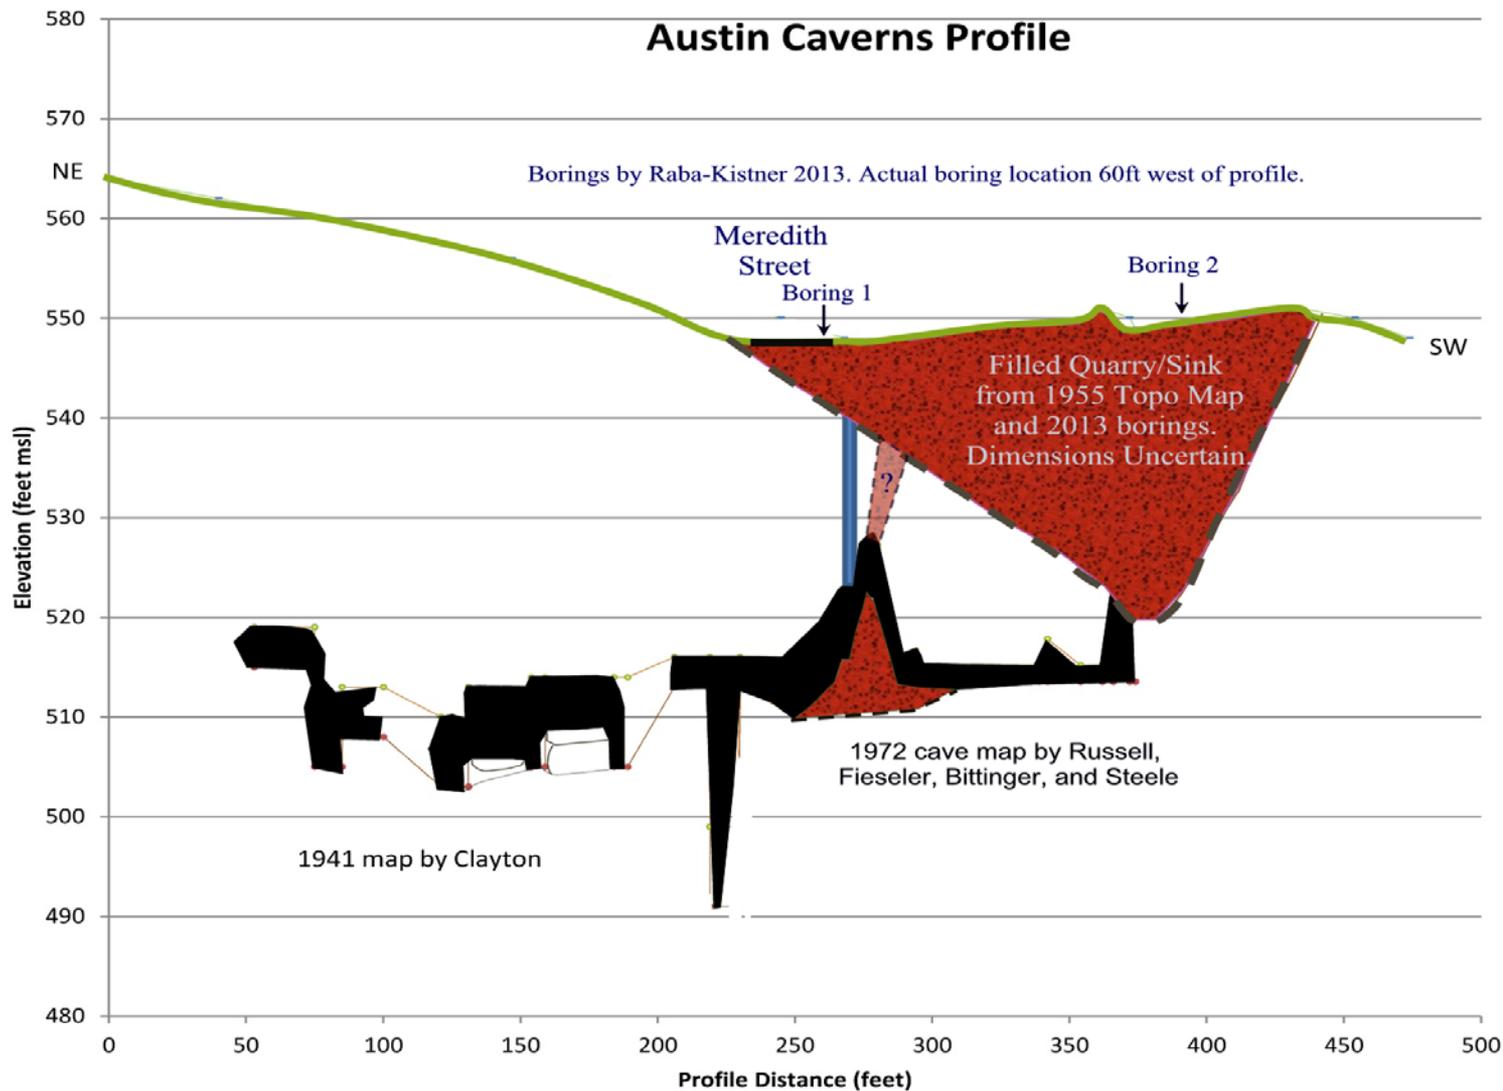
Austin Caverns Profile

Staff compiled cave maps and boring log data to produce this cross-section. Depth of larger cave passages below house to the north is approximately 35 to 40 feet. Narrow south passage is approximately 25 feet below triplexes to the south.

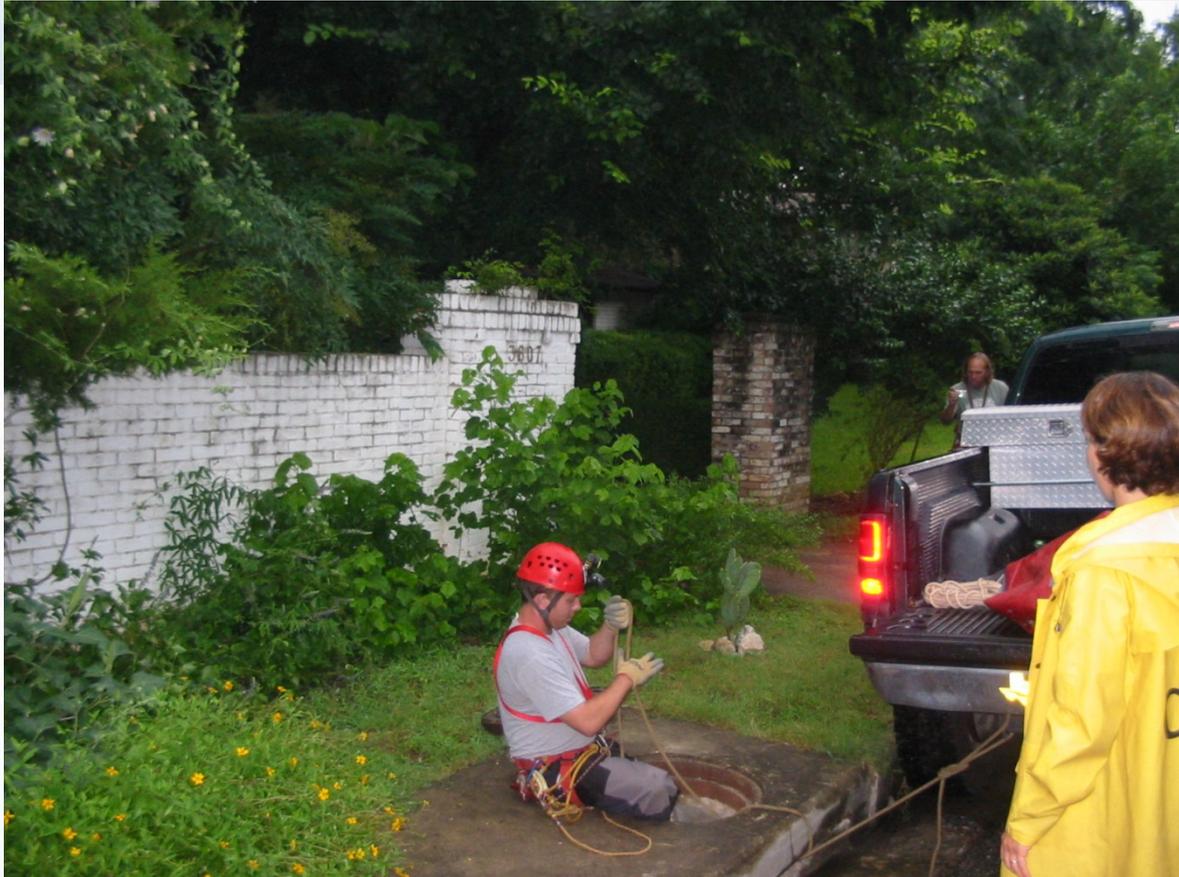
Largest cave chambers to the north (right) are inaccessible.

Current cave entrance is via the curbside inlet at 3605 Meredith Street.

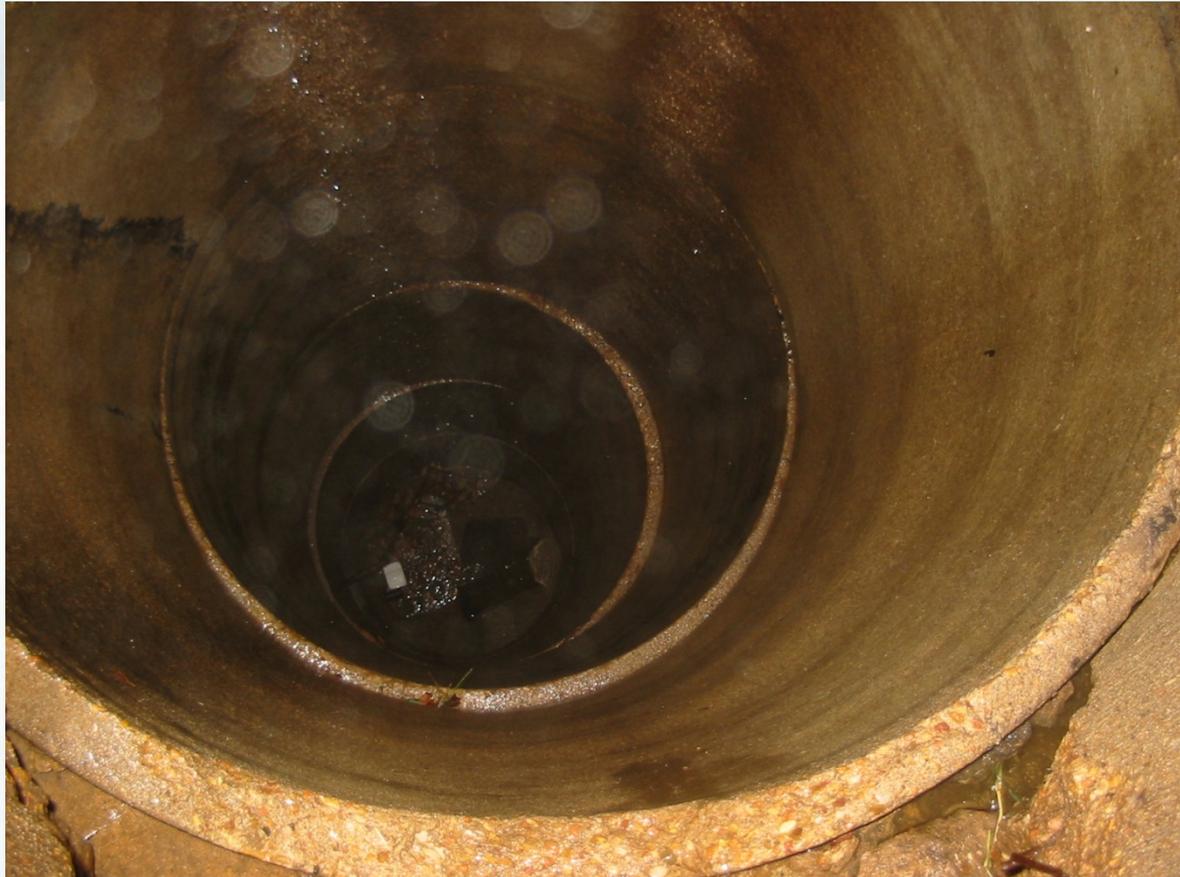
Vertical pipe in the inlet has shifted over 40 years.

- ❖ Concrete segments are offset; reports of street work near pipe
- ❖ Erosion and settlement undermined pipe at cave floor
- ❖ Cobble backfill has blocked view to assess current conditions
- ❖ Carbon dioxide levels and pipe instability require safety plan and engineering design for inspection entry

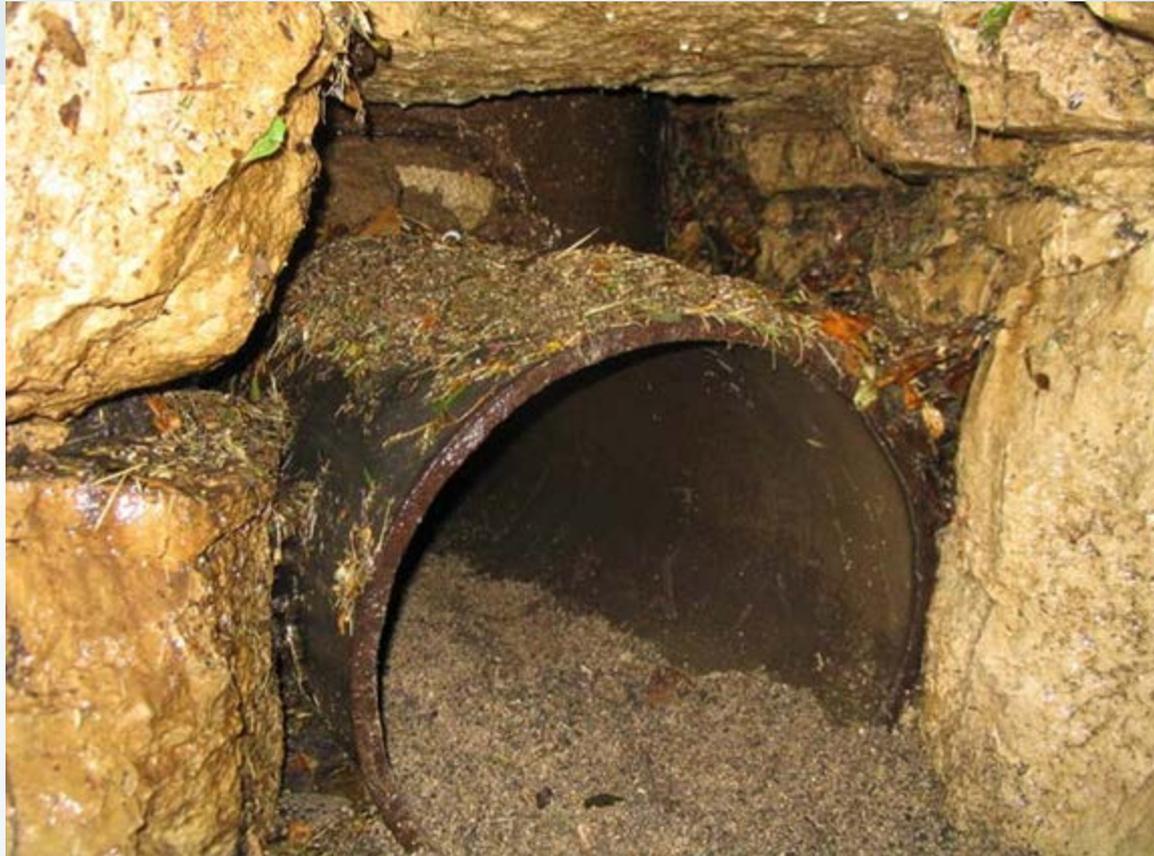
Exit of pipe into Austin Caverns south passage on 6/25/04, before project to clean out debris

Before 1998, the northern passage was accessible through a gap in the rocks.

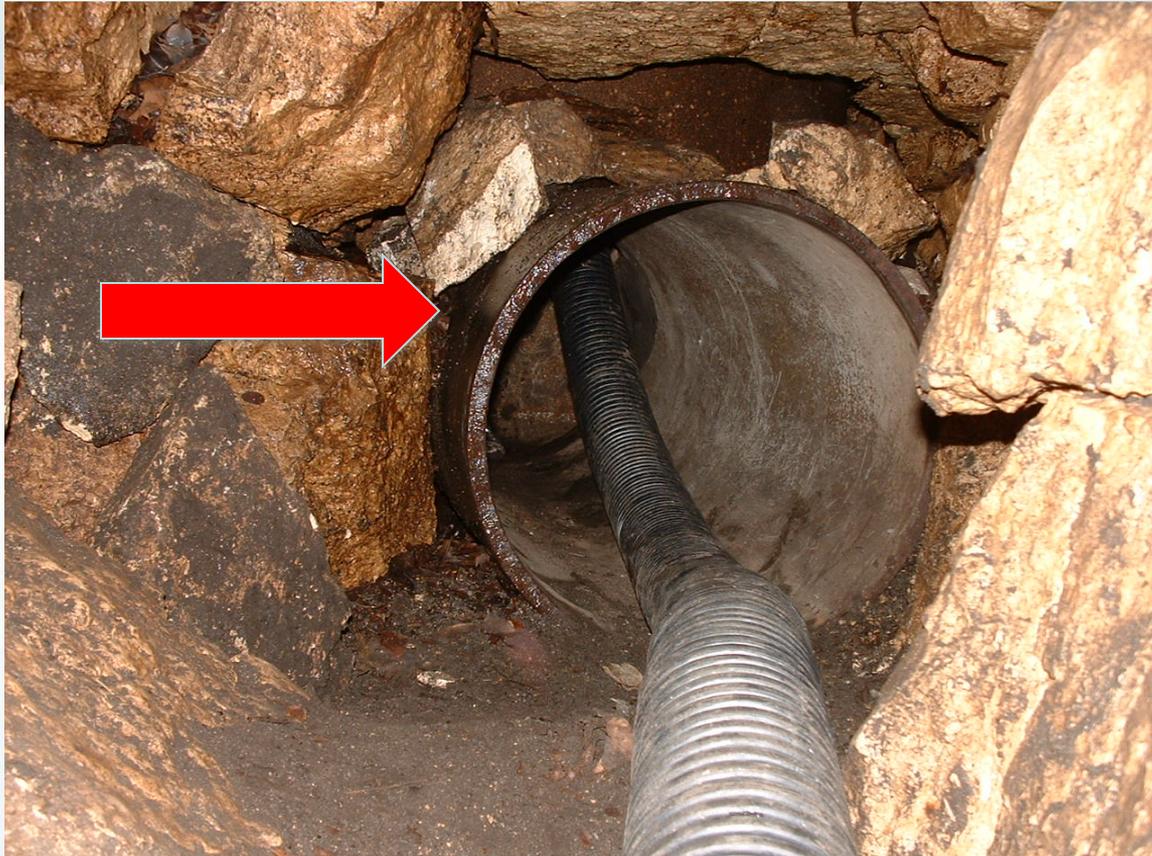
Exit of pipe after debris cleaned out. Corrugated pipe is for ventilation due to carbon dioxide levels.

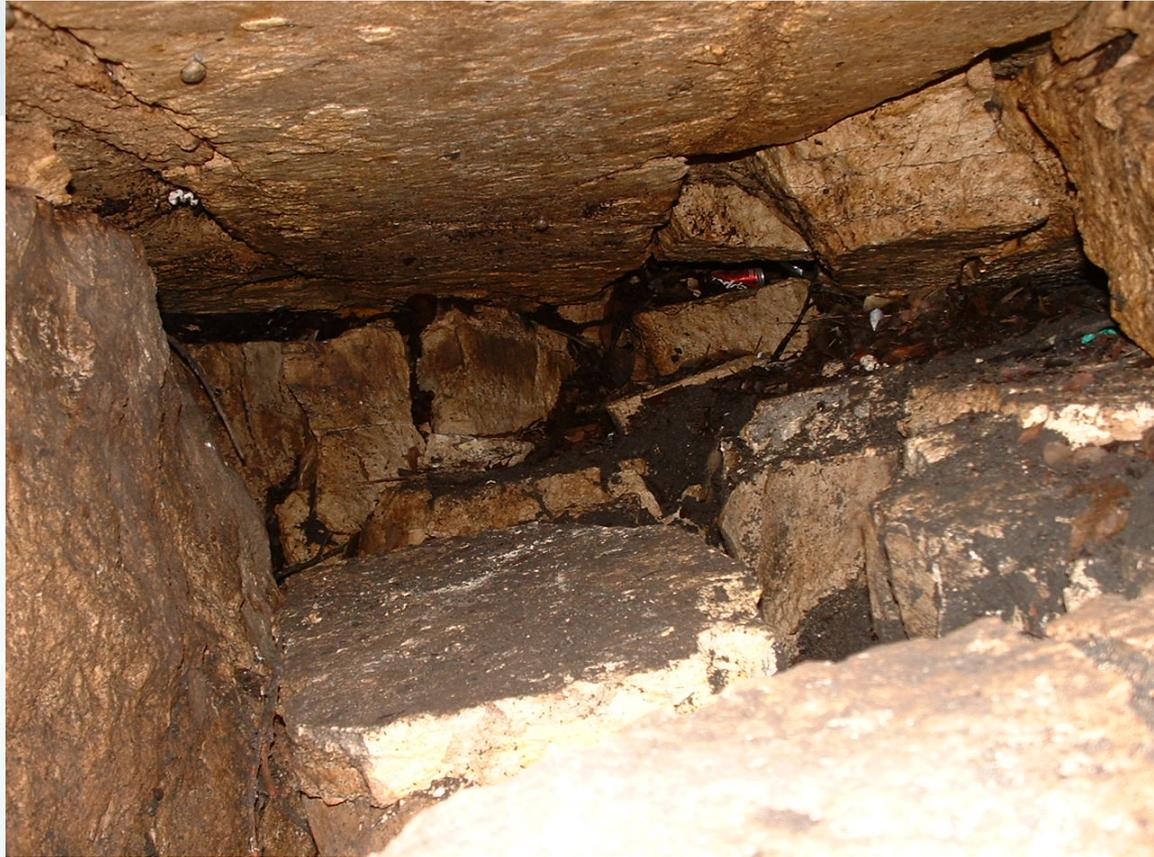
View of south passage after debris cleaned out. Blocks on floor indicate collapse of ceiling within last 30 years. Contractor was unable to excavate to find 1970s second entrance.

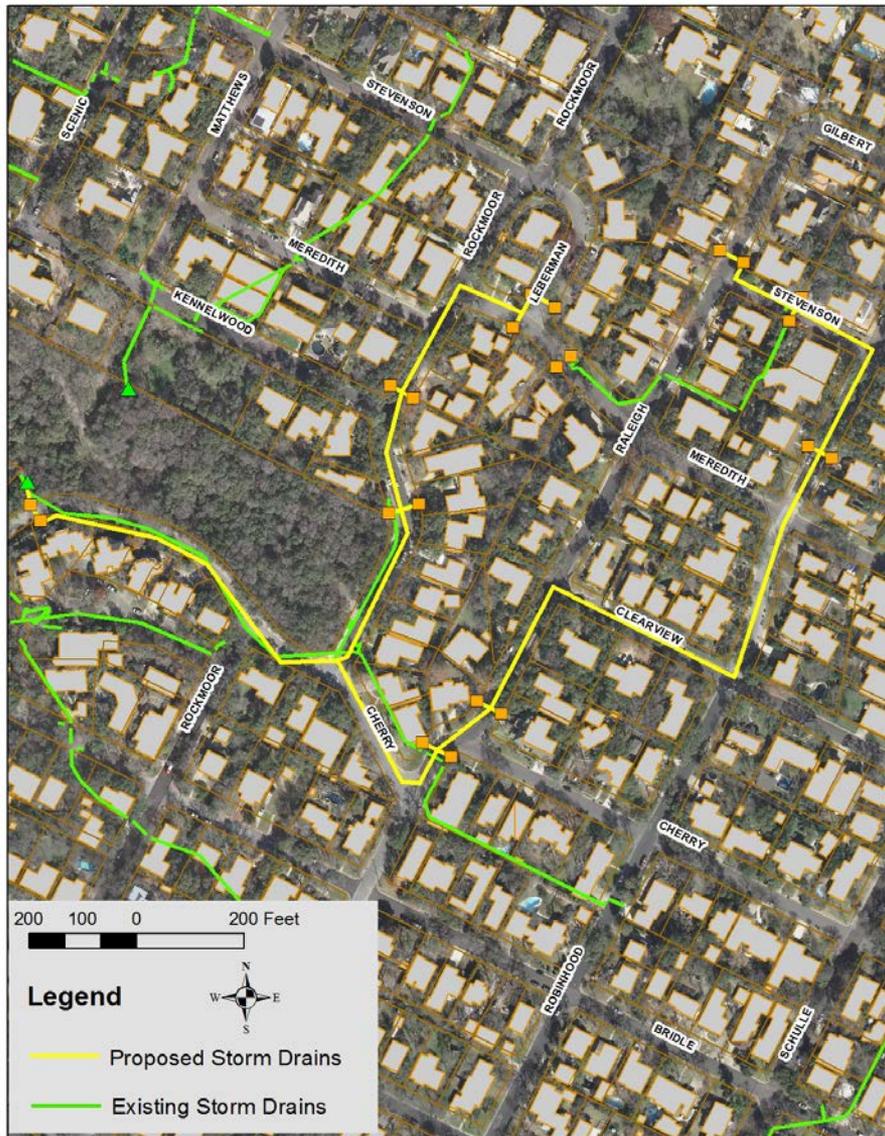
Recommended Alternative

- ❖ Avoids construction through the cave, which could affect the cave and compromise residential structures integrity.
- ❖ Reroutes majority of discharge into the cave to help prevent further cave erosion and restore natural balance.
- ❖ Buyouts will not help cave, stabilize cave or restore its ecosystem, undermined by residential development in 1960s.

- ❖ Compromise to alleviate flooding and ease the situation with the cave deterioration.
- ❖ Risk is always present – doing nothing is a significant risk.
- ❖ Road closures and construction are temporary disruptions.
- ❖ Public safety is the City priority.
