Oakwood Cemetery and Annex Fence Replacement and Gate Rehabilitation

City of Austin Parks and Recreation

June 11, 2018

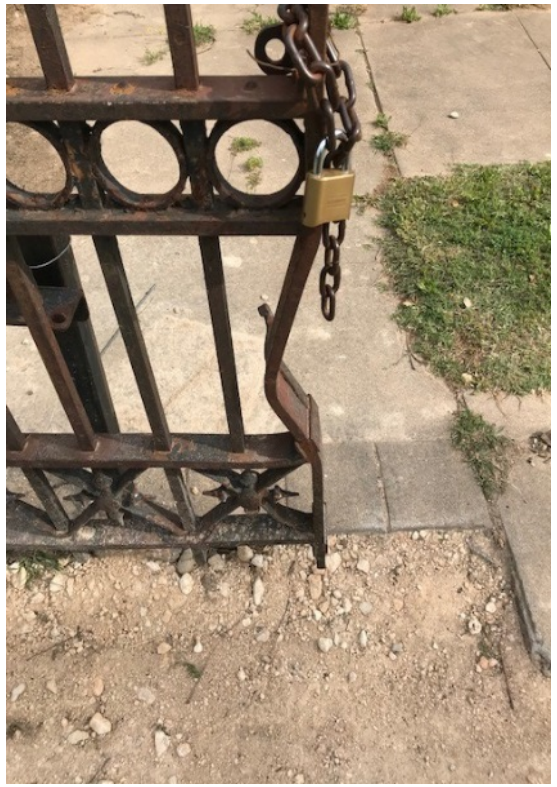
Oakwood Cemetery – West Entrance

Gate Restoration Existing Conditions

Remove pedestrian and vehicle gates and repair by an approved blacksmith

- Repair frames and frame members, straighten deformations
- Remove rust
- Restore damaged welds
- Repaint to match the original condition
- Restore connections at the granite columns and repair the hinge and latch mechanism
